**ALBANY HOUSE  
41 HIGH STREET, BRENTFORD  
LONDON BOROUGH OF HOUNSLOW**

**ARCHAEOLOGICAL EVALUATION**

**PCA REPORT NO: R11343**

**SITE CODE: AHY12**

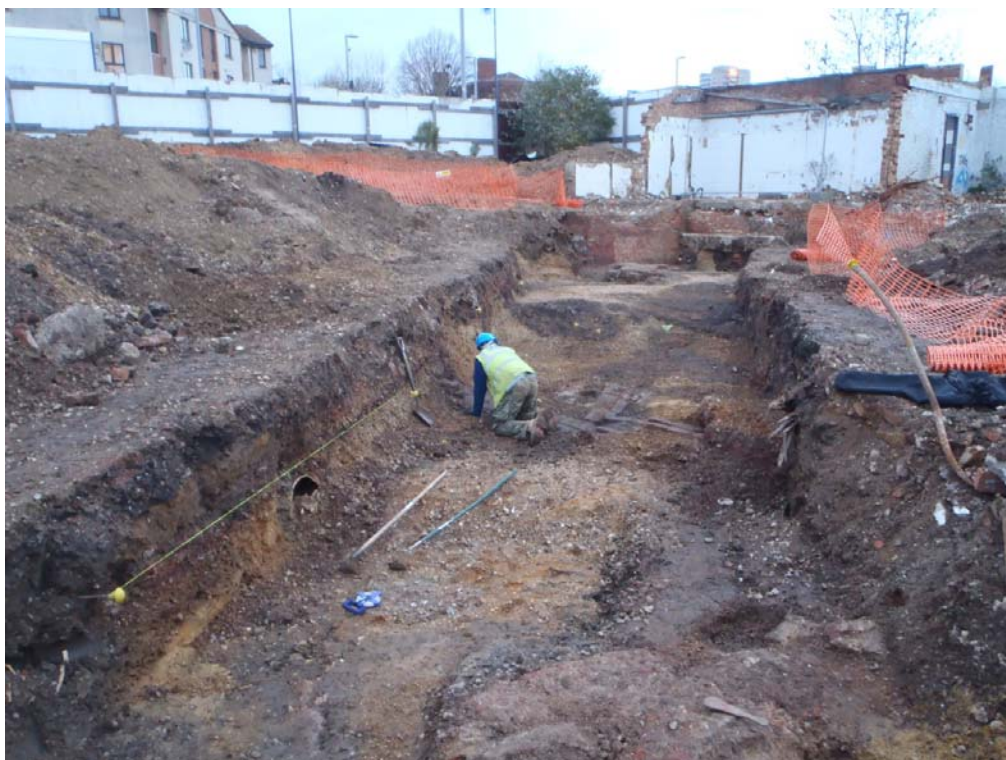
Plate 2: Trench 1 looking north, Section 5 in the foreground

- 8.1.5 A partially truncated pit [76] was noted in the western section edge (Section 5, Figure 5) at 6.5m OD to be 1.0m north to south and 0.30m deep, cutting the natural [13]. The northern side was seen to be gently sloping, the southern side was truncated by a modern pipe trench and the base appeared to have been concave. Filling this was a soft to loose, light brown grey clayey gravel [18], recorded at 6.5m OD to be 1.0m north to south by 0.3m thick.

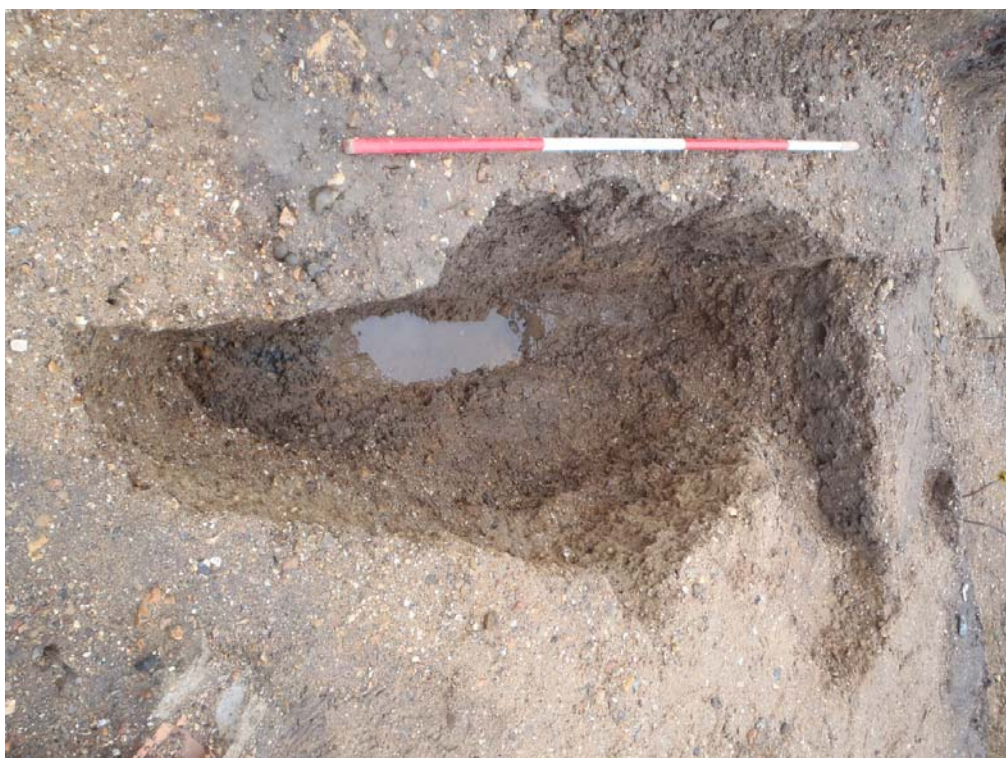
Plate 3: Pits [40] and [36] looking east

- 8.1.2 A large sub-rounded pit [40], with steeply sloping sides and a concave base, was seen at 6.87m OD measuring 2.6m north to south by 1.76m east to west and 1.1m deep, truncating the natural gravel. The primary fill was a soft dark grey brown sandy silt [39], with occasional CBM fragments and pottery, measuring 1.0m north to south by 0.24m east to west and 60mm thick. This was sealed by a loose, mid to dark grey brown, sandy gravelly silt [38] recorded at 6.87m OD measuring 2.6m north to south by 0.88m east to west and 1.0m thick. Very occasional CBM fragments were seen within this deposit. The upper fill was a soft dark grey brown clayey sandy silt [37] with moderate inclusions of small to medium sub-rounded gravels and occasional charcoal flecks, pottery and CBM fragments. This was seen at 6.87m OD measuring 2.44m north to south by 1.2m east to west and 0.6m thick. The finds recovered from the pit [40] were dated late medieval/early post-medieval period.

- 8.1.3 Fill [37] was truncated by a later sub-rounded pit [36]. This was observed at 6.82m OD, measuring 2.4m north to south by 2.3m east to west and 0.3m deep, with steeply to gradually sloping sides and a concave base. The primary fill [41] was a soft light whitish yellow sand measuring 0.74m north to south by 0.6m east to west and 0.16m thick. This

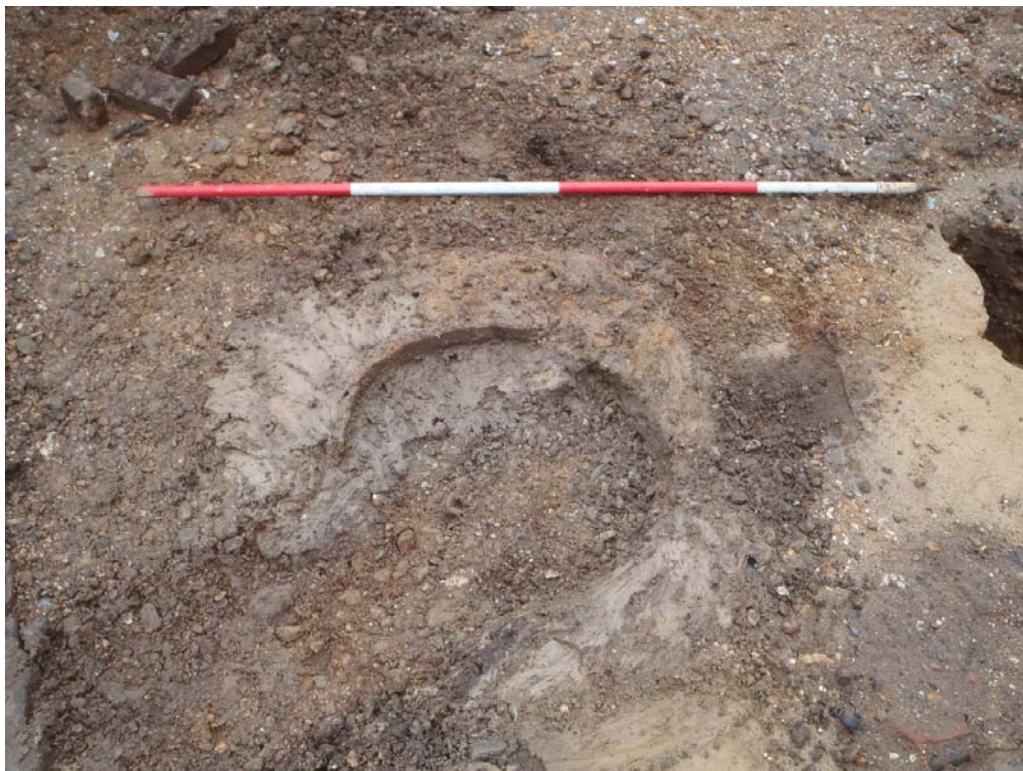
Plate 4: Clay lined pit [45] looking northwest

- 8.1.6 A sub-rounded cut [45] of a clay lined [43] storage pit was recorded at 6.25m OD, measuring 0.9m north to south by 1.08m east to west and 0.26m deep, cutting the natural [13]. The sides appeared to be near vertical and the base almost horizontal. What may be the badly corroded remains of a curved barrel hoop [44] was recorded at 6.25m OD within the cut. A clay backfill [43] with a width of 0.24m and a thickness of 0.26m was noted, between the cut edge [45] and the barrel hoop [44], at 6.25m OD. Pottery and CBM recovered from this deposit was dated 1630-1850. This was probably a waterproof packing for the feature. The pit was backfilled with a loose, mid grey brown, gravelly clayey sand [42] with occasional coal fragments, measuring 0.6m north to south by 0.62m east to west and 0.26m thick.

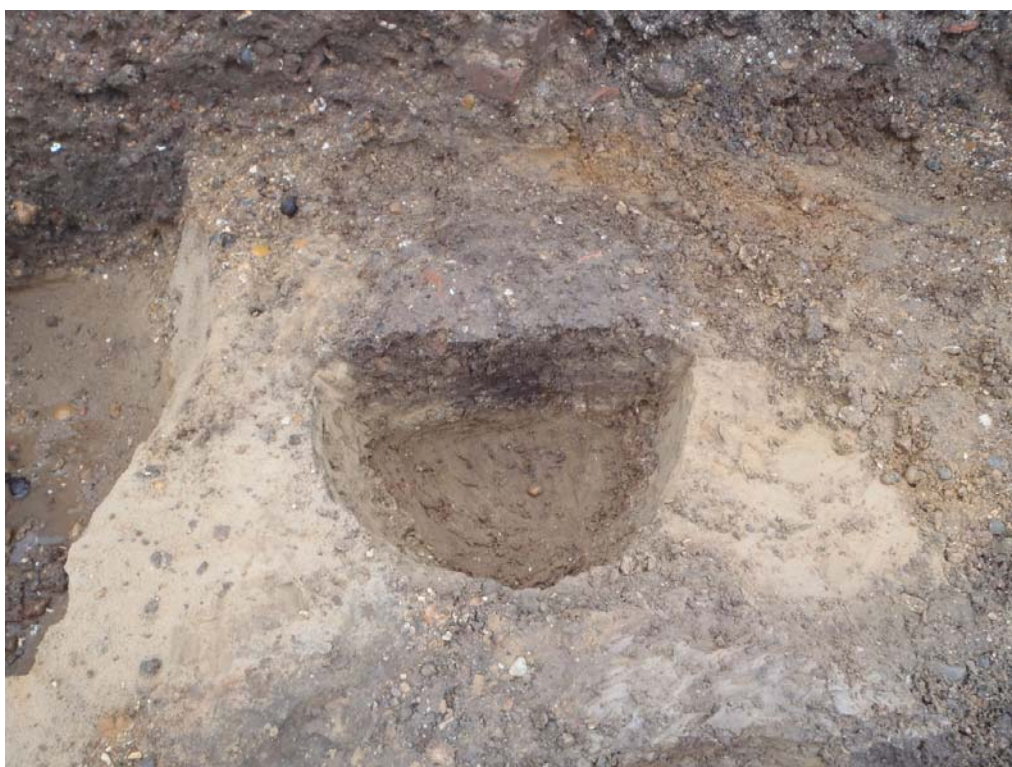
Plate 5: Posthole [48] looking east

- 8.1.7 To the east of [45] the sub-oval cut of a posthole [48] was recorded, at 6.22m OD, measuring 0.75m north to south by 0.96m east to west and 0.34m deep. The sides were seen to be nearly vertical and the base concave. A very soft deposit of dark blackish grey sandy silt [47], noted at 6.22m OD with a width of 0.34m and a thickness of 0.34m, was the remnant of a decayed post. The cut was backfilled with a soft, light to mid brown grey, gravelly sand [46] with occasional charcoal flecks, pottery, CBM and CTP (dated 1580-1700+).

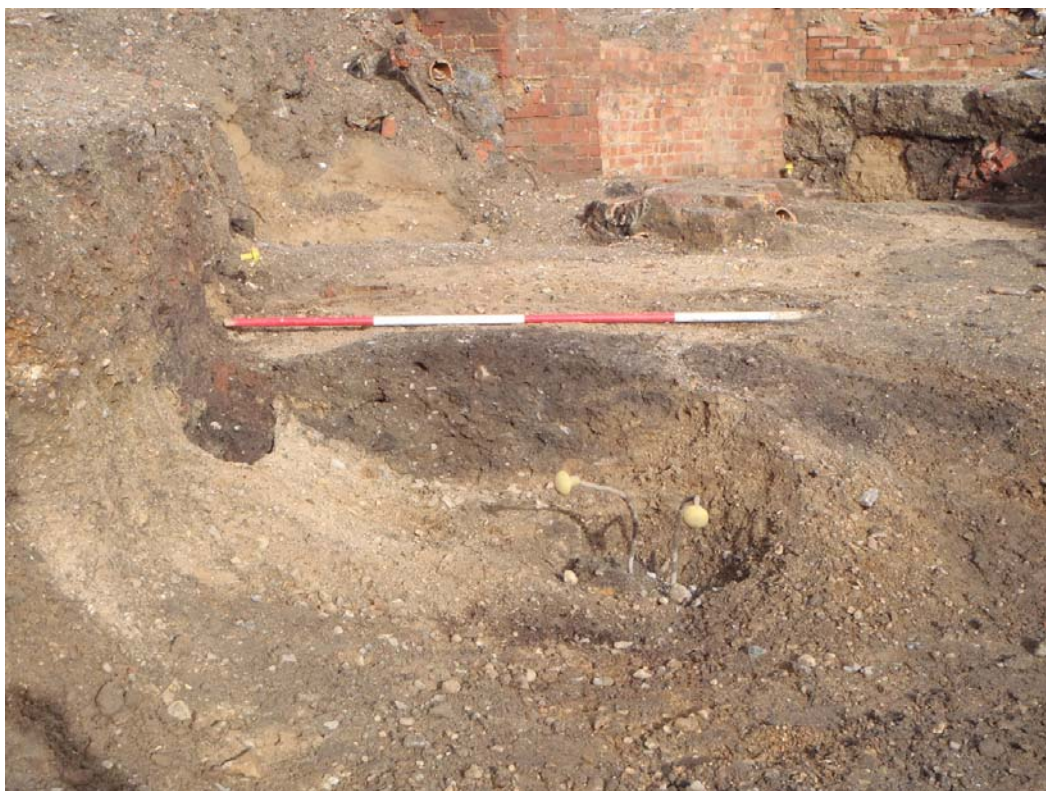
Plate 6: Pits [15] and [24] looking north

- 8.1.4 A sub-rounded pit [24], with gently sloping sides and a concave base, was noted truncating the natural [13] at 6.85m OD and measuring 1.16m north to south by 1.5m east to west and 0.4m deep. This was filled by a friable, mid to dark grey brown silty sand [23], with occasional inclusions of charcoal flecks, small sub-rounded gravels, CTP, pottery, bone and CBM. Pottery and CBM recovered from this was dated to the late 17<sup>th</sup> century. Pit [15] was recorded at 7.01m OD, truncating [23], with near vertical sides and a concave base, measuring 1.2m north to south by 0.2m east to west (the cut extended beyond the western trench edge) and a depth of 0.6m. This was filled by a soft to friable light to mid brown grey silty sand [14] with frequent CBM fragments and occasional burnt clay patches, bone and CTP (dated 1580-1730). The fill was observed at 7.01m OD, measuring 1.2m north to south by 0.2m east to west and 0.6m deep.

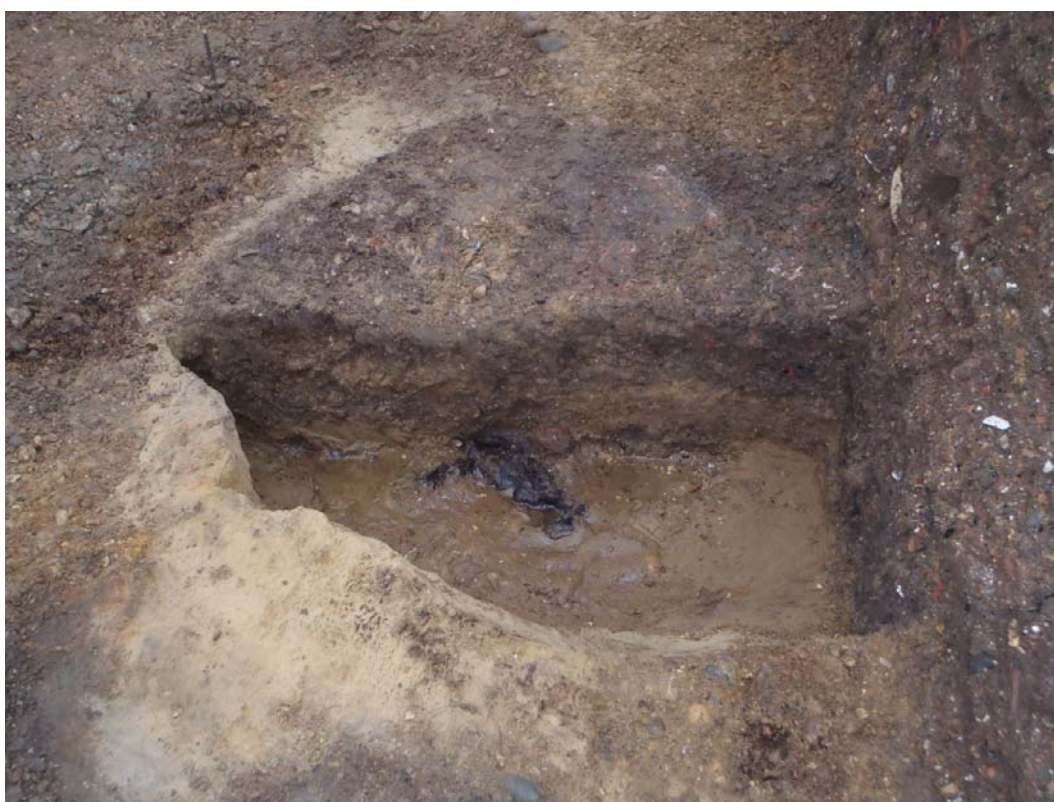
Plate 7: Pit [34] looking north

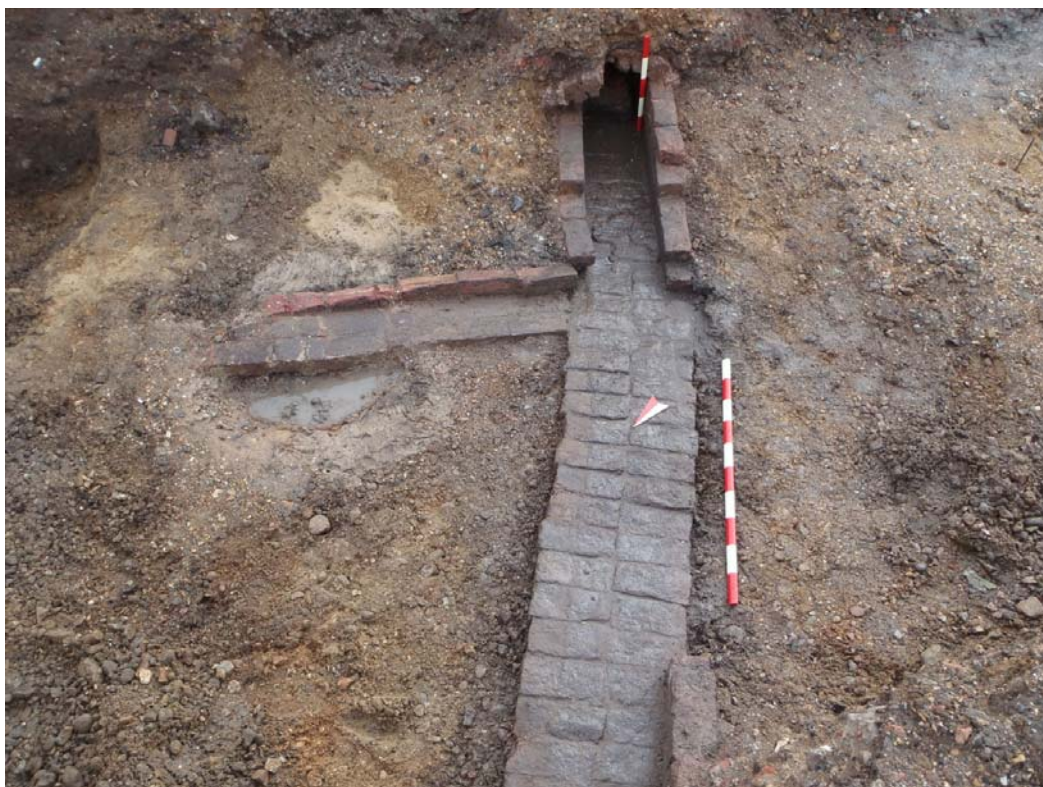
Plate 8: Drain [29] looking southeast

- 8.1.12 The cut [31] for a semi-circular (arched) brick drain [29] was observed at 6.47m OD truncating clay lined pit [45]. Aligned roughly east to west, the cut measured 0.64m north to south by 3.8m east to west, with a branch off to the north measuring 1.35m. The semi-circular drain [29] was recorded between 6.64m OD and 6.02m OD sloping down towards the river. Measuring 0.53m north to south by 3.8m east to west and 0.43m to the top of the arched roof the drain extended beyond the trench limits. It was built using two types of unfrogged reused red brick fabrics; Fabric 3034 and Fabric 3034 nr 3033, measuring 203x111x60mm, bonded with two different types of mortar. The arch was bonded with a hard light pink mortar and the base and sides with a soft pale grey lime mortar. Backfilling the construction cut was a mid grey brown silty sand [32] recorded at 6.24m OD with a width of 70mm. The whole structure was capped by a deposit of firm, mid grey brown silty sand [75] noted at 6.52m OD measuring 1.26m north to south and 0.18m thick (this deposit was truncated to the north, south and west by later intrusions). The drain was partially filled by a 0.10m thick deposit of very soft, dark blackish brown, sandy silt [30]. Pottery recovered from this was spot dated 1820-1900.

- 9.1.4 Arched drains were seen sloping off towards the river in Trench 1 and are probably part of the same system installed to serve the properties known on site in the 19<sup>th</sup> century. The heavily disturbed walls, observed in the south of the trench, could be part of one of these buildings.

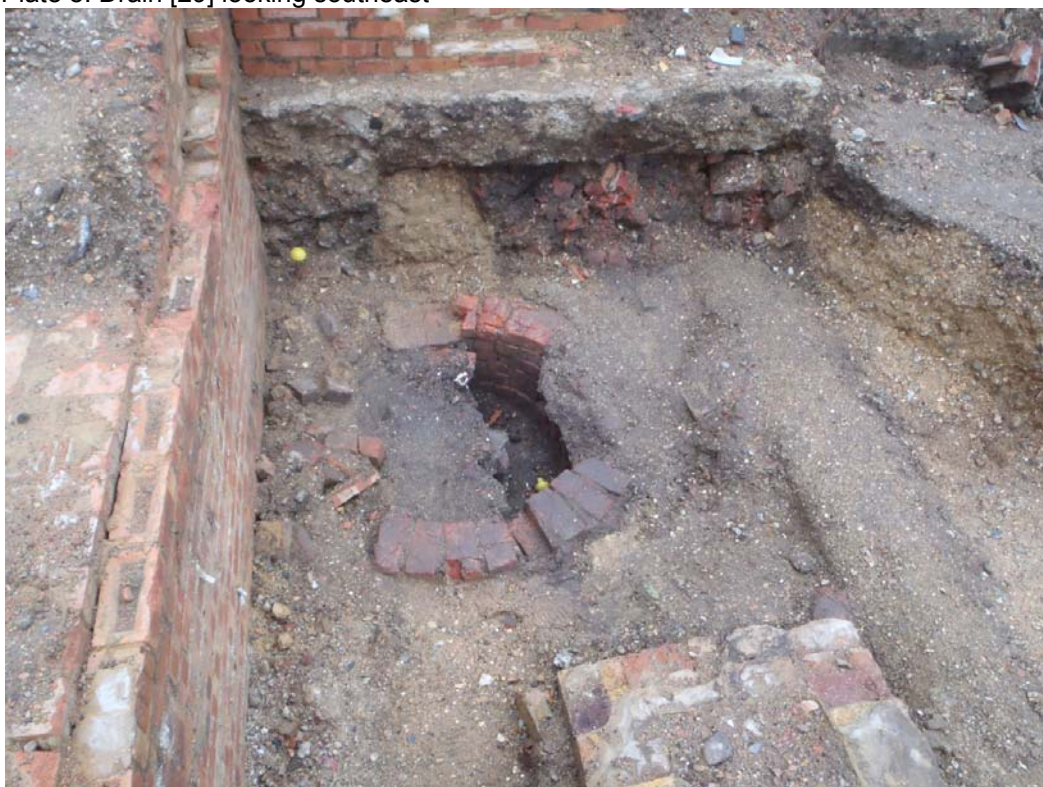
Plate 9: Well [25] looking northeast

- 8.1.22 In the north of the trench the construction cut [27] for a well [25] was recorded at 6.81m OD truncating the natural gravels [13]. Although heavily truncated the cut appeared to be rounded with vertical sides and a diameter of 1.74m. The well [25], was noted at 6.81m OD, constructed with unfrogged red brick measuring 215x100x60mm in a header bond giving the brickwork a width of 215mm and an inner diameter of 1.04m. It was only possible to excavate 0.52m of the well backfill because of the close proximity of the trench edge. A loose light yellowish brown sandy silt [26] with frequent gravels, small mortar fragments and occasional CBM backfilled the construction cut.

- 8.1.23 The backfill of the well was a deposit of soft dark blackish grey sandy silt [28] with frequent CBM, small to medium gravels and moderate fragments of grey concrete. This was recorded at 6.69m OD filling the interior of the well.
- 8.1.24 A thin layer of loose light whitish grey CBM and mortar [68] was observed at 6.81m OD measuring 0.72m north to south by 0.1m thick above layer [67].
- 8.1.25 In the western section face a deposit of soft mid brown grey silty sand [21] with occasional 20<sup>th</sup> century CBM fragments was recorded in section at 6.71m OD sealing the compacted gravels [17/20]. This measured 1.35m north to south by 0.15m thick. Capping [21] was a layer of friable, mid yellow brown, redeposited Brickearth-type deposit [22], noted at 6.95m

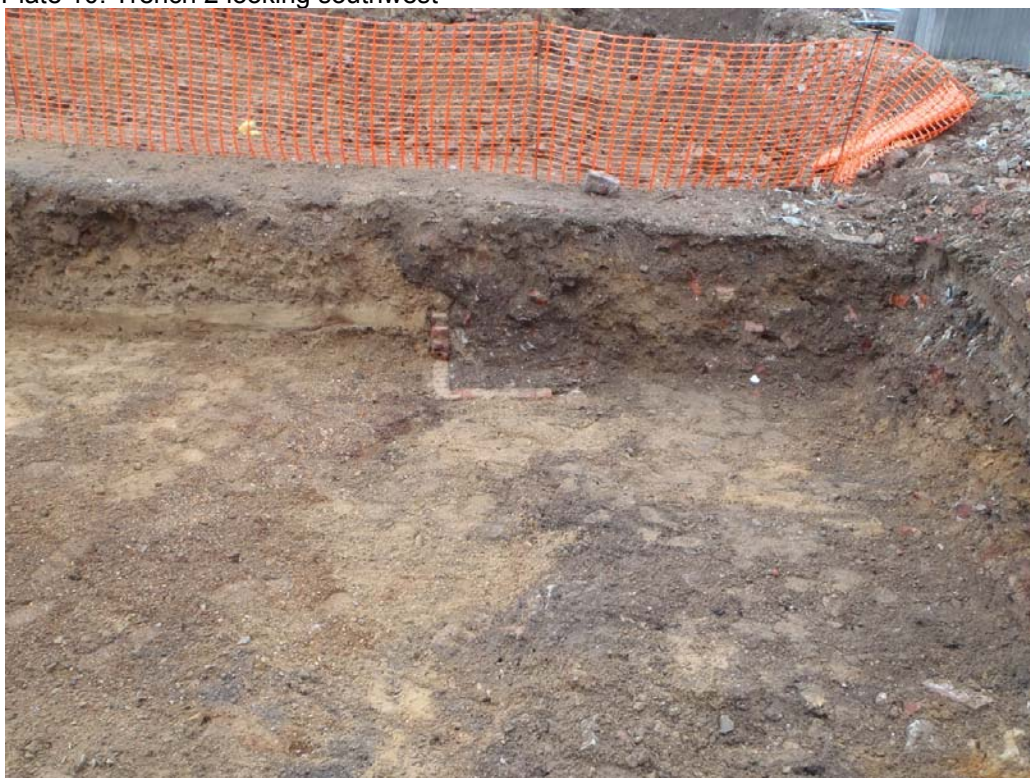
Plate 11: Section 1 looking southeast, showing cess-pit [2]

- 8.1.29 The rectangular cut [4] for a brick lined cess-pit [2] was seen truncating [5] at 7.64m OD. The sides were near vertical and the base was almost flat and it measured 1.34m northeast to southwest by 0.44m northwest to southeast (the cut extended beyond the southeastern trench limits) and 0.68m. Two types of brick fabric were used to construct the cess pit lining [2]; unfrogged red brick Fabric 3065 and Fabric 3043 nr 3033 measuring 225x100x66mm were bonded with a soft yellow brown lime mortar. The brickwork was noted between 7.58m OD and 7.02m OD measuring 1.28m northeast to southwest by 0.44m northwest to southeast with a width of 100mm (one header) and a depth of 0.59m. A loose mid grey gravelly sand [3] was recorded at 7.64m OD, backfilling the construction cut. The primary fill [12] was a soft dark brown sandy silty clay observed at 6.99m OD measuring 1.08m northeast to southwest by 0.28m northwest to southeast and 0.14m thick. This was sealed by a soft mid to dark grey clayey sandy silt [1] seen at 7.67m OD measuring 1.28m northeast to southwest by 0.28m northwest to southeast and 0.7m thick, with frequent bands of crushed mortar, CBM fragments, pottery, glass and CTP. The finds were dated to the late 17<sup>th</sup> to early 18<sup>th</sup> centuries.

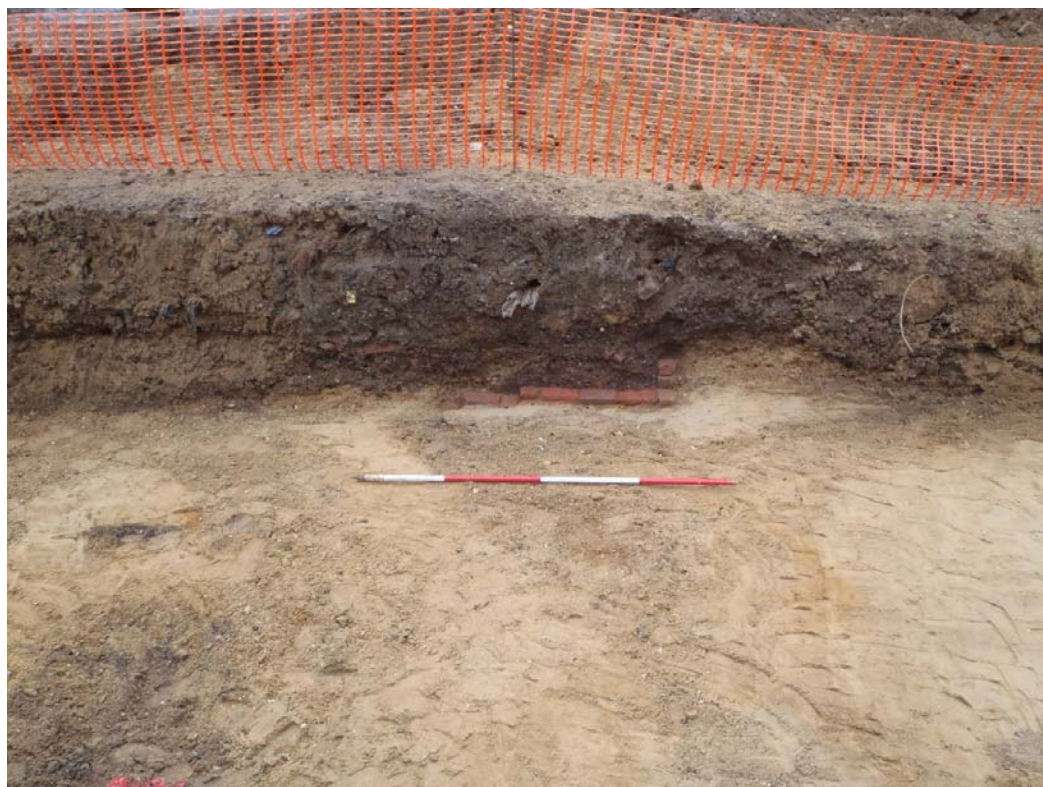
Plate 12: Section 2 looking southeast, showing cess-pit [7]

- 8.1.30 The construction cut [9] of the second cess pit [7] was also rectangular and lay slightly to the northeast. This was recorded at 7.67m OD measuring 1.5m northeast to southwest by 0.20m northwest to southeast (the cut extended beyond the southeastern trench limits) and 0.44m deep with near vertical sides. The lining [7] was constructed using two types of brick fabric; unfrogged red brick Fabric 3033 and unfrogged brick Fabric 3034 nr 3033 measuring 228x108x68mm - no bonding material was visible. The brickwork was observed at 7.53m OD measuring 1.38m northeast to southwest by 0.2m northwest to southeast and 0.20m deep. Backfilling the construction cut [9] was a loose mid grey brown gravelly sand [8/10] noted between 7.67m OD and 7.23m OD to have a maximum thickness of 0.35m

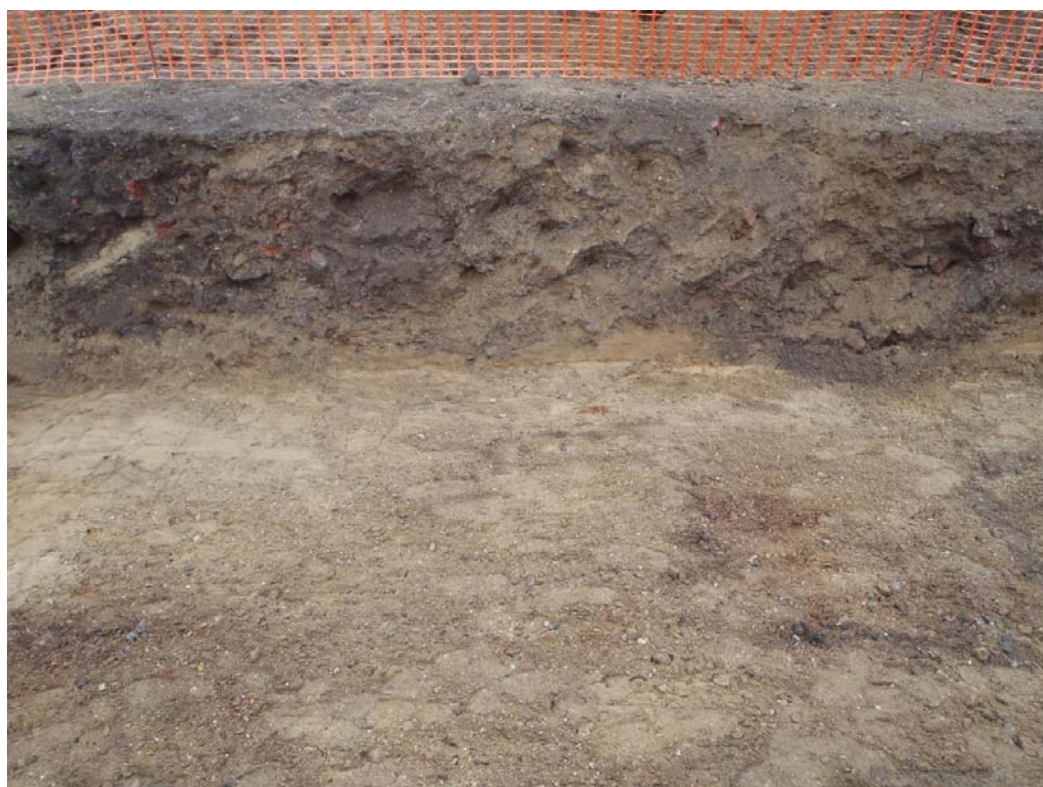
Plate 13: Section 3 looking northwest, showing 'brickearth' type deposit [11]

- 5.1.3 The investigations revealed deposits of natural sandy gravels in both trenches. In Trench 2 these were seen to be sealed with a natural Brickearth type deposit in the northern section face (see Section 3 FIG 5).

- 8.1.27 A layer of light to mid yellow brown gravelly sands [5] (similar to [13]) was observed between 8.04m OD and 7.14m OD, extending beyond the trench limits. This was capped by a heavily truncated deposit of brickearth type material [11], noted in the northwest section (Section 3) at 7.60m OD to be 2.3m in length and 0.18m thick.

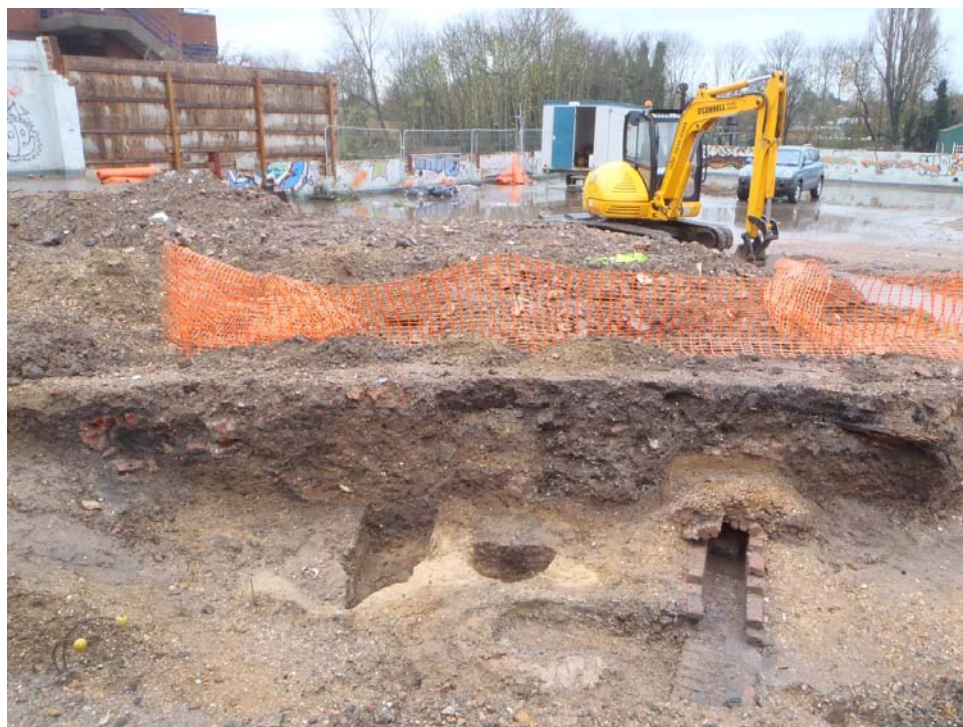
Plate 16: Sections 6 and 7 looking east, showing drain [29], posthole [48], pit [34] and gravel surfaces [66] and [74]

- 8.1.17 Similar deposits of compacted mid yellow brown clayey silty gravels were observed in the eastern trench edge, [74] and [66]. Sealing fill [63] layer [66] was recorded at 6.77m OD to be 0.72m north to south and 0.24m thick with truncations to the north and south. Layer [74] capped deposit [75] at 6.60m OD and measured 1.14m north to south with a thickness of 0.13m.
