MOAT FARM, STISTED, ESSEX,
CM77 8BW

ARCHAEOLOGICAL
MONITORING

DECEMBER 2012

**ARCHAEOLOGICAL MONITORING AT MOAT FARM,
STISTED, ESSEX, CM77 8BW**

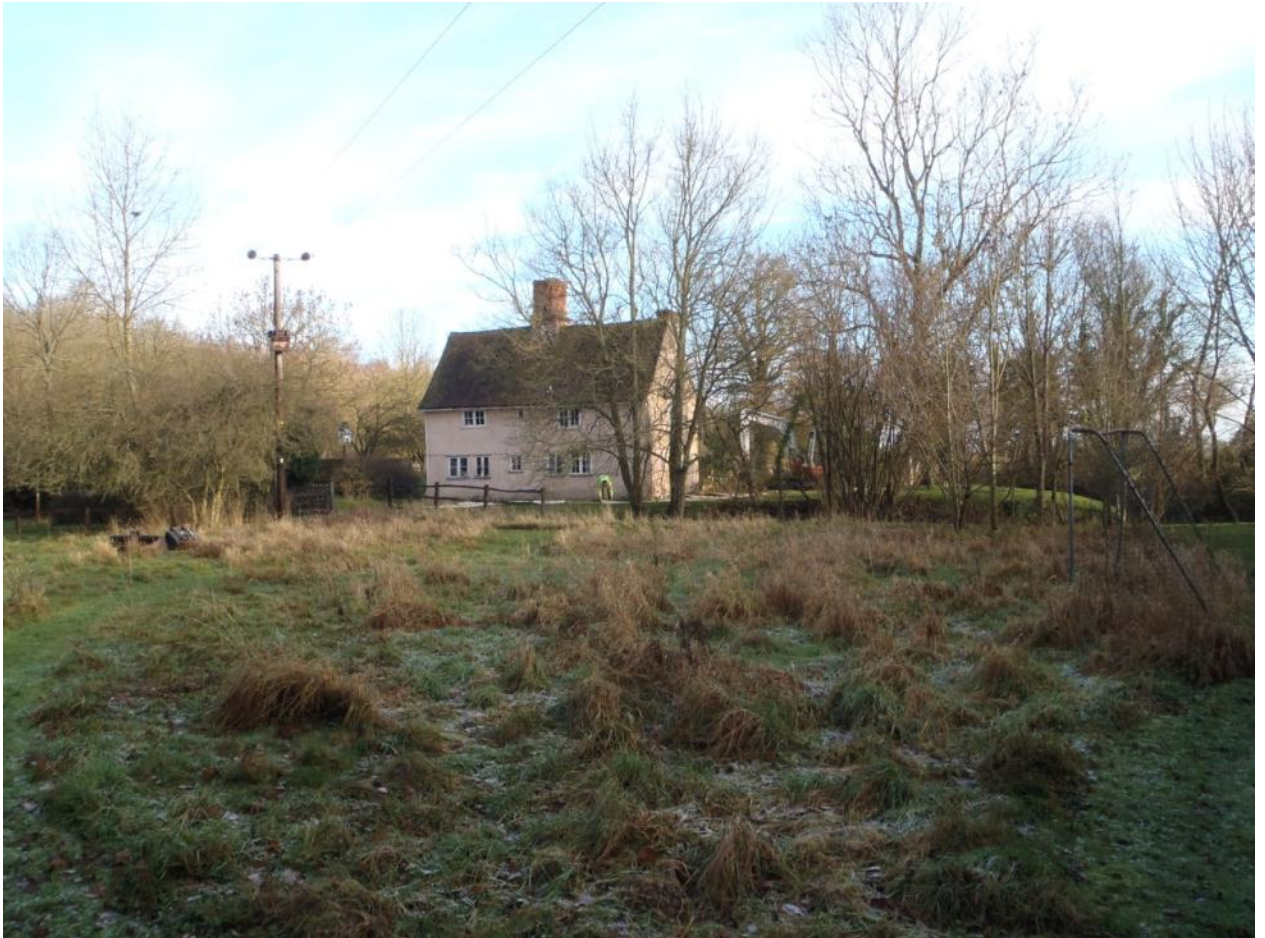
- 4.3 A visual appraisal of the site suggests that the ground within the moat is raised slightly above the level of the surrounding landscape (Plate 1). Levels taken using GPS (Leica 1200 Smartrover) show that the interior of the moat is indeed 0.30-0.50m higher than land immediately outside it (73.15-73.21m OD within the moat adjacent to the new garden room,

Plate 1: Moat Farm, view east towards 17th-century house from edge of property, beside Moat Road. Note raised level of moated platform adjacent to southern arm of moat.

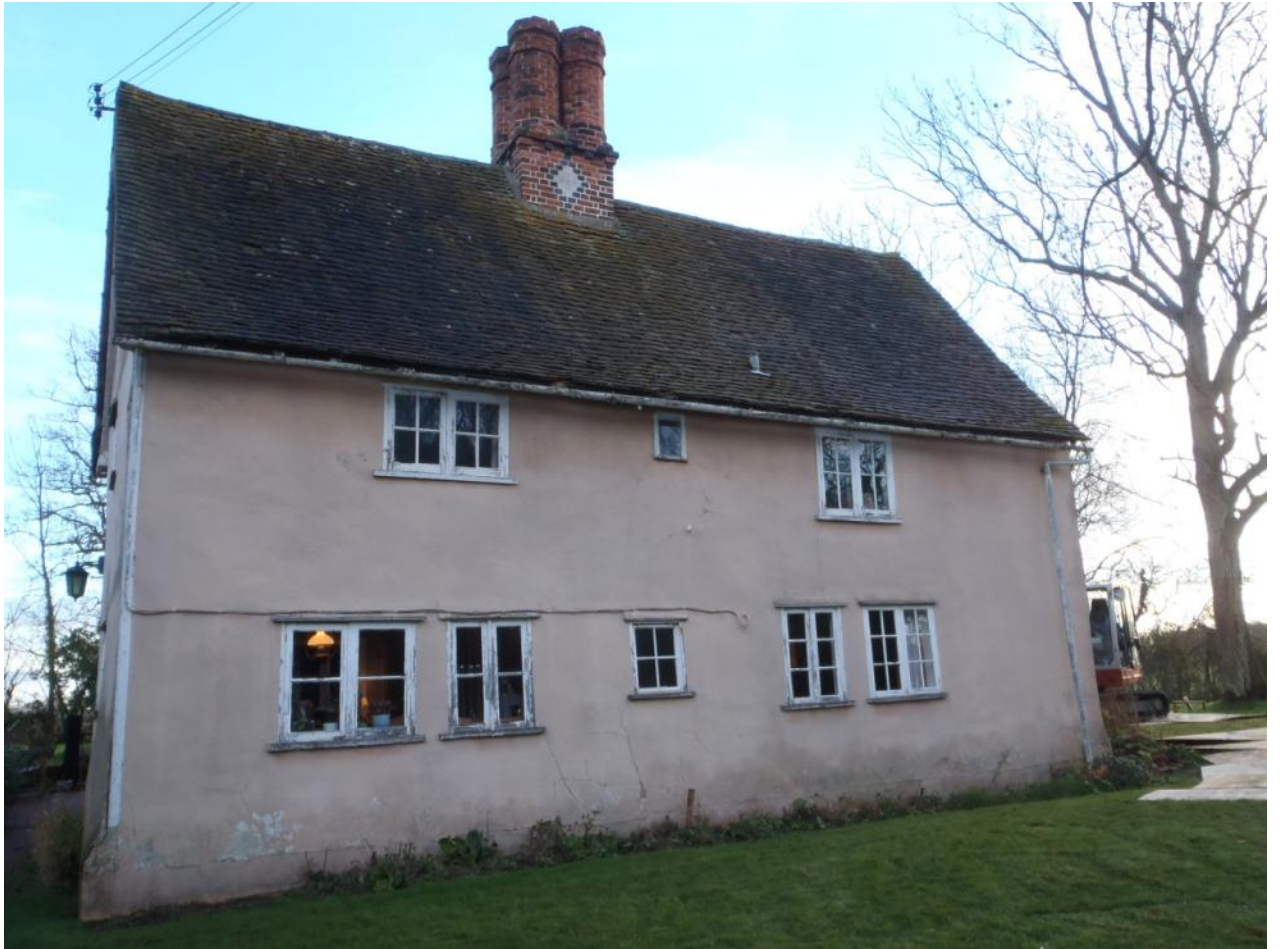
- 1.3 Moat Farm is located approximately 2.5km north-east of Stisted, between Halstead and Braintree in north Essex (centred on NGR TL 80797 27215). The existing building is a Grade II Listed 17th-century timber-framed house with later alterations and additions (Plate 2), situated within a moated enclosure of presumed medieval date (Plate 3). The archaeological monitoring was of groundworks associated with the construction of a new single-storey timber-framed garden room (Planning References: BTE/01462/11/FUL & BTE/01463/11/LBC) adjoining the south-eastern gable wall of the existing house (Plate 4).

Plate 2: Moat Farm House, west elevation

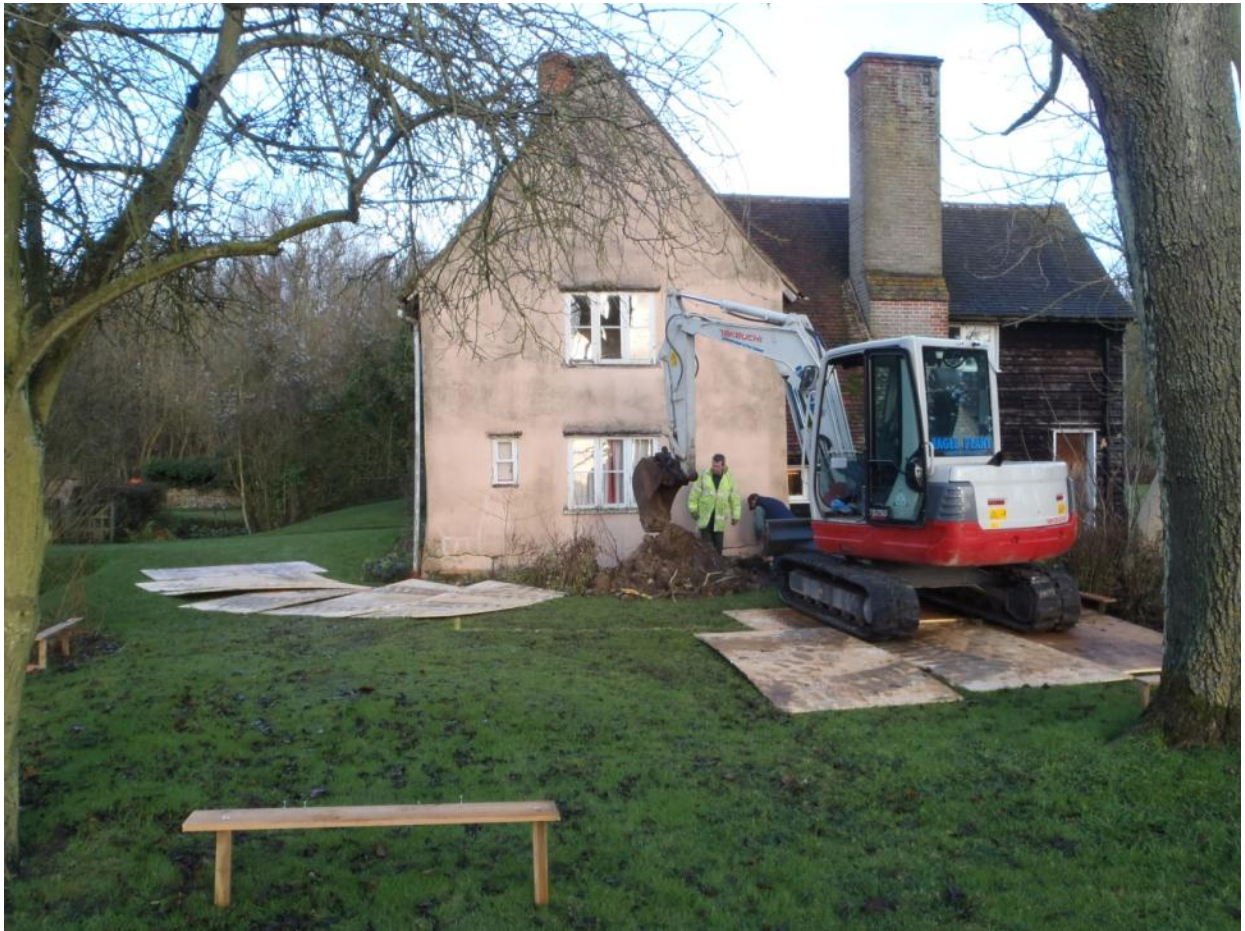
Plate 4: Location of new garden room, adjoining the south-eastern gable wall of the early-17th-century farmhouse, view north

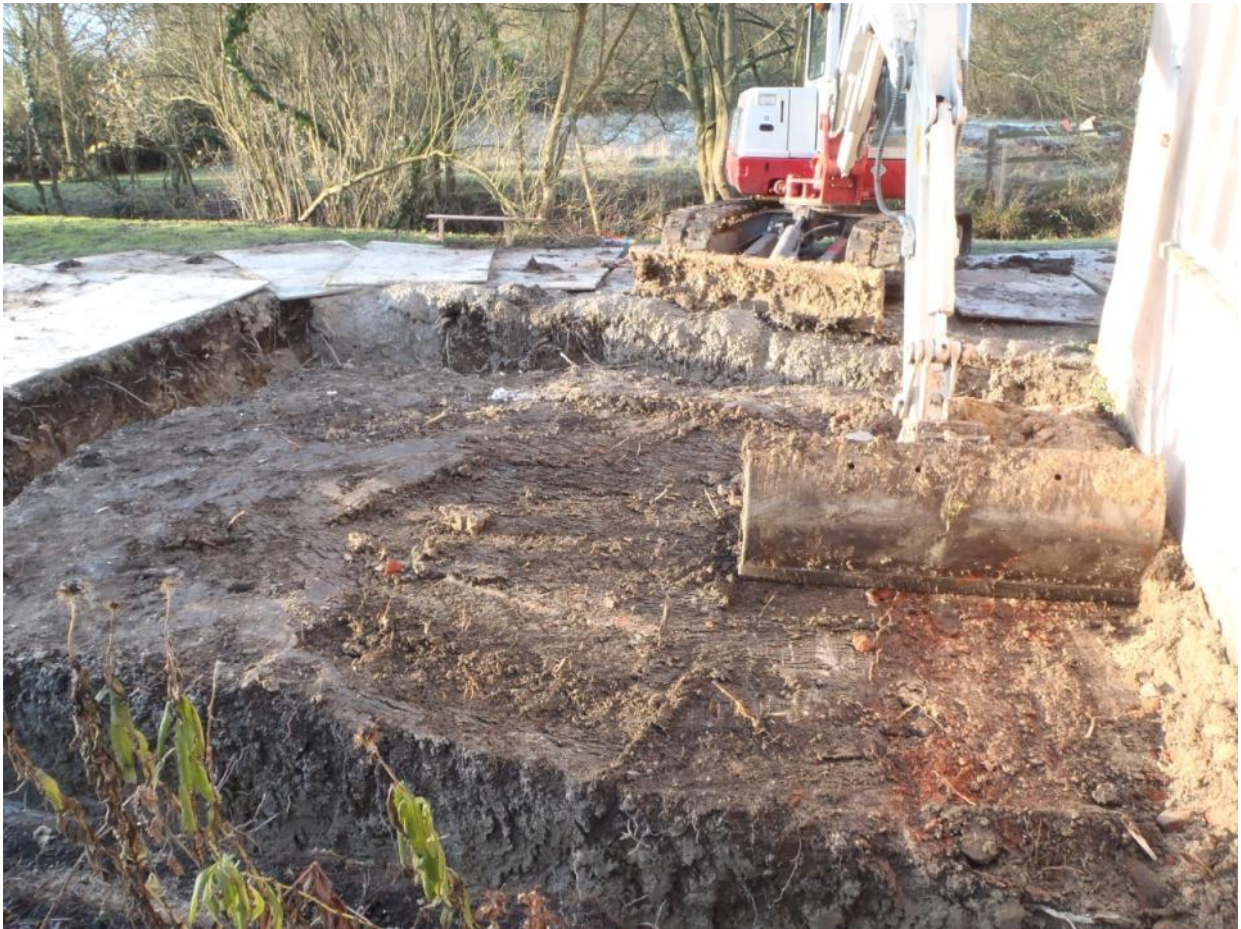
- 4.1 The sequence of subsurface deposits was uniform across the majority of the new building's footprint. Dark brown/ black loam garden soil (1) 0.25m deep overlay a made ground layer (2) 0.20-0.25m thick. The made ground (Plate 5) comprised fairly firm mid brownish-grey clayey silt containing occasional flecks of chalk and degraded red brick/ tile. This layer contained around ten fragments of tile and two sherds of pottery, the latter both found on the interface between the made ground (2) and the natural clay (3). One potsherd is a moderately-abraded flat-topped jar rim in local medieval sandy greyware (Essex Fabric 20; 12th- to 14th-century); the other is a small body sherd in the same fabric (pers. comm. Berni Seddon). The tile is medieval peg roof tile made in a coarse sandy fabric with coarse moulding sand. This deposit appears to be a build-up of medieval occupation material, possibly levelled in the area immediately surrounding the extant house during its construction in the early 17th century. The presence of these finds on the site adds weight to the presumed medieval date of the moat and the conjectured presence of a medieval dwelling predating the early-17th-century house. No archaeological features were observed within/ cut into the made ground.

- 4.4 Immediately adjoining the south-eastern gable wall of the house, removal of a modern brick path constructed by the present owner revealed a thin builder's sand bedding layer for the path, overlying a brick rubble levelling layer (6) 0.15m deep. Beneath this was made ground (2) and the natural chalky clay (3).

Plate 5: Removal of Made Ground (2) and (immediately adjacent to gable wall of house) Levelling Layer (6) under archaeological supervision

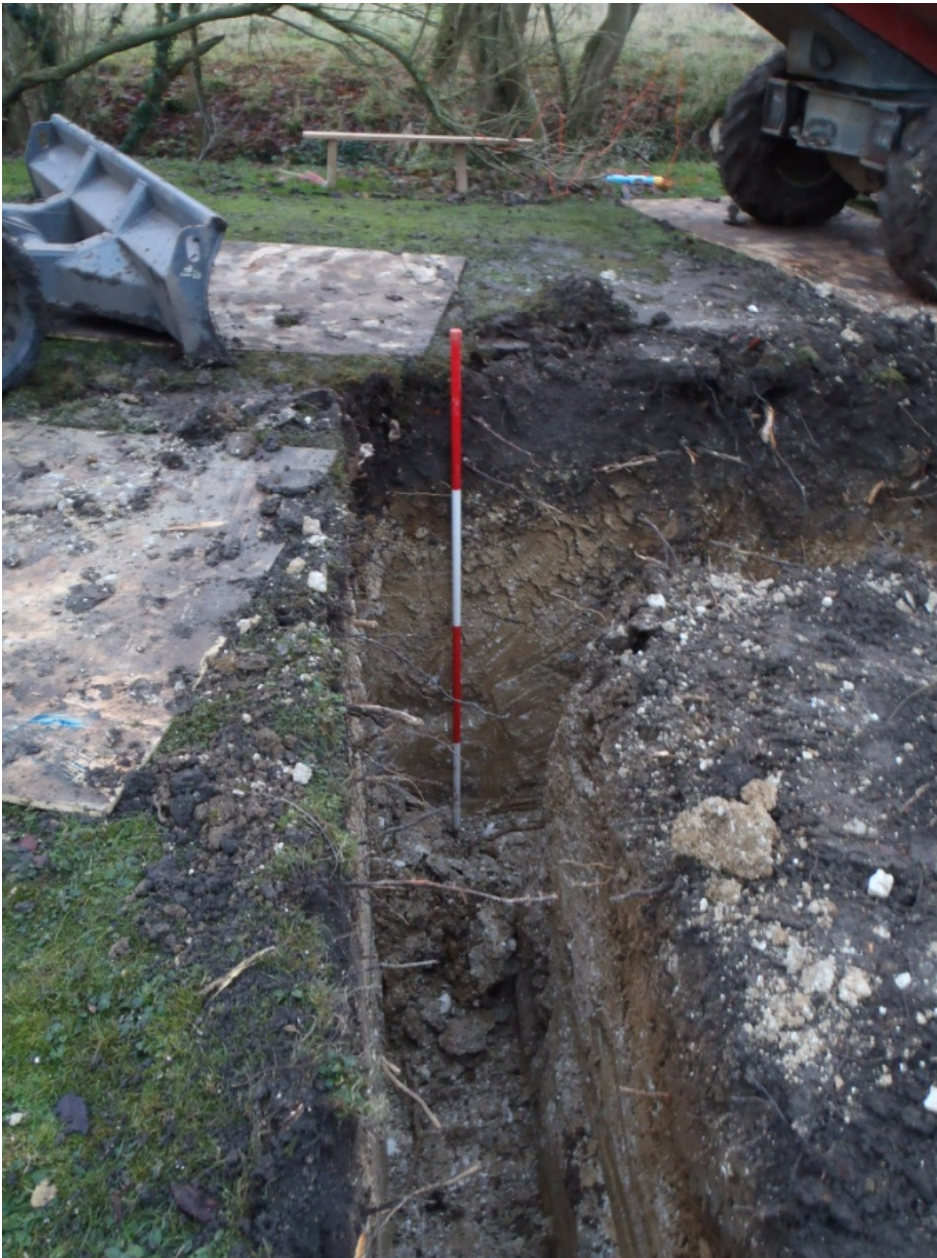
- 4.2 Directly below the made ground was the natural clay geology (3), a firm light to mid grey/ yellowish-brown clay containing abundant (40%) chalk flecks and small to medium-sized chalk nodules (10-200mm) and occasional (<5%) medium-sized (50-150mm) rounded flints (Plate 6). The natural clay was present at between 0.45 and 0.50m below existing ground level (72.70m OD).

Plate 6: South-eastern strip foundation (end wall of garden room), view west showing (from top to base of section): Garden Soil (1), Made Ground (2) and Natural Clay (3) (2m scale)

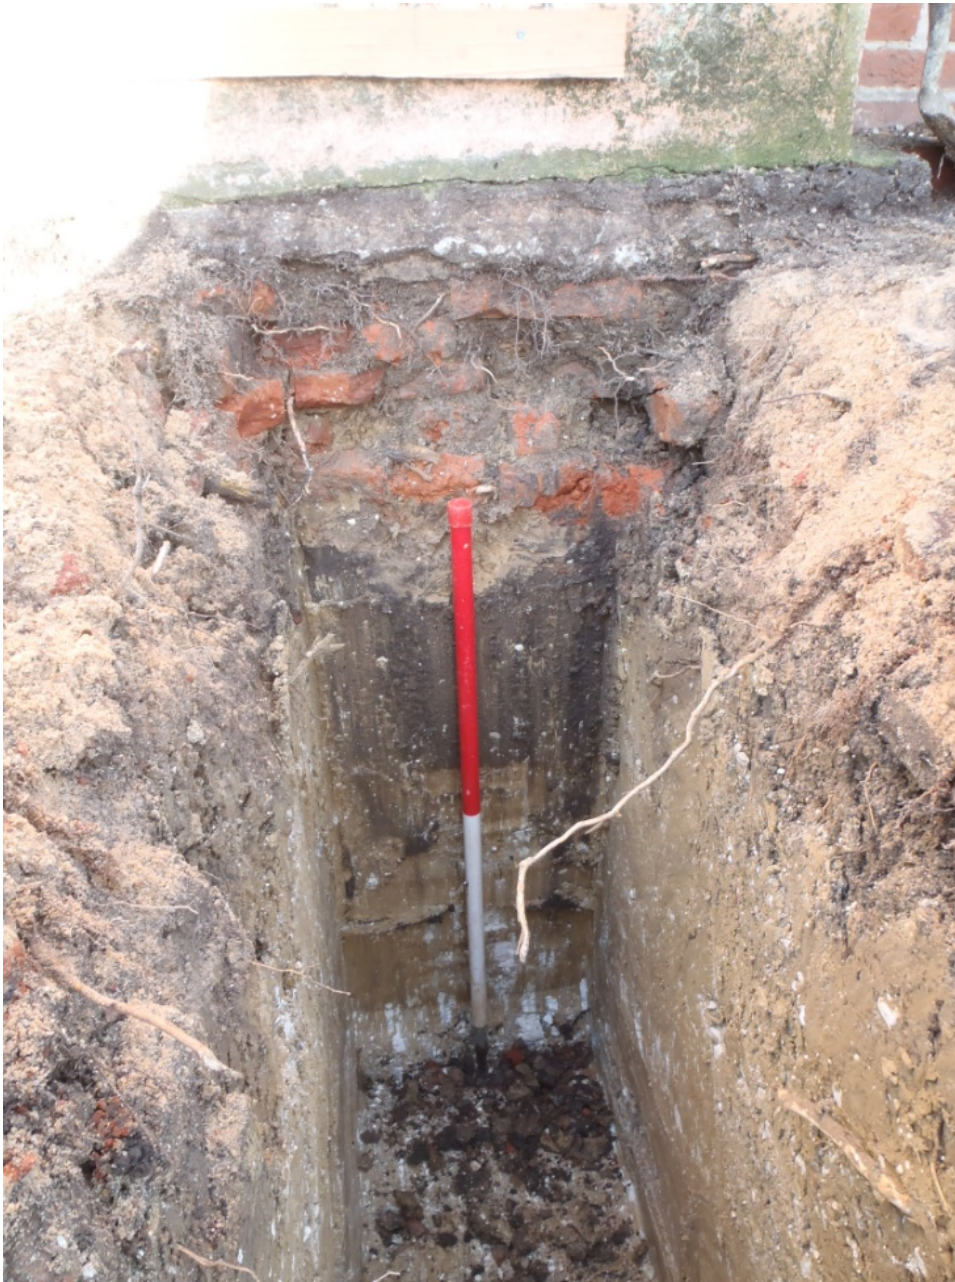
- 4.6 Where the foundation trenches of the new garden room adjoin the south-eastern gable wall of the existing 17th-century house, the foundations [5] for its timber frame were exposed and found to comprise un-bonded red bricks (dimensions: 112-115mm wide x 40-55mm deep; length not visible) laid in 3 – 4 rough header courses (between 0.17 and 0.29m high in total) directly onto 0.10m of made ground (2) overlying the natural clay (Plate 7). The bricks are un-frogged and vary in their dimensions but generally have fairly regular, 'sharp' angles. The owner of the cottage, Mr Mel Mackay,

stated that the sill beams of the gable walls were replaced by the previous owner, an architect, in the 1950s, so the observed foundation wall may consist of reused bricks and not itself be of any great antiquity. On the long sides of the building, oak sill beams rest on these shallow brick foundations.

Plate 7: North-eastern strip foundation, view north-west showing brick foundation wall [5] for sill beam of existing timber-framed house (1m scale)
