**BUCCLEUCH HOUSE, CLAPTON
COMMON, E5 9AN
LONDON BOROUGH OF HACKNEY**

ARCHAEOLOGICAL EVALUATION

PCA REPORT NO: R11370

SITE CODE: BCL13

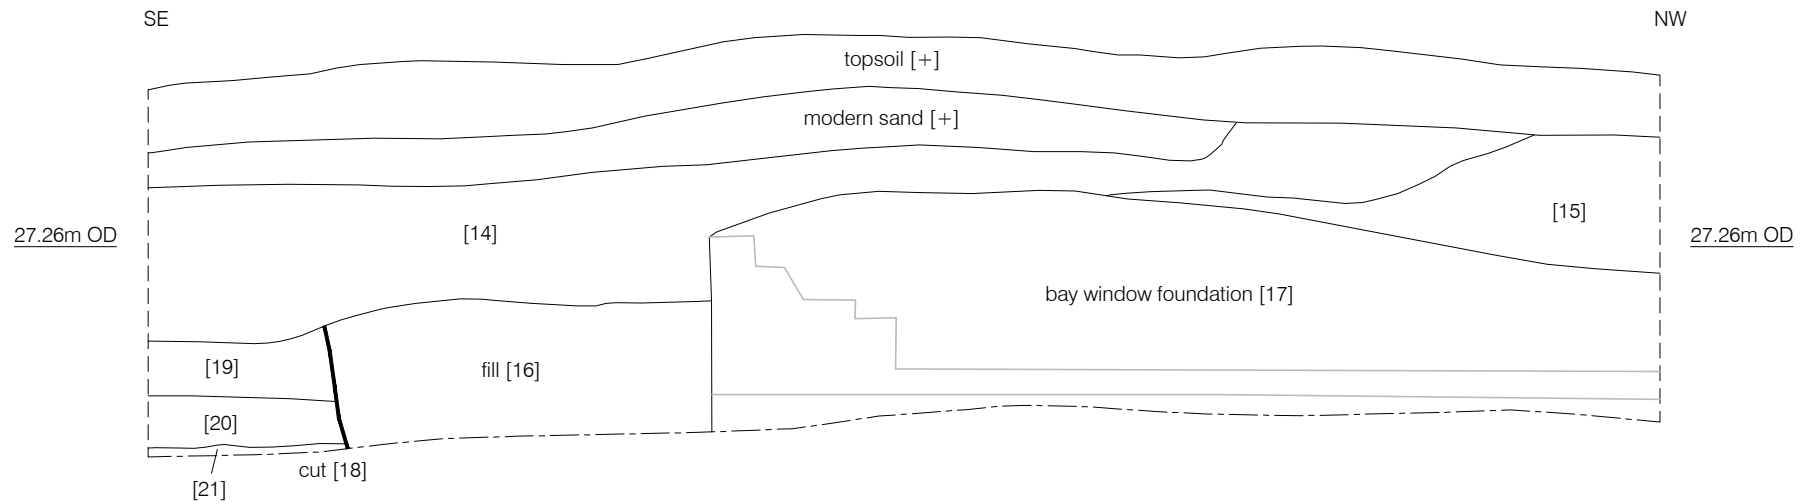
Section 2
Trench 3
Northeast Facing

- 7.3.4 In Trench 3 evidence of the bay windows, also seen in the mid-late 19th century OS Town Plan maps, was encountered. Truncating the redeposited brickearth [19], what is interpreted as a construction cut [18] relating to the bay windows was seen in section, and partially in plan. It was sub-rectangular with very steep sides. It was not excavated and as such the depth and character of the base could not be established, however it extended to at least 0.45m in depth where observed. Where it could be recorded the cut measured 1.48m by 1.05m extending into the south-western LOE and truncated on the northern side by a later service. It was recorded at 27.01m OD.

- 7.4.3 Sealing the bay window footings in Trench 3 was a layer of silty clay [15] & [23], which comprised of a soft mottled yellow/brownish grey silty clay. It contained very frequent fragments of CBM, mortar and concrete and frequent small sub-angular pebbles. It was 0.46-7m thick and observed at around 27.58m OD. Partially overlying this layer towards the east of the trench was a 0.15-0.20m thick dump of loose dark greyish reddish brown clayey sandy silt [14] containing frequent amounts of CBM, concrete and mortar. These mixed dump layers form a made ground that likely relates to the 1950's construction work undertaken on site.

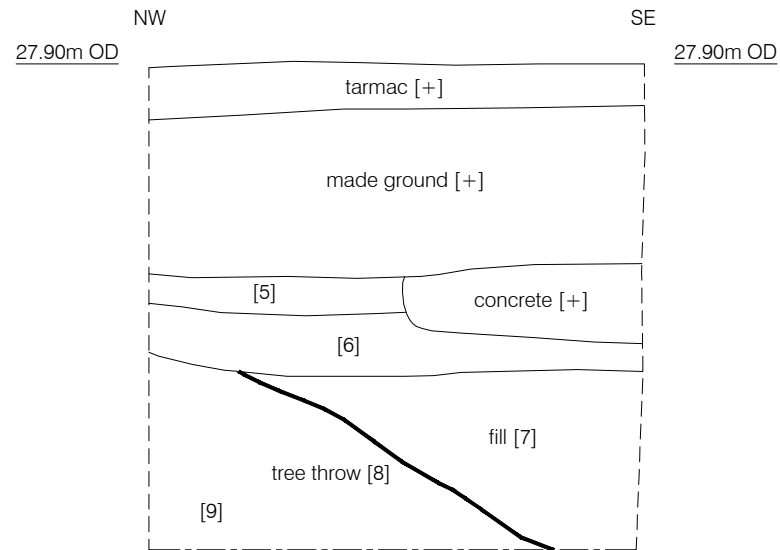
Section 3
Trench 1
Southwest Facing

7.3.1 Observed truncating the natural sand and gravel [9] in Trench 1 was a cut feature. Seen in section only, the sides were gradual with the base appearing concave where seen. It measured at least 1.30m in length and extended beyond the LOE of the trench in width. It measured c.0.60m in depth and was observed at 26.90m OD. The fill of this feature comprised a soft mid orangey brown silty clay [7] which contained occasional, well sorted gravel inclusions and frequent roots/rootlets towards the base. Given the presence of the

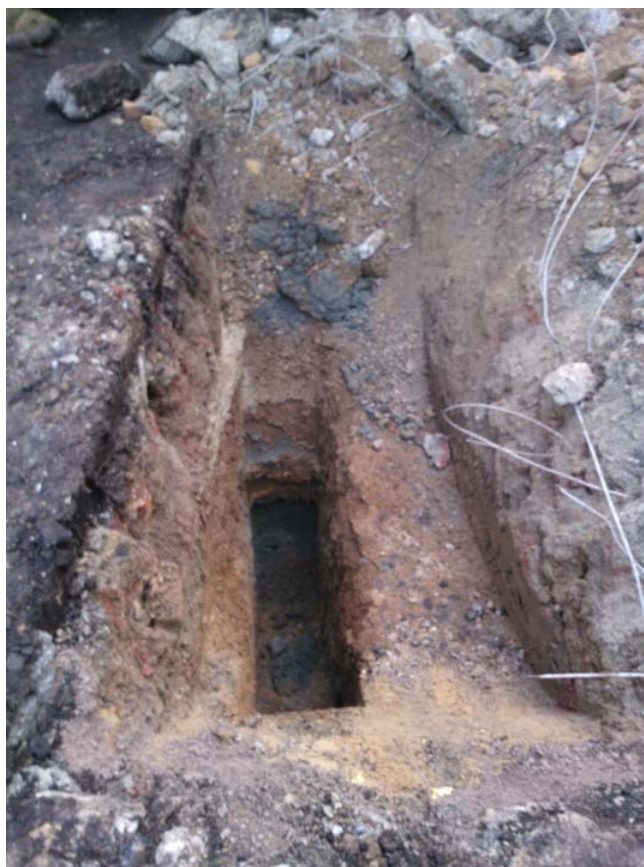
Plate 1: Post-ex shot of Trench 1 (facing south-east)

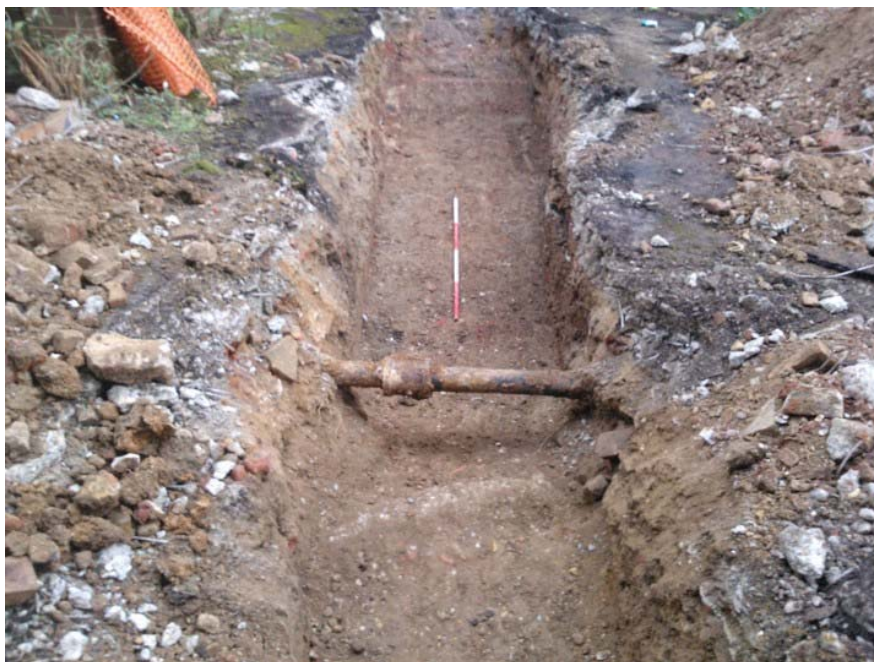
Plate 2: Post-Ex shot of Trench 2 (facing south-west)

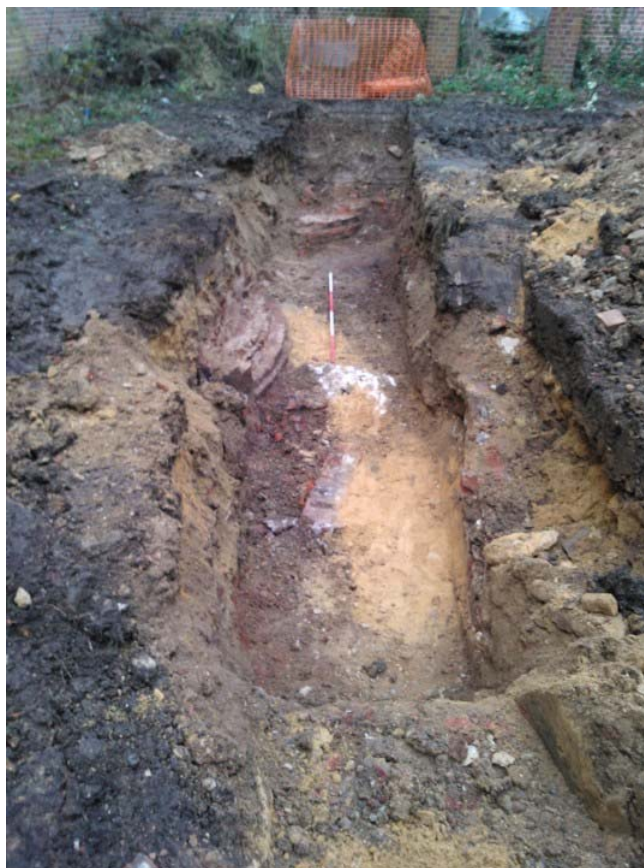
Plate 3: Post-Ex shot of Trench 3 (facing west)

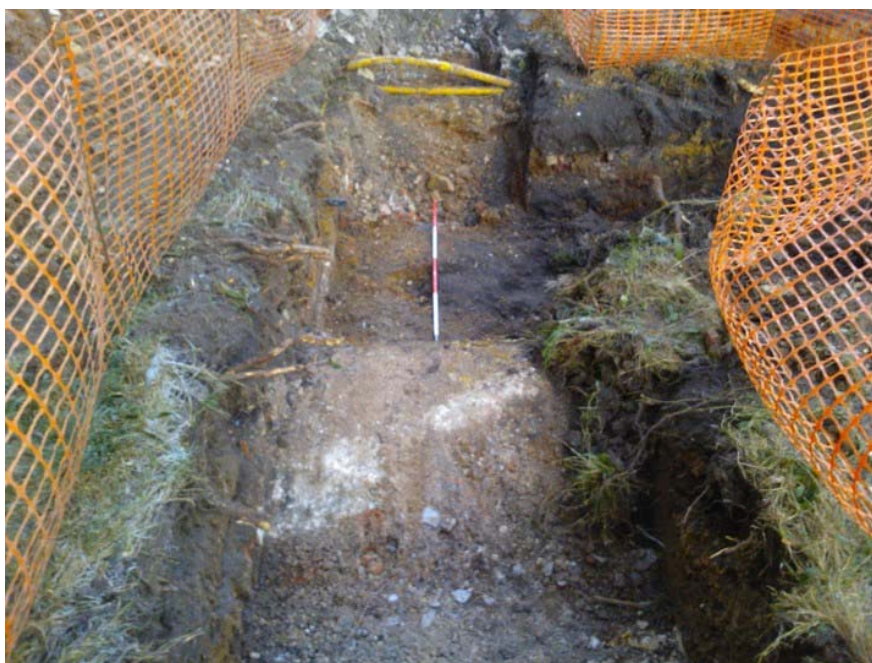
Plate 4: Post-Ex shot of Trench 4 (facing north-west)
