**PHOTOGRAPHIC SURVEY
OF STEWART'S GARAGES,
72 FARM LANE, FULHAM,
LONDON BOROUGH OF
HAMMERSMITH AND
FULHAM, SW6 1QA**

PCA REPORT NO. R11379

FEBRUARY 2013

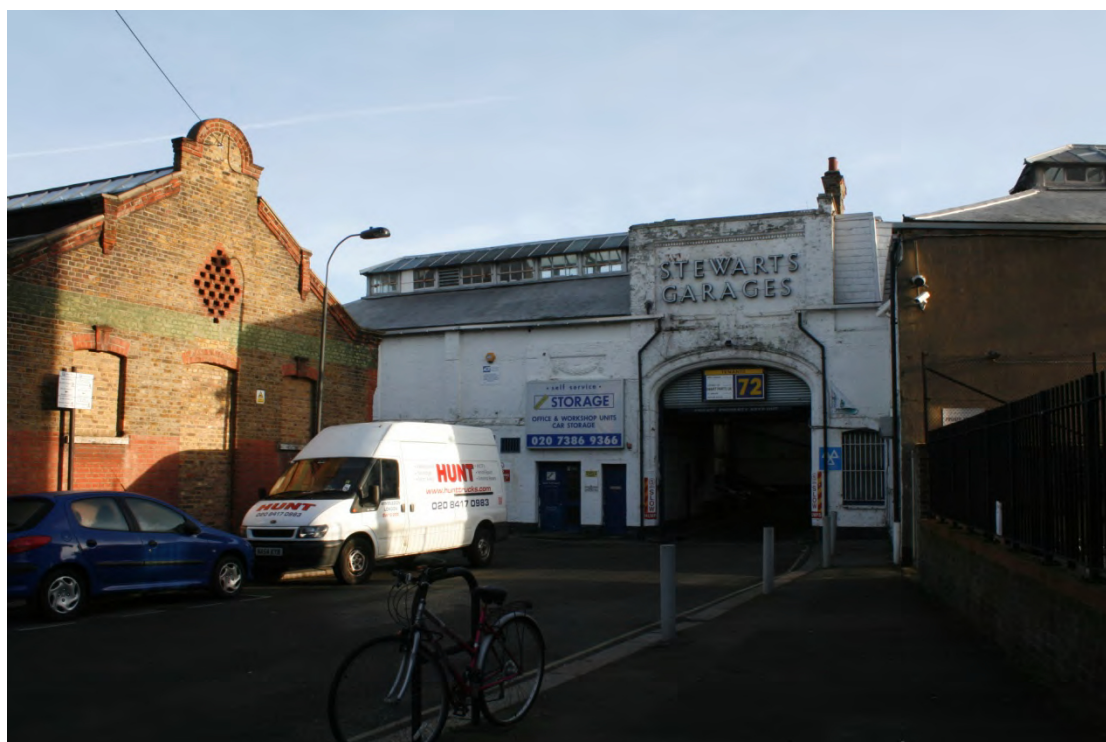
Plate 1: South-west facade with entrance from Farm Lane, looking north-east (72FmLa D100 001)

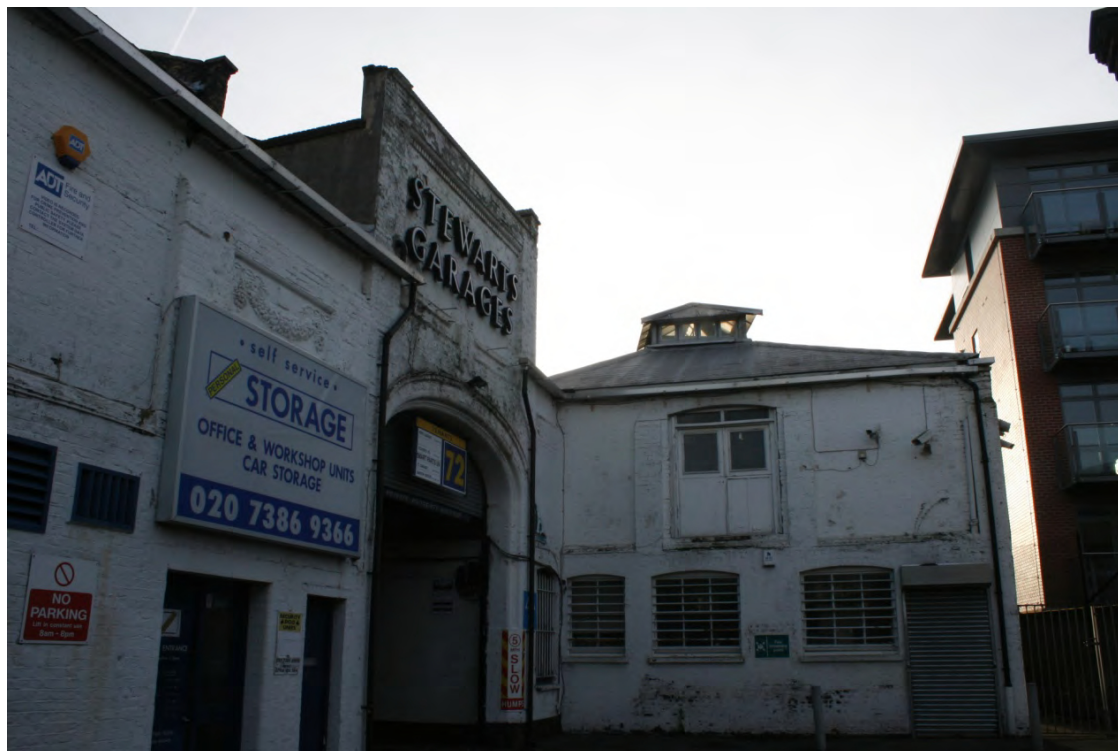
Plate 2: South-west facade with entrance (left) from Farm Lane, looking south-east (72FmLa D100 002)

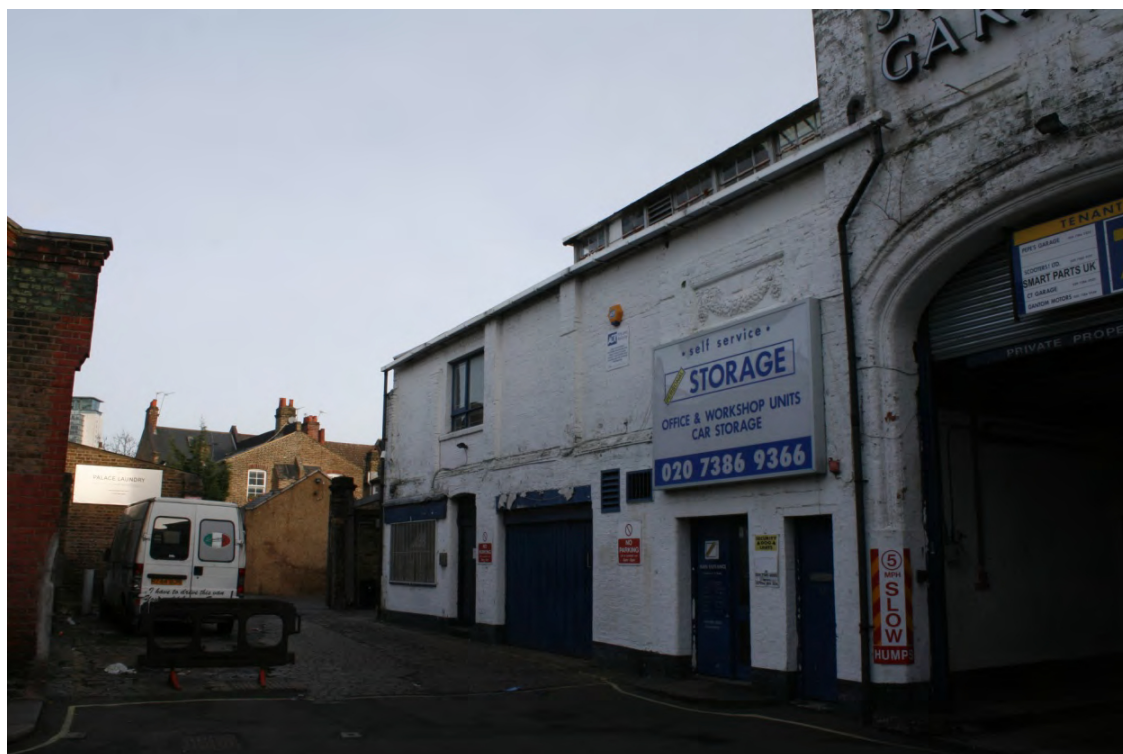
Plate 3: South-west facade with entrance from Farm Lane, looking north (72FmLa D100 003)

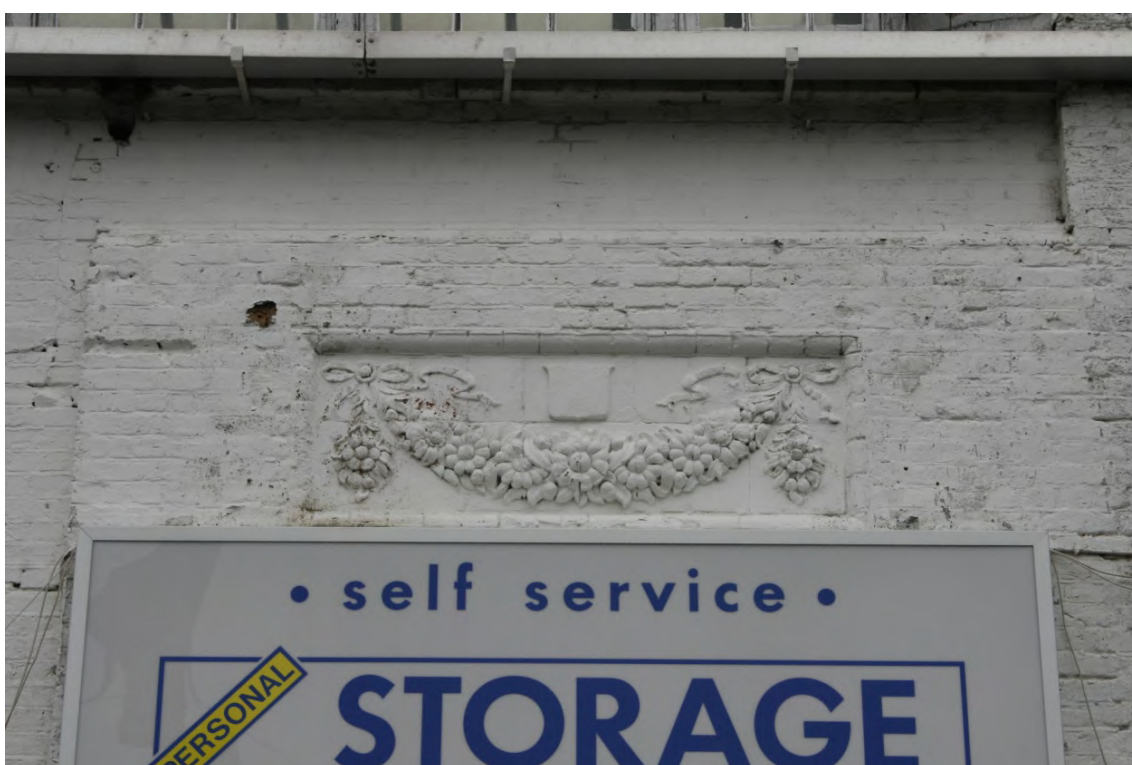
Plate 4: Terracotta embossed plaque with fruit design on south-west facade, looking north-east (72FmLa D100 030)

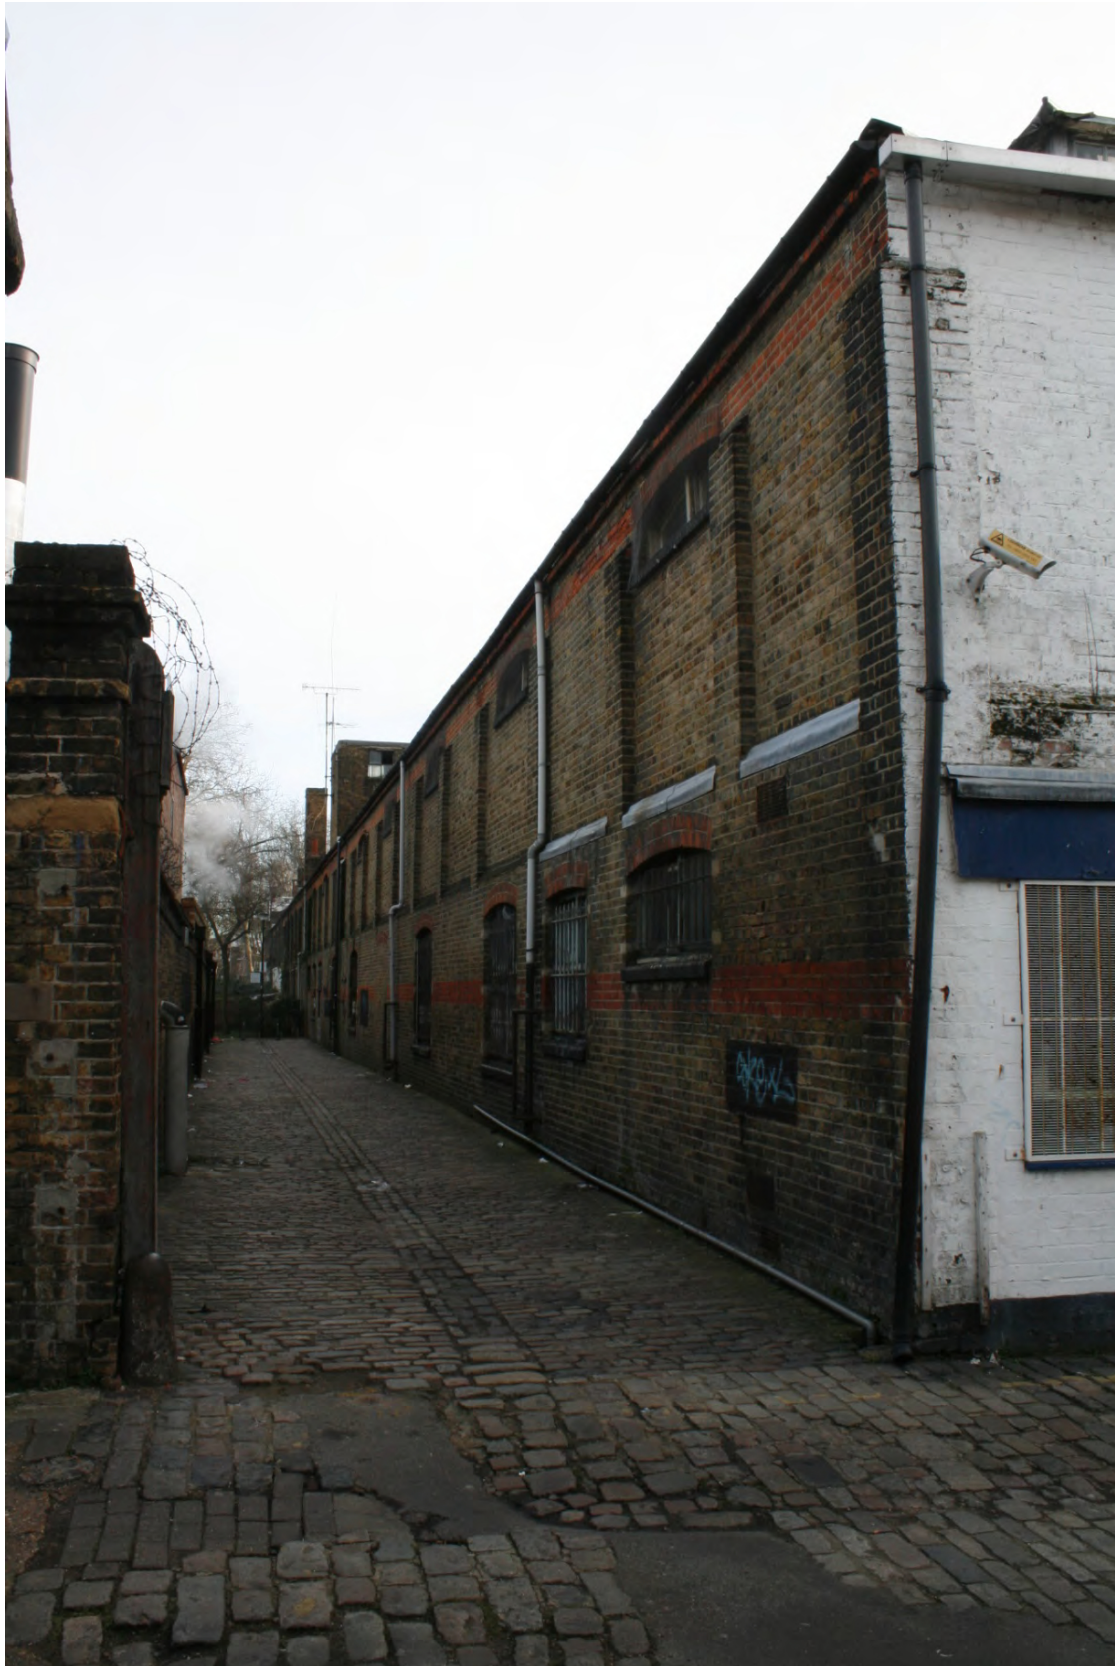
Plate 5: Long north-west elevation (right) and adjacent alleyway, looking north-east (72FmLa D100 04)

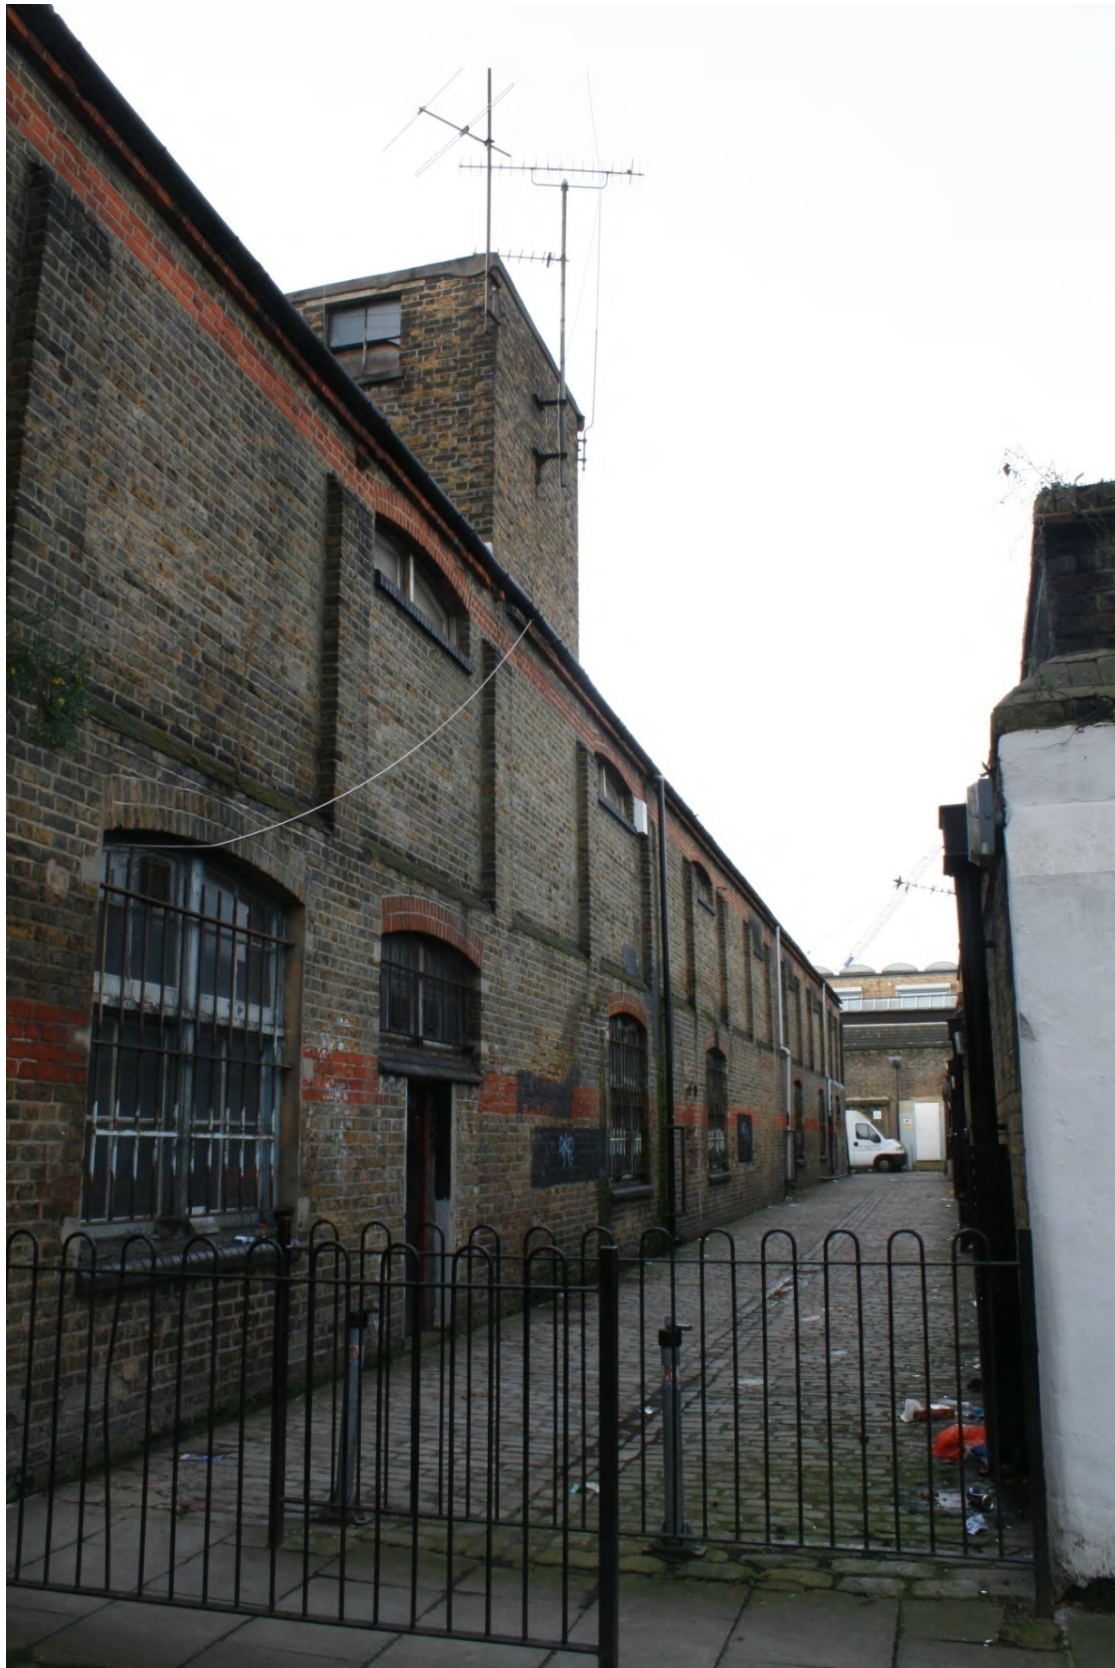
Plate 6: Long north-west elevation (left) and adjacent alleyway, looking south-west (72FmLa D100 05)

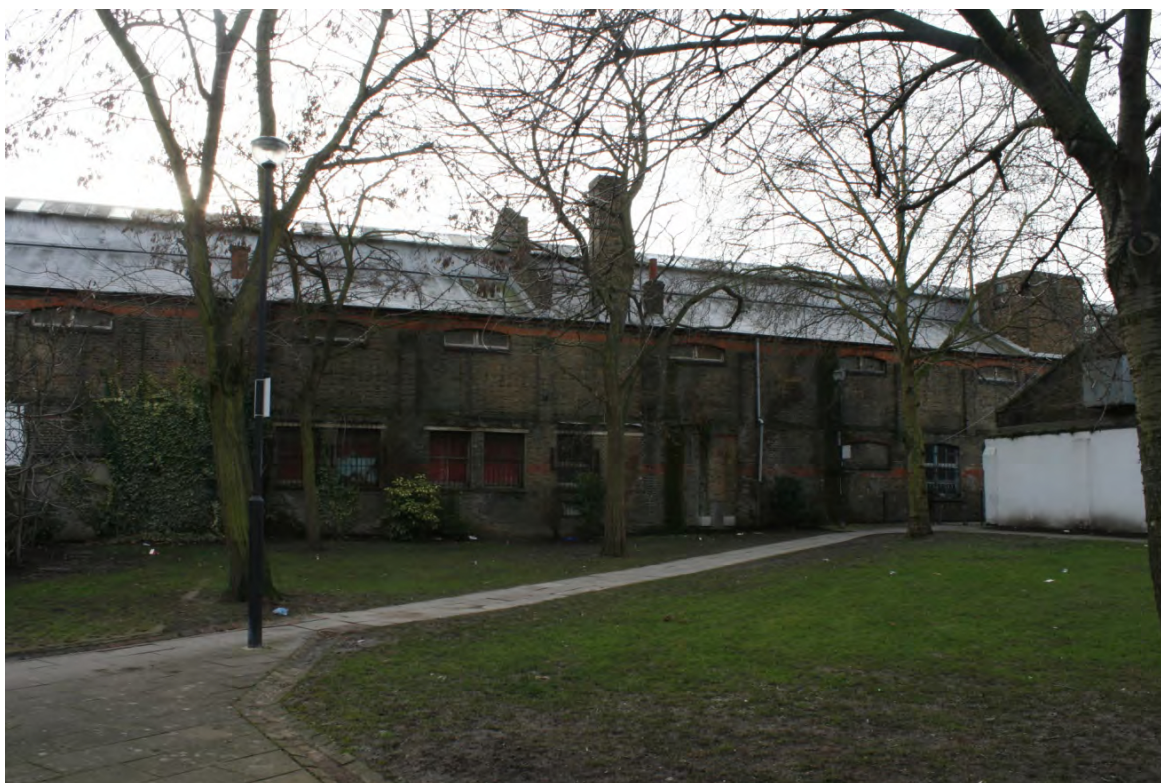
Plate 7: Central part of long north-west elevation, looking south (72FmLa D100 06)

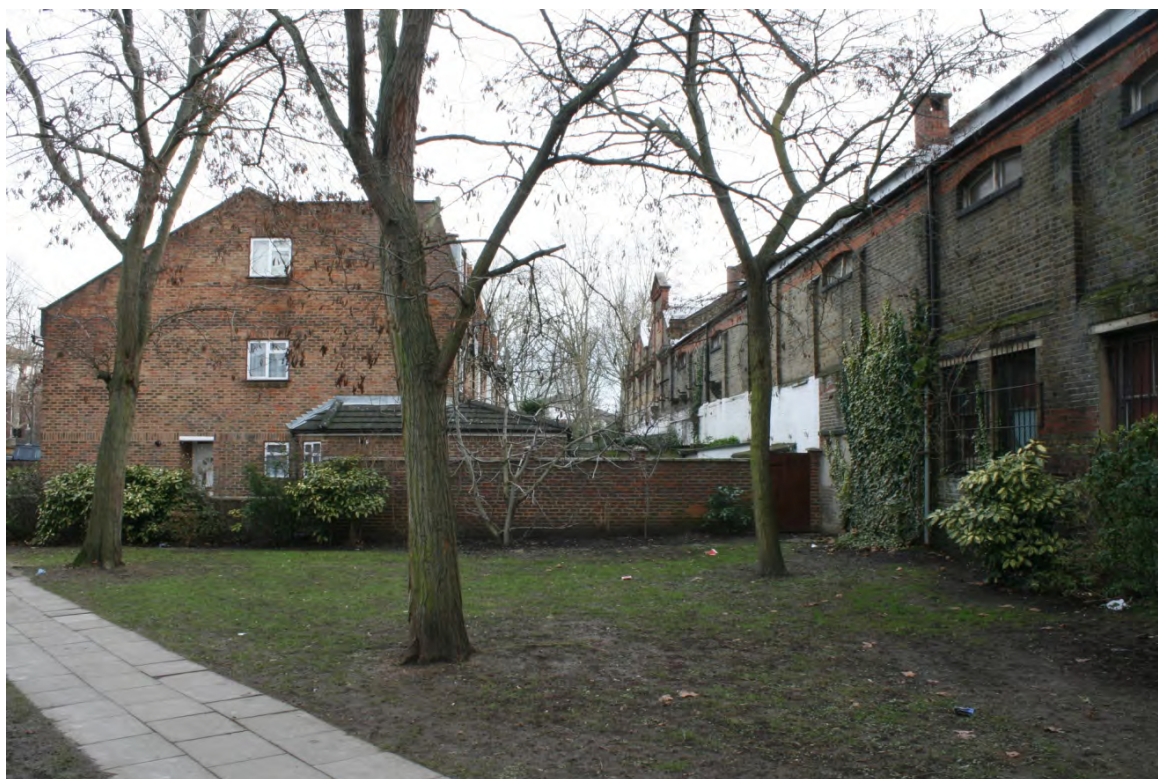
Plate 8: North-east end of long north-west elevation opposite private rear gardens, looking east
(72FmLa D100 07a)

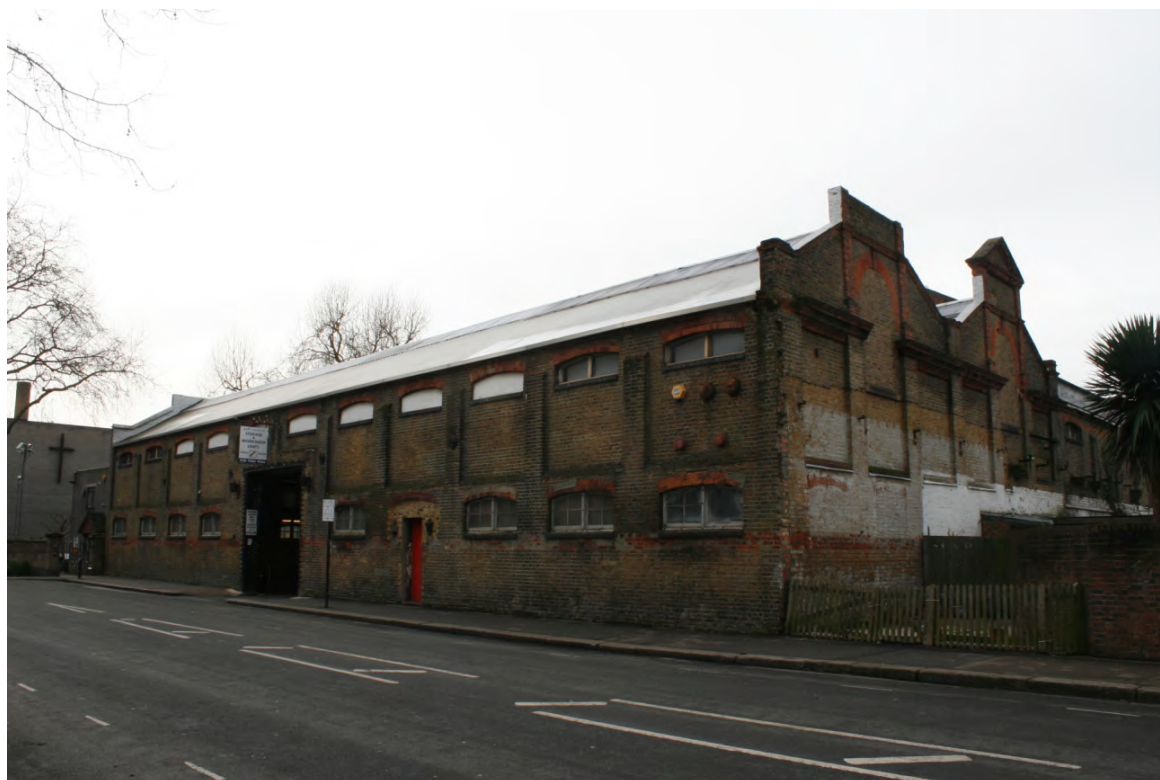
Plate 9: North-west (right) and north-east (left) elevations and Seagrave Road, looking south-west (72FmLa D100 008a)

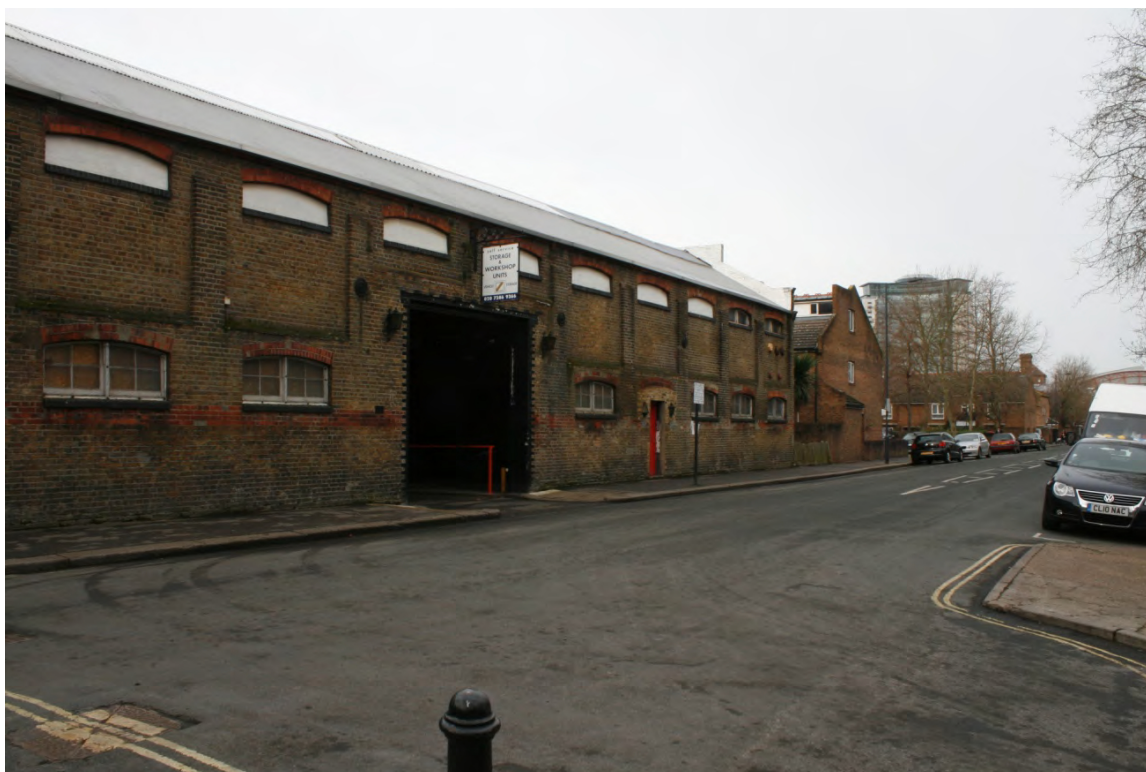
Plate 10: North-east elevation and Seagrave Road, looking west (72FmLa D100 009)

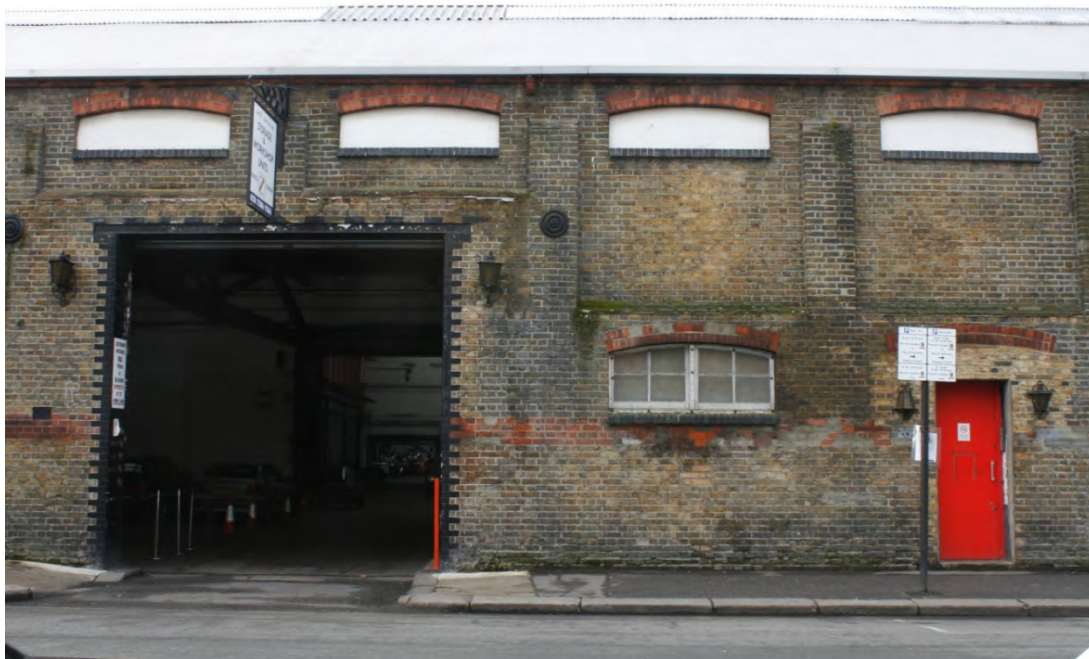
Plate 11: Inserted entrance in north-east elevation from Seagrave Road, looking south-west (72FmLa D100 010)

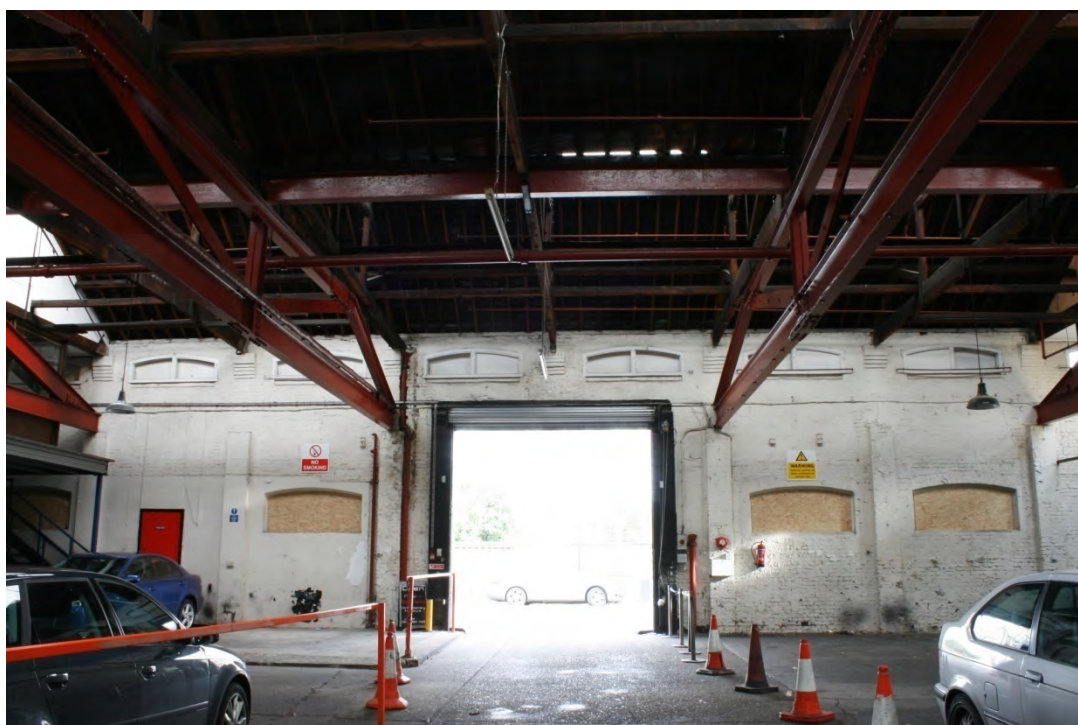
Plate 12: Internal view of the entrance from Seagrave Road in the north-east elevation, looking north-east (72FmLa D100 012)

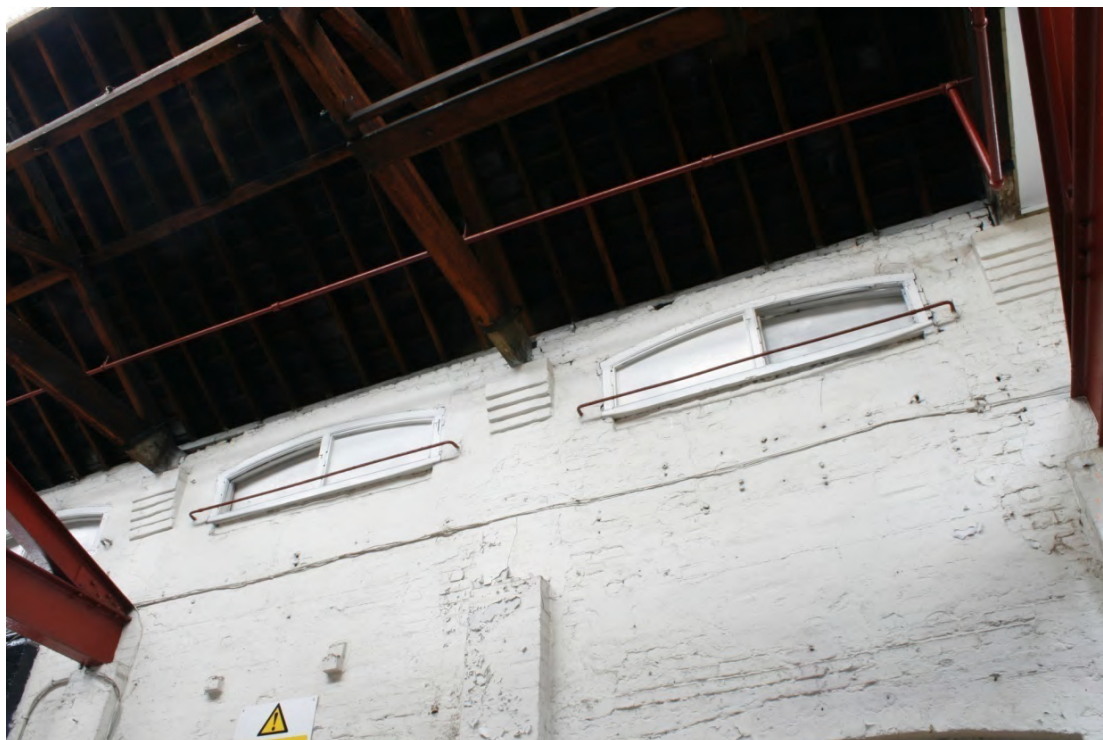
Plate 13: Internal view of blocked transom windows in the north-east elevation, looking north-east (72FmLa D100 017)

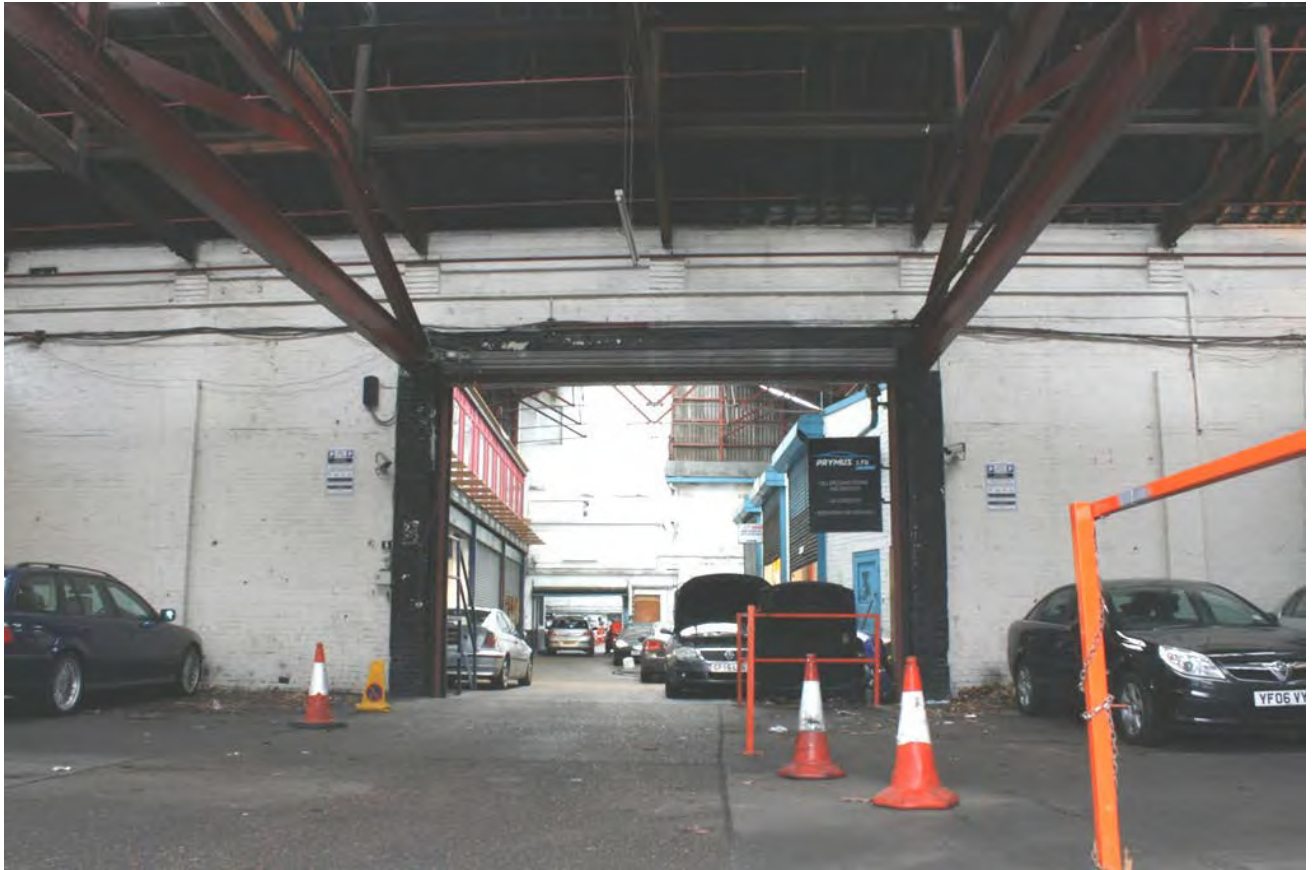
Plate 17: Entrance into main workshop area of garage from the north-east end of the building, looking south-west (72FmLa D100 020)

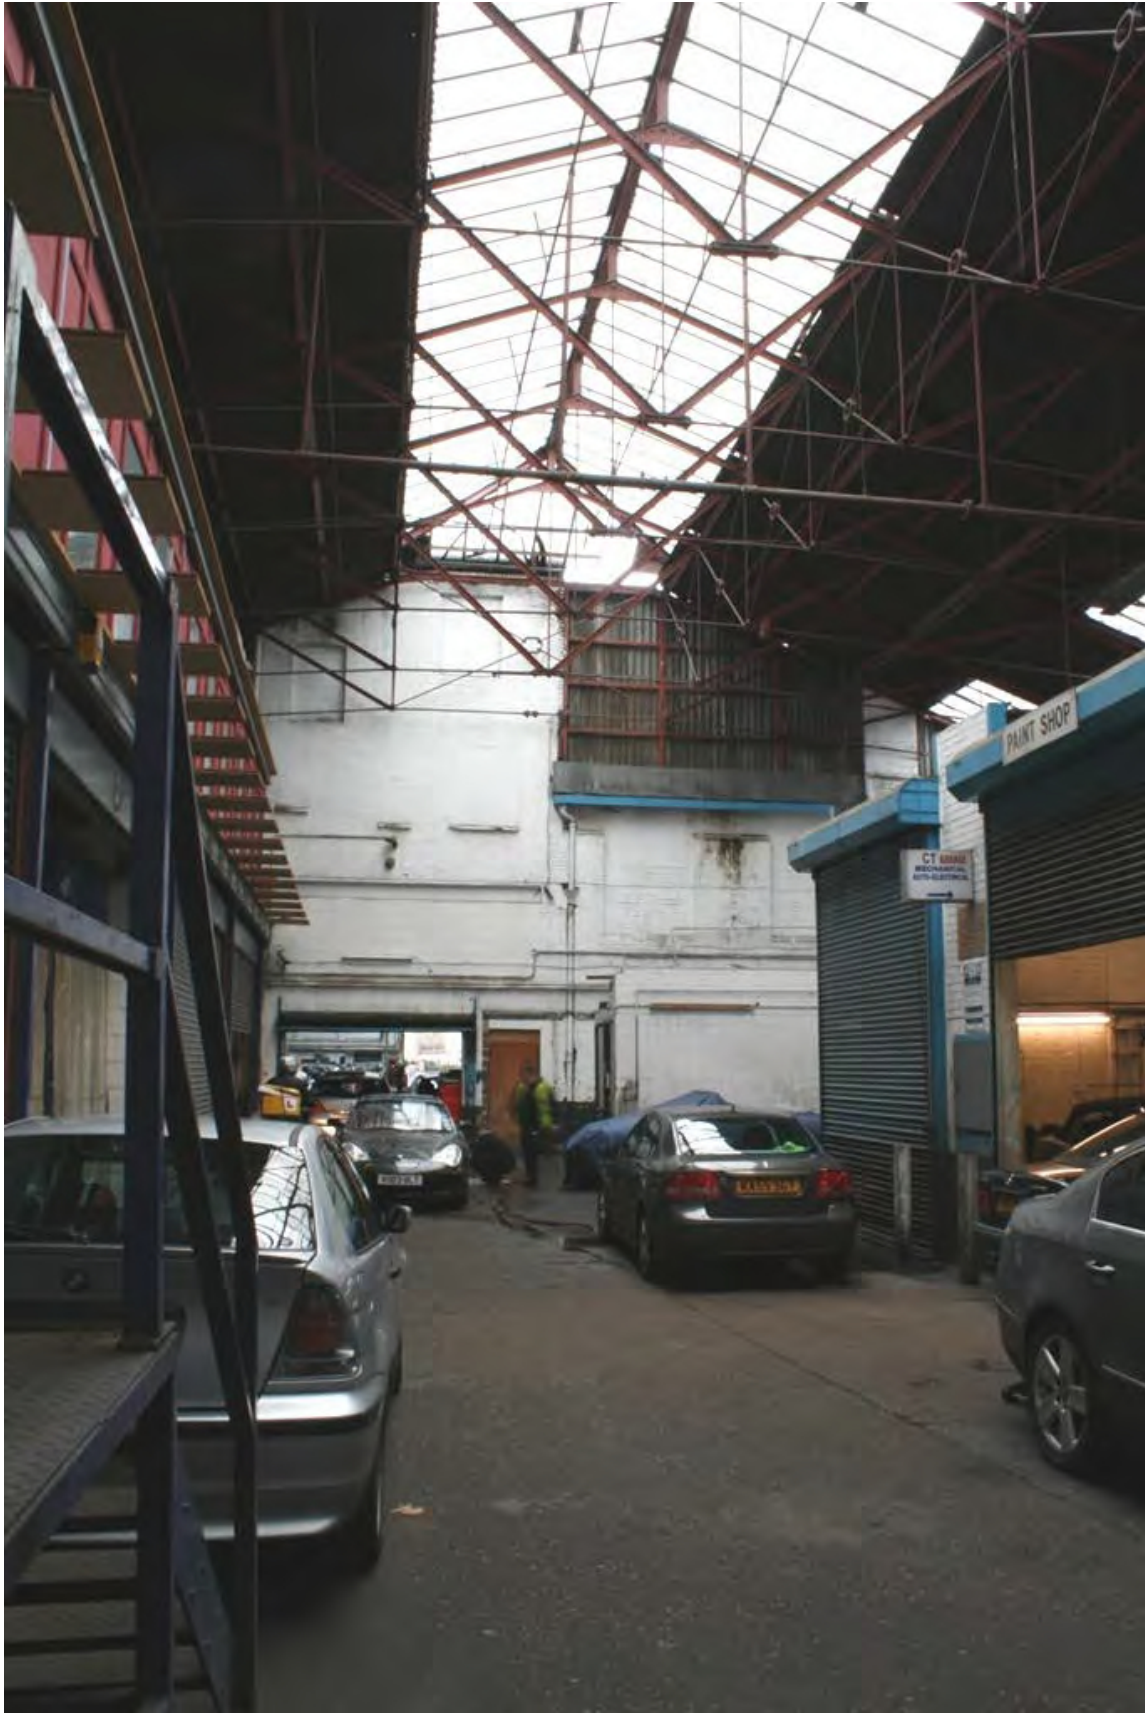
Plate 18: Main workshop area of the garage, looking south-west (72FmLa D100 021)

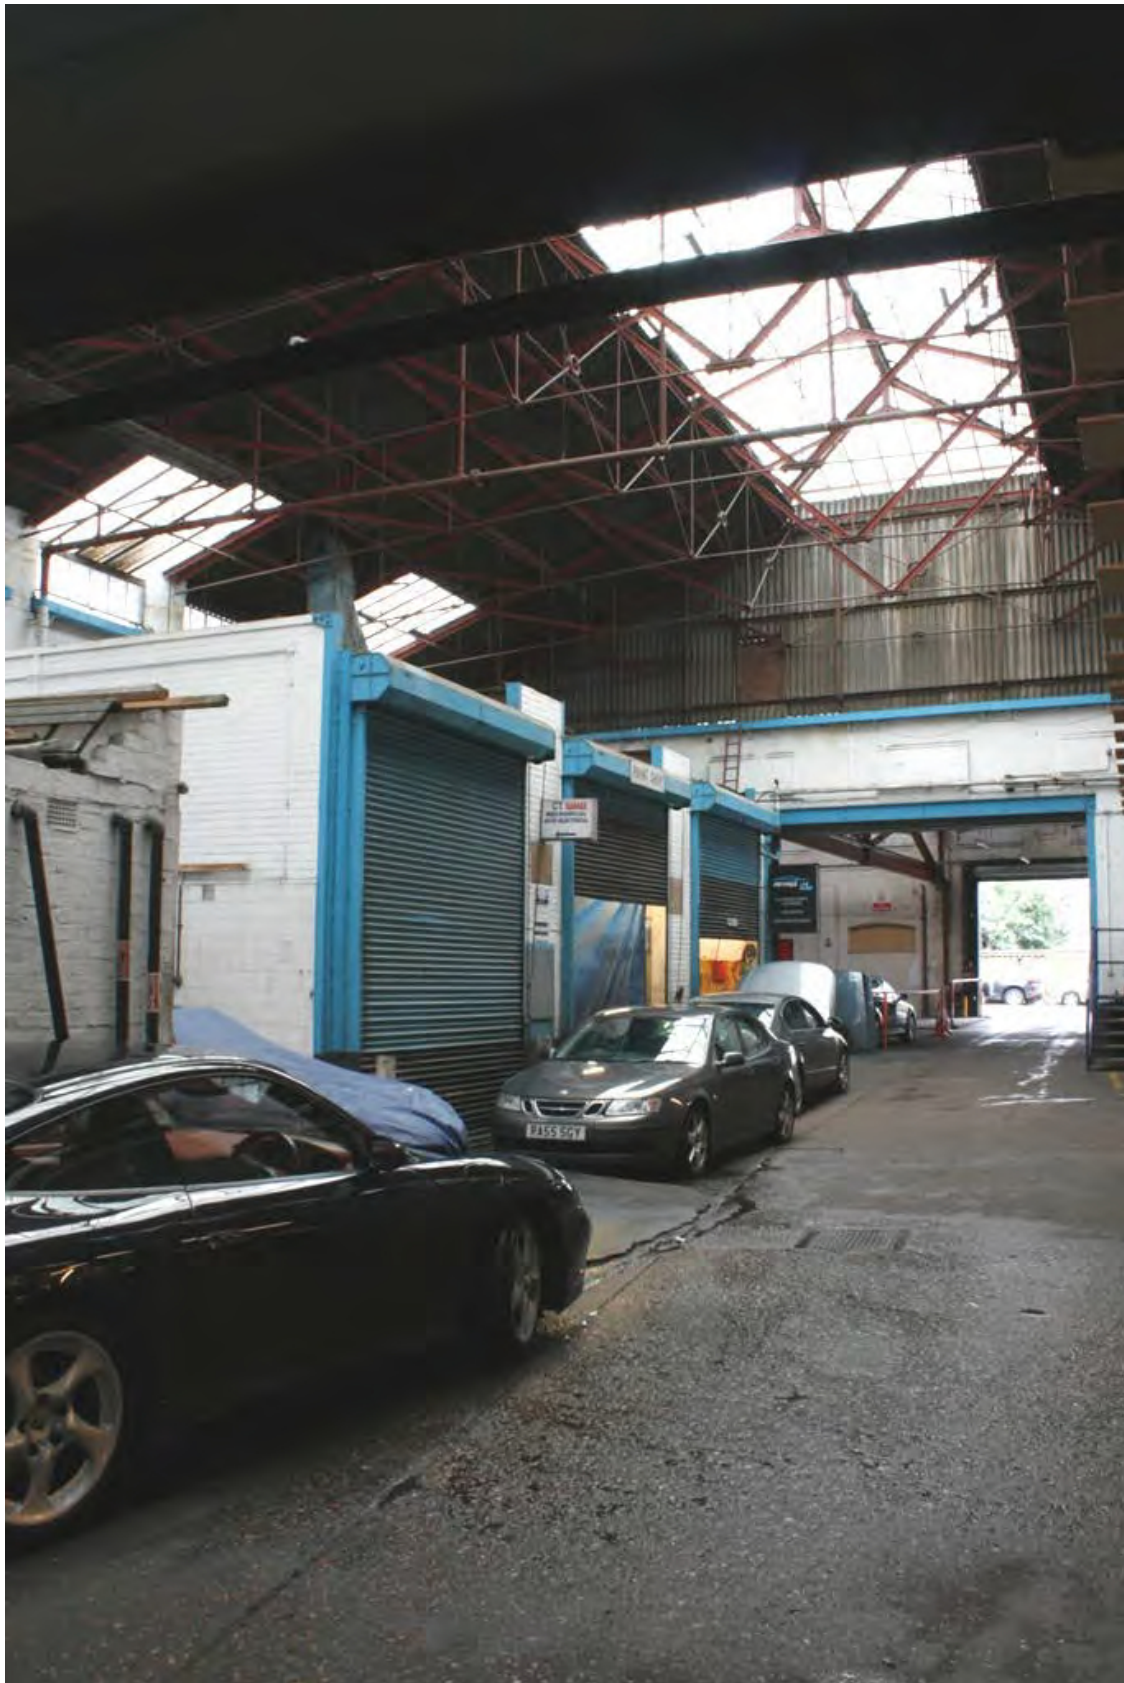
Plate 19: Main workshop area of the garage and Seagrave Road entrance (beyond), looking north-east (72FmLa D100 025)

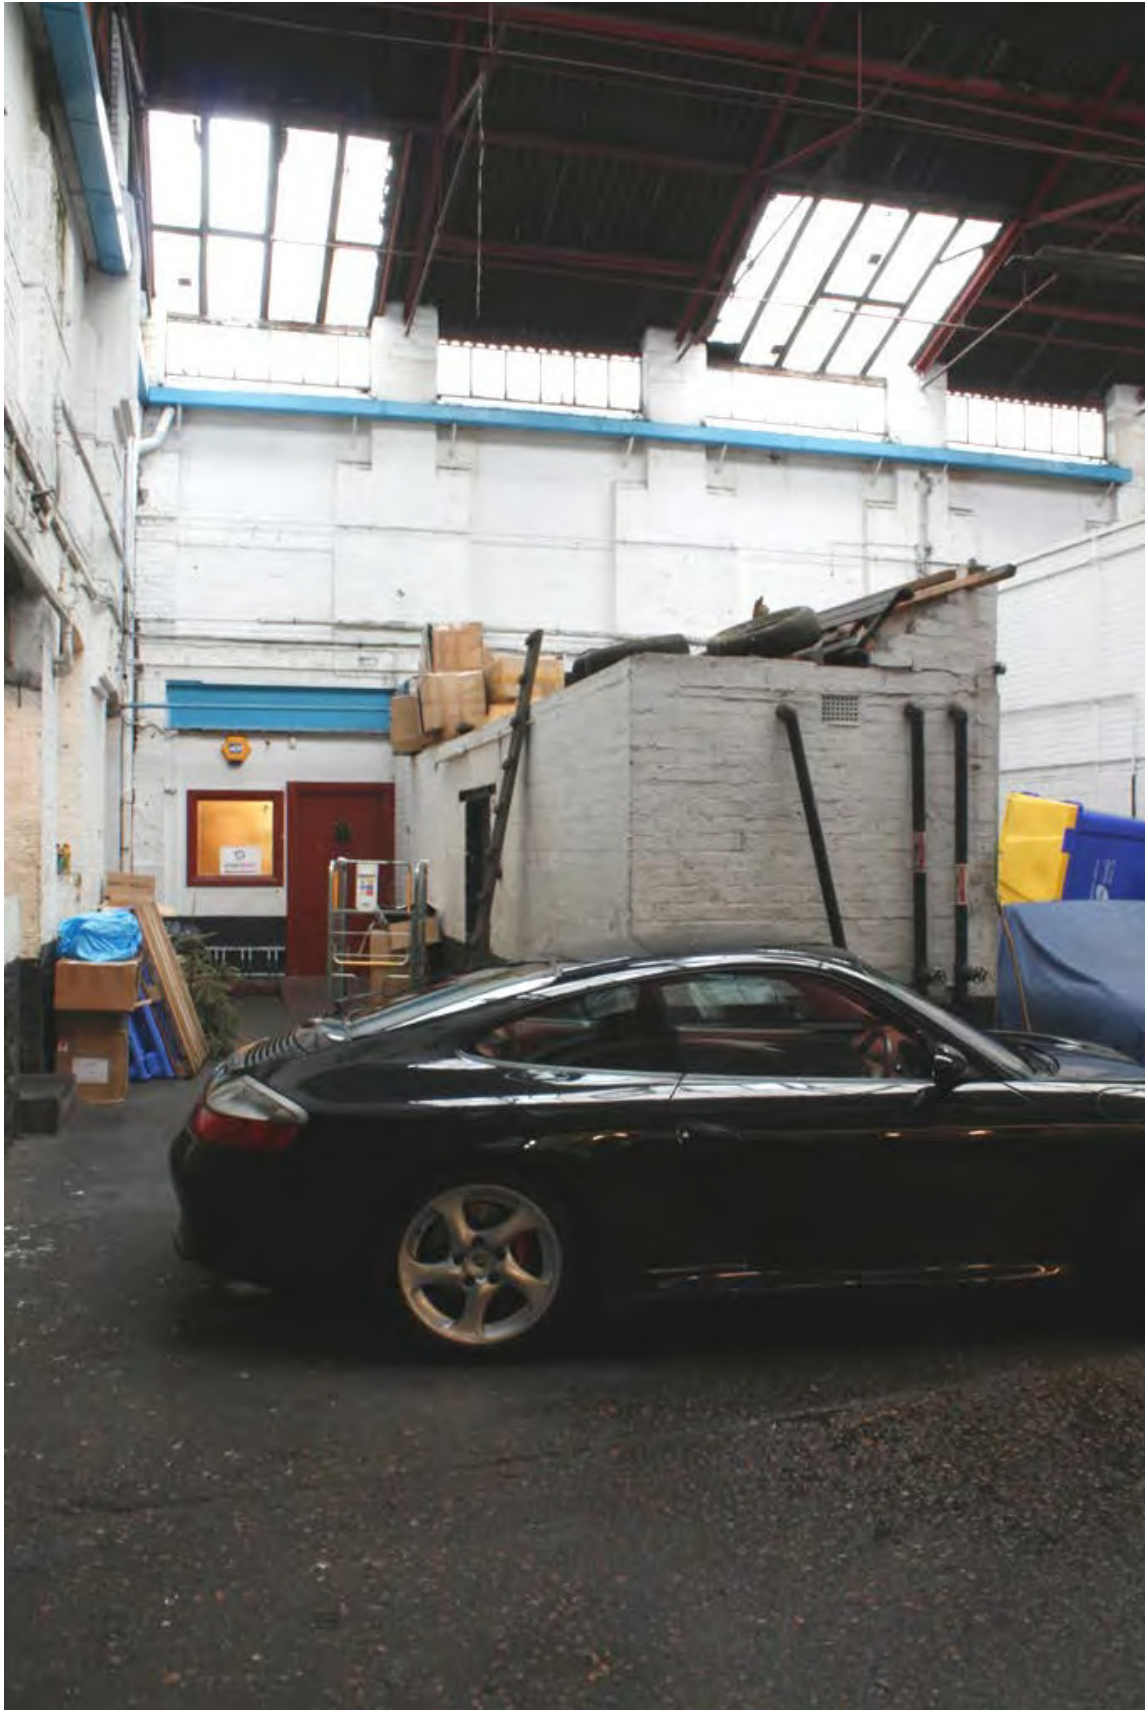
Plate 20: Skylights in the main workshop area of the garage, looking north-west (72FmLa D100 026)

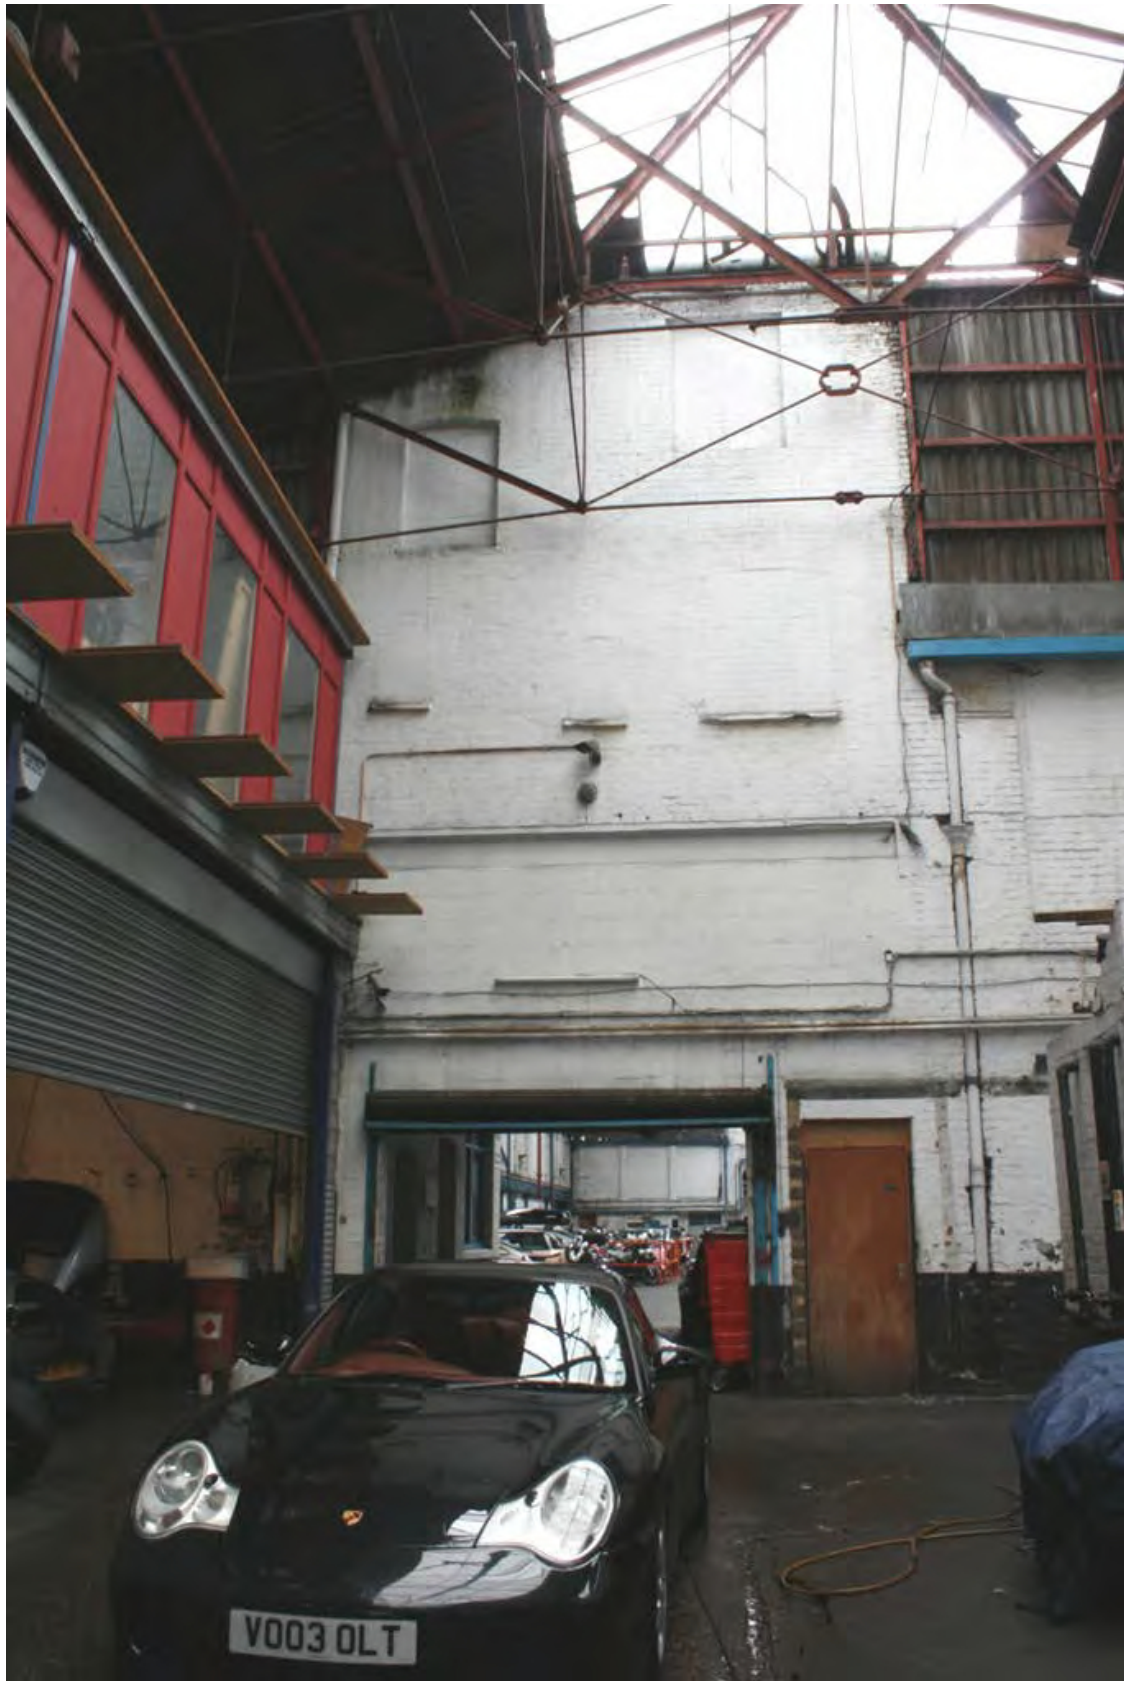
Plate 21: Passageway entrance from the main workshop area of the garage to the parking area beyond, looking south-west (72FmLa D100 023)
