**PHOTOGRAPHIC SURVEY
OF STEWART'S GARAGES,
72 FARM LANE, FULHAM,
LONDON BOROUGH OF
HAMMERSMITH AND
FULHAM, SW6 1QA**

PCA REPORT NO. R11379

FEBRUARY 2013

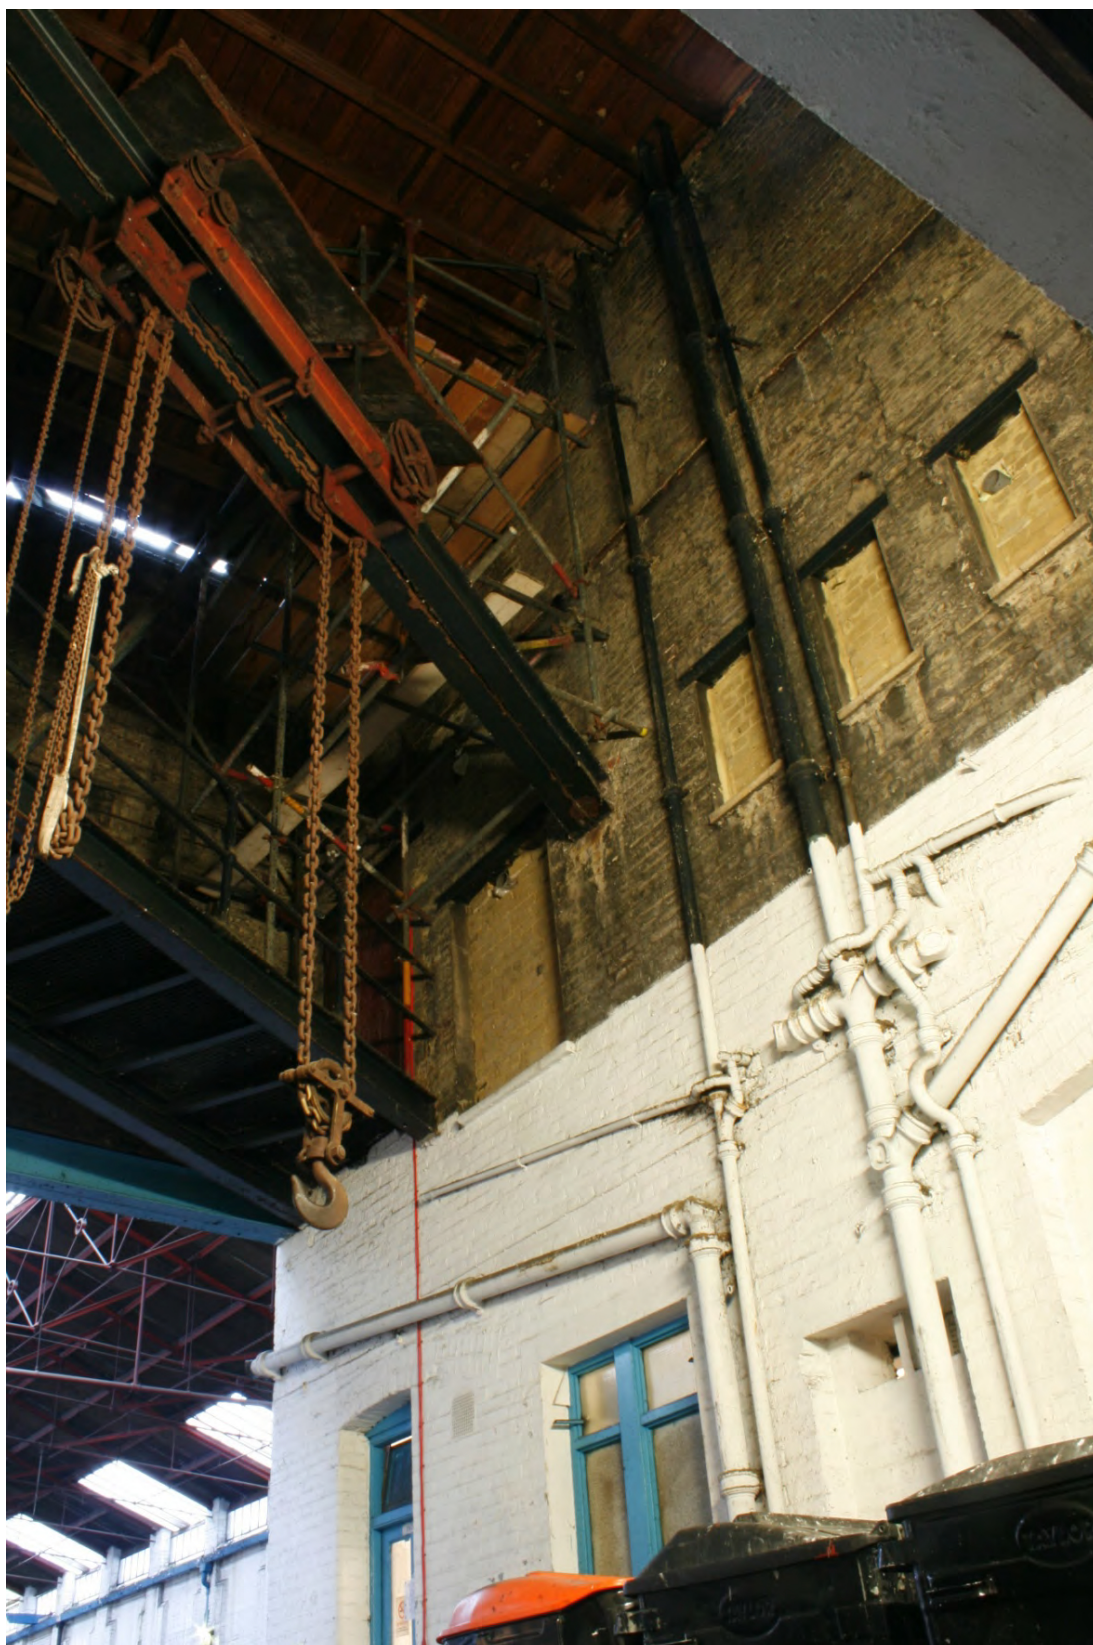
Plate 22: Passageway from the main workshop area of the garage to the parking area beyond showing blocked windows, overhead bridge and winching mechanisms, looking west (72FmLa D100 052)

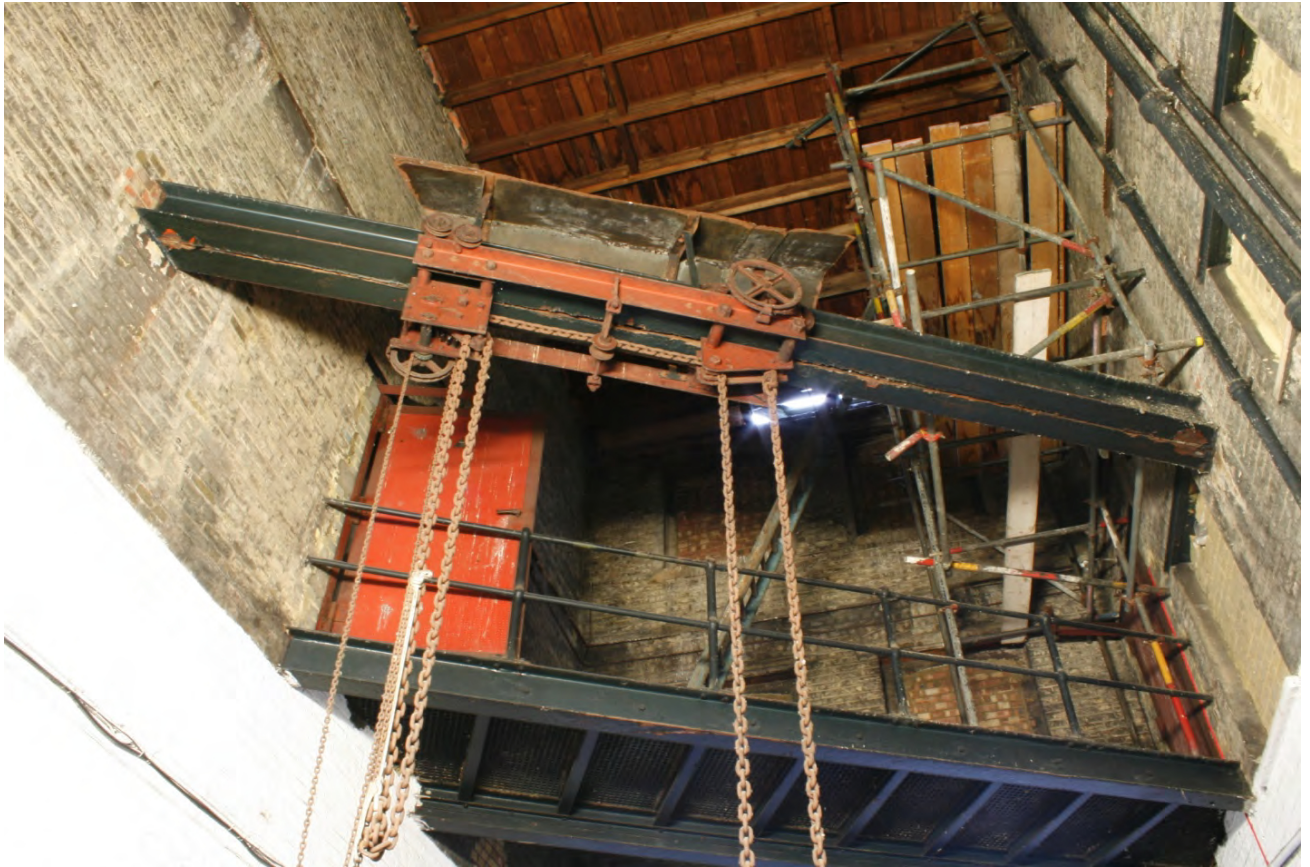
Plate 23: Overhead bridge and winching mechanisms within passageway from the main workshop area of the garage to the parking area beyond, looking south-west (72FmLa D100 053)

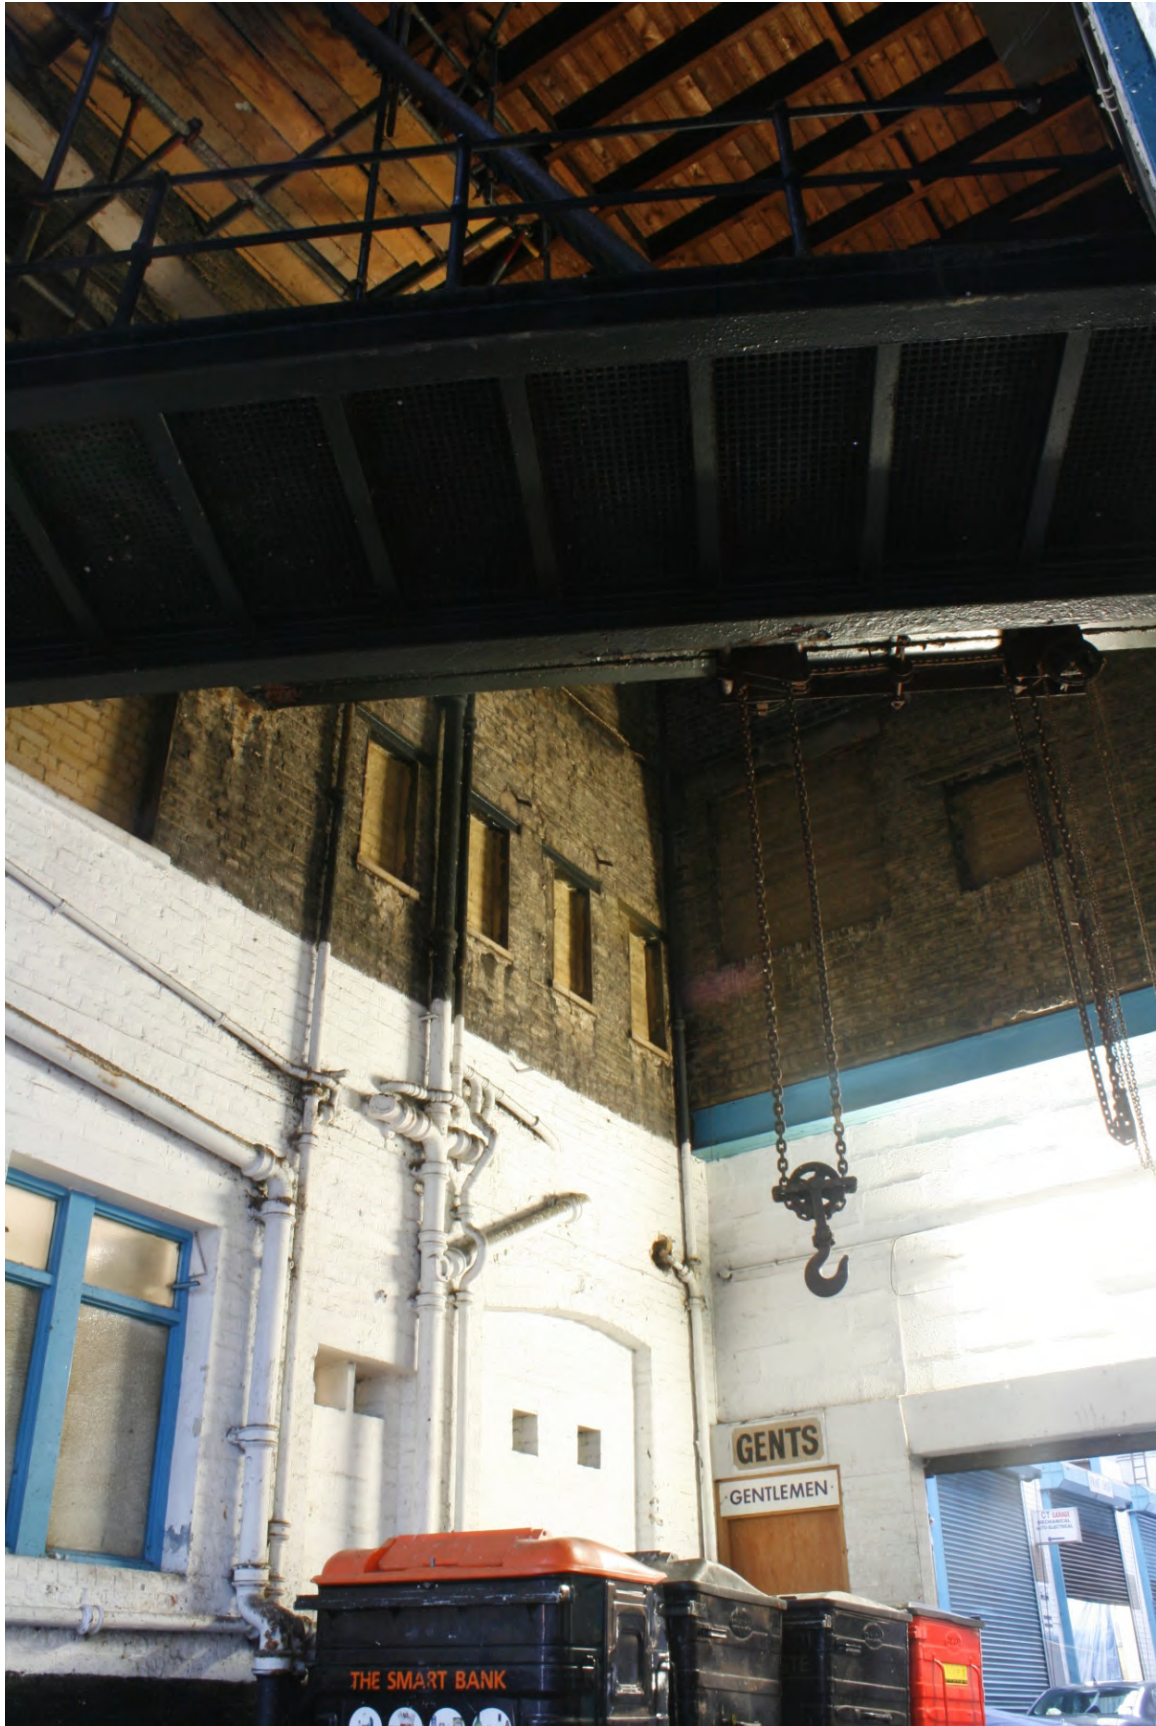
Plate 24: Overhead bridge within passageway, looking north (72FmLa D100 051)

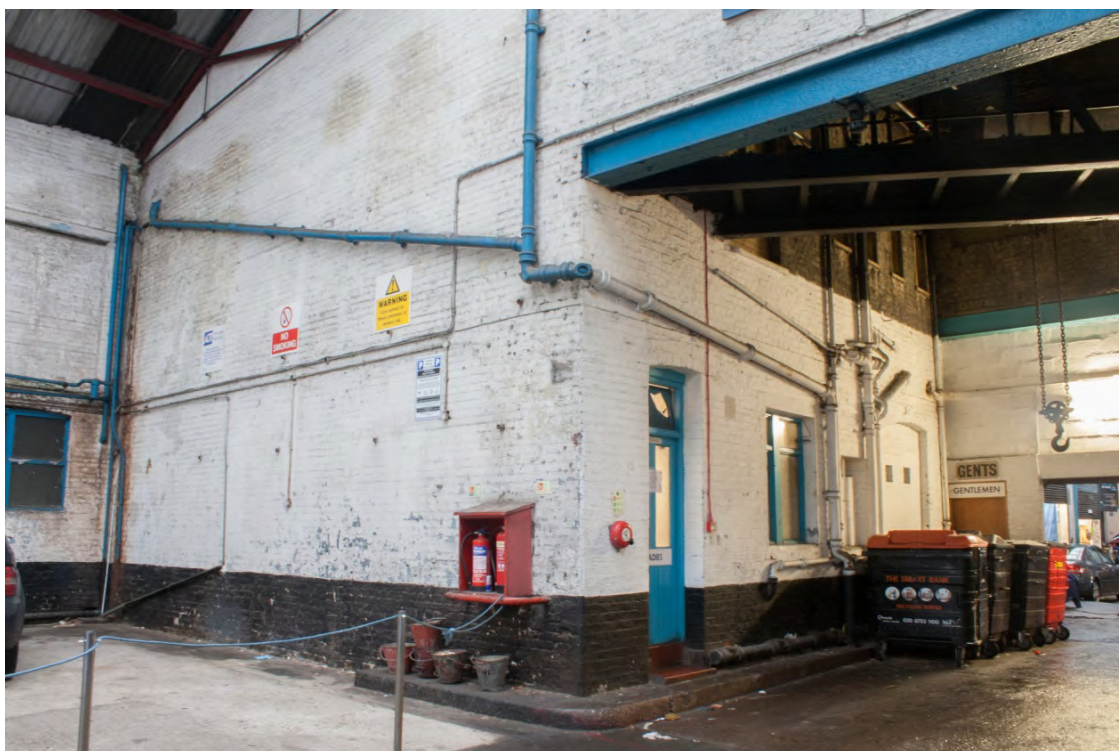
Plate 25: Passageway entrance leading from the parking area at the south-west end of the building to the main workshop area beyond, looking north (72FmLa D100 055)

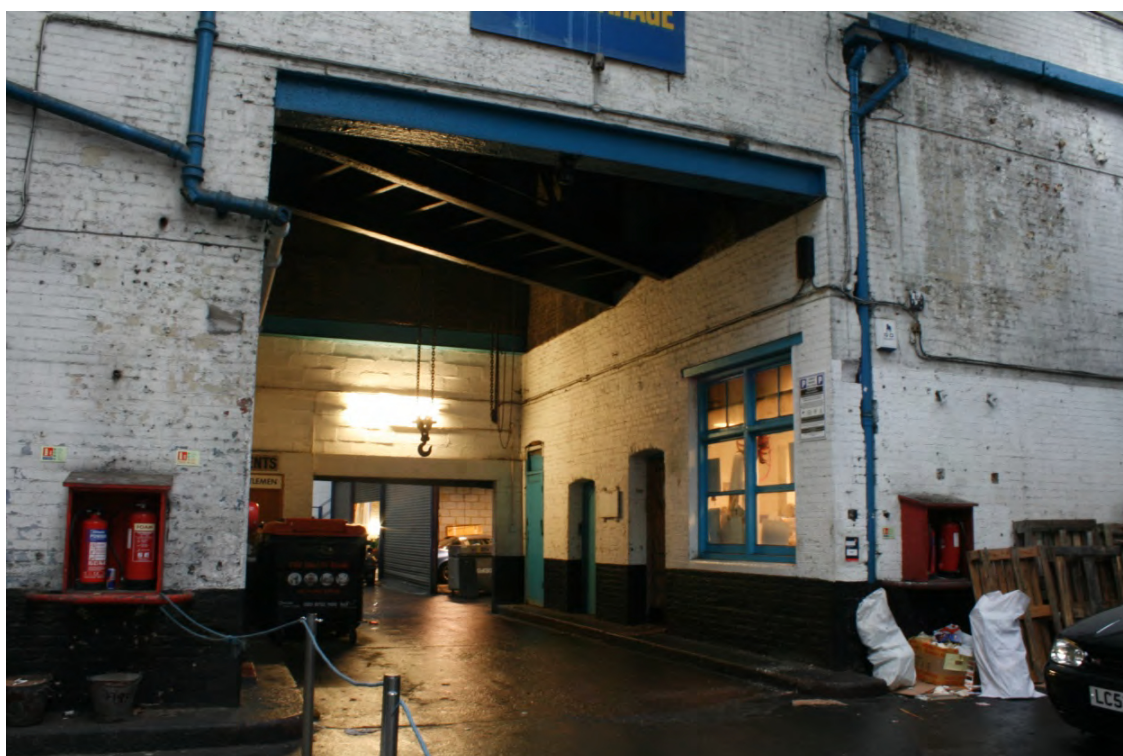
Plate 26: Passageway entrance from the parking area at the south-west end of the building to the main workshop area beyond, looking south-east (72FmLa D100 054)

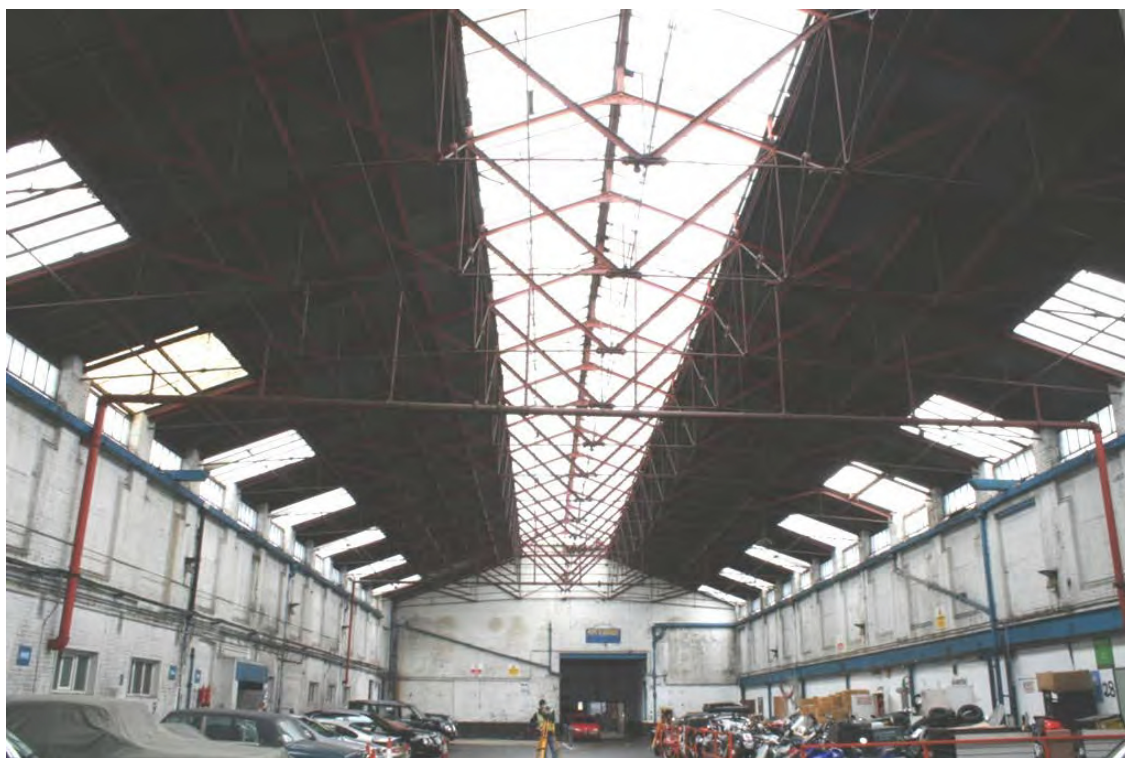
Plate 27: Parking area at the south-west end of the building, looking north-east (72FmLa D100 031a)

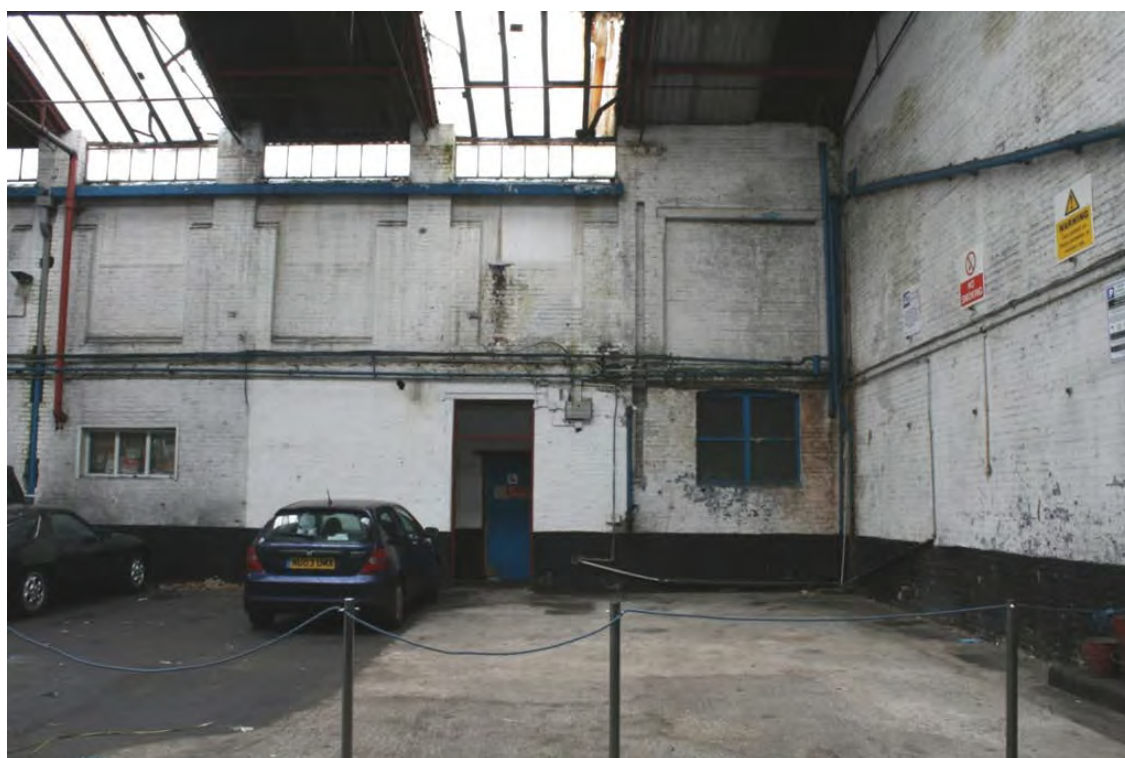
Plate 28: Original window opening (right) and later inserted door (centre) and ground floor window (left) on the north side of building, looking north (72FmLa D100 032)

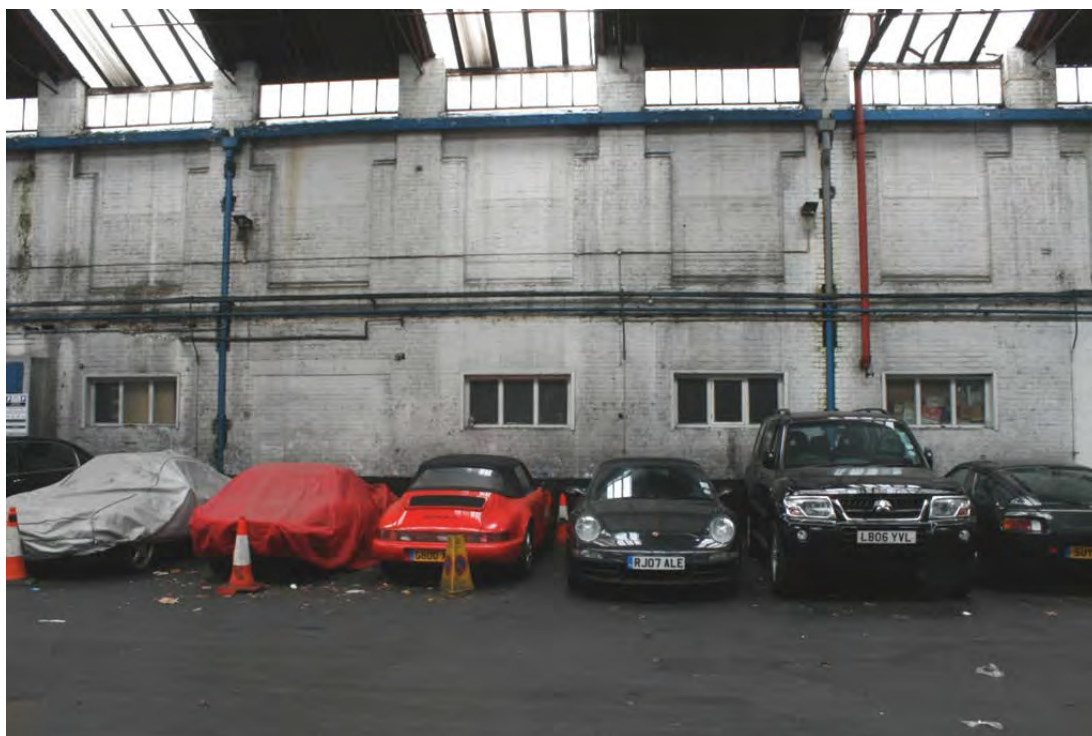
Plate 29: Inserted ground floor windows and blocked double doorway on the north side of building, looking north-west (72FmLa D100 033)

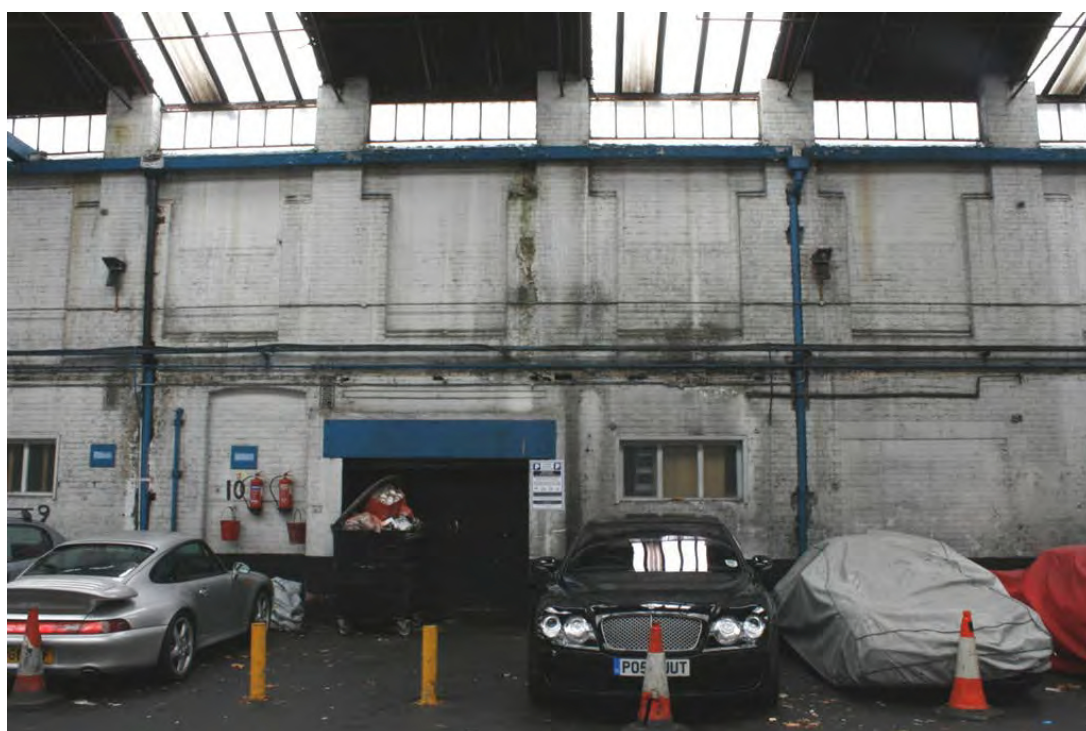
Plate 30: Inserted ground floor windows, original doorway (since infilled with brickwork), inserted double doorways (one blocked) on the north side of the building, looking north-west (72FmLa D100 034)

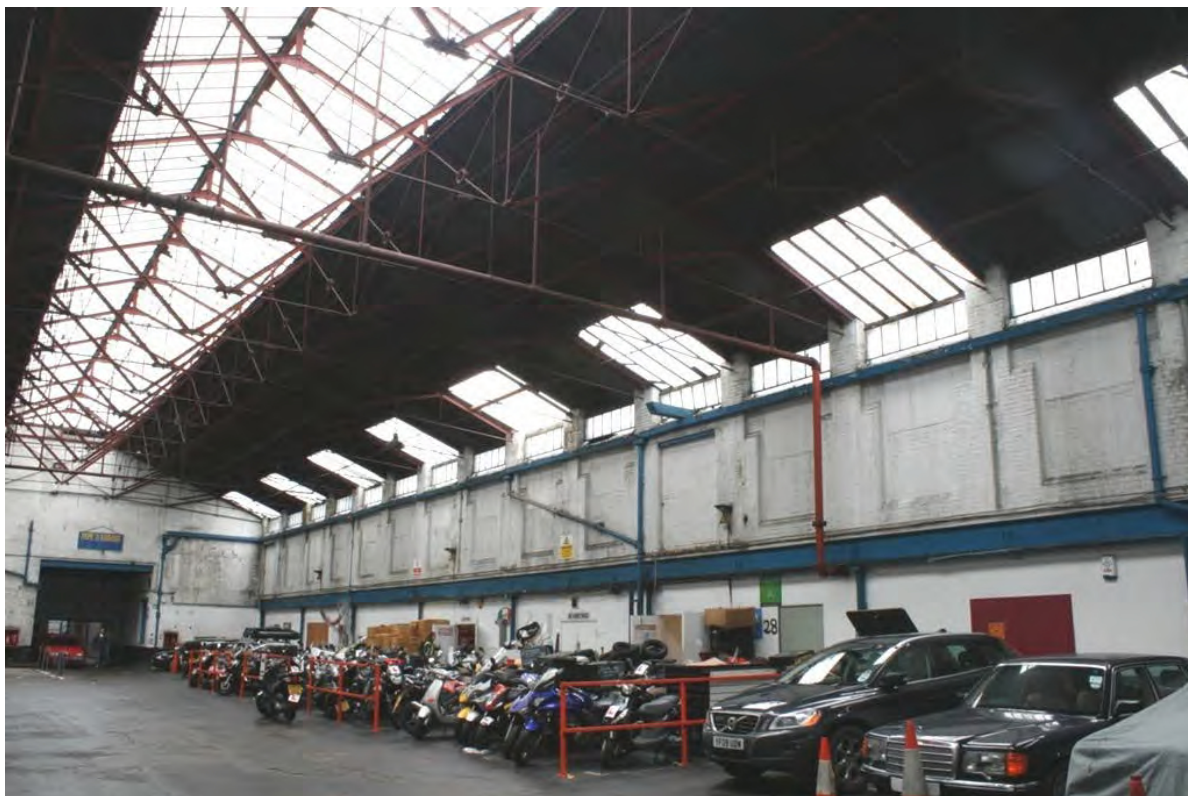
Plate 31: New workshops on the south side of the building, looking east (72FmLa D100 037)

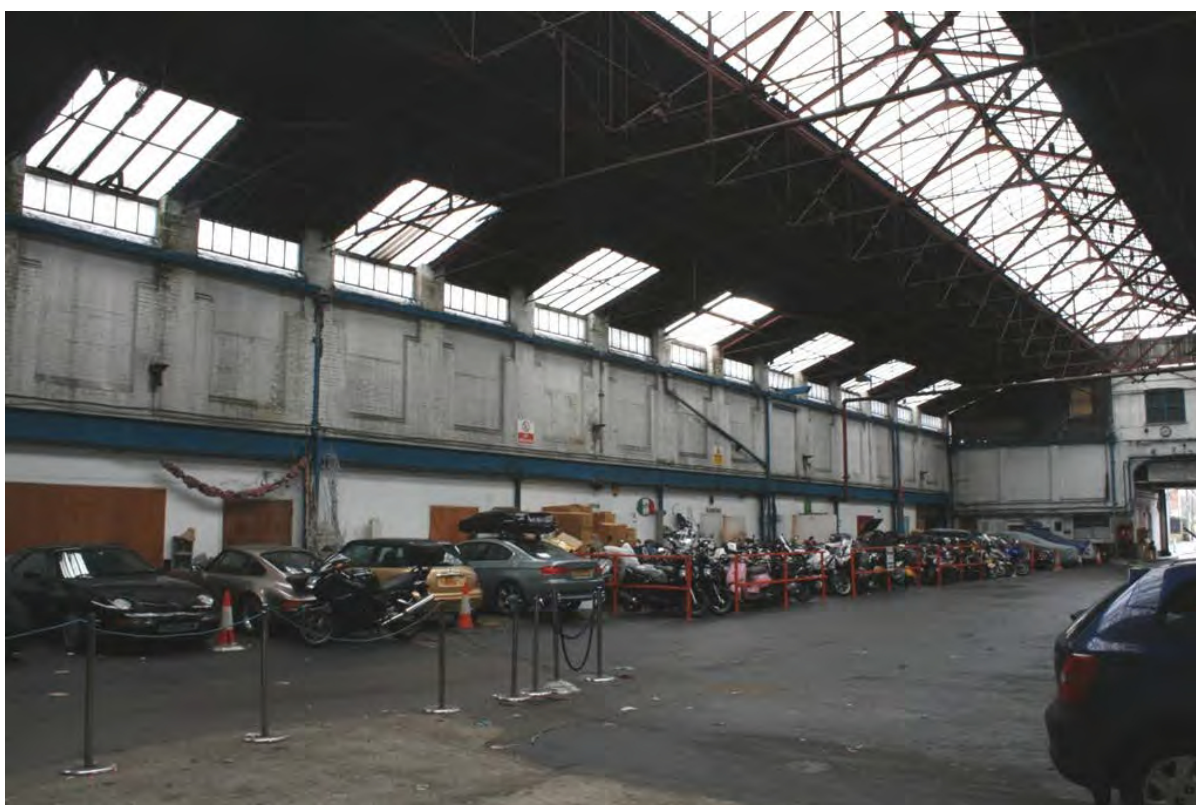
Plate 32: New workshops on the south side of the building, looking south-west (72FmLa D100 038)

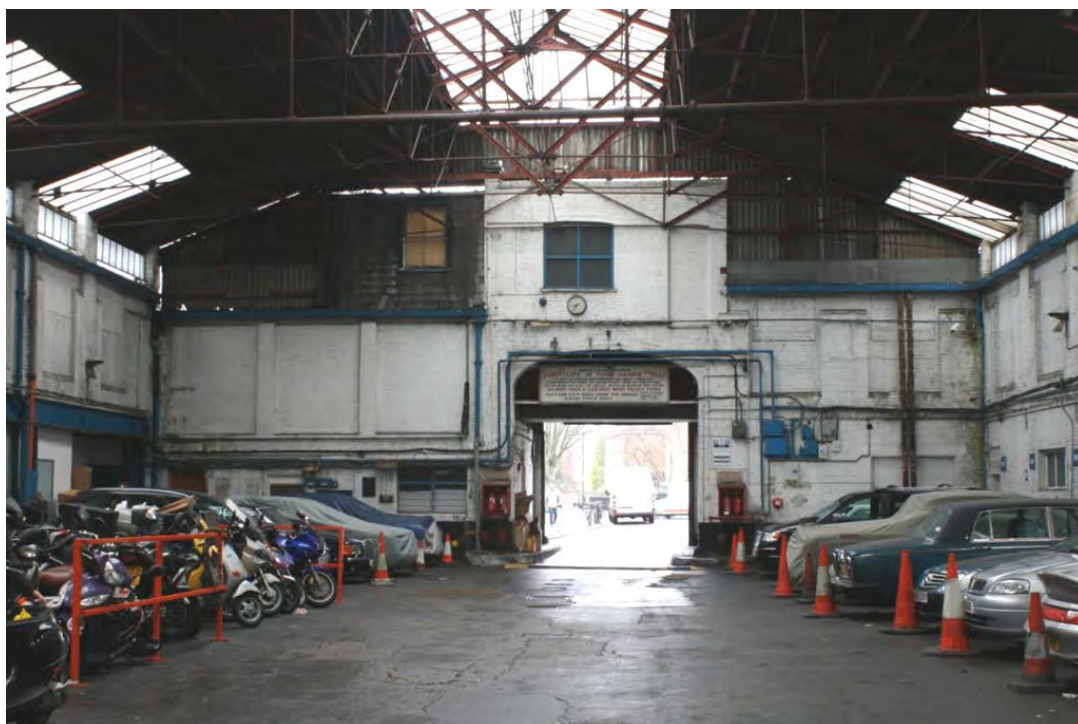
Plate 33: Internal view of the passageway entrance from Farm Lane into the building, looking south-west (72FmLa D100 041)

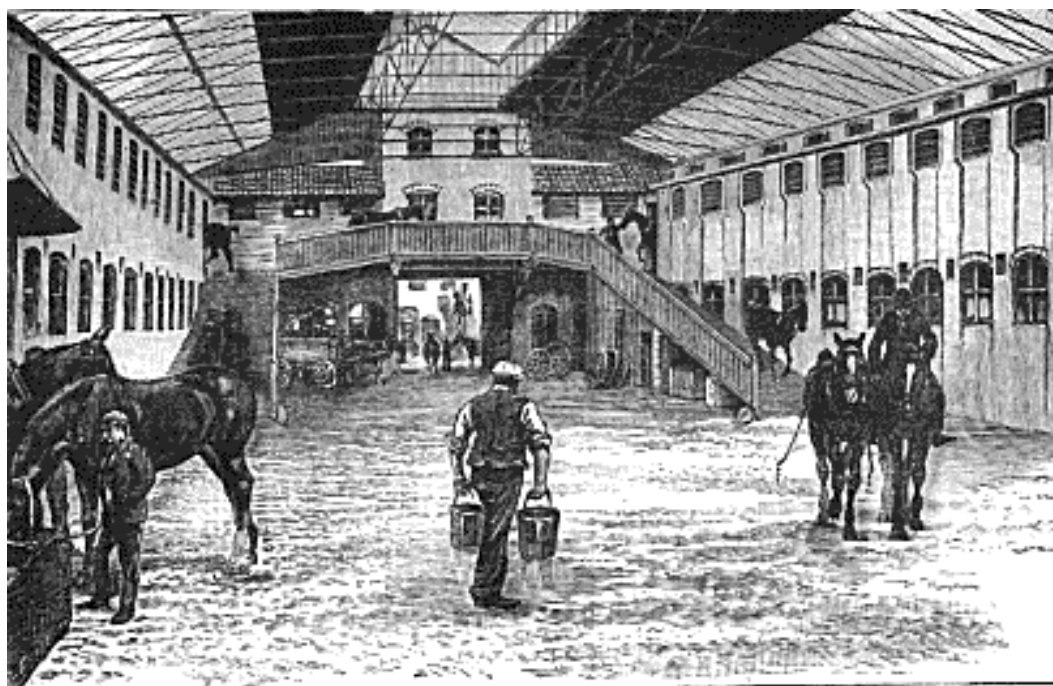
ROAD CAR COMPANY: FARM LANE YARD

Plate 33a: Late 19th century view (the same view as Plate 33) of the London Road Car Company depot showing the passageway entrance from Farm Lane into the building, looking south-west (<http://www.victorianlondon.org/publications6/horse-01.htm>)

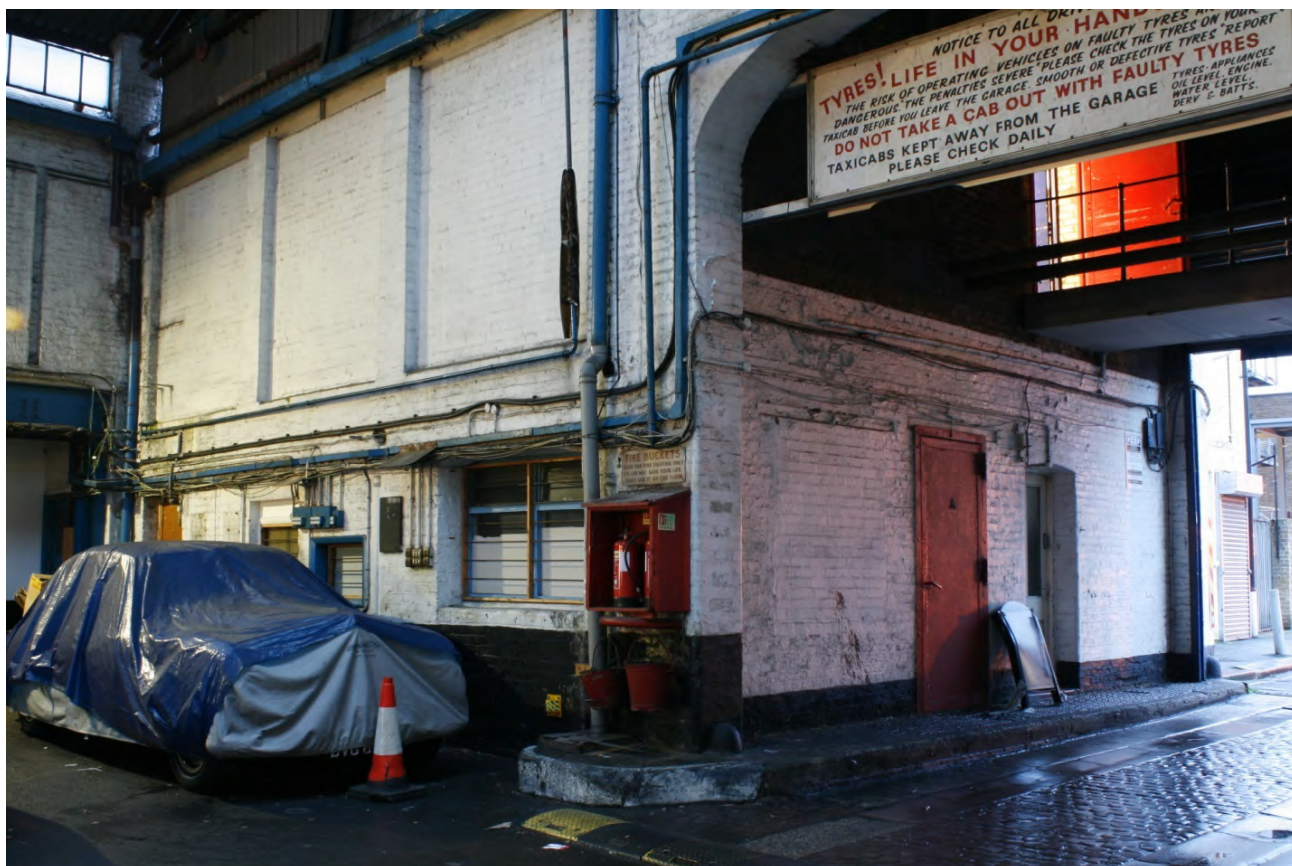
Plate 34: Internal view of the passageway entrance from Farm Lane into the building, looking south-west (72FmLa D100 057)

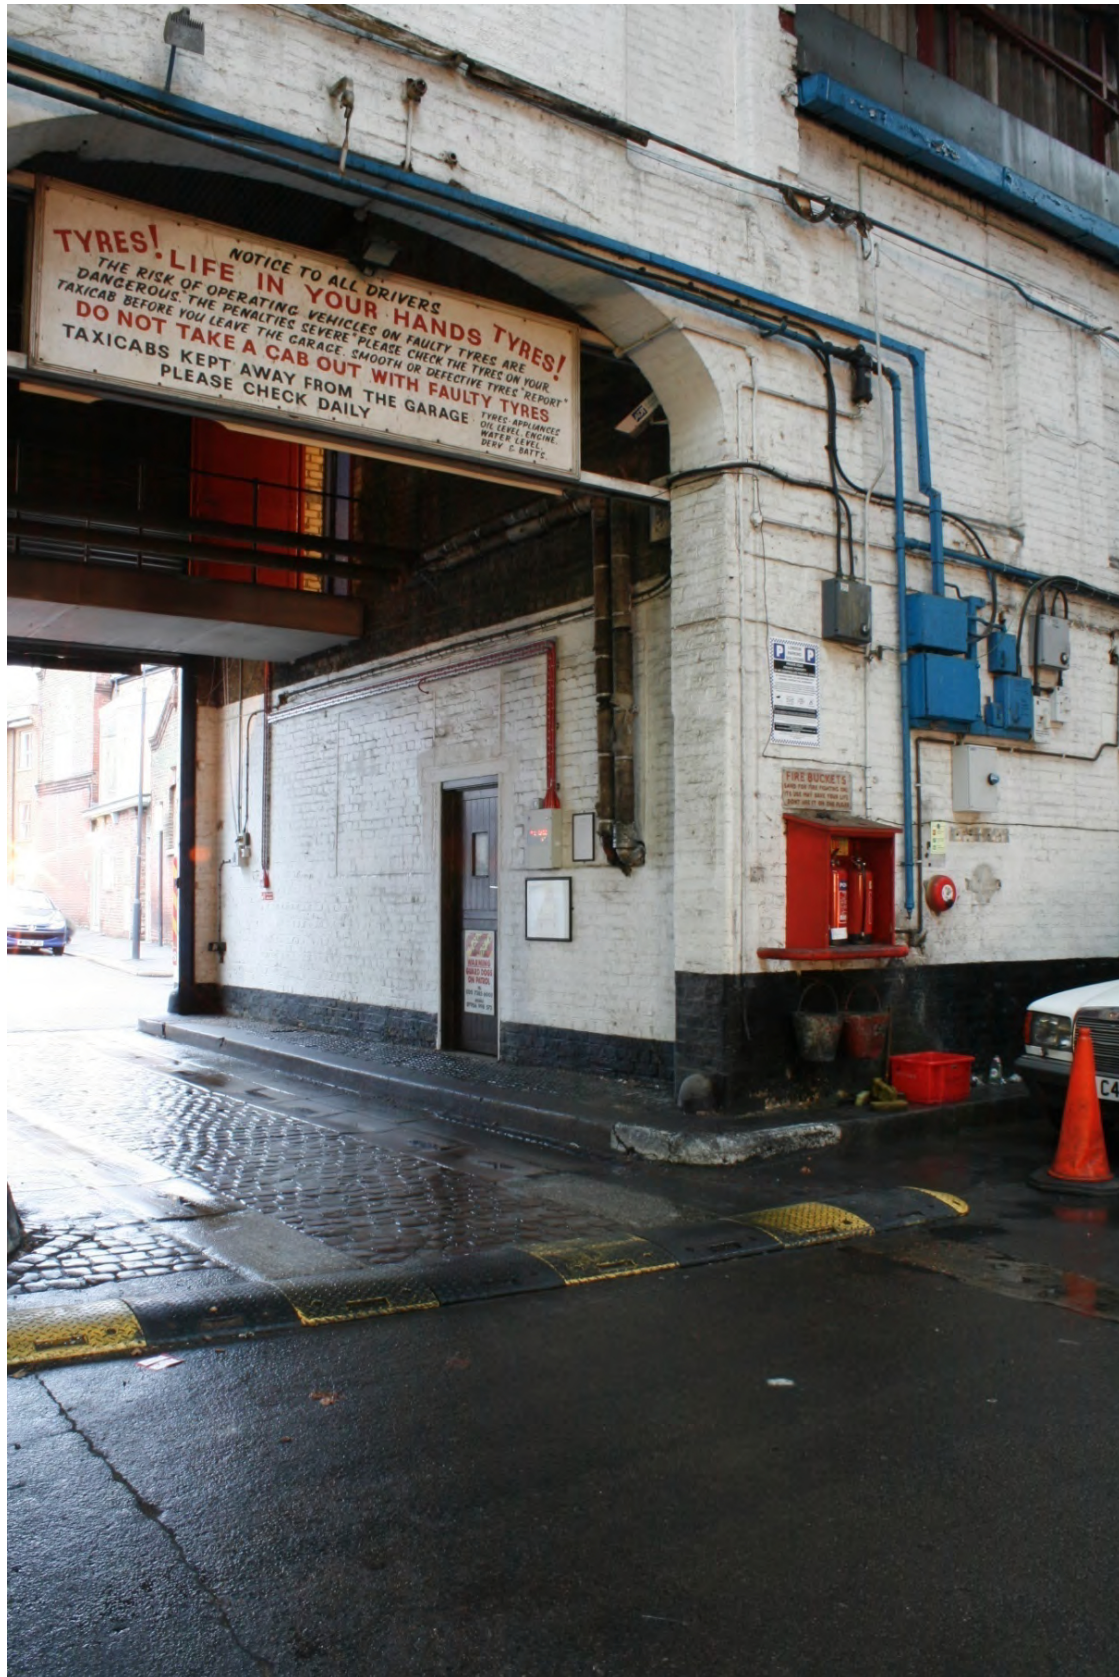
Plate 35: Internal view of the passageway entrance from Farm Lane into the building, looking north-west (72FmLa D100 056)

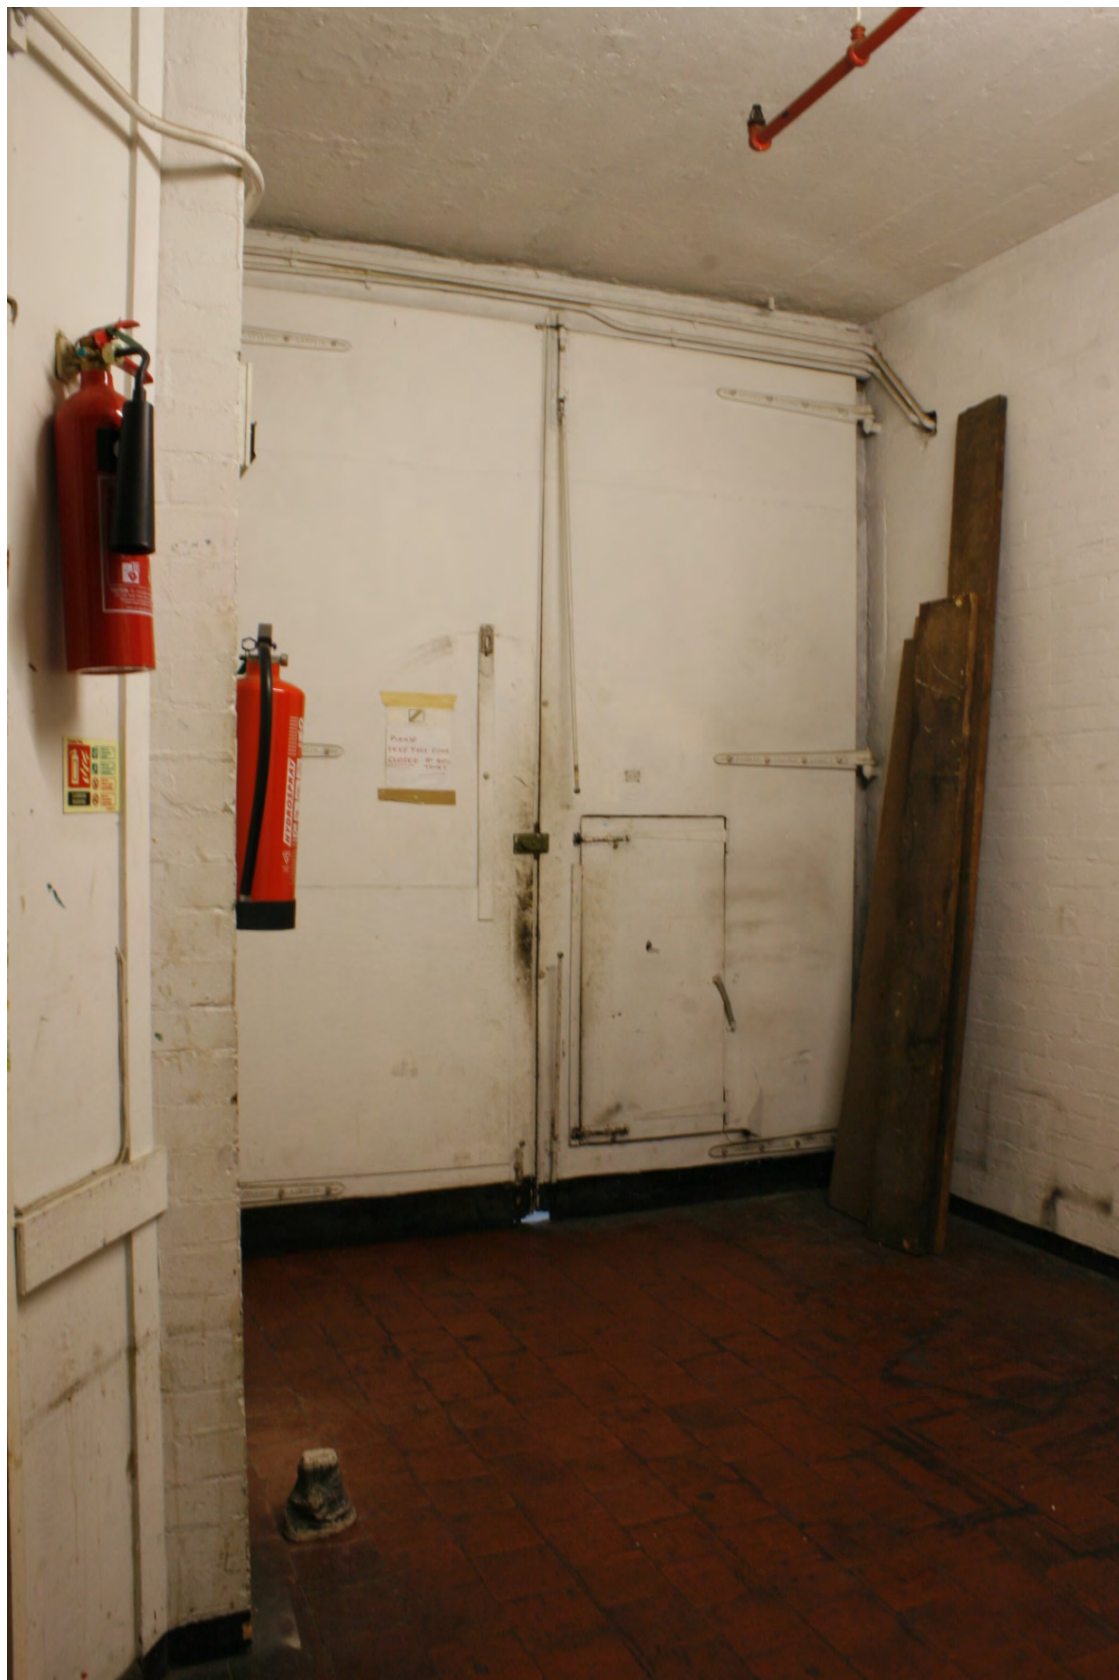
Plate 36: Double door with cast iron strap hinges stamped Charles Collinge of Lambeth, looking south (72FmLa D100 043)

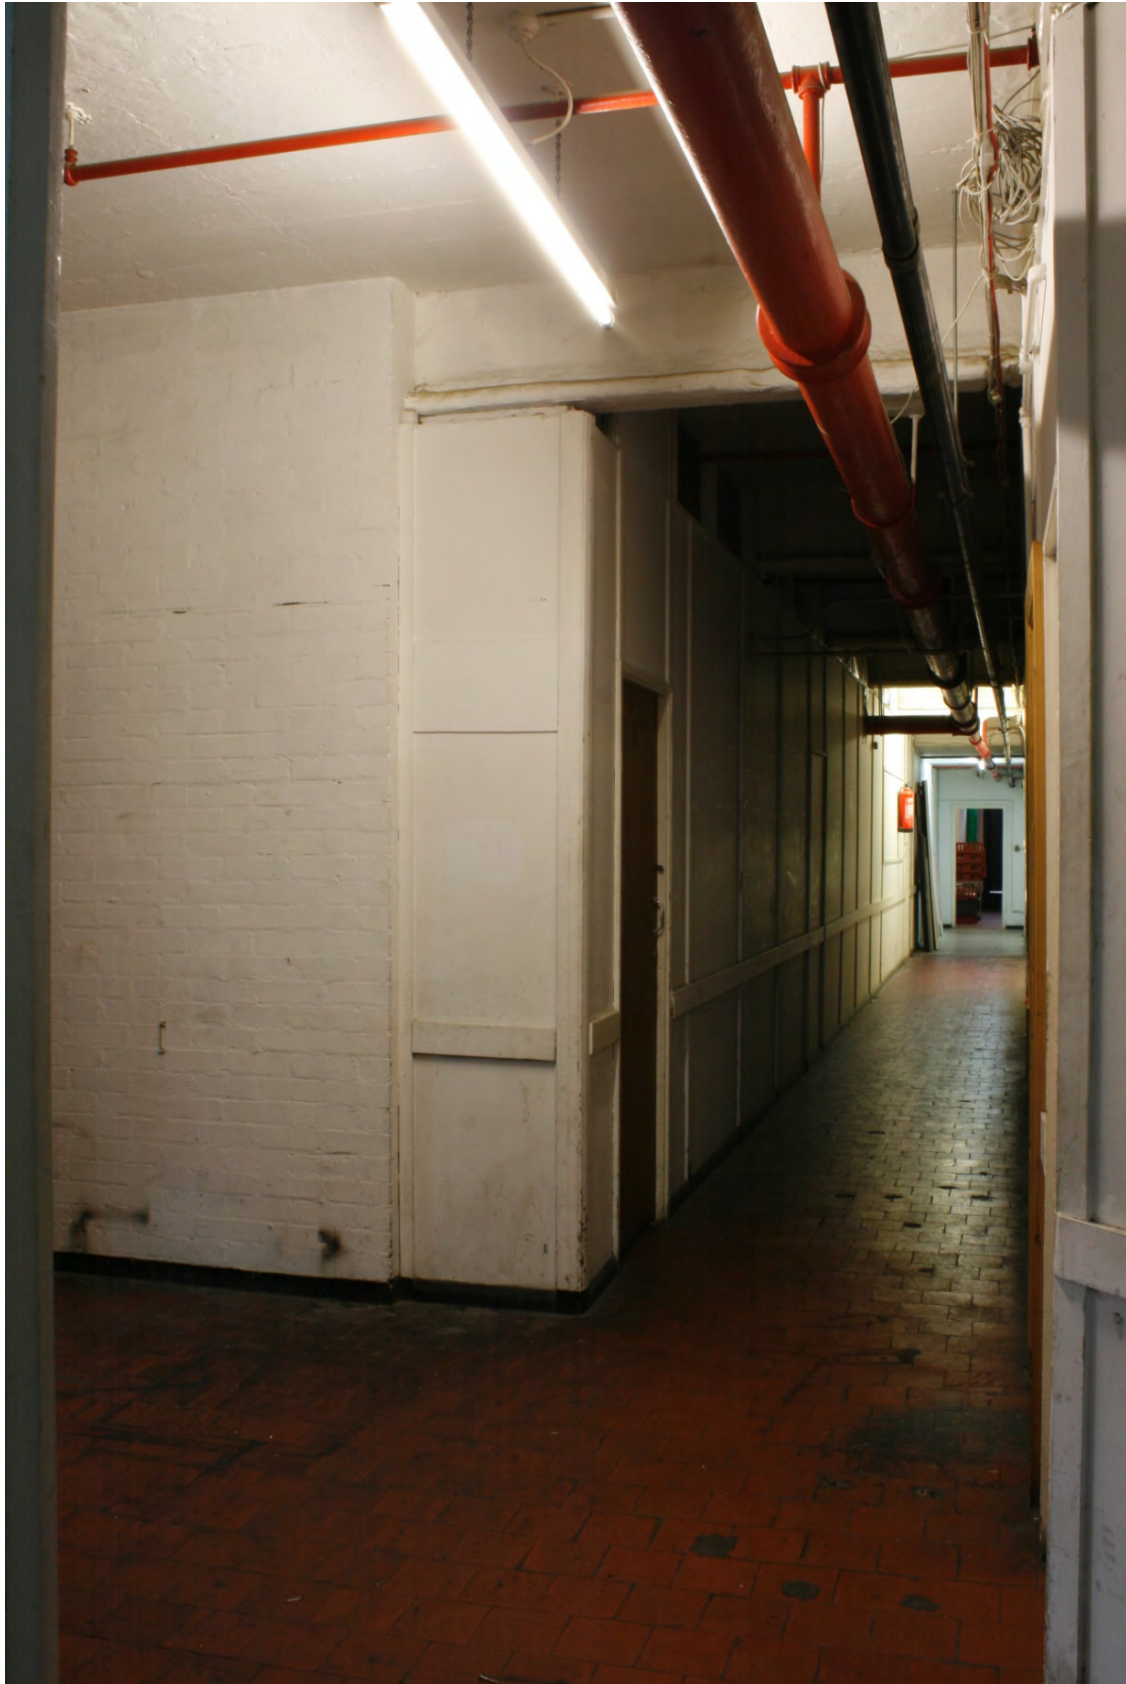
Plate 37: Ground floor access corridor within storage area on the north side of the building, looking south-west (72FmLa D100 044)

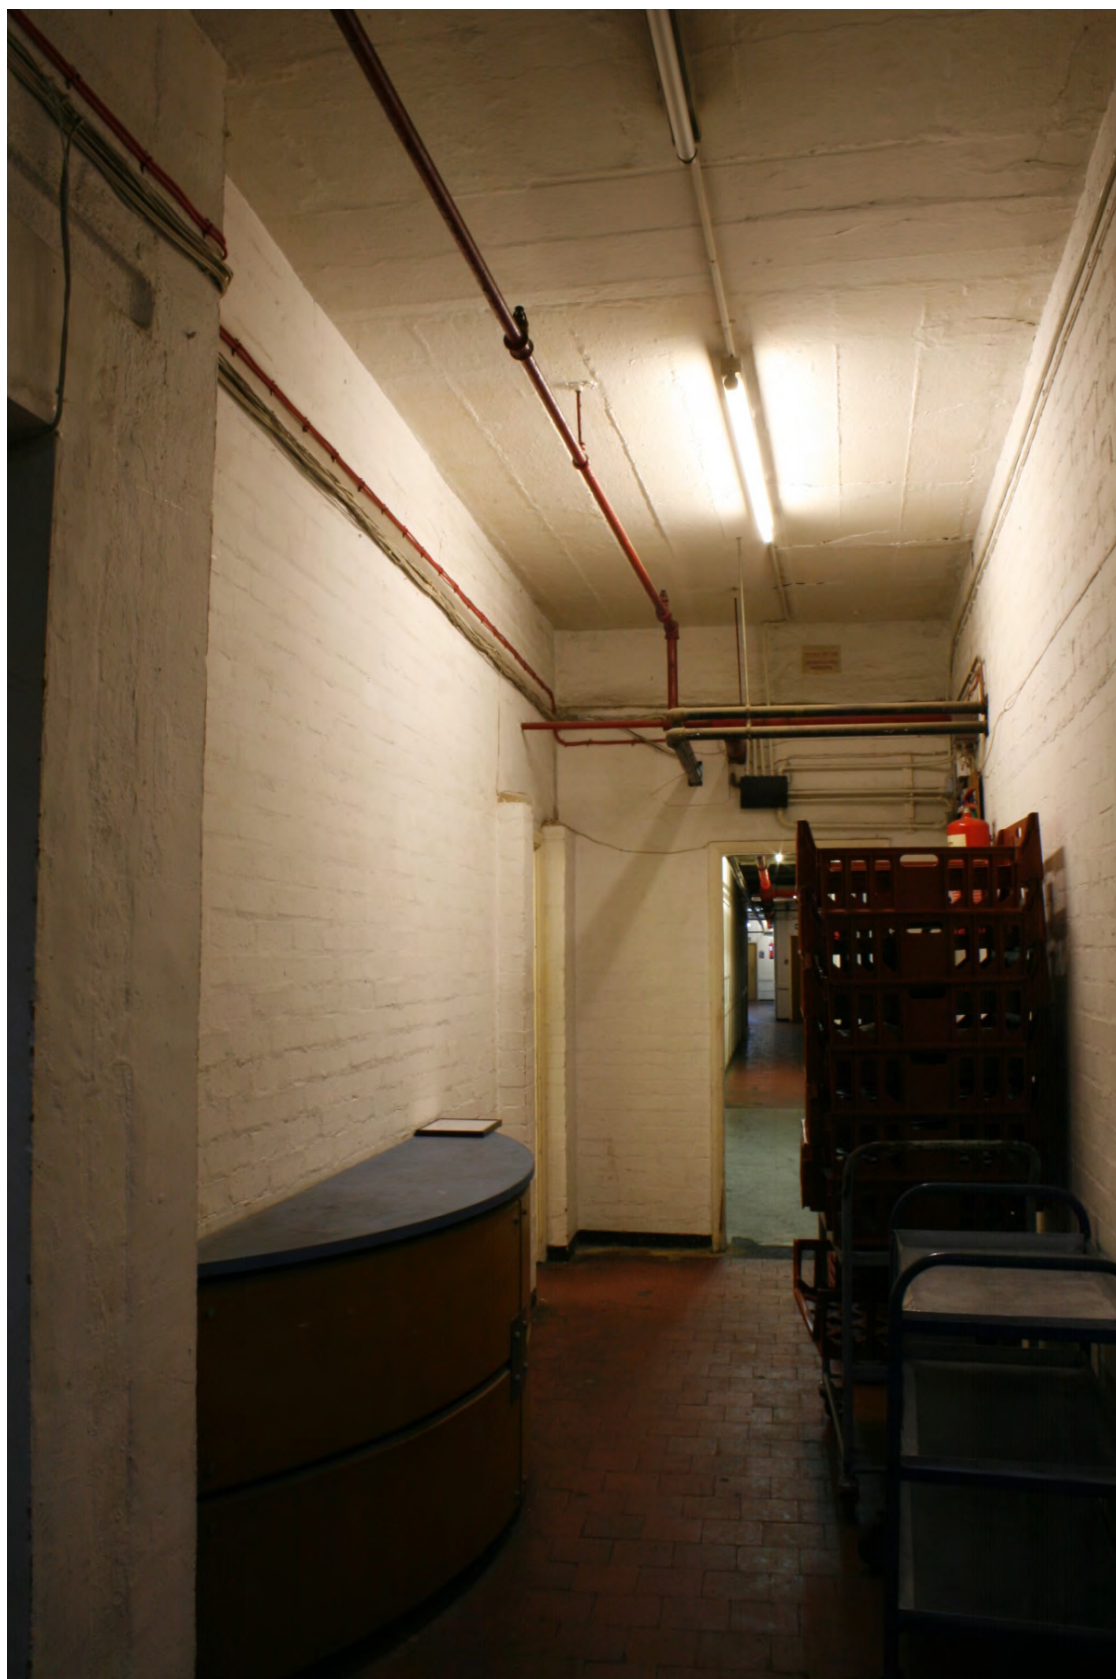
Plate 38: Ground floor access corridor within the storage area on the north side of the building, looking north-east (72FmLa D100 049)
