**PHOTOGRAPHIC SURVEY
OF STEWART'S GARAGES,
72 FARM LANE, FULHAM,
LONDON BOROUGH OF
HAMMERSMITH AND
FULHAM, SW6 1QA**

PCA REPORT NO. R11379

FEBRUARY 2013

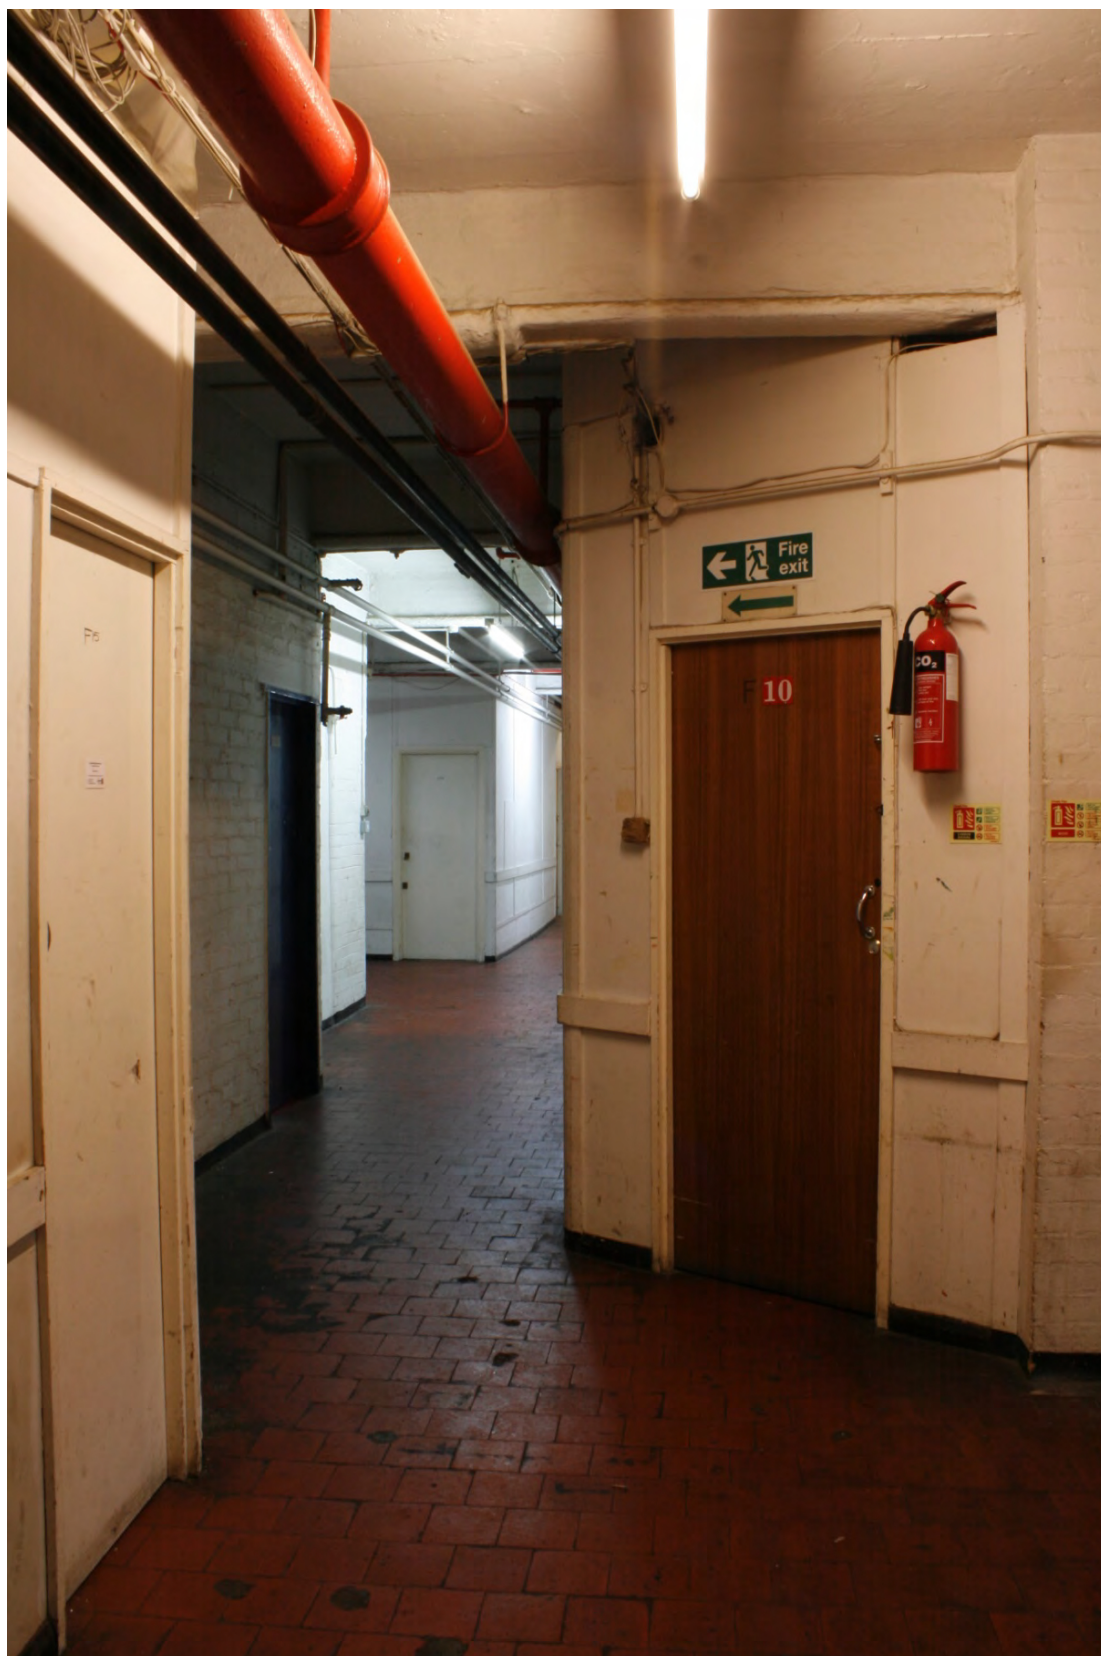
Plate 39: Ground floor access corridor within the storage area on the north side of building showing added late 20th century plywood partition walls and doorway, looking north-east (72FmLa D100 045)

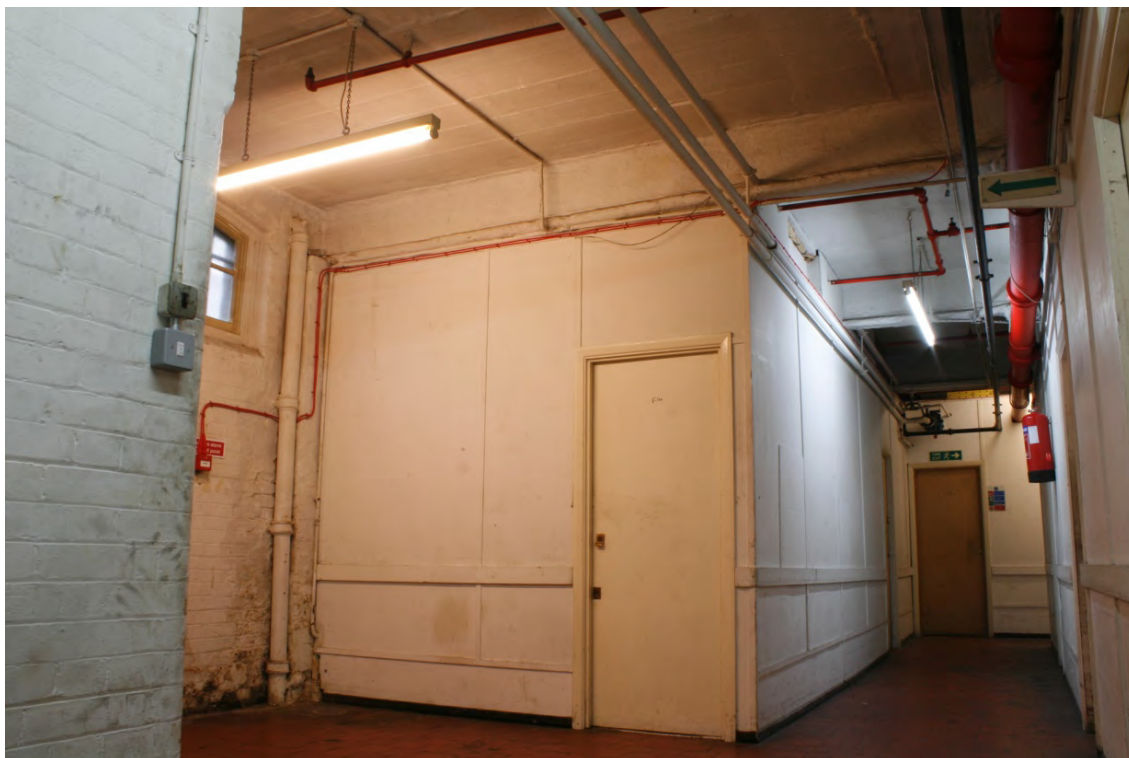
Plate 40: Ground floor access corridor within the storage area on the north side of building showing added late 20th century plywood partition walls and two doorways, looking east (72FmLa D100 046)

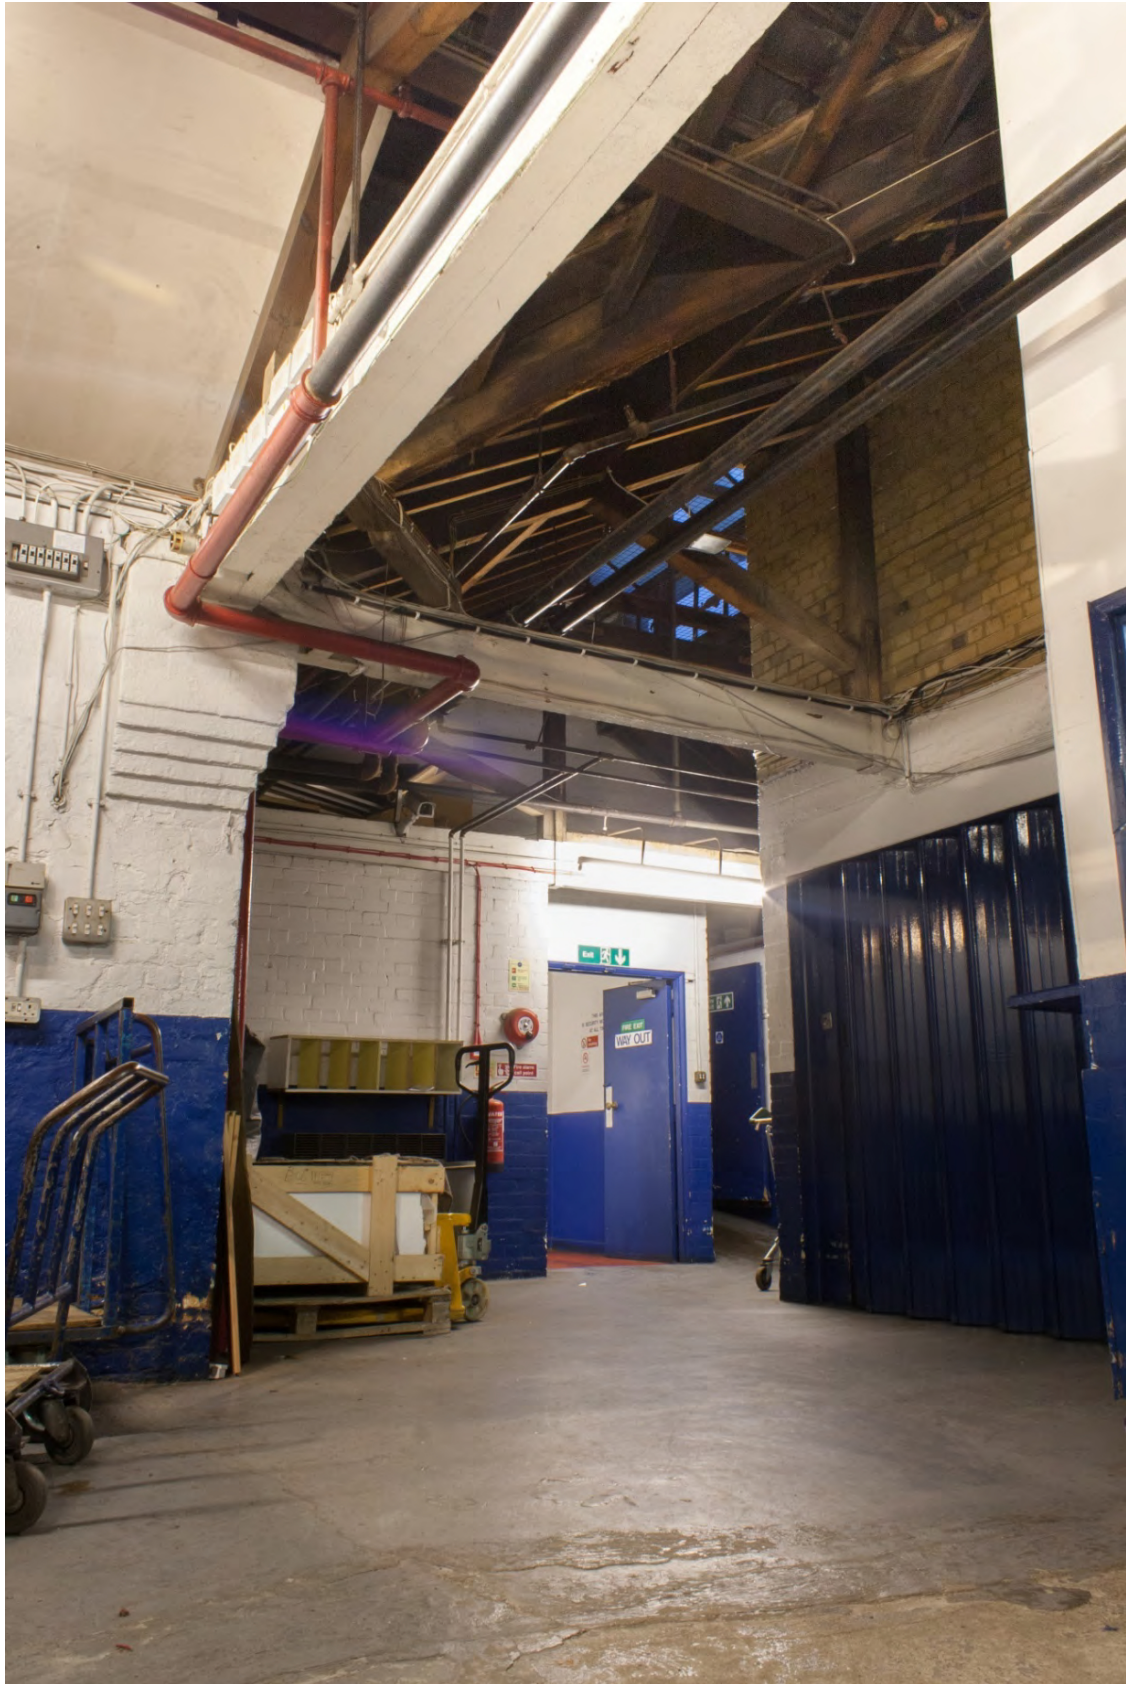
Plate 42: Entrance into the first floor storage area on the north side of the building, showing roof structure and 20th century brick partition walls, looking south (72FmLa D100 058)

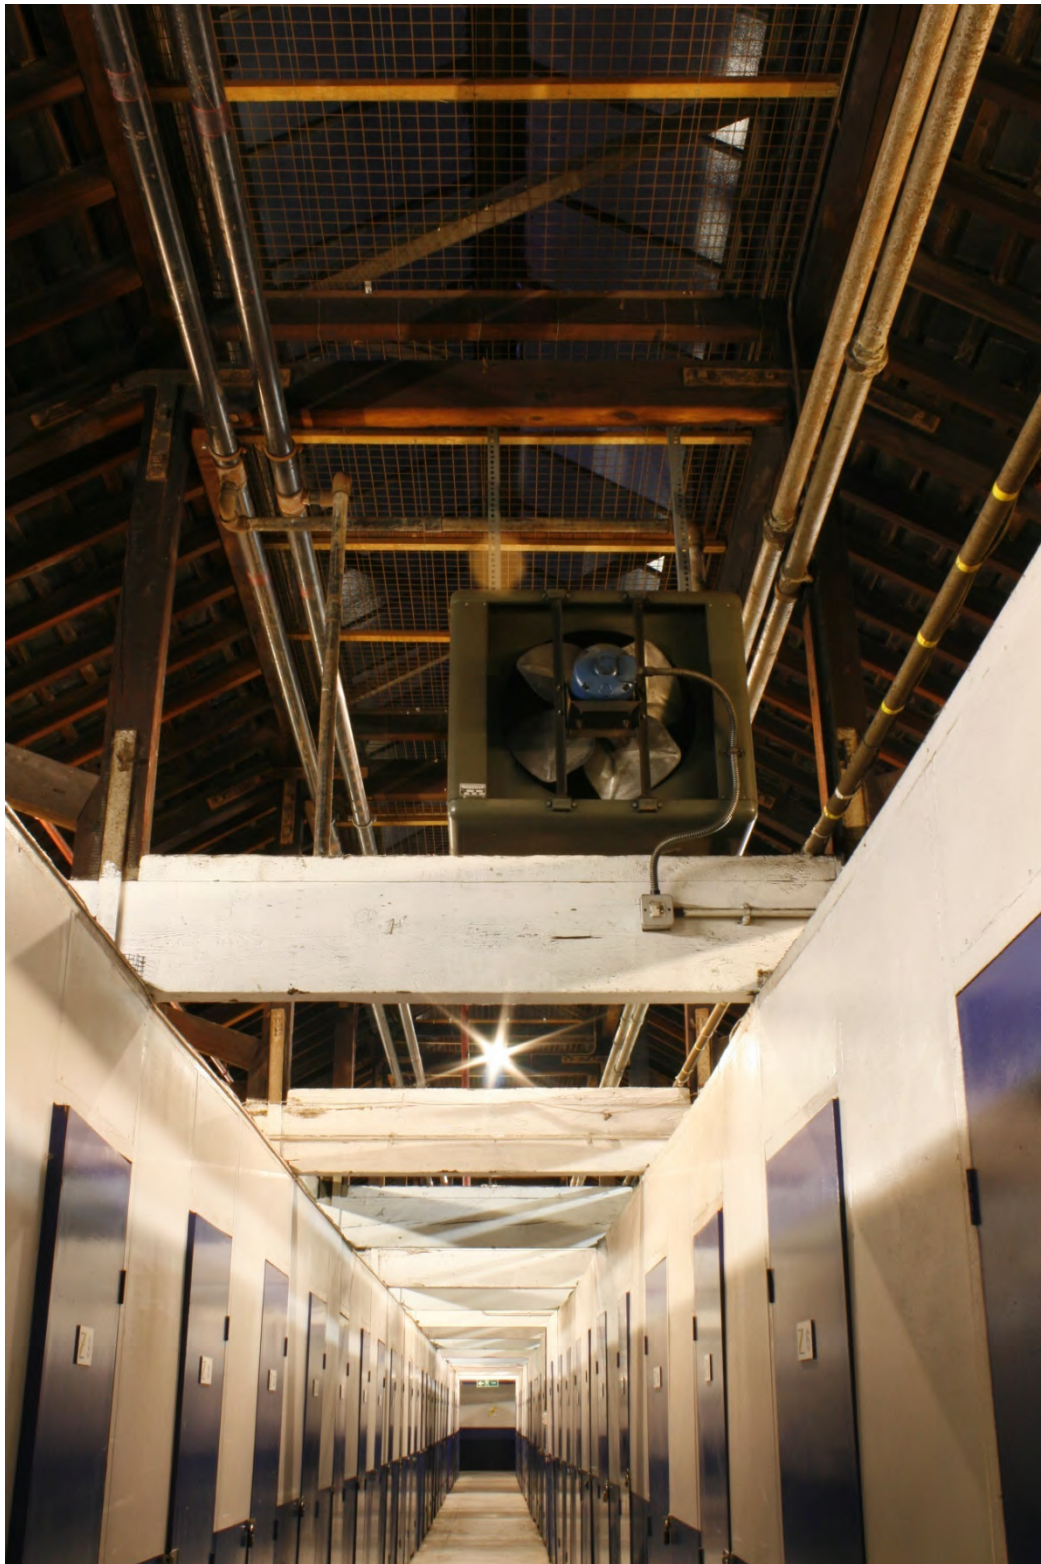
Plate 43: First floor access corridor along storage area on the north side of the building, showing original Queen truss, looking north-east (72FmLa D100 059)

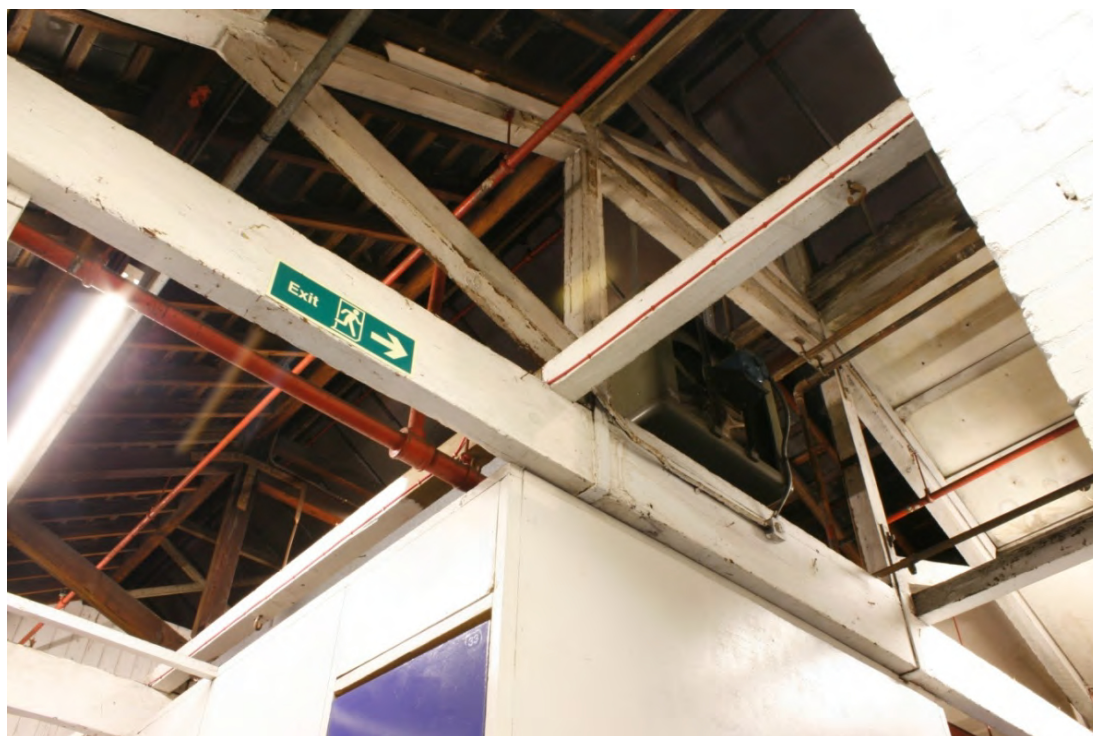
Plate 44: Original Queen truss above the first floor storage area on the north side of the building, looking east (72FmLa D100 060)

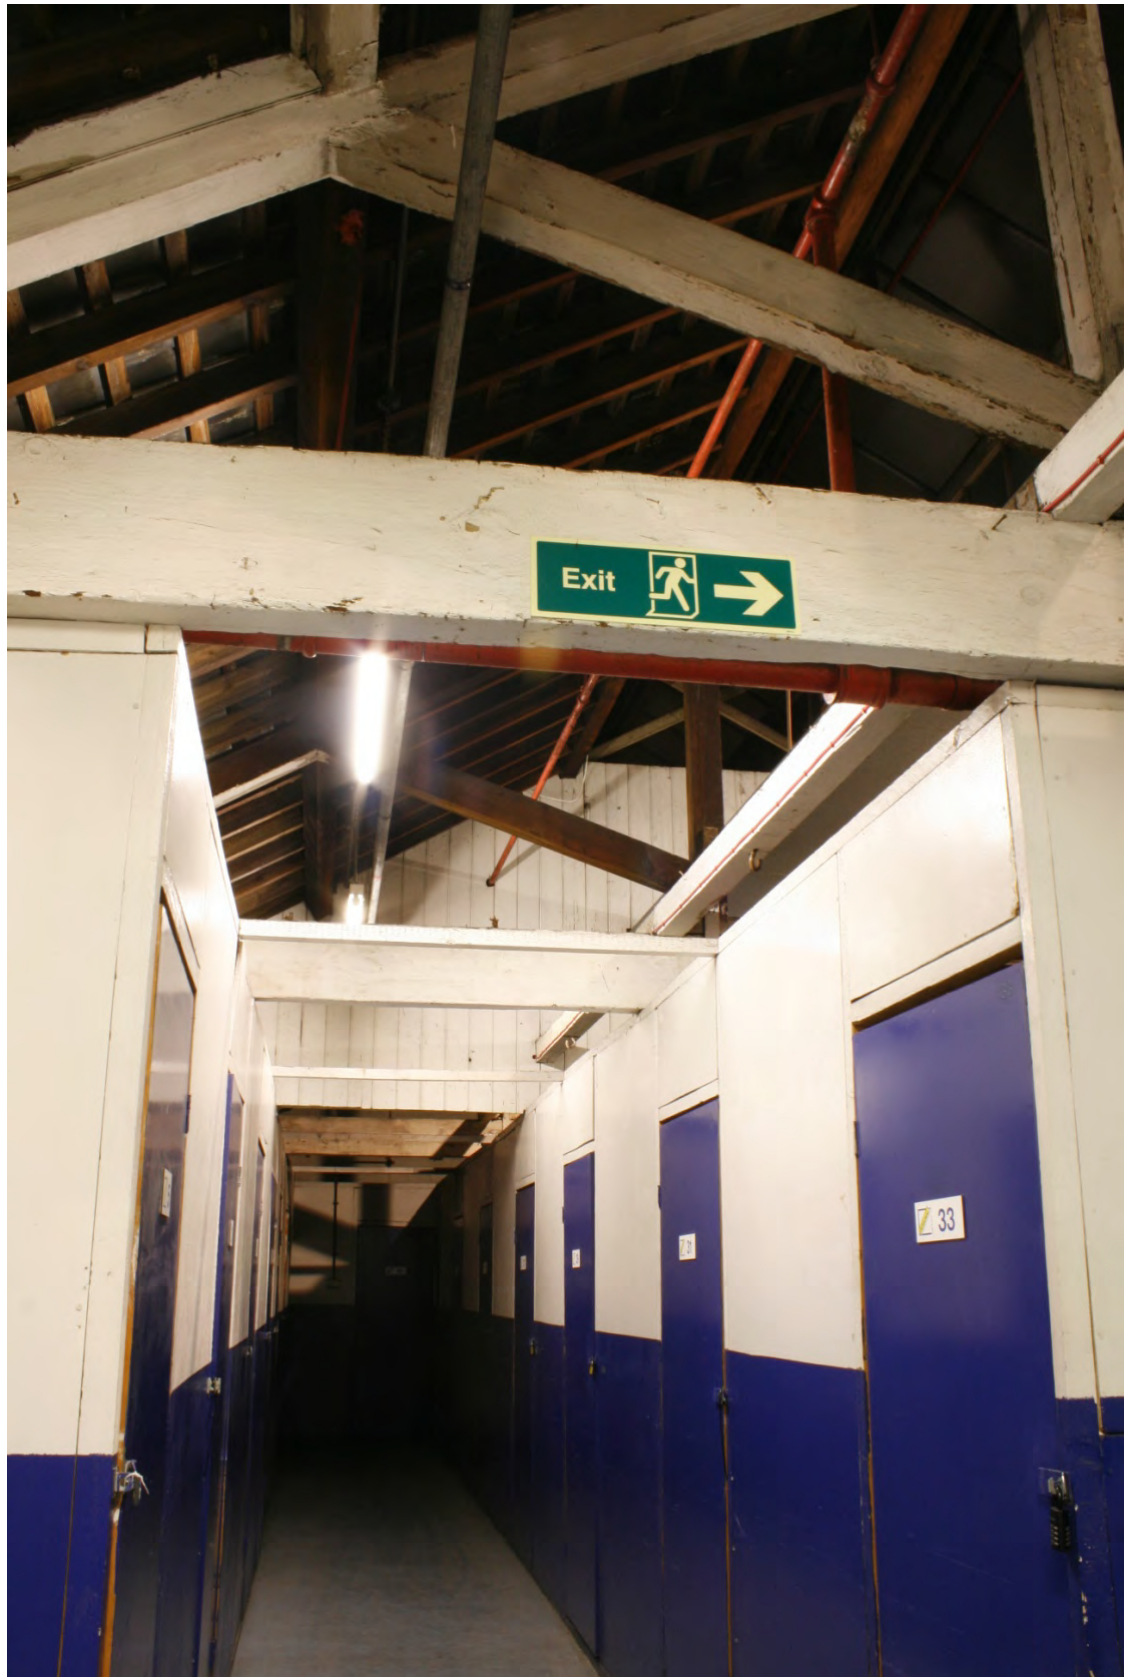
Plate 45: First floor access corridor along the storage area on the north side of building with original timber roof trusses overhead, looking north-east (72FmLa D100 041)

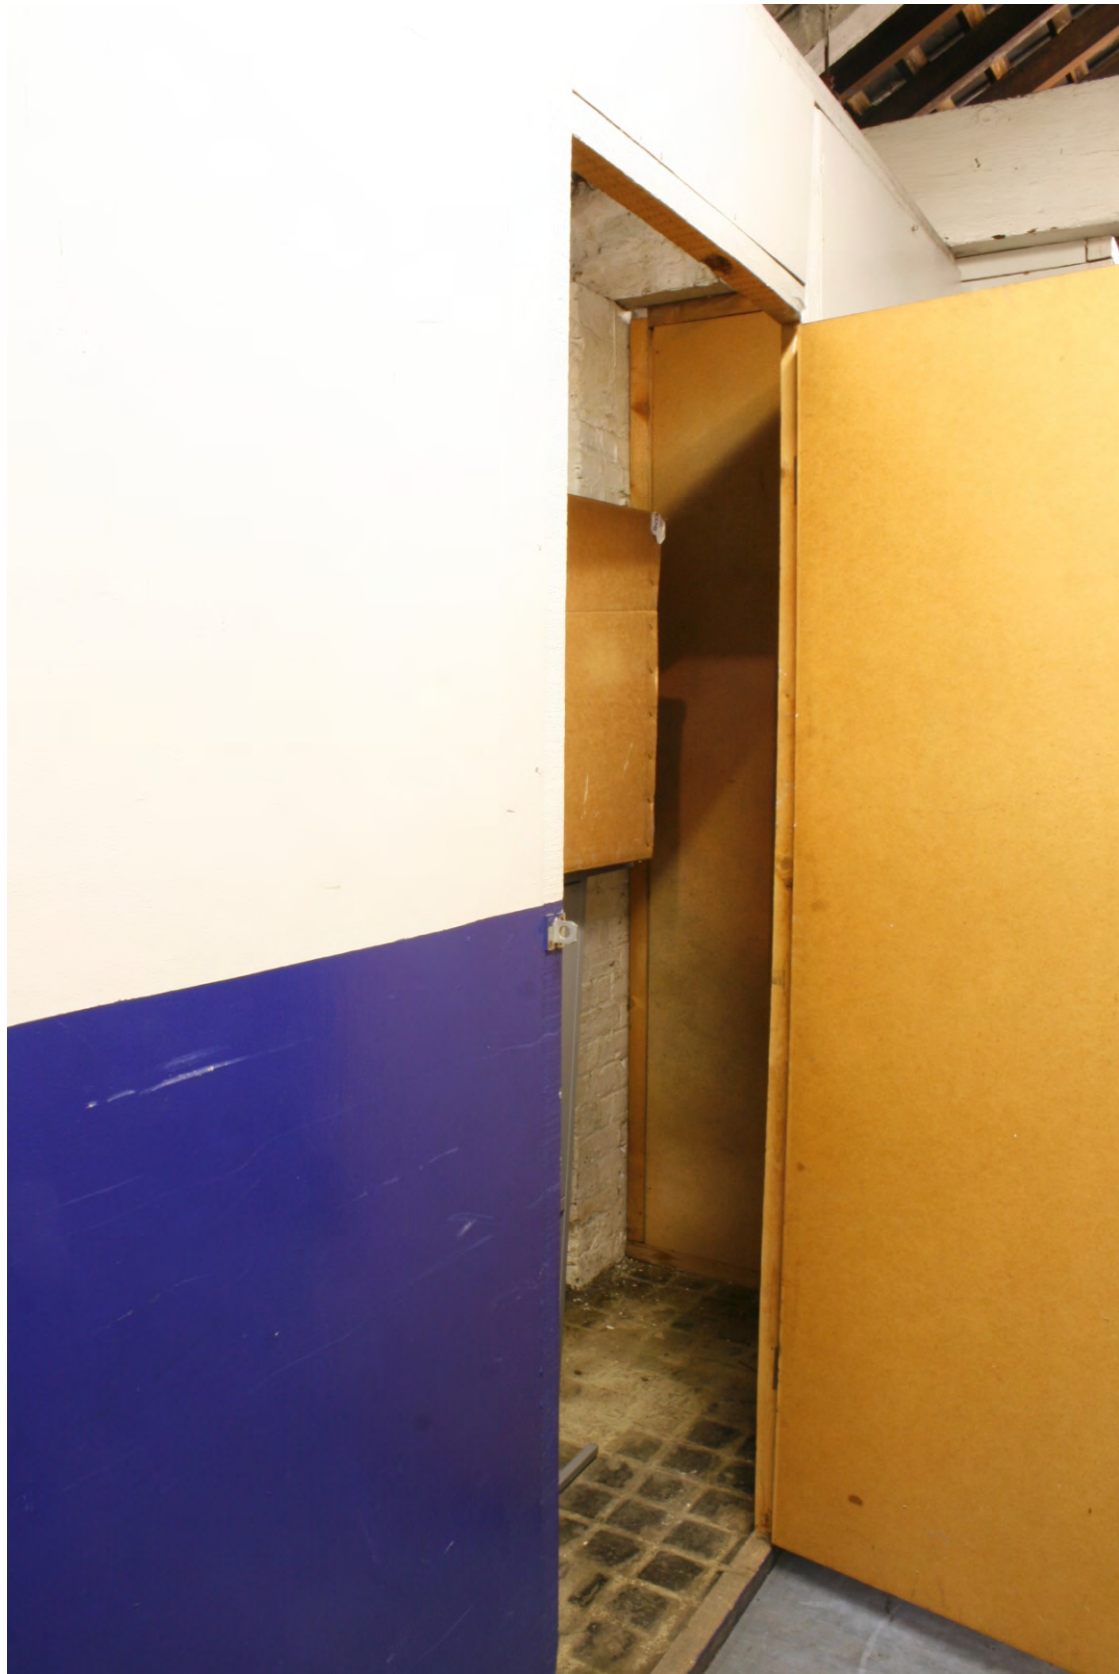
Plate 46: Original cobbling within a small storage space area on the first floor, looking north (72FmLa D100 062a)
