**93-113 GROUNDS AVENUE,
MARCH, CAMBRIDGESHIRE,
PE15 9BG**

**ARCHAEOLOGICAL TRIAL
TRENCH EVALUATION**

**PRE-CONSTRUCT ARCHAEOLOGY
R11395**

Site Code : CGAM13

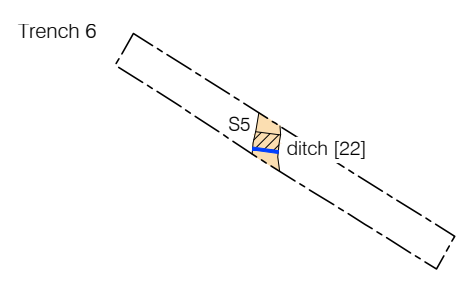
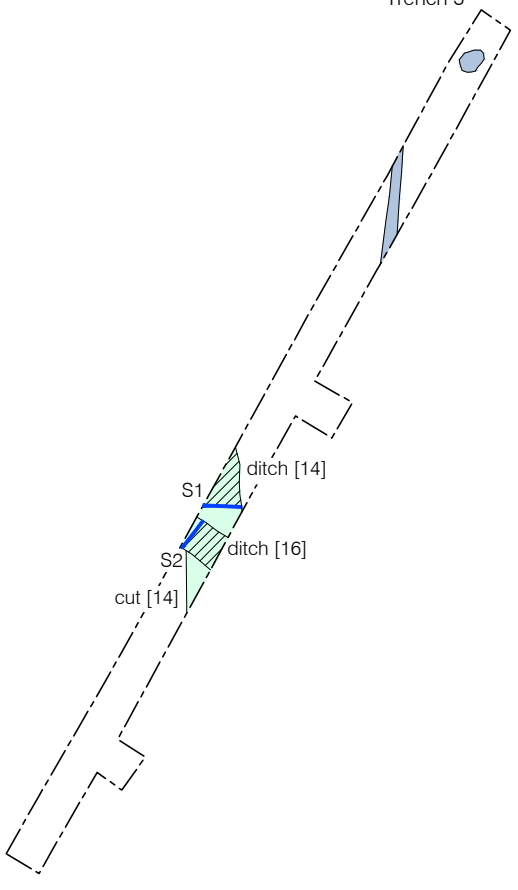
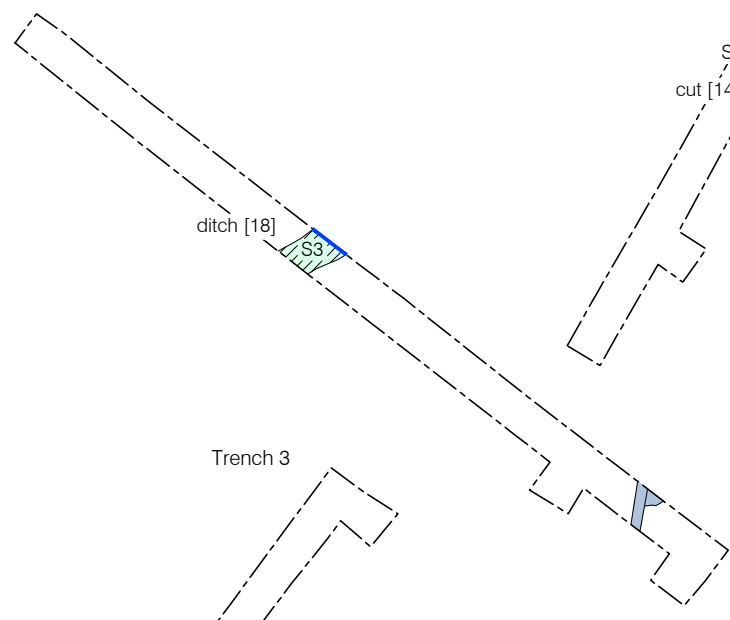
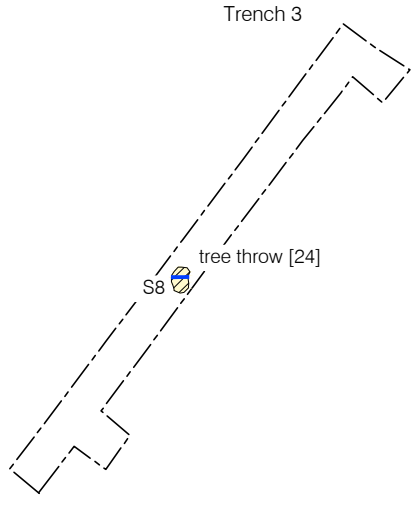
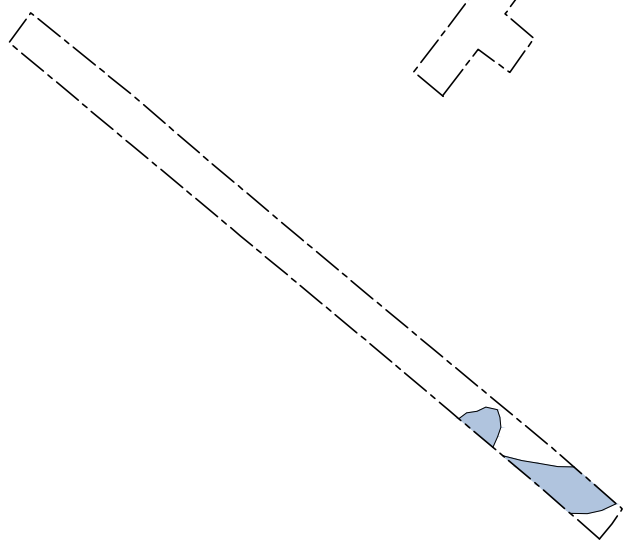
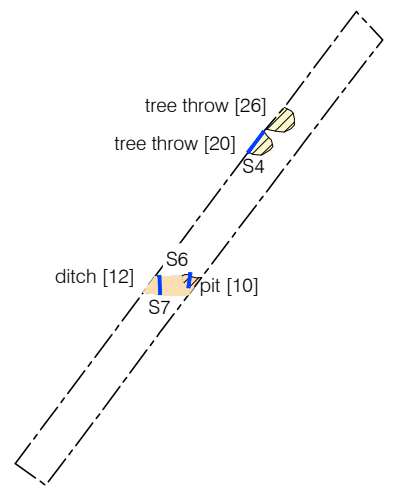
Figure 3
Trench Plans
1:400 at A3

2.6 Features planned but not excavated due to flooding in the trenches (Fig. 3):

Discrete pit and ?E-W-aligned ditch in SE end of Trench [2]

?N-S-aligned ditch and possible pit in SE of Trench [4]

Pit in NE of Trench [5]

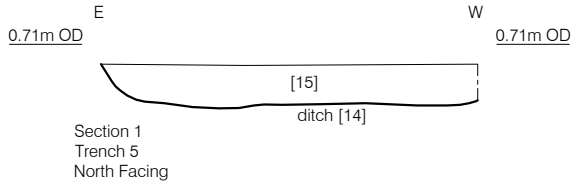
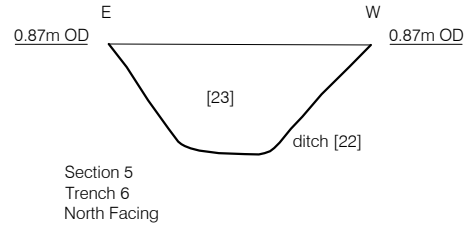
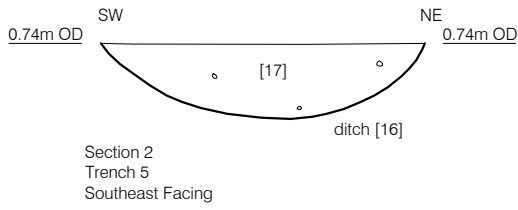
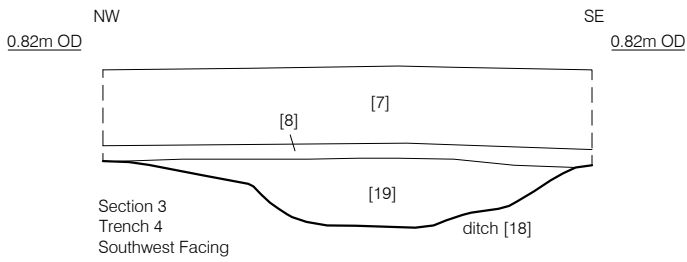
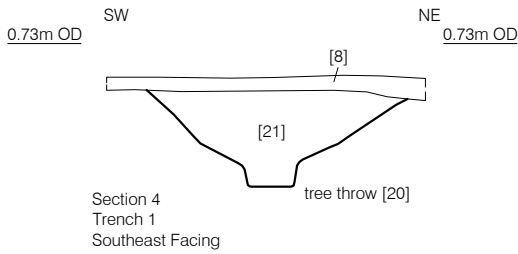
Figure 4
Sections
1:40 at A4

- 3.2 A shallow north-to-south-aligned ditch [14] extended across the middle of Trench [5] (Plates 12 and 13; Fig. 3). It was partly outside the trench but was at least 6m long, 2m wide and 0.20m deep. It had moderately-sloping concave sides and a flat base (Fig. 4) and was filled with firm mid greyish-brown silty clay containing occasional small flint pebbles (15). A 1m slot was excavated across the width of the ditch and was subsequently extended to 2m, but no finds were present. Ditch [14] was aligned down the slight slope of the site and is likely to have fulfilled a drainage function, as well as possibly forming a field boundary.

- 3.3 Ditch [14] was cut by north-west-to-south-east-aligned Ditch [16], which extended across the width of Trench [5]. Ditch [16] was 2.10m+ long, 1.70m wide and 0.40m deep, with moderately-steep concave sides and a rounded base (Fig. 4). It was filled with firm light yellowish-grey clay (17). A 1m slot excavated across the ditch was subsequently extended to 2m to enhance finds recovery, but no finds were present. The ditch was sealed by the subsoil, suggesting that it was of some antiquity.

- 3.4 Ditch [18] extended on a north-east to south-west alignment across Trench [4] (Plate 14; Fig. 3). It was 2.20m+ long, 2.22m wide and 0.36m deep, with gradual stepped sides and a rounded base (Fig. 4). It had a single fill of firm mid orangey-grey silty clay containing occasional medium-sized angular flints and charcoal flecks (19). The

- 3.6 A third tree hollow [24] was excavated in Trench [3] (Plate 16; Fig. 3). It was roughly oval in plan with a shallow west side, a steep concave east side and a rounded base (Fig. 4). It was 1.39m by 0.90m across and 0.20m deep. It was filled with compact mid orangey-grey slightly silty clay (25). After being half-sectioned and recorded, the remaining fill was excavated but no finds were present. Tree Hollow [24] was sealed by the subsoil.

- 3.7 Ditch [12] was an east-to-west-aligned ditch extending across Trench [1] (Plates 1 and 17; Fig. 3). It had steep to near-vertical straight sides and a flattish base and measured 0.90m across by 0.29m deep (Fig. 4). It was filled with firm mid greyish-brown silty clay (13) which contained no finds. It was cut through the subsoil, suggesting a relatively recent date.

- 3.9 A pit [10] was cut through the subsoil (8) and into the fill of Ditch [12] (13) (Plate 17; Fig. 3). Pit [10] was oval in plan with moderately-steep concave sides and a rounded base (Fig. 4); it measured 0.64m across by 0.16m deep and extended beyond the limits of the trench to the east. It was filled with firm dark brown silty clay (11). After being half-sectioned and recorded, the remaining portion of the feature that lay within the trench was 100% excavated but no finds were present. However, the stratigraphic position of the pit cutting both the subsoil and Ditch [12] suggests a relatively recent (*i.e.* post-medieval or modern) date.

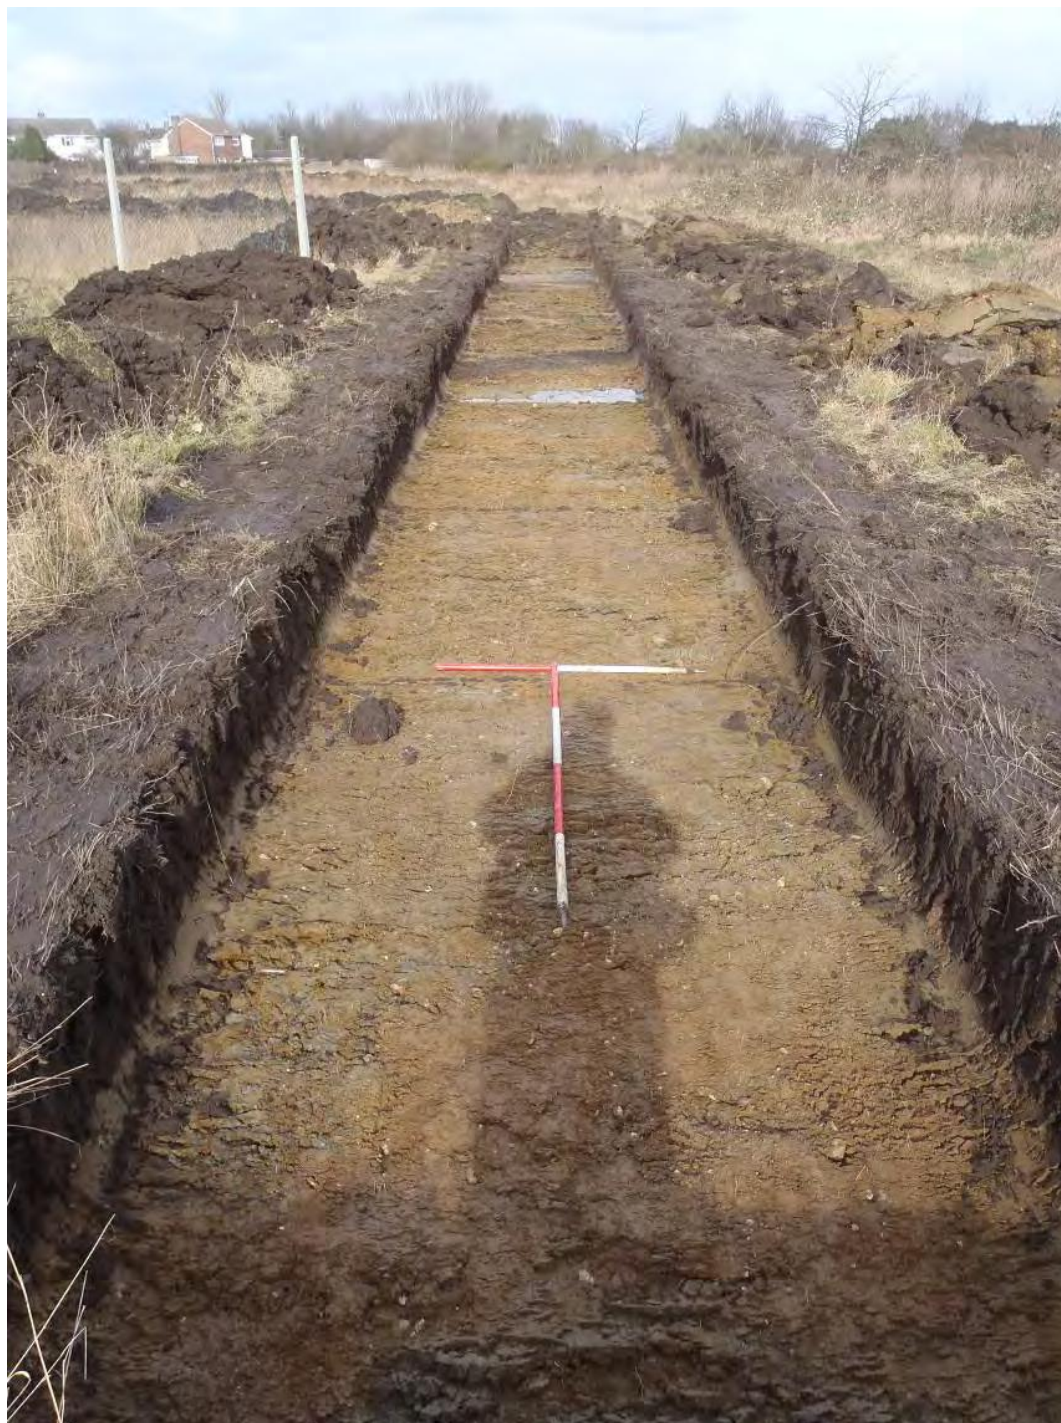
Plate 1: Trench [1], view north-east towards Ditch [12]

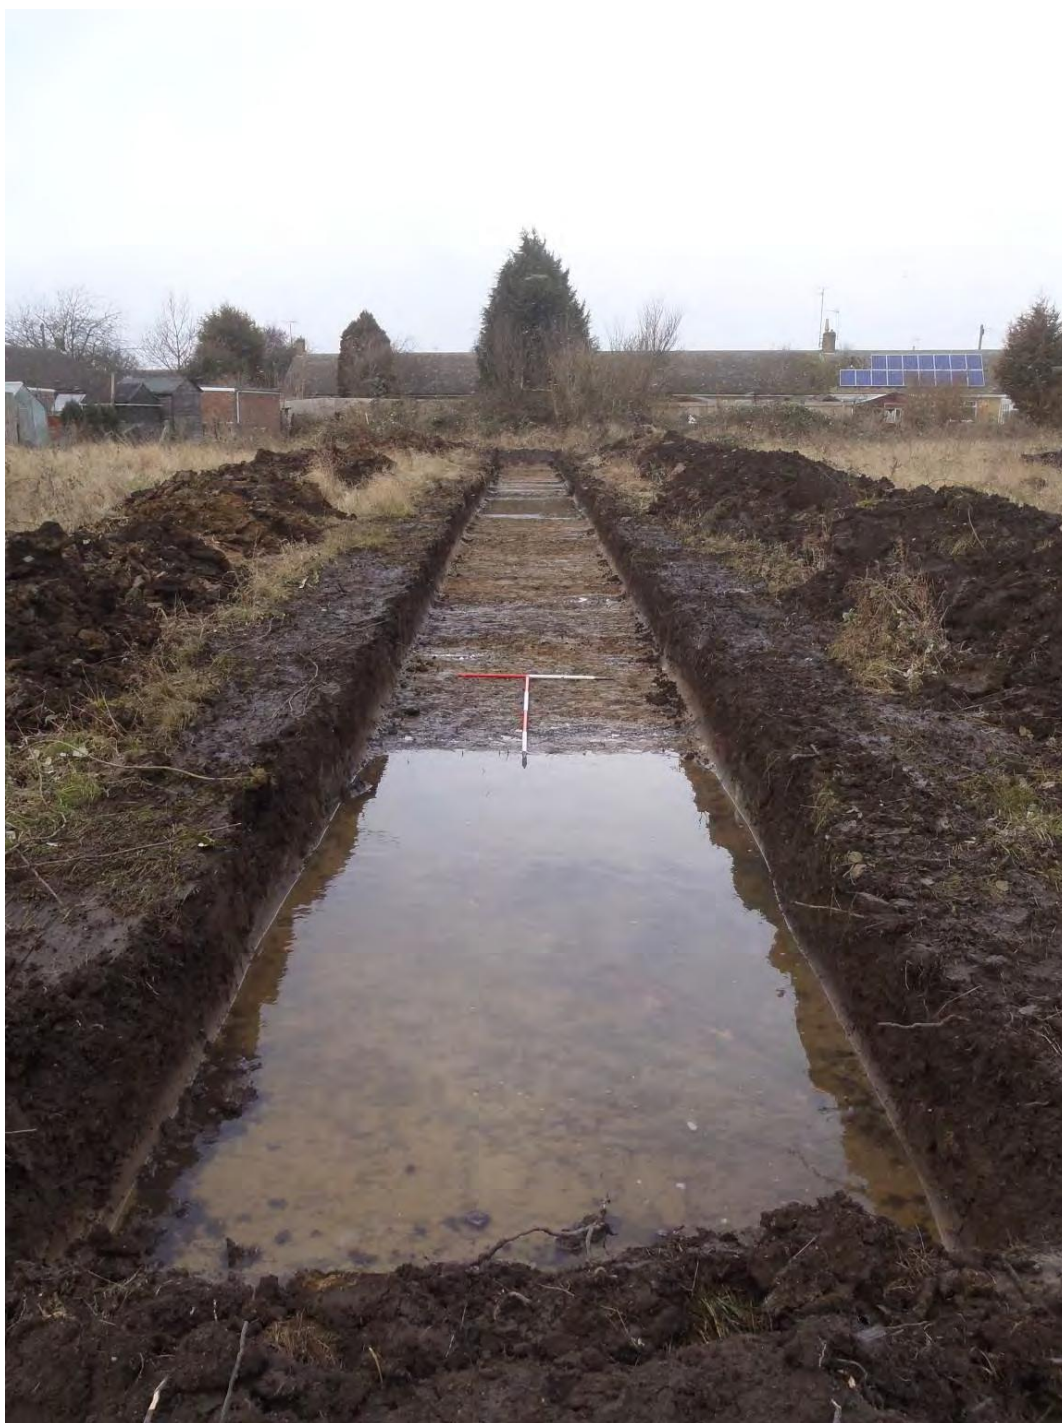
- 2.5 Due to the site's fen-edge location (the natural geology was present at a height of between 0.36 and 1.10m AOD, with the ground rising to the west) and the exceptionally wet winter, trenches began filling with ground water as soon as they had been opened (Plates 2, 3, 5 and 8-11). 1.5m deep sumps were machine-excavated at the ends/ adjoining the sides of the worst-affected trenches to aid drainage, but this did not solve the problem. Features were planned using GPS on the first day of fieldwork, but by the second day several features had been entirely covered by rising water. Pumping was not a viable option as the ground was saturated and there was nowhere dry to pump water to. Bailing-out the bases of excavated features with a bucket proved futile, as the water immediately percolated back into the trench.

Plate 2: Trench [2], view north-west. The ditch in the foreground was not excavated as it was rapidly covered by rising water after the trench was opened.

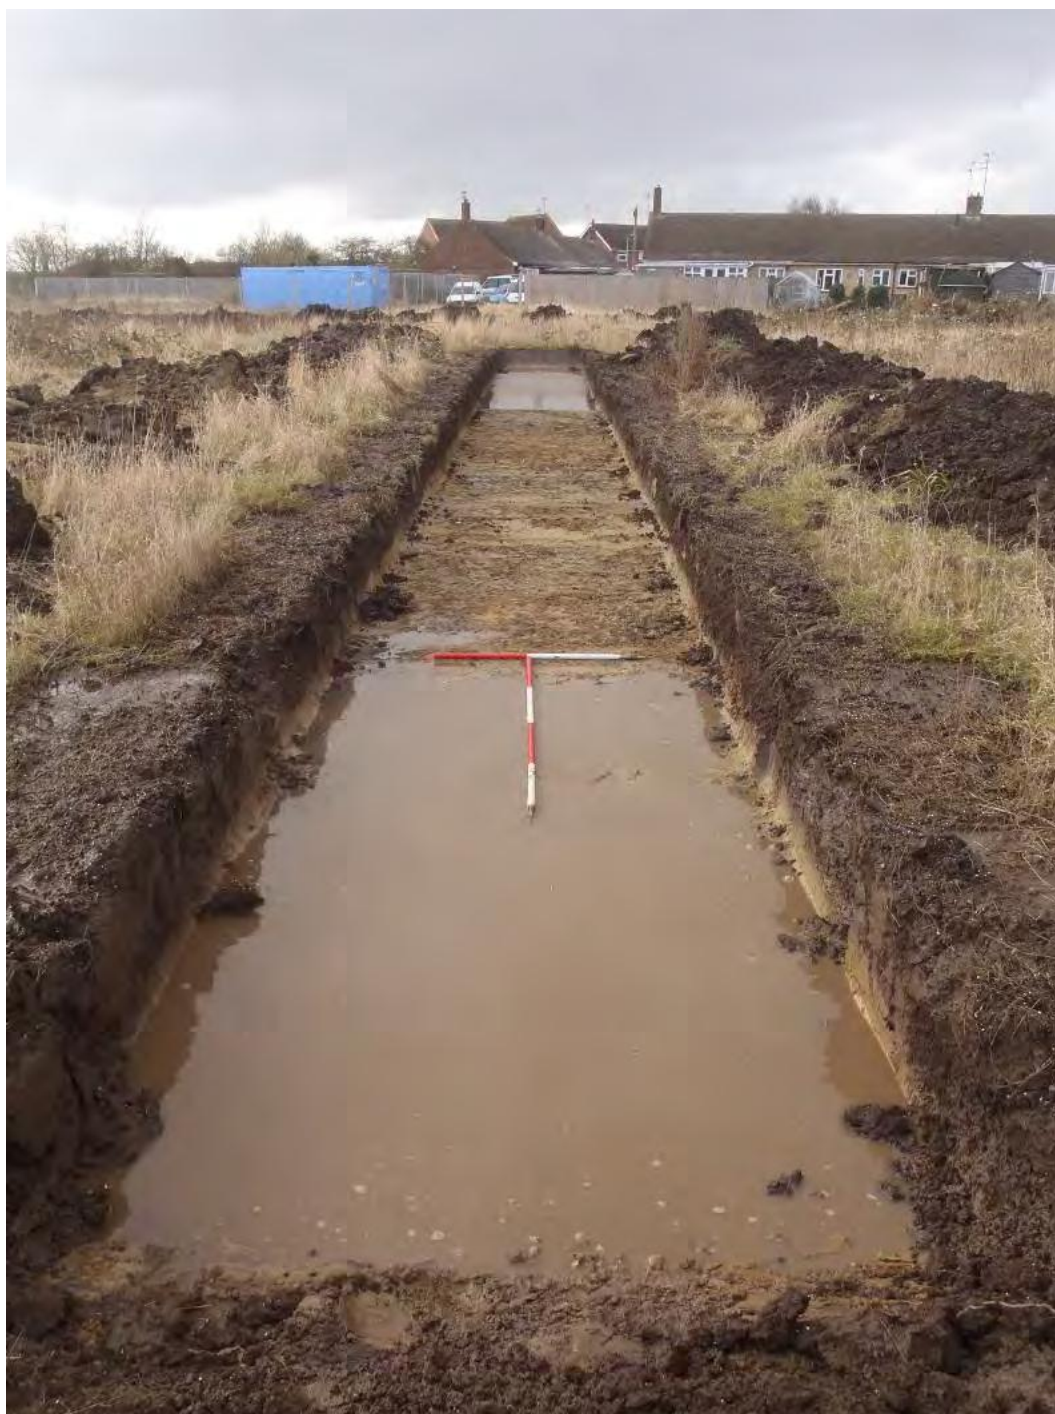
Plate 3: Trench [3], view south-west

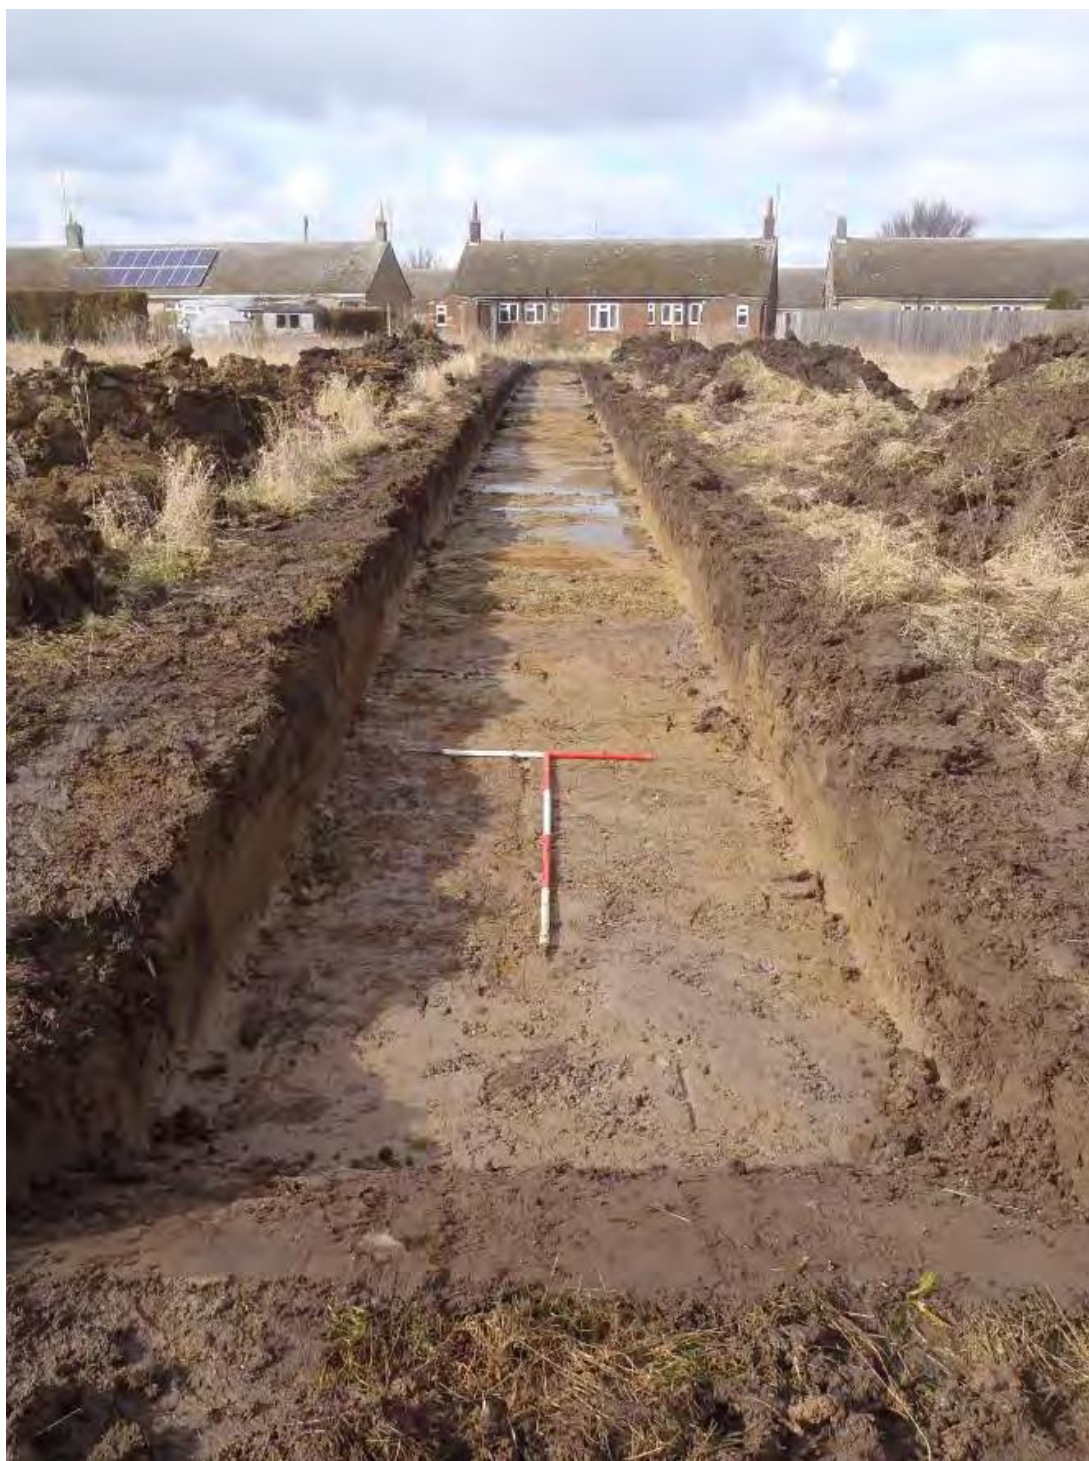
Plate 4: Trench [4], view north-west. The ditch in the foreground was covered by rising water soon after the trench was opened, and therefore could not be excavated.

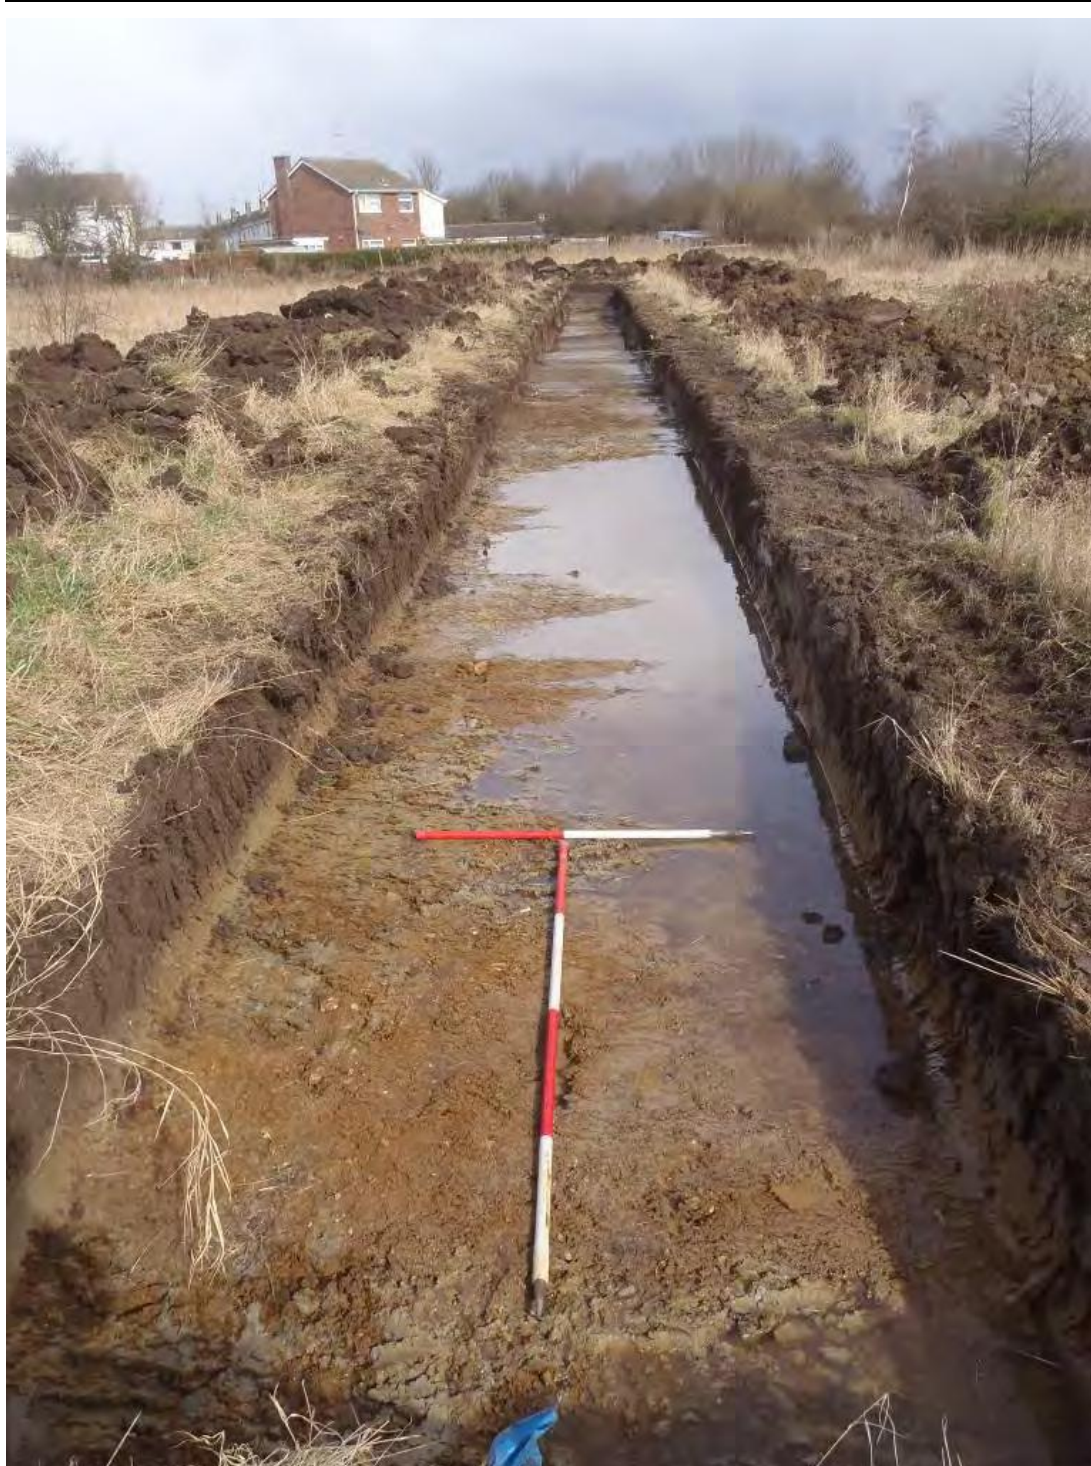
Plate 5: Trench [5], view north-east

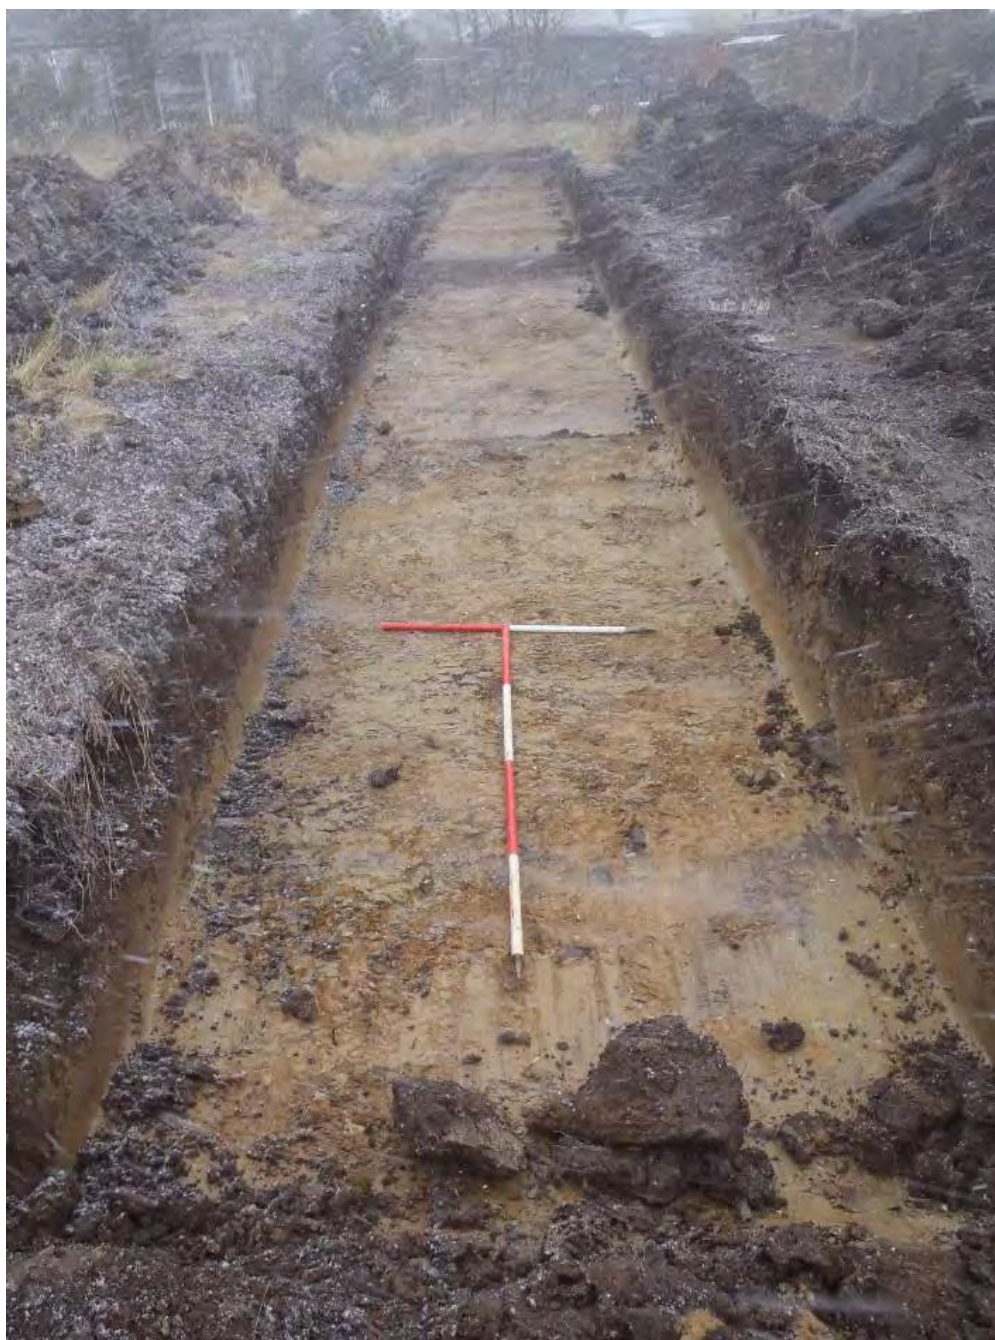
- 3.8 Ditch [22] extended on a north to south alignment across the middle of Trench [6], in the north of the site (Plates 6 and 18; Fig. 3). It was at least 30m long, 1.40m wide and 0.58m deep. It had steep straight sides and a flat base and contained a single fill of dark grey/ black silty clay (23) which contained three abraded pieces of post-medieval ceramic building material and a single small sherd of residual Roman greyware pottery (Katie Anderson, *pers. comm.*) in the excavated slot (Fig. 4). The ditch was cut from the topsoil level. The ditch continued southwards at an oblique angle across Trench [5], where its upper levels were machine-excavated and found to contain modern brick (not retained). Ditch [22] was a post-medieval/ modern drainage ditch aligned down the slope of the site. Ditches [12] and [22] were aligned

Plate 6: Trench [6], view south-east towards Ditch [22]

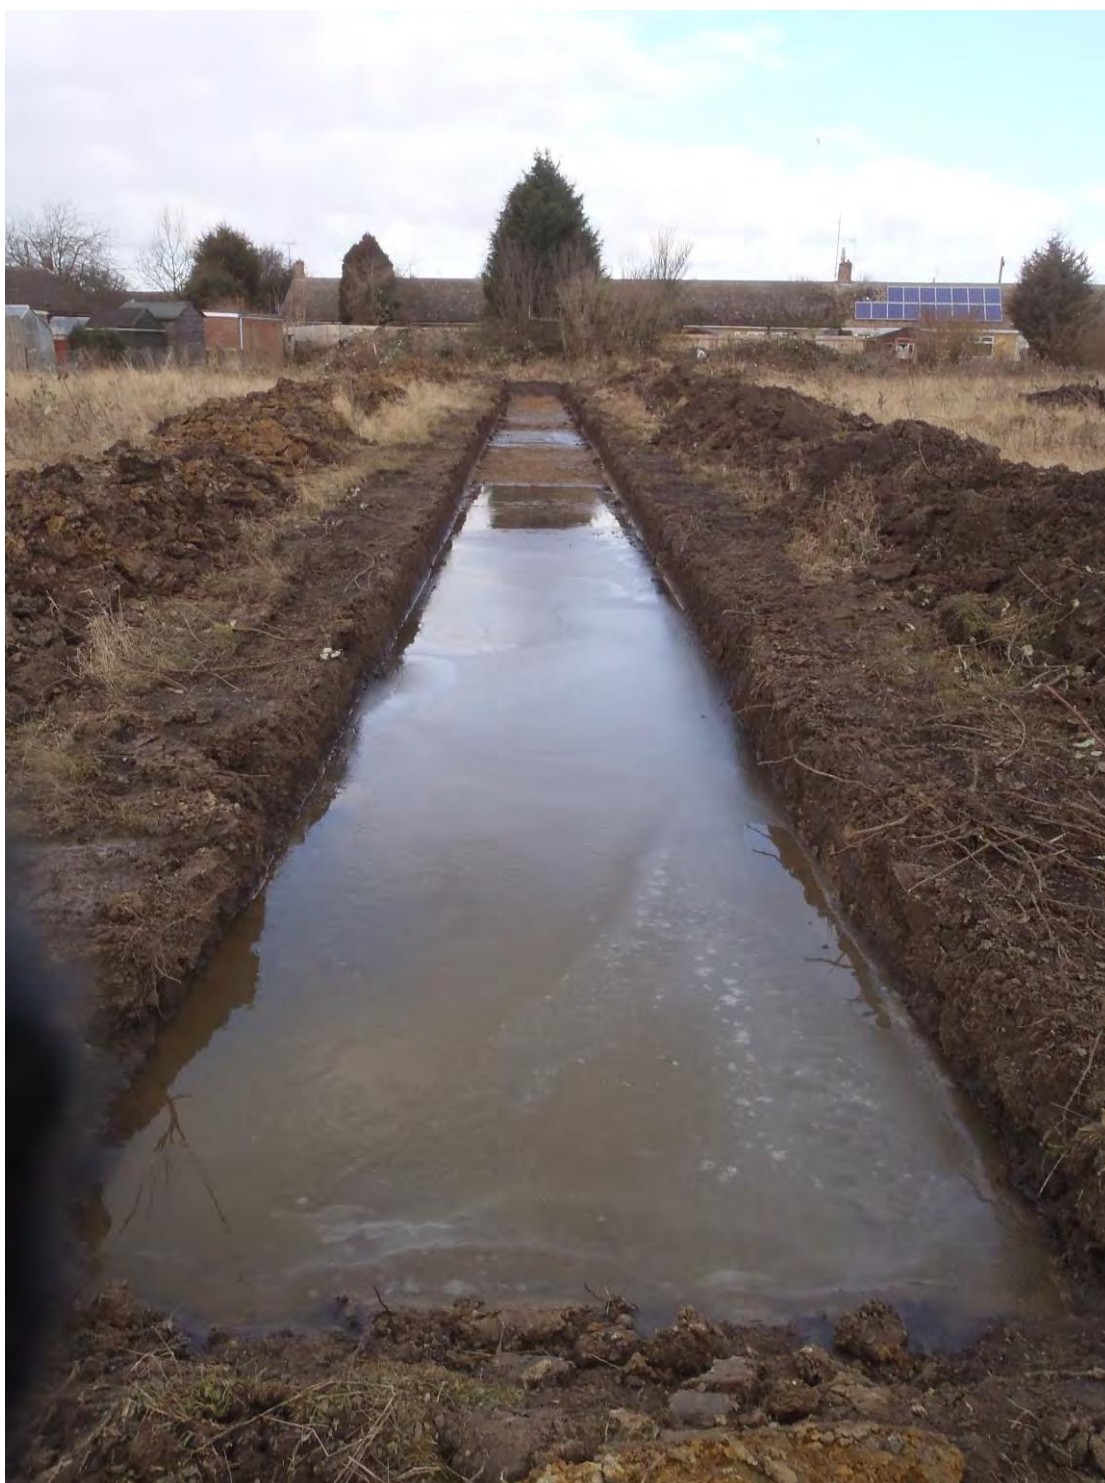
Plate 8: Trench [2], view north-west showing full extent of flooding

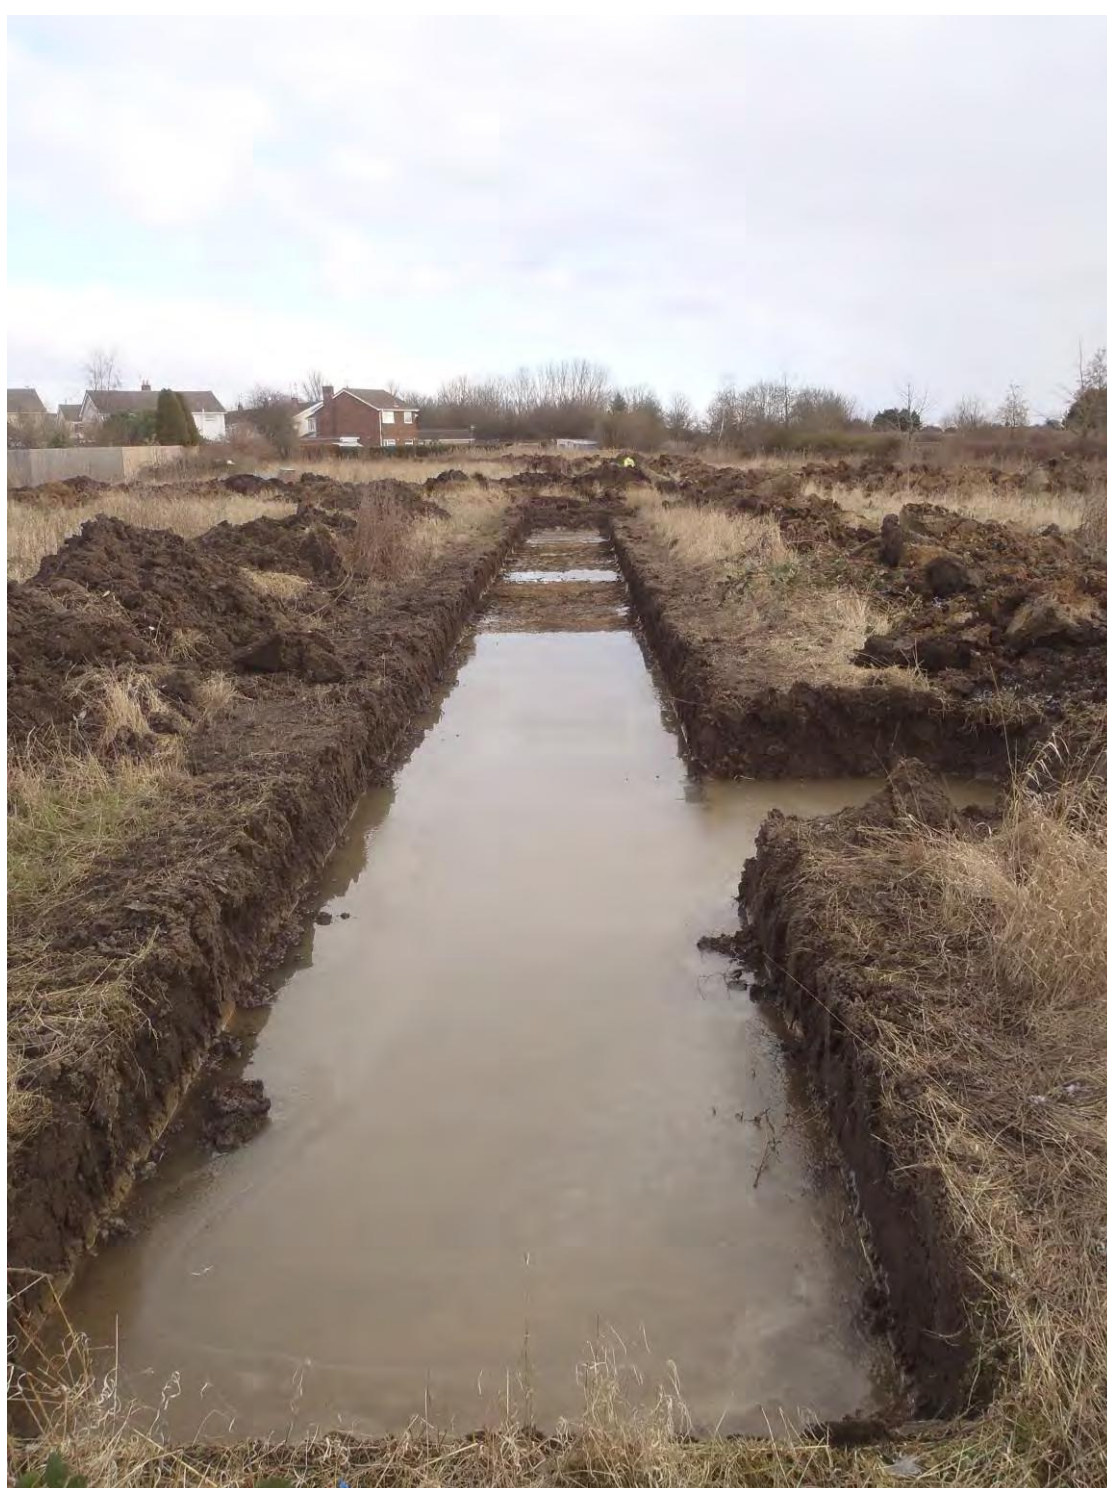
Plate 9: Trench [3], view north-east showing flooding

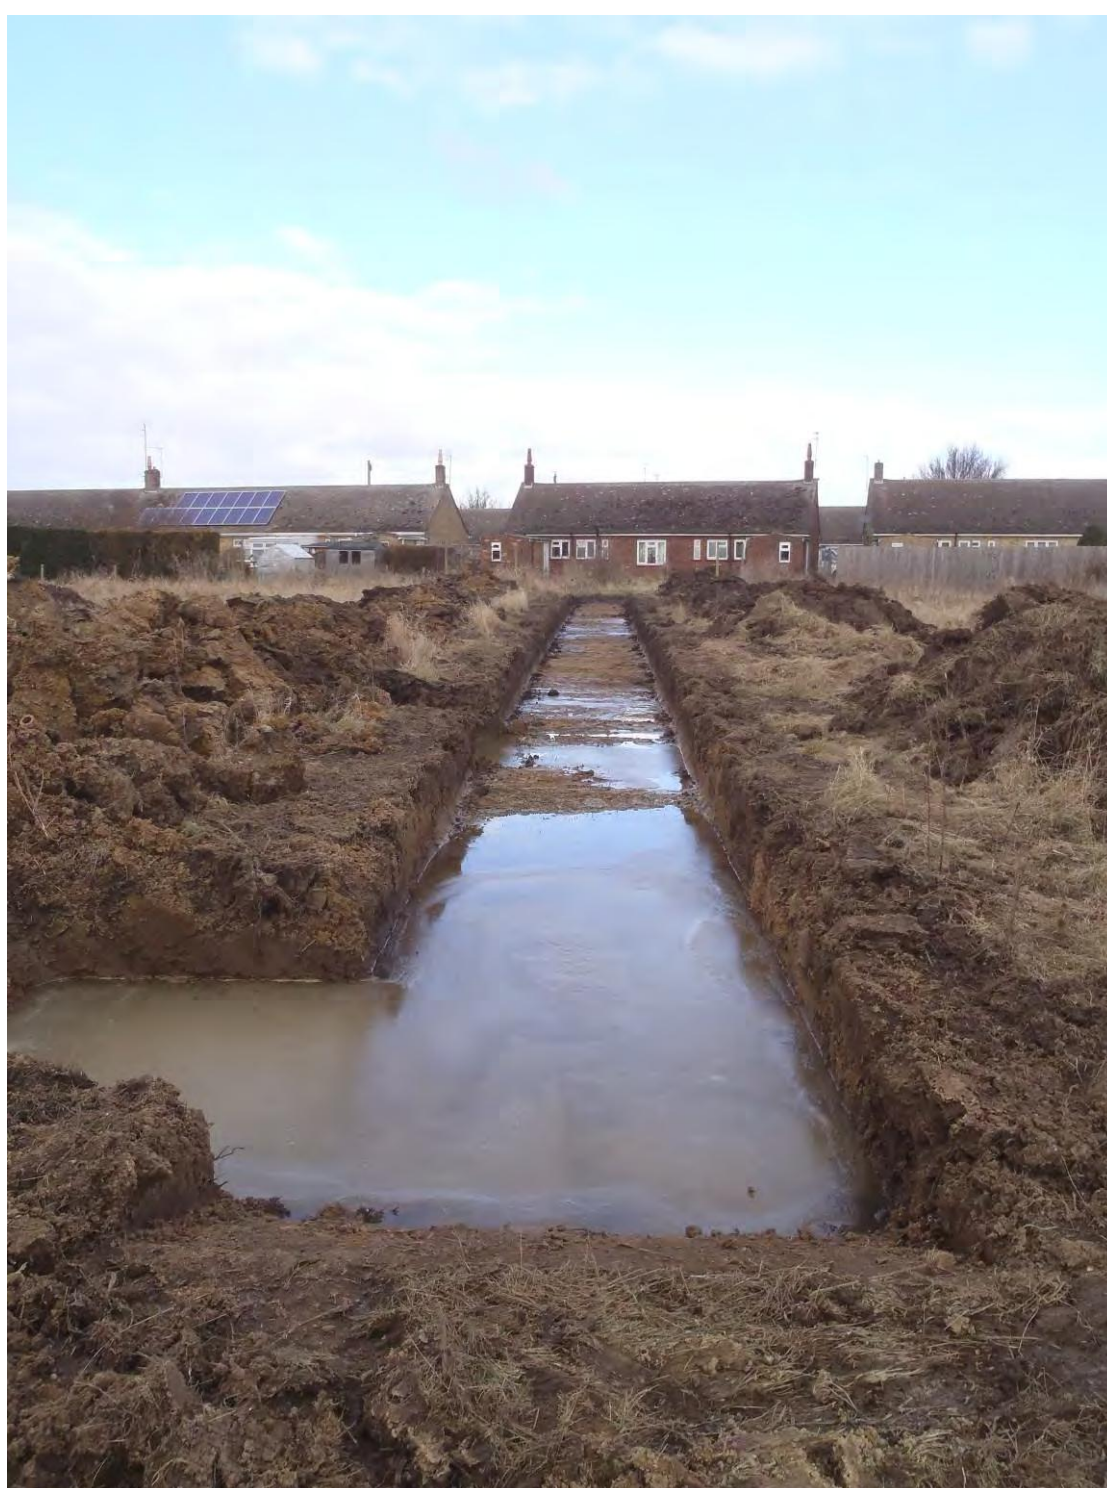
Plate 10: Trench [4], view north-west showing flooding

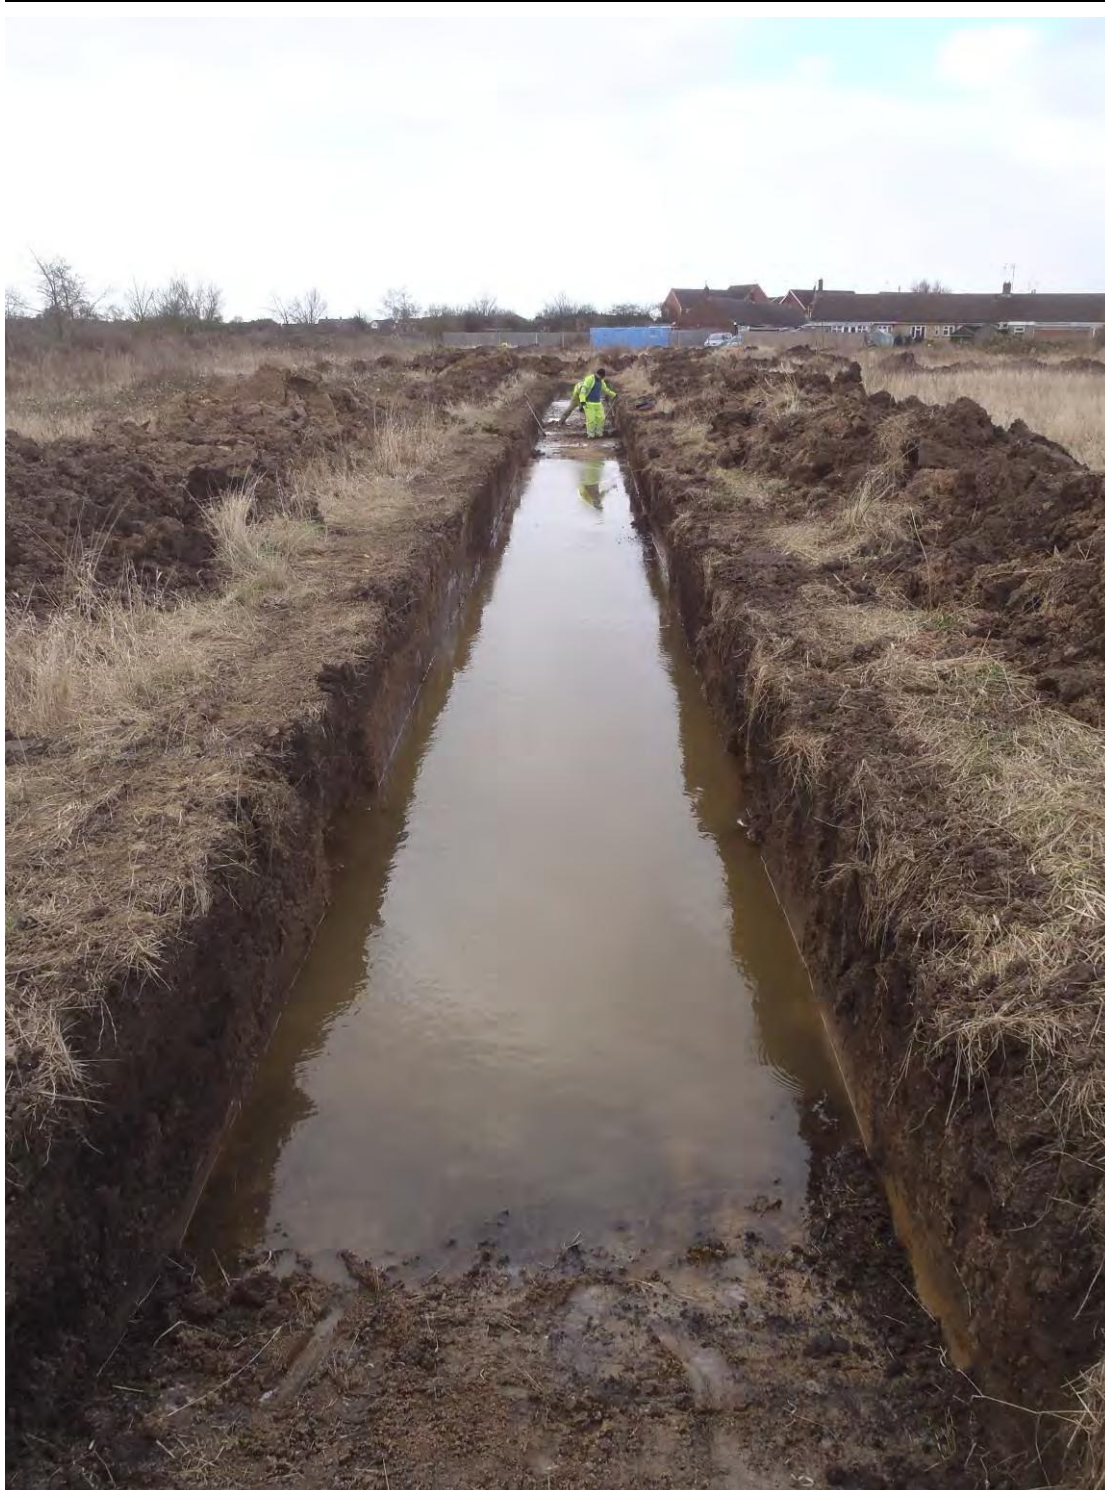
Plate 11: Trench [5], view south-west showing flooding

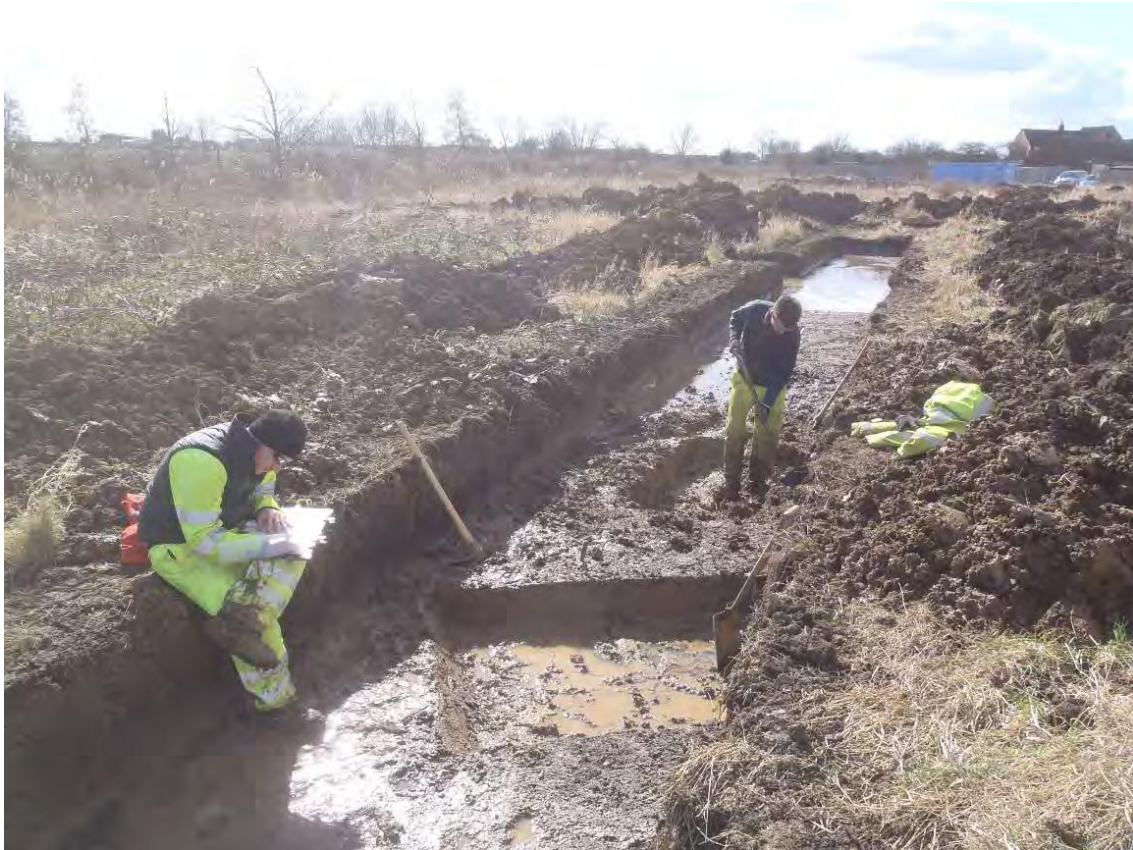
Plate 12: Ditches [14] and [16] (Trench [5]) during excavation, view south-east

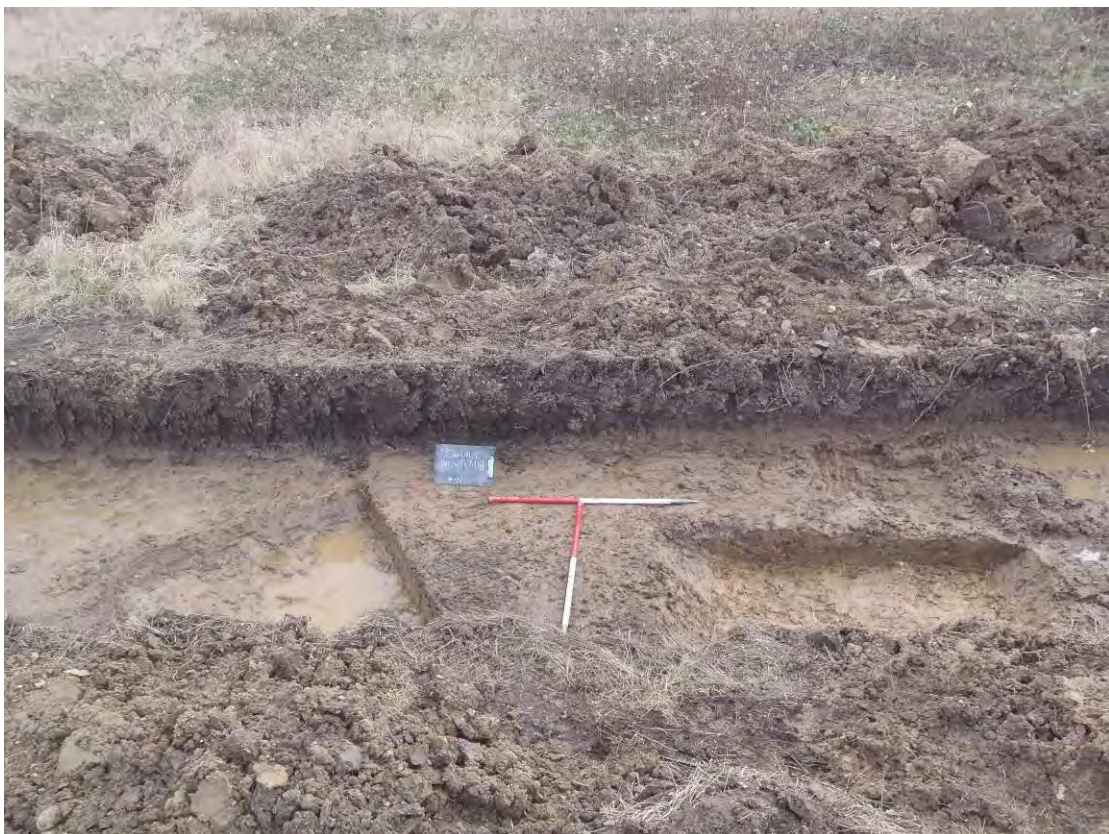
Plate 13: Ditches [14] and [16] (Trench [5]), view east

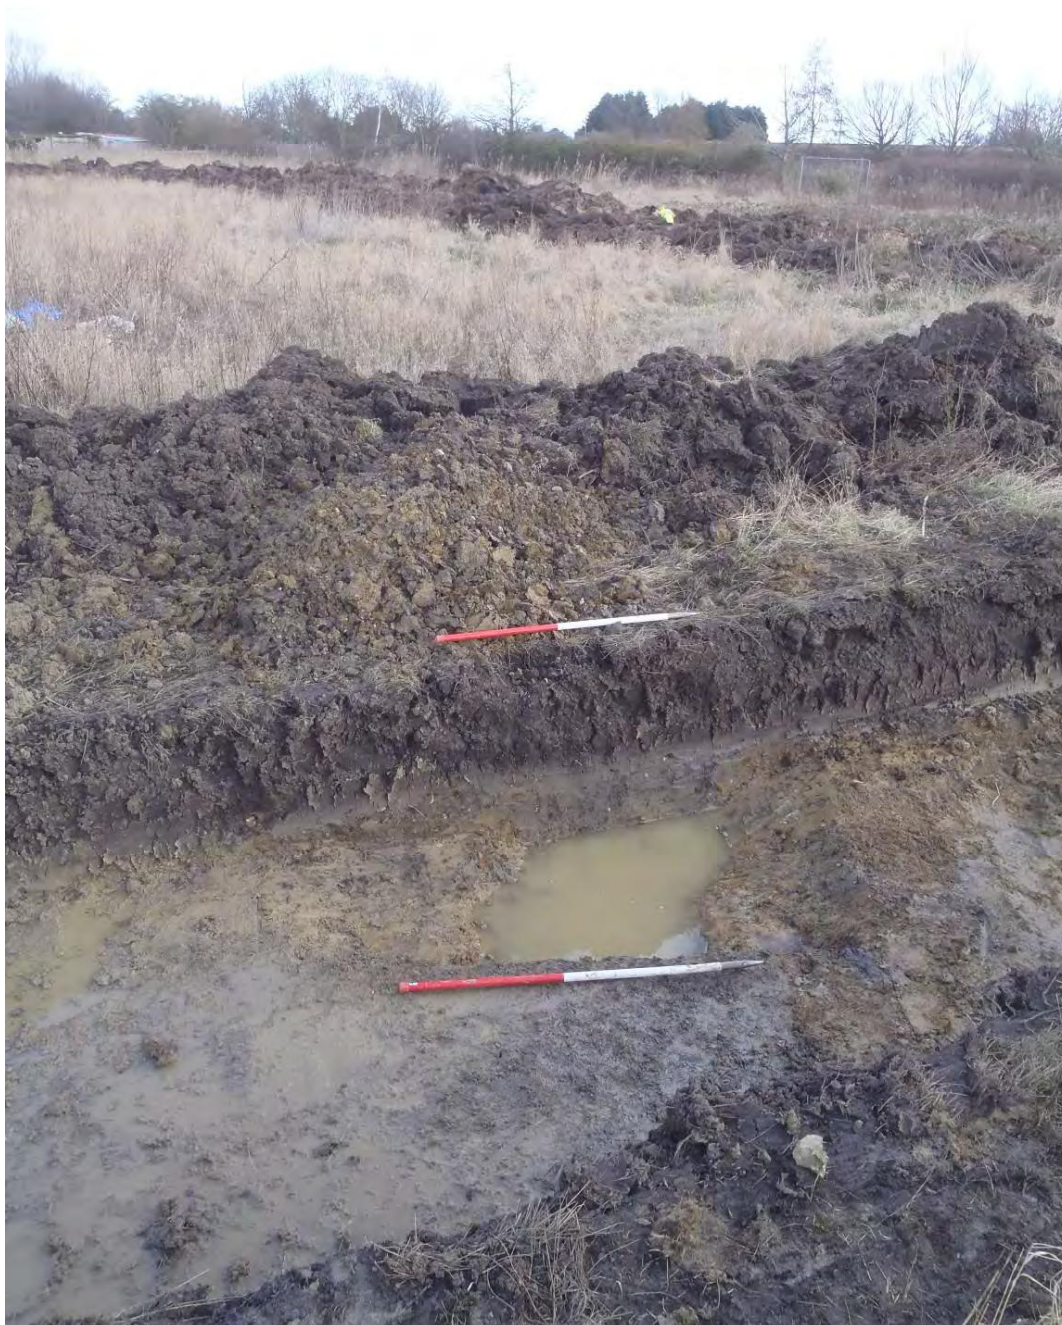
interface between (19) and the natural clay (9) was heavily-mineralised in places, suggesting that it was of some age. A 1m slot across the ditch was excavated and subsequently extended to 2m but no finds were present. The ditch was sealed by the subsoil. Ditch [18] was of similar size to Ditch [16] (Trench [5]) and aligned approximately perpendicular to it, suggesting that they were related field/ enclosure boundaries.

Plate 14: Ditch [18] (Trench [4]), view east
