**93-113 GROUNDS AVENUE,
MARCH, CAMBRIDGESHIRE,
PE15 9BG**

**ARCHAEOLOGICAL TRIAL
TRENCH EVALUATION**

**PRE-CONSTRUCT ARCHAEOLOGY
R11395**

Site Code : CGAM13

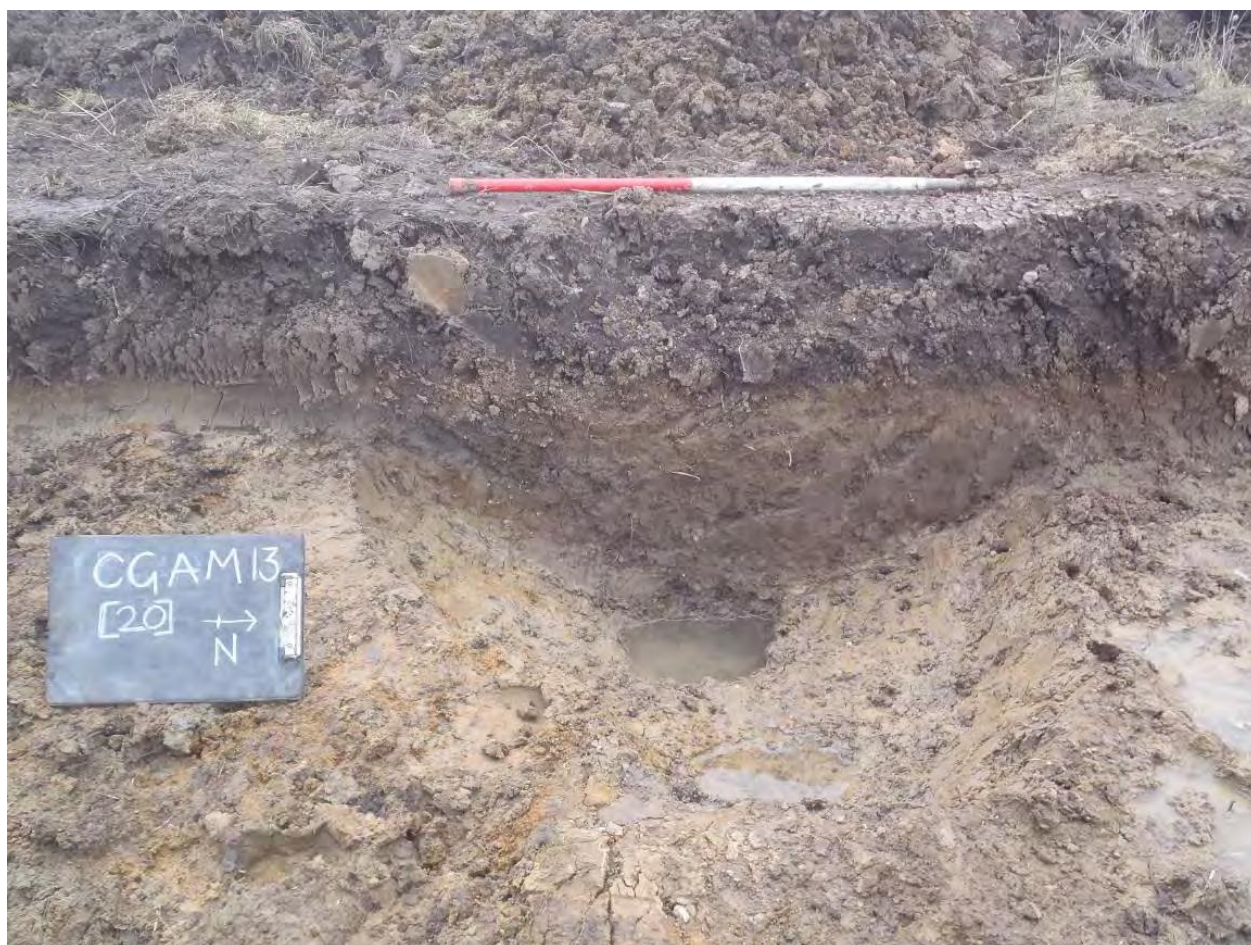
- 3.5 Two undated tree hollows [20] and [26] were present in Trench [1] (Fig. 3). Both were sealed by the subsoil and extended beyond the western limit of the trench. Tree Hollow [20] was roughly circular in plan, with irregular steep sides and an irregular pitted base; it measured 1.38m across by 0.51m deep (Plate 15; Fig. 4). It was filled with firm mid greyish-brown silty clay (21) which contained no finds. Immediately adjacent to the north-east of [20] was another Tree Hollow [26]. This was larger, but also had an irregular profile and sterile mid greyish-brown clay fill (27). Tree Hollow [26] was sealed by the subsoil.

Plate 15: Tree Hollow [20] (Trench [1]), view north-west

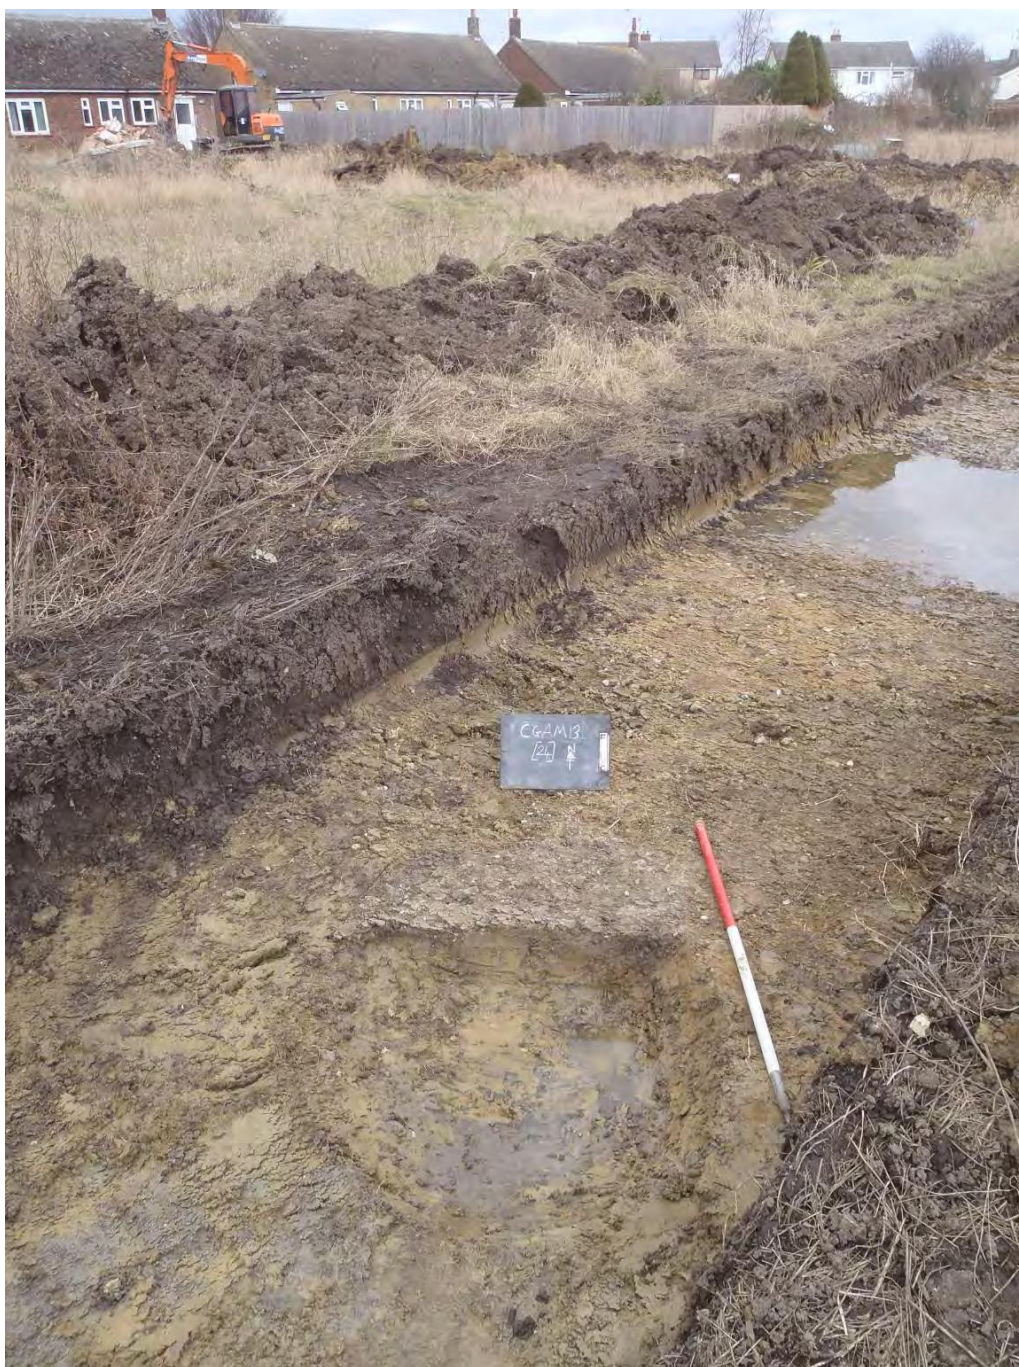
- 3.6 A third tree hollow [24] was excavated in Trench [3] (Plate 16; Fig. 3). It was roughly oval in plan with a shallow west side, a steep concave east side and a rounded base (Fig. 4). It was 1.39m by 0.90m across and 0.20m deep. It was filled with compact mid orangey-grey slightly silty clay (25). After being half-sectioned and recorded, the remaining fill was excavated but no finds were present. Tree Hollow [24] was sealed by the subsoil.

Plate 16: Tree Hollow [24] (Trench [3]), view north

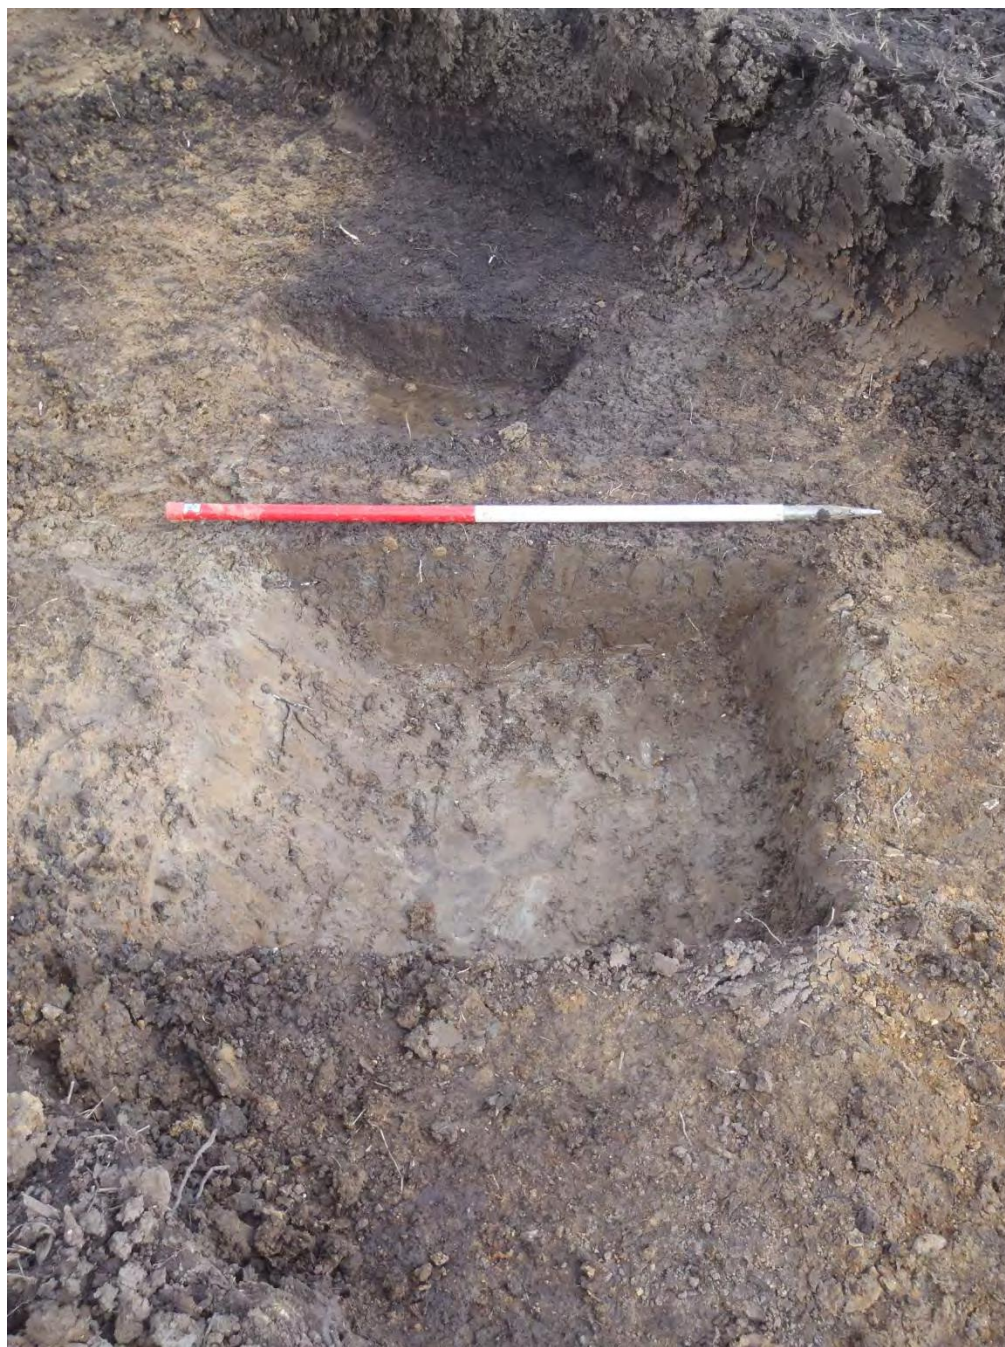
- 3.7 Ditch [12] was an east-to-west-aligned ditch extending across Trench [1] (Plates 1 and 17; Fig. 3). It had steep to near-vertical straight sides and a flattish base and measured 0.90m across by 0.29m deep (Fig. 4). It was filled with firm mid greyish-brown silty clay (13) which contained no finds. It was cut through the subsoil, suggesting a relatively recent date.

- 3.9 A pit [10] was cut through the subsoil (8) and into the fill of Ditch [12] (13) (Plate 17; Fig. 3). Pit [10] was oval in plan with moderately-steep concave sides and a rounded base (Fig. 4); it measured 0.64m across by 0.16m deep and extended beyond the limits of the trench to the east. It was filled with firm dark brown silty clay (11). After being half-sectioned and recorded, the remaining portion of the feature that lay within the trench was 100% excavated but no finds were present. However, the stratigraphic position of the pit cutting both the subsoil and Ditch [12] suggests a relatively recent (*i.e.* post-medieval or modern) date.

Plate 17: Ditch [12] and Pit [10] (Trench [1]), view east

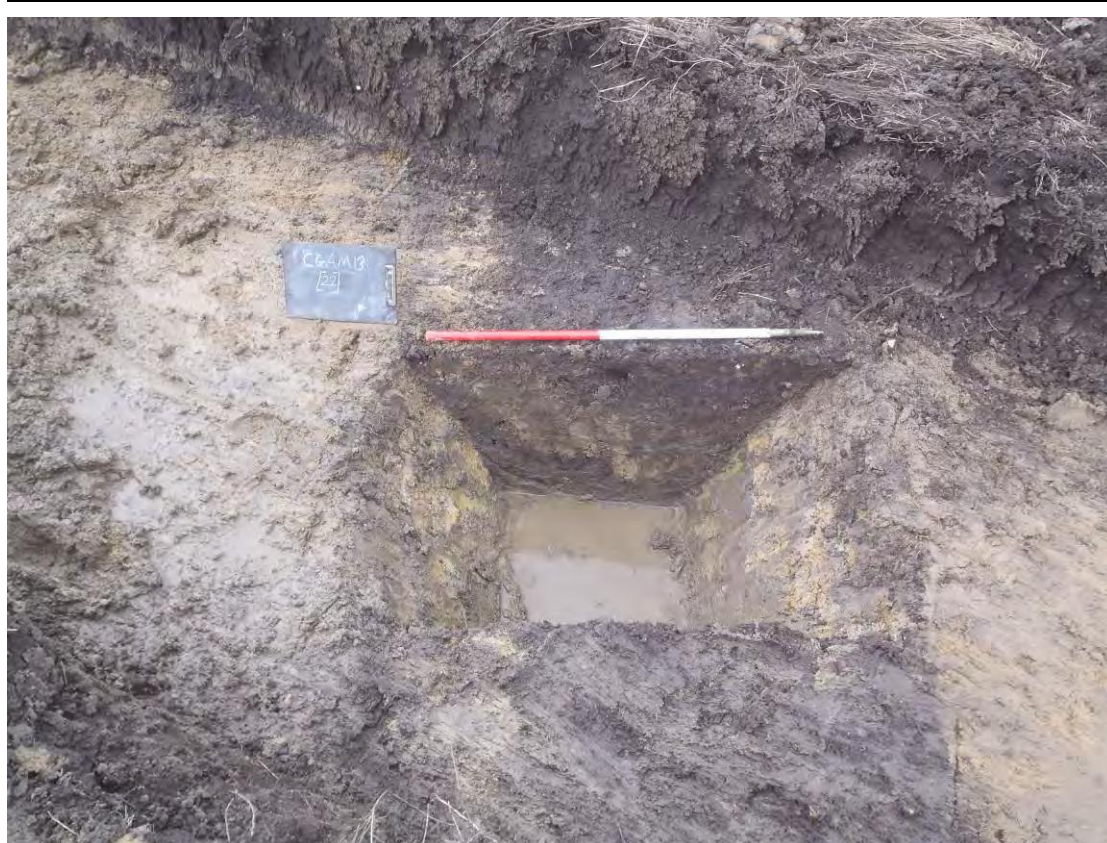
- 3.8 Ditch [22] extended on a north to south alignment across the middle of Trench [6], in the north of the site (Plates 6 and 18; Fig. 3). It was at least 30m long, 1.40m wide and 0.58m deep. It had steep straight sides and a flat base and contained a single fill of dark grey/ black silty clay (23) which contained three abraded pieces of post-medieval ceramic building material and a single small sherd of residual Roman greyware pottery (Katie Anderson, *pers. comm.*) in the excavated slot (Fig. 4). The ditch was cut from the topsoil level. The ditch continued southwards at an oblique angle across Trench [5], where its upper levels were machine-excavated and found to contain modern brick (not retained). Ditch [22] was a post-medieval/ modern drainage ditch aligned down the slope of the site. Ditches [12] and [22] were aligned

perpendicular to each other and were both cut through the subsoil; they may have been related field boundaries.

Plate 18: Ditch [22] (Trench [6]), view north
