**NEW UNION WHARF, ISLE OF DOGS
LONDON BOROUGH OF TOWER
HAMLETS**

ARCHAEOLOGICAL WATCHING BRIEF

PCA REPORT NO: R11419

SITE CODE: NUW13

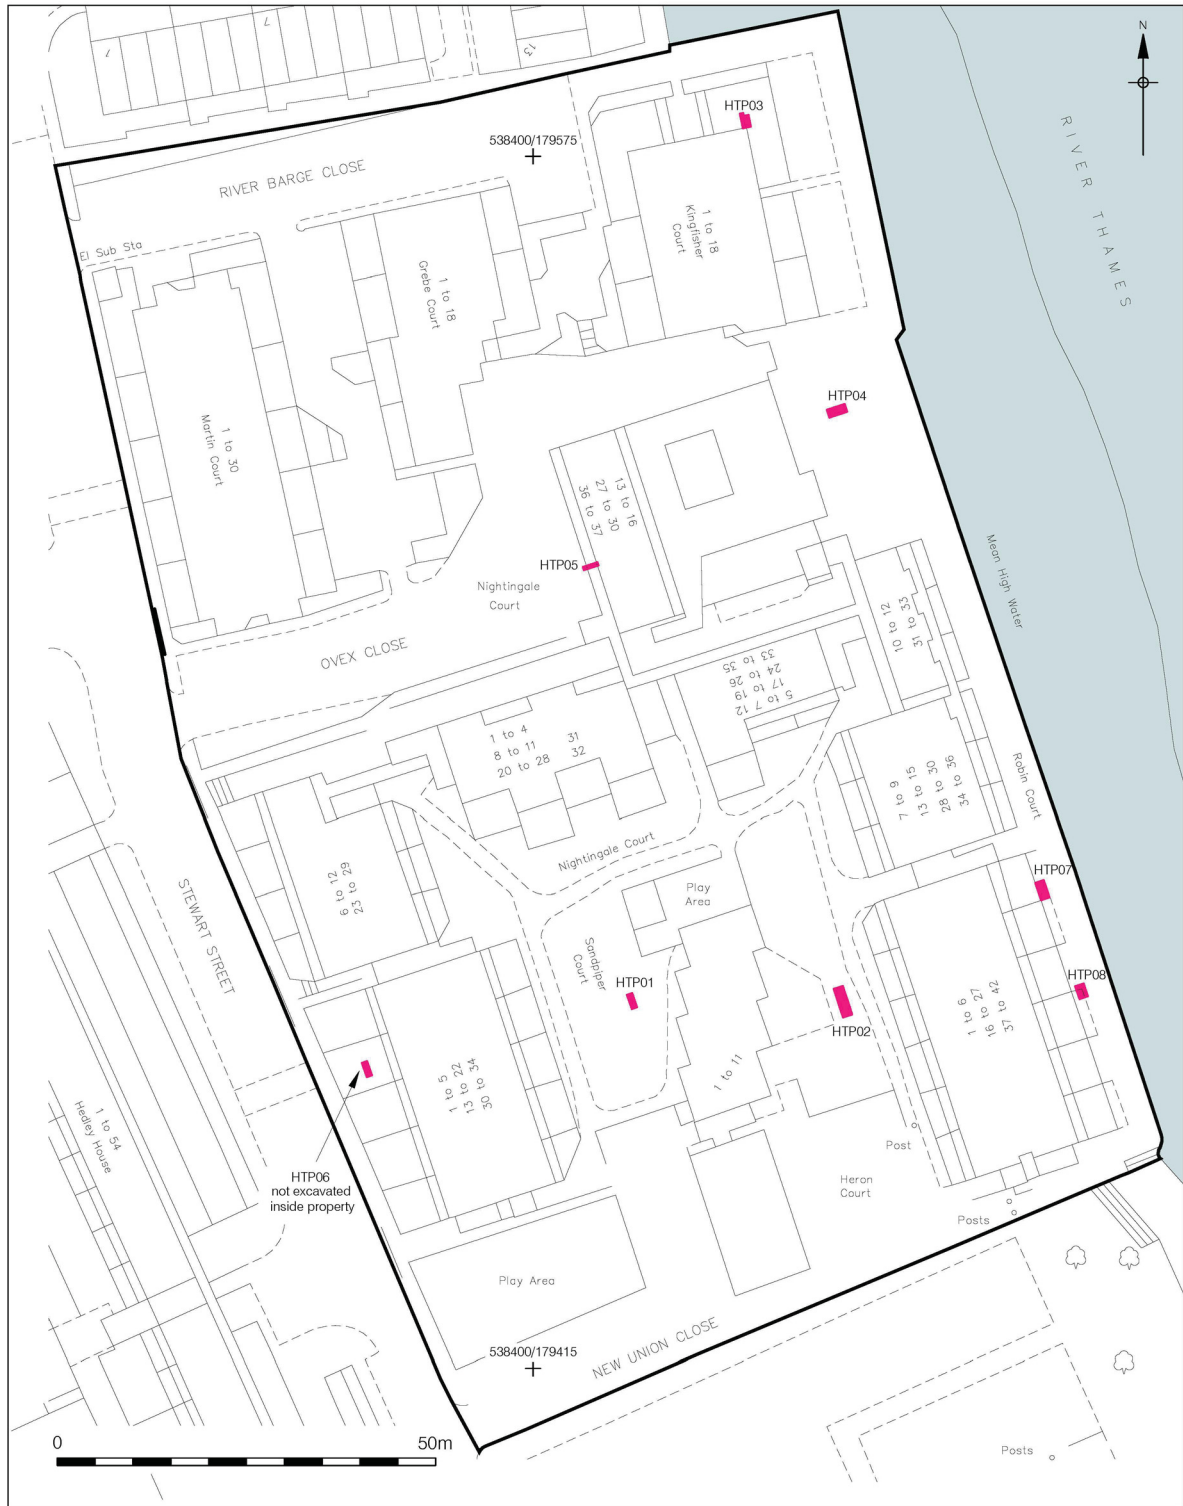
Figure 2
 Trial Pit Location
 1:1,000 at A4

- 2.5 The watching brief consisted of six hand excavated trial pits and two machine excavated trial trenches (Figure 2). The hand excavated trial pits were excavated to a maximum depth of 2m below ground level (BGL) and the machine excavated trial trenches were excavated to a maximum depth of 3.15m BGL.

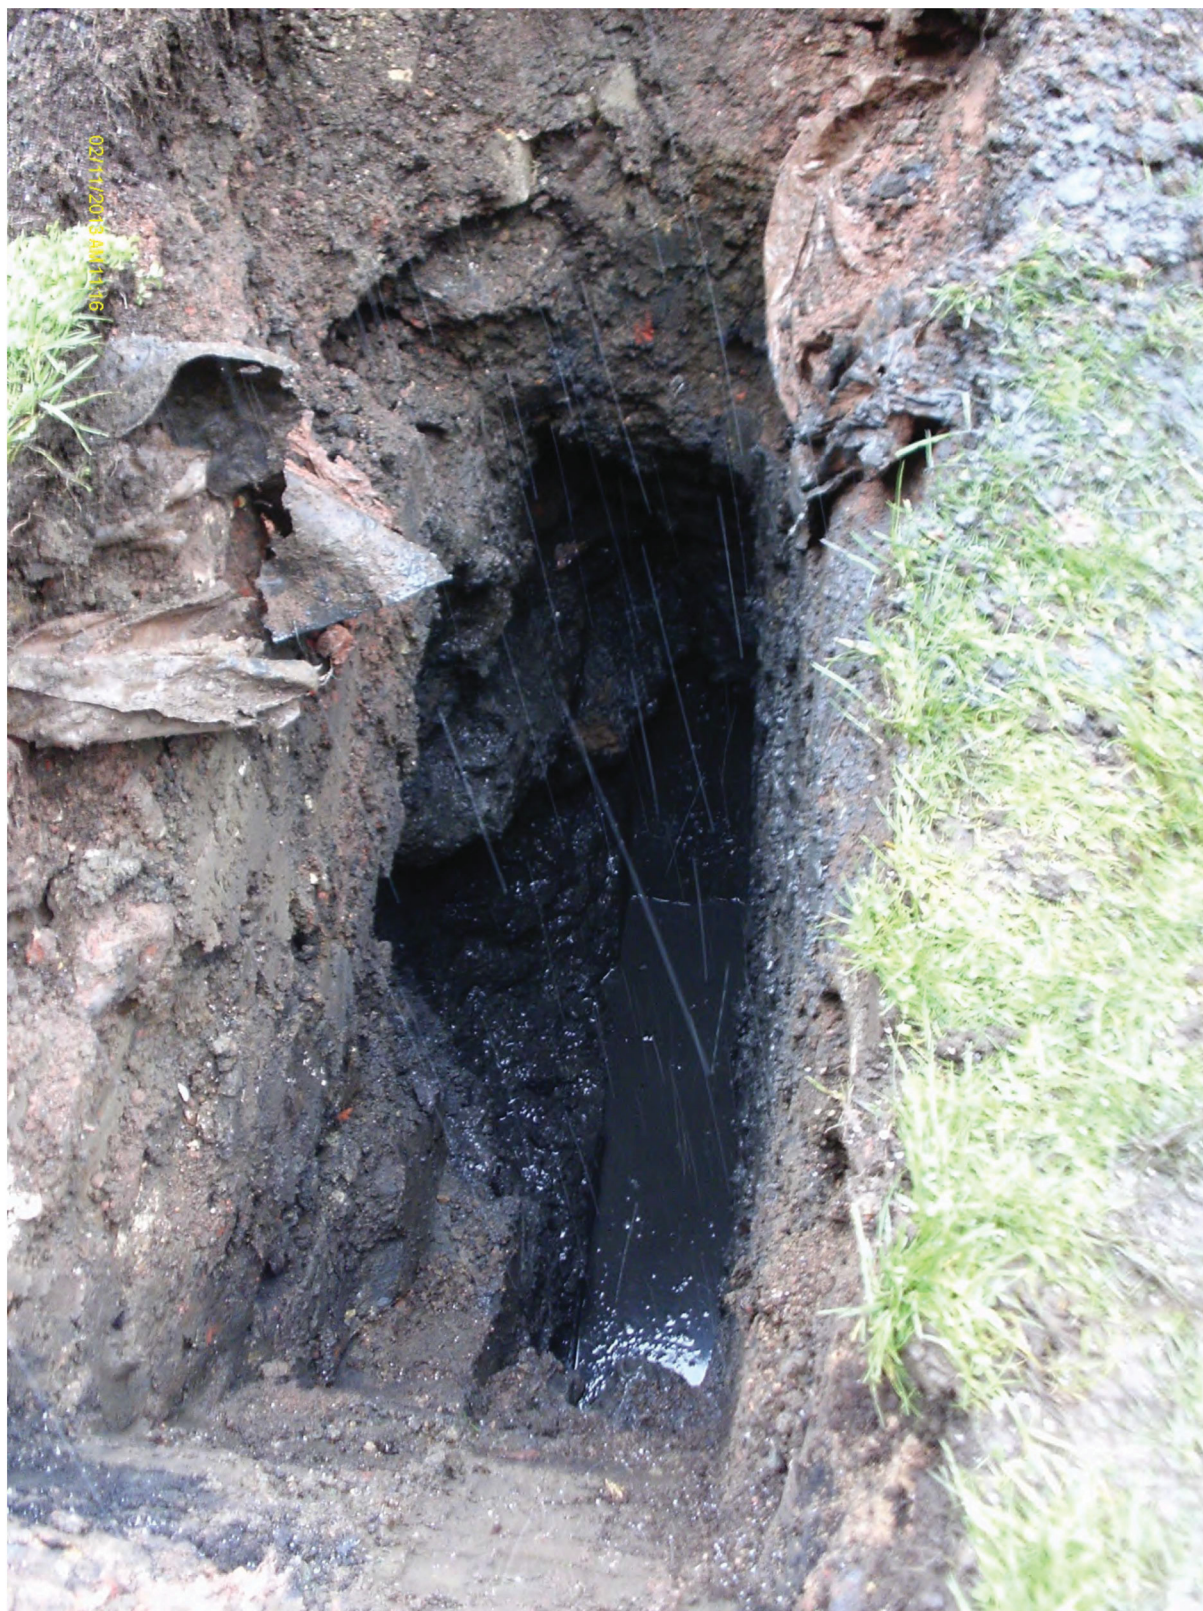
Image 1: East facing view of HTP01

7.1 HTP01 (Image 1)

- 7.1.1 The base of HTP01 revealed loose/soft dark brown sandy silt [4] with very frequent small fragments of decayed wood inclusions. This waterlogged layer was found 3m BGL and measured 2m east-west, 0.75m north-south, 0.15m in thickness. It was interpreted as a possible post-medieval layer associated with the 19th century shipyard complex.

- 7.1.2 Layer [4] was overlain by a waterlogged layer [3] which consisted of very dark brown silty clayey gravel with occasional oyster shell inclusions with dimensions of 2m east-west, 0.75m north-south and 1.2m thickness. This layer was found at 1.74m BGL and was interpreted as post-medieval made ground.

- 7.1.3 At 1.33m BGL was observed a very stiff mid grey bluish silt clay layer [2] with occasional small fragments of CBM and decayed wood. This layer was observed across the trench and was 0.4m thick. The water table was found at approximately 1.5m BGL. This layer was interpreted as post-medieval made ground.

- 7.1.4 Layer [2] was overlain by mid to dark brown sandy gravelly silt [1] found at 0.73m BGL. This layer was 0.6m thick and was observed across the trench. It was interpreted as post-medieval made ground.

- 7.1.5 The sequence was capped by modern made ground and top soil for the existing lawn.

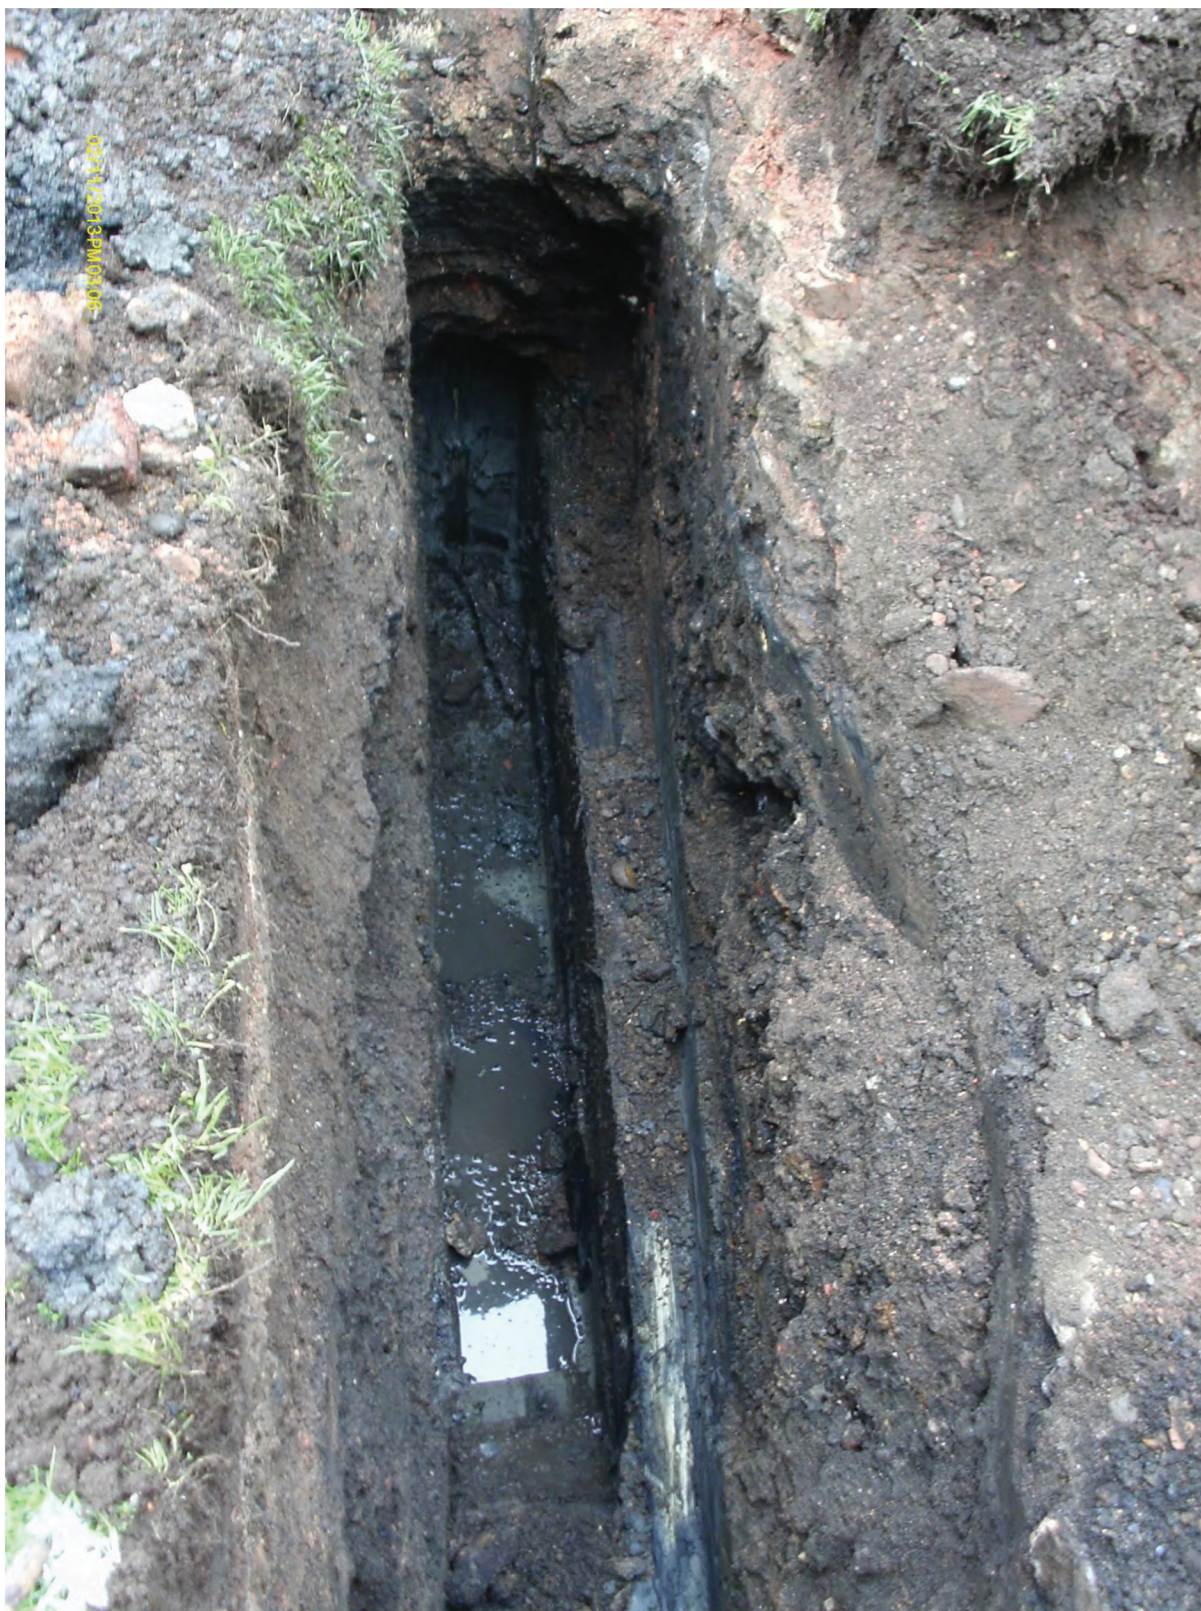
Image 2: East facing view of HTP02

7.2 HTP02 (Fig 3 and Image 2)

- 7.2.1 The base of HTP02 revealed a stiff mid grey bluish sandy clay [9] deposit with very occasional flint pebbles and small fragments of decayed wood. This deposit found 1.7m BGL was interpreted as alluvium and measured 4m north-south, 0.24m east-west and 1.34m thick.

- 7.2.2 Deposit [9] was truncated by timber posts [7] and [8]. Their dimensions were of approximately 0.2m wide by 0.7 high and were observed in the west facing section of the trench only. They were sealed by horizontal timber [6] which was found 1.8m BGL. Timber [6] was orientated north-south and its dimensions were 4m long, 0.4m high and approximately 0.35m wide. Timbers [6], [7] and [8] were interpreted as timber pile foundations and baseplate associated with an historic (19th century) river wall structure.

- 7.2.3 Timber [6] was overlain by mid to dark brown sandy silt [5] found 0.9m BGL. This layer/deposit had frequent fragments of CBM and concrete and moderate fragments of decayed wood and was interpreted as a possible backfill of a robbed wall associated with the original structure supported by timbers [6], [7] and [8]. Context [5] was sealed by approximately 0.9m of modern made ground and top soil for the existing lawn.

- 8.2 A number of post-medieval structures were identified across the study site. These included a timber baseplate supported by timber posts, located in the southern part of the site (HTP02). This structure was interpreted as a timber foundation/support and is possibly associated with Yarrow's Yard wharf shown on the 2nd edition OS map of 1896 and 1900 Goad Insurance Plan (see Fig 8).

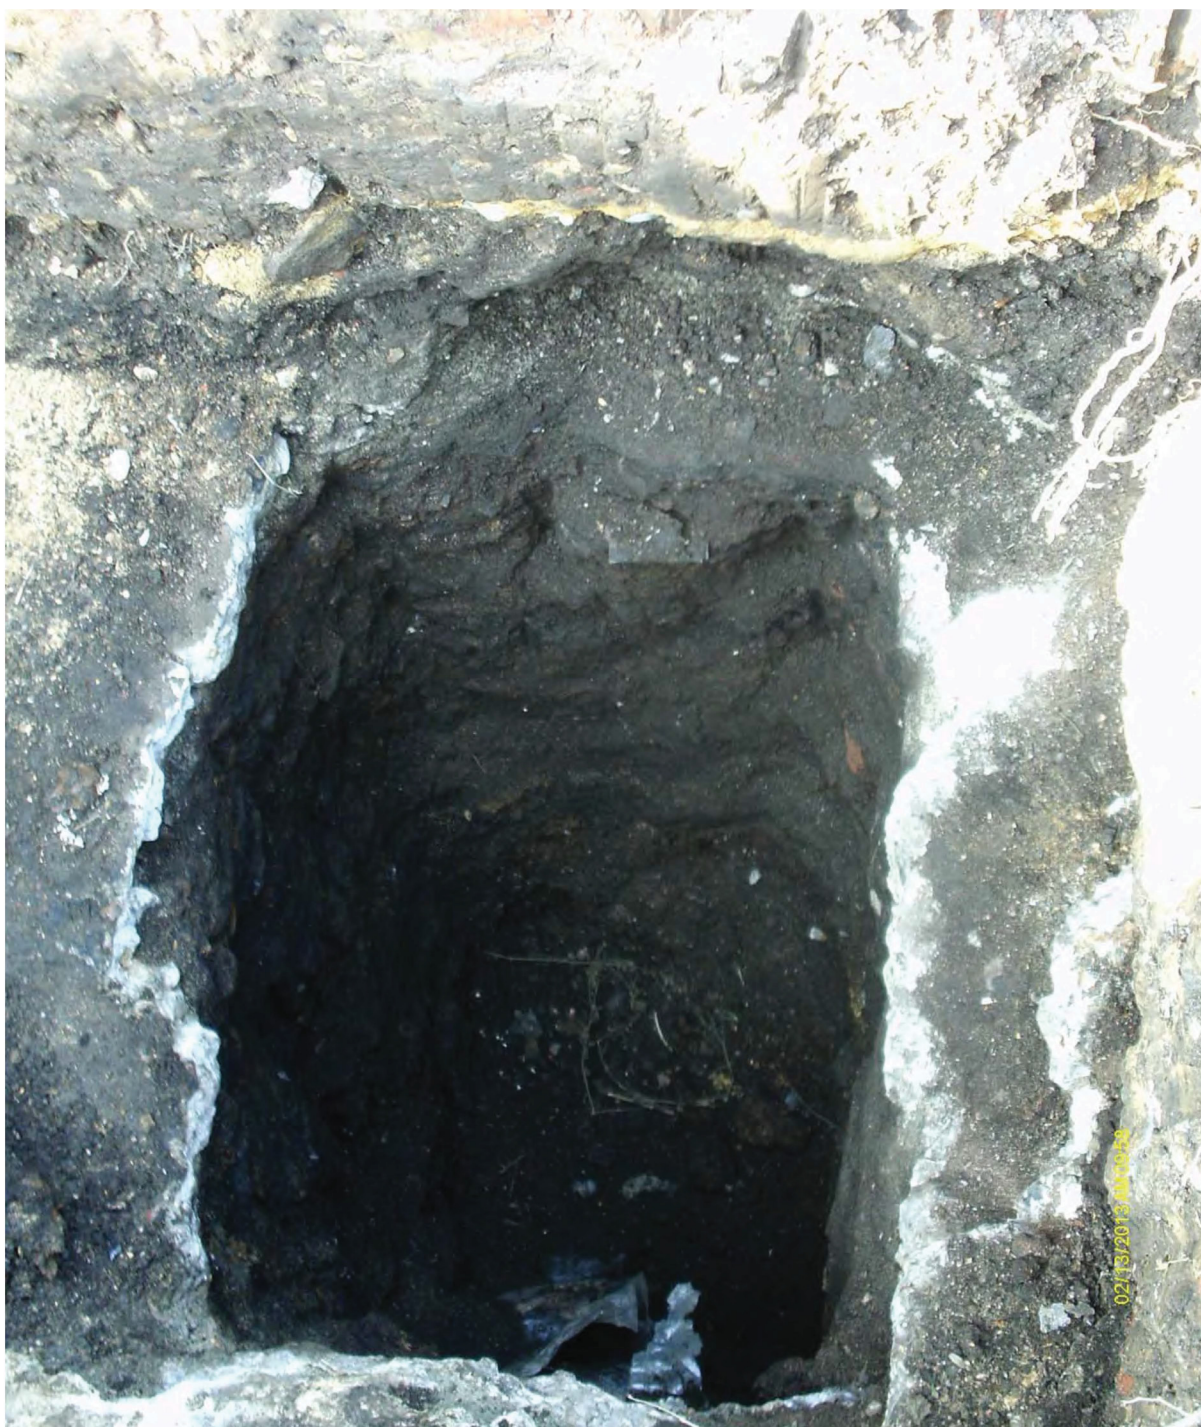
Image 3: West facing view of HTP03 showing concrete slab [10] (to the right) and layers [13], [12] and [11]

7.3 HTP03 (Fig 4 and Image 3)

- 7.3.1 The earliest layer revealed in this test pit was very soft very dark brown organic sand silt layer [13] found 1.90m BGL. This layer was partially exposed and measured 0.5m north-south, 1.1m east-west and 0.1m thick and had very frequent small fragments of decayed wood inclusions. It was interpreted as a probable post-medieval layer.

- 7.3.2 Layer [13] was overlain by layers [12] and [11] found at 1.35m, 0.93m BGL. The overall thickness of layers [12] and [11] was 0.97m which consisted of dark brown sandy gravelly silt with metal slag and occasional oyster shells, chalk flecks, animal bones and CBM flecks inclusions. Contexts [12] and [11] were interpreted as post-medieval reclamation dumps.

- 7.3.3 Concrete slab [10] sealed layer [11] at 0.83m BGL. This concrete probably represents the 1950s ground surface before the construction of the latest river wall (constructed in the mid 1970s).

- 7.3.4 The archaeological deposits encountered within this trial pit appear to be associated with the Blackwall Iron Works as depicted on the 1869 and 1896 OS maps and 1900 Goad Insurance Plan (see Fig 9).

- 8.3 A concrete surface constructed above a sequence of post-medieval layers was identified in the northeast corner of the site (HTP03). This was interpreted as an external concrete surface associated with the Blackwall Iron Works as depicted on the 1900 Goad Insurance Plan (see Fig 8).

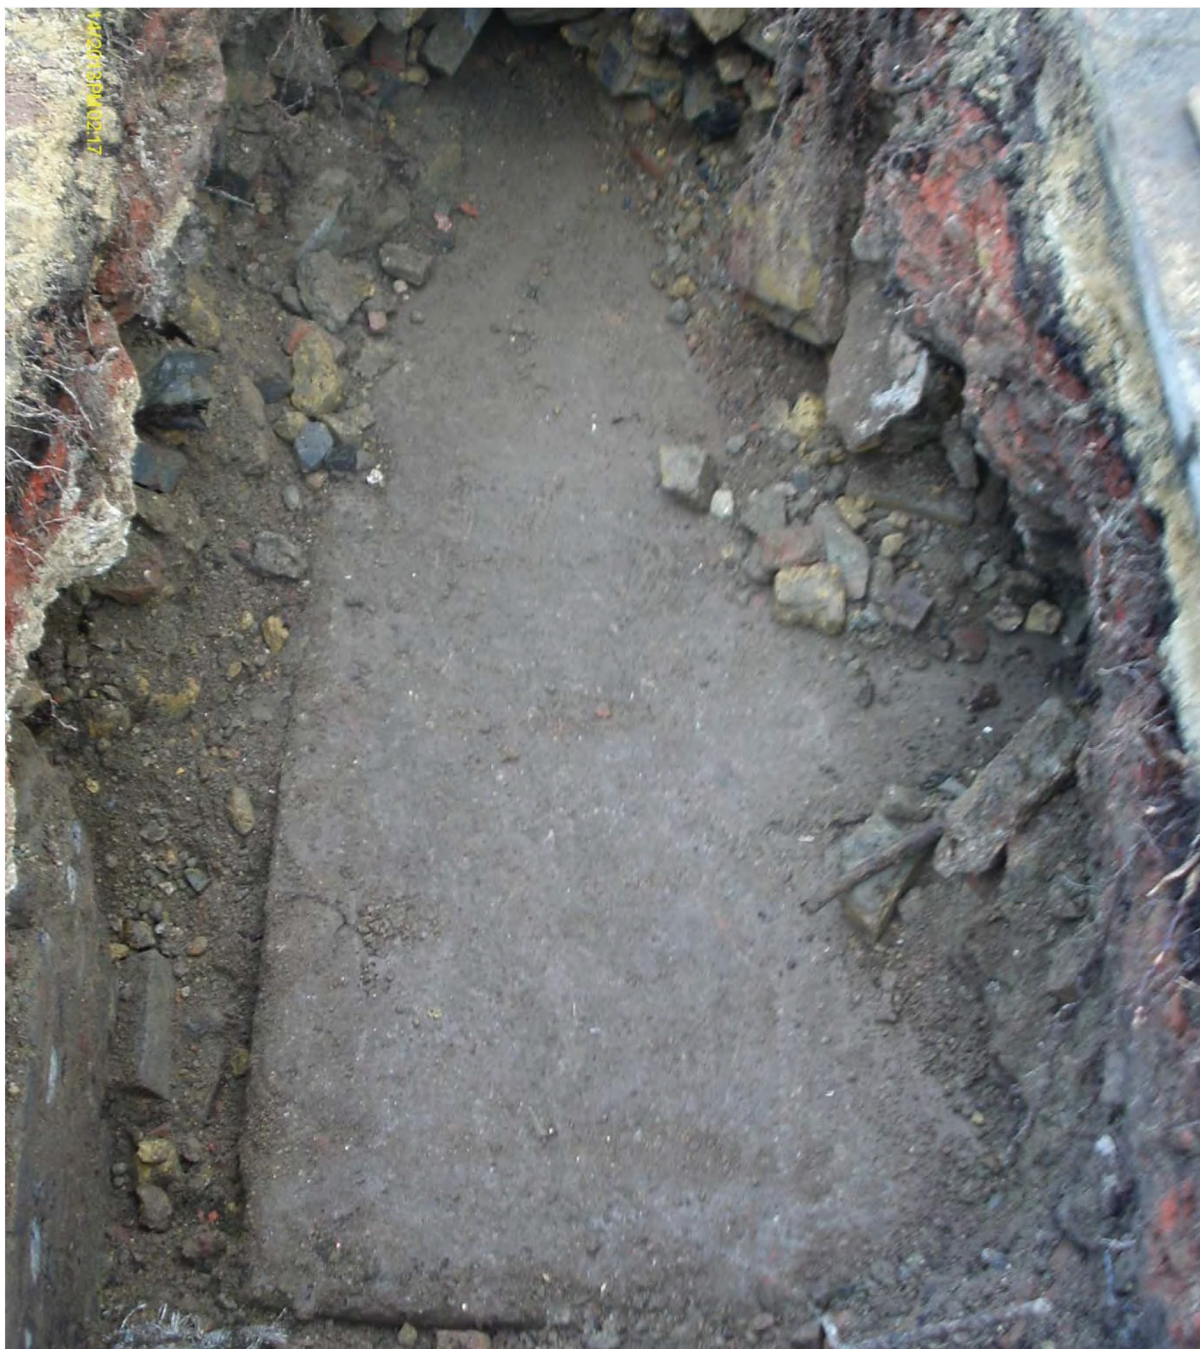
Image 4: East facing view of HTP04 showing modern pile cap

7.4 HTP04 (Image 4)

- 7.4.1 The earliest deposit encountered in this test pit was modern concrete for the pile cap associated with the anchor for the present river wall. The top of the pile cap was found approximately 1.15m BGL and was at least 1.05m thick. The concrete was sealed by approximately 1m of demolition rubble and bedding sand for the paving slab. No archaeological deposits encountered in this trial pit.

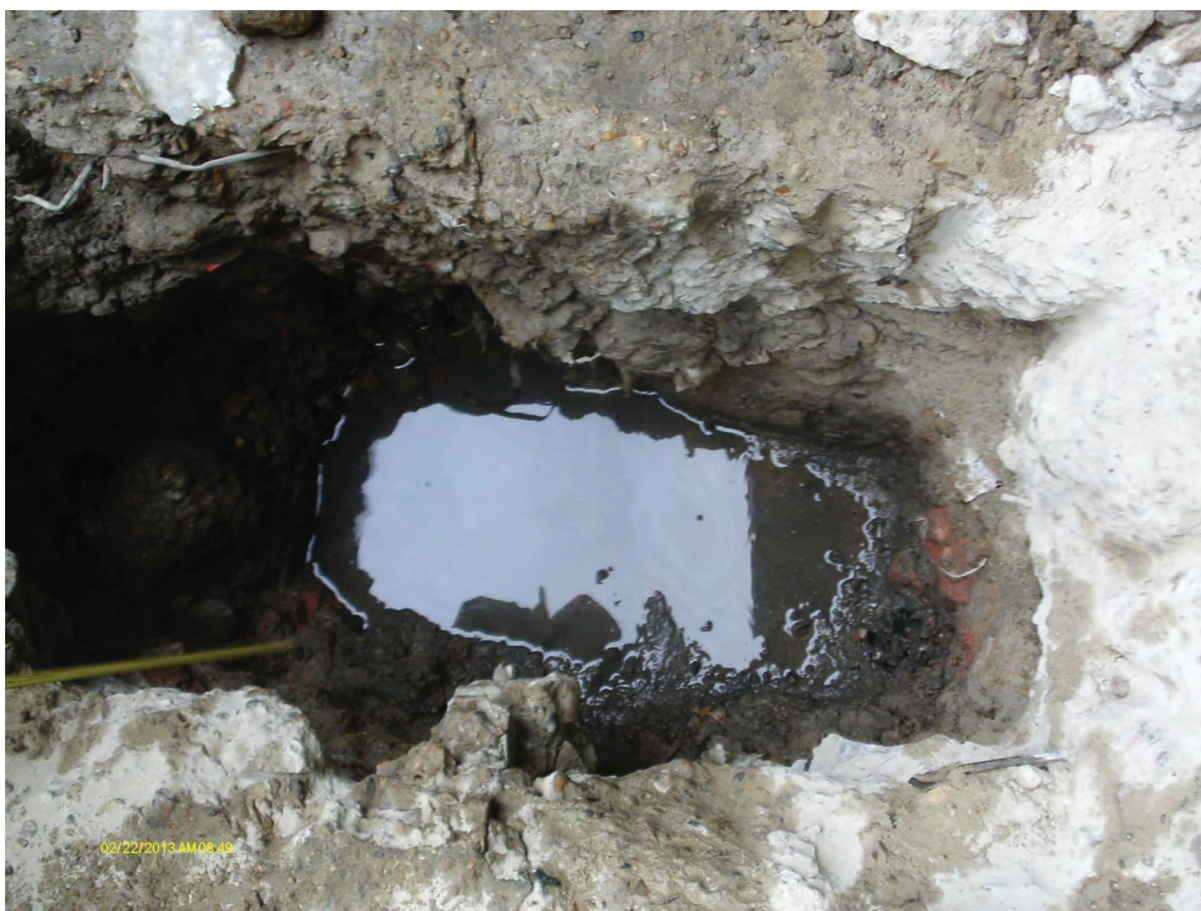
Image 5: West facing view of HTP05

7.5 HTP05 (Fig 5 and Image 5)

7.5.1 The earliest structure observed in this trial pit was a possible north-south orientated brick wall located along the west side. The interpretation of this possible brick wall is not certain due to the very small area excavated and the very poor condition of the brickwork. However, the position of this possible north-south wall is consistent with the outline of the western edge of the barge building slips featured on the Goad Insurance Plan of 1939 (Fig 9). The brickwork was sealed by 0.81m of modern concrete for the car park.

- 8.4 A possible north-south orientated masonry wall was observed in the central area of the study site (HTP05). The interpretation of this feature is not certain due to the very small area excavated and the very poor condition of the brickwork. However, the position of this possible north-south wall is consistent with the western edge of the barge building slips as shown on the Goad Insurance Plan of 1939 (see Fig 9).

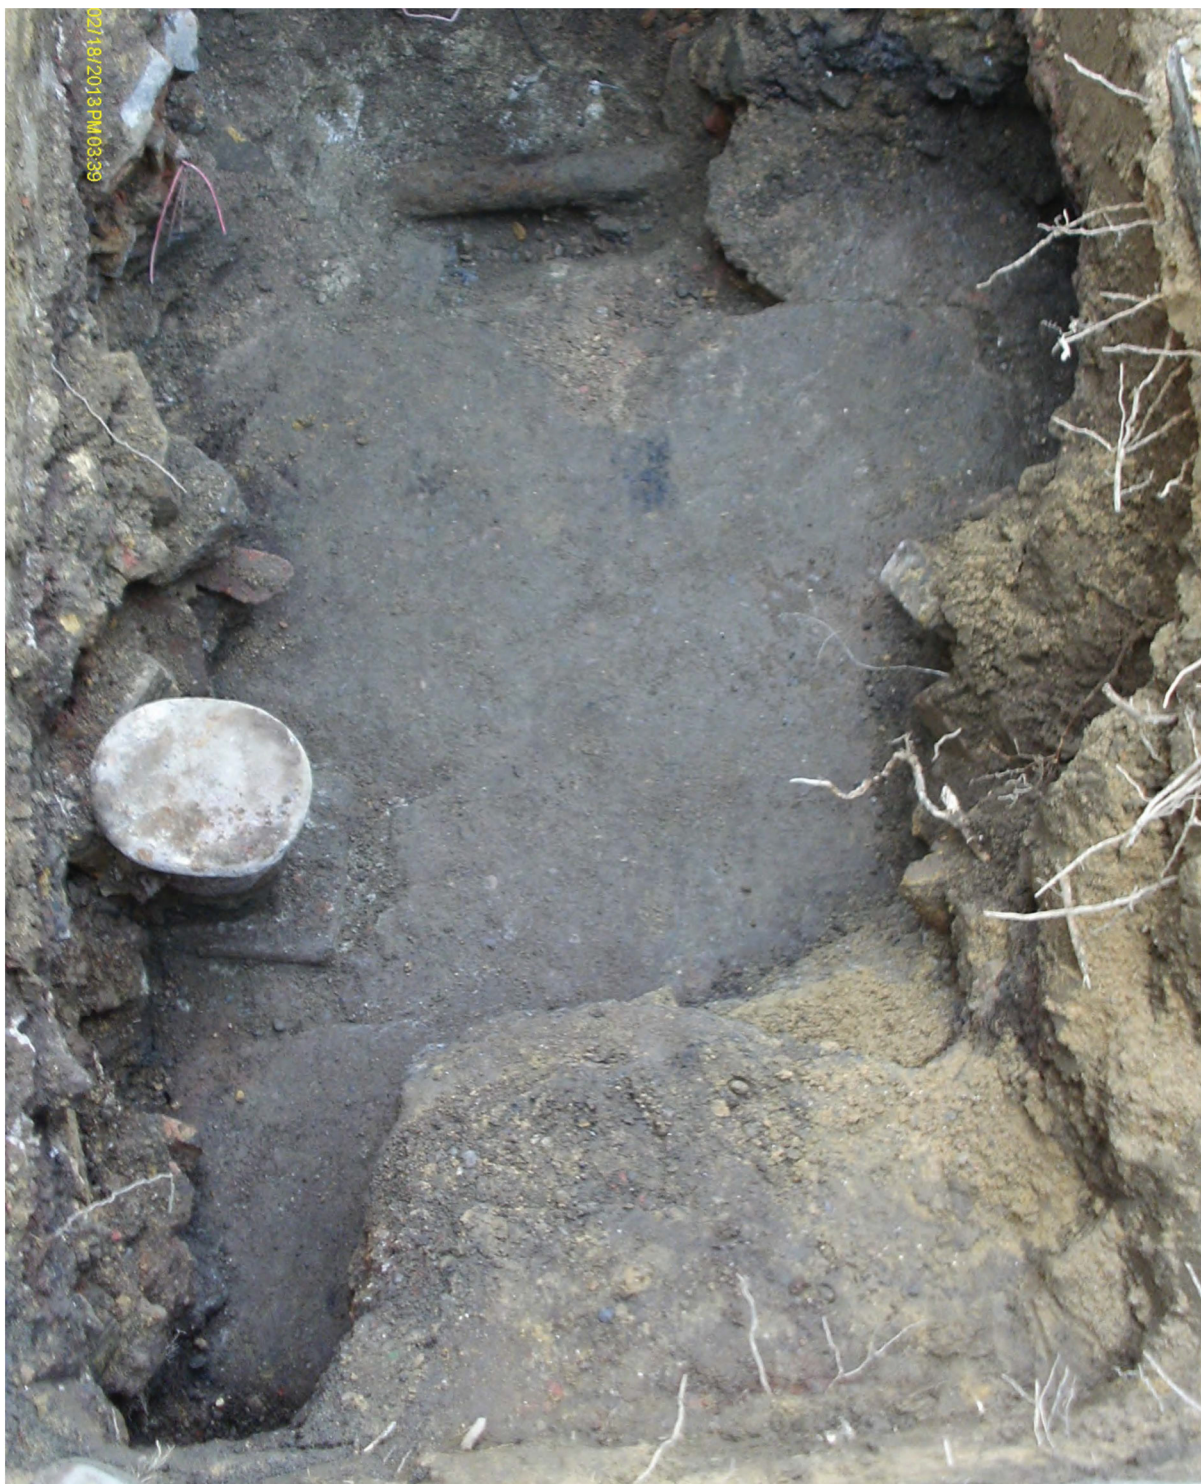
Image 6: North facing view of HTP05 showing concrete [14] and mooring bollard to the left

7.6 HTP07 (Fig 6 and Image 6)

- 7.6.1 The base of this trial pit revealed concrete base/floor [14] found 1.02m BGL. Concrete [14] was on a north-south orientation and measured 1.65m north-south and 1.10m east-west. To the east it formed a step with an inclination toward the River Thames. A cast iron mooring bollard set within concrete [14] was observed approximately 0.80m from the eastern limit of the concrete [14].
- 7.6.2 Concrete [14] and the bollard represents part of the Yarrow's Yard as depicted on the OS map of 1896 (not shown) and Goad Insurance Plan 1900 (Fig 8).
- 7.6.3 Concrete [14] was overlain by approximately 1m of made ground in turn sealed by modern paving slabs.
- 7.6.4 This trial pit has good archaeological potential for the understanding of the early phase (19th century) of the River Thames wall.

- 8.5 The base of this HTP07 revealed north-south orientated late post-medieval concrete base/floor [14]. To the east it formed a step with an inclination towards the River Thames. A cast iron mooring bollard set within concrete [14] was observed approximately 0.80m from the eastern limit of the concrete. Concrete [14] and the bollard are likely to represent part of the river wall at Yarrow's Yard as depicted on the Goad Insurance Plan (see Fig 8).

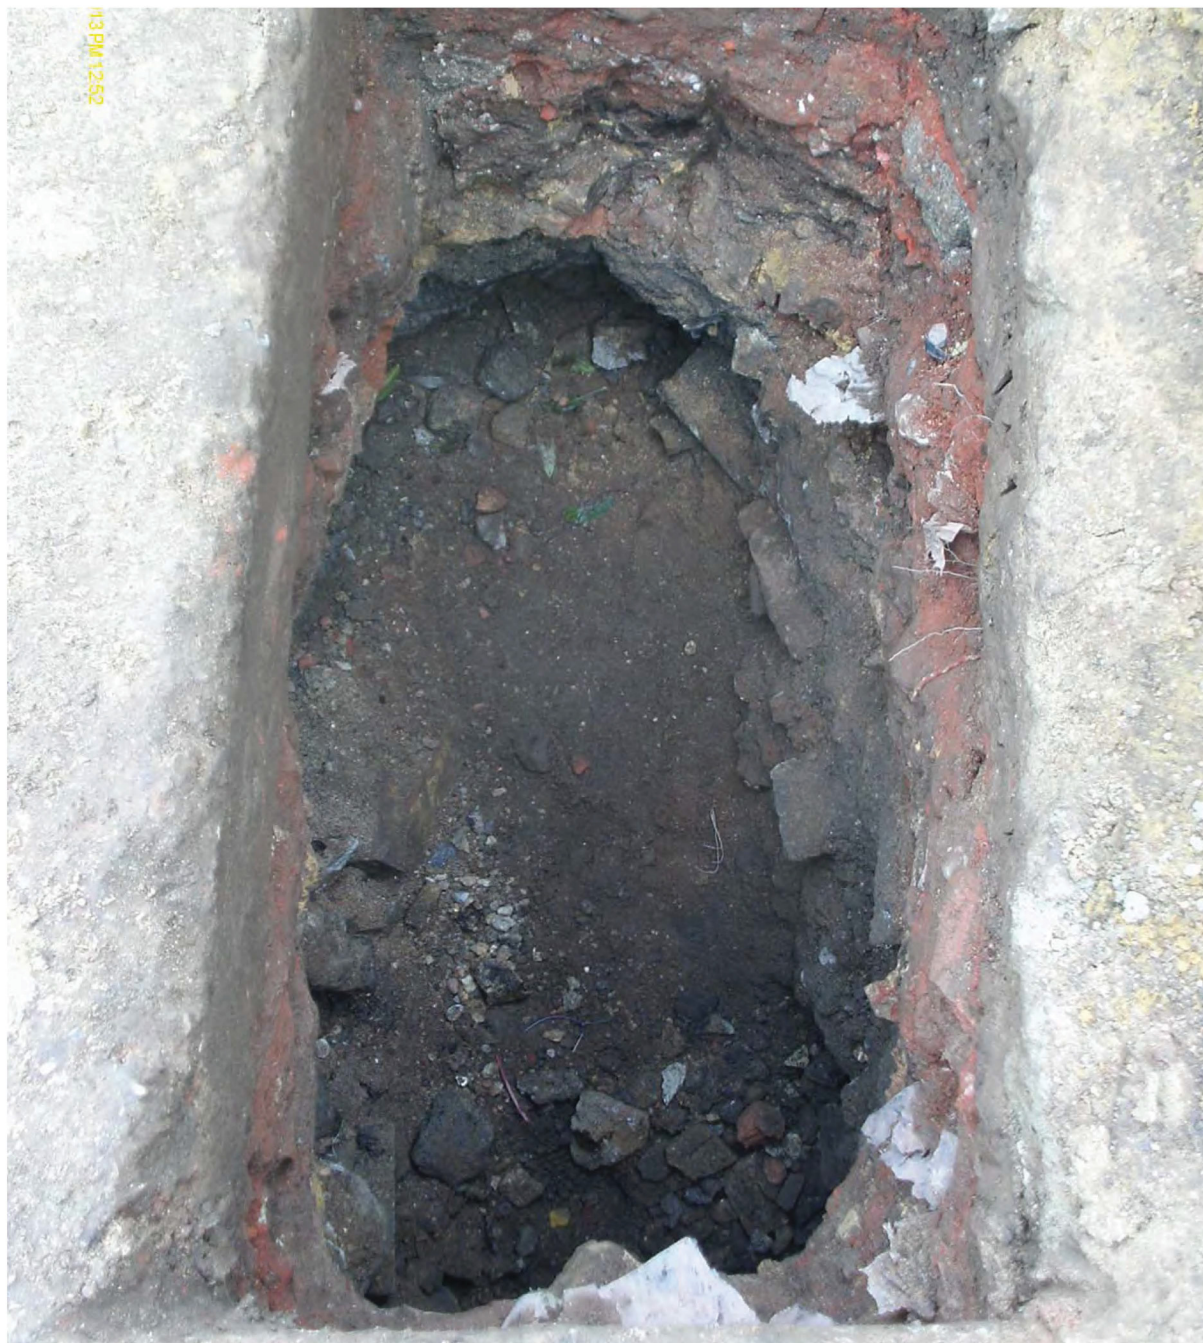
Image 7: South facing view of HTP08

7.7 HTP08 (Fig 7 and Image 7)

7.7.1 This trial pit revealed only modern deposits. This trial pit was excavated to a maximum depth of 1.76m BGL. No archaeological deposits encountered in this trial pit.
