**Former Roman Hill Primary School,
Love Road, Lowestoft, Suffolk,
NR32 2NY:**

**An Archaeological Trial Trench
Evaluation**

PCA REPORT NO: R11445

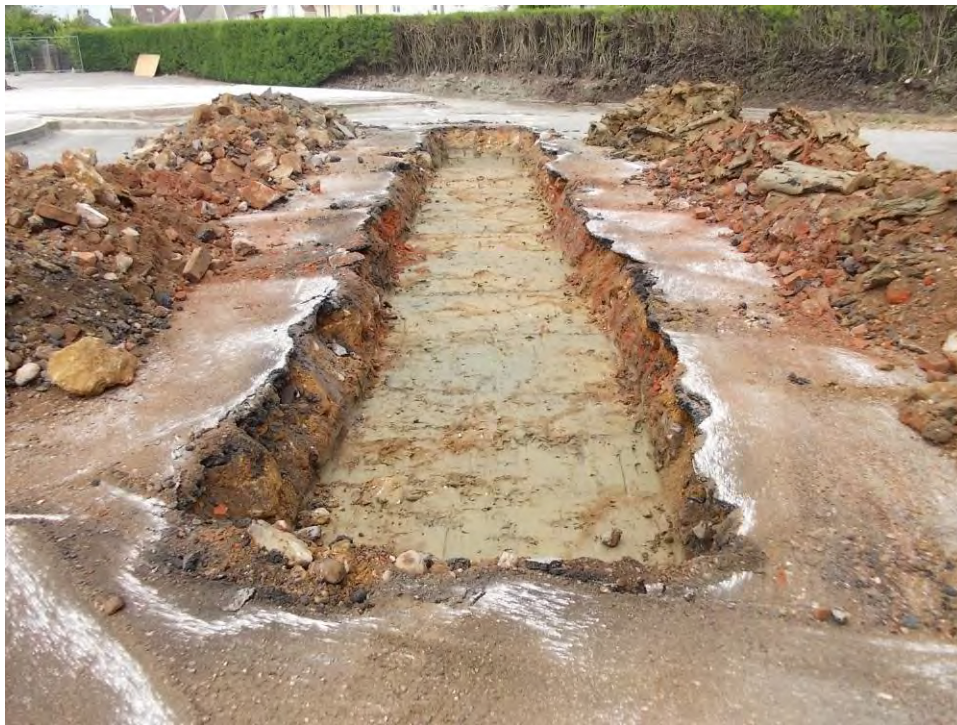
4.1 Natural Clay (1) was encountered at a height of between 14.32m OD and 14.26m OD within this trench, 0.37-0.48m below modern ground level. No features were encountered cut into this clay, although there was evidence that small frost polygons had formed on its surface under peri-glacial conditions.

Plate 1: Trench 1: view northwest showing Natural Clay (1) in base of trench, with evidence of frost polygons.

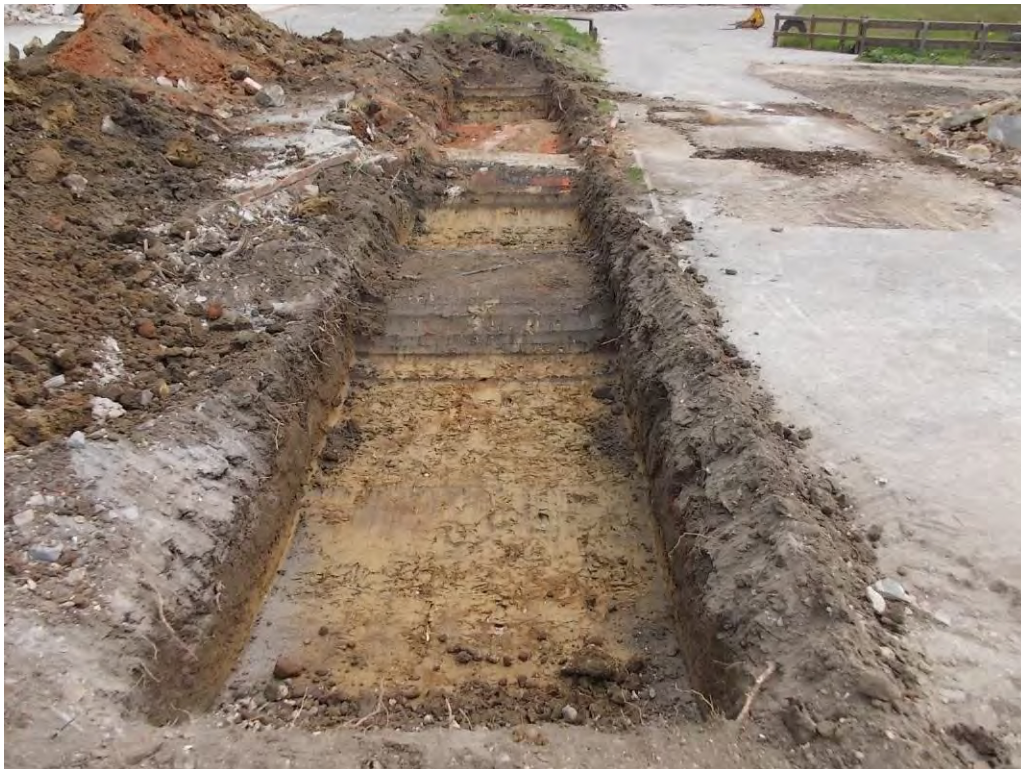
- 4.3 Natural Clay (2) was exposed at a height of between 14.15m OD and 14.10m OD. As in Trench 1, no archaeological features were present within this trench.

- 4.4 Overlying the natural clay lay a 0.05-0.10m thick layer of finely crushed brick material (3), most probably arising from brick production and dating to the 19th century. The underlying clay showed no signs of scorching or burning, hence it is unlikely that this material was deposited while still at a high temperature, nor did the brick deposit show signs of wear on its upper face associated with having been laid down as a surface.

Plate 2: Trench 2: view east showing natural clay (2) in base of trench, with modern intrusions visible.

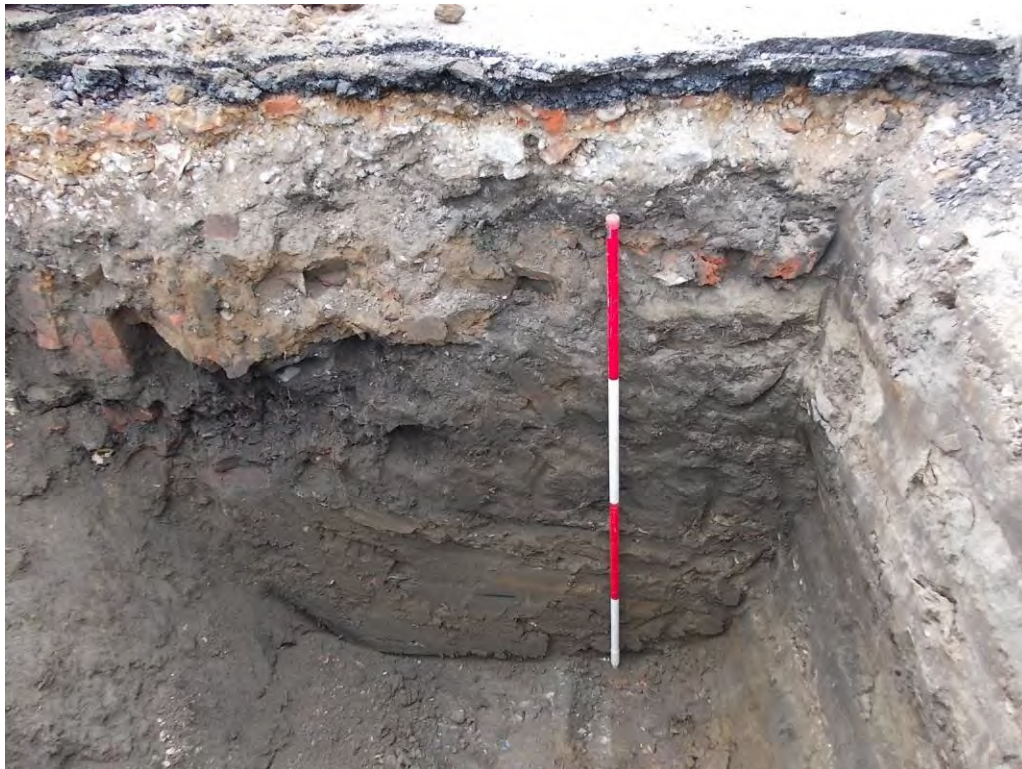
4.6 Natural deposits were not encountered in this trench due to extensive deep truncation caused by clay extraction pits. The earliest (and lowest) deposit encountered comprised the late-19th-century backfill (4) of these clay workings. This was encountered at a height of between 13.34m OD and 12.96m OD and was more than 1.75m deep. The deposit had a partly domestic character (containing inclusions of domestic pottery and glass bottles), which suggests that the extraction pits were used in part as a landfill from the adjacent late Victorian terraced houses. A test pit into Layer (4) was excavated at the west end of the trench in an attempt to ascertain the depth at which the natural geology survived. However, no natural was encountered at a depth approaching 2.5m below modern ground level. For safety reasons, the test pit was backfilled and the remainder of the trench excavated to a depth of 1.30m only, into the upper levels of Layer (4).

Plate 3: Trench 3: north-facing section at west end of trench showing 19th-century quarry backfill (4) with modern made ground above. 2.00m scale.

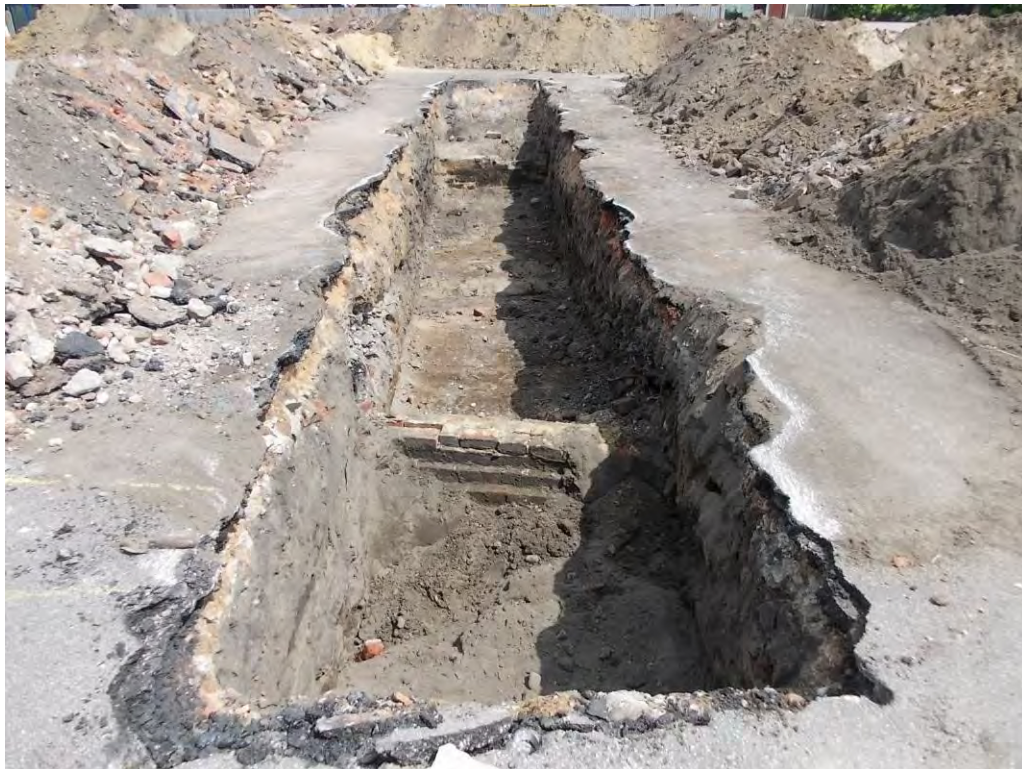
- 4.7 Built over this deposit were two parallel walls (5) and (6), aligned northeast to southwest, and probably forming external walls of the same building. Wall (5), the westernmost, lay at a height of 13.18m OD, was 0.55m wide and 0.23m high. Wall (6), to its east, was exposed at a height of 13.29m OD, was 0.35m wide and 0.48m high. These two walls appear to correspond closely with a long building shown on the 3rd Edition Ordnance Survey map (dating to 1927; Figures 3 and 6). It is not clear whether the site was still occupied by the brickworks at this date (unlike the two earlier Ordnance Survey maps, it is not marked as such), thus making it possible that this building had another function.

Plate 4: General view of Trench 3, looking east, with Wall (5) in foreground and Wall (6) in background.

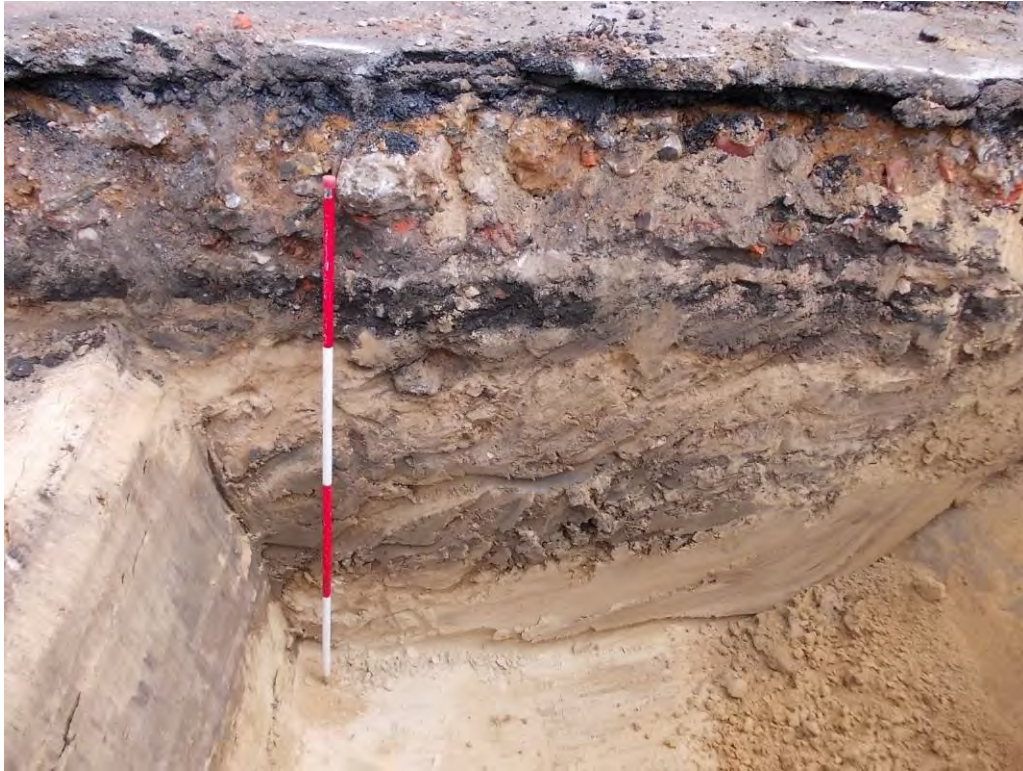
- 4.10 Pit [11] was seen to be between 0.60m and 1.10m deep and was backfilled with dumped layers of sand and clayey silt (9). Its base was encountered at a height of between 11.87m OD and 12.37m OD. Although the cut of Pit [11] was not identified in the northernmost sondage, its backfill (9) was present, strongly suggesting that a very large extraction pit (probably measuring well in excess of 12.00m from north to south) lay within the northern part of the trench. As this area is shown on the 1st Edition Ordnance Survey map (c. 1886-1890; Figure 4) as being in the immediate vicinity of a brick kiln (and its attendant chimney), it is probable that this extraction pit dates to the later 19th or first half of the 20th century.

Plate 5: Trench 4: section showing Backfilled Sand (9) within Quarry Pit [11] and Natural Sand (10) below. 2.00m scale.

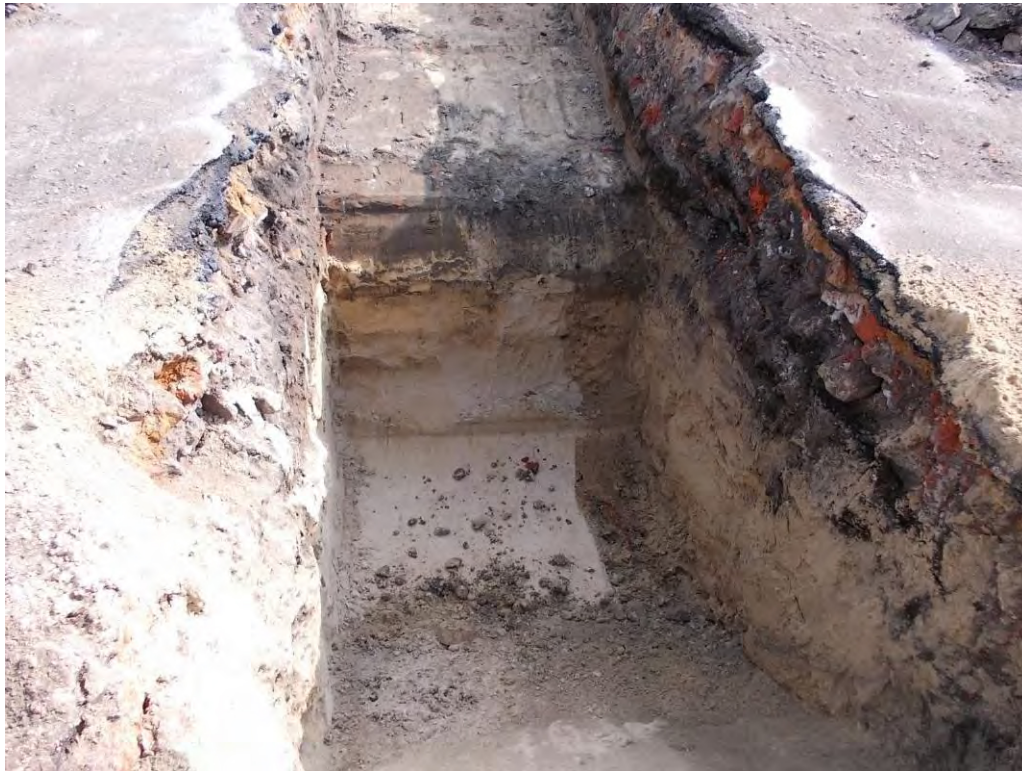
4.11 Pit [13], further to the south, was partially exposed on the eastern side of the trench at a height of 13.00m OD and was excavated by machine to 11.85m OD, at which point machining was stopped for safety reasons. The exposed part of the feature measured 2.50m from northeast to southwest, 0.40m+ from northwest to southeast, and was 1.15m+ deep. The pit was backfilled with a sandy silt deposit (12) which contained inclusions of concrete and therefore dates to no earlier than the late 19th or early 20th century.

Plate 6: Trench 4: view northwest of deep machine-excavated sondage into late-19th- to 20th-century Quarry Pit [13], to right of sondage truncating Natural Sand (10) (left). Depth of sondage: 2.00m below modern ground surface.

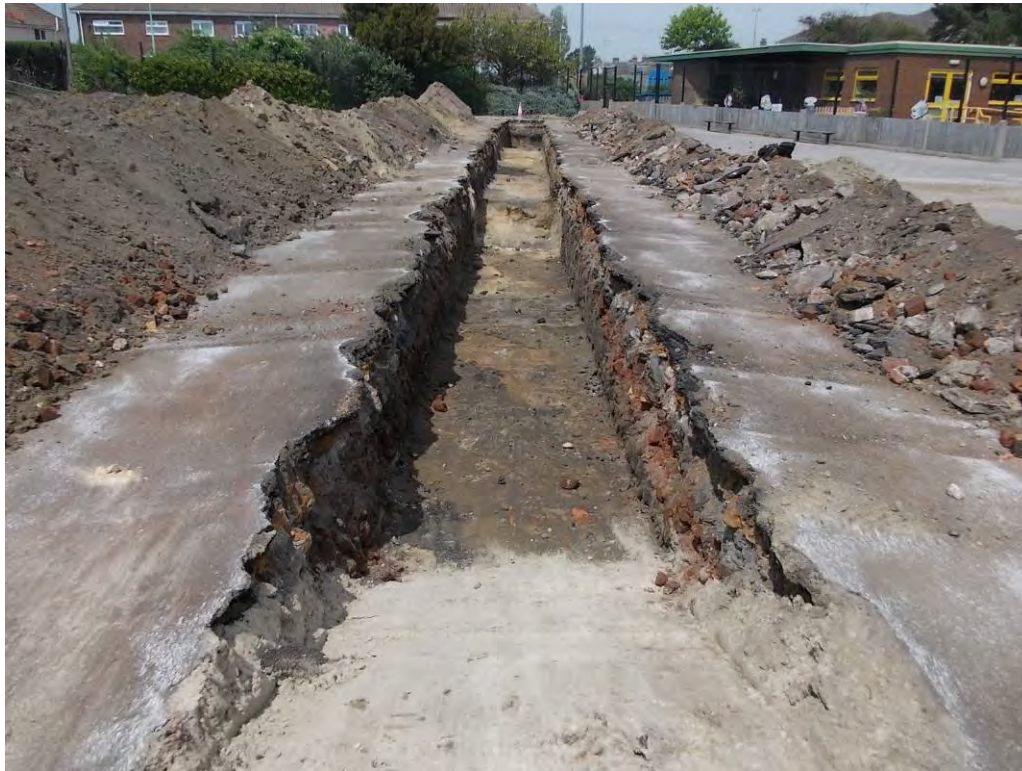
4.12 Another large clay extraction pit [15] was encountered in the south end of Trench 4, at a height of 12.66m OD. It was exposed for a distance of 10.50m from northeast to southwest and only a small part of the northeast edge of the pit was exposed. It had been backfilled with a silty sand deposit (14), which contained inclusions of glass, brick and coal, and dates from the 19th century. Due to the depth at which this pit was encountered, it was not fully excavated. Due to the presence of large quantities of buried asbestos at the southern end of the trench, further excavation was slightly curtailed for health and safety reasons.

Plate 7: Trench 4: view north with large Quarry Pit [15] in foreground.

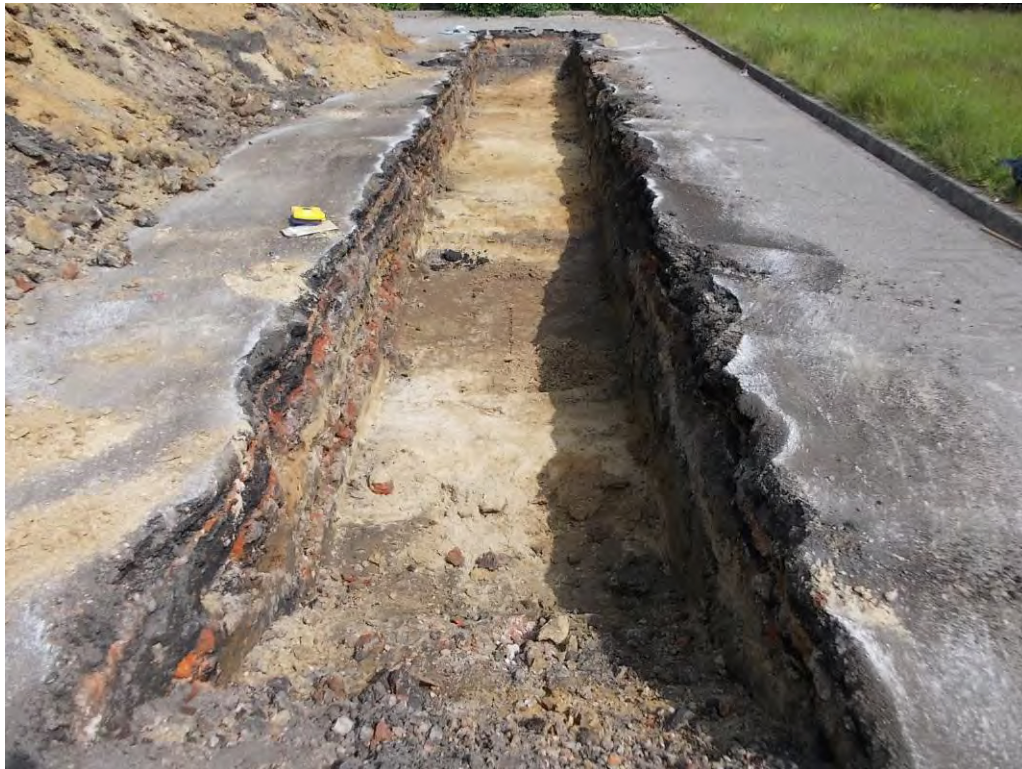
- 4.14 Natural Sand (20) was encountered throughout the trench at a height of between 12.59m OD and 12.71m OD. This was very similar in character to the natural sand deposits (10) encountered in Trench 4, a short distance to the northwest.
- 4.15 Trench 5 also contained two 19th-century pits [17] and [19], both situated at the western end of the trench. Pit [17] measured 2.40m from east to west and extended to the north and south beyond the trench. It was exposed at a height of 12.59m OD. Within its backfill (16) were occasional inclusions of peg tile and clay tobacco pipe stems, which date this to the late 18th or 19th century. It was rather smaller in size to the other pits of similar age exposed elsewhere on the site, which might suggest a more domestic origin, although its backfill displayed no signs of being derived from domestic waste (unlike Layer (4) in Trench 3).

4.16 The eastern edge of another pit [19] was exposed at the western end of Trench 5, and uncovered for a stretch of 1.50m. It appeared at the same level OD as [17] and appeared to be of a similar age, as its backfill contained inclusions of coal and frogged red brick. A modern pit and posthole (mid 20th century+) were identified at the east end of the trench.

Plate 8: Trench 5: general view looking east, showing Natural Sand (20) in base of trench and 19th-century pits [17] and [19] in foreground.
