11–15 Borough High Street and 2 London Bridge Street, London Borough of Southwark

Post-Excavation Assessment

Thameslink Archaeological Assessment 2: Archaeological Excavations at 11-15 Borough High Street and 2 London Bridge Street, London Borough of Southwark

Site Codes: BVK11 (with reference to BVA08 & BVY09)

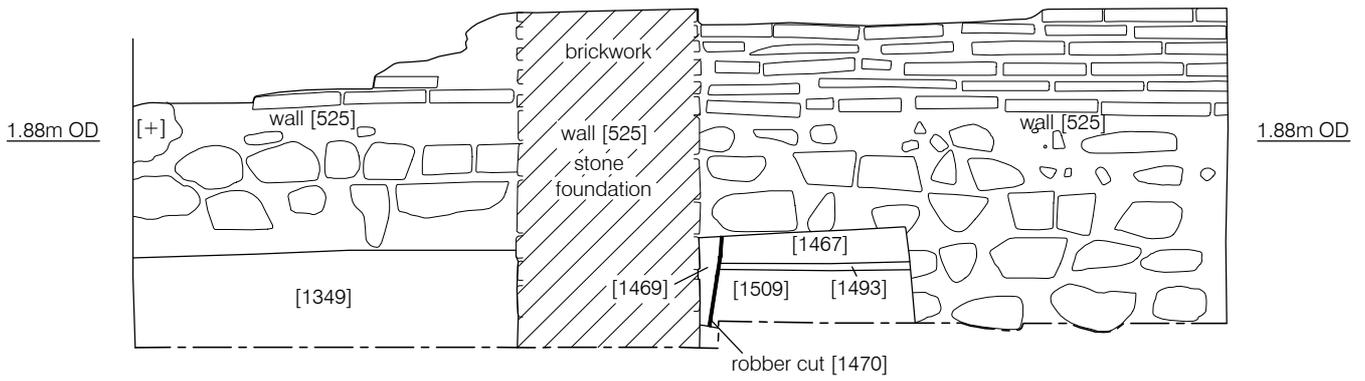
Section 47
Area A1
East facing elevation of wall [525]

inferred by scarring along the south face of [525] at 2.10m OD. The upper limits of the foundation courses for both walls were recorded at 2m OD.

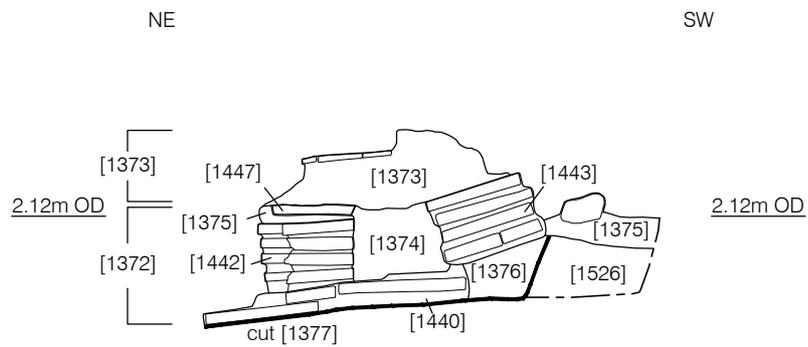
Section 38
Area A1
Northwest facing section through brick flue/drain

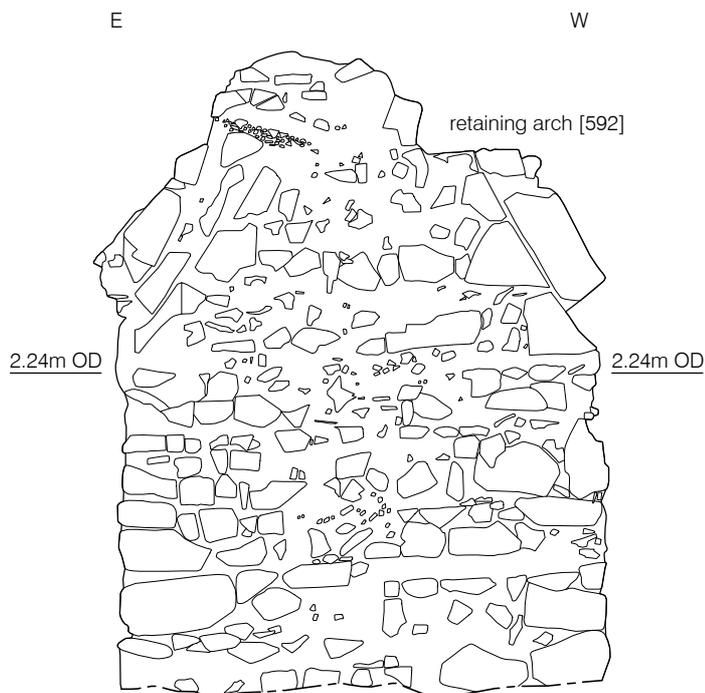
Section 75
Area B
North facing elevation of retaining arch [592]

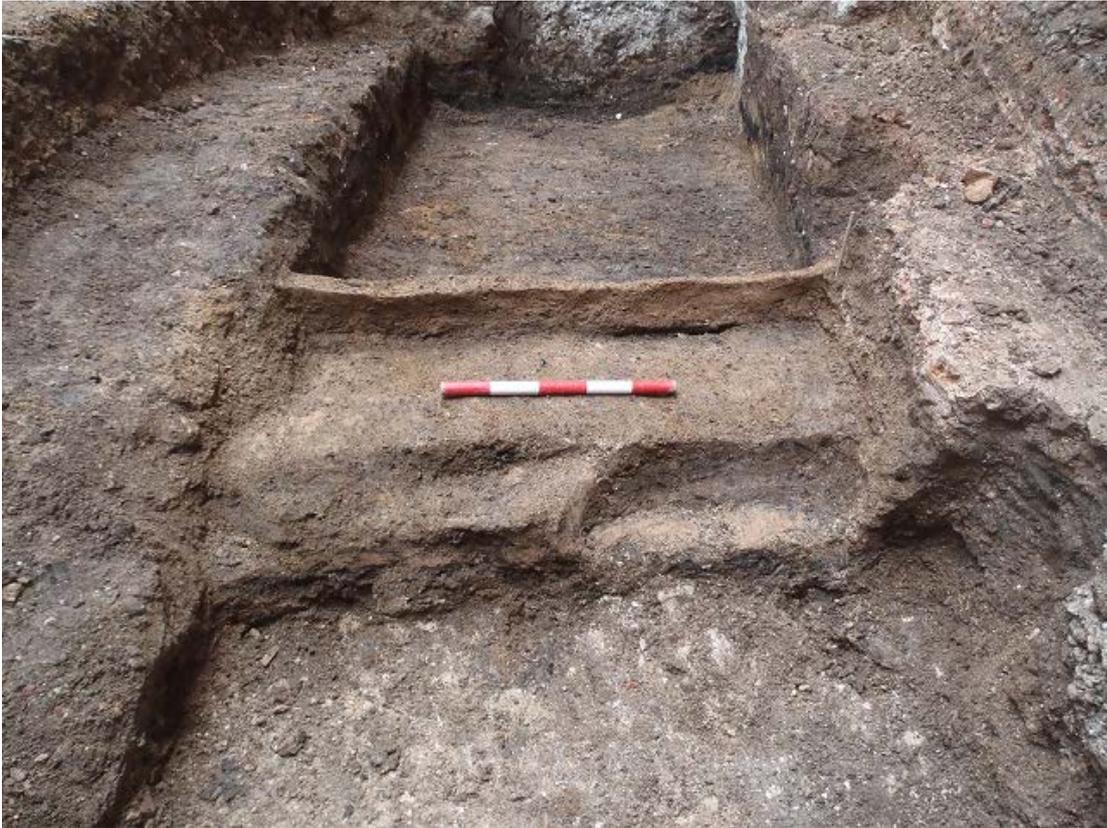
Plate 1: Brickearth partition [930], Area A2, view to north-east, 0.5m scale.

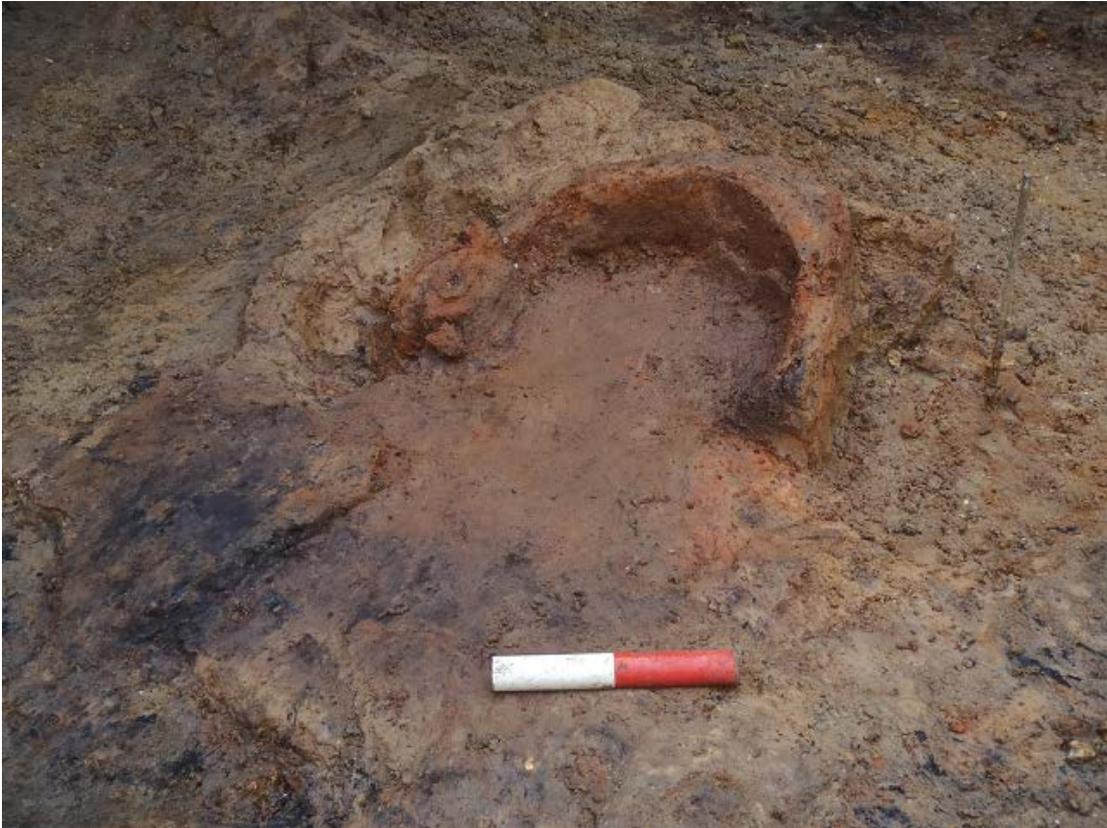
Plate 2: Clay hearth lining [1620]/[1616], Area B, view to north-east, 0.20m scale.

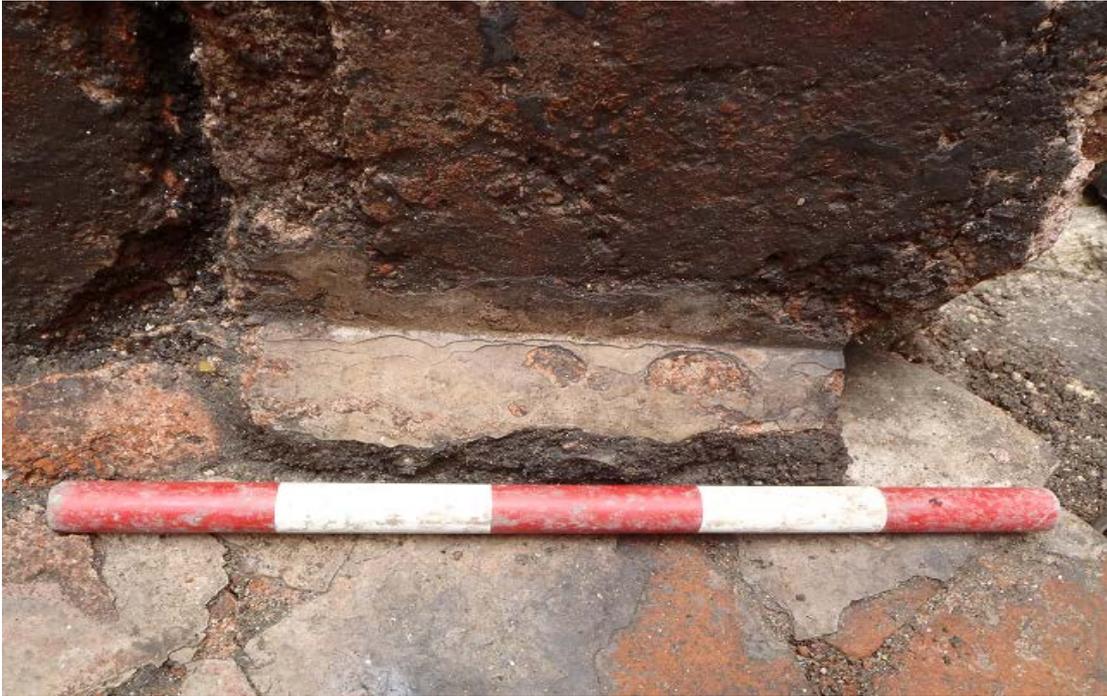
Plate 3: Opus Signinum 'lip' against curvilinear wall [589] over floor [658], Room 4, Area A1, view to north-east, 0.5m scale.

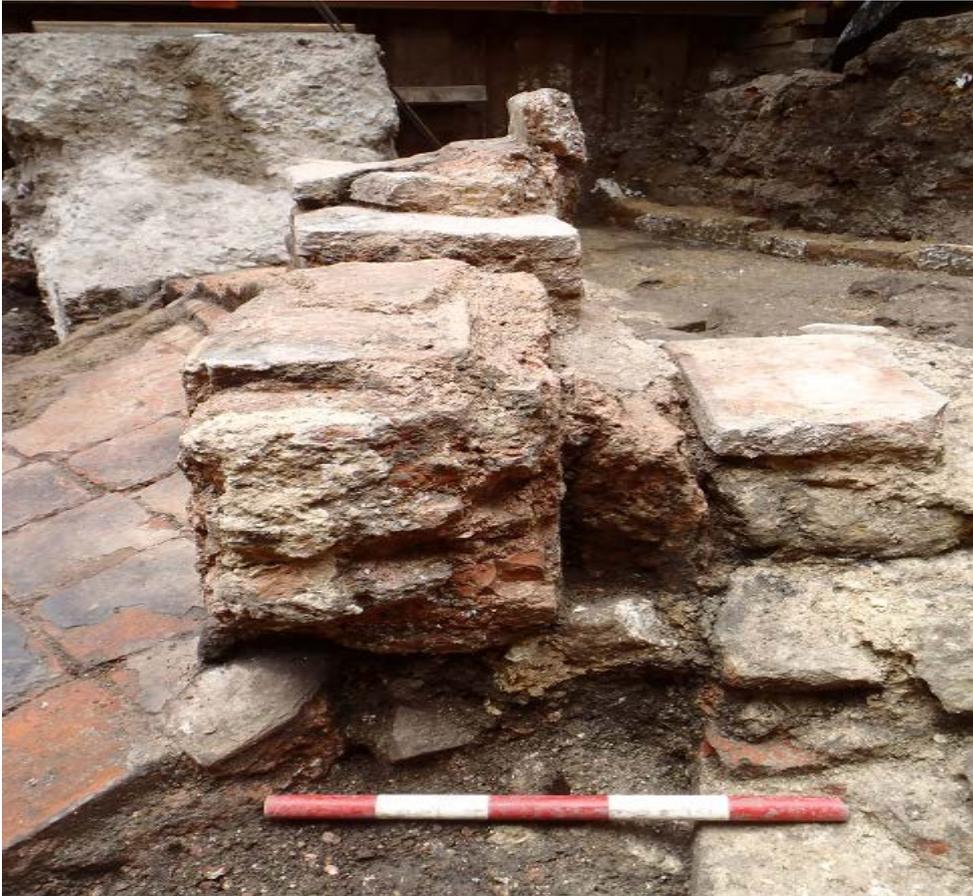
Plate 4: Illustrating construction of outer curvilinear wall [589] against insulating wall [555], Room 4, Area A1, view to north-west, 0.5m scale.

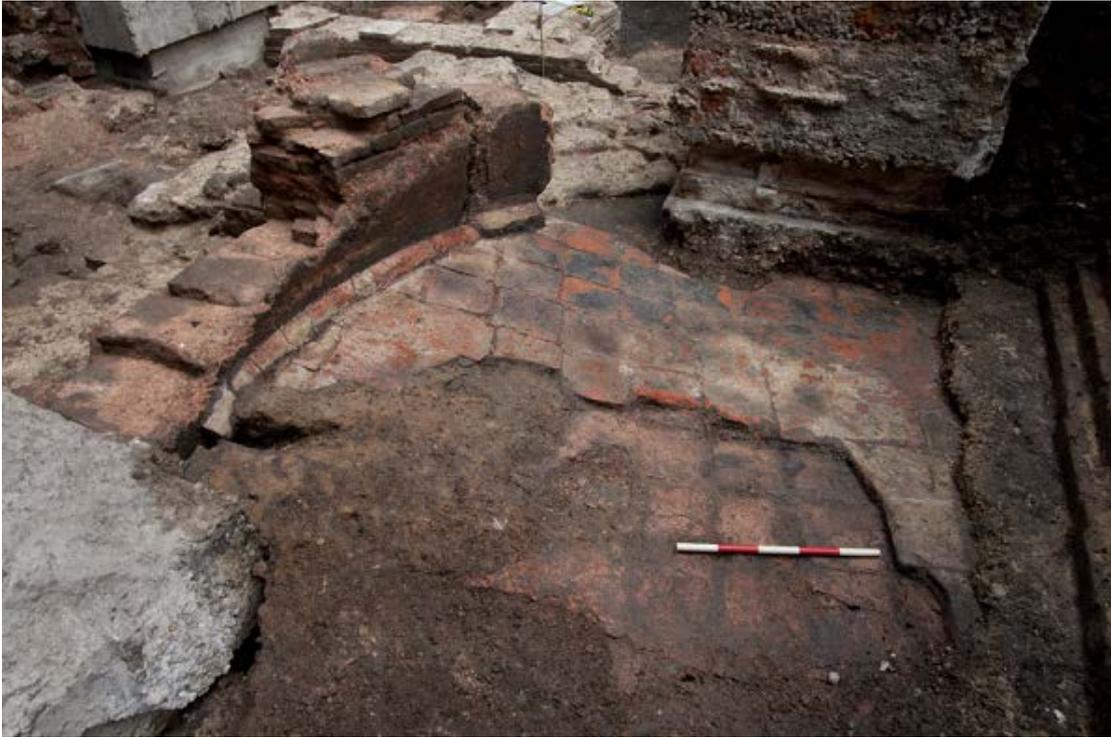
Plate 5: 'Laconicum'/Room 4, Area A1. Brick floor [658] in foreground, view to east, 0.5m scale.

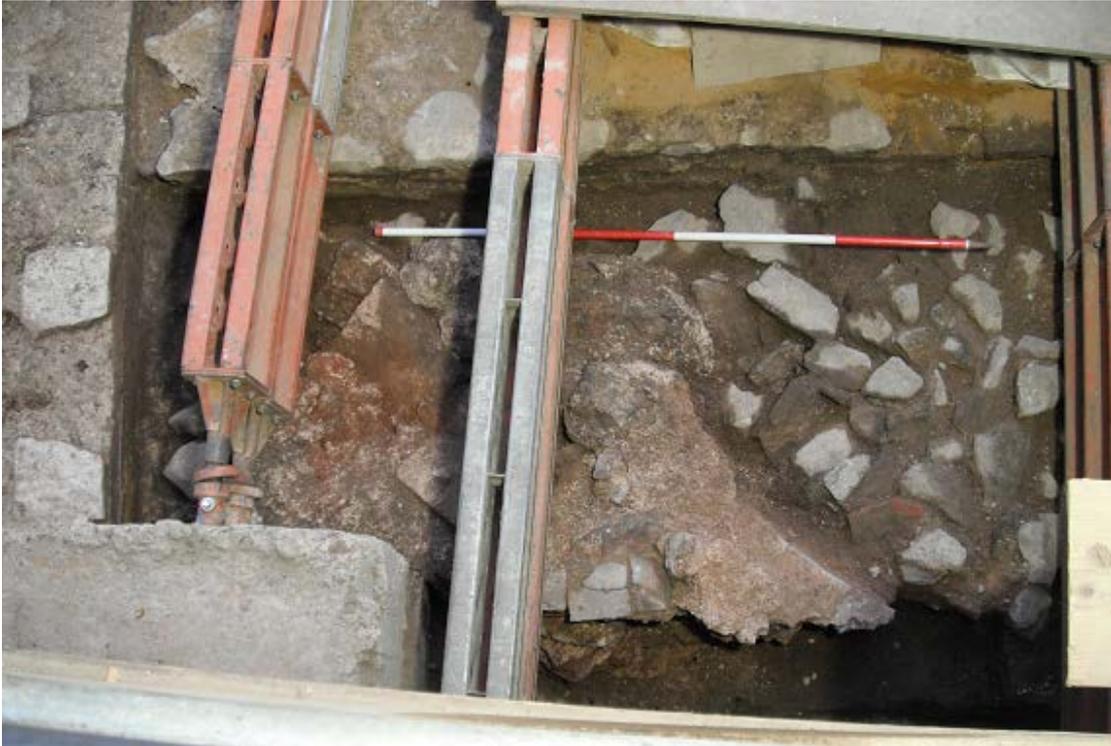
Plate 6: Room 1, Area A1, illustrating drainage feature [1372], view to south-west, 2m scale.

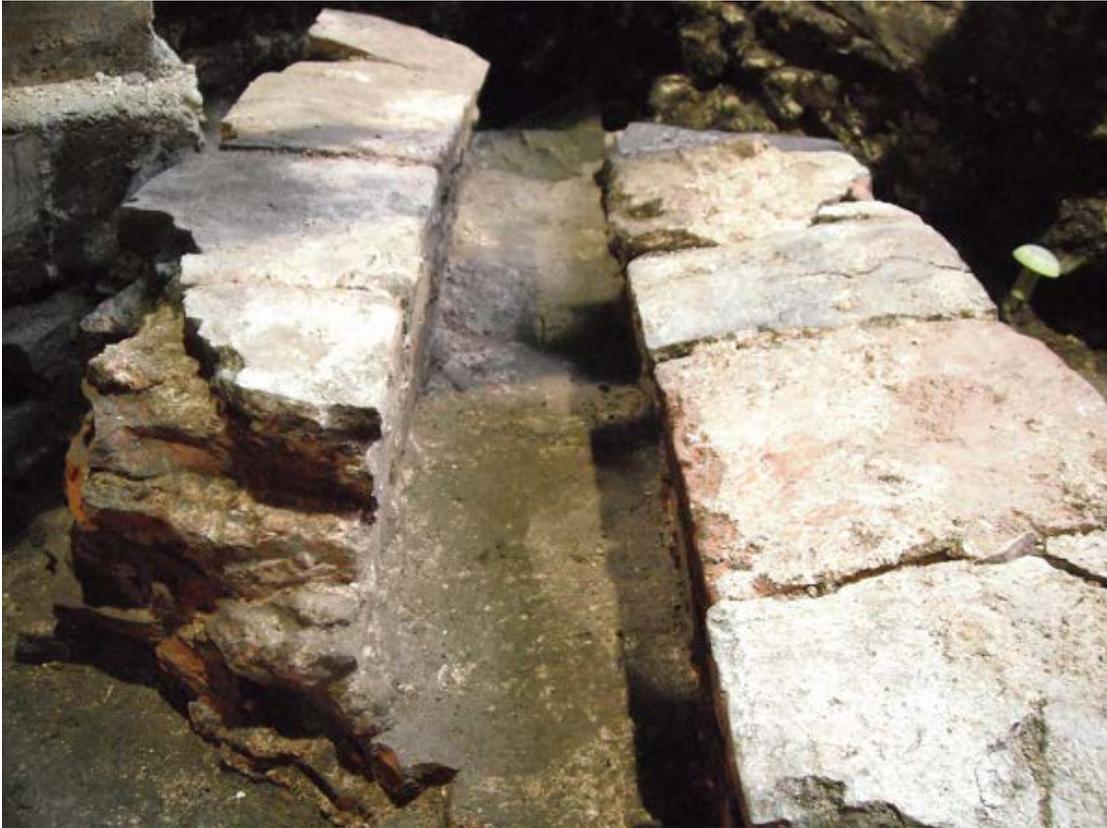
Plate 7: Interior of drain [1372], Area A1, view to south-south-east.

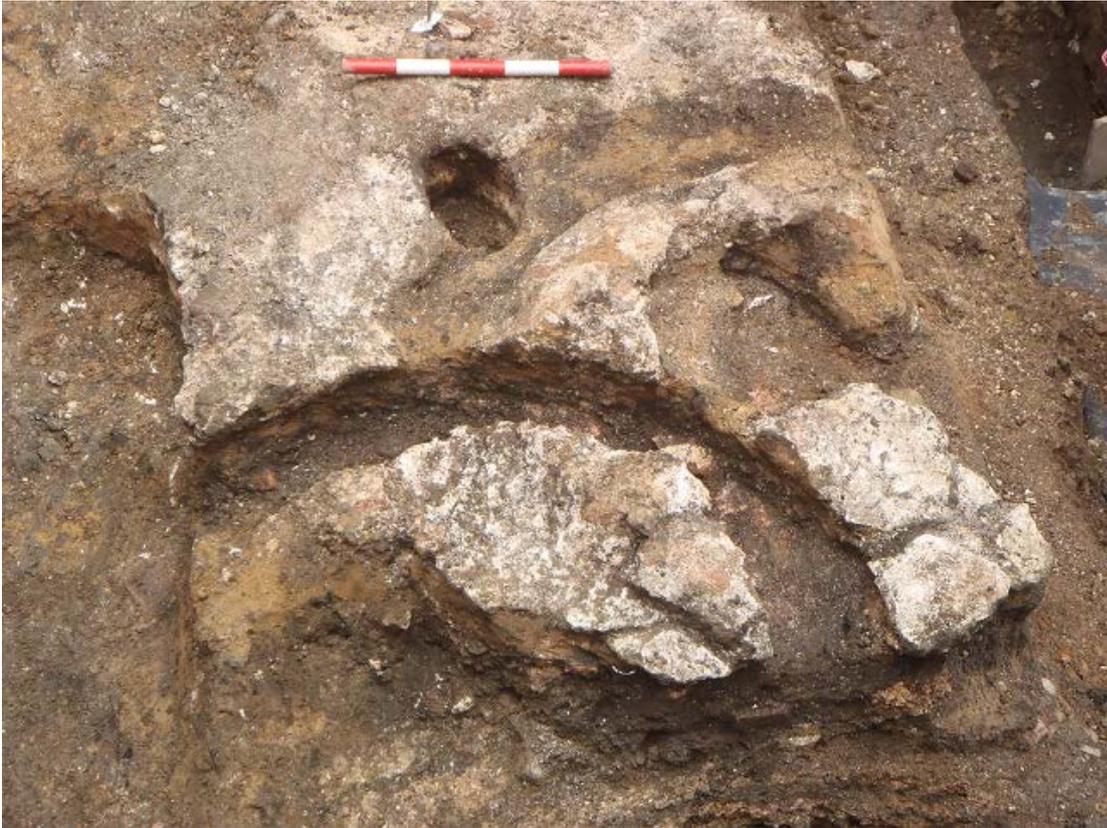
Plate 9: Intercutting curvilinear cut features [1016] and [1025] to left and right of frame respectively, Area B, view to south-east, 0.5m scale.

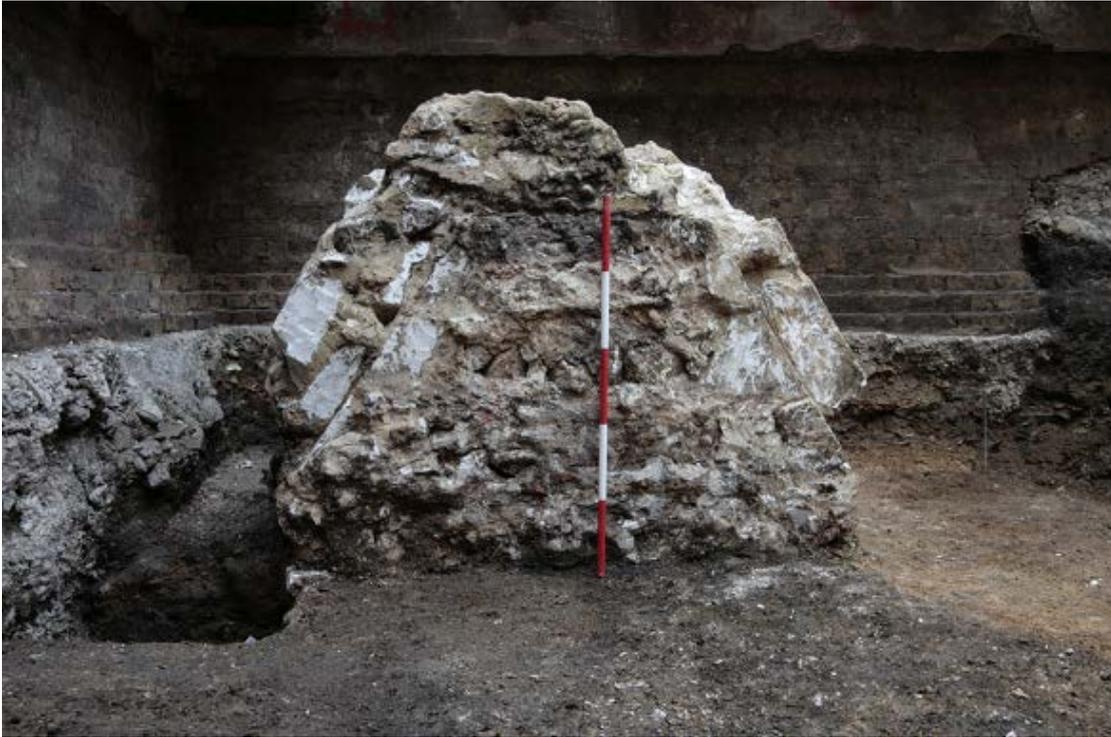
Plate 11: Chalk pier [592] Area B, view to south-west, 1m scale.

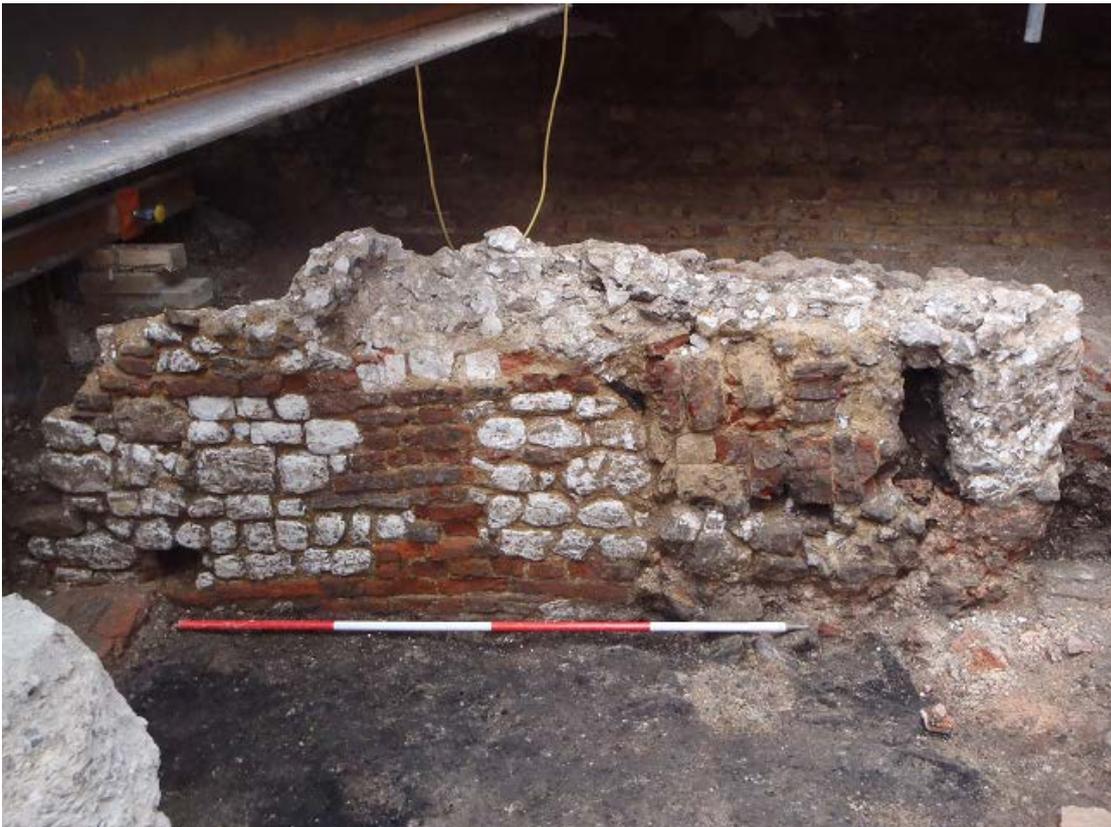
Plate 12: Post-medieval brick and chalk wall [505]/[504], Area A1, view to north-east, 2m scale.

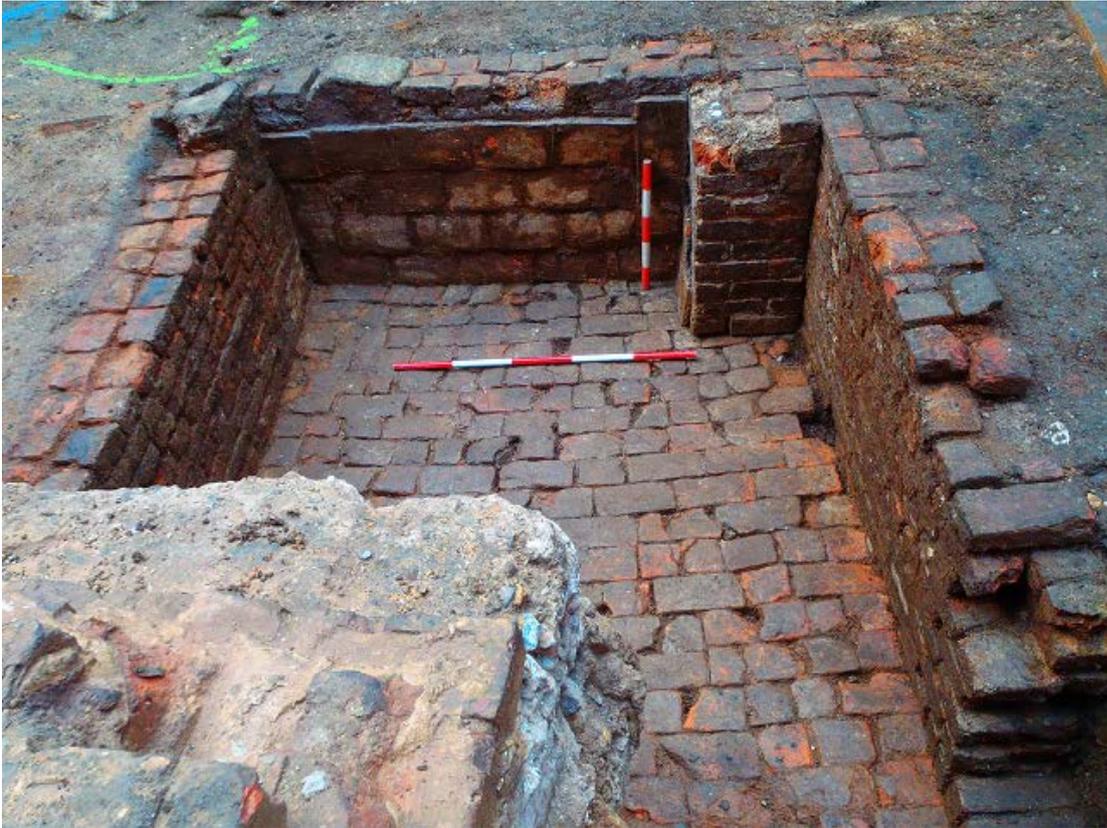
Plate 13: Post-medieval cess pit [596] with brick floor [1331] and buttress [1332], Area B, view to north-west, 1m and 0.5m scale.

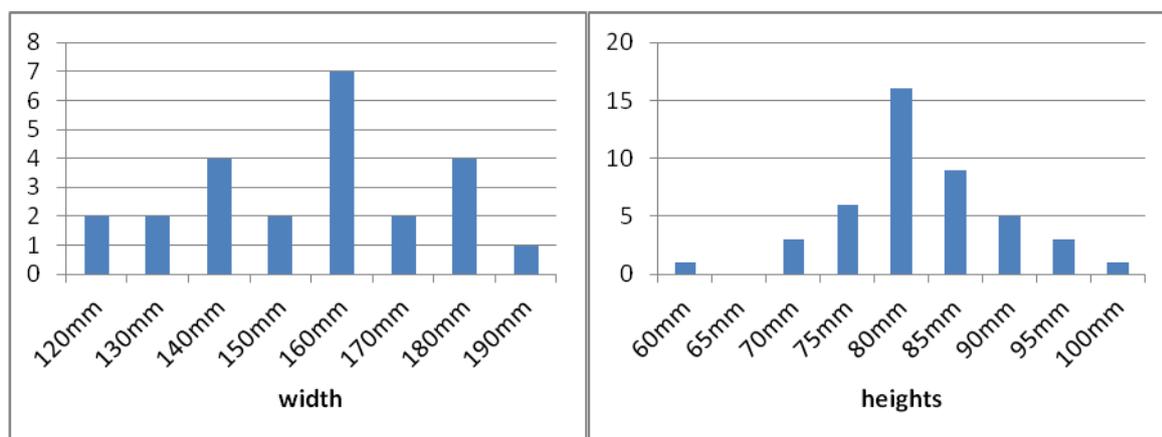
The imbrex was heavily fragmented with no complete tiles surviving and no complete lengths present (the maximum surviving being 240mm). Two complete widths of 130 and 160mm survived with heights of 70 and 80mm. Sufficient profile was present on a number of tiles to estimate overall widths ranging from 120 to 190 mm and heights of 60-100mm, though 75-85mm was most common (Figs. 1 and 2). Thickness ranged from 11 to 25mm, with there often being considerable variation between the tile edge and central body. Both angular and rounded profiles were present and it was common for the tiles to thicken considerably to corners and edges.

Figures 1 and 2: Imbrex widths and heights

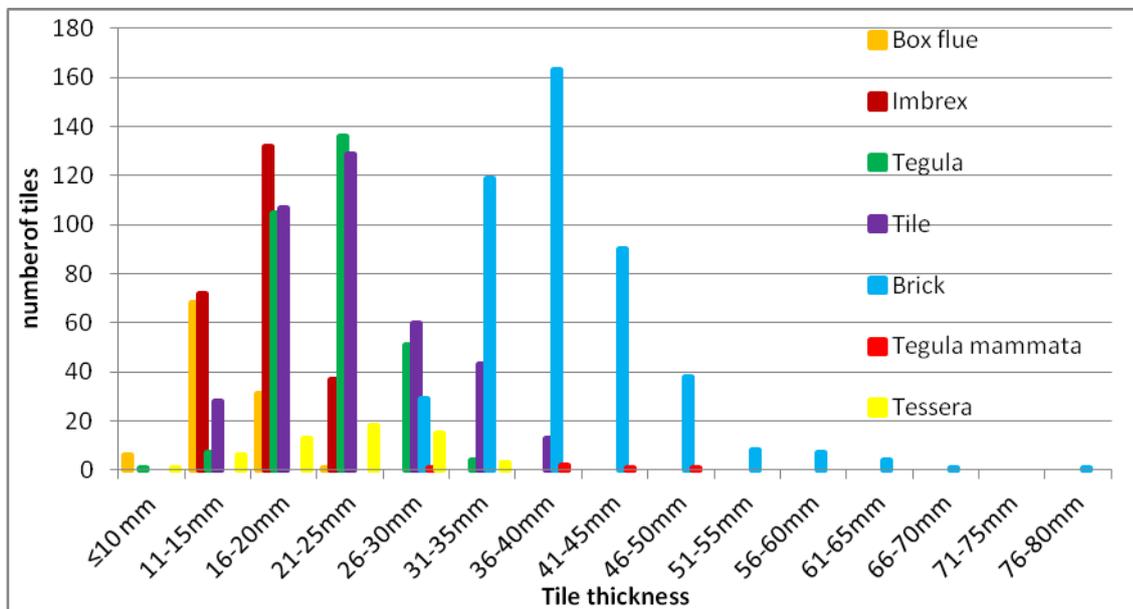
A large proportion of the assemblage has been classified as plain tile, where no diagnostic characteristics survived. A comparison of thickness with other tile forms (Fig. 3) suggests much of it is likely to be derived from tegula though at the lower end of the thickness range it is likely to include some imbrex and box flue, whilst at the higher end of the range (26-40mm) there is likely to be a much higher proportion of brick. All fragments of 40mm thickness and above were designated as brick.

Figure 3: Comparison of tile thickness in relation to form
