**OLD SWAN BRIDGE,
PULBOROUGH, WEST
SUSSEX
AN ARCHAEOLOGICAL
INVESTIGATION**

REPORT NO: R11466

JULY 2013

Archaeological Investigation

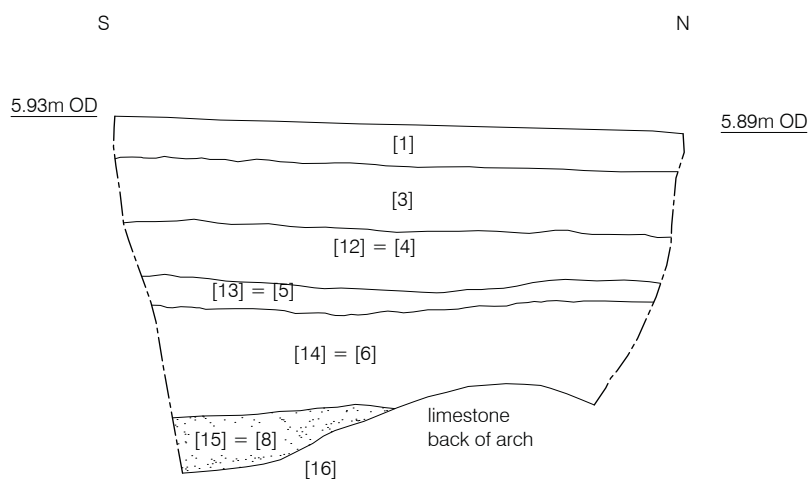
Section 3
Trial Hole 1, east facing

- 7.4.5 In Trial Hole 1, overlaying the previous contexts was layer [14]. This was a 0.15 to 0.23m thick layer of crushed and compacted chalk with occasional small to medium flint nodules as an inclusion. The top of this layer was encountered at 0.40m below ground level at 5.53mOD and is interpreted as an 18th century levelling layer (Figure 6). The same deposit was noted in Trial Hole 2 as context [6] where it was recorded as being between 0.18m and 0.30m thick, the top at between 0.55m below ground level (5.27mOD) and 0.57m below ground level (5.17mOD) (Figure 5).

- 7.4.6 In Trial Hole 1, overlaying [14] was context [13], a 0.02m to 0.06m thick layer of friable mid greenish yellow sandy mortar with moderate small well-rounded pebbles as an inclusion. This thin band of mortar was encountered at 0.34m below ground level at 5.59m OD and is interpreted as an 18th century mortar layer, possibly the remains of a bedding layer for cobblestones that once surfaced the bridge (Figure 6). This deposit was the same as context [5] observed in Trial Hole 2, where it was noted as being 0.03 to 0.05m thick. The top of the deposit was encountered at between 0.52m below ground level (5.30mOD) and 0.54m below ground level (5.20mOD) (Figure 5).

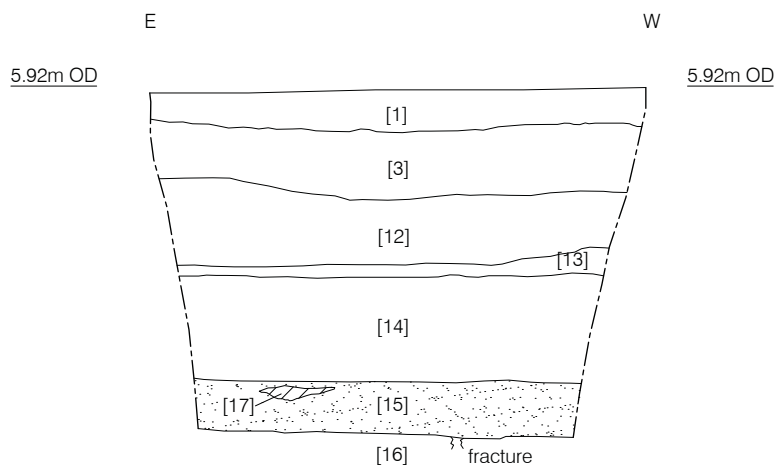
Section 4
Trial Hole 2, north facing

[17] = [19]

- ST limestone block
-

yellow mortar
-

pink mortar

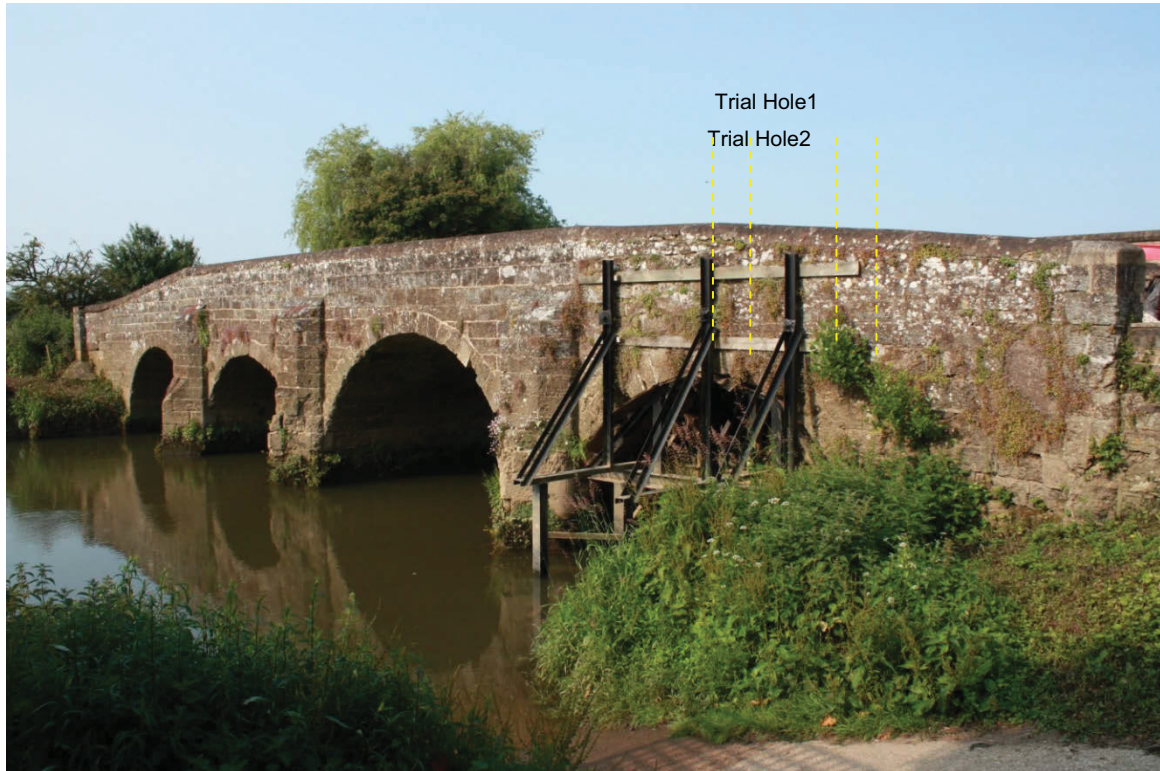
Plate 1 D1/23. East side of Old Swan Bridge, Pulborough crossing the River Arun, looking SW. The approximate positions of the trial holes is marked. Note 1990s steel supports below arch.

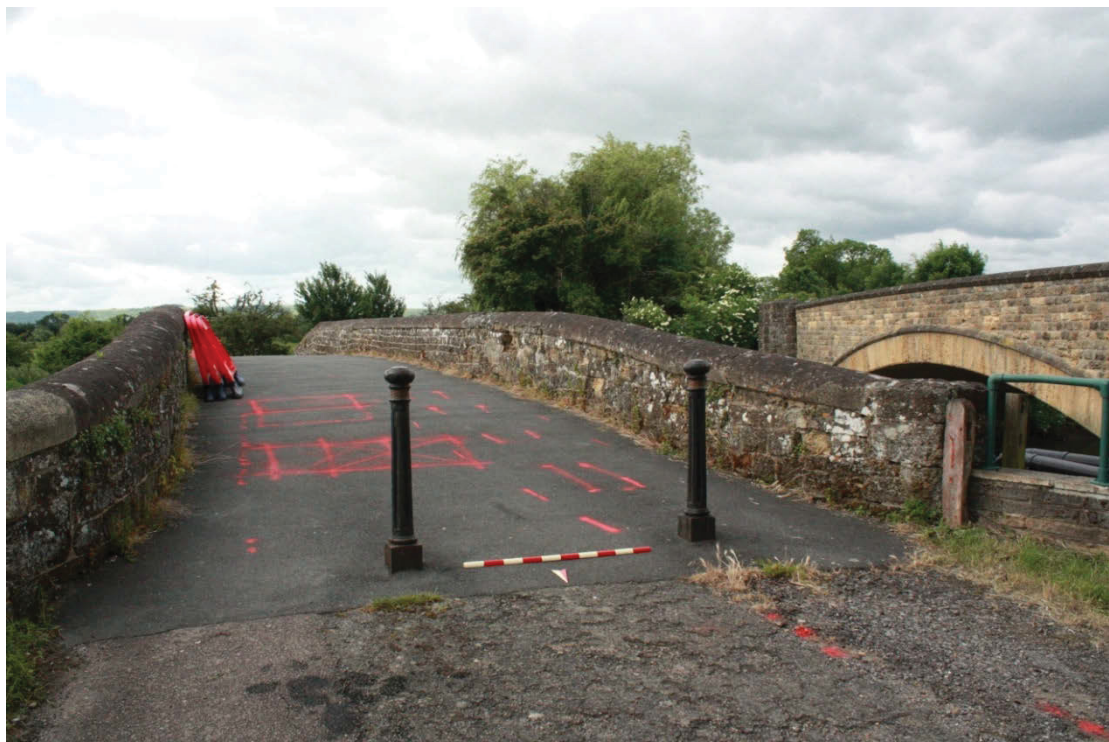
Plate 2. D1/4 North end of Pulborough Bridge. Red paint lines indicate position of Trial Holes, Trial Hole2 closest to camera. The modern single span bridge is to the right, Scale 1m looking SW.

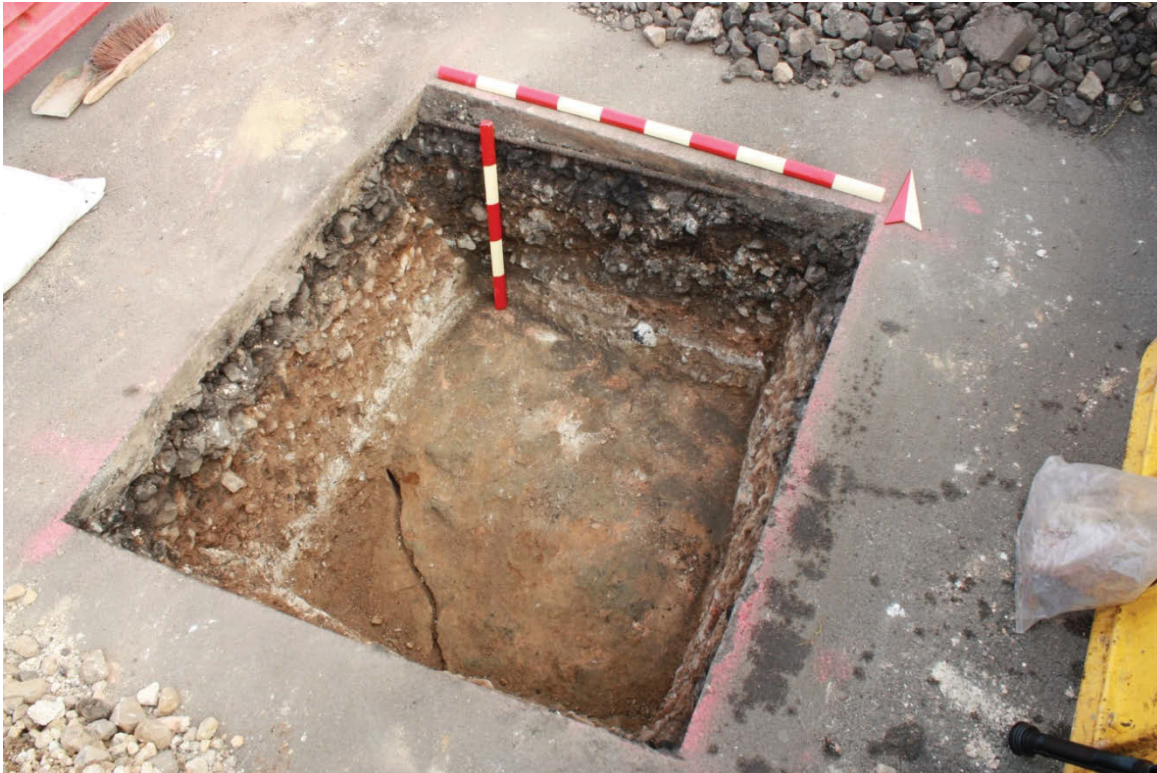
Plate 3. D1/10. Trial Hole 1. Inner back of stone arch [16] in base of trench. Scales 0.5m and 1m looking N.

- 7.4 Trial Holes 1 & 2 (Figures 3,4,5,6. Plates 3-8)
- 7.4.1 Seen in the base of both Trial Holes 1 and 2, the earliest level reached was the stone masonry internal structure of the bridge (Figures 3, 4, 5. Plates 3, 4, 5, 6). In Trial Hole 1 this was given the context number [16] and from its curved profile (from north down to south) this appeared to be the extrados of the arch forming Span 1. Constructed from local Lodsworth Greensand Sandstone from the local Upper Greensand, it measured 0.85m north-south by 0.80m east-west. It curved up from south (at 5.18mOD) to north (at 5.37mOD). The stone was roughly finished and although no joints were visible (the surface was obscured by patches of mortar) its size would suggest more than one stone was present. A 20mm wide crack was noted running across the south-west corner of the stone [16] (Figure 4, 5. Plate 4).

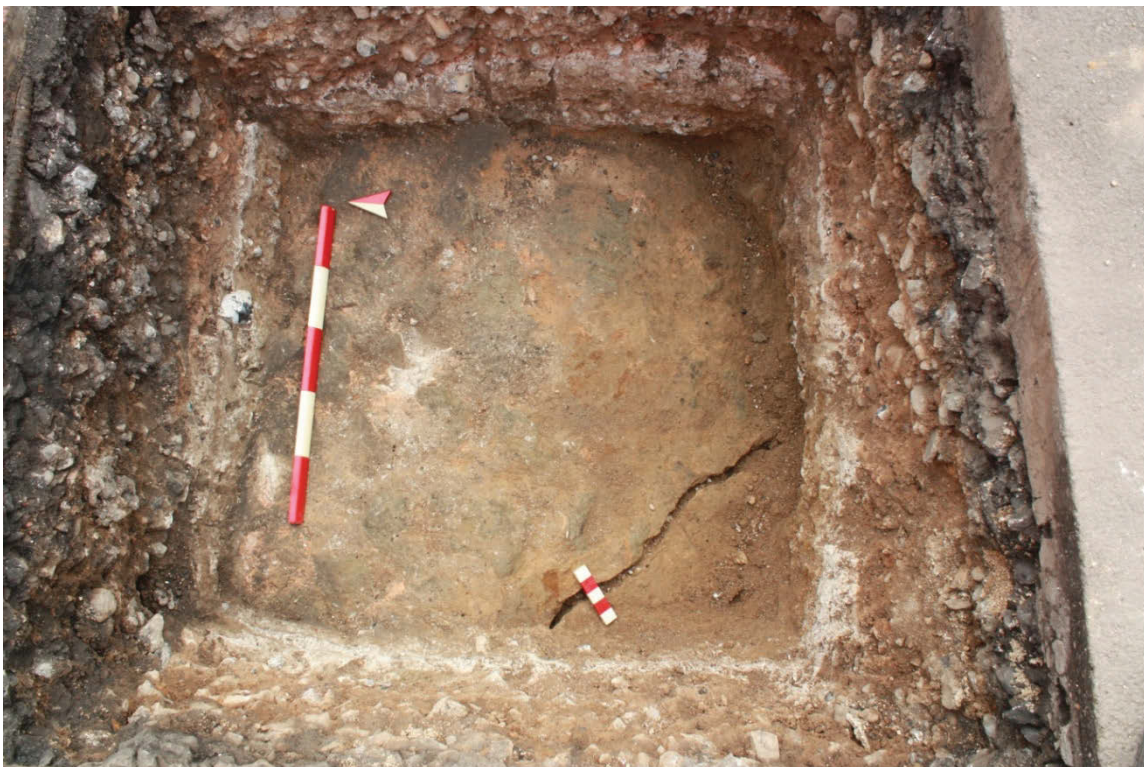
- 8.7 Trial Hole 1 revealed a 20mm wide crack across the south-west corner of the stone [16]. It is unknown if it penetrated through the entire thickness of the stone, but the width of the fracture on the surface would suggest so (Plates 3 & 4).

Plate 4. D1/18. Trial Hole1. Base of trench showing arch stone [16]. Note fracture. Scales 10cm (over fracture) 0.5m, looking E.

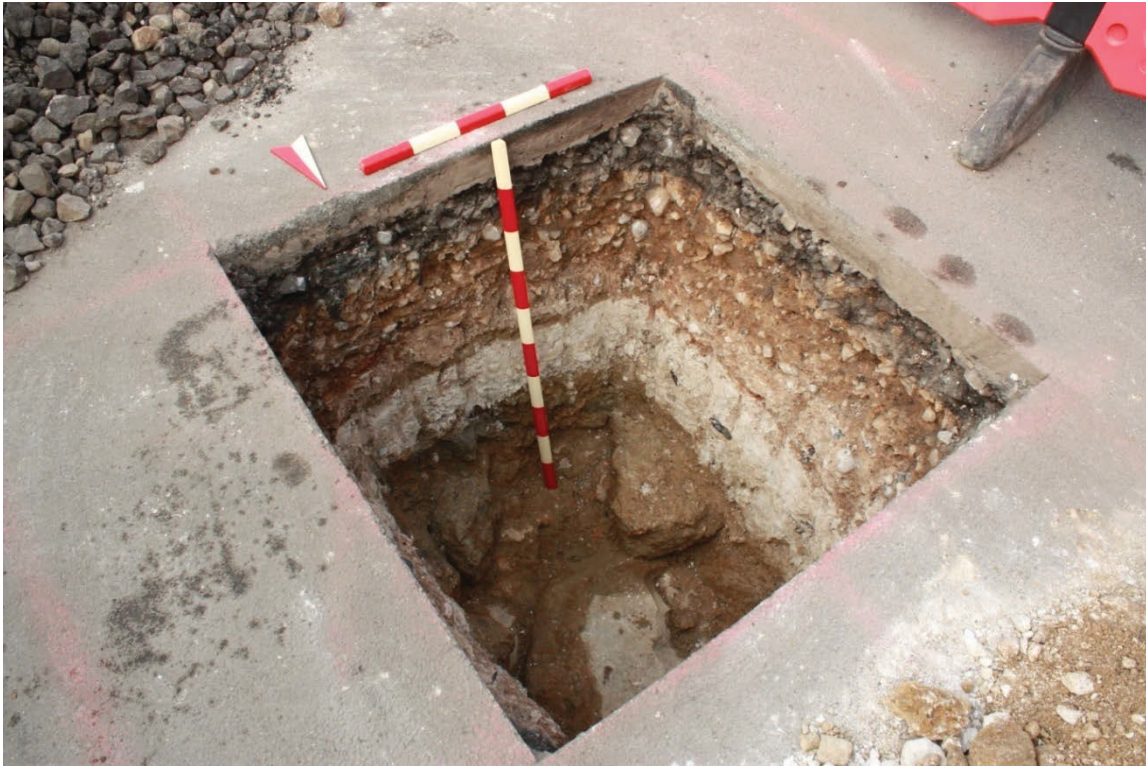
- 7.4.2 In Trial Hole 2 the masonry construction had a different character. Masonry [7] was identified as local Lodsworth Greensand Sandstone (Dr Kevin Hayward pers. com.), but here it consisted of roughly hewn slabs laid in random courses. Dimensions varied; a smaller example measured 200mm by 150mm by 100mm thick while a larger example measured 400mm by 500mm by 200mm thick. The top of this masonry deposit was encountered at between 0.86m (4.95mOD) and 0.95m (4.77mOD) below ground level. It is interpreted as the rubble infill of the bridge's northern abutment (Figures 4 and 5, Plates 5 and 6).

Plate 5. D1/8. Trial Hole2. Rubbly stone infill of abutment in base [7], overlain by white chalk levelling layer [6]. Scales 1m and 0.5m, looking SSW.

- 8.8 The position of Trial Hole 2 revealed a different characteristic of the internal structure of the bridge. The location of Trial Hole 2 placed it above the point, externally, where the intrados slopes steeply down to meet the impost. Therefore masonry [7] is likely to be the upper layers of the rubble infill of the bridge's northern abutment where it overlaps, and therefore masks, the stonework forming the arch of span 1 (Plates 5 & 6).

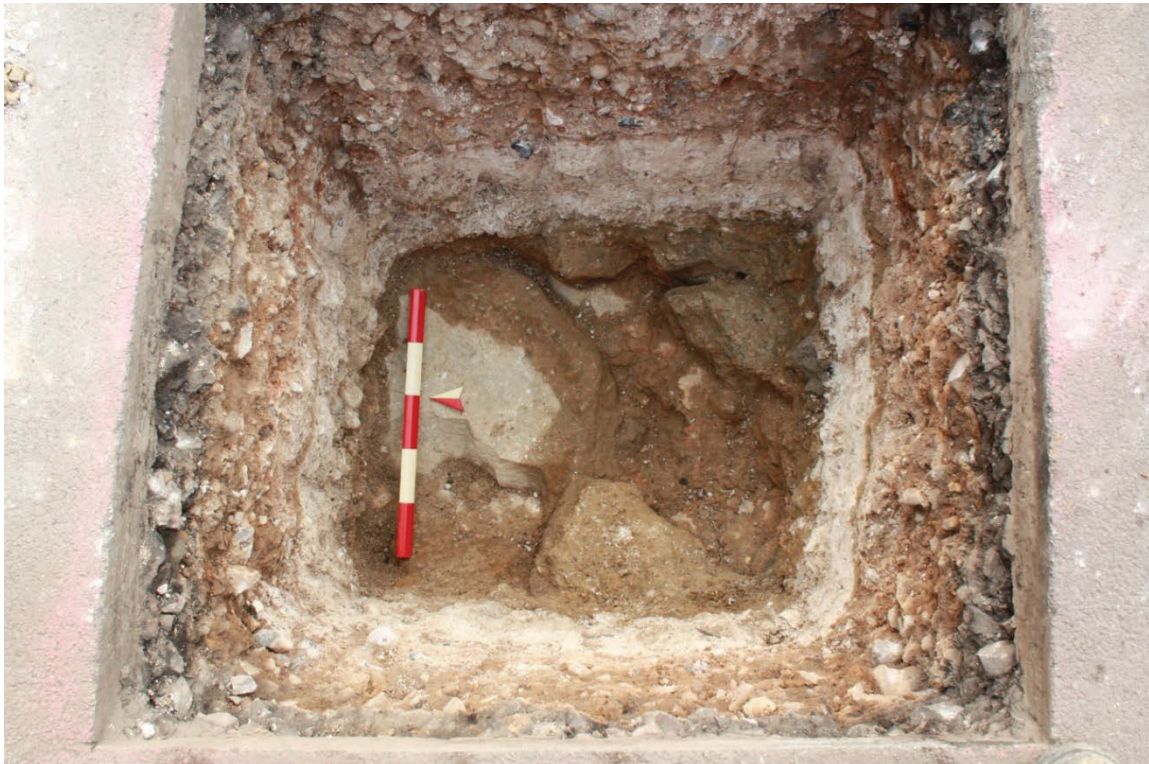
Plate 6. D1/16. Base of Trial Hole2 showing masonry [7] and white chalk layer [6]. Scale 0.5m looking East

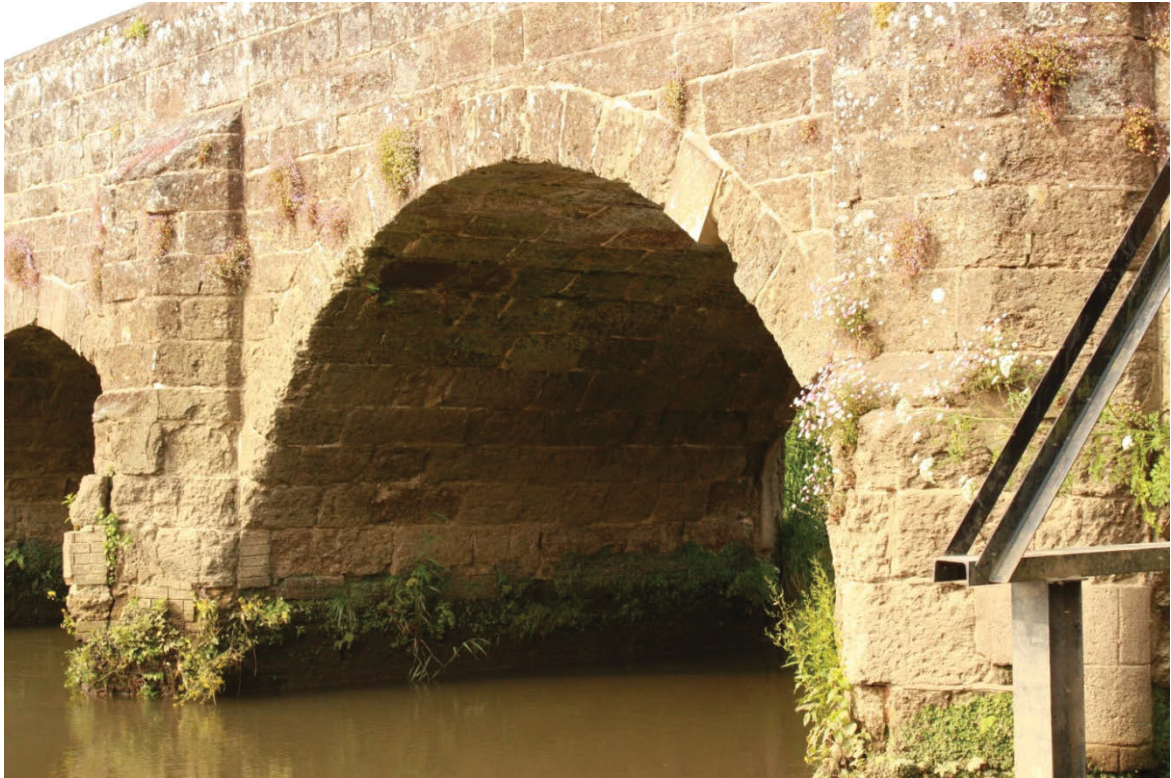
- 8.6 The masonry forming the arch of span 1 appears to be only one course thick (Figure 6, Plate 7). The course of the arch on the exterior of the bridge measured 0.50m thick. Comparing the levels on the underside of the exterior of the arch (4.93mOD) with the level at the highest point of the exposed stone in the base of the trench (5.43mOD) reveals the same dimension, 0.50m, as measured on the exterior; thus the stones forming the arch are one course thick.

Plate 7. D1/24. Detail of span 2, east side of Pulborough Bridge showing arch construction. Looking SW.

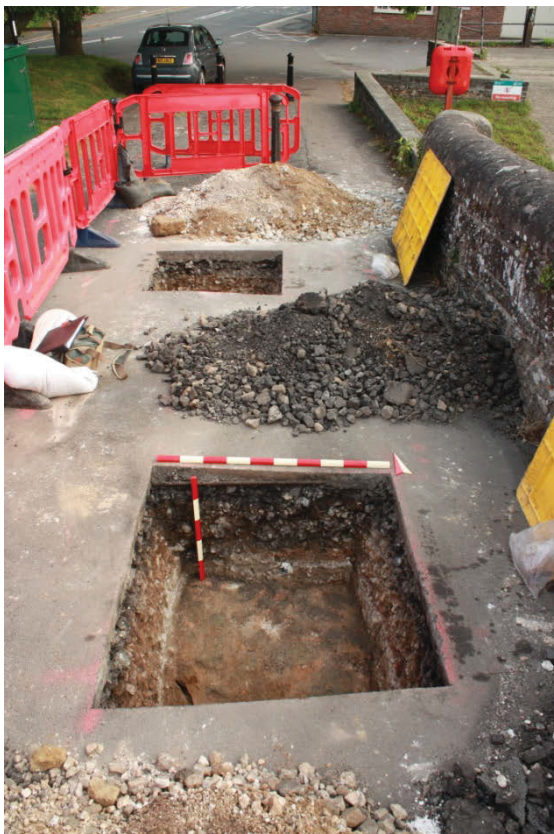
Plate 8. D1/11 North end of bridge. Trial Hole1 in foreground with Trial Hole2 beyond. Scales 1m and 0.5m. looking N.
