**HISTORIC BUILDING
RECORDING OF THE
REDUNDANT RAILWAY
VIADUCT, WESTFIELD WAY,
LONDON BOROUGH OF
TOWER HAMLETS, E1**

PCA REPORT NO. R11459

SEPTEMBER 2013

HISTORIC BUILDING RECORDING

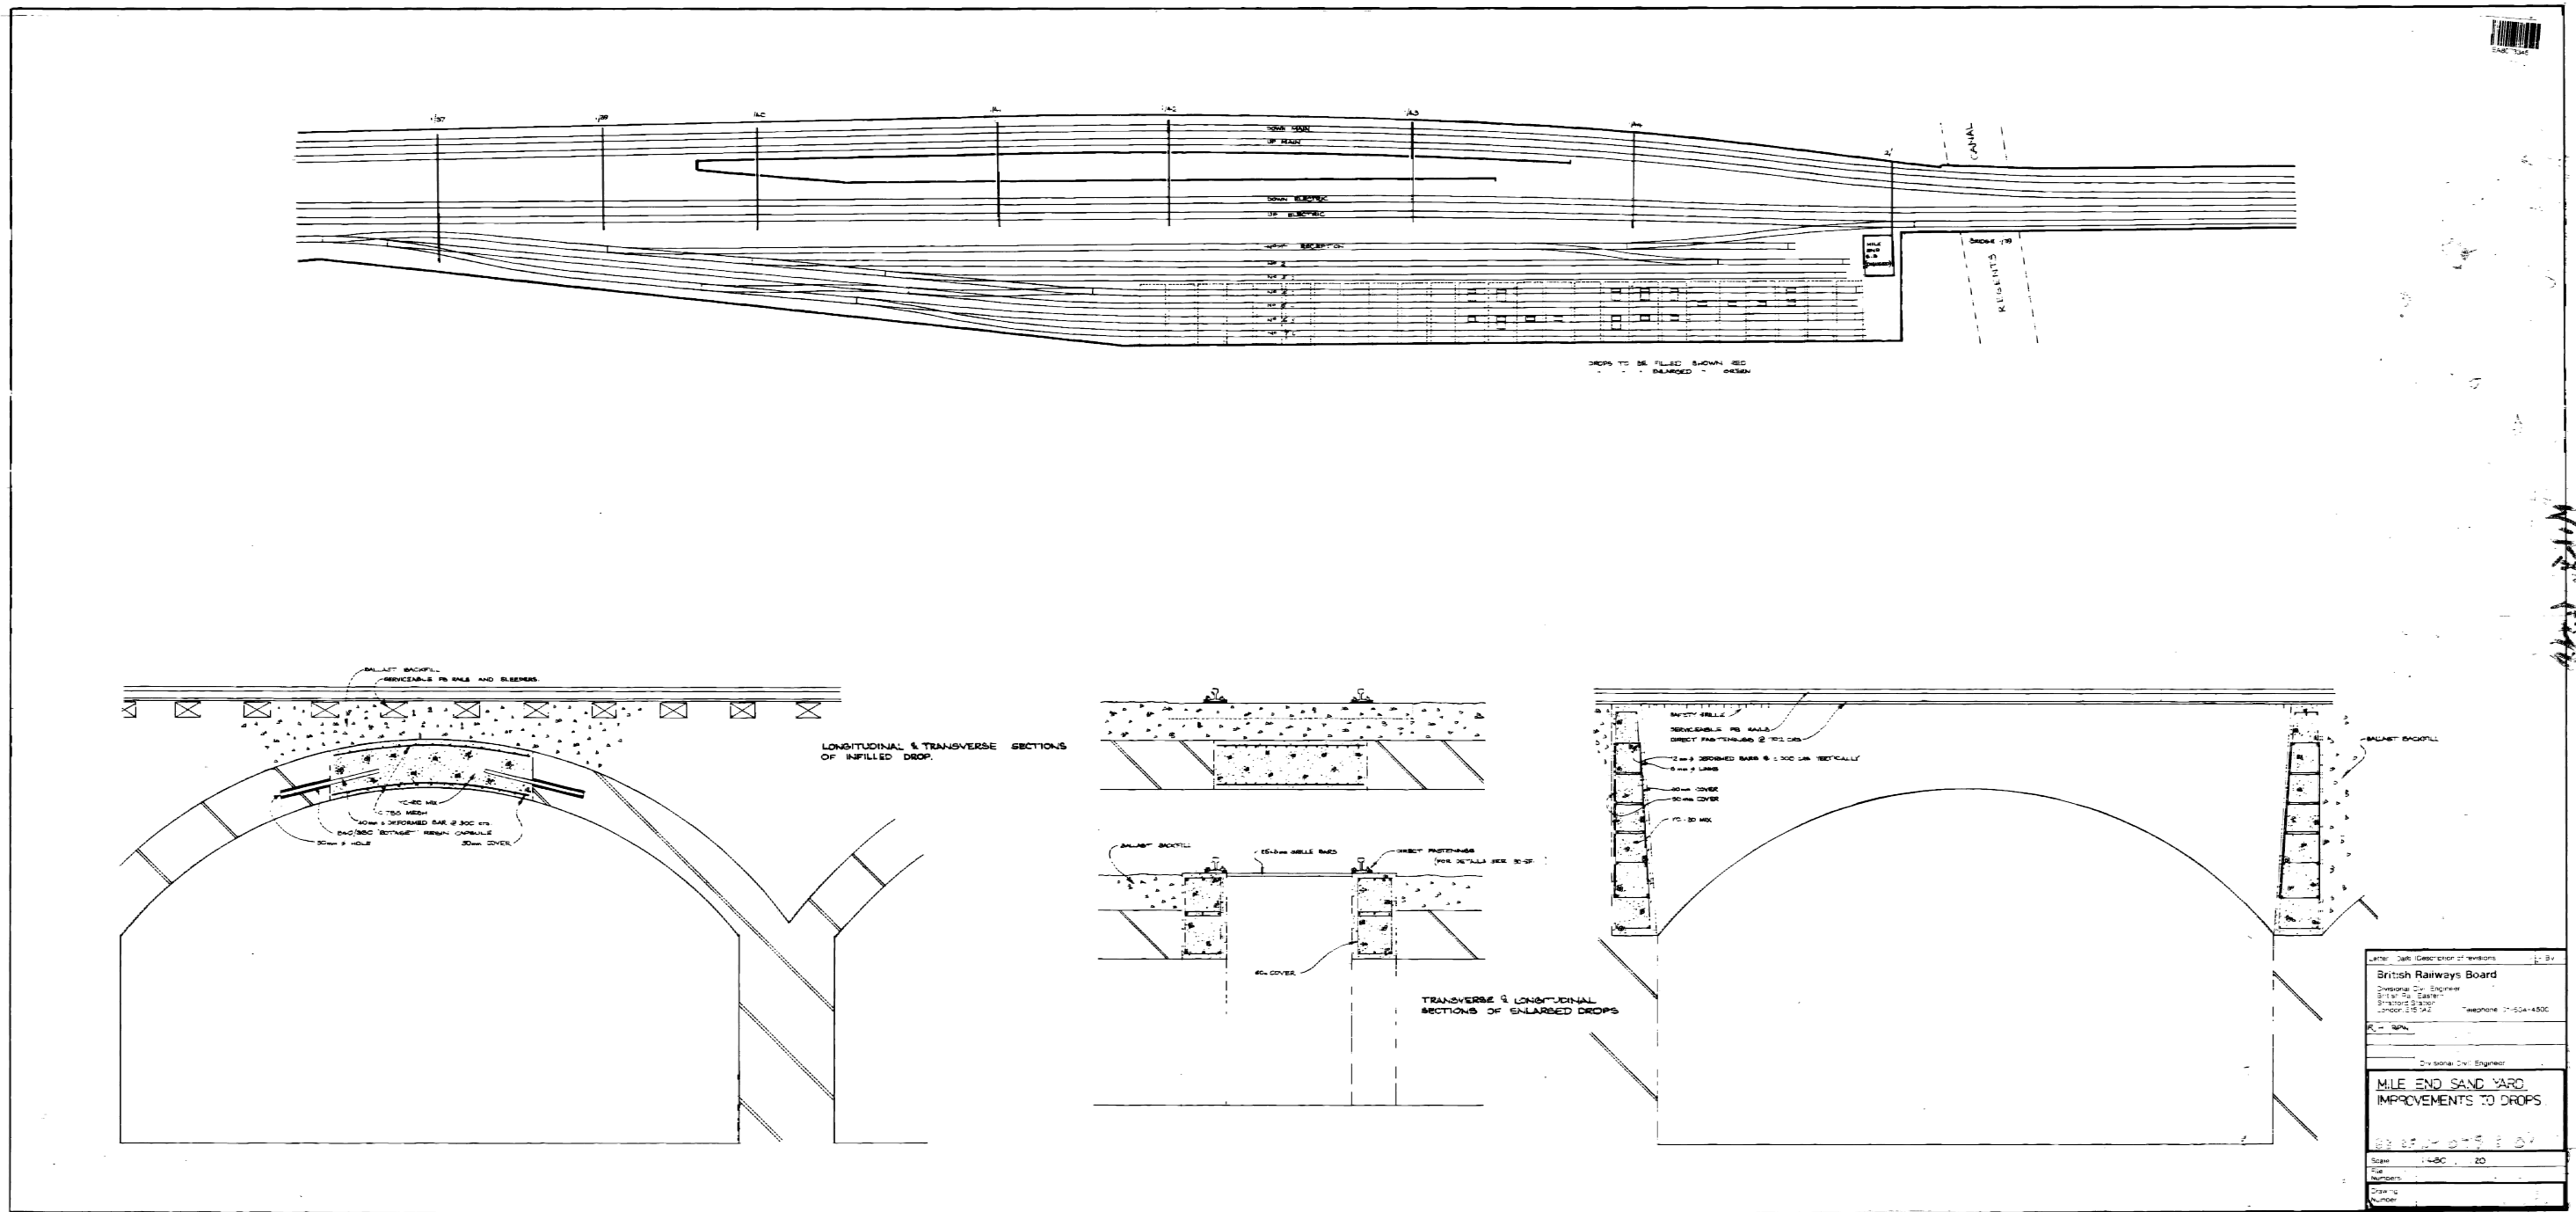
- 6.7.2 Both of the former coal drop openings in **Arch 12** remained 'open', albeit blocked from above by shuttered concrete. The southern drop had historically been blocked with yellow stock brickwork in English bond, but had subsequently been re-opened along its northern side in order to create a new east-west aligned drop. A caption to **Figure 12** suggests that the 'new' drop had previously been lined with a timber frame, part of which was already 'missing' by the late 1980s/early 1990s. Most of the remainder of the frame had been taken out since, exposing the brickwork surrounding the aperture. In contrast the aperture of the northern drop had not been closed historically, which meant that its historic timber lining had been retained (**Plate 24**). This lining was constructed of two large heavy scantling beams per edge, held in place from above by heavy through bolts with square nuts and washers. The timber lining was substantial, measuring 5 inches by 12 inches deep. Cross sections of these linings drawn c.1991 are shown in **Figure 12**. The southern end of the drop had been blocked from above with shuttered concrete. Annotations to **Figure 11** suggest that this blocking took place c.1988/9.

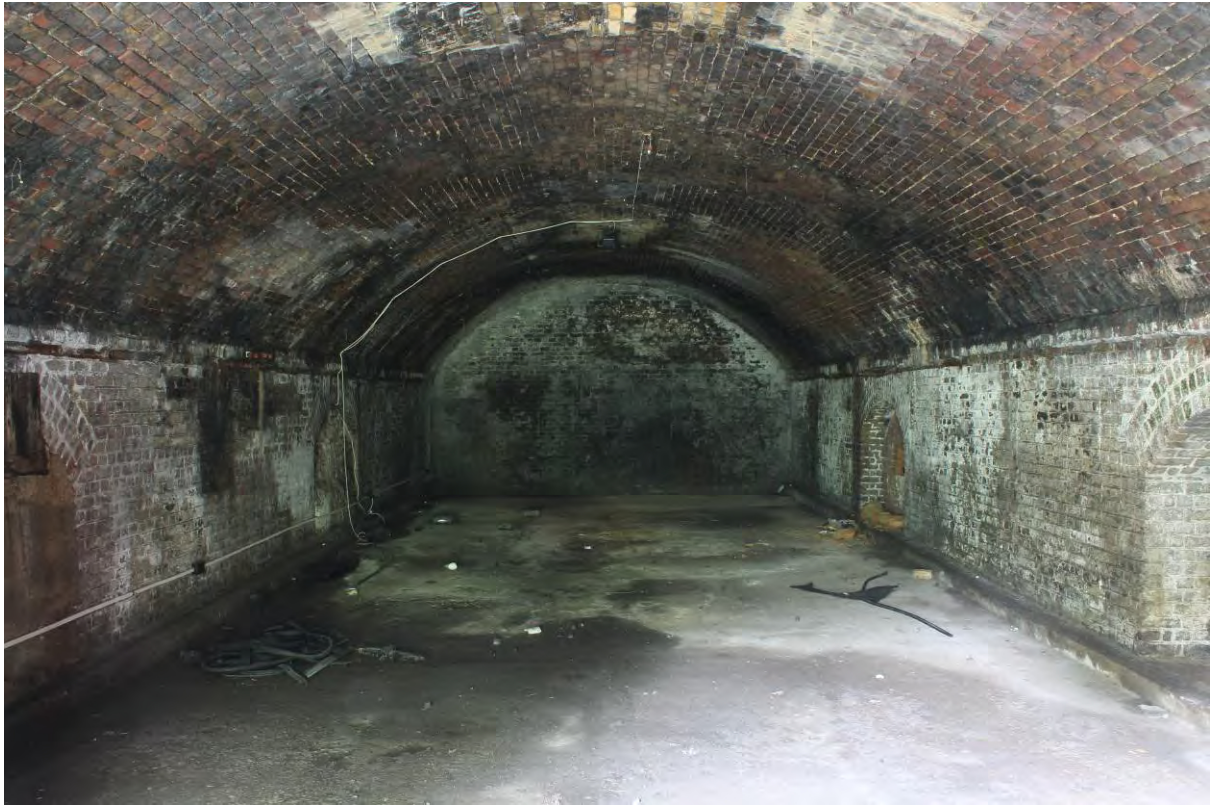
Plate 13 Arch 7 looking north

- 6.5.9 Arch 7 (**Plates 13 and 14**) was enclosed by a makeshift part-railway sleeper and part-boarded doorway during the initial building survey. Localised repair of the arch, parapet and the western jamb was present. Internally the arch displayed the same arrangement of transverse arches, all blocked using modern materials of either Fletton brickwork or shuttered concrete. The two yellow stock brick blockings to the former coal drops were the only features within the vaulting. A modern addition of a concrete-built drip gully had been added along the base of the walls while some areas of wall had been re-pointed using a hard cement based mortar.

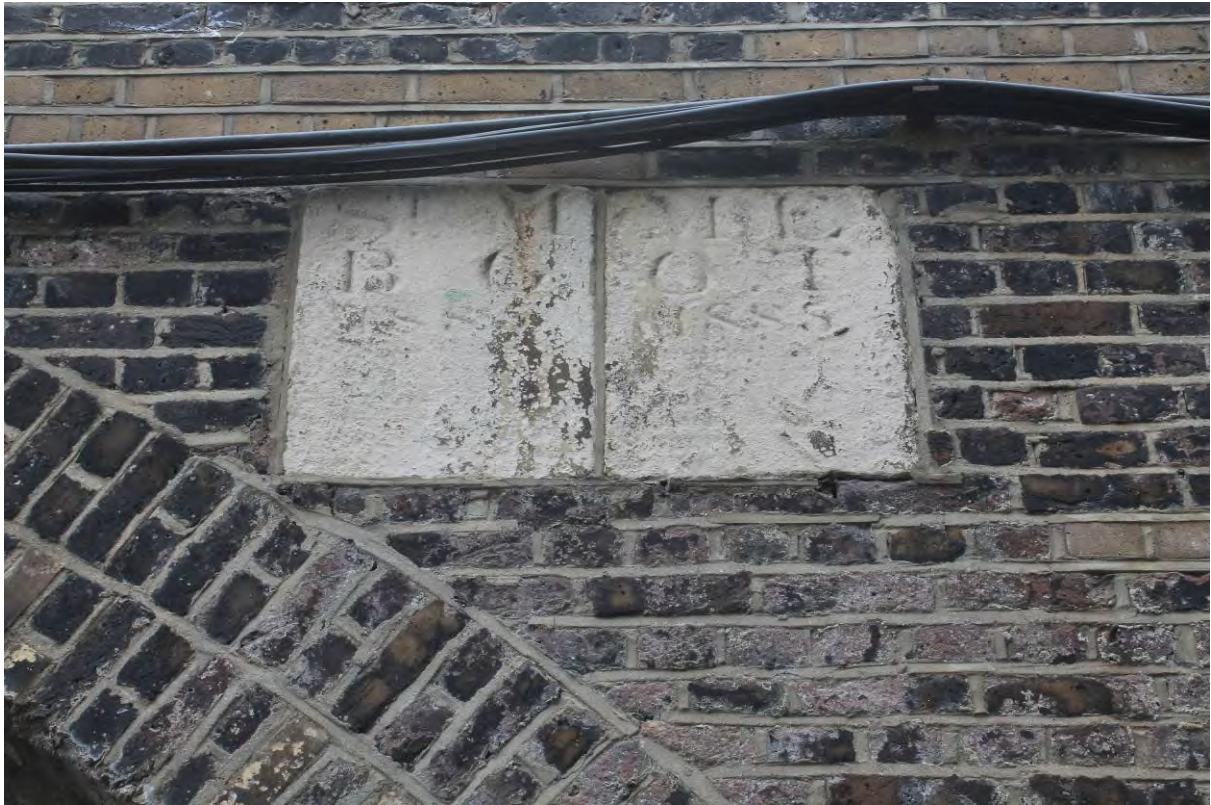
Plate 19 Boundary stone over Arch 12

- 6.6.3 The external elevations of these arches had in places been repaired using modern yellow brickwork, particularly along the bases/jambes of the arch openings. A cast iron cylindrical 'sleeve' fixed into the brickwork of the viaduct using a T-shaped flange was present within the spandrel between Arches 10 and 11 (**Plate 18**). Its function is unclear although it appears to have been used as a guide or housing to locate piping or similar from the siding above. The spandrel to the east between Arches 11 and 12 incorporated the boundary marker stones for the parishes of St Matthew and Mile End Old Town (**Plate 19**).

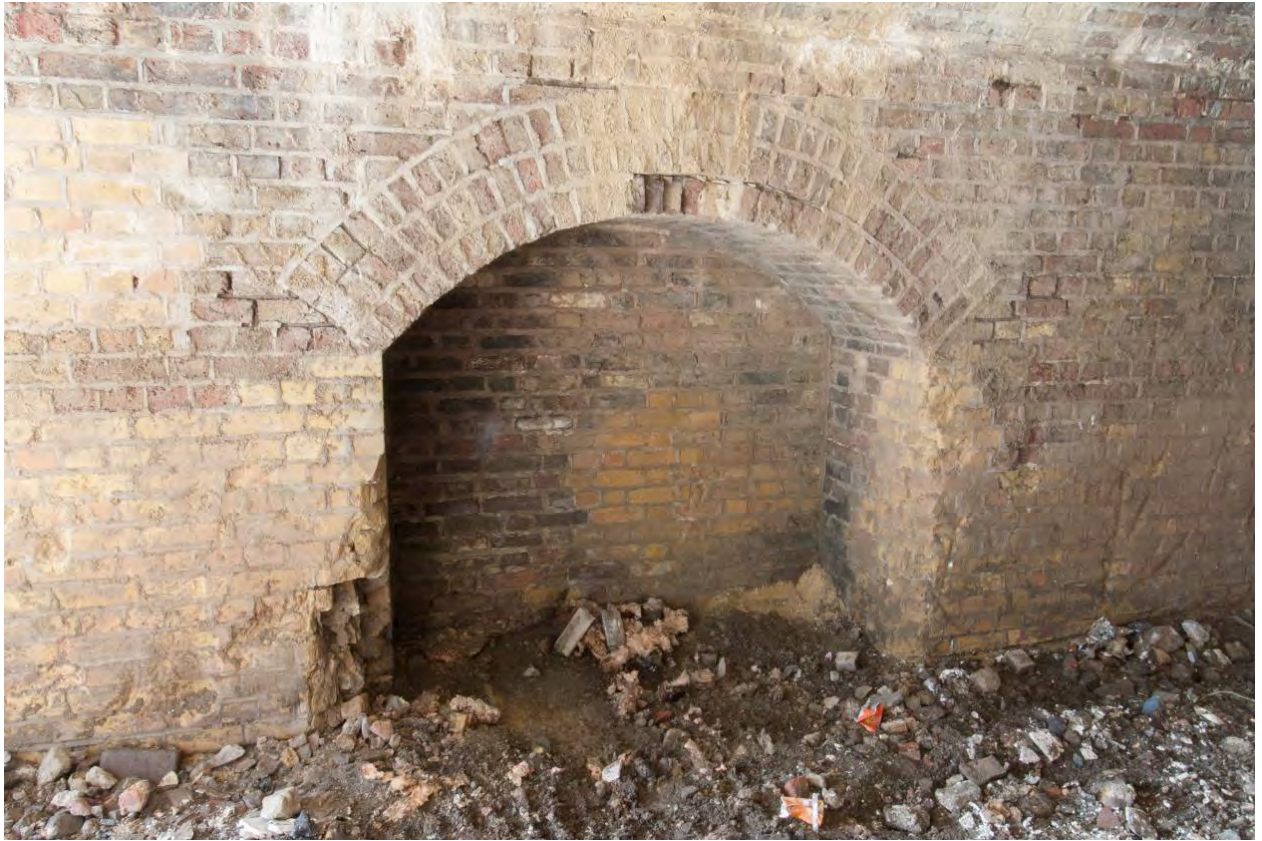
Plate 23 Transverse arch in Arch 12 looking west (RWV13 D101 8359-2)

- 6.7.1 **Arch 12** was the westernmost of the group of arches that were used as receptacles for sand and aggregates during the second half of the 20th century. The interior was constructed to the same design as adjoining arches, containing four transverse arches (all blocked with recessed brickwork), and two drops in the roof of the arch (**Plate 22**). The brickwork of the south western transverse arch contained signs of recent damage, while the adjacent wall also bore scars inflicted by the bucket of a mechanical excavator when moving sand from within the arch (**Plate 23**).

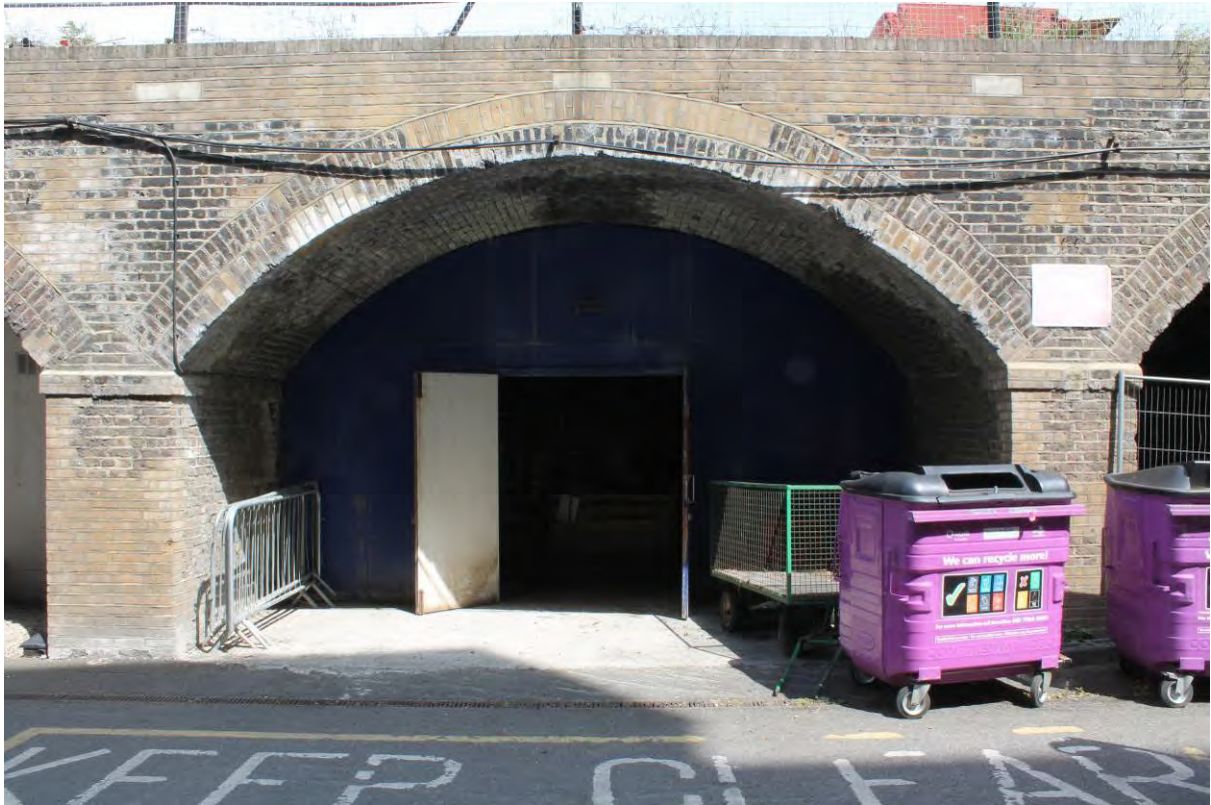
Plate 33 Arch 17 looking north

- 6.8.1 The brick courses and the parapet above **Arch 17** had been repaired using the same yellow brickwork seen elsewhere (**Plate 33**). The opening of the arch had been closed in recent years using a recessed (set back 2.44m) lightweight timber partition wall with a central door opening. This partition wall was built in a similar style to those to the east (Arches 14-16) but did not incorporate the same internal structure, leaving the arch open. The position and alignments of both the transverse arches and the coal drops in the crown of the vaulted ceiling were consistent with those recorded elsewhere. The two former coal drops were both blocked from above (siding level), but 'open' from below. The southern drop comprised an opening edged with a cement render along the eastern and western sides. The northern 'opening' however retained a timber lining, consistent structurally with that recorded in Arches 12 and 13, though it did not include evidence of Baltic markings (**Plate 34**). The fact that these openings were not brick-blocked suggests they were operational while the viaduct was still in use in an industrial context. Only one of the transverse arches of Arch 17 had been totally blocked, the two along the eastern side were part blocked re-using railway sleepers and the north-western arch fully blocked in brick recessed back from the wall line (**Plate 36**).

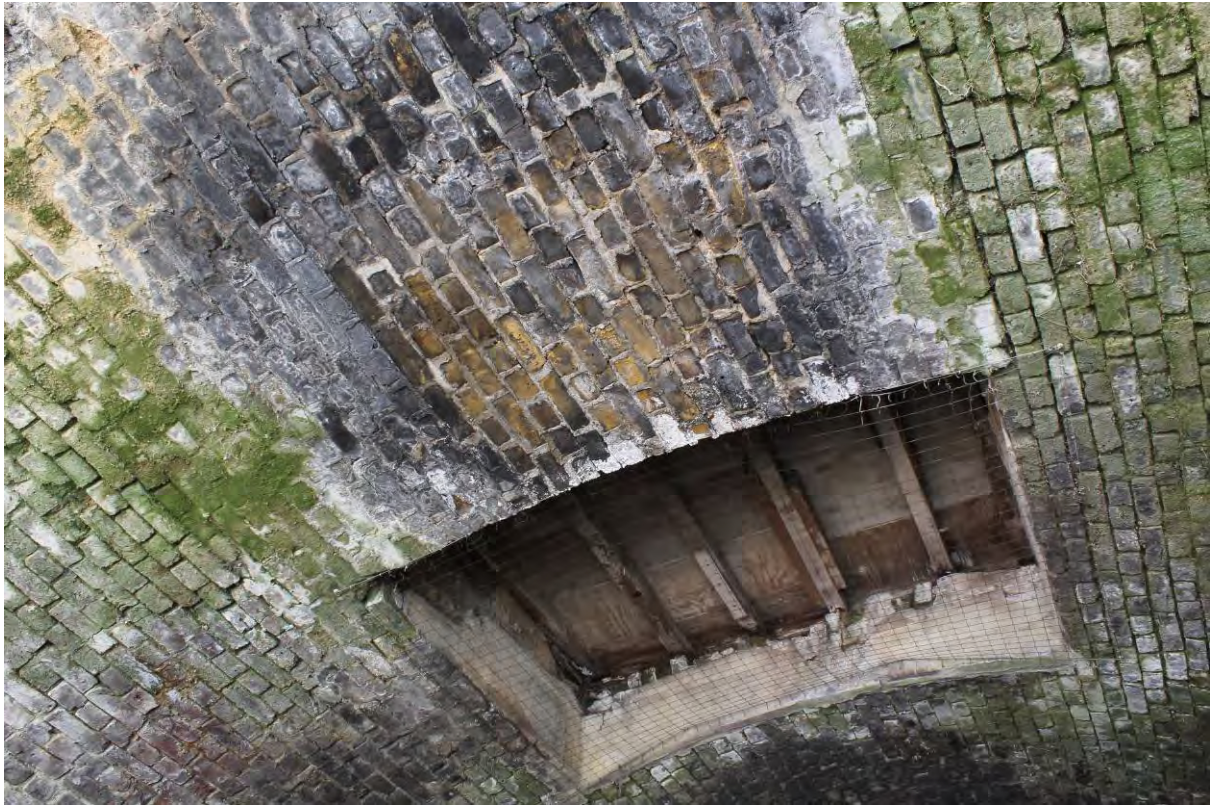
Plate 37 Later inserted opening into former blocking, Arch 19

opening in Arch 18, this opening was aligned east-west and was edged using shuttered concrete (**Plate 37**). The northern of the two coal drop openings was also unblocked but appears to have been slightly enlarged or had collapsed along its eastern edge. Some evidence of a timber shuttering to the opening was still present along the western edge. The modern use of the arches for storing sand was evident from the deep scarring (**Plate 38**) within the walls of the arches, caused by the bucket of a mechanical excavator or similar.

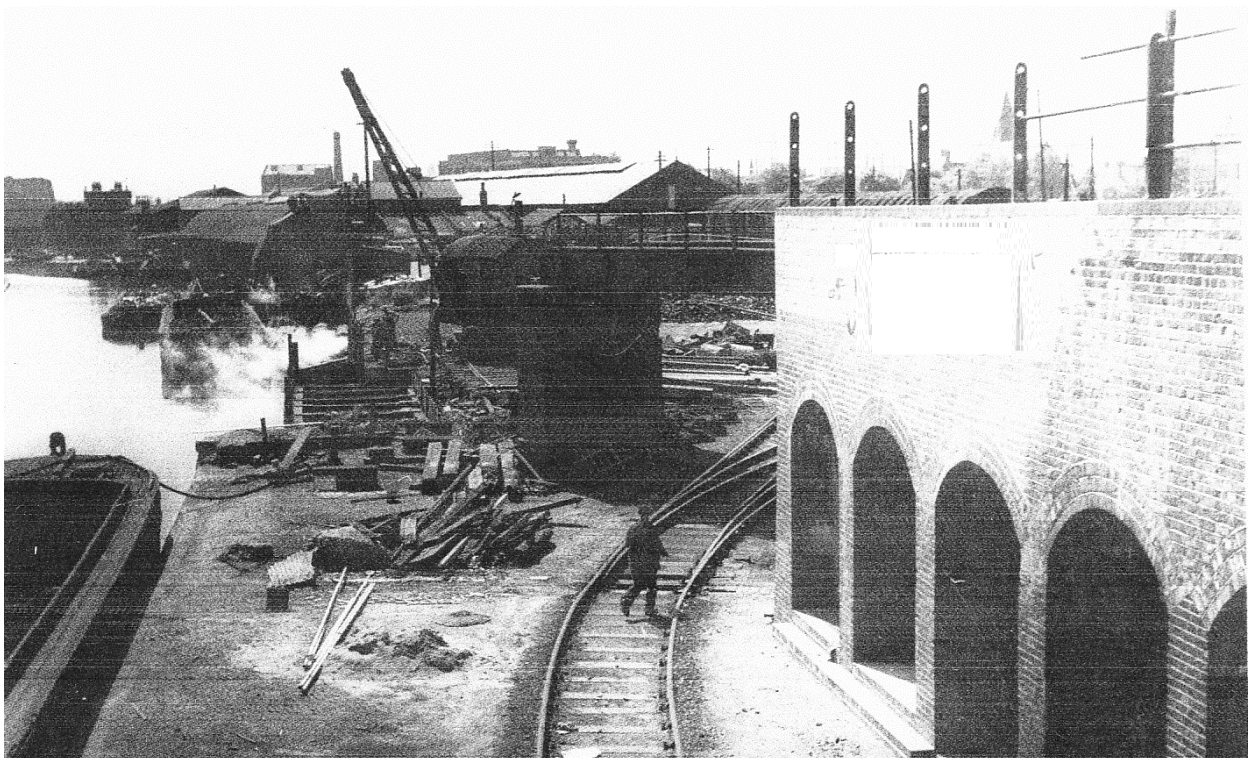
Plate 52 Repairs to the bomb-damaged coal wharf at the Mile End and Devonshire Street Coal and Goods Depots, c.1945

- 5.9.1 An historical photograph taken shortly after the end of the War showed the impact of wartime damage at the east end of the coal drops viaduct (**Plate 52**). Taken after the ruins of ‘the toboggan’ had been cleared, the photograph showed the redundant girder bridge at the south-east end of the viaduct, shortly before it too was removed. The extent of this repair work was reflected in the extensive use of engineering bricks at the south-eastern angle of the viaduct. An Ordnance Survey map of 1948 showed the site following the removal of the last traces of both the bridge and the coal shoots (**Figure 9**). The map also revealed the extent of wartime destruction in nearby Bradwell Street and Longnor Road, both of which had lost a substantial proportion of their housing stock to enemy bombing.

- 6.3.4 The rebuilding of the south-east end of the viaduct with blue engineering bricks appears to relate to repair during or shortly after the Second World War, in order to make good bomb damage. A photograph of the east elevation of the viaduct taken c.1945 (**Plate 52**) appears to show the wall newly rebuilt.
