**ARCHAEOLOGICAL MONITORING  
OF GROUNDWORKS AT GLEBE  
HOUSE, WALDEN ROAD,  
HADSTOCK, ESSEX**

**PCA REPORT NO: 11472**

**JULY 2013**

**Site Code:** HDGH13

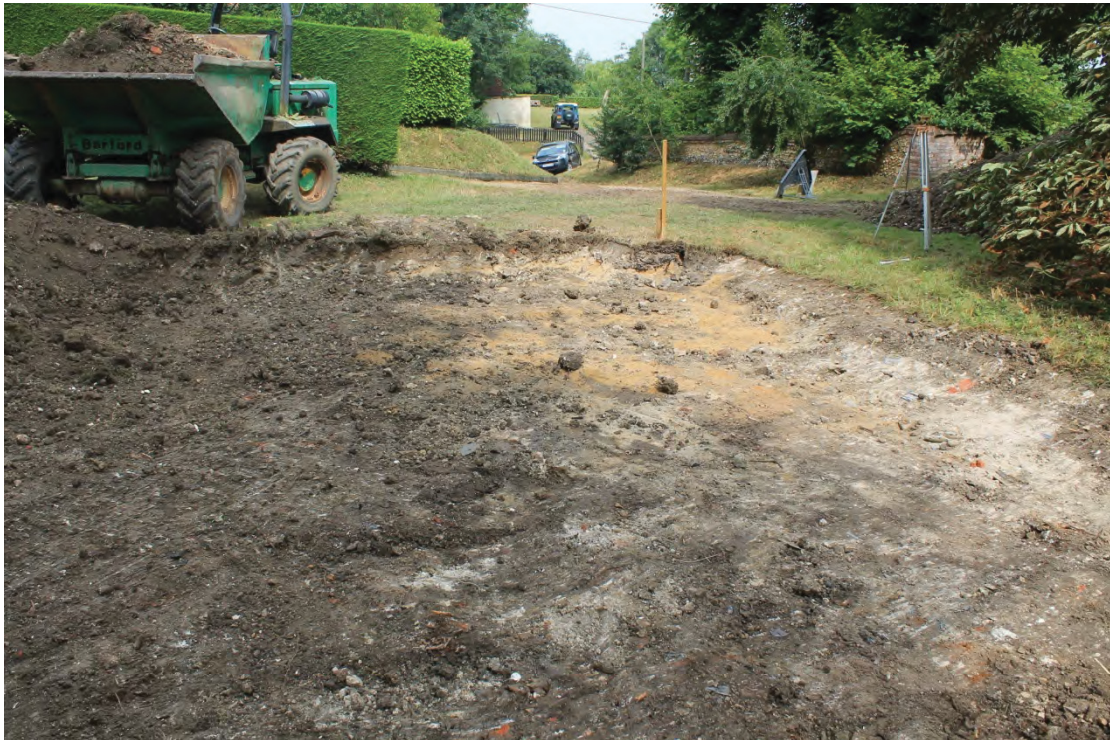
Plate 1 Site during excavation, looking W

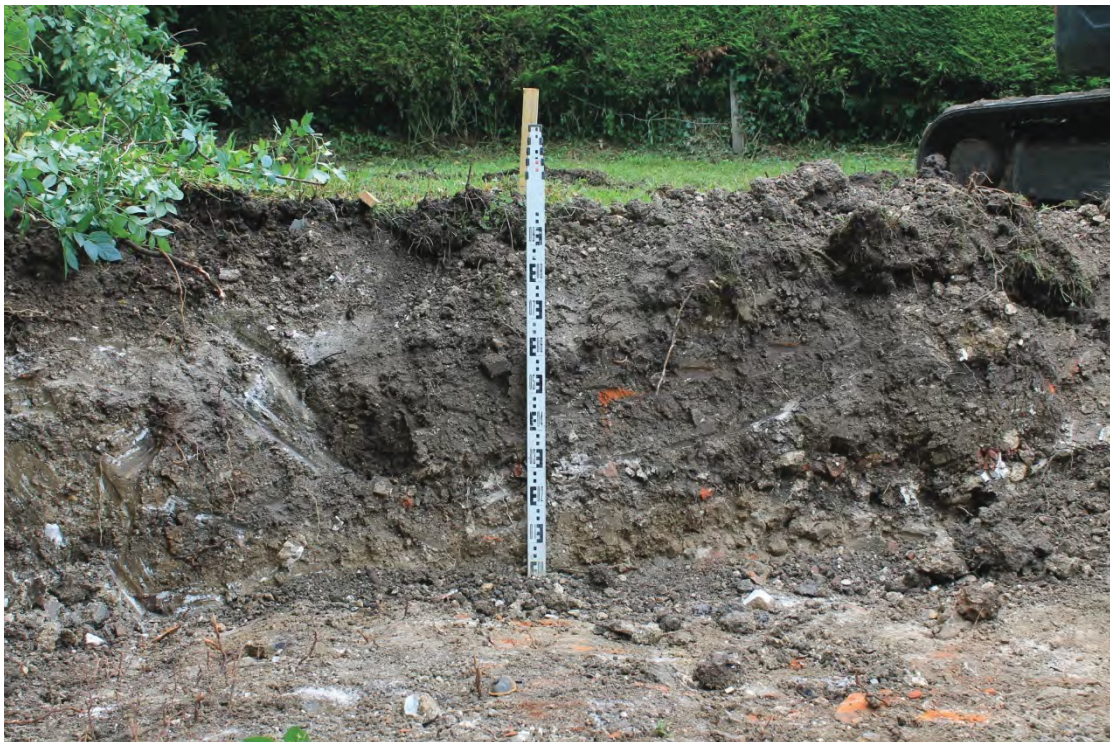
- 5.1 The excavated footprint measured 7.5m east-west and 10.8m north-south and was excavated to a depth of 0.45m at the northern end and up to 1.2m at the southern end, as it terraced into the slope. Excavation of the over-site revealed an insubstantial covering of modern topsoil, measuring between 0.10-0.15m, overlying a considerable deposit of made ground. The made ground varied in character across the footprint, comprising lenses of yellow sand, up to 0.25m thick, at the northern end and mixed deposits of grey/brown clayey soils and re-deposited chalk and clay to the south. This made ground included a moderate amount of general house and building debris, such as fragmented and broken post-medieval brick, grey slate, ash and charcoal. All of this material was later post-medieval and probably, given the character of the building materials, later 19th century or early 20th century in date.

- 5.2 Excavation into the sloping ground to the south revealed that the made ground appeared to be contained within natural hollow or terrace, although the base and sides were not identified as the natural underlying chalk subsoil was not reached. The made ground did however become increasingly chalkier toward the southern baulk, suggesting that the edge of the feature may not have been much deeper or further south.

Plate 2 Depth of made ground along southern excavation boundary, looking S

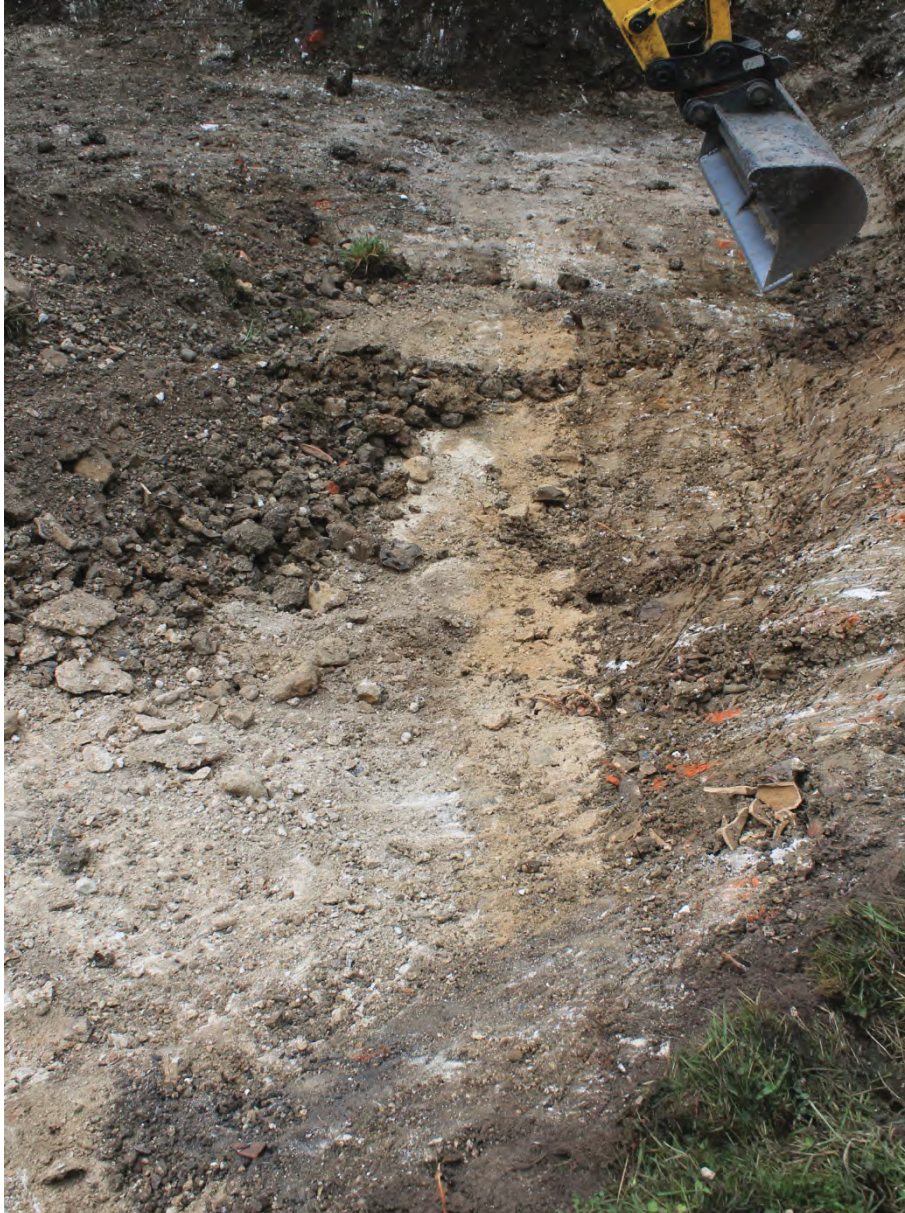
- 5.4 This wall was aligned east-west and measured c.4.4m in length, 0.26m (1 brick width) in width and butt ended c. 2.8m from the eastern baulk. The relationship between the wall foundation and the made ground was unclear, though it was overlain by later waste deposit of similar character, suggesting a gradual re-landscaping of the area.

- 5.5 Examination of the wall foundation revealed it was mainly constructed using large flint nodules set in a sandy lime mortar, but also incorporated red, frogged, half bricks measuring 100mm x 60-65mm. These bricks were handmade bricks and typical of an 18th-19th century date.

- 5.6 Though the function of the wall was not immediately clear, there was no evidence to suggest that it formed part of a free standing structure such as a building, but may have been a retaining or boundary wall which formed part of the terracing of the land in this area. As the site of Glebe House and the development area was formerly part of Glebe Farm, it seems very probable that this wall is directly associated with the farm and is likely to have been one of the farm boundaries depicted on the later 19<sup>th</sup> century OS mapping. The presence of building debris and the made ground in this area may be a consequence of the demolition of nearby farm buildings belonging to Glebe Farm (which appears to have remained as a working farm until just after the Great War, 1914-18) and the sites subsequent re-landscaping in preparation for its change to domestic use (Glebe Cottage and latterly Glebe House).

Plate 3 Post-medieval E-W wall foundation, looking E
