GOLDHILL FARM, GOLDHILL,
CASTLESIDE, COUNTY DURHAM

HISTORIC BUILDING RECORDING

HISTORIC BUILDING RECORDING REPORT

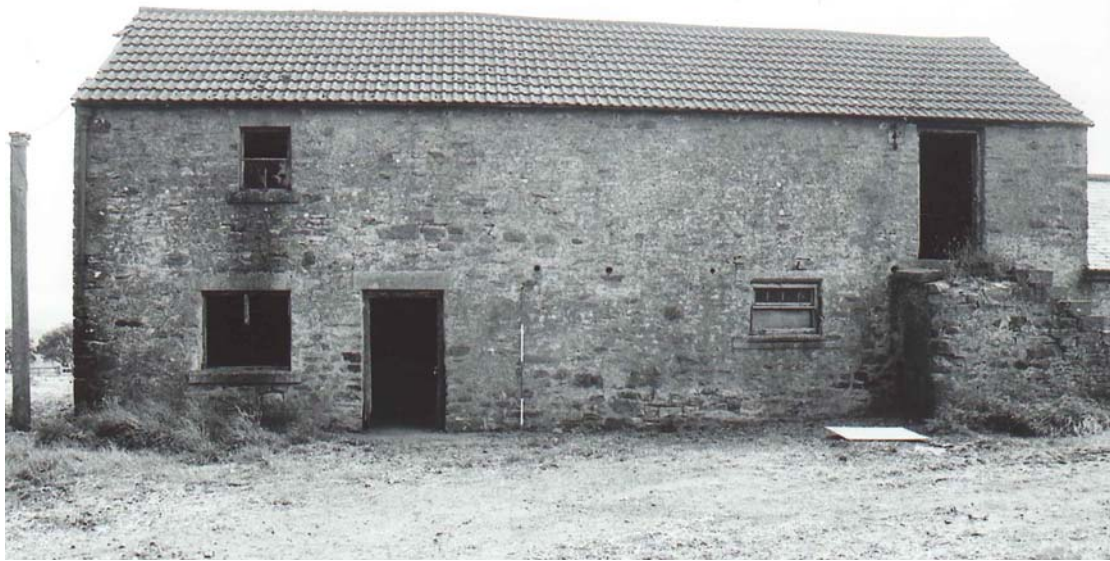
Photograph 1: Combination barn, west range, north part, west facing elevation (scale 2m)

- 5.6.1 The pitched roofs of the north part of the west range and the north wing range were covered with concrete pantiles on a mortar bed with concrete half-round ridge tiles (Photographs 1 and 2). The height of the west range exceeded that of the north range by c. 0.40m. At the intersections of the roofs lead valleys were noted. Internally, the pantiles overlay horizontal timber batons attached to common rafters which were supported by two purlins on each roof slope. These rested upon the principle rafters of a king-post truss that had an iron bolt fixing at the foot of the king-post, through the tie beam. All the timbers were squared and sawn and the entire roof of this portion of the complex is likely of early 20th-century date.

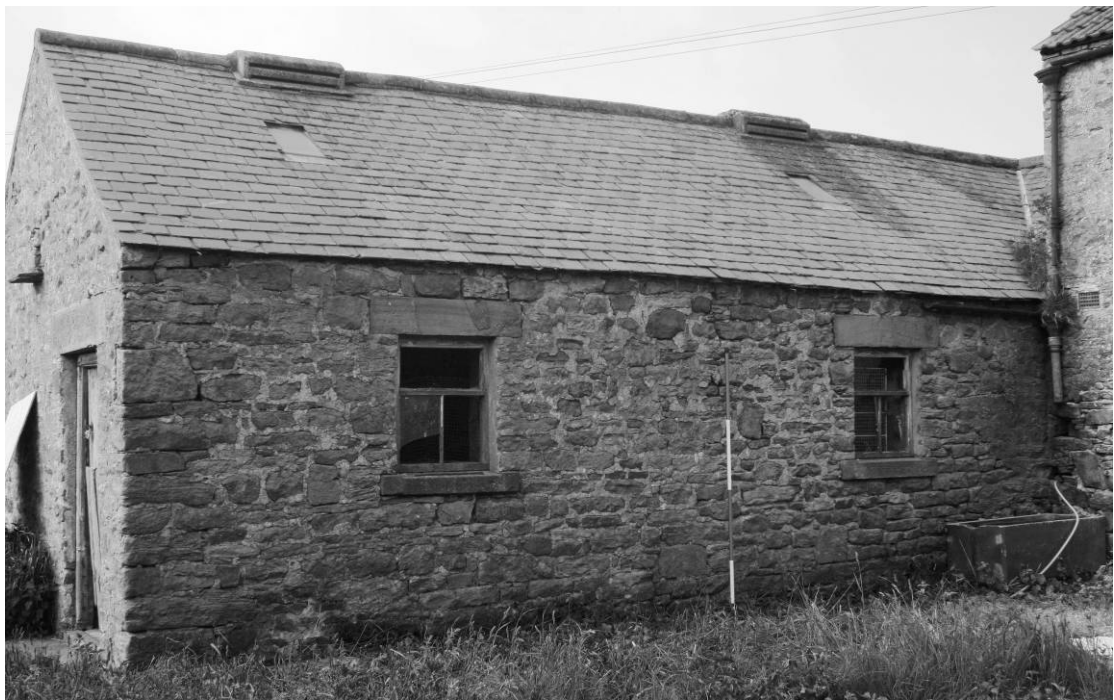
Photograph 6: Combination barn, south range, north facing elevation (oblique) (scale 2m)

- 5.6.2 The pitch, height and covering materials of the roofs of the single-storey part of the west range and the south (central) wing range were identical (Photographs 6, 11 and 13). Throughout, the covering material consisted of thin slates over horizontal timber batons with concrete half-round ridge tiles. In the south wing range, two pre-cast concrete ventilation structures interrupted the ridge line and four roof lights were noted on the south side and two on the north side (Photographs 6 and 11). A single roof light was noted on the west side of the south part of the west range (Photograph 14). Throughout, the timber batons were attached to common rafters which were supported by two purlins on each roof slope. In the south wing range, the purlins rested upon the principle rafters of a king-post truss that had an iron bolt fixing at the foot of the king-post through the tie beam and in the south part of the west range the purlins rested on the principle rafters of a tie-beam truss.

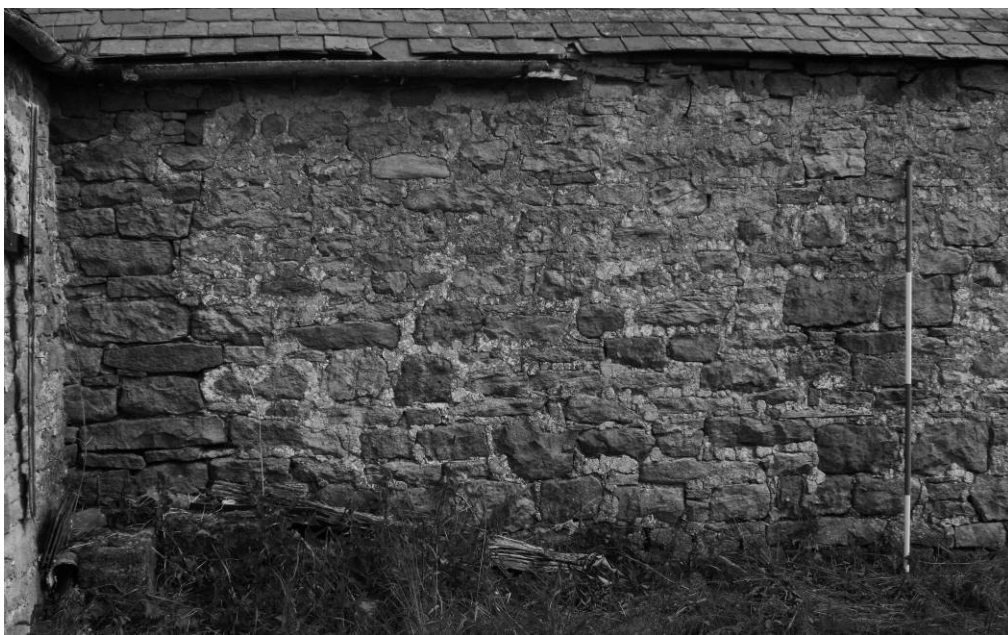
Photograph 8: Combination barn, south range, south facing elevation (west part) (scale 2m)

- 5.2.14 The south elevation of the south (central) wing range was again constructed in lime mortared sandstone rubble. Differential pointing in a section c. 1.30m wide to the west indicates either localised repair or rebuild or an infilled former aperture (Photograph 8).

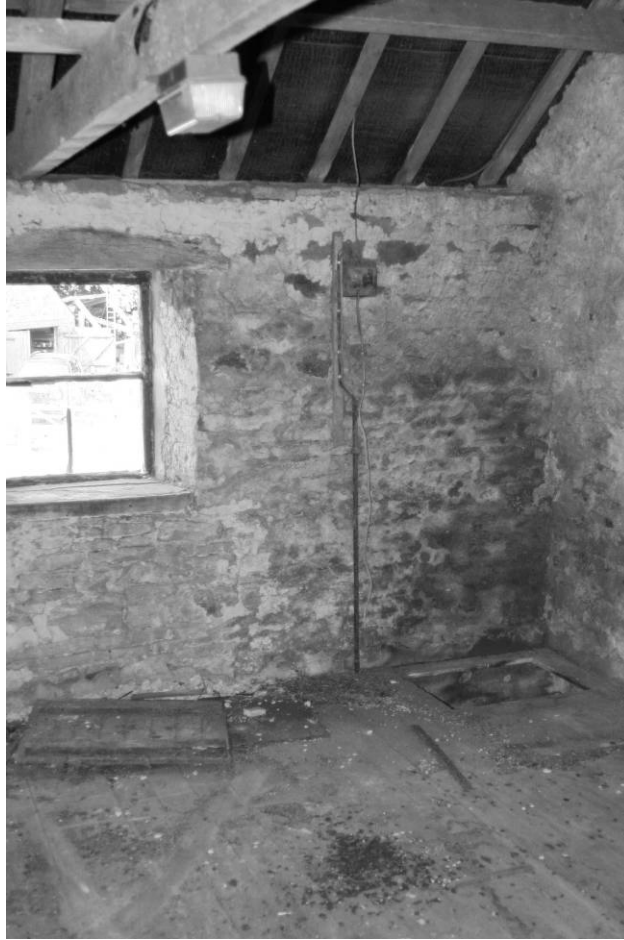
Photograph 17: Combination barn, west range, north part, first floor, north room interior

- 5.4.20 The northernmost room (Photograph 17) measures c. 4.50m square and is lit by a single window in the west wall with doorway access to the adjacent room to the south in the south-east corner and to the north wing range in the east wall. The masonry of the walls was largely obscured by slobbered mortar render, painted white, and a square hatch was noted in the floor, in the north-west corner of the room.

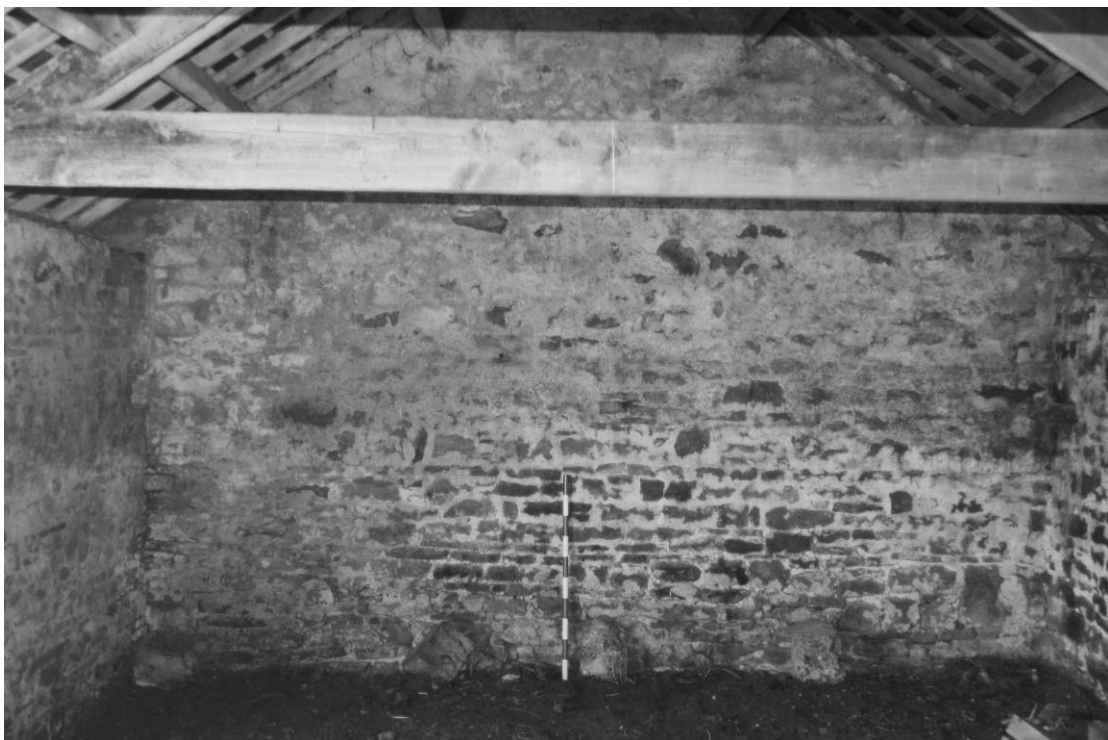
Photograph 26: Combination barn, west range, south part, south room interior, end wall (scale 1m)

- 5.4.15 The southernmost stable (Photograph 26) is c. 7.75m in length with no windows and access to the southern part of the yard area to the east by a very wide, c. 2.40m, doorway that would have housed a double-doors, these no longer present. The door sill comprised large sandstone blocks at each end, with square sockets for door jambs, and a rectangular sandstone slab. A small patch of cobbled surface was noted beneath the soil and organic material covering most of the floor and this probably continues throughout the room. Again, the walls are largely obscured by a mortar render, painted white, but with some areas of masonry exposed.

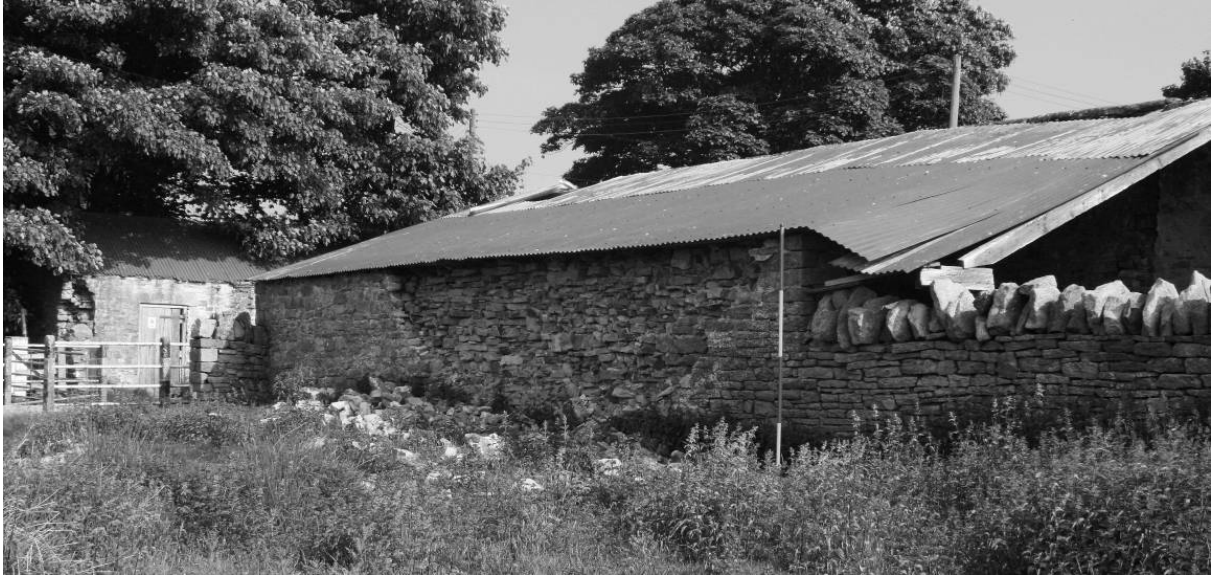
Photograph 31: Lean-to barn, south-west facing elevation (oblique), showing wall collapse (scale 2m)

- 5.3.6 The lean-to barn abutting the south-west range of animal housing for the most part comprises a timber-frame structure with pitched roof. To the north-east, at the higher end of the roof pitch, the joists are housed within the wall of the adjacent animal housing, while at the lower end of the roof pitch the joists are housed within the wall which forms part of the site boundary. A structure is first depicted at this location on the Ordnance Survey map of 1921. The lean-to/site boundary wall was in very poor condition, with significant collapse (Photograph 31).

- 5.3.12 The south-west elevation of the L-plan block, the wall of the lean-to barn, is essentially part of the existing site southern boundary wall, constructed in sandstone rubble, bonded with lime mortar (Photograph 31). The wall was in very poor condition with a c. 8.0m long section of collapsed at the time of the building recording. It likely dates to the addition of the lean-to barn, with the building first depicted at this location on the 1921 Ordnance Survey map.
