**AN ARCHAEOLOGICAL
WATCHING BRIEF DURING
COURSE IMPROVEMENTS
AT THE ROYAL MID
SURREY GOLF CLUB, THE
OLD DEER PARK,
RICHMOND, LONDON
BOROUGH OF RICHMOND
UPON THAMES**

REPORT NO: R11495

Site Code: RYS 09

Archaeological Watching Brief

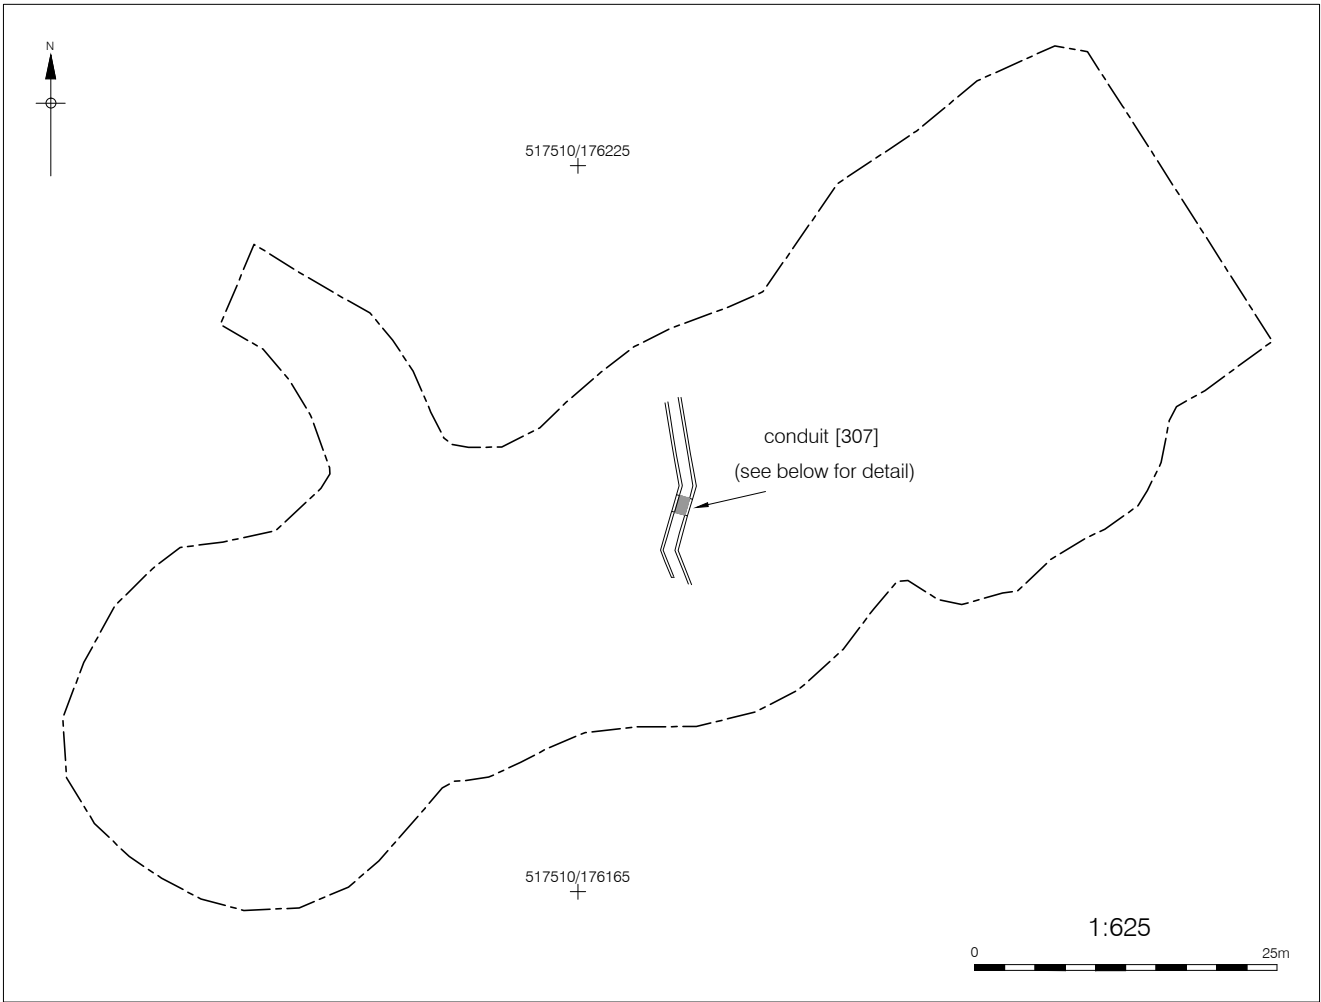
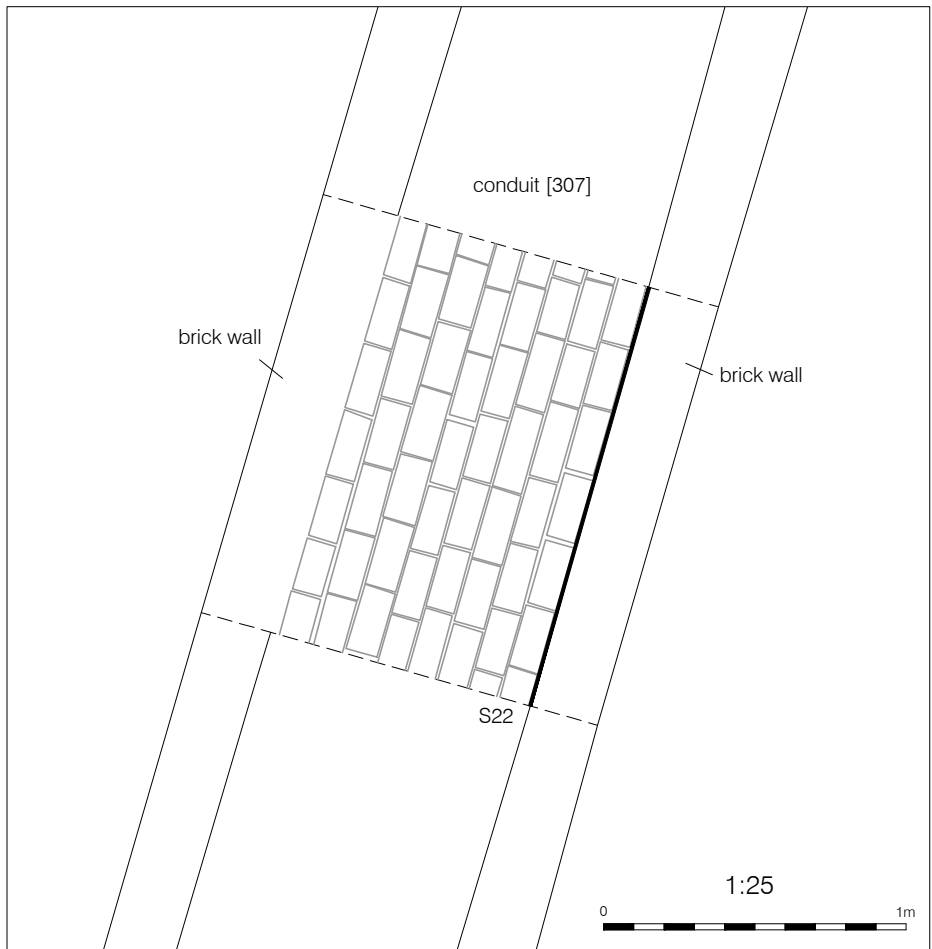
Figure 3
Plan of Hole 8
1:625 and 1:25 at A4

7.4.1 The natural sands and gravels were truncated by a construction cut [308] containing a brick conduit [307] which crossed roughly north-south across the centre of the excavation.

7.4.2 The conduit was formed of two parallel walls 0.23m thick, placed approximately 0.89m apart, with a flat brick floor laid between them. The walls survived to a height of 2.96m OD, 0.36m above the floor surface. They were constructed of red brick laid in English Cross bond fashion, cemented together with a soft sandy lime mortar. The floor was constructed with similar brick, laid on bed in an off-set running, or stretcher bond fashion. It is most likely that the conduit was originally arched to form a roof; if so this was no longer in evidence.

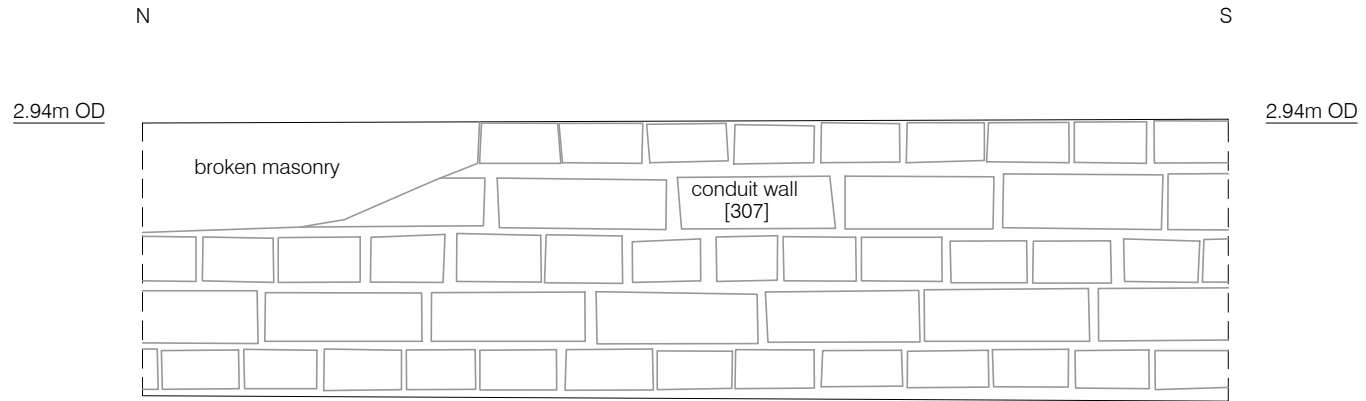
Figure 5
Section 22
1:10 at A4

Section 22
Hole 8
West Facing Elevation

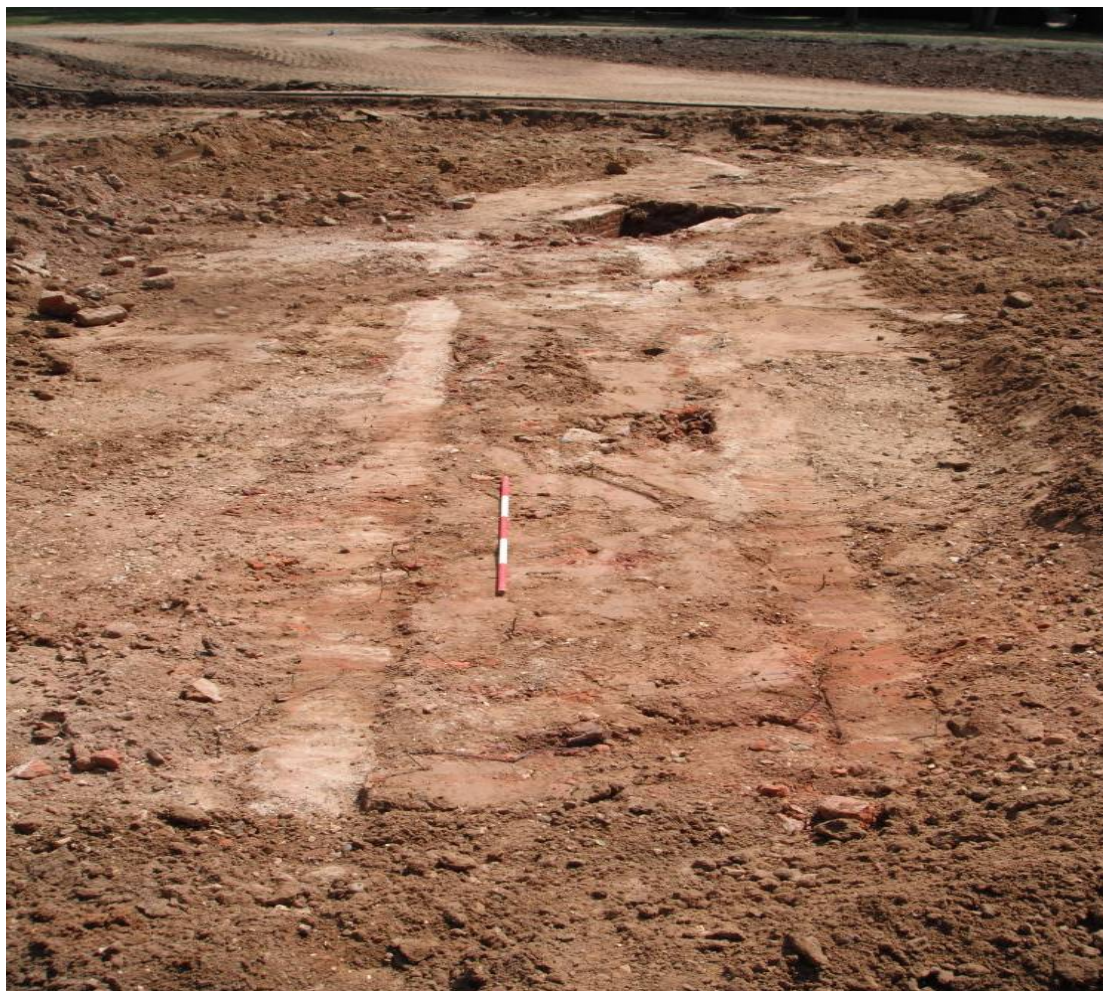
Plate 3 North facing view of Conduit Hole 8

7.4.4 The space between the walls had been backfilled with construction material [306], which for the most part consisted of bricks and mortar identical to the structure itself. This may suggest that the upper part of the conduit had collapsed, however, it appears more likely that the conduit had been deliberately demolished, as a fragment of ashlar masonry could be seen in this deposit, surely from a different structure. The conduit showed no sign of containing any organic deposits, or evidence of having silted up, suggesting that it either may have carried fresh water or that it was very effective in draining whatever it serviced.

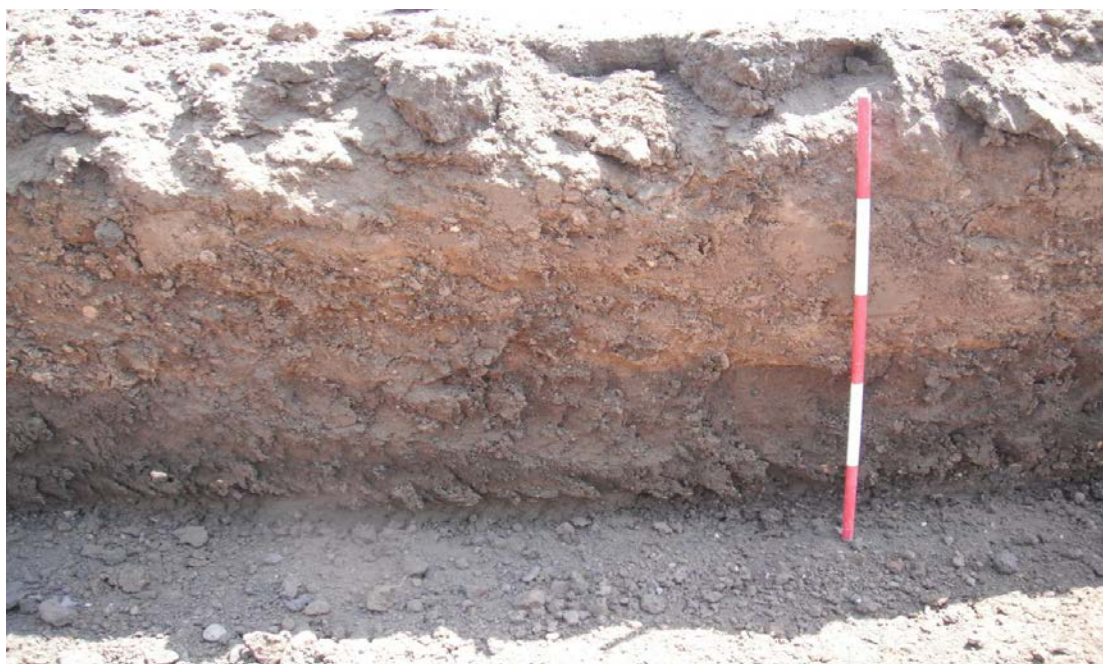
Plate 4 South facing view of Section 21, Hole 9

- 7.8 Natural Deposits (Plate 4)
- 7.8.1 The base of the excavation was formed by a layer of natural gravelly sands, Context [313]. This is of an unknown thickness as only the surface of the deposit was exposed by the excavation. This deposit was interpreted as being part of the natural Kempton Park Gravels.

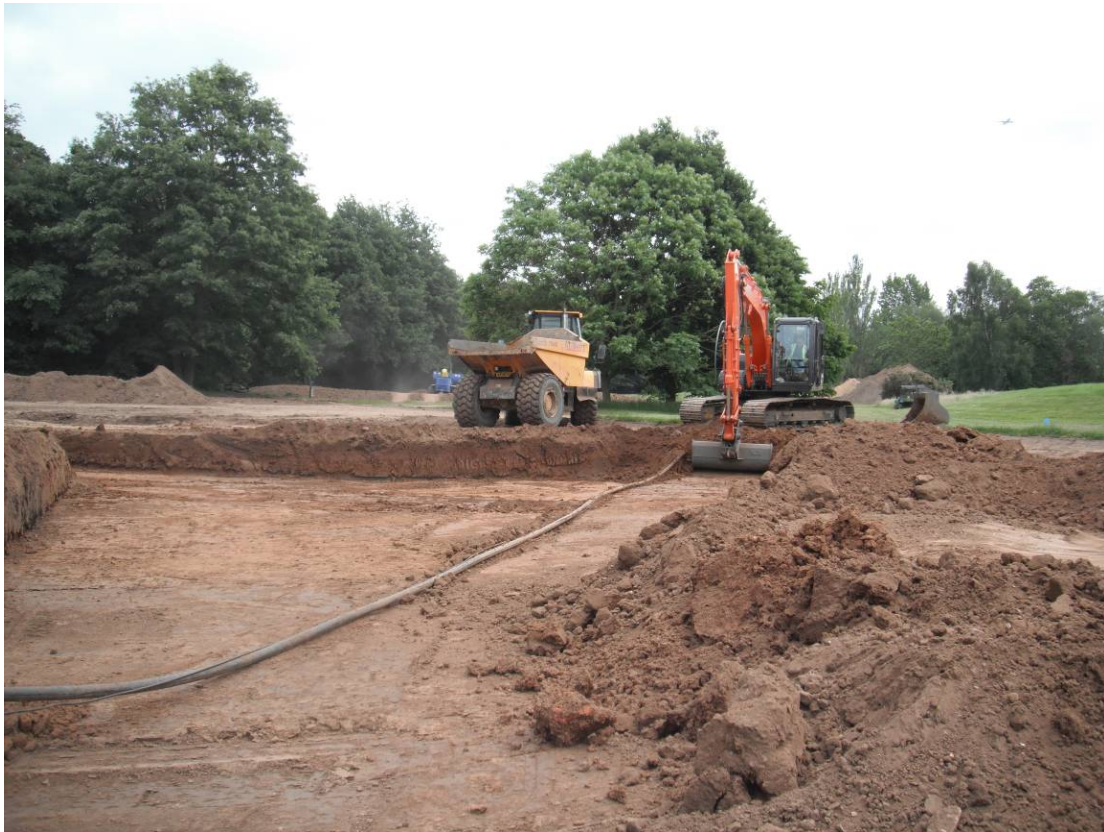
Plate 5 North east facing view of Hole 8

7.2.1 The base of the excavation was formed by a layer of natural gravelly sands, Context [305]. This was of an unknown thickness as the excavation did not penetrate this deposit to any great depth. This deposit was interpreted as being part of the natural Kempton Park Gravels. This deposit was encountered at a depth of approximately 2.95m OD.

7.5.1 The overlying deposits encountered appear to represent dumping or modification of the natural deposits found on the site, as they all contained frequent small pieces of broken brick and burnt coal, suggestive of disturbance in the late post medieval period.

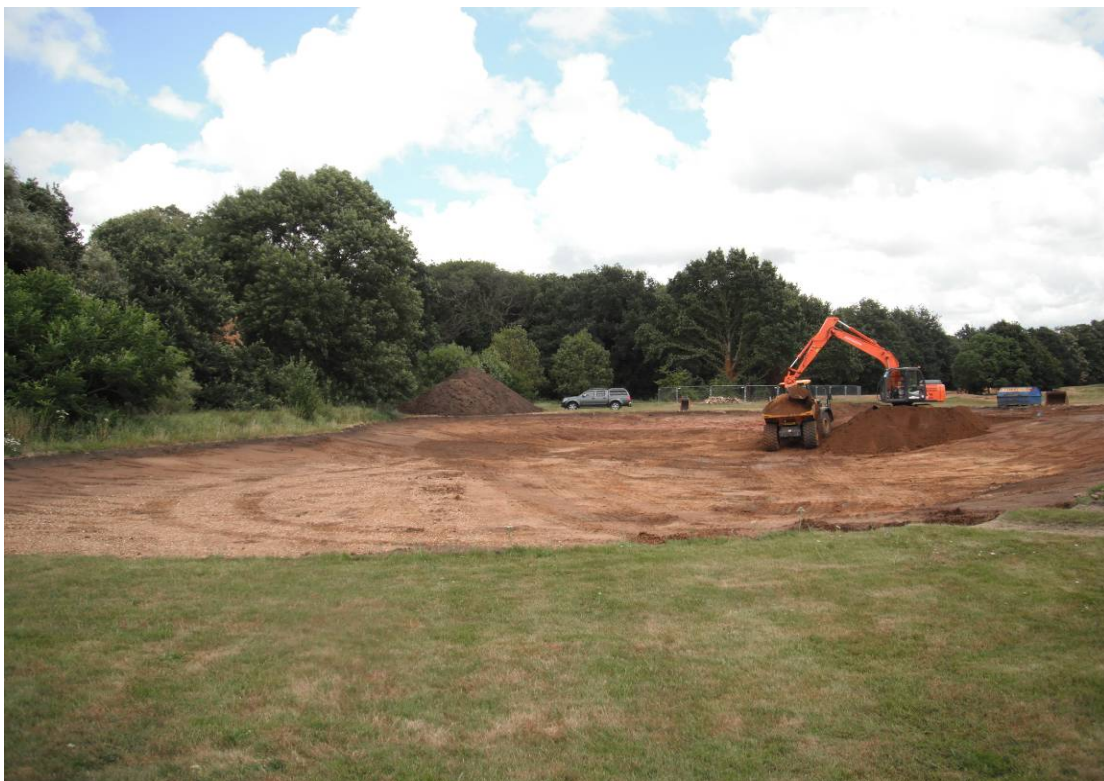
Plate 6 North facing view of Hole 9

- 7.7.1 An in filled ditch was observed at the eastern edge of the excavation for the new wetland at Hole 9. This appeared to run roughly parallel with a brick wall observed in an archaeological evaluation trench placed through this location. This was cut into a sequence of deposits which had a more natural, less disturbed nature than in Hole 8.

- 7.9.1 The deposits encountered appeared to represent a more natural sequence of deposits found on the site, as the broken brick and burnt coal fragments, found in Hole 8, were largely absent, suggestive of less disturbance in the late post medieval period.
