**HISTORIC BUILDING
RECORDING OF THE PENNY
GALLERY AND BLOCK 200,
KINGSTON COLLEGE,
RICHMOND ROAD, ROYAL
BOROUGH OF KINGSTON
UPON THAMES, KT2 5BP**

PCA REPORT NO. R11510

SEPTEMBER 2013

HISTORIC BUILDING RECORDING

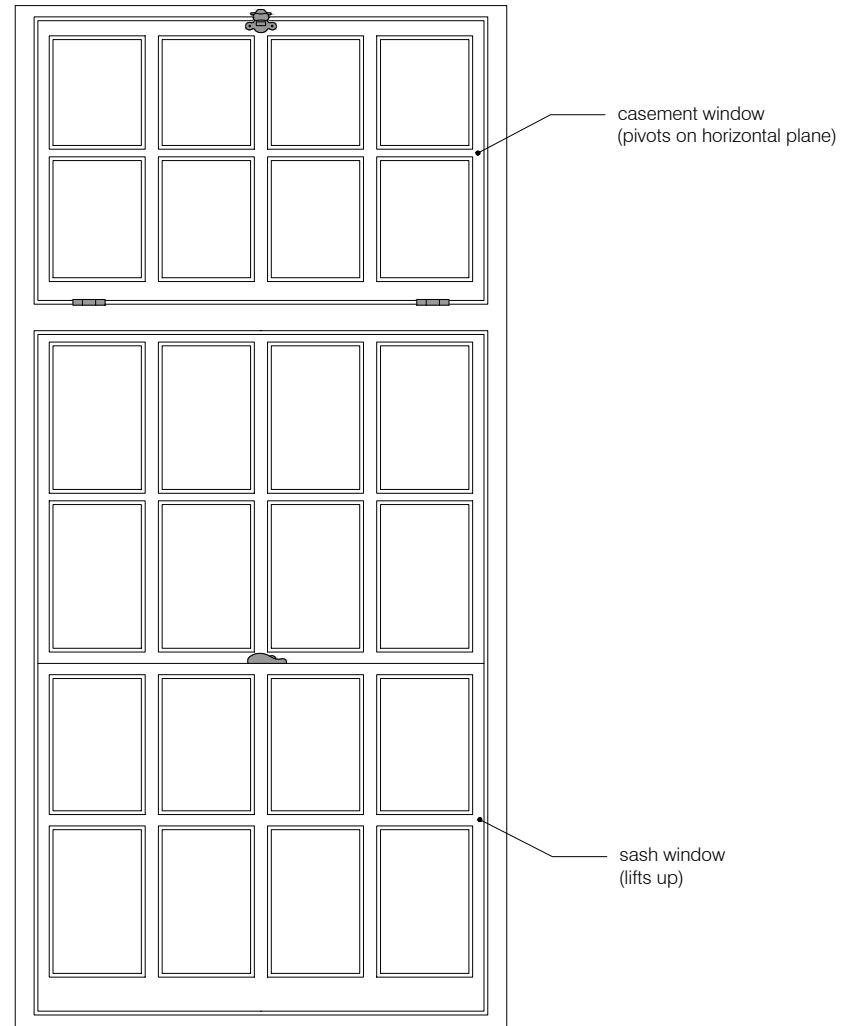
Figure 10
 Penny Gallery and Block 200
 Windows
 1:20 at A4

Detail 1
 Room 1, Penny Gallery, 1828
 Window at North end of the East wall

Detail 2
 Room 10a, Block 200, 1907
 Window at West end of the North wall

6.2.3 The windows are large timber-framed casement windows with a pivoting upper section. They are the same style as the windows shown on the c.1906 photograph of the 1818 Junior School (**Plate 1**) and are thought to be original. The sills are 90mm thick and carved from a hard grey stone (possibly limestone) that has weathered well and is in good condition.

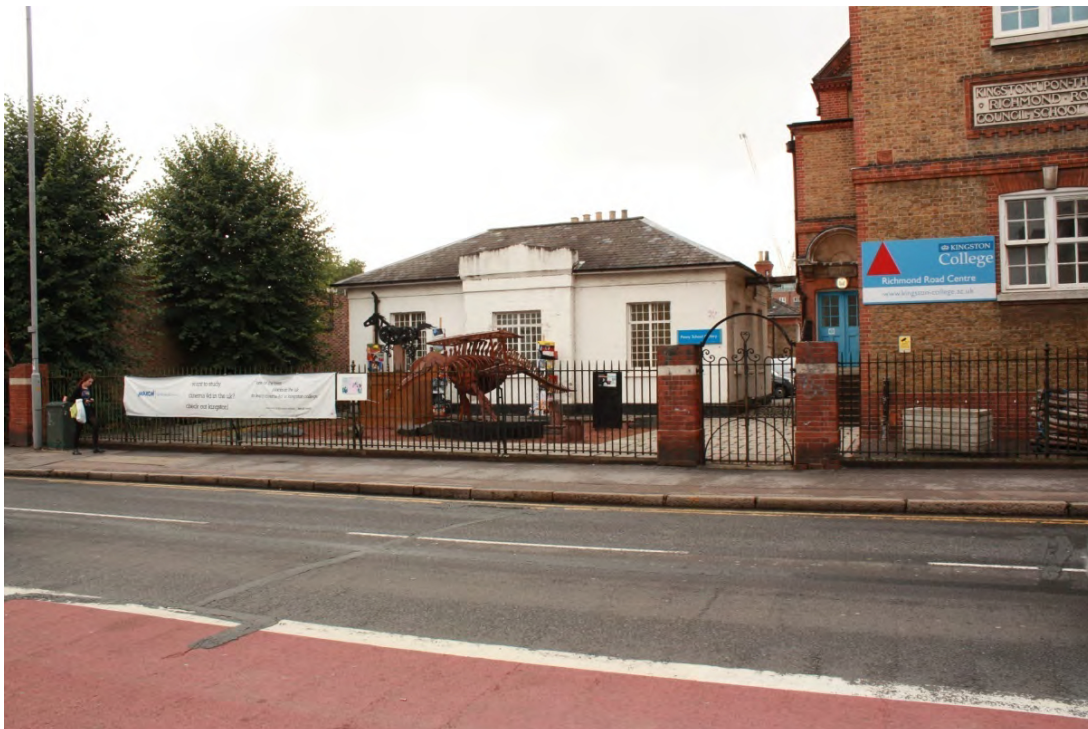
Plate 2: Front (east) elevation of the Penny Gallery, built 1828, looking west. The brick building to the right (north) replaced the building shown above in Plate 1 in 1907 (D 4: 5)

6.2.4 The front (east) elevation of the Penny Gallery faces onto Richmond Road. Placed centrally in this elevation is a shallow portico with a pediment above an entablature (**Plate 4b**). In the centre is a timber casement window with multiple panes, a stone windowsill and a plain rectangular lintel. Set low down and on each side of the portico

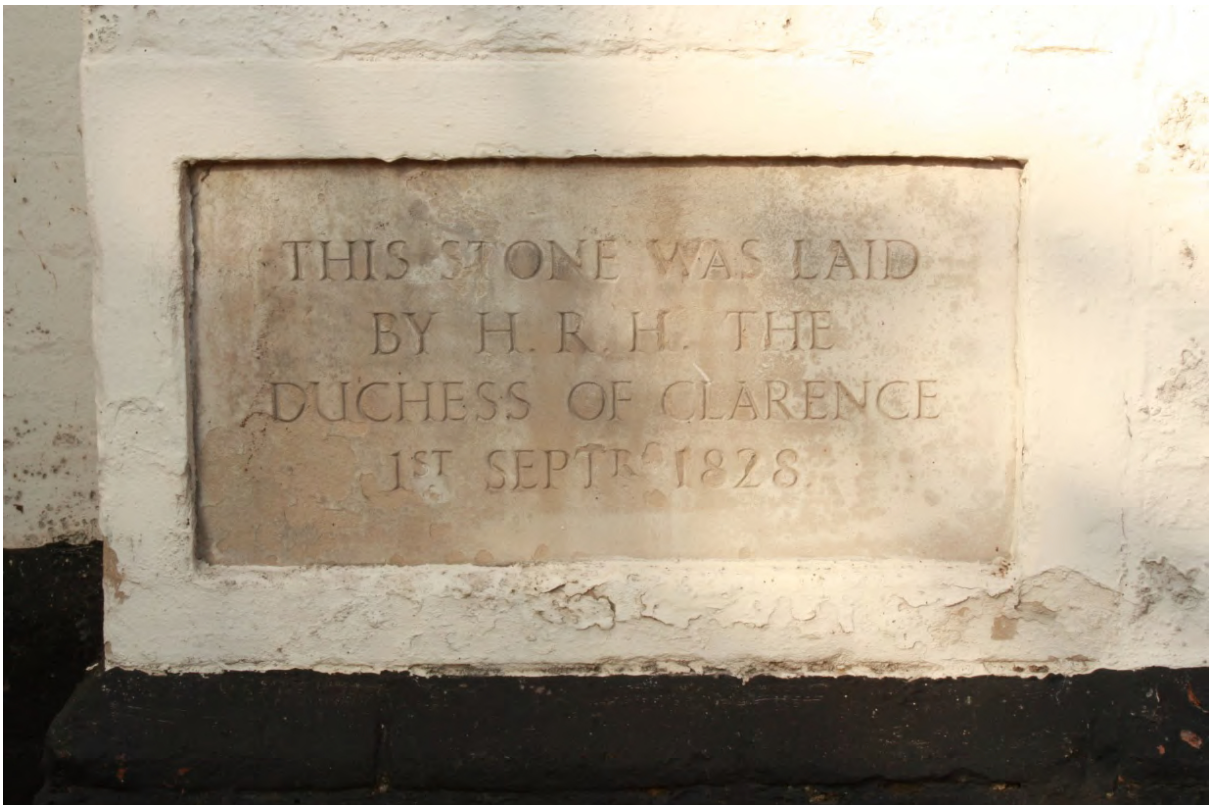
Plate 4a: Foundation stone in the front (east) elevation of the Penny Gallery, looking west (D1/13)

6.1.1 The Penny Gallery was built in 1828 and extended in 1907 (now known as Block 200). A foundation stone set into the east elevation of the Penny Gallery is dated of 1st September 1828 (**Plate 4a**). The Penny Gallery is first shown on the 1840-42 Kingston Tithe map (**Figure 3**). The building was the Infants School of Kingston Public Schools. The Junior School to the north of the Infants School was first built in 1818 and was demolished and replaced by the current school building in 1907.

are large dressed and smoothed stones (**Plate 4a** and **4b**), slightly recessed into the brickwork; that on the south side has the following inscription carved into the stone in capitals using a serif script:

THIS STONE WAS LAID
BY H.R.H. THE
DUTCHESS OF CLARENCE
1ST SEPT^R 1828

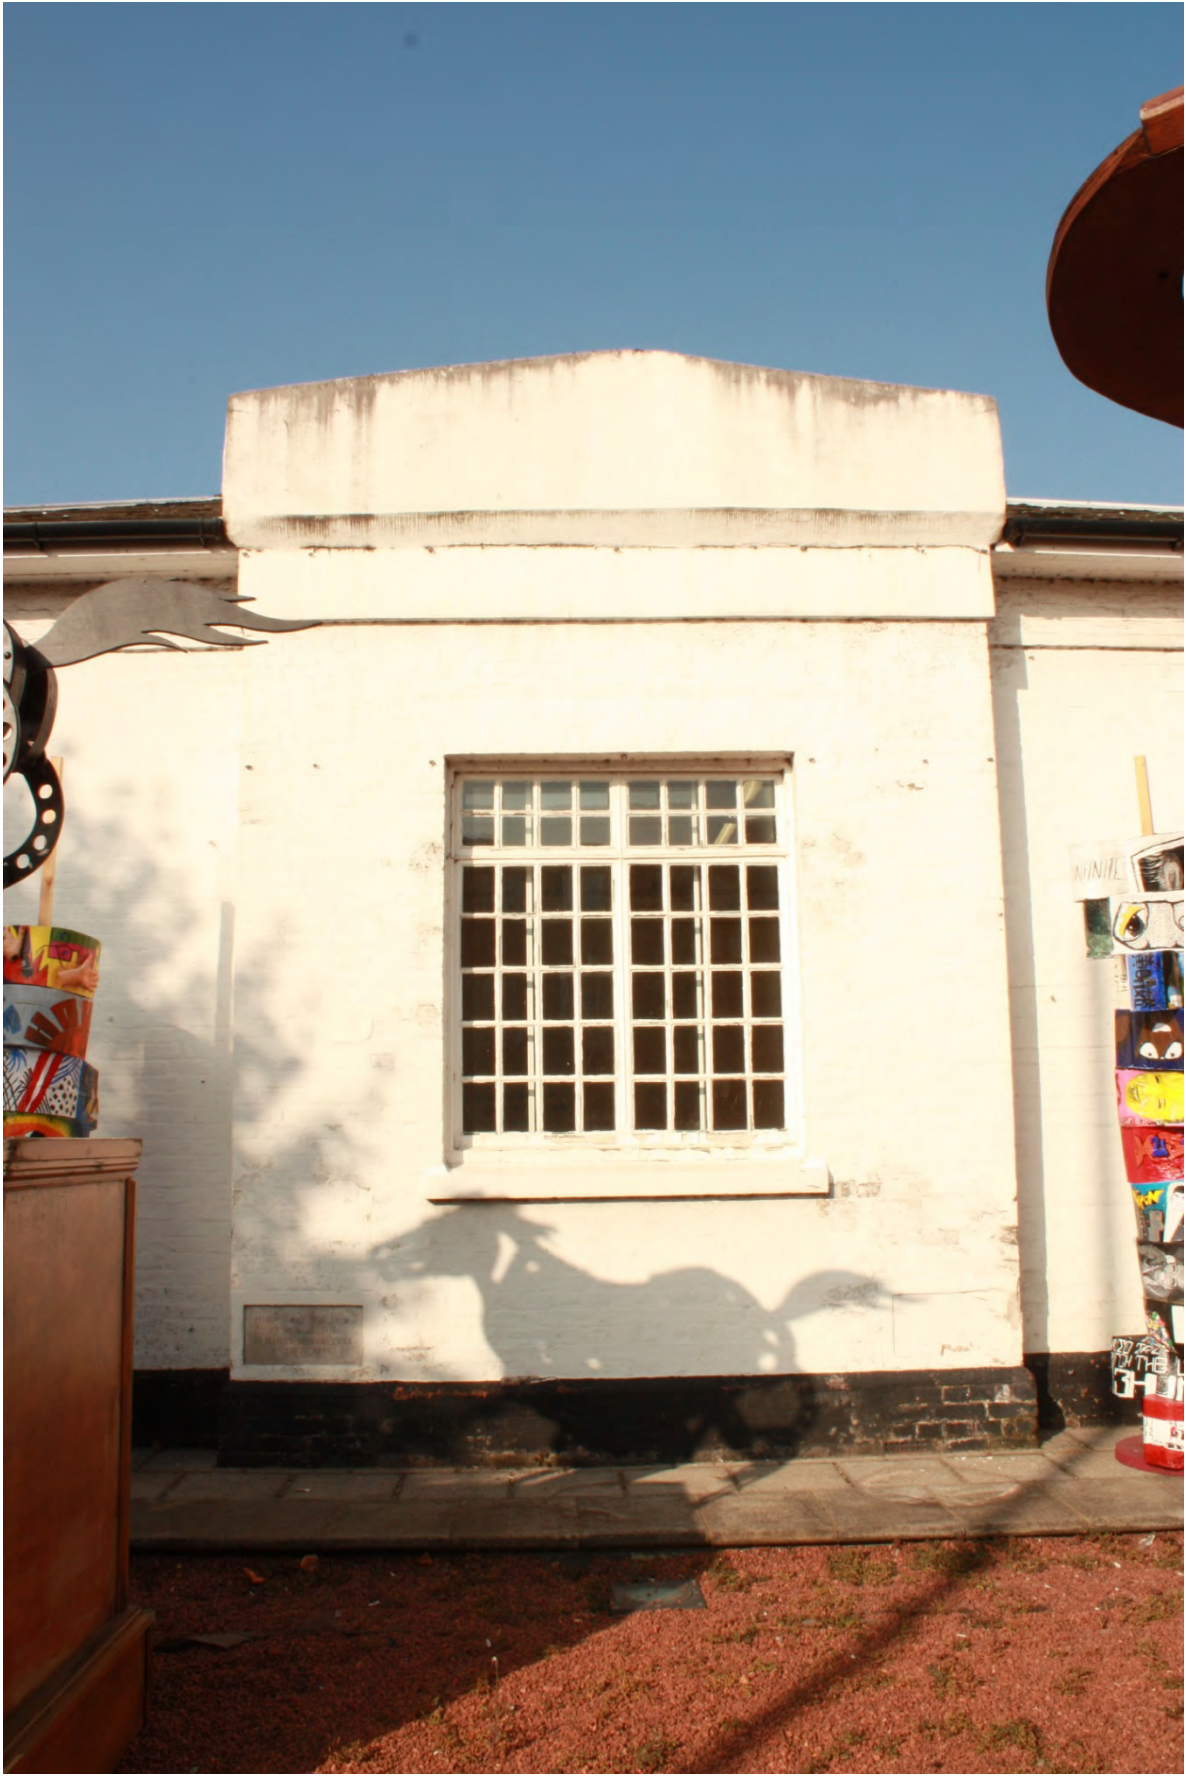
Plate 4b: Central portico in the front (east) elevation of the Penny Gallery, looking west. (D1/15)

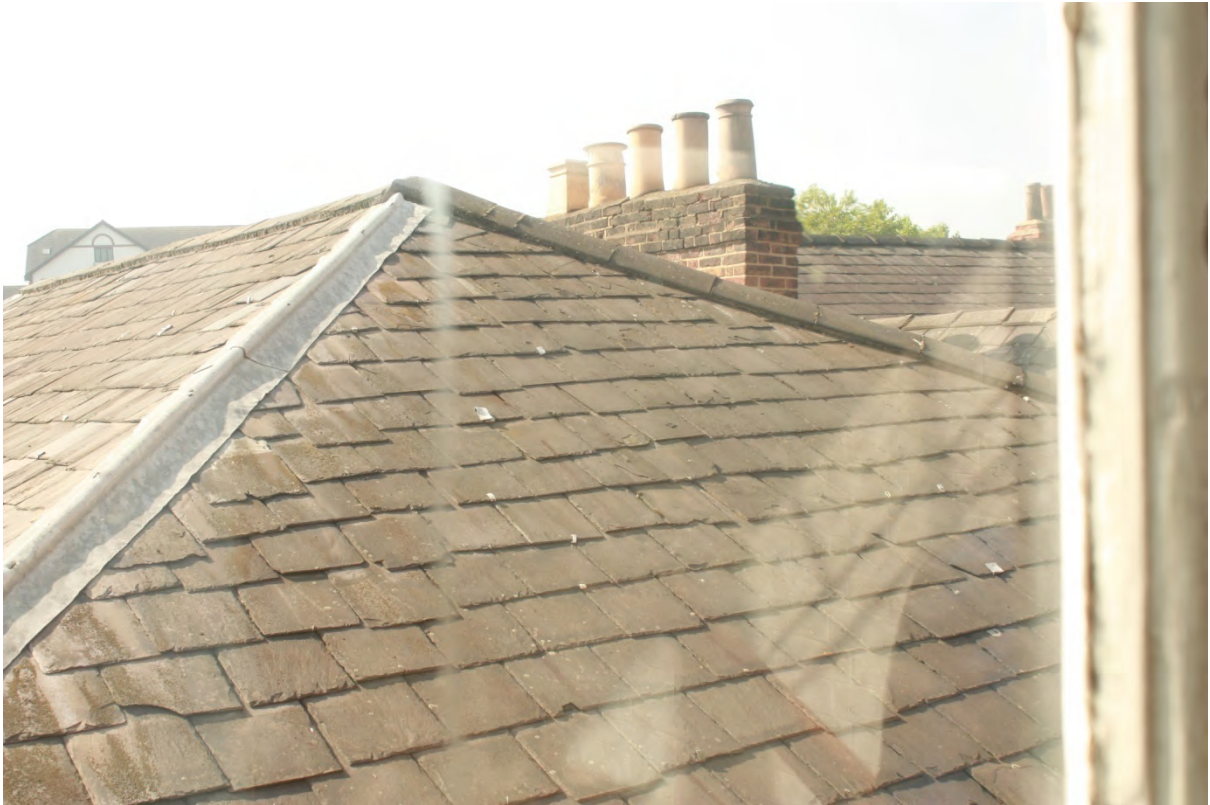
Plate 4g: Hipped roof over Room 1 of the Penny Gallery, looking south-west (D2/3)

- 6.3.8 The two fireplaces in the east walls of Rooms 2 and 3 fed into a chimney stack with five chimney pots (**Plate 4g**). It is thought that the three missing fireplaces were on the west wall of Room 1 and heated the three rooms that appear to be marked by changes in the floorboards.

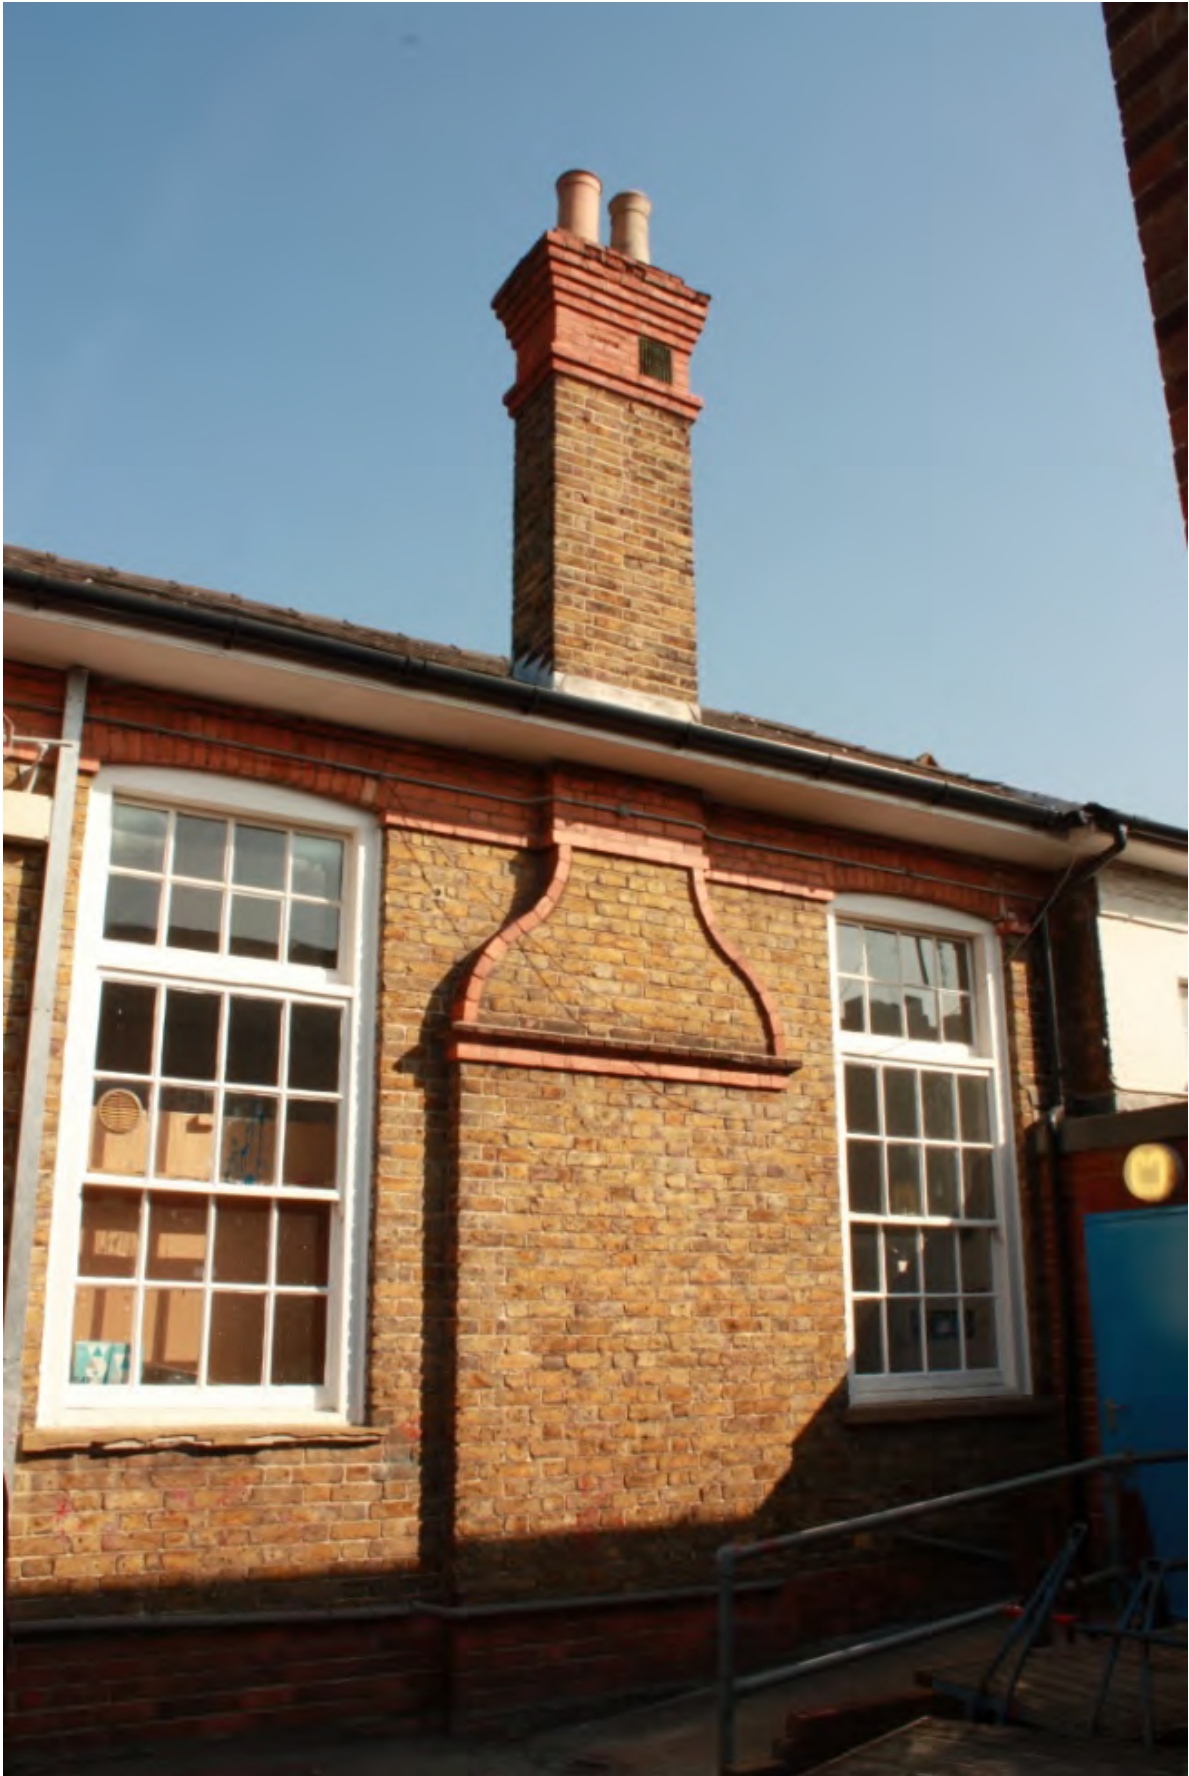
Plate 6: Chimney breast and stack on the south elevation of Block 200, looking north-east (D1/24)

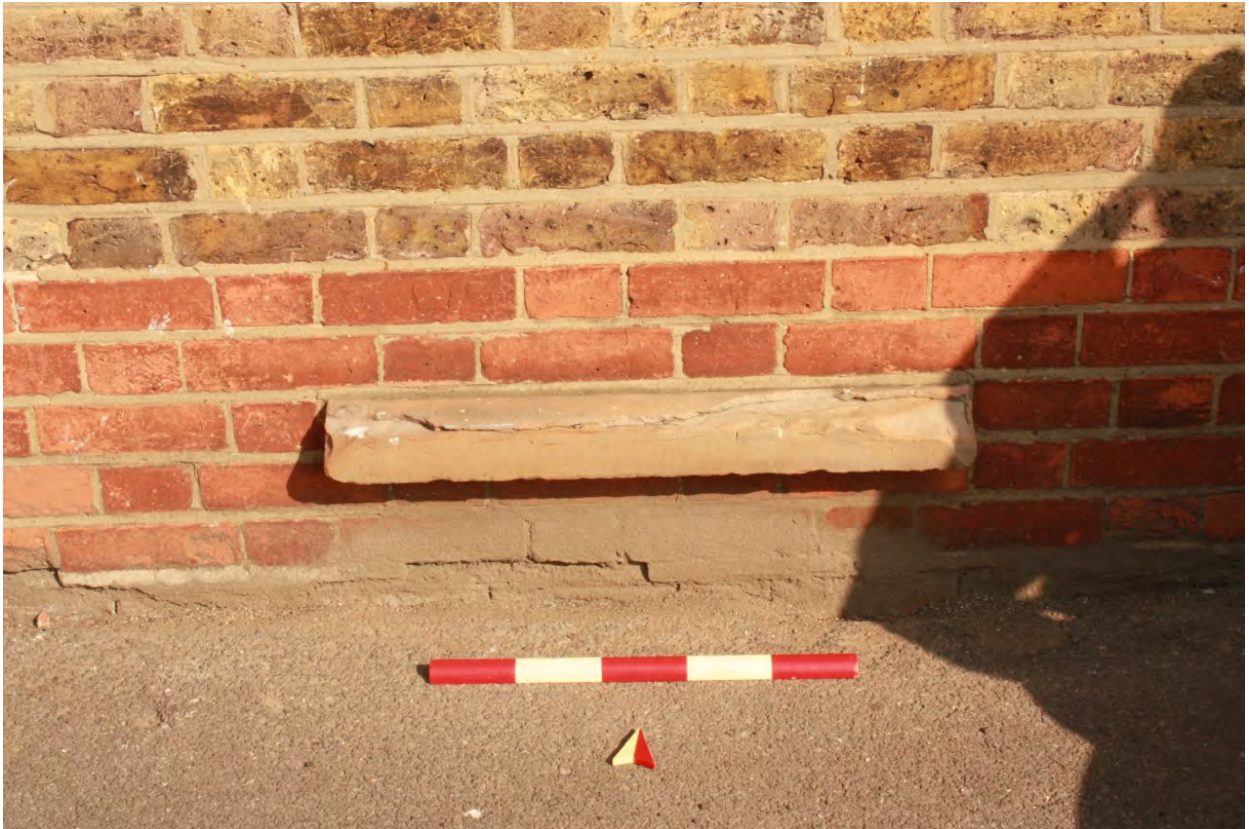
Plate 7: Stone sill boot scraper on the south elevation of Block 200, looking north. Scale 0.5m (D1/35)

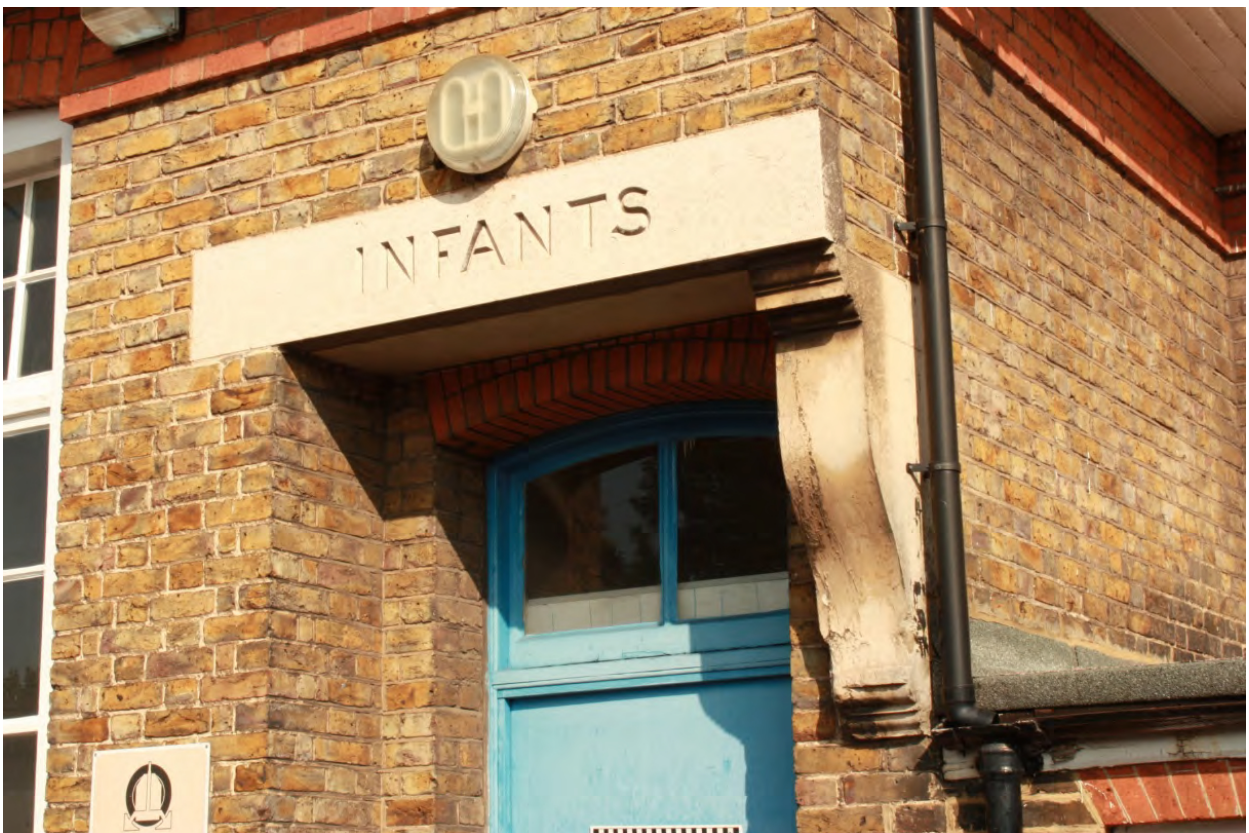
Plate 8: Main entrance showing porch over the front door in the south elevation of Block 200, looking north-west (D1/22)

- 6.3.16 Most of the doors have been replaced and converted into exit-only modern crash fire doors. The front door, which is sited at the western end of the south elevation, has been boarded over. Above the front door is a small porch, on one side a curved and moulded stone bracket supports a large stone lintel inscribed in serif capitals with the title 'INFANTS' (**Plate 8**).

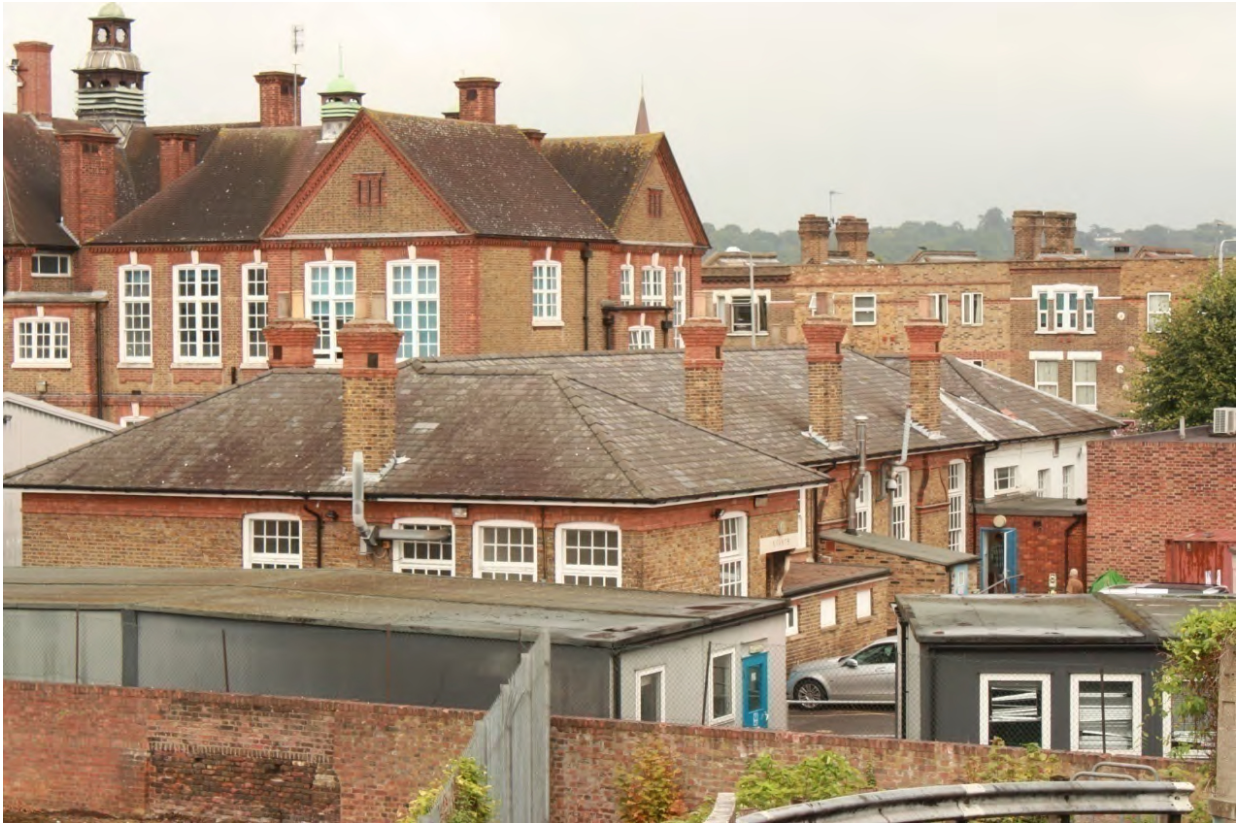
Plate 9: Block 200 in the centre with the Penny Gallery (white building) to the right (east), looking north-east. The main former Junior School building lies to the left (north). (D4/3)

- 6.3.15 The roof over Room 6 is hipped and covered in rectangular slate tiles (**Plate 9**). The ridges are covered by dark grey clay angled ridge tiles. Valley gutters are formed of lead work. The guttering and down pipes are replacement plastic.

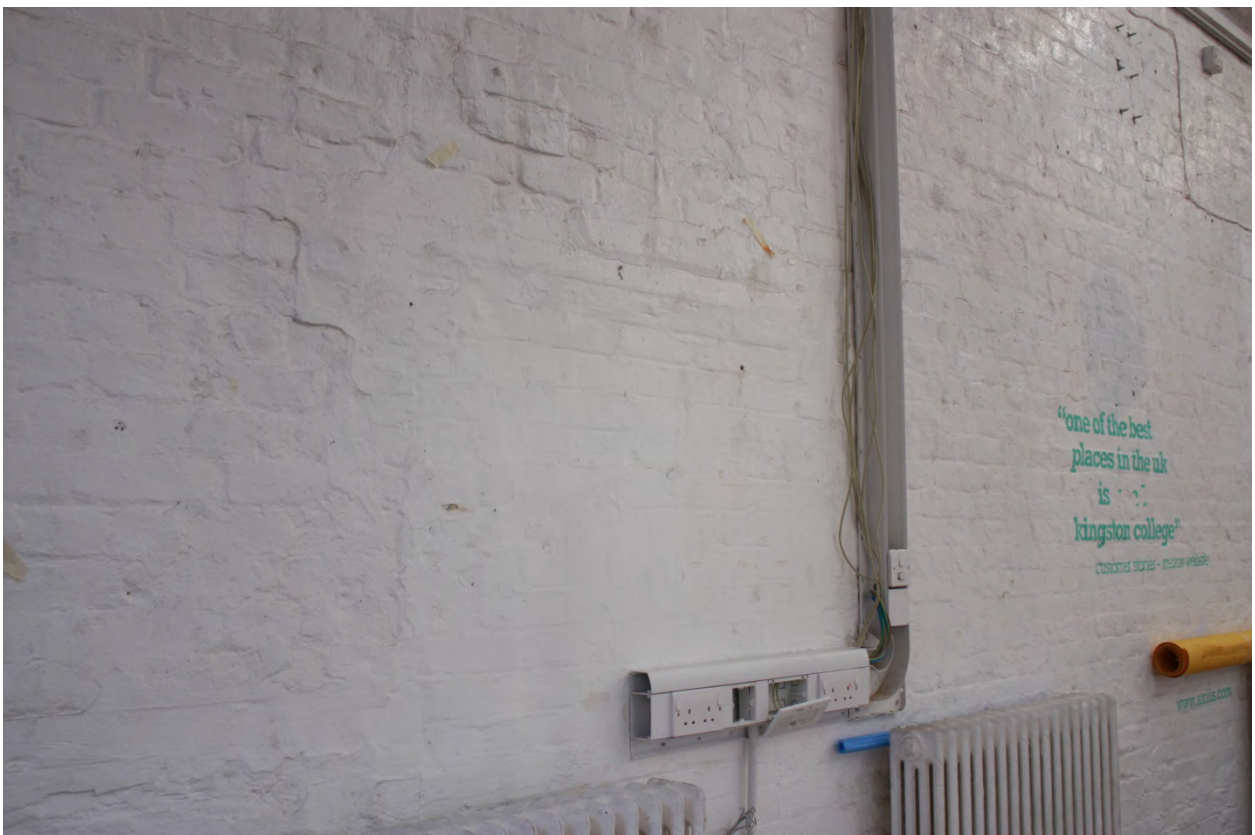
Plate 12c: Blocked doorway in the west wall of Room 1 in the Penny Gallery, looking north-west (D3/3)

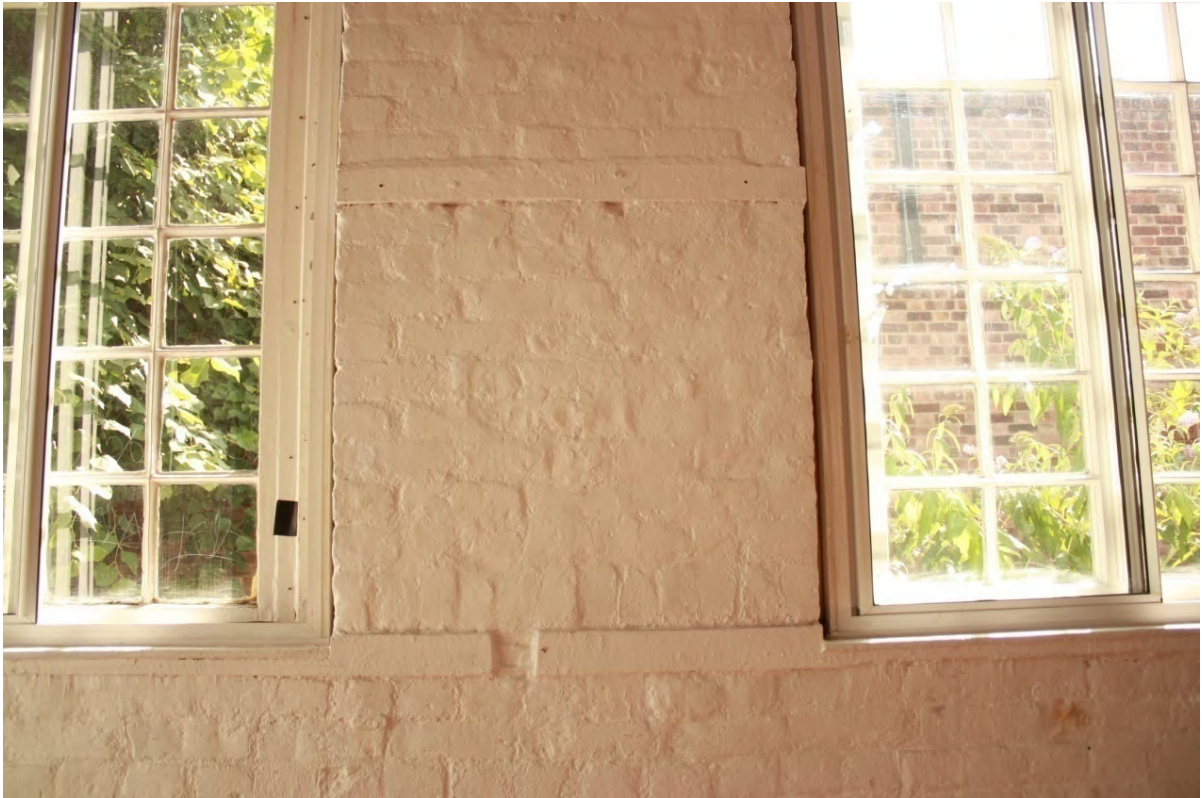
Plate 13: South internal wall of Room 1 in the Penny Gallery showing timber battens embedded in the brickwork, looking south (D2/23)

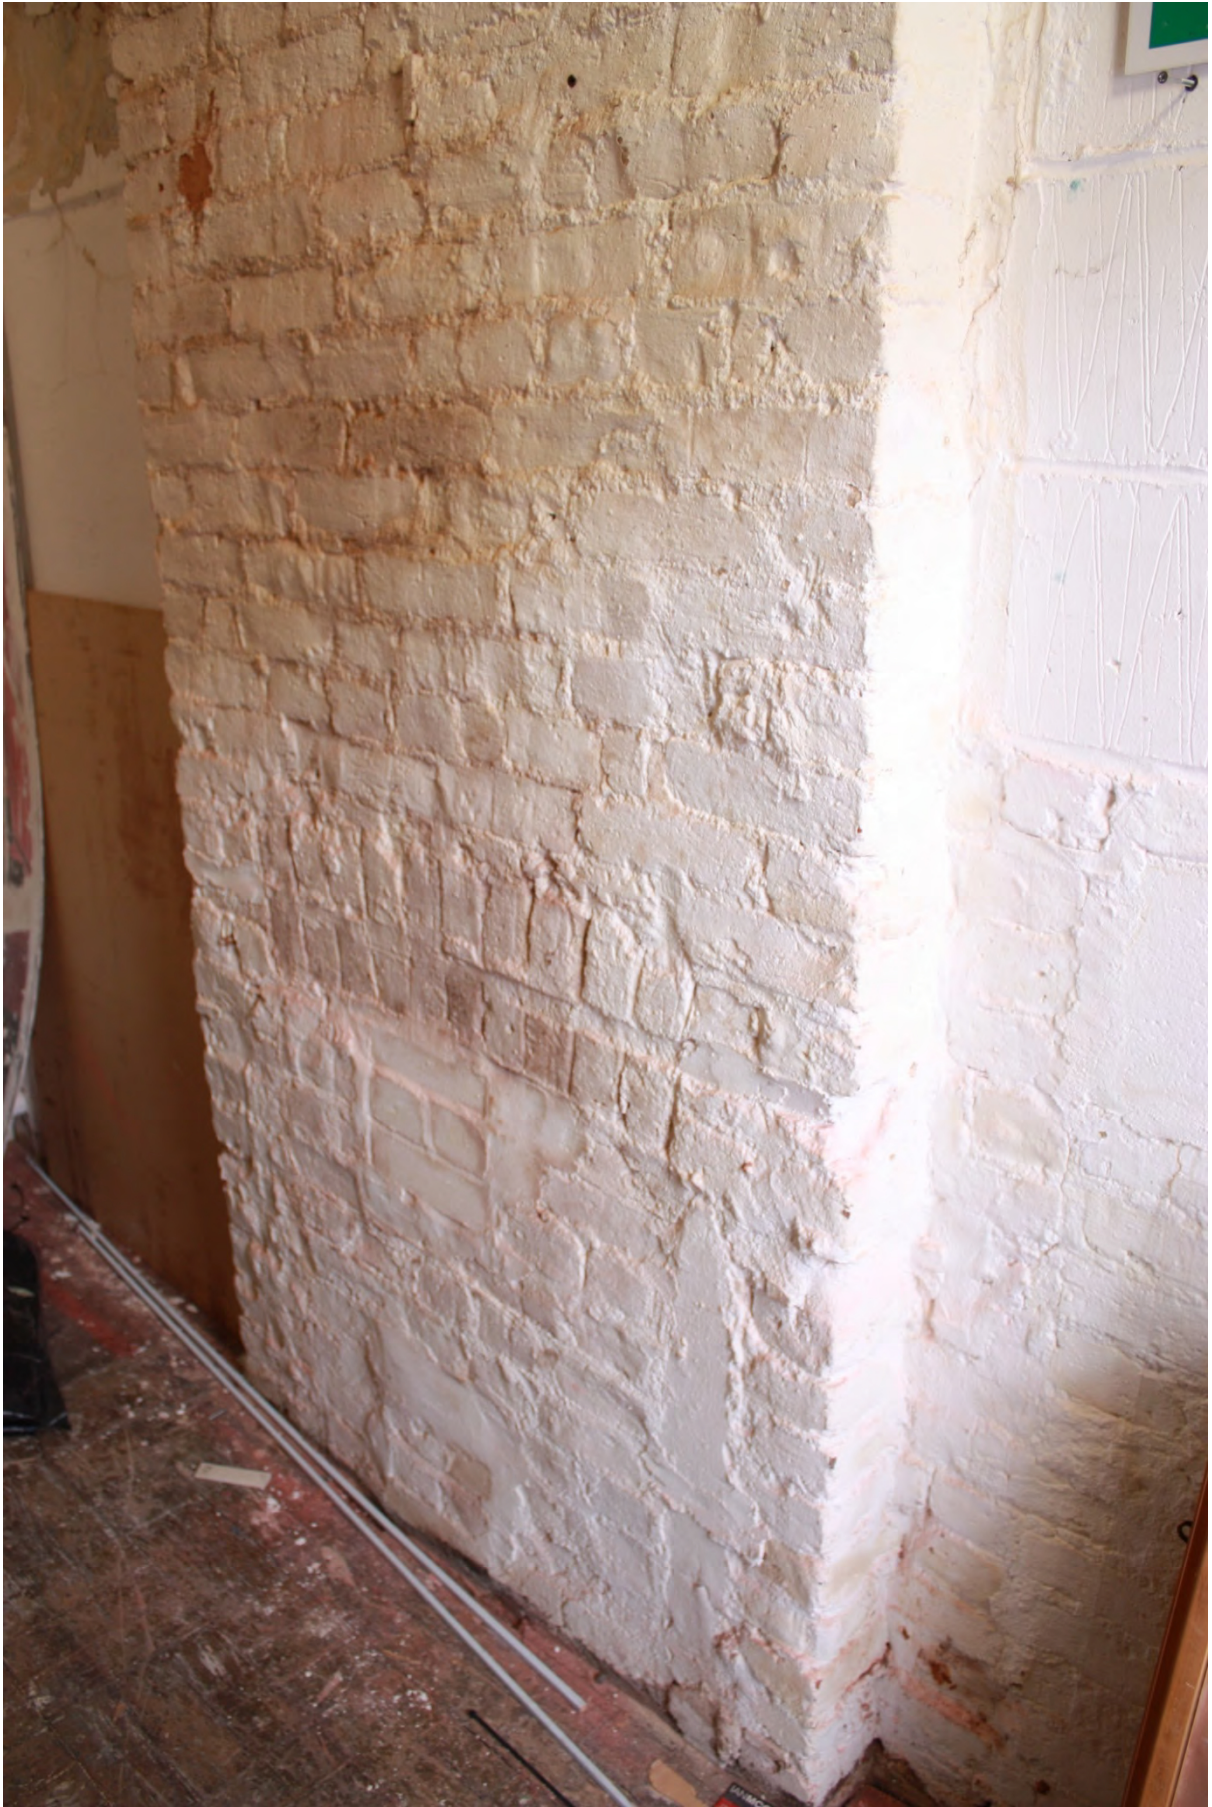
Plate 14a: Blocked fireplace in the east wall of Room 3, looking north-east (D2/27)

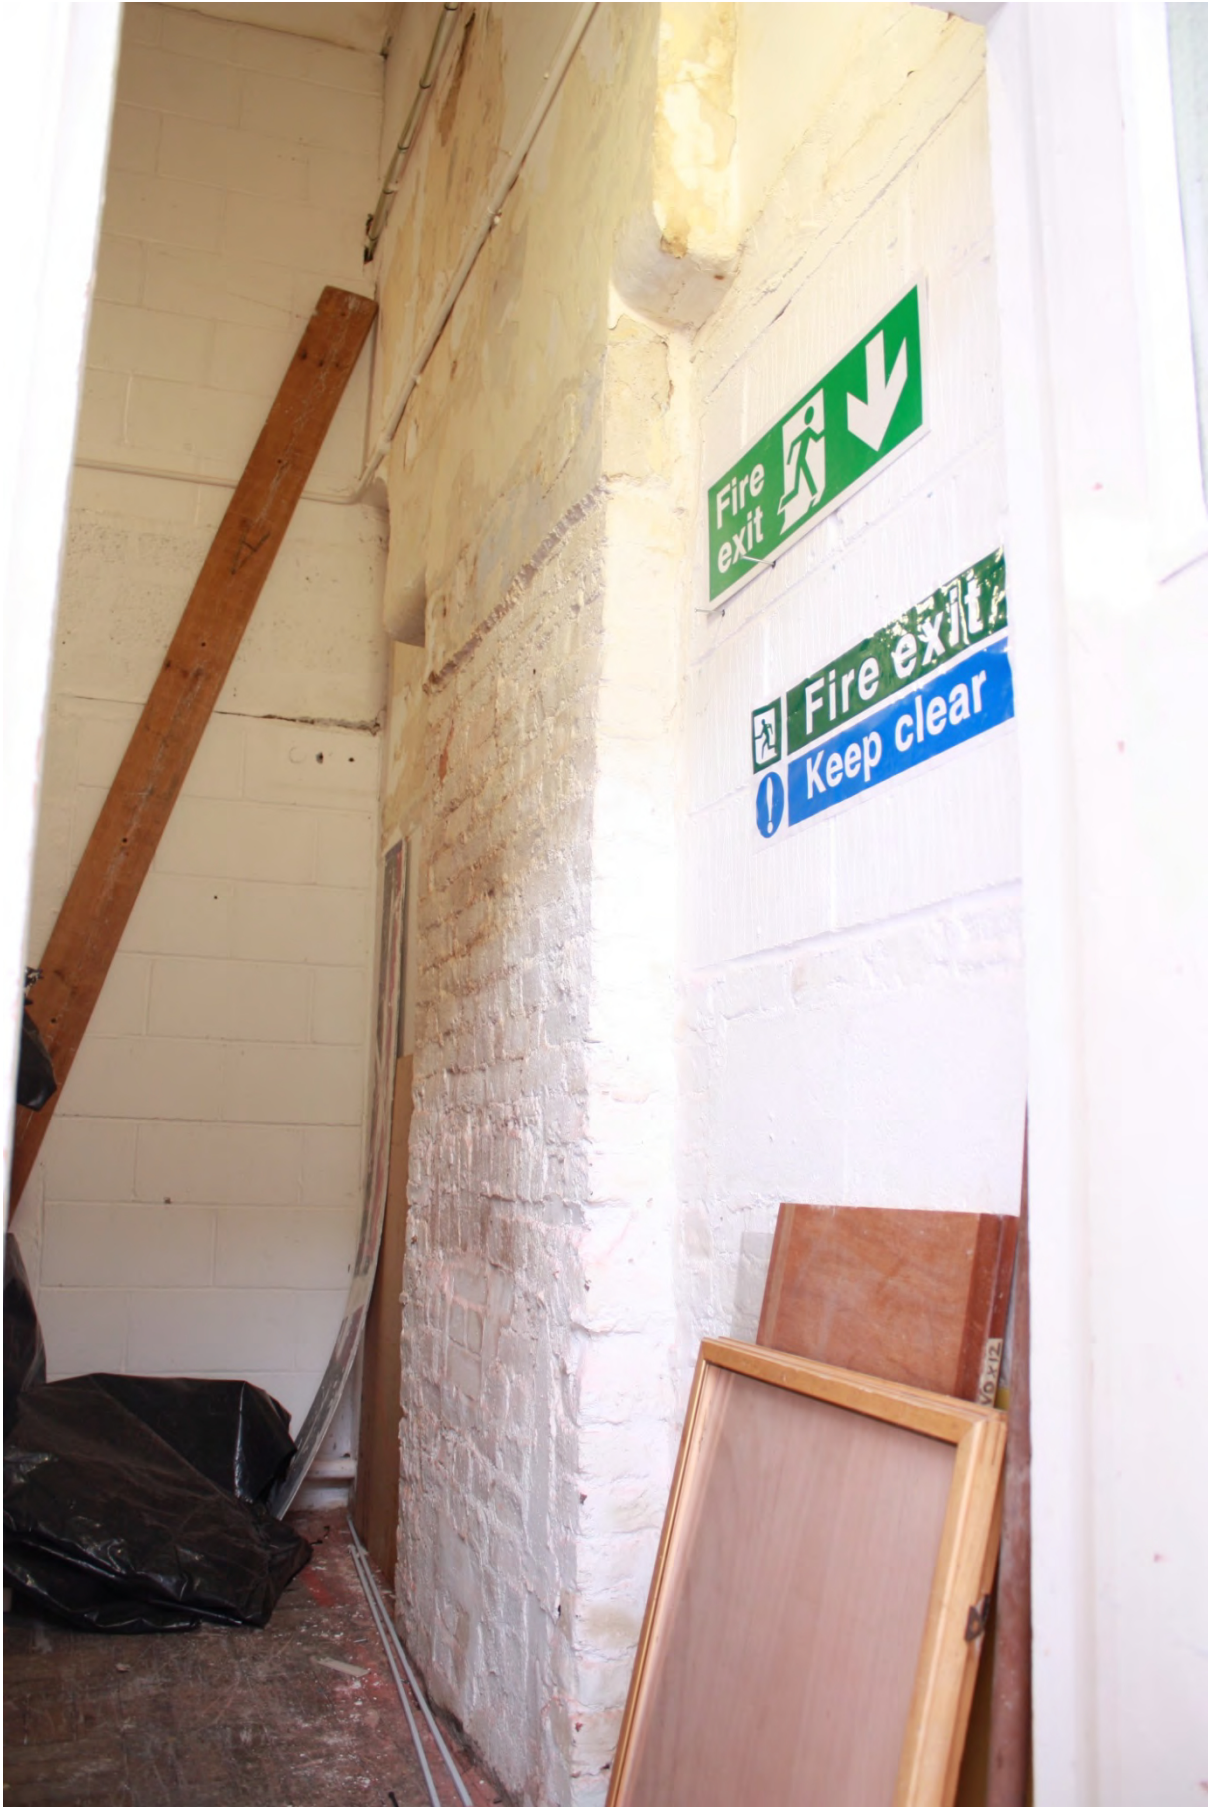
Plate 14b: Blocked fireplace in the east wall of Room 3, looking north-east (D2/27)

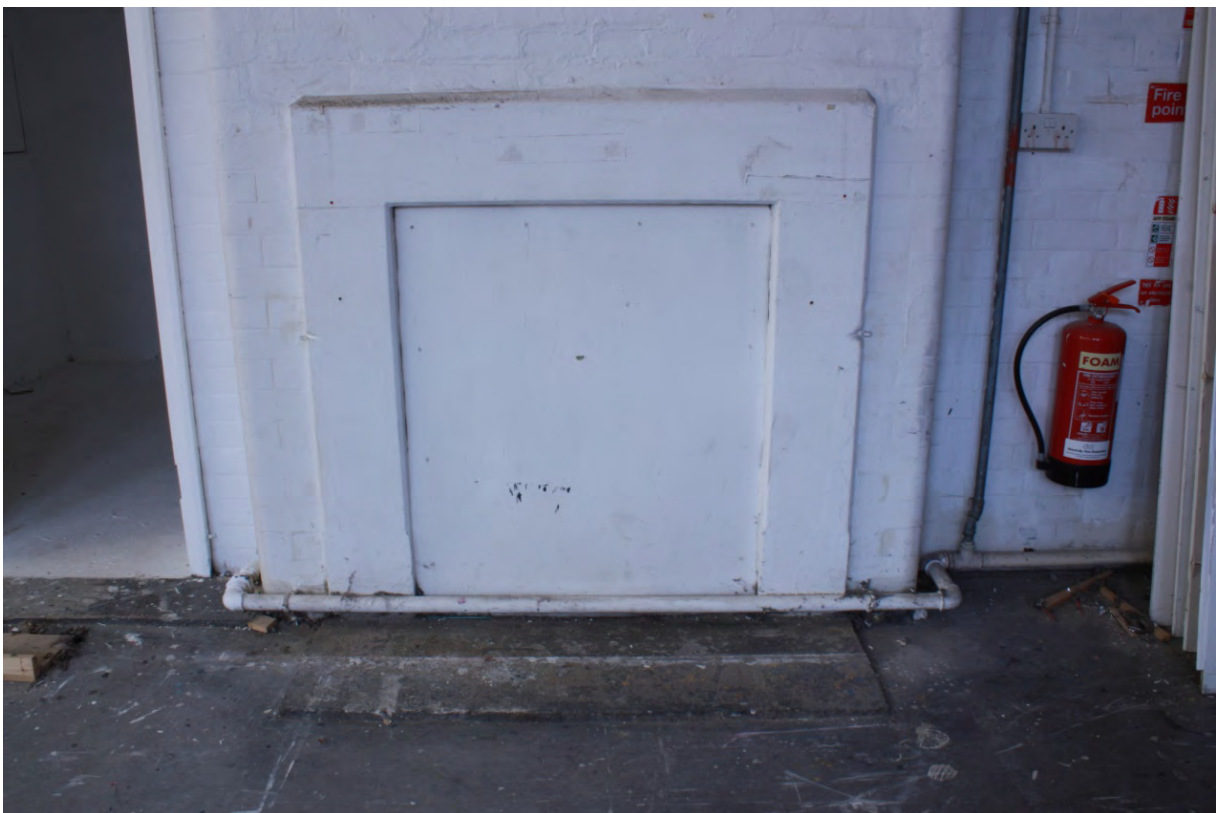
Plate 17a: Fire surround in the south wall of Room 6 in Block 200, looking south (D4/11)

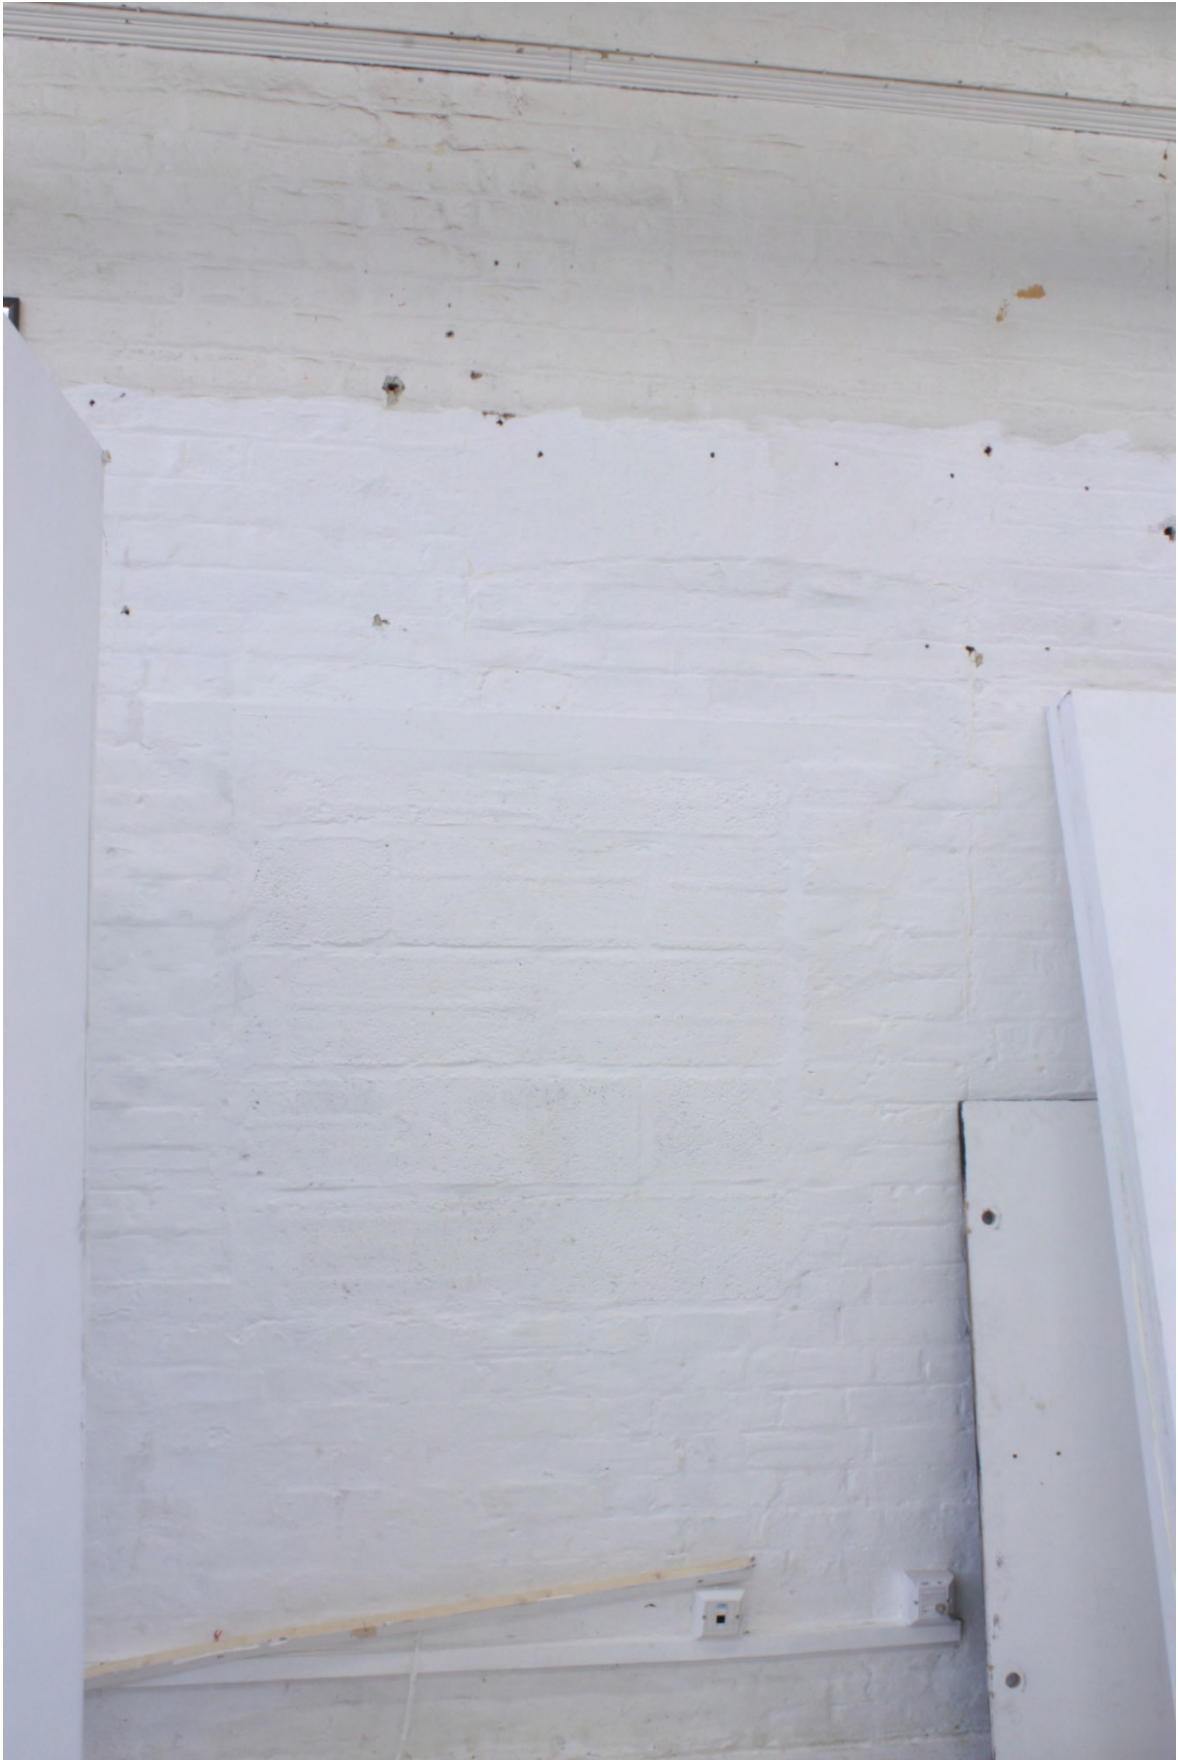
Plate 17b: Former doorway converted to a window which was then blocked in the east wall of Room 6 in Block 200, looking east (D4/13)
