**HISTORIC BUILDING
RECORDING OF THE PENNY
GALLERY AND BLOCK 200,
KINGSTON COLLEGE,
RICHMOND ROAD, ROYAL
BOROUGH OF KINGSTON
UPON THAMES, KT2 5BP**

PCA REPORT NO. R11510

SEPTEMBER 2013

HISTORIC BUILDING RECORDING

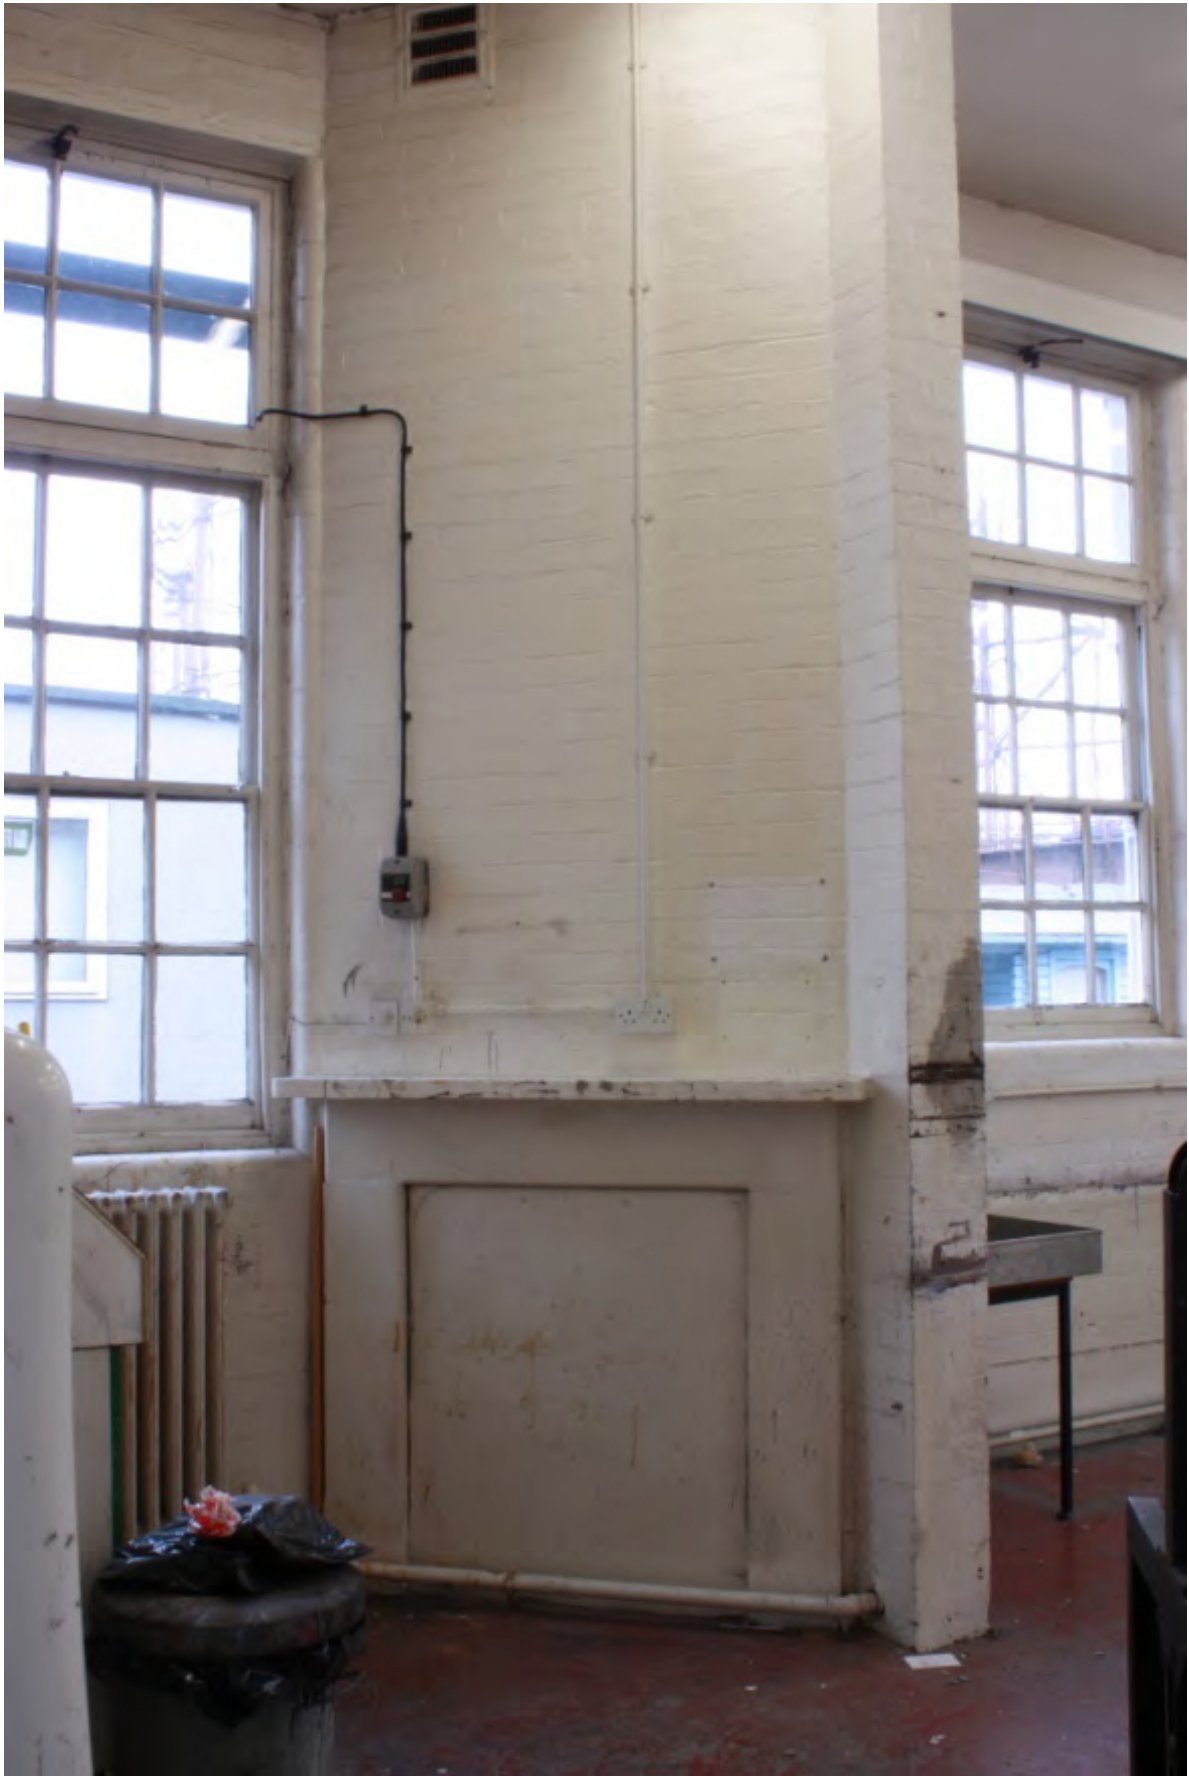
Plate 18: Angled chimney breast and fire surround (the only one with a mantel shelf *in-situ*) in the west wall Room 10b in Block 200, looking north-west (D3/29)
