FULHAM PALACE

ASSESSMENT OF AN

ARCHAEOLOGICAL

WATCHING BRIEF

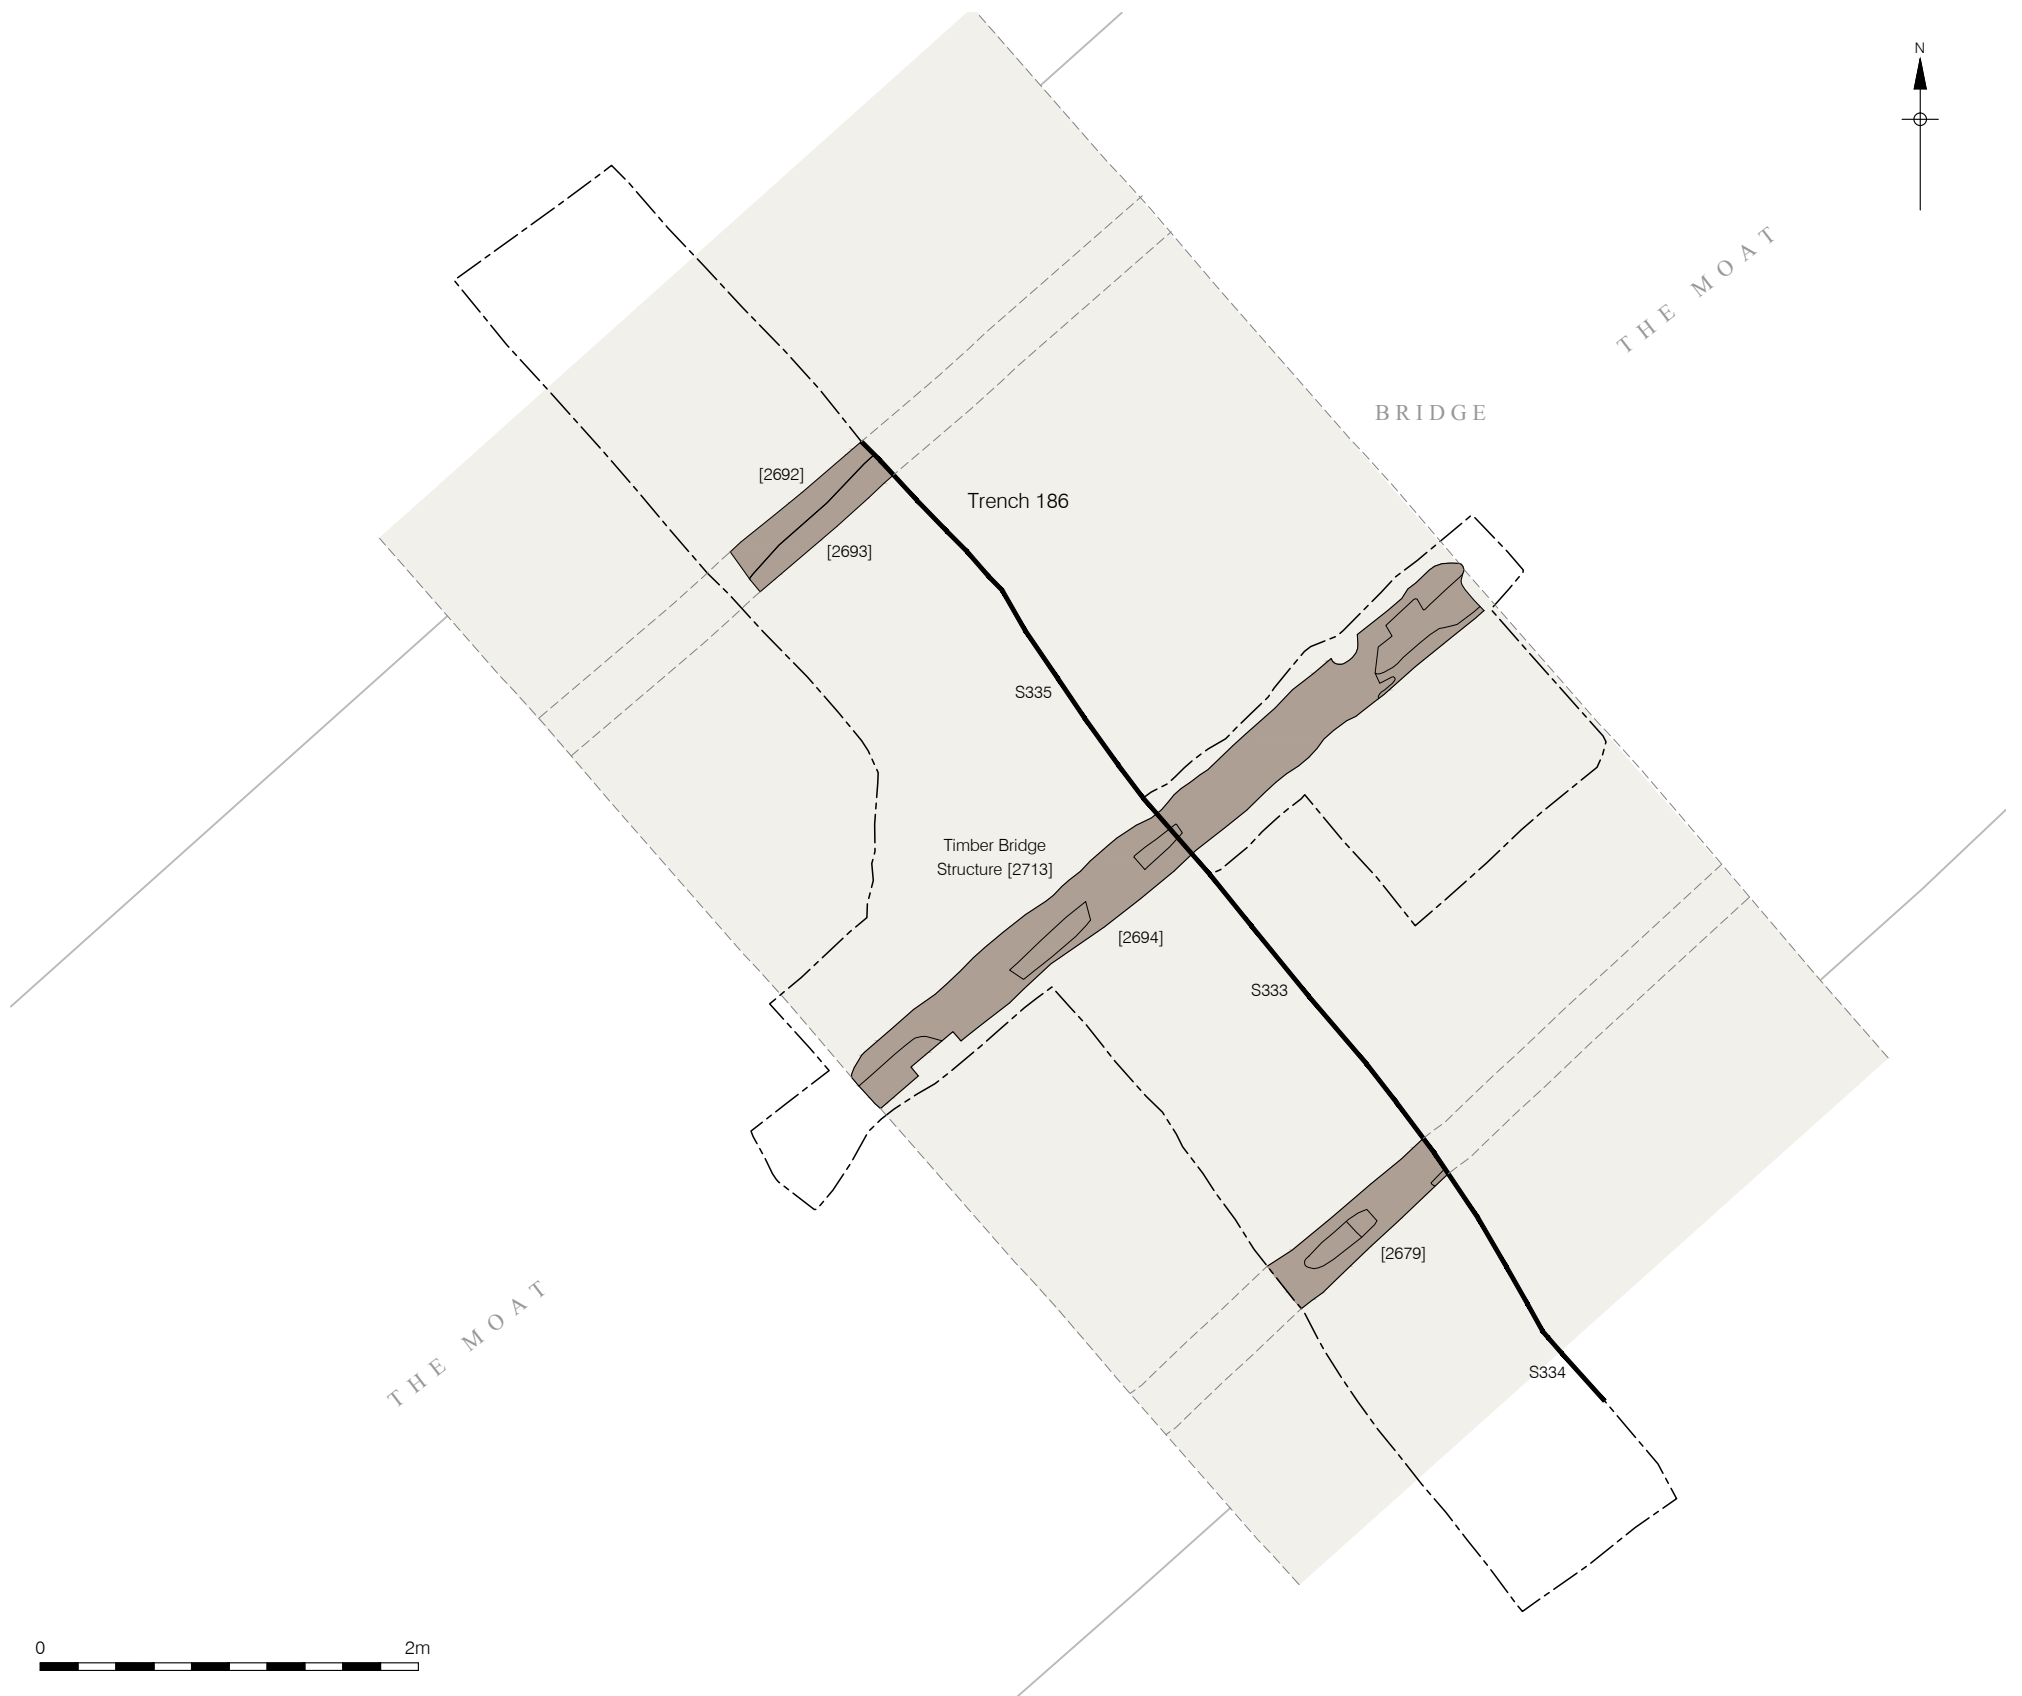
Figure 19
Phase 5: Late Medieval to Tudor features
Trench 186, Bridge Timber Structure
1:40 at A3

Phase 5 bridge timber

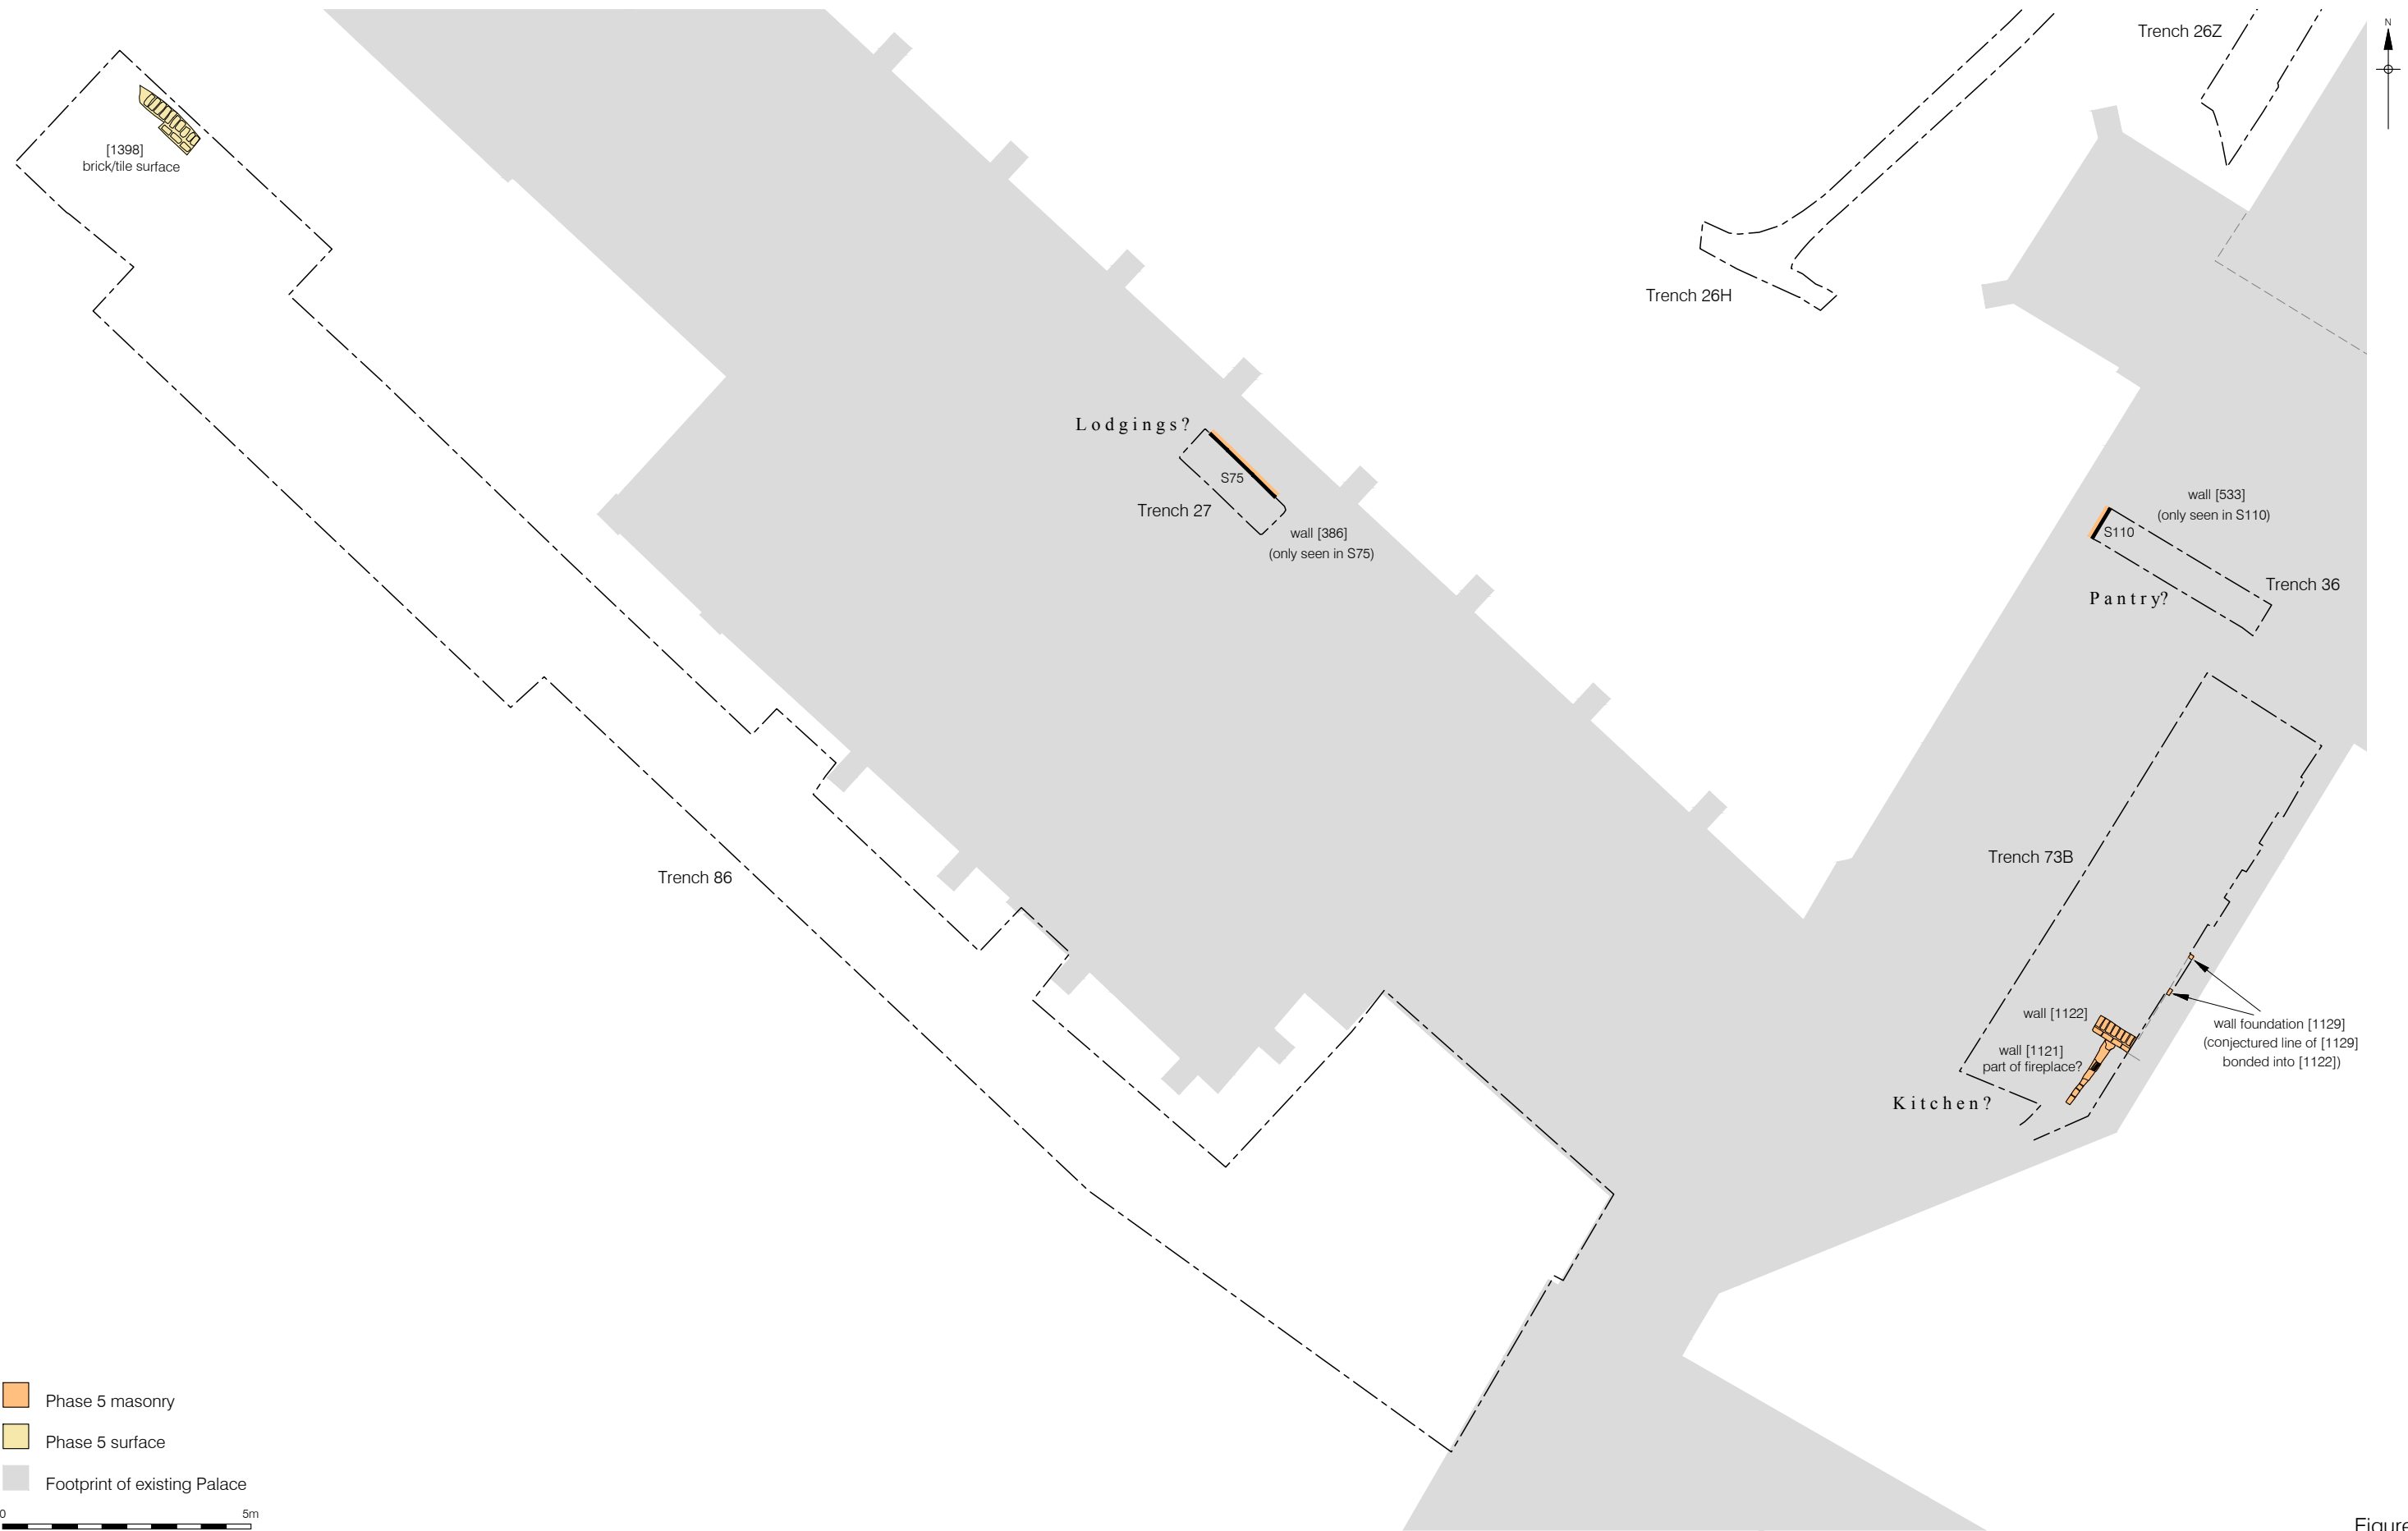
Figure 22
Phase 5: Late Medieval to Tudor features
The West Courtyard, Great Hall & East Courtyard Range of Buildings
1:125 at A3

Phase 5 masonry
 Phase 5 surface
 Footprint of existing Palace

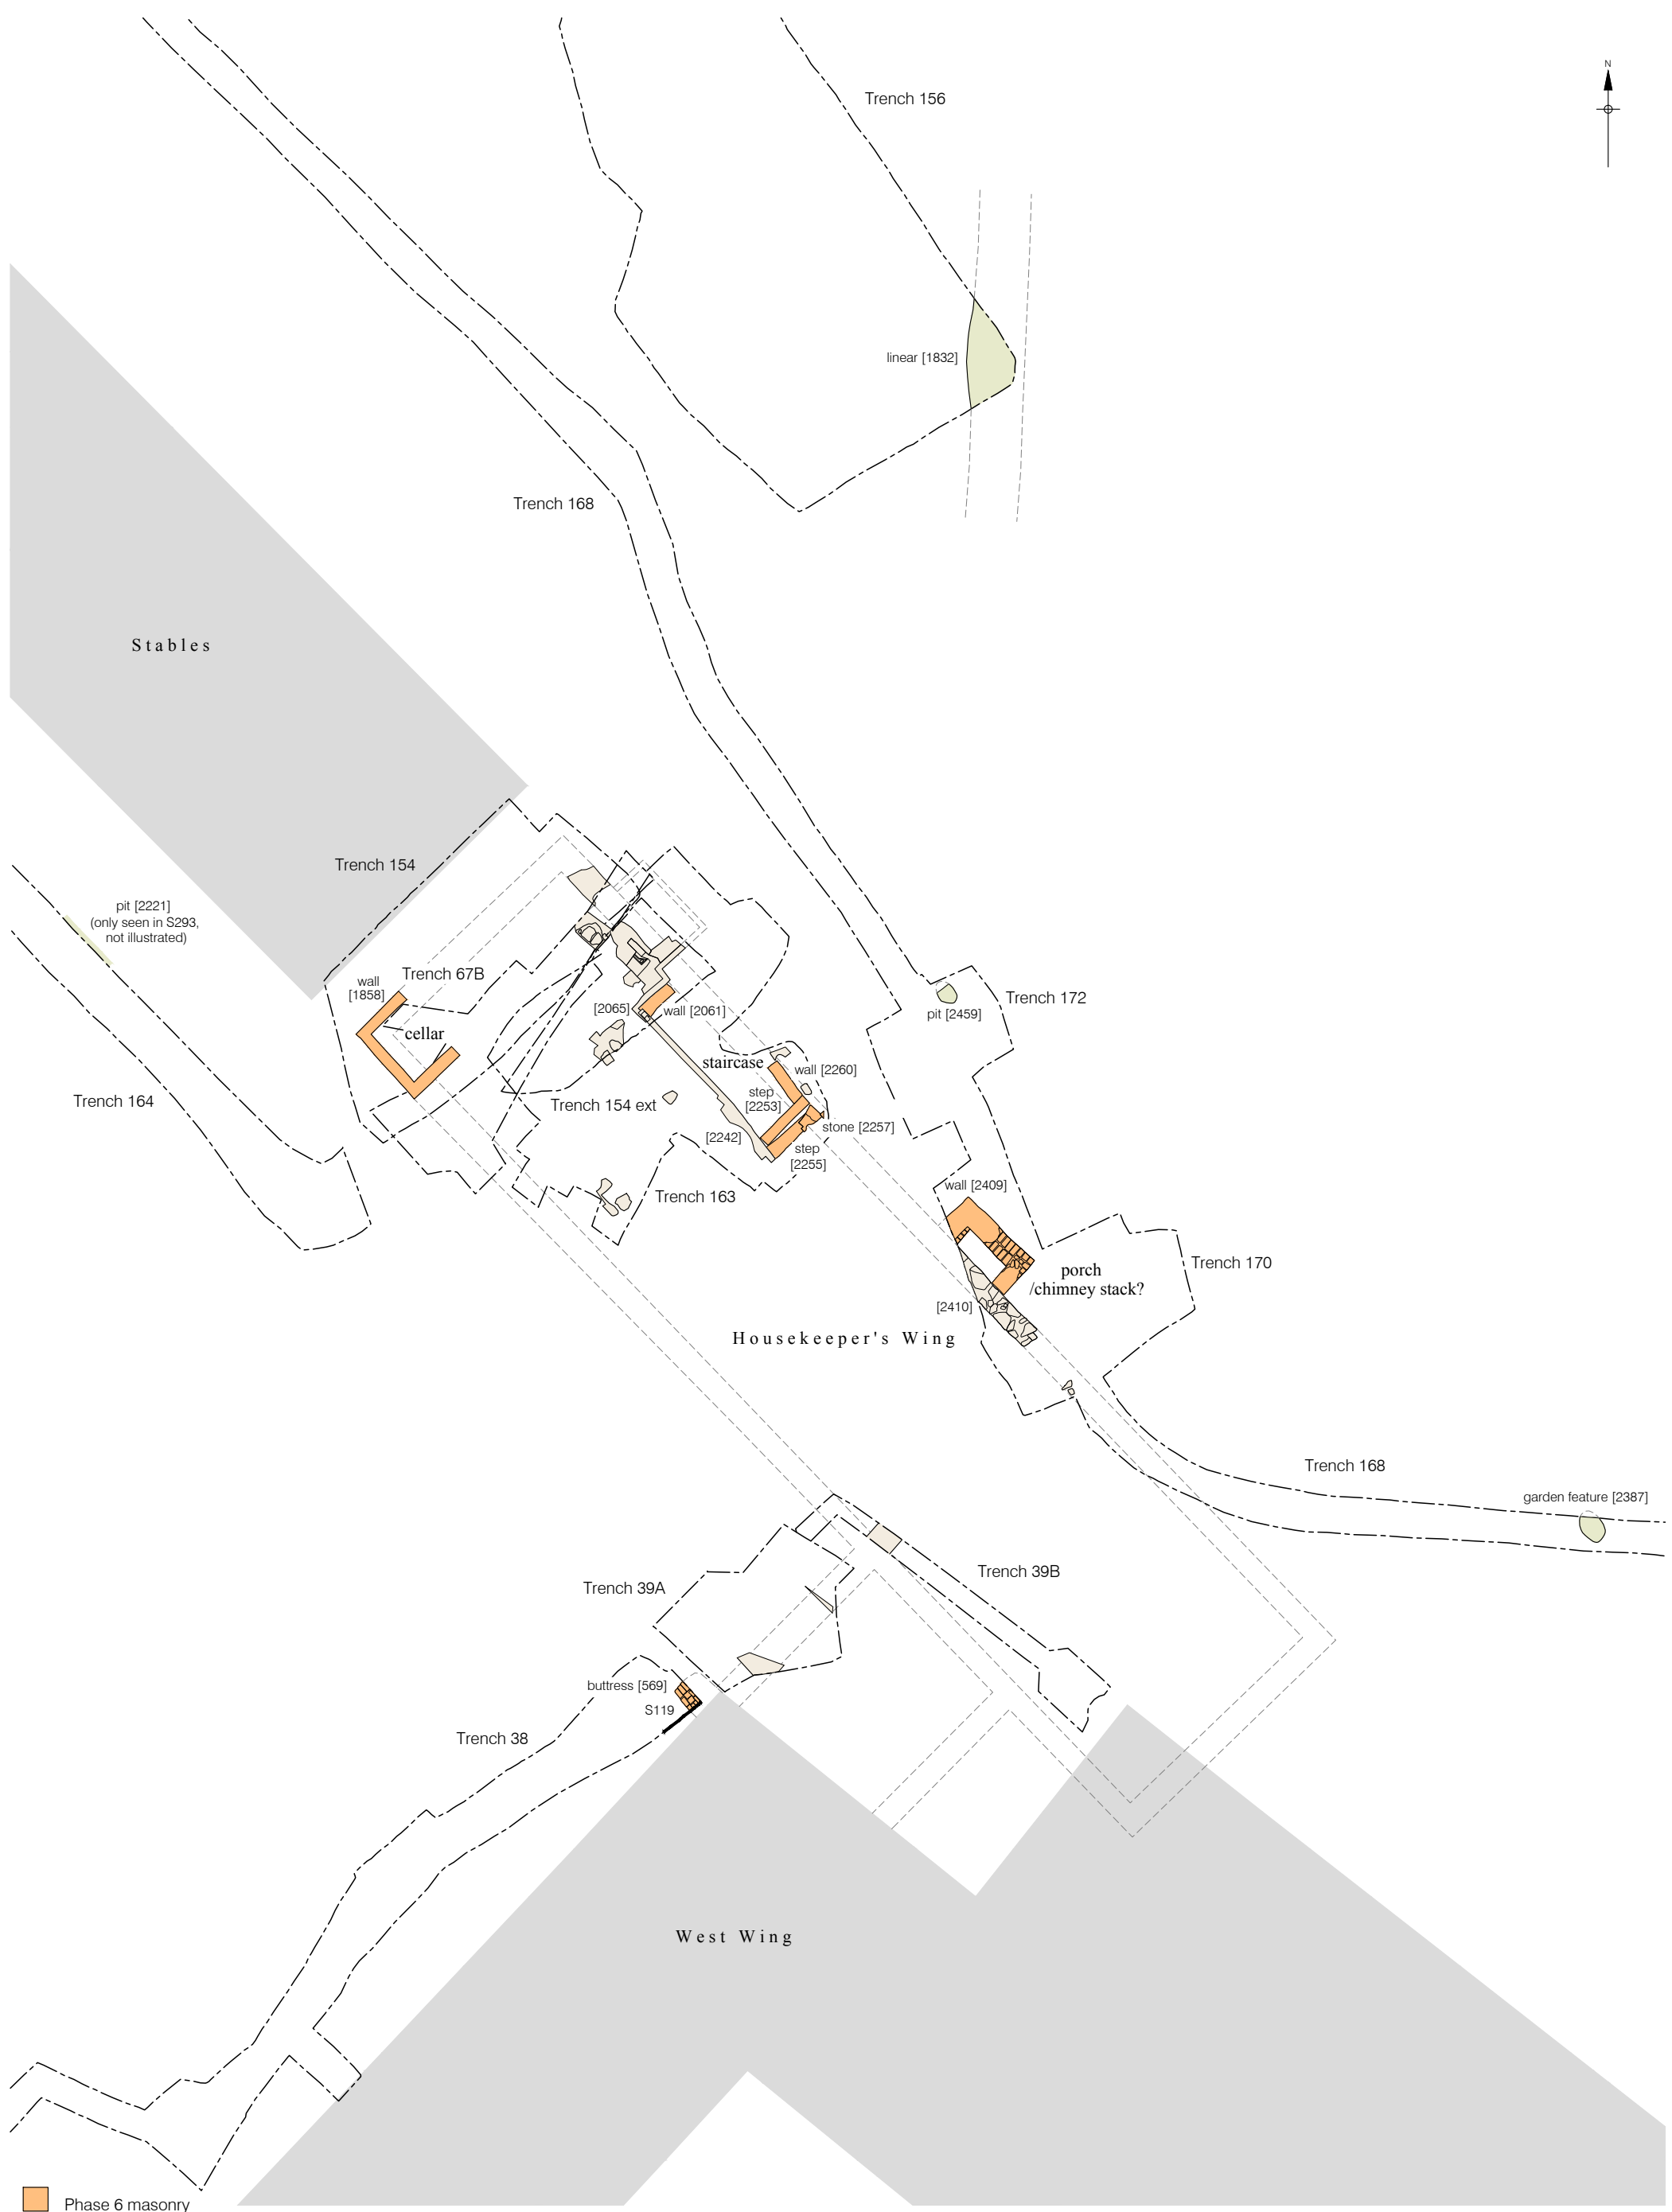
Figure 36
Phase 6: 17th - 18th Century features
Moat Bridge, Entrance carriageway & Granary
1:125 at A4

- Phase 6 masonry
- Phase 6 cut feature
- Retained features from Phase 5
- Footprint of existing Palace & Stables

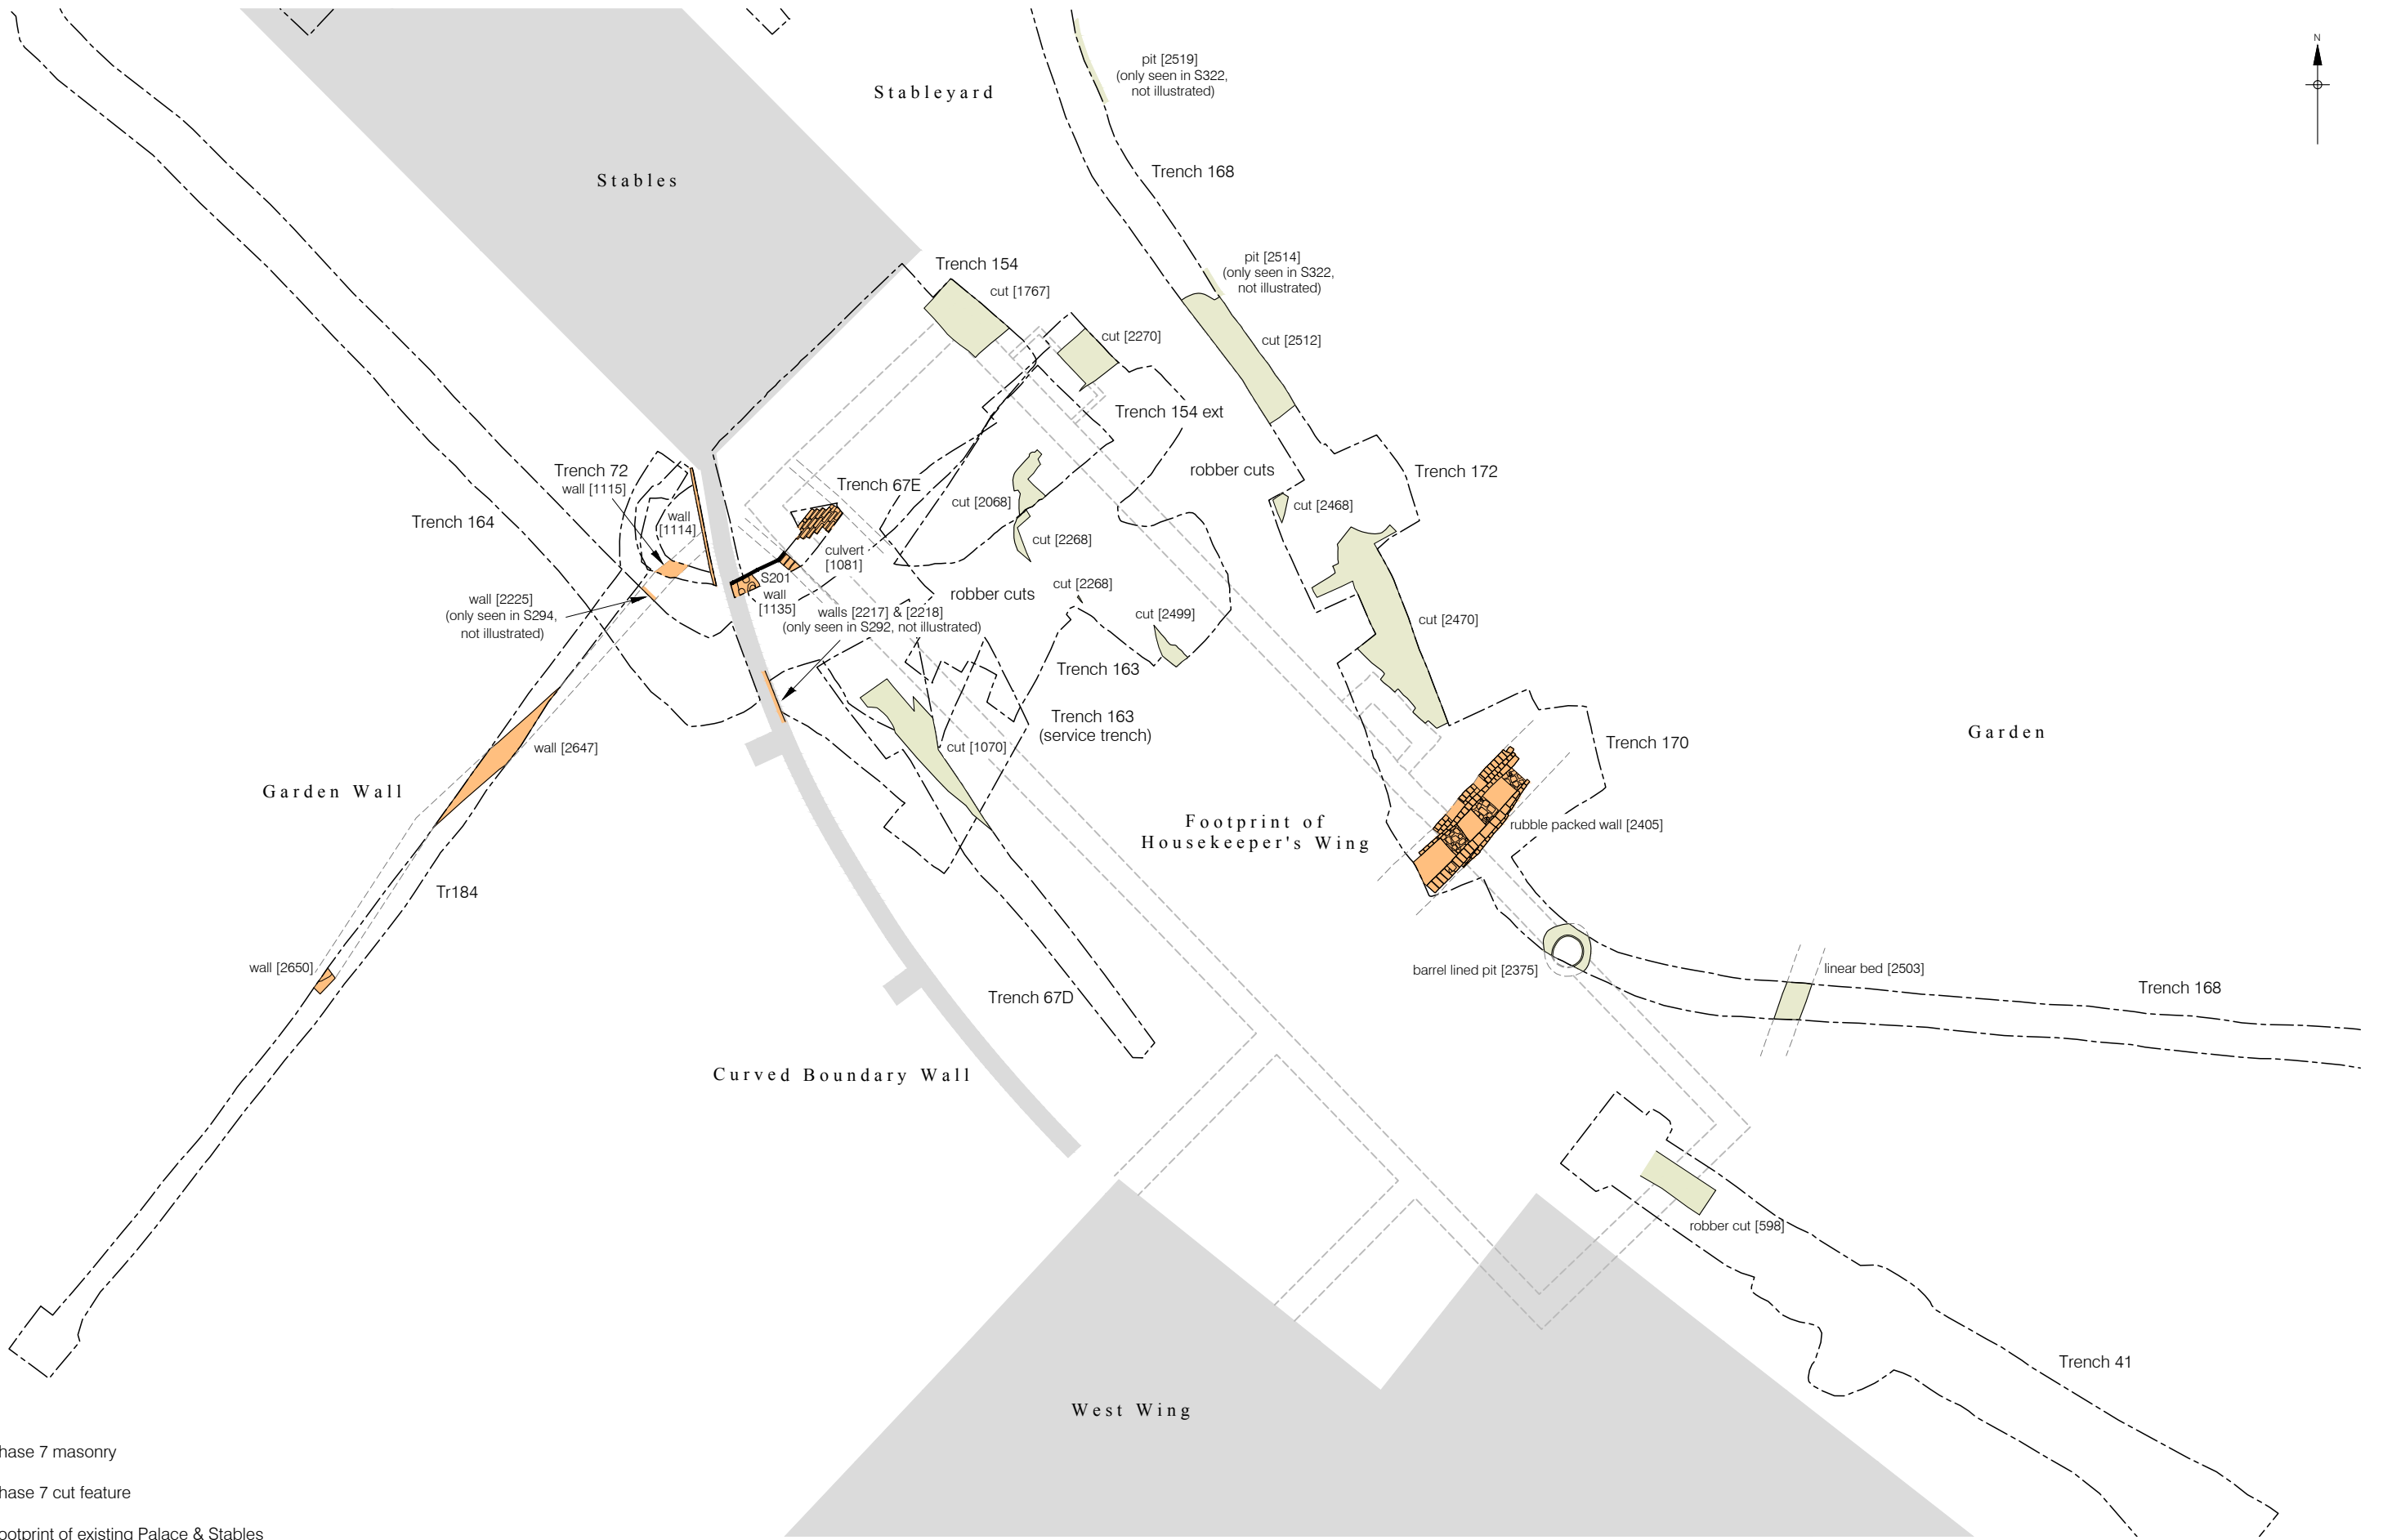
Figure 51
Phase 7: 18th Century features
Location of Moat Trenches
1:400 at A4

- Phase 7 masonry
- Phase 7 cut feature
- Footprint of existing Palace & Stables

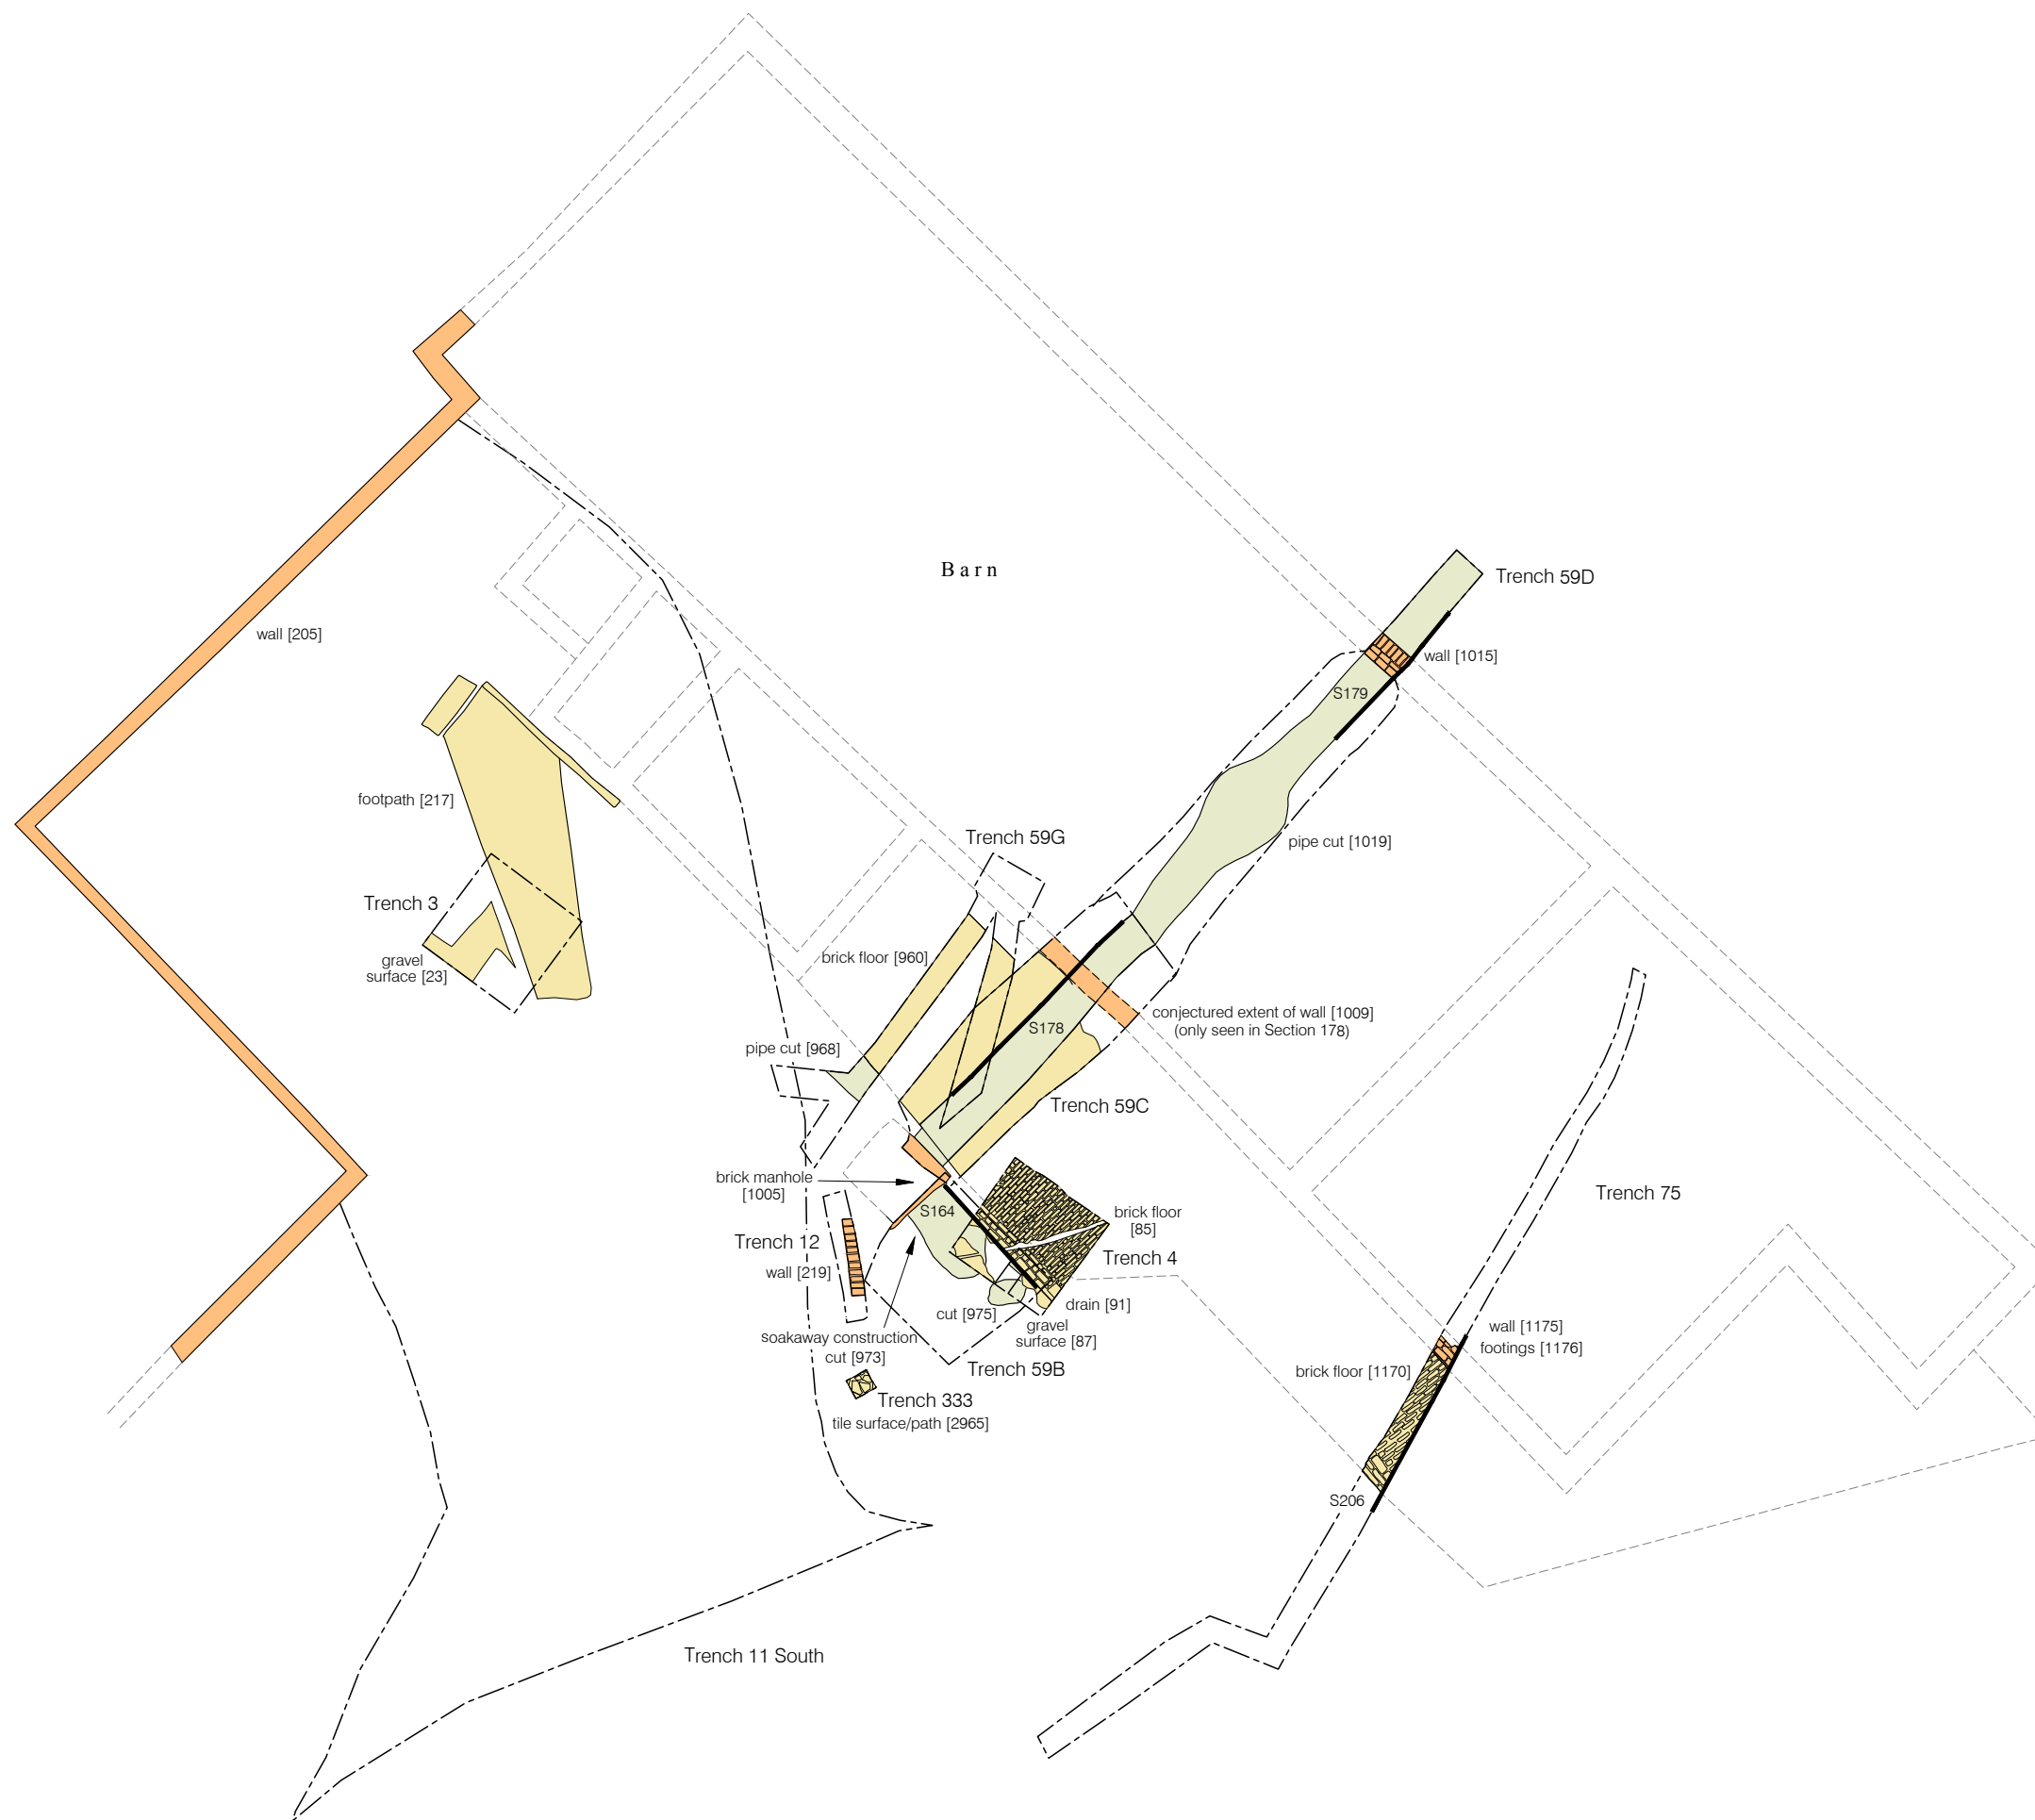
Figure 62
Phase 8: 19th Century features
The Moat
showing details of The Bridge & Sluice
Overview 1:400; The Bridge 1:125 & Sluice 1:25 at A3

- Phase 8 masonry
 - Phase 8 moat fill within Trenches, Boreholes & Window Samples
 - Footprint of existing Bridge
 - Moat outline from 1865 Ordnance Survey
- 0 20m
- © Pre-Construct Archaeology Ltd 2013
04/10/13 HB

7.9.3 Trench 100, designed to investigate the historic sluice (Figures 62 & 78, Sections/Elevations 250, 251, 252, 253, 254 & 255) situated near the west corner of the moat, measured 2m x 3m x 1.50m (depth). A NW-SE aligned brick wall was the earliest stratigraphic unit encountered [1504], which formed the (lower) level of the retaining wall around the sluice structure. It was constructed with a variety of different sized bricks (brick types 3032-3034) bonded with a grey lime mortar. The highest remaining part of this wall was 3.67m OD. The lowest observed level was 3.28m OD. The age range of the wall has been estimated at somewhere between 1780 and 1850. This wall is considered to represent the 1842 rebuild of the sluice.

- 7.9.6 Restoration of the moat during the Phase II works revealed parts of the Moat Bridge that had been buried under the ground since the moat was backfilled in the 1920s (Figure 62). On the south side of the bridge, in Trench 155, a brick abutment [2854] was observed on the northwest edge. It was constructed out of a combination of frogged red post-Great Fire brick, large reused 17th- to 18th-century red brick and Portland stone. They were bonded with a combination of Roman cement and lime mortar and appeared to be constructed around the base of the bridge, adding credence to the view that this masonry is contemporary with it and does not represent the remains of an earlier structure. The surviving brick and stone work measured 1.14m NE-SW by 0.50m (into the LOE) NW-SE by 1.80m in height at 3.54m OD. There was no evidence of any surviving abutment present on the southeastern bank, although it is possible it exists below the LOE of the trench which penetrated no further than the 1920s backfill.

- 7.9.8 Further masonry, in the form of the remains of a retaining wall [2676] on the southeast bank were also observed in Trench 186 (Figures 62 & 79, Section 334). It was comprised of three red bricks and bonded Portland cement which continued beyond the LOE of the trench. The original construction cut [2675] which truncated a 19th-century fill of the moat [2671] measured 1.05m NE-SW by 0.50m NW-SE and was recorded at 2.43m OD. It was filled by a soft/loose mid brownish grey silty sand [2677] which contained moderate amounts of small flint pebbles and small flakes of CBM. Its depth exceeded 0.30m where it met the LOE of the trench.

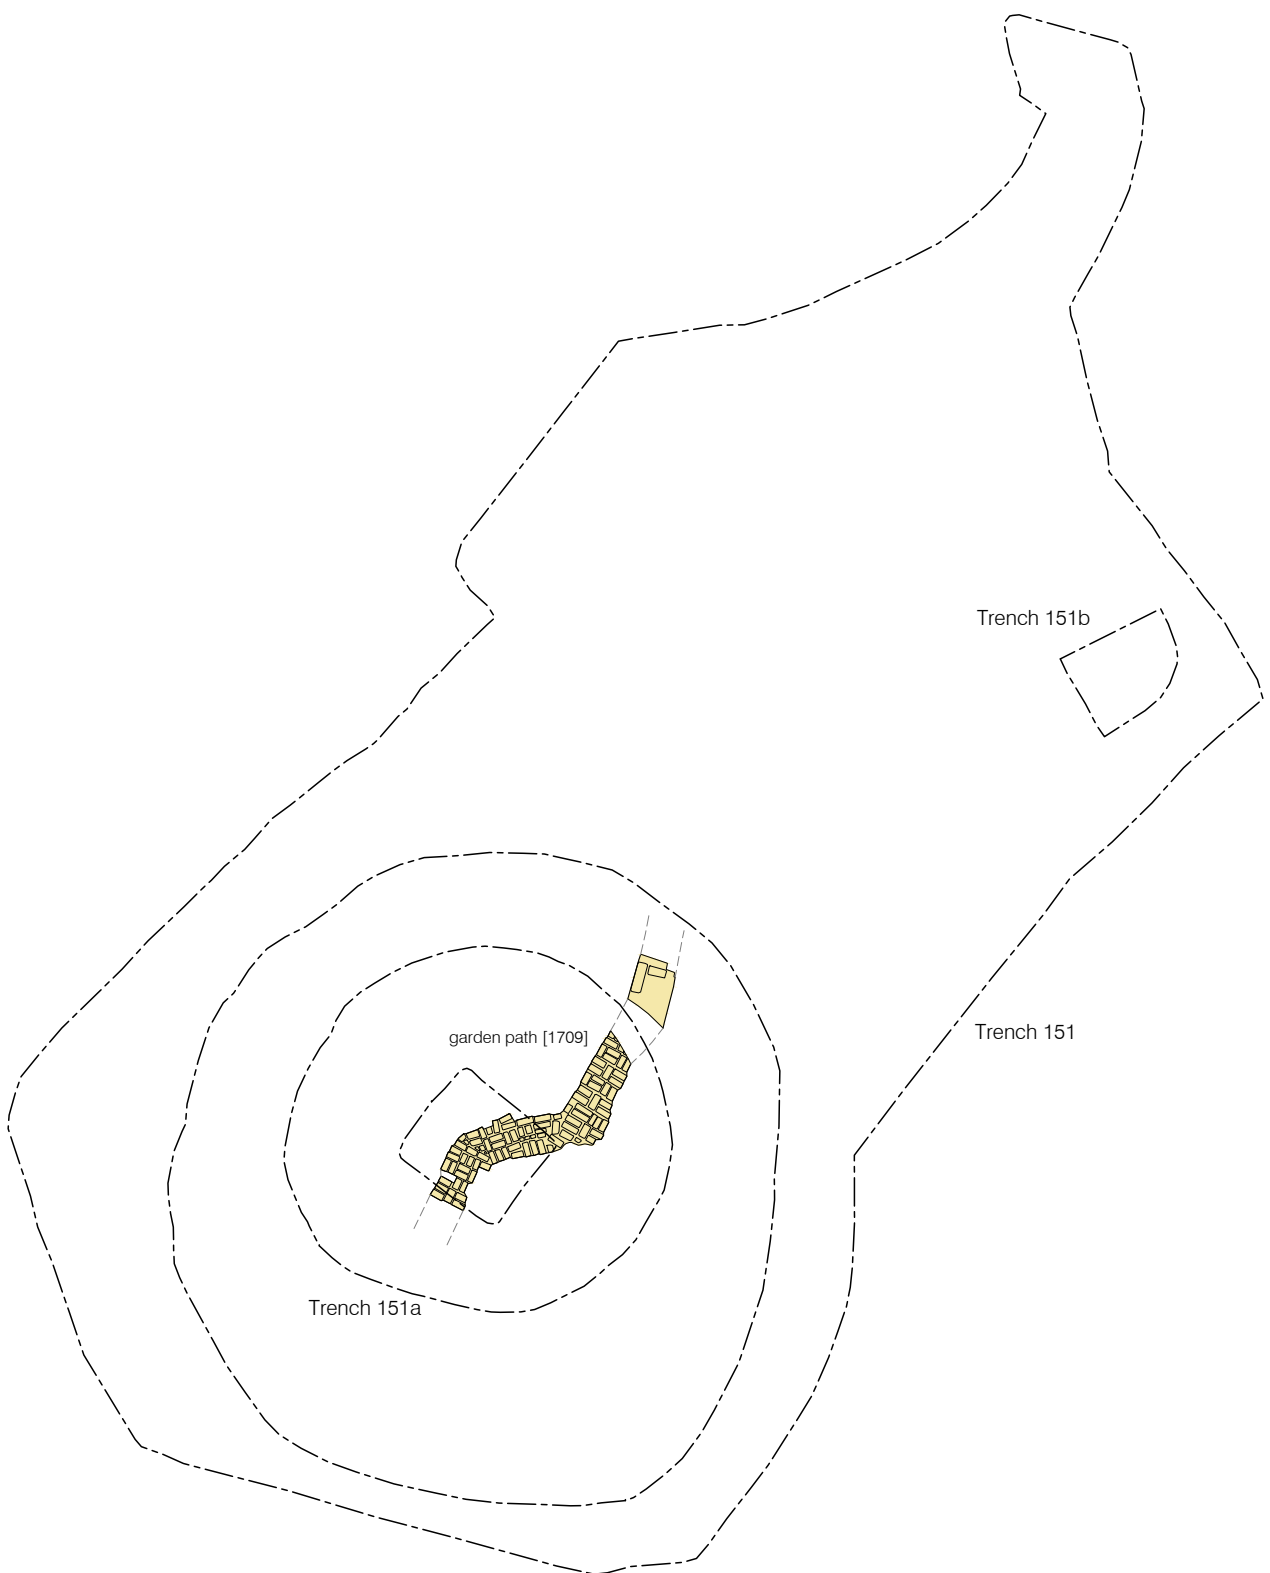
Figure 65
Phase 8: 19th Century features
Coachman's Lodge
1:125 at A4

Phase 8 surface
