FULHAM PALACE

ASSESSMENT OF AN

ARCHAEOLOGICAL

WATCHING BRIEF

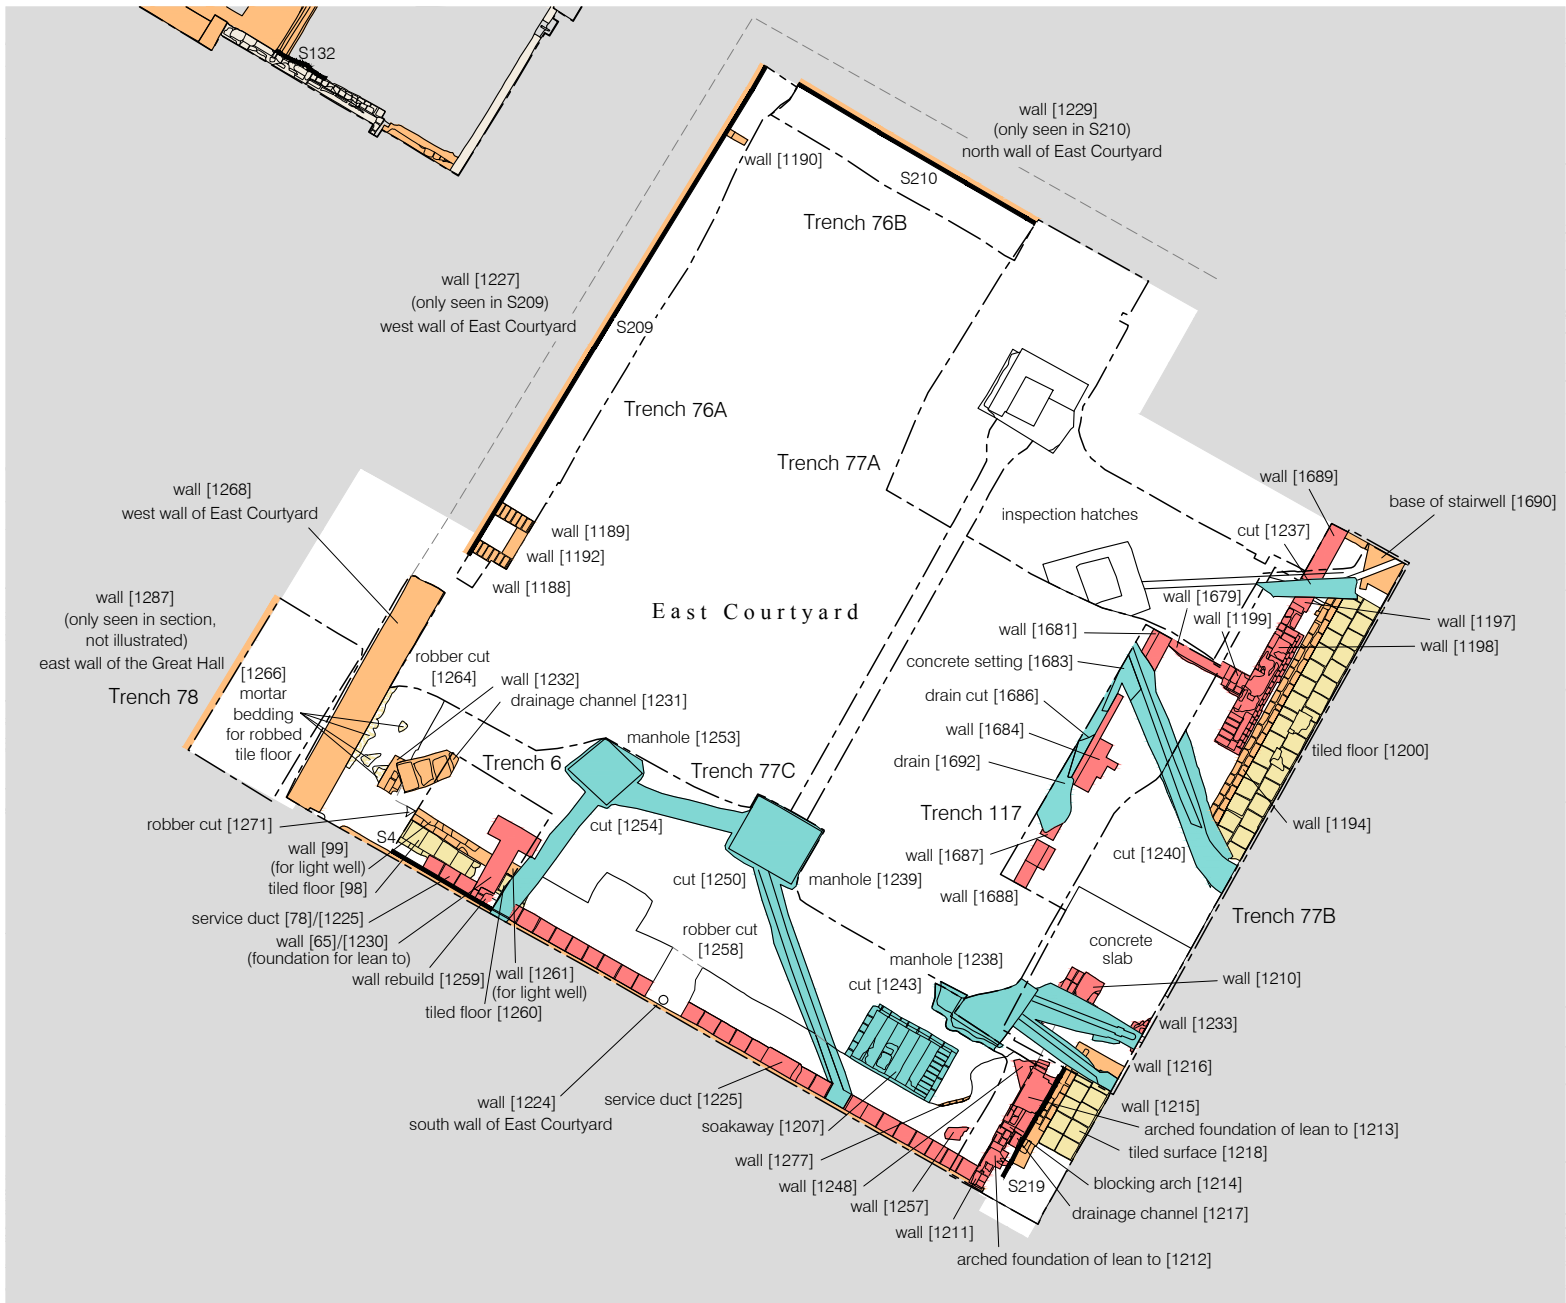
Figure 72
Phase 8: 19th Century features
Phased plan of Bishop Sherlock's Dining Room
1:50 at A3

- Phase 8 masonry (post 1818)
- Phase 8 floor surface (post 1818)
- Phase 8 masonry (pre 1873)
- Phase 8 drainage features (post 1873)

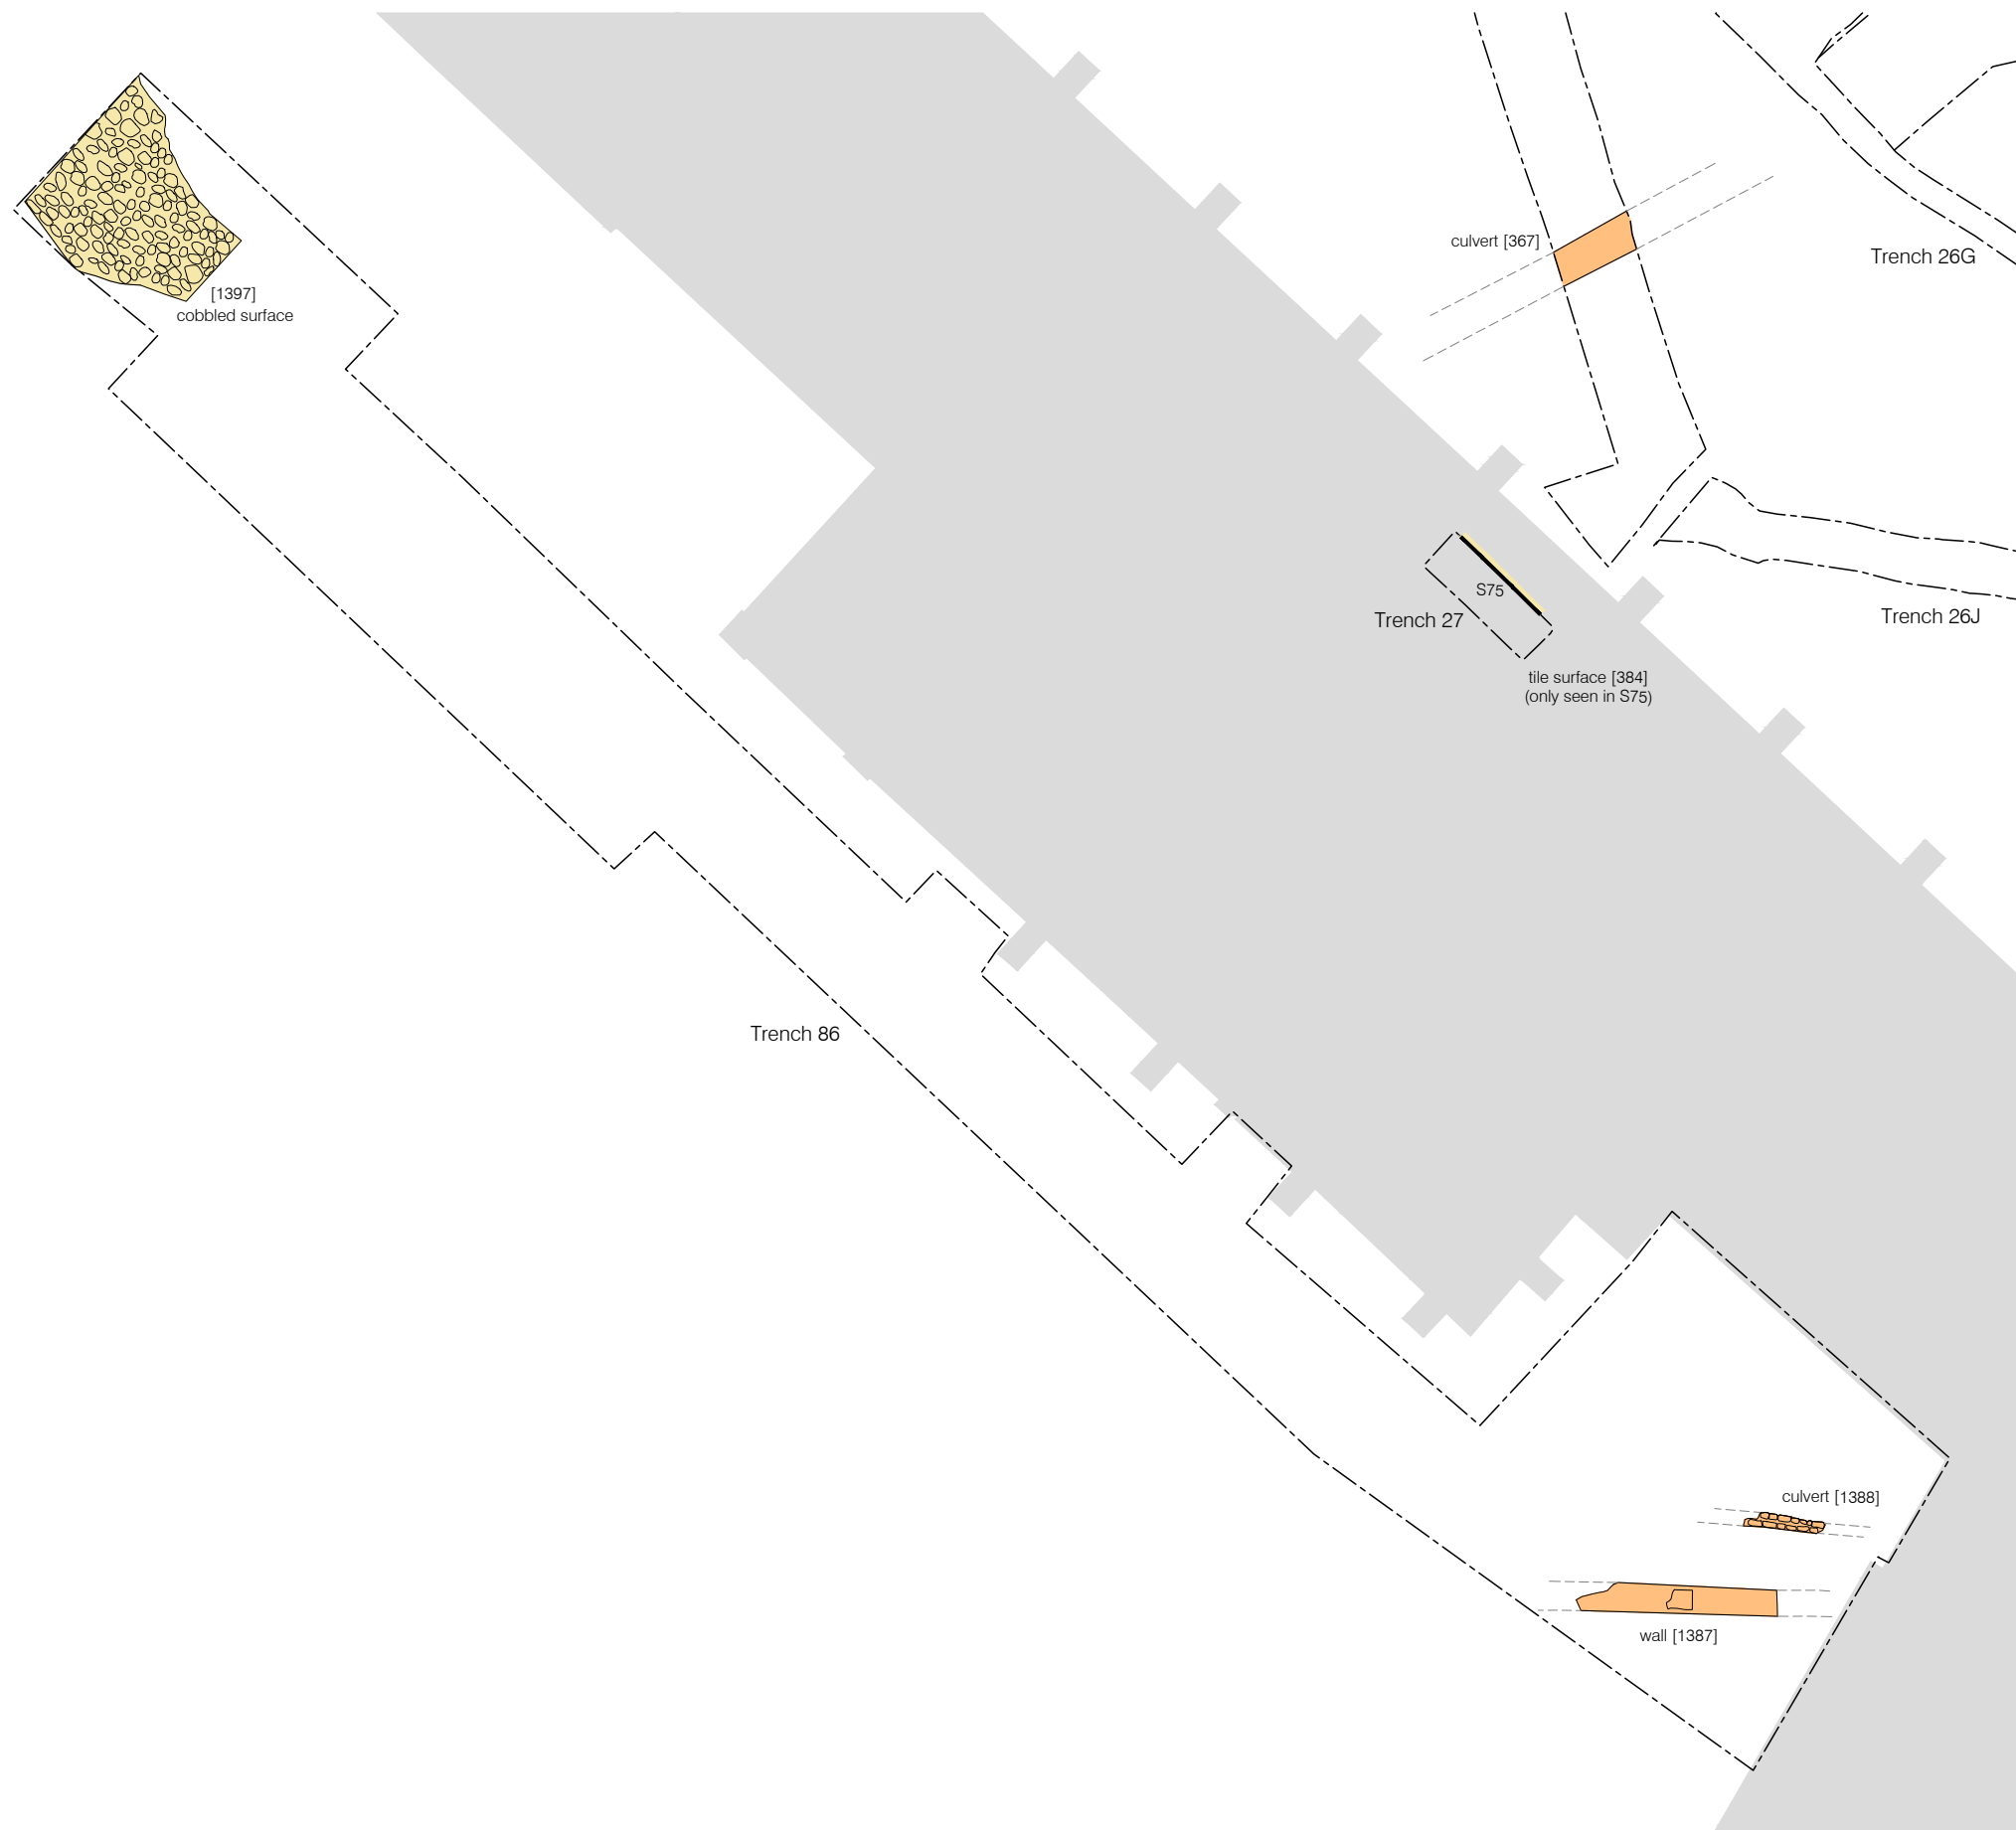
Figure 74
Phase 8: 19th Century features
Kitchen & Area South of Palace
1:125 at A3

- Phase 8 masonry
- Phase 8 surface
- Footprint of existing Palace

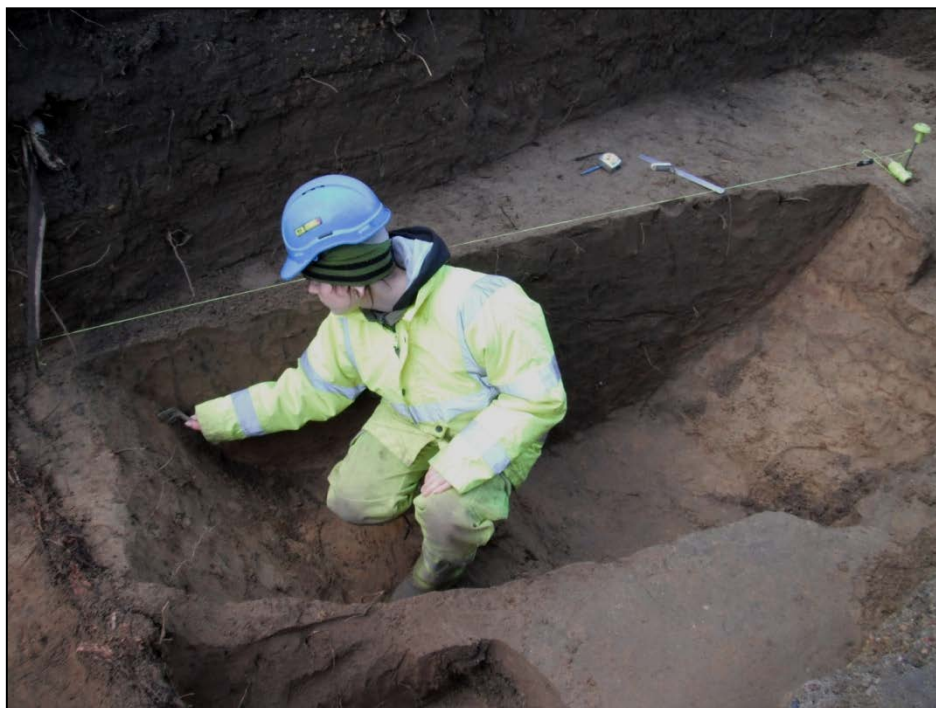
Plate 1: Southwest facing shot of Roman Ditch (with recut) in Trench 165

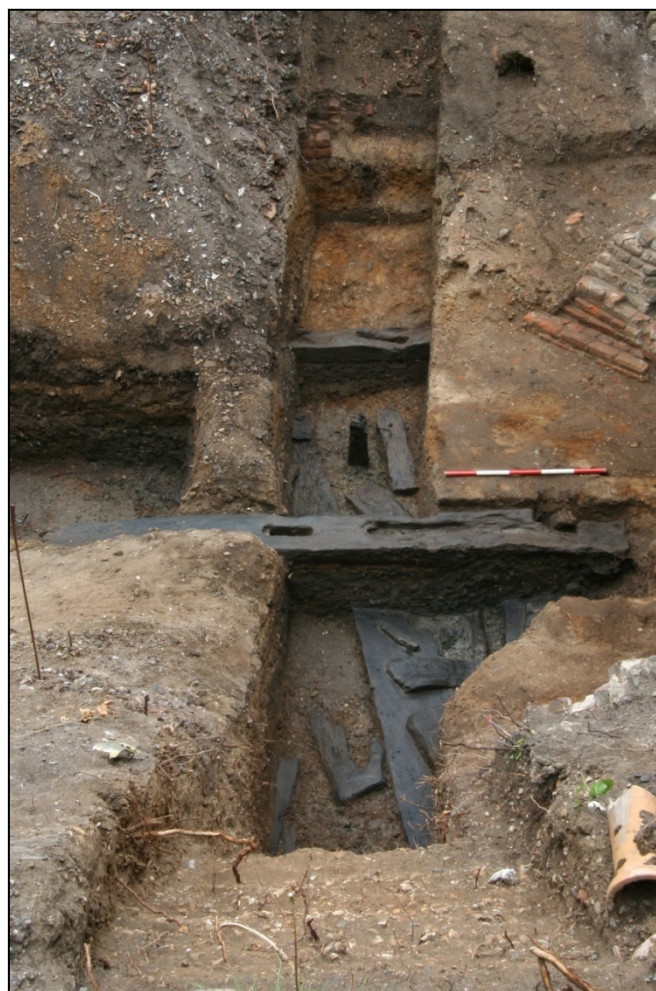
Plate 2: Southeast facing shot of medieval & Tudor Moat Timbers in Trench 186

7.6.3 Of more significance, however, were the *in situ* remains of a timber trestle like structure [2713] most likely forming a late medieval/Tudor period bridge across the moat, discovered in Trench 186 (Figure 19; Plate 2). A total of five timbers were encountered that are believed to relate to said structure, the data for which is presented in the table below.

attributed to this phase the most significant of which were the three parallel oak beam timbers [2679], [2692]/[2693] and the larger central beam [2694]. They were all placed on a NE-SW orientation, parallel to the moat edges (See Fig. 9 and Plate 2 in the main assessment report). Where best preserved it was possible to see that they had been made box halved, that is cut (almost certainly sawn) from a beam hewn from a whole log. In the central and southern examples decayed mortice joints survived in their upper faces, whilst the northern example was too decayed to retain such features. Taking into account their location, form and jointing it appears most likely that they were sill beams (or 'sole plates') for three trestles of a timber framed moat bridge. The central beam was probably the best preserved with two clear and two probable mortice joints the best preserved of which originally had a central locking peg. The mortice joints would have originally housed the tenons of upright posts or braces. The central sill beam survived 4.22m long by 380mm wide and 150mm thick. One slightly confusing feature is that the mortices do not appear to have been set out in a totally symmetrical fashion which may suggest that there were also relict joints indicating previous use. This issue can be addressed further during the analysis phase of work.

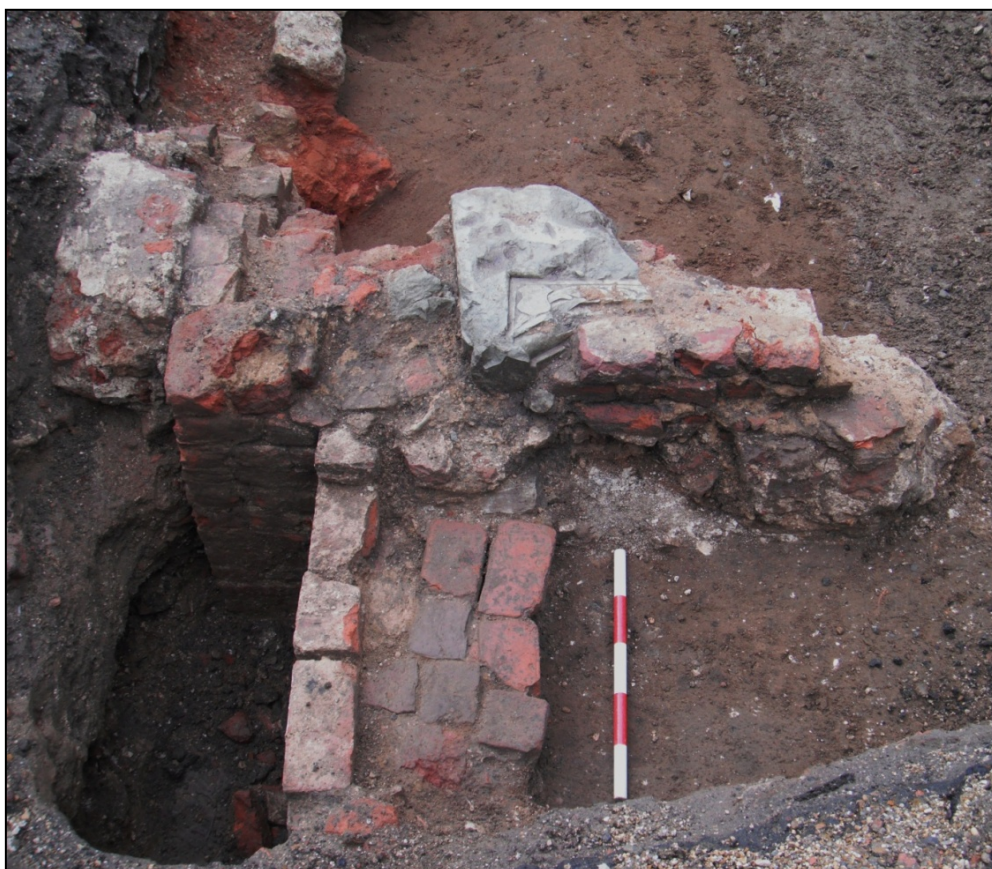
Plate 4: Southwest view of masonry related to the Tudor and 17th-century phases of the Housekeeper's Wing (including the reused Tudor lintel) in Trench 154

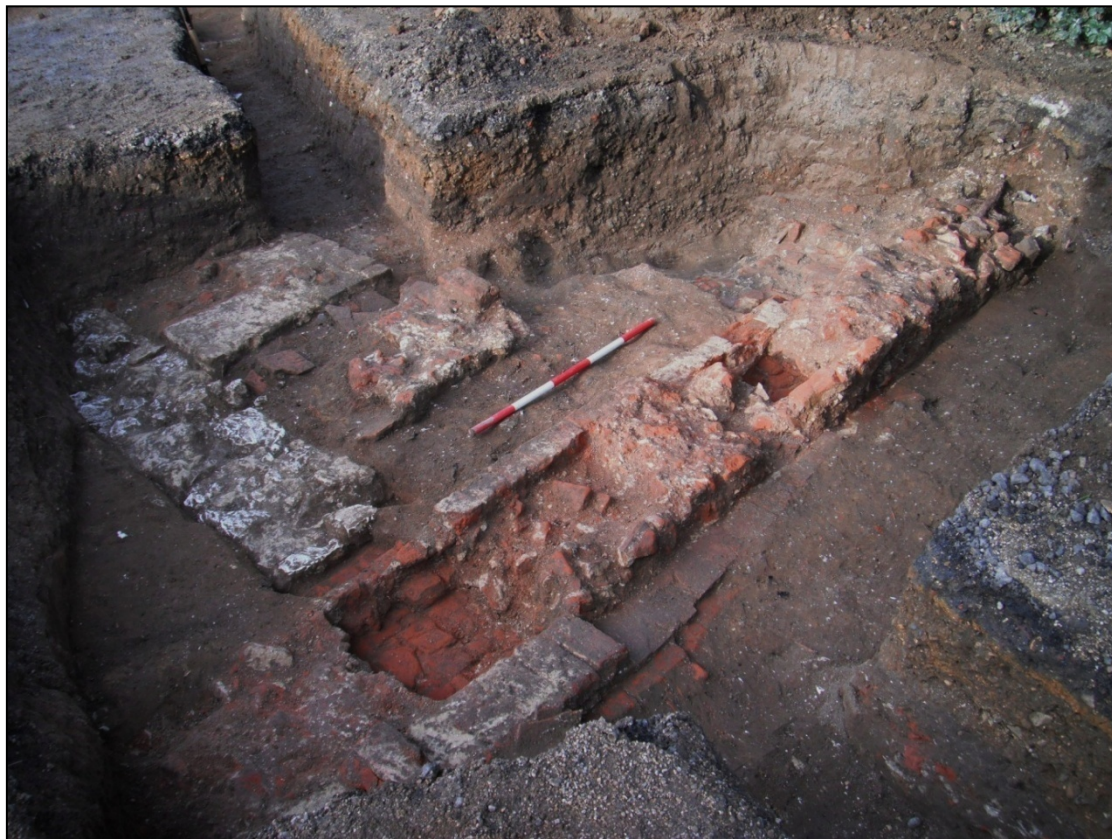
Plate 5: North facing view of Tudor and 17th-century walls related to Housekeeper's Wing truncated by an 18th-century rubble packed Garden Wall in Trench 170

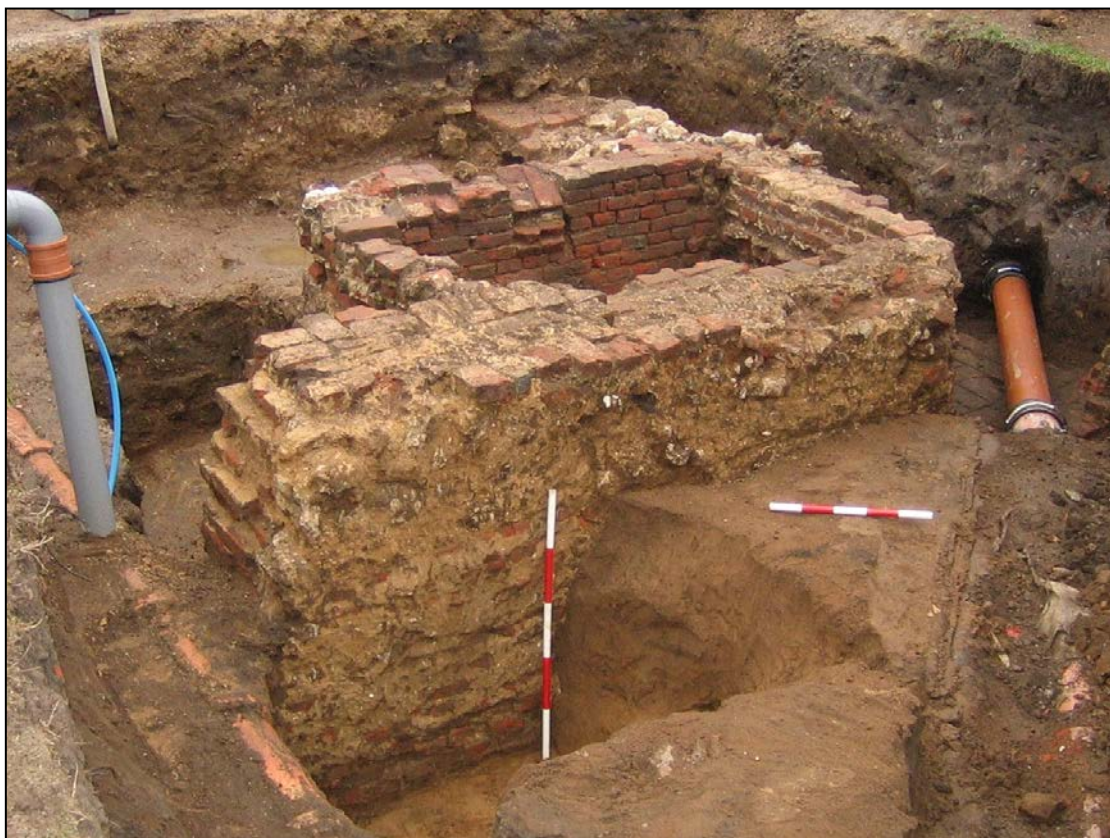
Plate 6: Southwest facing shot of Tudor and 17th-century masonry related to the State Wing in Trench 9

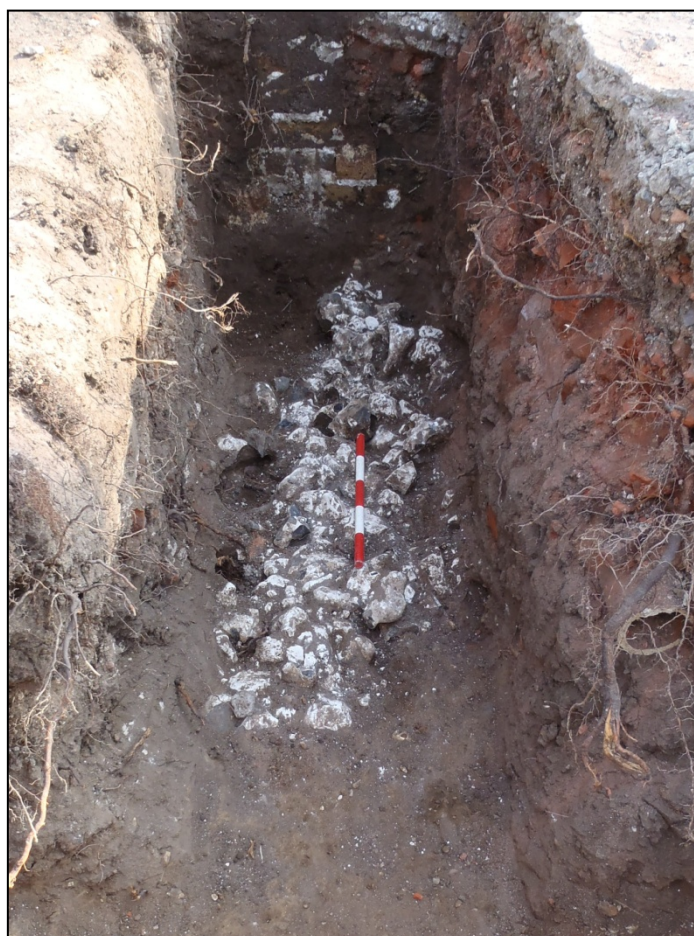
Plate 8: Northeast view of Late medieval to Tudor chalk and flint rubble foundation in Trench 253

Chalk and flint Wall Foundation (Figure 26; Plate 8)

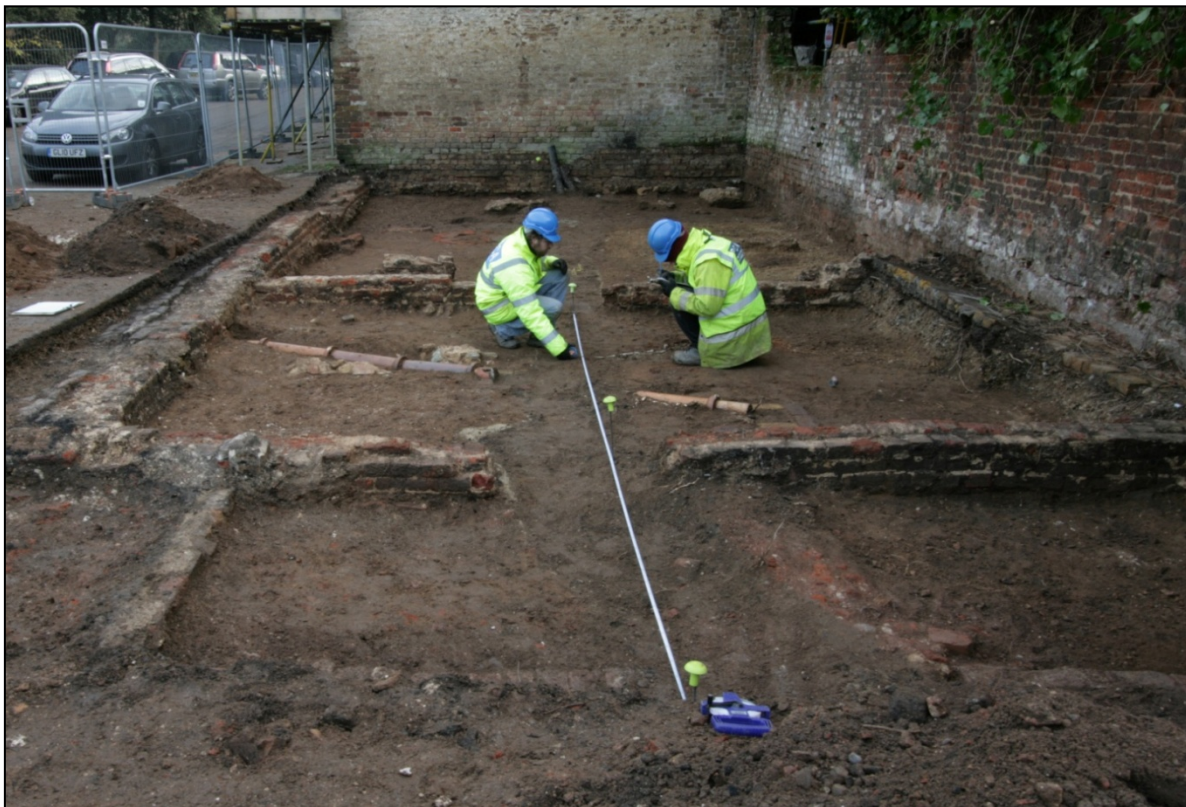
Plate 9: Southeast facing shot of Tudor, 18th- & 19th-century masonry encompassing the stables in Trench 153

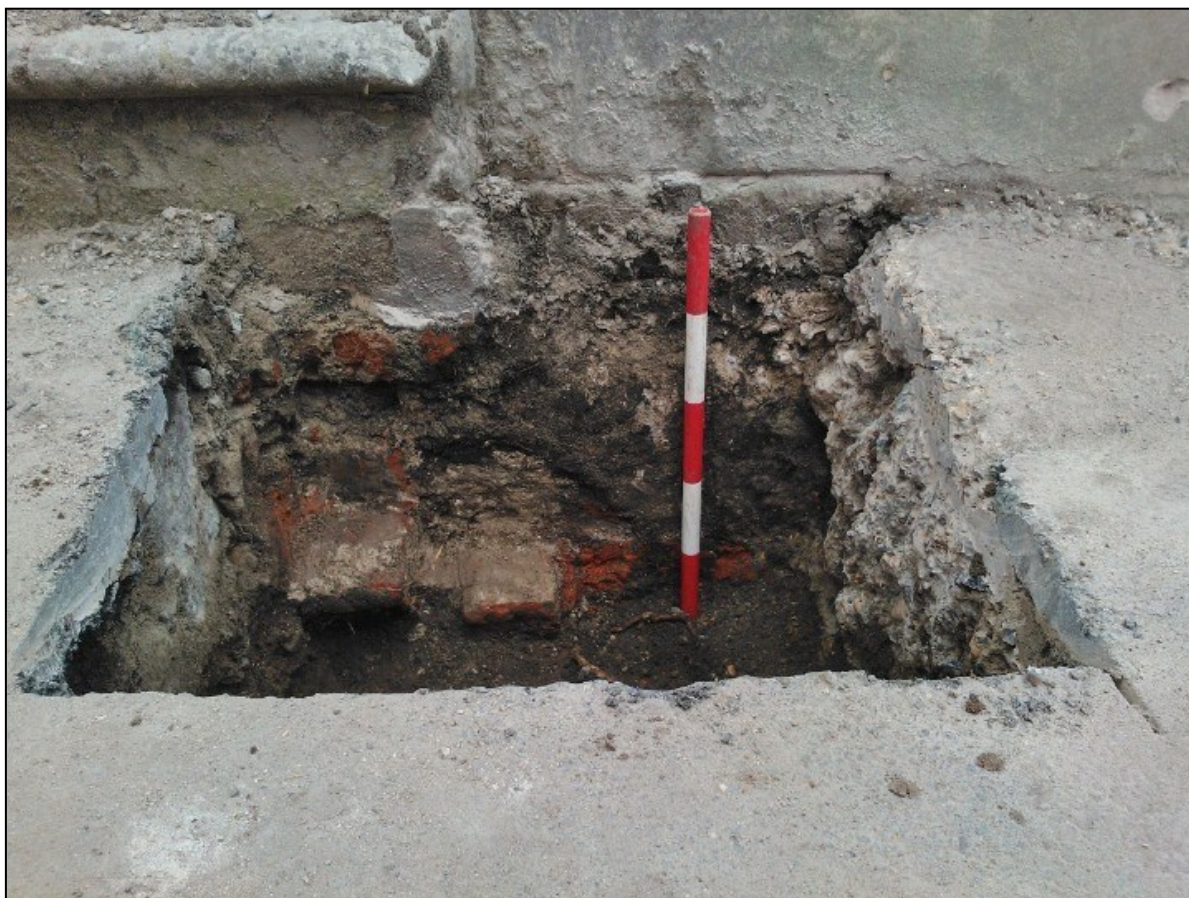
Plate 10: Northeast shot of 18th-century brickwork beneath the 19th-century gate pier in Trench 280

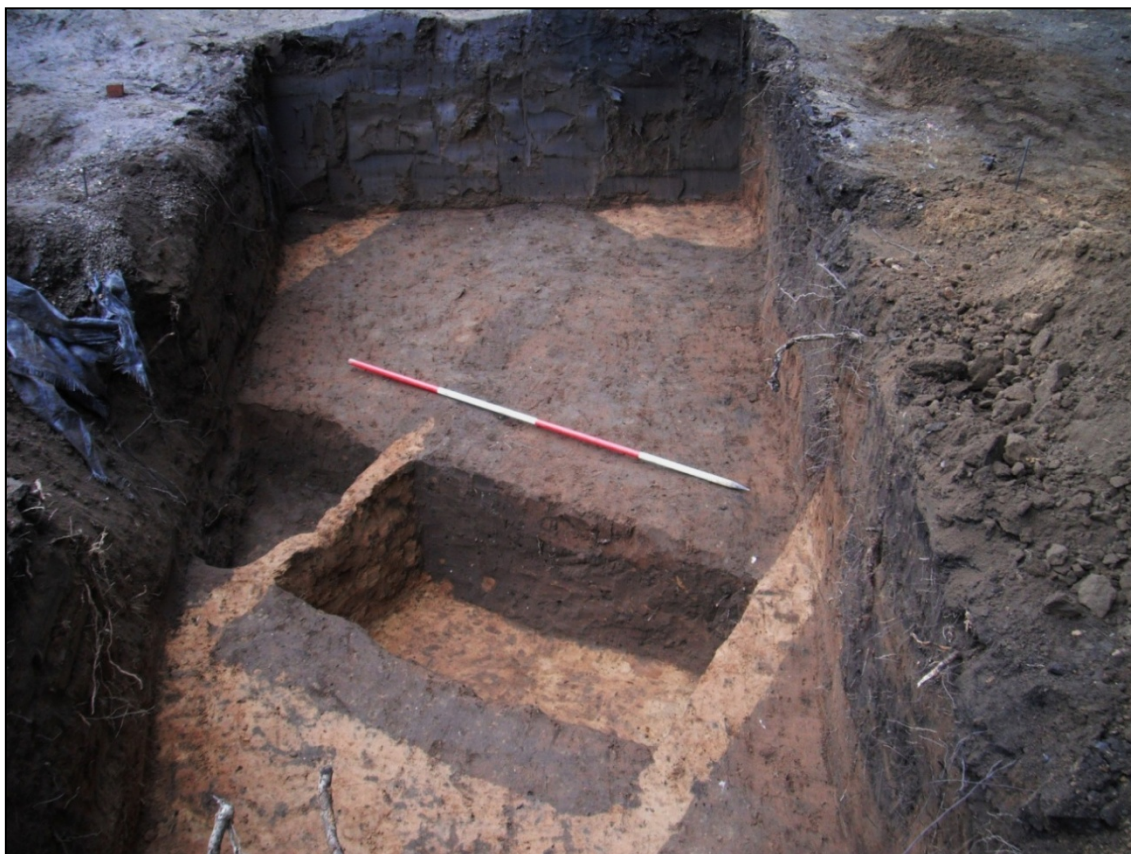
Plate 11: Southwest view of 18th-century Quarry pits in Trench 169

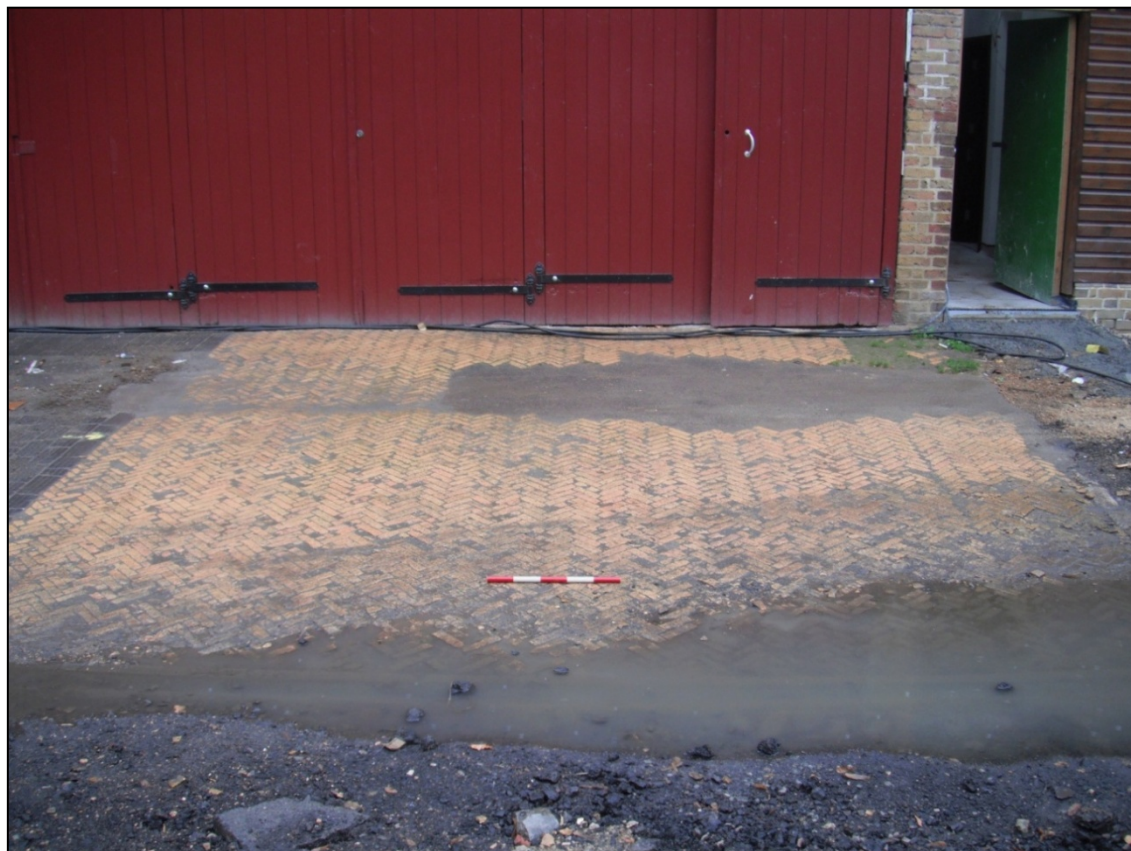
Plate 12: Southwest facing shot of the 18th- to 19th-century Herringbone floor exposed in the Stable Yard

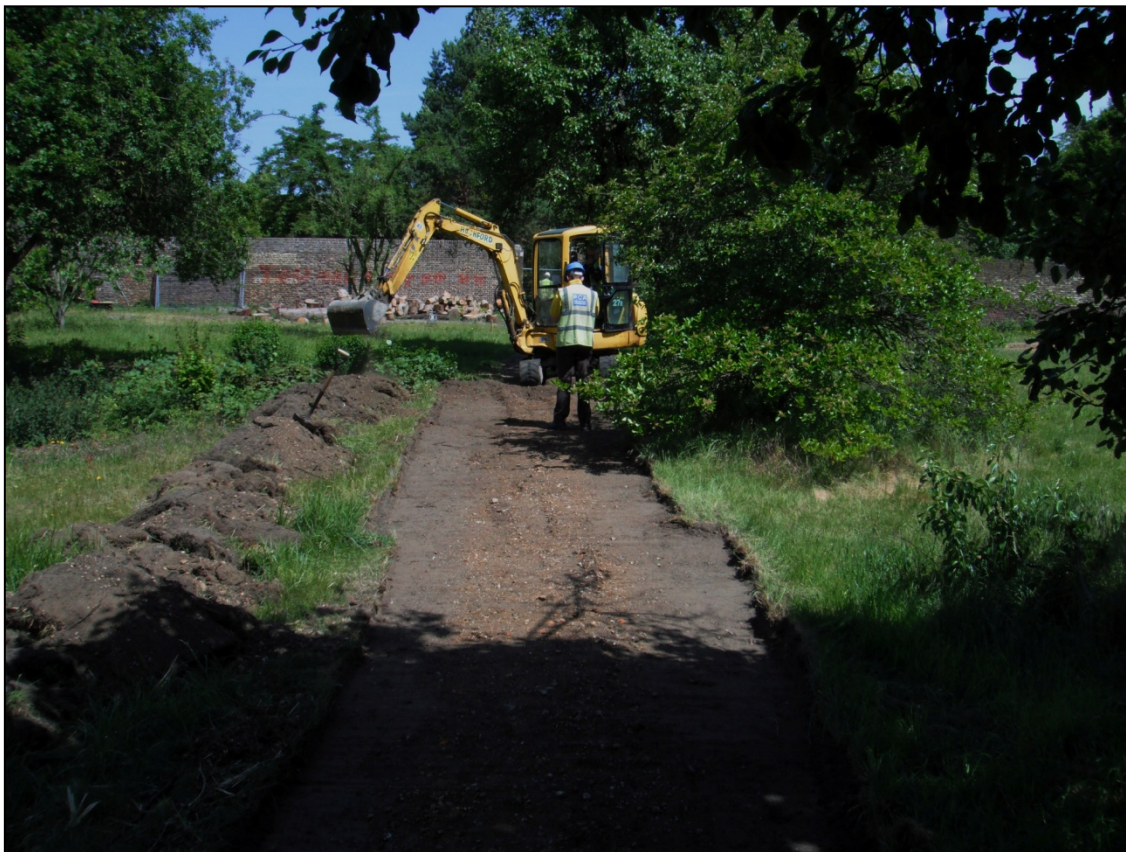
Plate 13: Northeast shot of 18th- to 19th-century Walled Garden paths being exposed in Trench 190

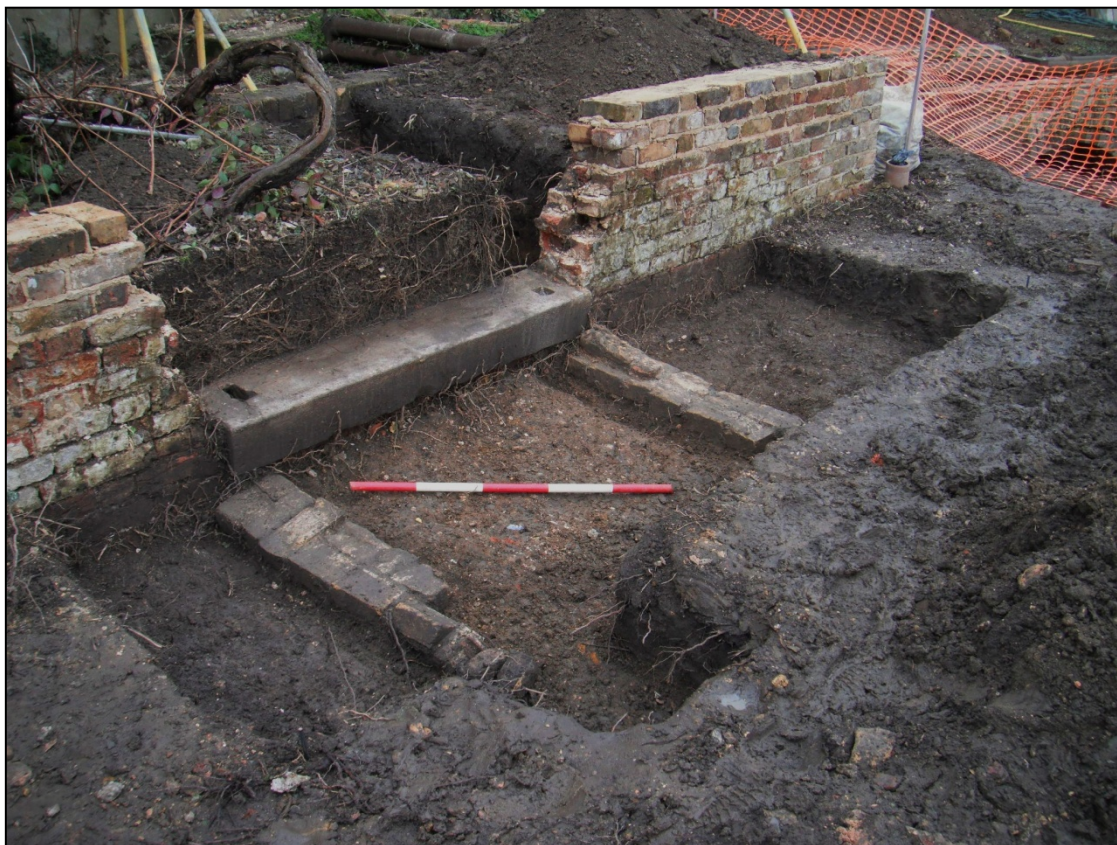
Plate 14: Northeast facing view showing remains of 19th-century entrance to Vinery in Trench 166

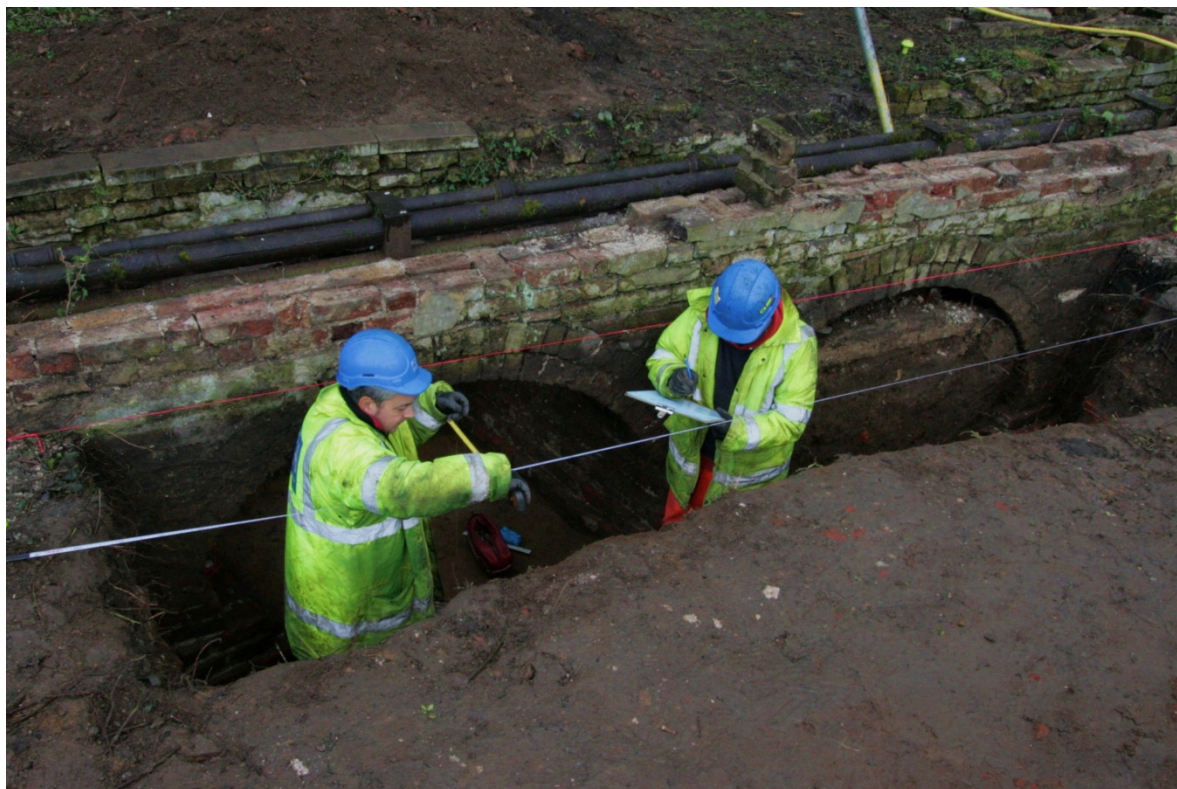
Plate 15: Northeast facing shot of arches related to the 19th-century 'hypocaust' system in Vinery Trench 159 being recorded

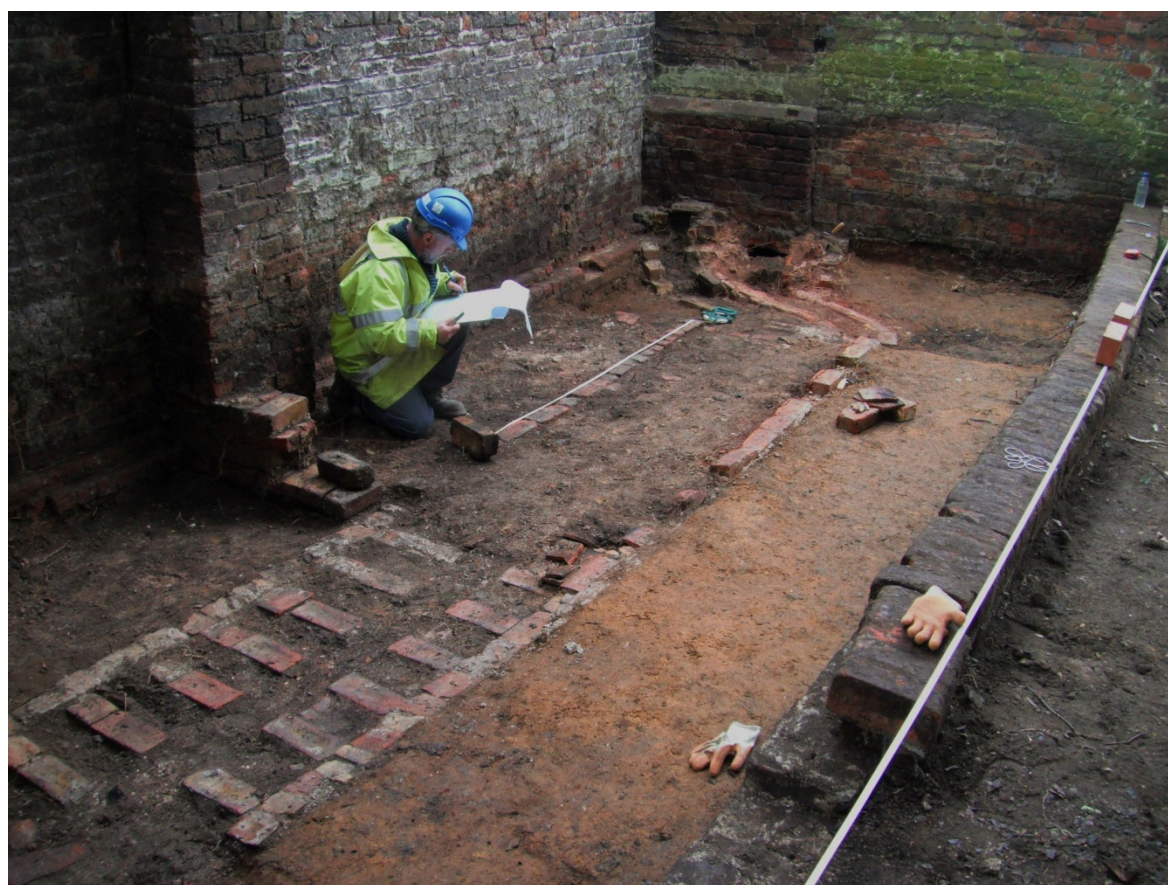
Plate 16: Southwest view of the 19th-century masonry connected with the hypocaust in Bothy Trench 158

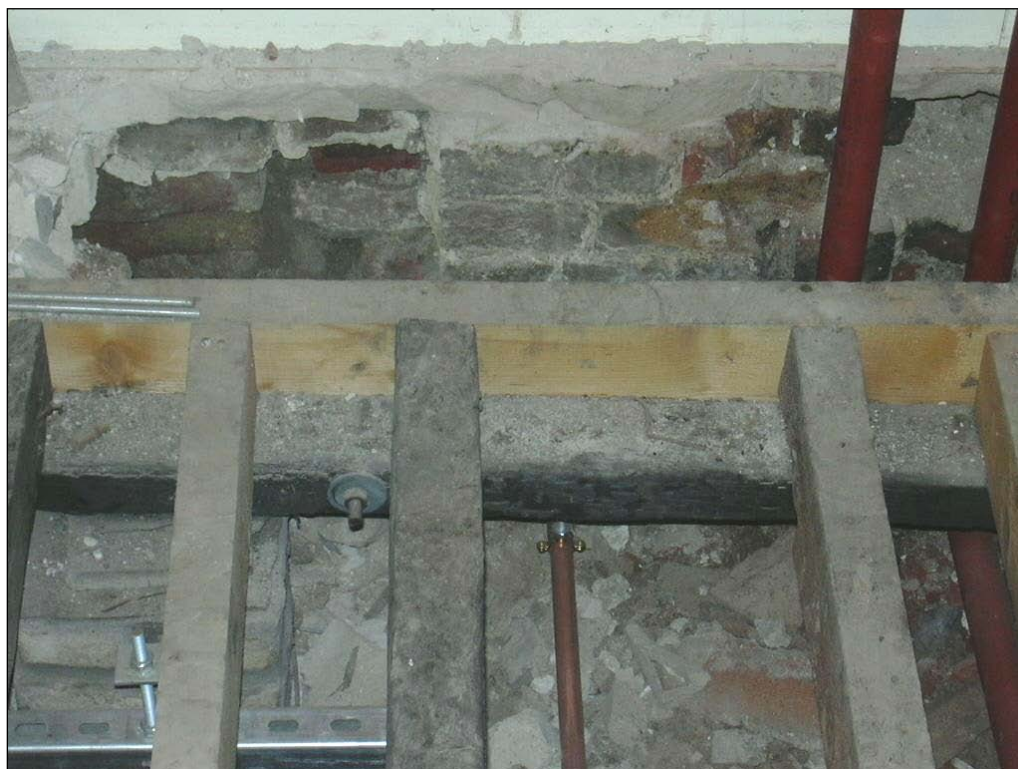
Figure 4: Possible Tudor Brickwork below later floor joists (Room 44 ↑E)

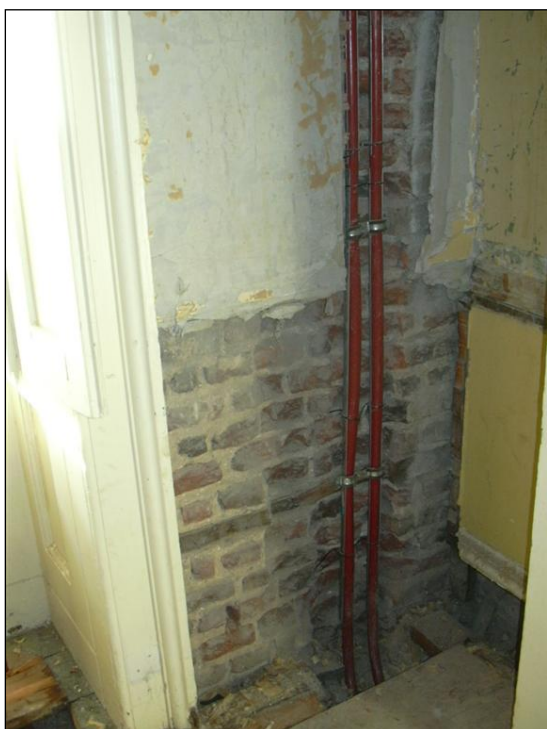
Figure 7: Possible Tudor brickwork (lower courses) revealed by insertion of modern services (Room 29 ↑SW)

In Bishop Terrick's Dining Room (Room 29), early brick fabrics were also apparent in the internal elevation of the south (external) wall (Figure 7). These may relate to a former garden wall enclosing the East Courtyard, as indicated on the 1764 survey by Stiff Leadbetter (See Figure 17). Removal of floor boards to Room 30 (Terrick's Drawing Room) and Room 29 also revealed that there has been previous replacement of the historic fabric in this area (Figure 8). Construction techniques for the floors were recorded, as they were at several other places in the building.

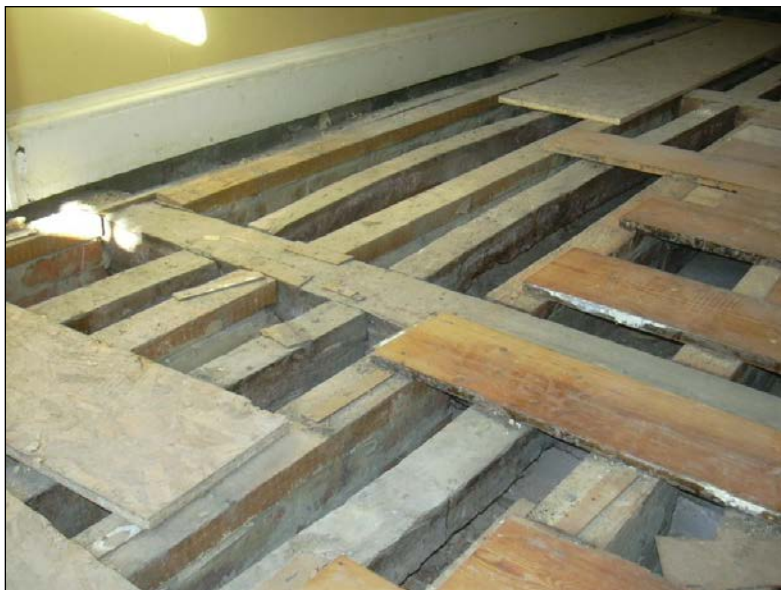
Figure 8: Bishop Terrick's Dining Room (Room 29 ↑S) Floor Details

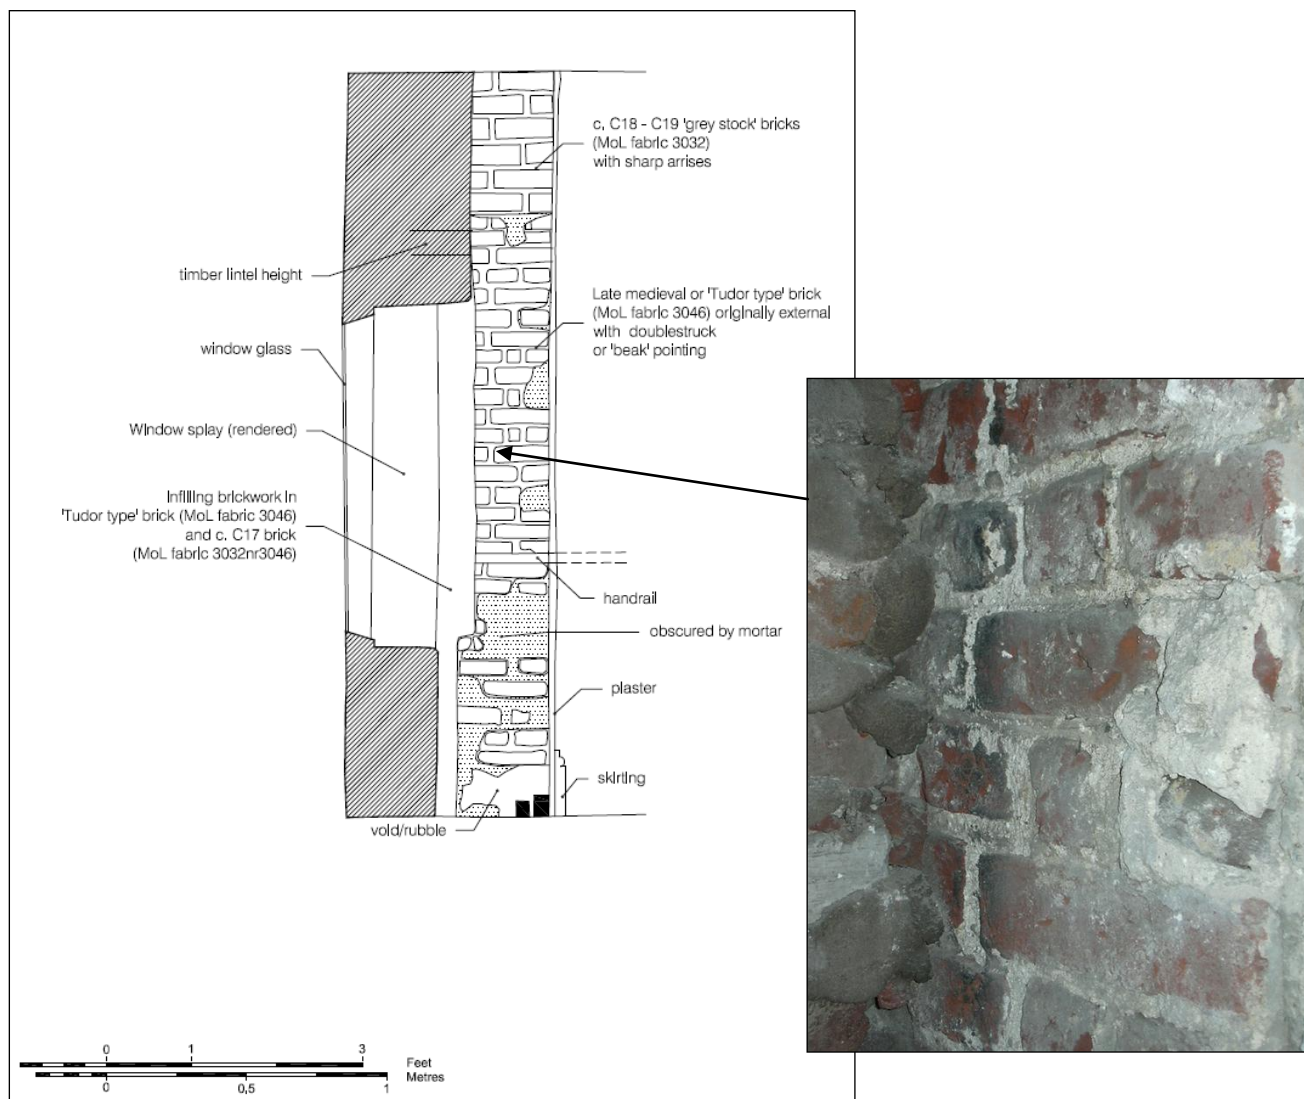
Figure 10: Late medieval or early Tudor brickwork with double-struck, or 'beak', pointing (Room 129)

Of particular interest was the evidence of a previously external wall, at the junction of Rooms 129 and 126. This wall was abutted by the small, mullioned window found at the southeast angle of the West Courtyard. The remains of the earlier wall would originally have extended to the east, roughly parallel to the south wall of the Great Hall. Early 'Tudor type' unfrogged and uneven brick (MoL fabric 3046) was bonded with thickly jointed lime-sand mortar, which had been 'double-struck' (also known as beak pointing). This almost certainly indicates a previously external wall in this location, and the use of double-struck pointing suggests an early Tudor date. It is possible, therefore, that the remains of this wall represent the southernmost external wall for the late 15th- to mid 16th-century kitchen range postulated by Rodwell (1988).
