FULHAM PALACE

ASSESSMENT OF AN

ARCHAEOLOGICAL

WATCHING BRIEF

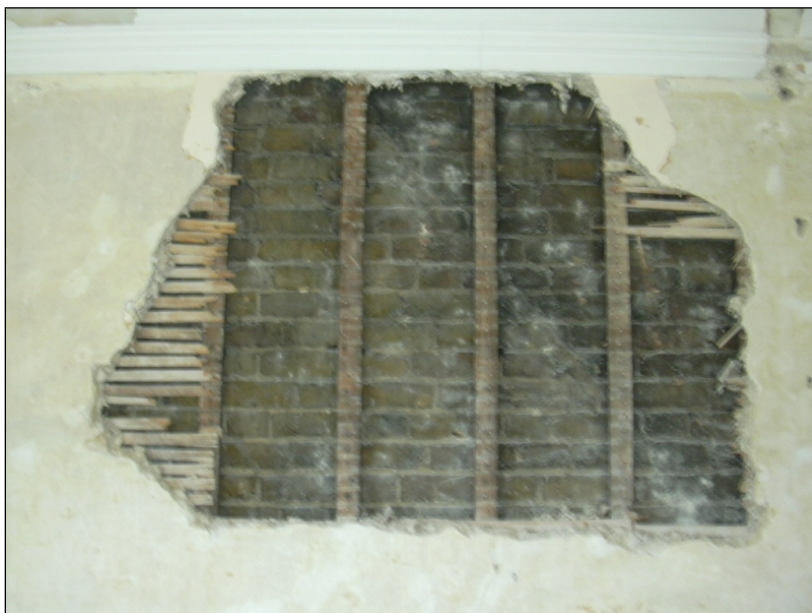
Figure 11: Room 214, differential staining on east (external) wall

Investigations in this area were limited to general observations. Removal of floor boards in Rooms 213 and 214 revealed that a timber barrel vaulting technique was employed in the construction of the first-floor state rooms below (see Figure 12). An inserted doorway was noted in Room 214, and differential staining on revealed masonry may suggest a previous flue line, or possibly previously external wall line (Figure 11). In Room 211 typical carpentry techniques for the floors were noted. Boards were nailed directly onto NS running joists with laths for ceiling plaster underneath.

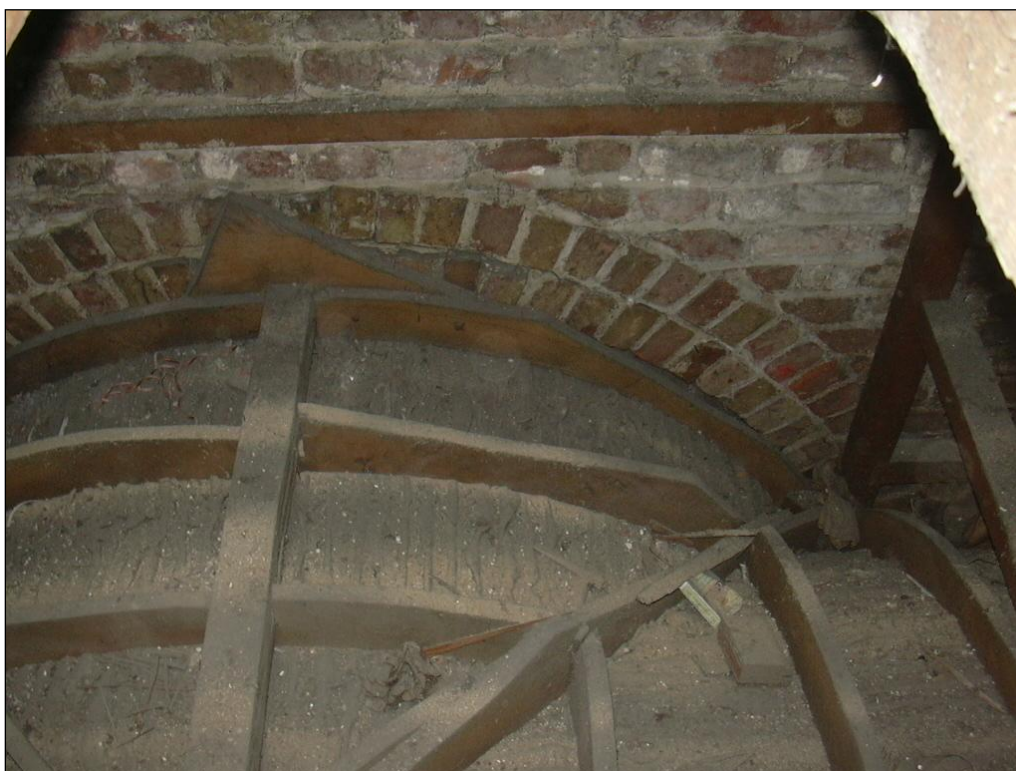
Figure 12: Floor void above the East Court South range, second floor corridor (Room 227), revealing the timber vaulting for double-height ground floor corridor (↑E)

The removal of floorboards in Corridor 227 provided an opportunity to observe the construction of the vaulting for the double-height corridor on the ground floor. Where observed, this was entirely executed in timber. The form of the vault was determined by a timber frame, acting as a former for the barrel shape, and executed with wood laths. Where the timber arches were tied into walls, these were supported by brick arches constructed of a double course of bricks on edge (Figure 9). The brick fabrics used were observed to be 'grey stock' types of probable 18th- or 19th-century date (MoL fabrics 3032 and 3034).

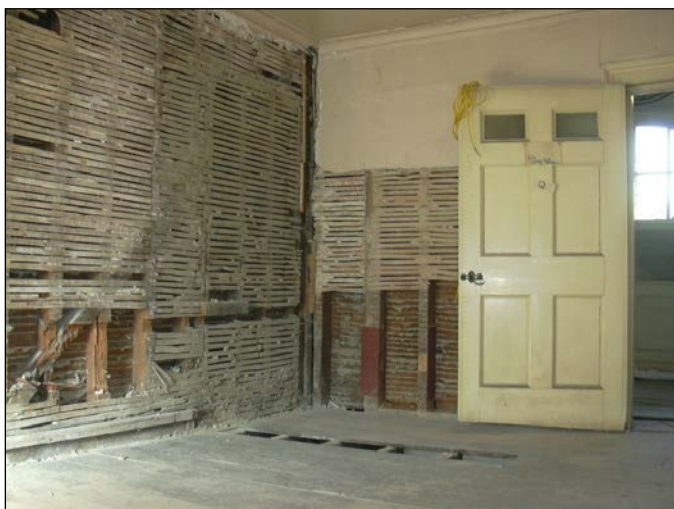
Figure 14: Stripped-off plaster revealing typical studwork and lath wall construction (Room 231 ↑NW)

Stripping of wallplaster in Room 231 had also exposed typical stud-and-lath construction for the partition walls in the northwest corner (Figure 11). This technique was noted generally elsewhere. Vertical studs, approximately 4¼ x 2½ inches thick were generally spaced about one foot apart (laths were cut approximately to this length). The laths were affixed generally with square-section iron nails, and covered with lime-sand plaster, bonded with hair (probably horsehair).

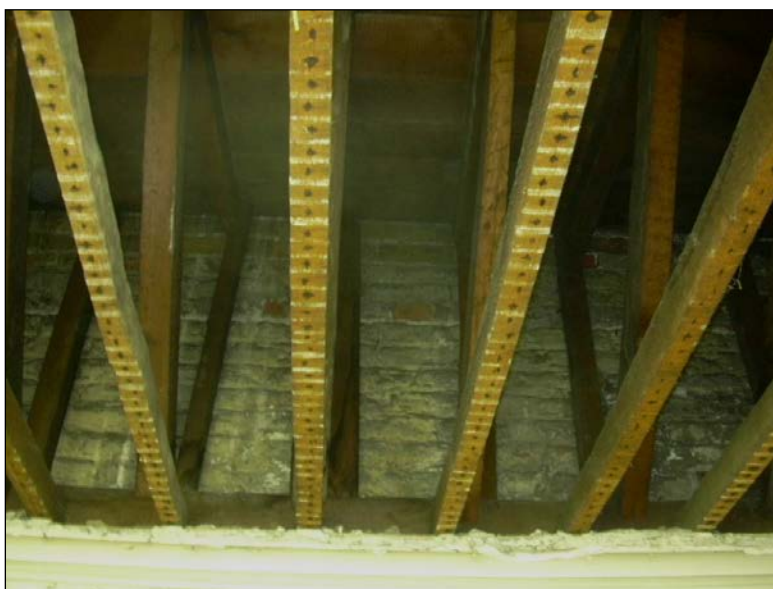
Figure 15: Brickwork with later build above rooms 230 & 231 (Room 227 ↑S)

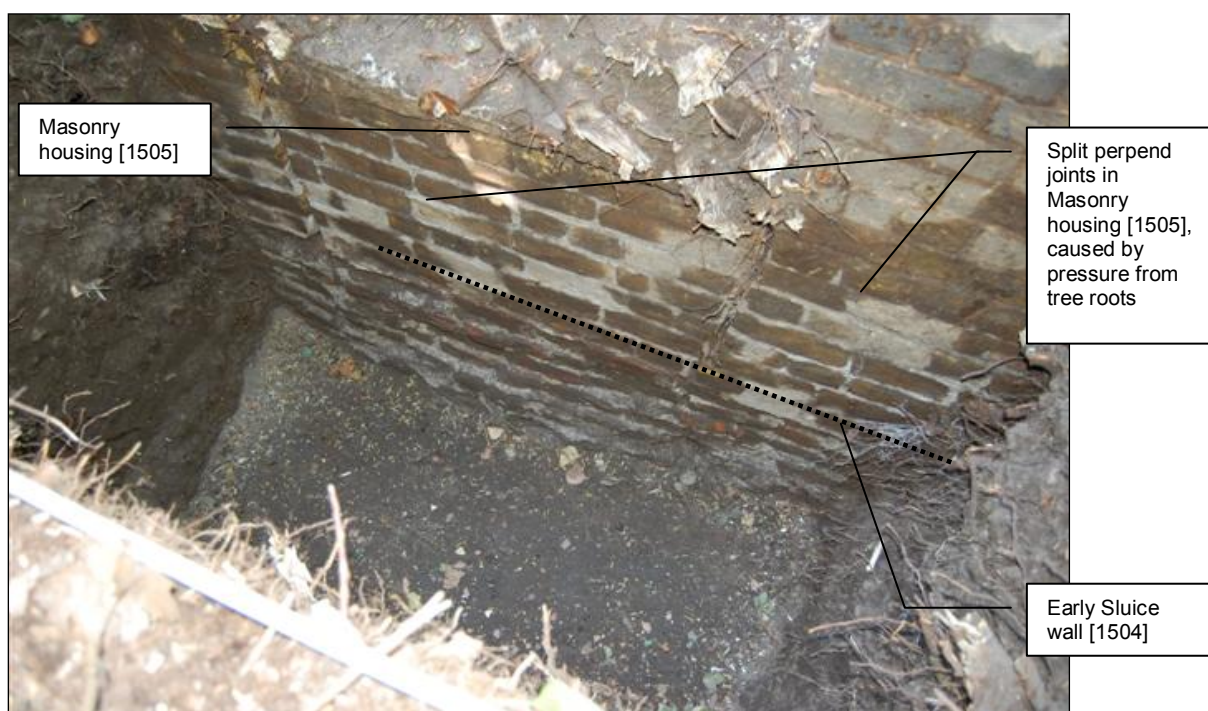
The masonry structure [1505] above consisted almost entirely of frogged yellow 'London Stock' brick (MoL fabric 3035, dated 1780-1920) supporting the cast-iron winding mechanism [1510]. The brickwork is capped on the visible supporting wing wall and around the base of the winding mechanism with a white oolitic limestone identified as Portland Stone. The structure [1505] was bonded with a Portland cement-based mortar. This type of bonding material was first patented in England by Joseph Aspdin in 1824 (http://www.cement.org/basics/concretebasics_history.asp). It was being produced commercially by his son William in 1838 in Gateshead and London (Ashurst & Ashurst 1988), but was not in widespread use until the 1850s and the structure is therefore thought to date to between 1820 and 1895. It is probably contemporary with the Bishops Park section of the Thames embankment in c.1893, which was constructed as part of the creation of the park (Figures 19 & 20). The sluice in its final form is clearly shown on the 1894-6 Second Edition Ordnance Survey, and therefore must have been constructed by this date (Figure 21).

Figure 19: S elevation of moat sluice

formed bricks with fairly sharp arrises (*i.e.* lacking the characteristics of earlier 'Tudor' type bricks) the age range of the wall is suggested to be between 1780 and 1850. This would tie in with a documented date of rebuilding for the sluice in 1842 following a flood (*ibid.*) and would explain the presence of apparently earlier and abraded brick in the fabric 3033 group as material reused from the original structure.

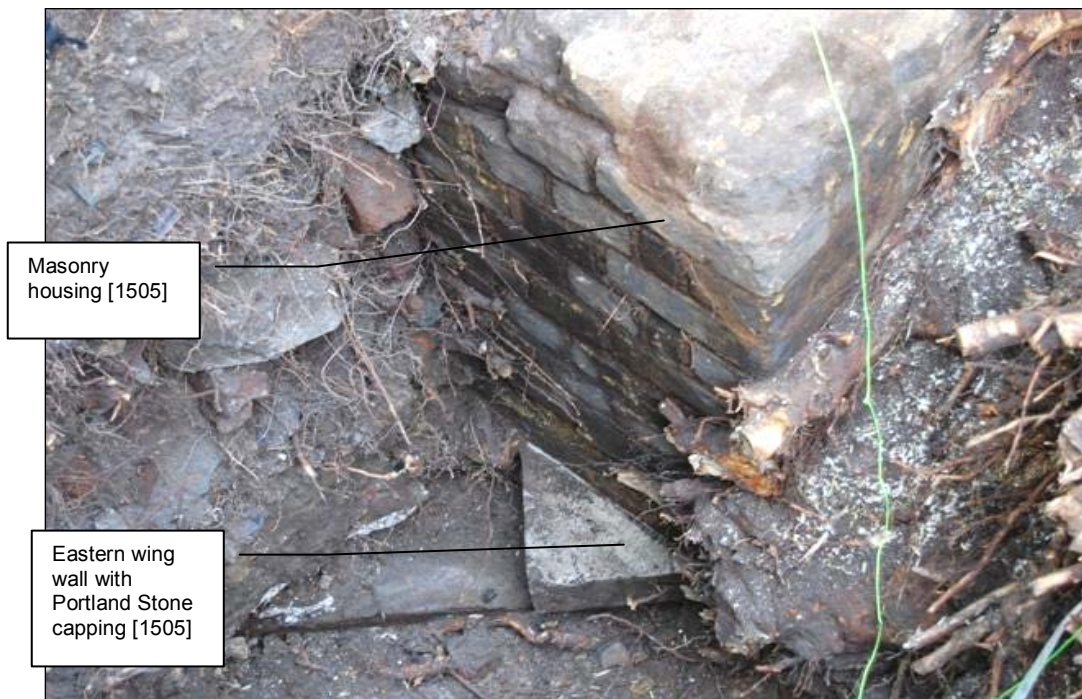
Figure 20: N elevation of moat sluice and eastern wing wall

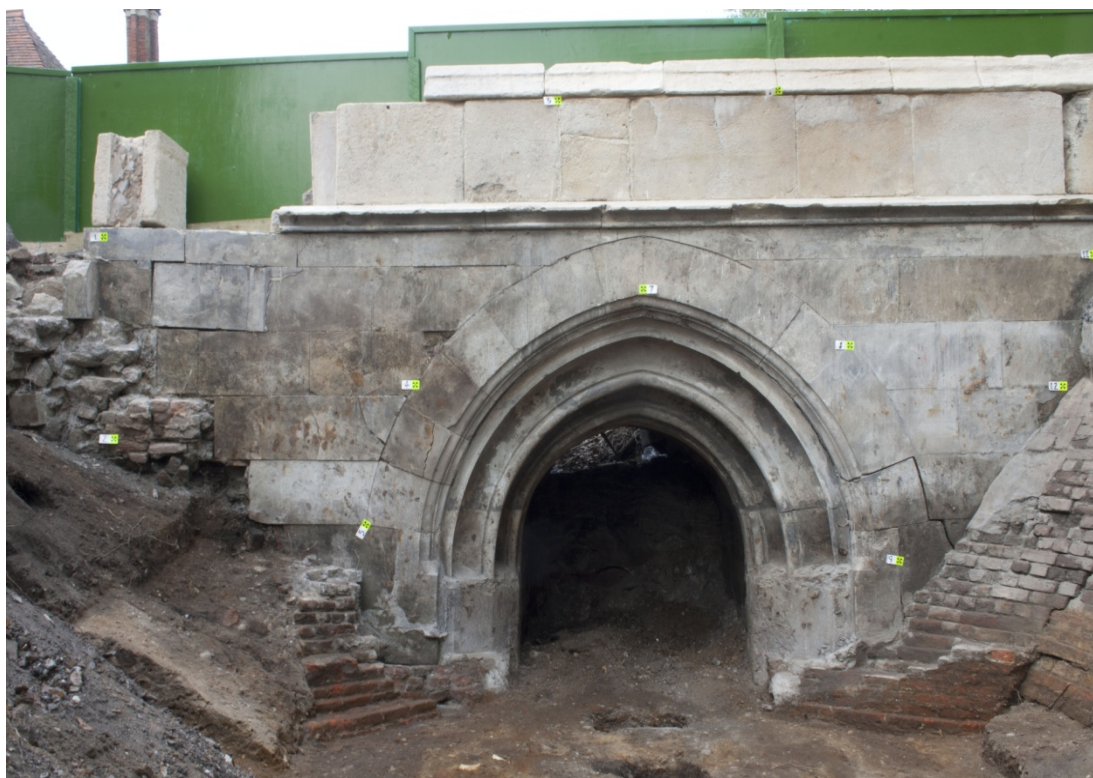
The Moat Bridge is a grade II listed 15th-century medieval bridge which crosses a moated enclosure of 13th-century date (Figure 22). The Moat Bridge formed the principal historic entrance onto the site and is strongly associated with the principal approach to the Western Courtyard of Fulham Palace. The moat had been infilled between 1921-24, obscuring the lower section of the bridge but leaving the parapet walls and their triangular copings, still visible. A pair of early 19th-century Gothick-style piers with traceried panels are positioned toward the western end of the bridge at its roadside junction. The ashlar block parapet walls and copings were both photographed and drawn in elevation during recording works in March 2011. This survey, including a transverse section through the bridge structure and a photographic record, carried out in April 2011, was extended to the entire bridge once it was fully revealed. The bridge was shown to be an accommodation bridge with a single central two centred Gothick pointed arch of three principal recessed orders and spandrels faced with regular, flush ashlar blocks laid as half lap in regular courses ($4\frac{1}{2}$) below a moulded stone brattished string defining the base of the parapet wall. The ashlar blocks used for the parapet walls were considerably larger than those used for the bridge facing, suggesting a reworking of the parapet, possibly when the Gothick piers were added and the lodge built in the early 19th century. The two-centred arch was turned in gauged ashlar blocks and sprung from plinths which formed stopped ends to the arch. The abutments were built in red brick laid in English bond. The bridge bed was latterly resurfaced using tarmac, although this appears to overly stone cobbles, still visible along the edges.

Figure 22: Moat Bridge, southwest facing

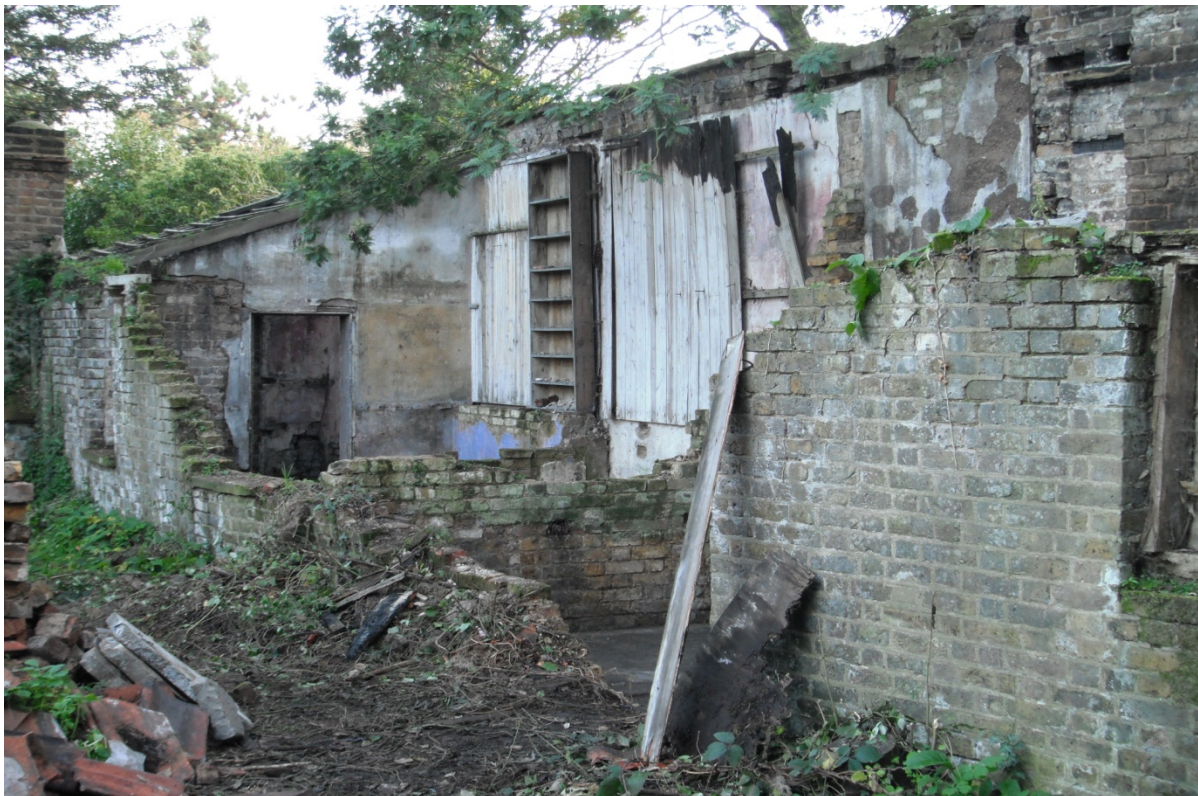
The bothy is a Grade II listed linear range of garden storage and garden ancillary buildings thought to have been originally constructed during the early 19th century in c.1821 (Figures 23& 24). The bothy follows the extramural curve of the walled garden, the latter dating from c.1766-1800 and predating its construction, and are brick and tile construction built up against the northern side of the wall. The bothy comprises a single contemporary lean-to structure to the north of and abutting the garden wall, which is in turn sandwiched between the bothy and the glass house/Vinery buildings to the south. The bothy incorporates a series of small rooms or spaces, all a single bay in depth, including a pot store, potting shed, boiler room, seed store etc and is mainly constructed using a stock brick laid in Flemish bond. Analysis has shown that the central bays or rooms were built during the original construction phase in c.1816-28 while the outer bays were later additions or rebuilding events post dating the 1850s.

Figure 23: Exterior of Bothy, facing southeast

The bothy was in a ruinous state at the time of the survey, but it was generally constructed of unsubstantial brickwork of half brick width and with a tiled lean-to roof, which in some areas had collapsed and lost its pan and/or plain tile roof covering. As part of the survey works carried out during November 2010 the footprint and internal features of the bothy were fully recorded in plan and a photographic record maintained. Some 19th-century internal features had survived including examples of internal timber doors, shelving, small stoves, fireplaces and a boiler pit used for heating the bothy and the adjacent Vinery. The rooms reused for staff accommodation (B01.01-3) had had their window openings rebuilt and concrete lintels inserted, similar modifications were seen in the form of concrete screed floors, although brick floors laid on bed as stretcher courses survived in (B01.04 propagation room, B01.06 gardener's office) and on edge in the seed store B01.05. Scarring within the brick floor of B01.04 shows that this large room was former subdivided, east of the doorway, into two separate rooms. A corner fireplace and an area of adjacent brick flooring in room B01.08 suggest the former location of a small gardener's office area. This lay just to the west of a former planting bed area. Central to the bothy was the former boiler house, which retained evidence of the brick base and the rear of the boiler flue stack. Extensive rebuilding in this area using Fletton type bricks may suggest a 20th-century reworking.

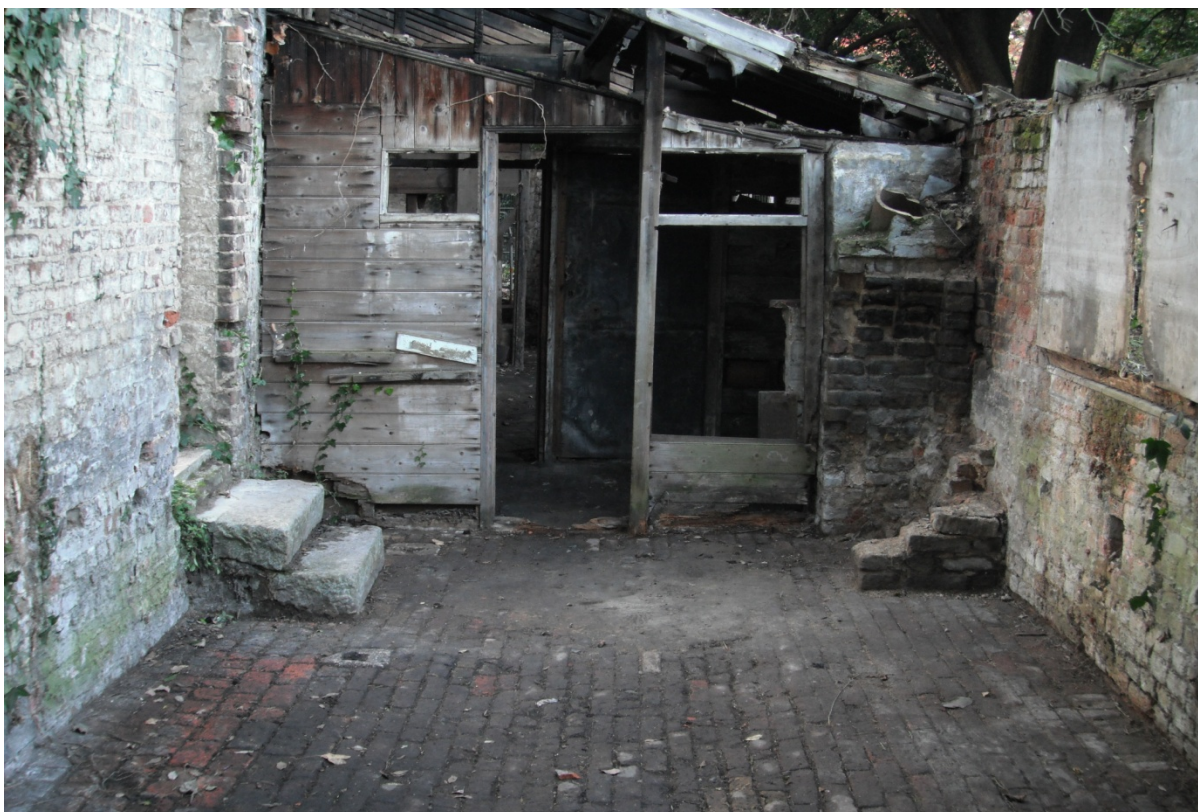
Figure 24: Interior of Bothy, facing northwest

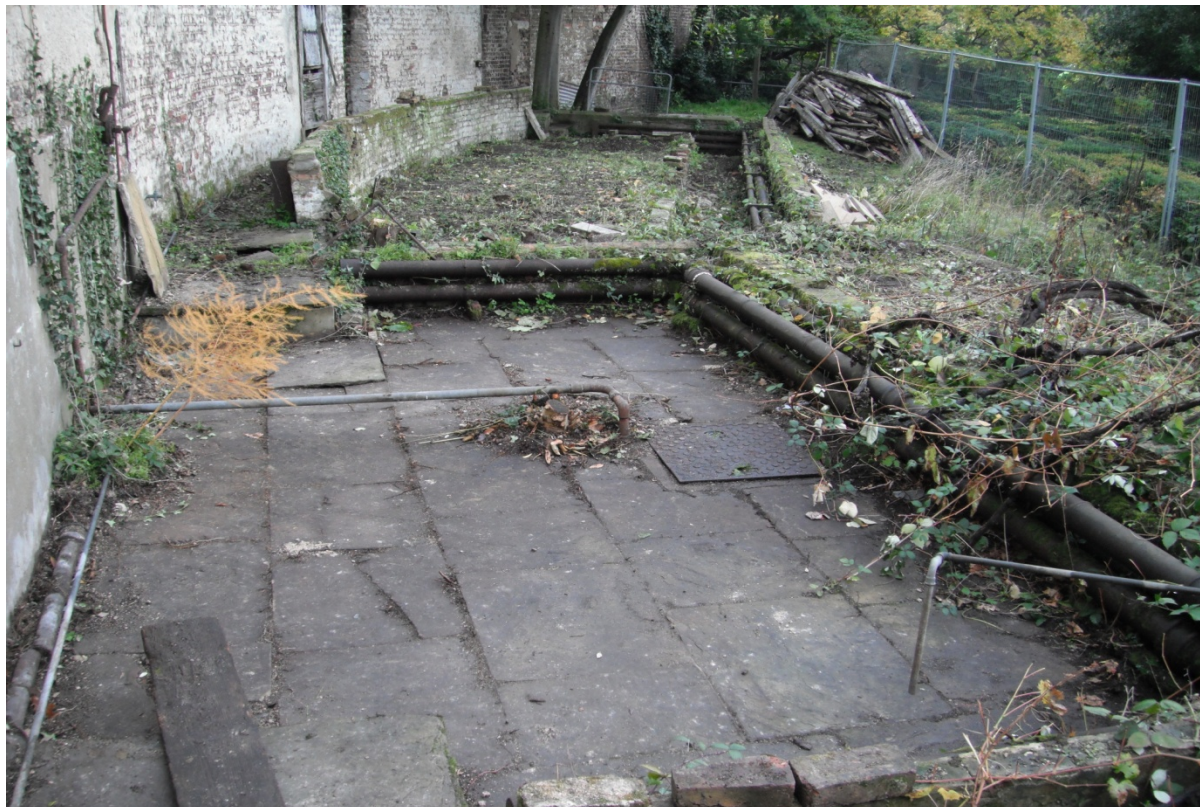
The vinery was constructed in c.1821-1828 within the circuit of the walled garden and against the internal curve of the garden wall. It is built up against the wall and has associations with the bothy, a broadly contemporary structure built adjacent to and along the outer circuit of the wall (Figures 25 & 26). The vinery or former glasshouses comprises three principal bays, a forward set central section of 4 bays, flanked by slightly narrower ranges of 8 bays in width to the east and west. The central section was also slightly taller than the side bays, which also were built with a slight camber to along the wall roof junction. The vinery closely follows the curvature of the garden wall, to which it abuts, and are constructed using brick-built dwarf walls supporting a construction of timber framing with mono-pitch lean-to roof structures and (formerly) glass panes (removed at time of survey and stored in the bothy).

Figure 25: Vinery, facing southeast

The vinery was in a ruinous state at the time of the survey but was recorded in plan, section and in elevation during a period spanning October 2009-February 2010 and June to March 2011 and photographically during November 2010. Remnants of ashlar render were present on the rear wall of the vinery, particularly in the central and western ranges. Their character using an ashlar form, suggests a classical influence and accordingly a later Georgian/Regency date. The render was crossed at regular intervals by vertical nailed timber batons, added to support the timber trelliswork for the vines. The absence of render in the eastern bays, supports the documentary inference that these were bays were used differently as a pinery/vinery (Brown 2009). Excavation of an evaluation trench along the front of these eastern bays also uncovered a series of subterranean arches built into the base of the foundation/dwarf walls. The arches were a rough brick construction of two on-edge

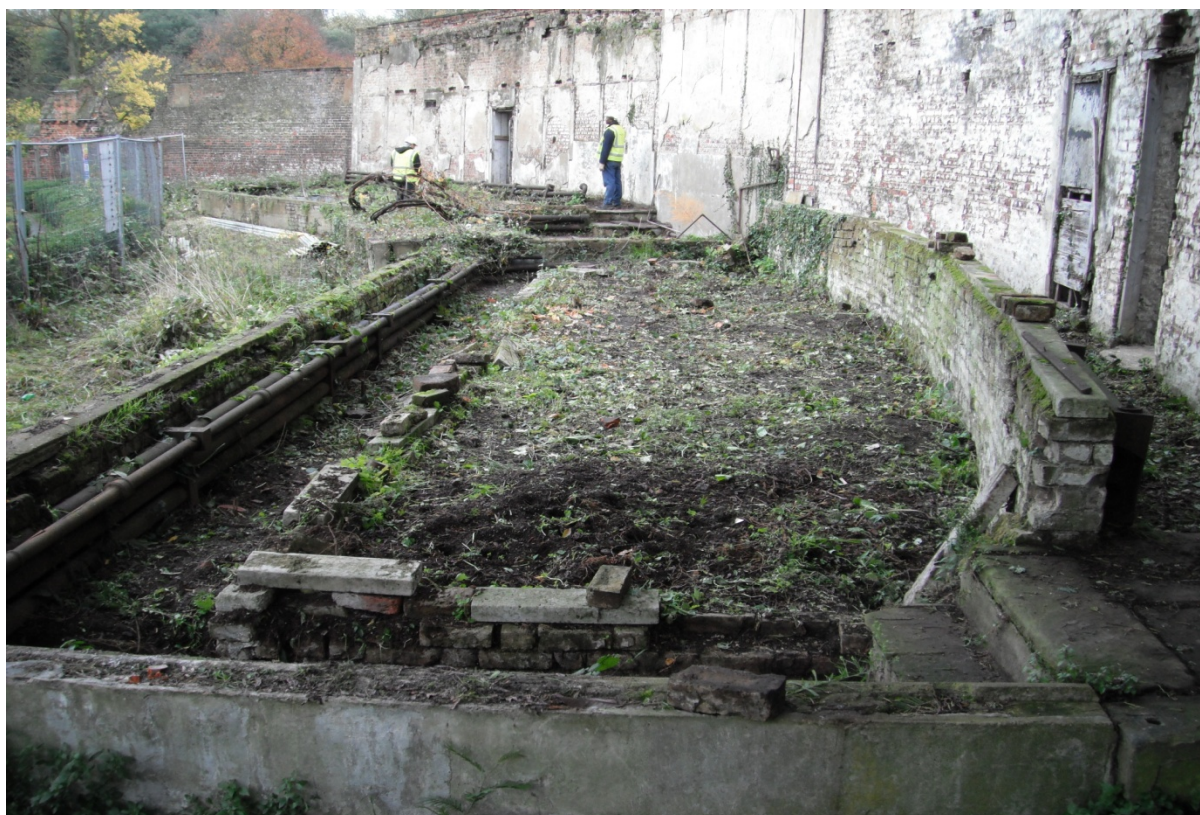
Figure 26: Vinery, facing west
courses, which sprang from a stepped out brick plinth/foundation. Their presence in this area and a

feature recorded as a probable pine pit (pineapples) within the eastern bays may support this notion of an alternative use for this area.
