**HISTORIC BUILDING
RECORDING OF THE NORTH
REGENT'S CANAL WALL
FROM ST PANCRAS LOCK
TO THE CTRL RAILWAY
BRIDGE, KING'S CROSS
CENTRAL, LONDON
BOROUGH OF CAMDEN**

PCA REPORT NO. R11577

NOVEMBER 2013

HISTORIC BUILDING RECORDING

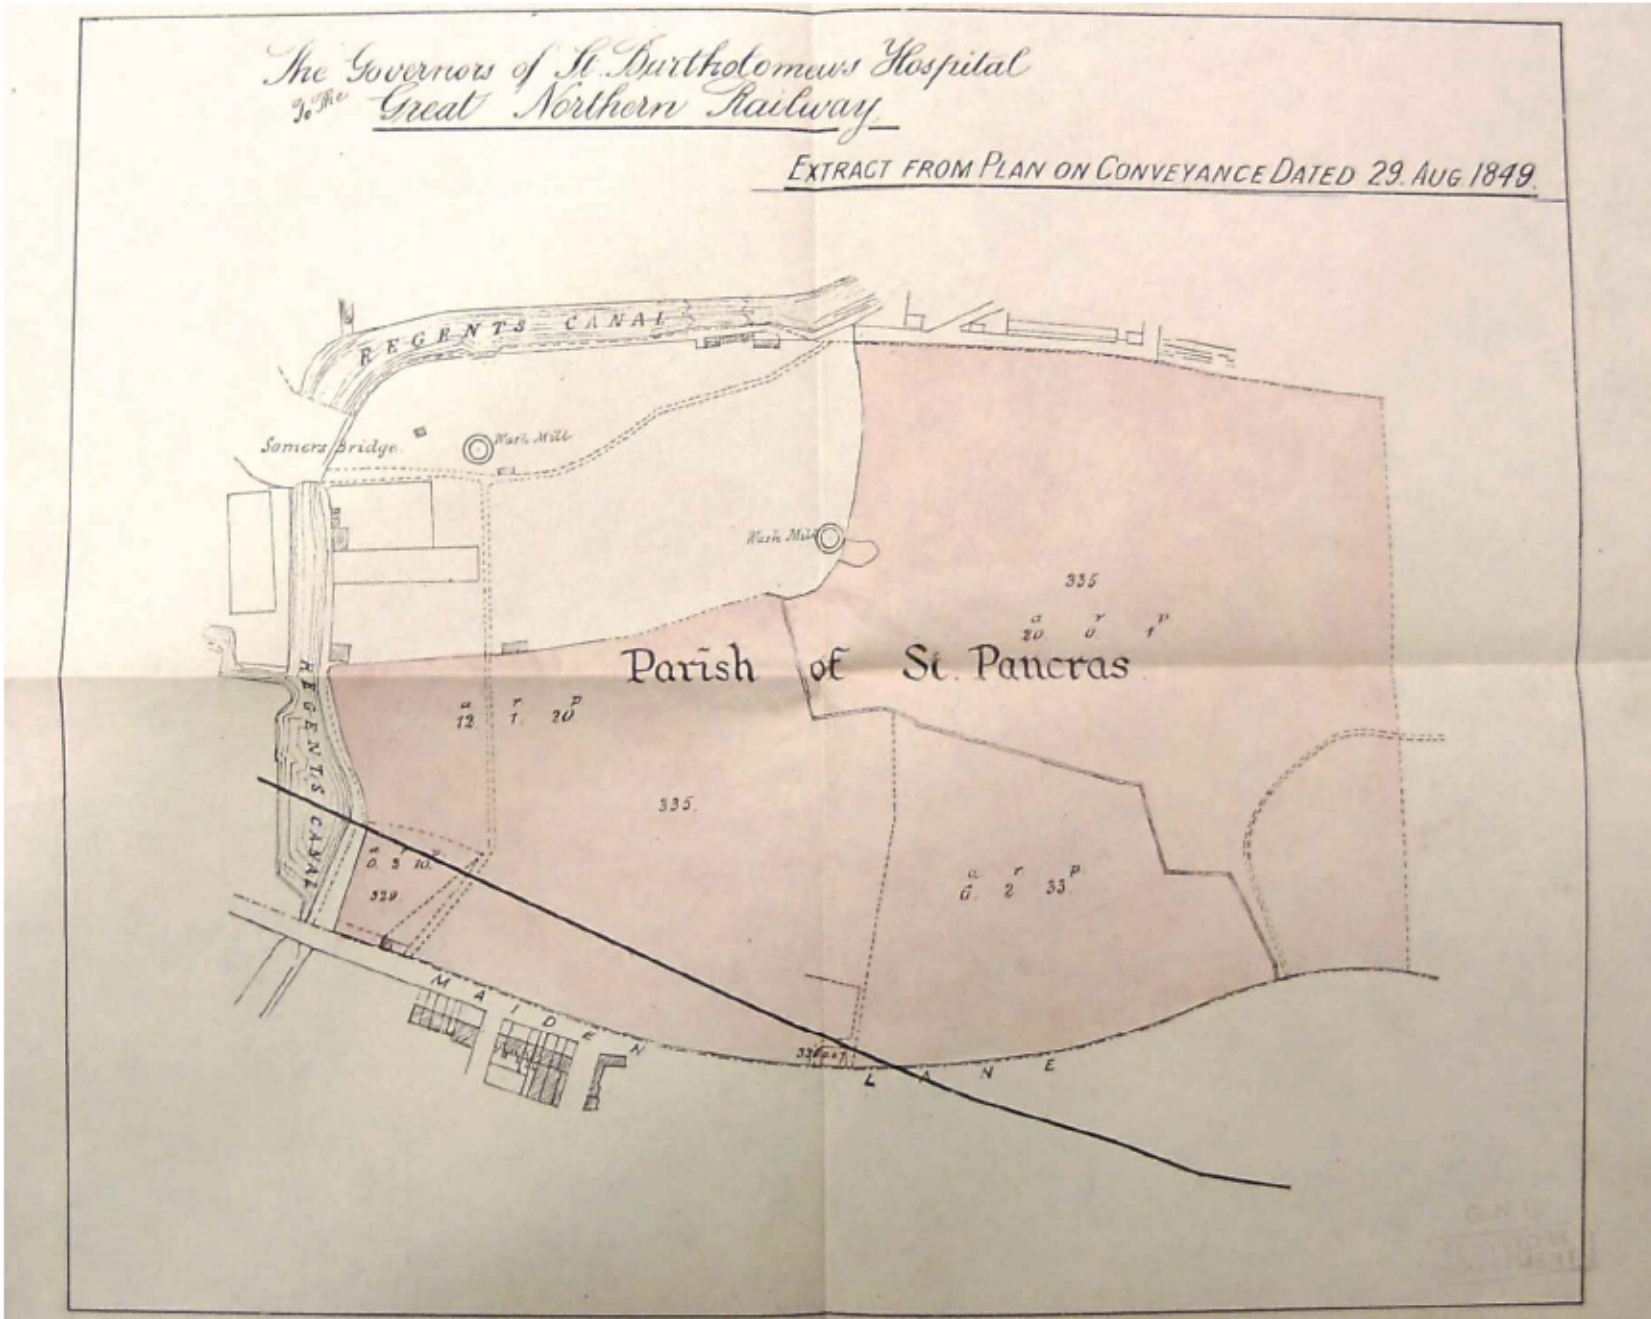
Figure 4
Plan of Conveyance, 1849
Approx. 1:4,000 at A4

EXTRACT FROM PLAN ON CONVEYANCE DATED 29. AUG 1849.

- 4.1.10 A contract to construct the St Pancras lock house worth £102 was awarded to the builder Francis Read in June 1820 (Faulkner, 1990: 48). A photograph of the lock taken in 1911 showed that the cottage was a single-storey structure, surmounted by a large shallow roof that also covered a veranda at the front of the property (**Plate 1**). The presence of at least two tall chimneys suggests that the building was heated. The photograph also showed what appeared to be a toll booth at the southern end of the cottage, adjacent to the southernmost lock gate. It is likely that the complex also included facilities for watering and resting the horses that drew the canal barges. The lock house is first shown on the 1849 plan (**Figure 4**).

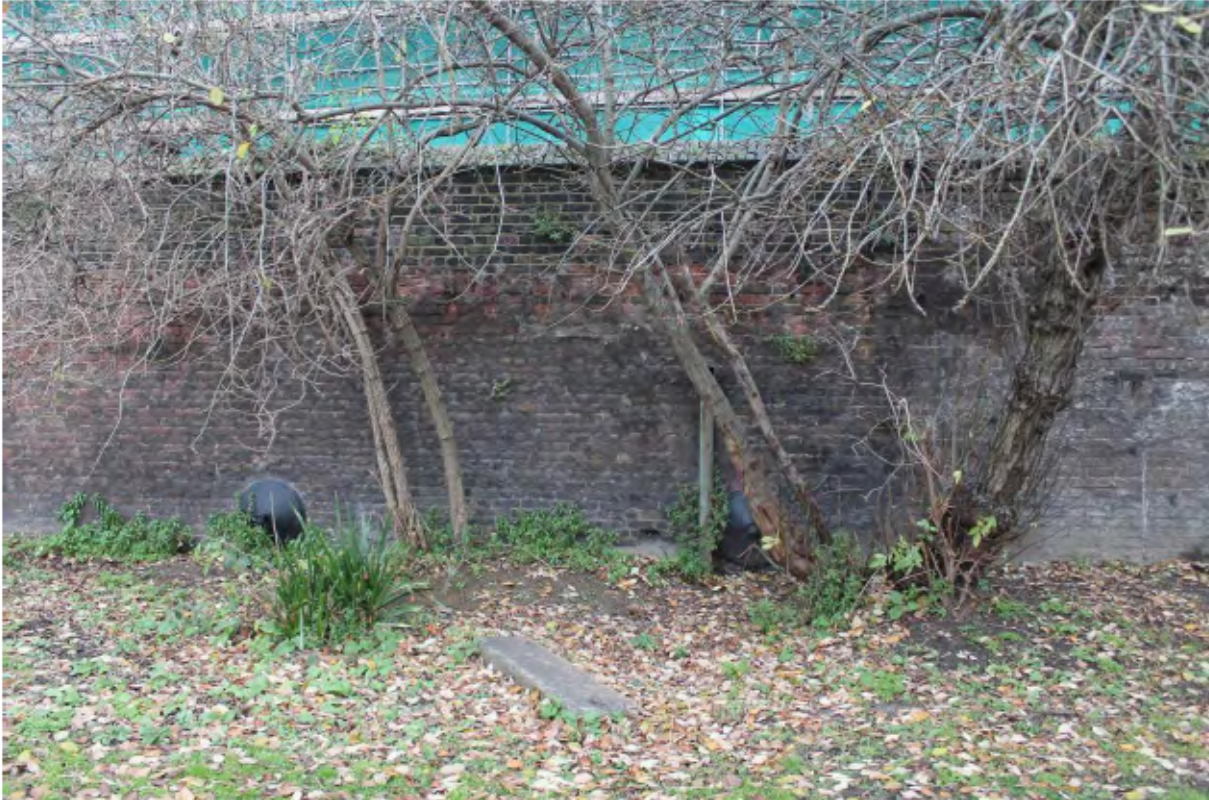
Plate 2: Tie-bar plates at the base of the south-west (canal) side of the north canal wall next to St Pancras Lock (between Points L and M), looking north-east

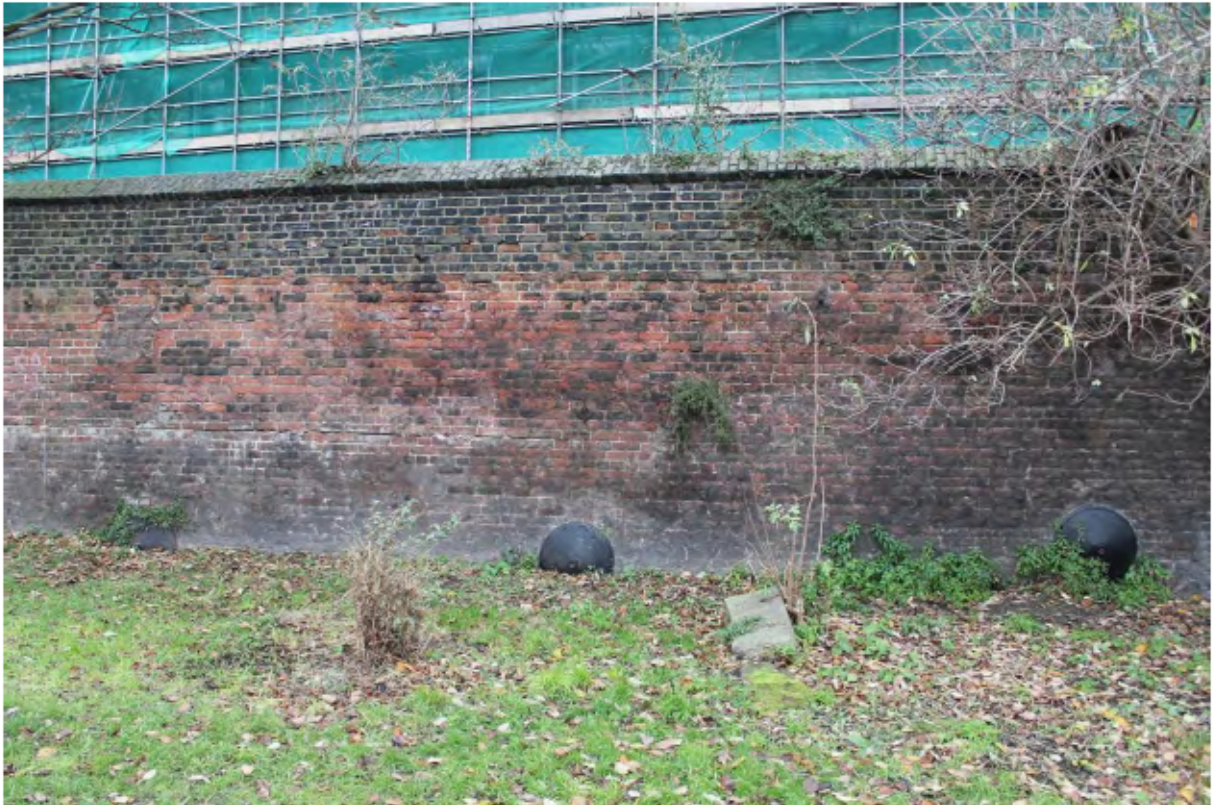
- 5.2.4 Between Points L and M, at the south-eastern end of the survey and in an area adjacent to the lock, evidence of a former building or structure, in the form of a vertical wall scar, 2m in height and 0.3m wide, is present on the south-west (canal) side of the wall. It is located just to the south-east of a modern ventilating or stench pipe to an underground drain and a water stopcock (**Figure 17; Plate 2**). There was no evidence of a return for the wall scar but a significant section of the canal wall brickwork immediately to the north-west of the scar is spalled (**Plates 2 and 3**). Above this, the brickwork (upper eleven courses) is pointed, while below the brickwork is not and is less well preserved. This unpointed and spalled brickwork extends to the west for approximately 13.7m where later patching and pointing obscures a definitive end or return wall. This marks the location of the 1820 lock-keeper's cottage and outbuildings, against which the c.1850 Goods Yard wall was erected (**Plate 1**). Furthermore the presence of small tethering rings set into the canal wall within the area of the removed building suggests that it may also have provided shelter/livery for the canal horses, while barges were passing through St Pancras Lock.

Plate 3: Tie-bar plates and scarring of former building on the south-west (canal) side of the north canal wall next to St Pancras Lock (between Points L and M), looking north-east

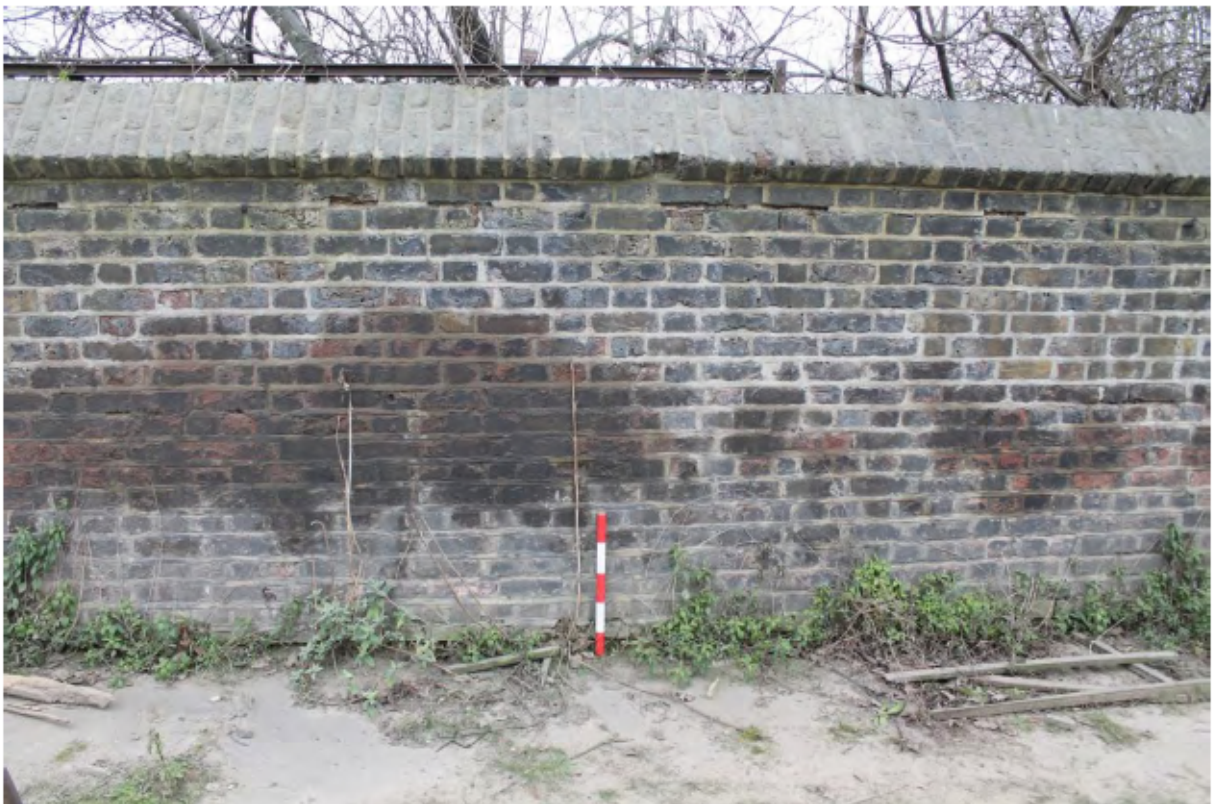
Plate 4: North-east (land) side of the north mid-19th century canal wall at Point L, looking south-west

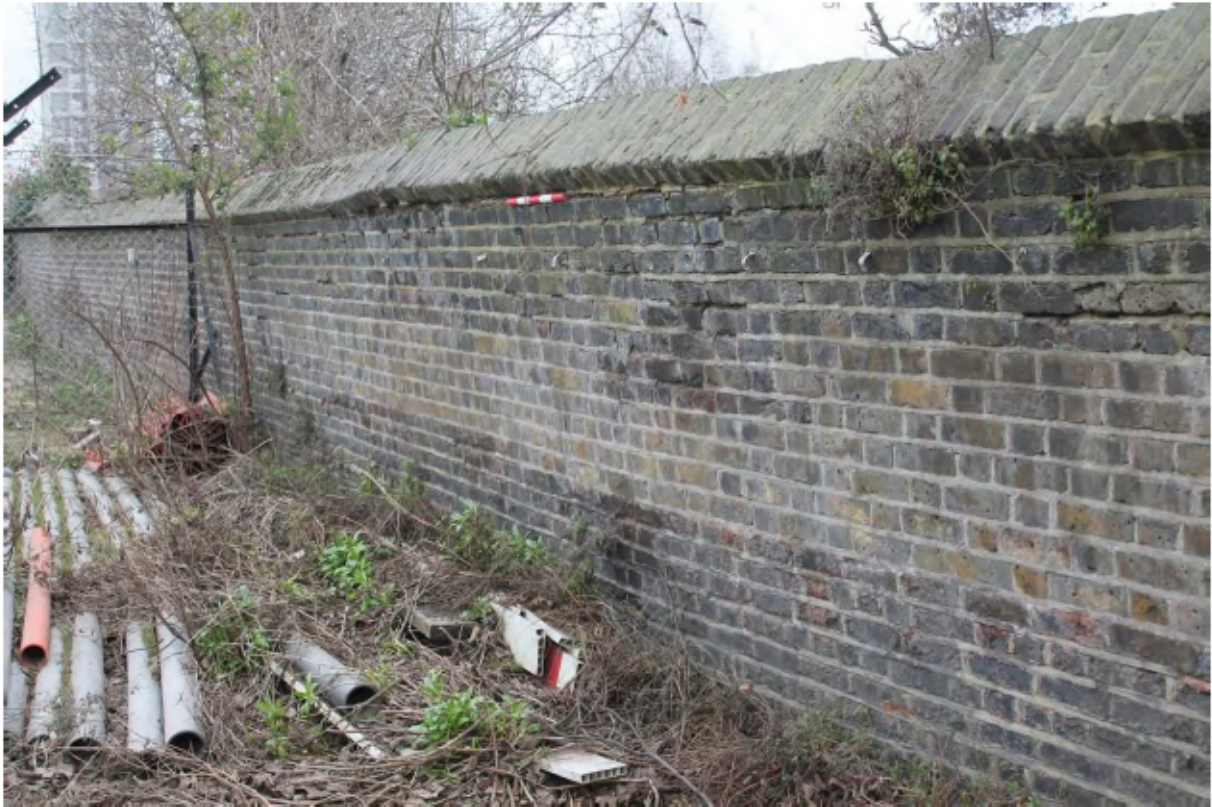
- 5.2.3 The mid-19th century brickwork continues at full height (measuring 3.35 to 3.4m or 40 courses below the coping) uninterrupted to the north-west from Point L for 21.2m to Point M. Later patch repairs using yellow stock brick are present roughly half-way down the wall towards Point M (**Figures 17 and 18; Plates 5 to 7**).

Plate 5: North-east (land) side of the north mid-19th century canal wall, looking south-east from Point M towards Point L

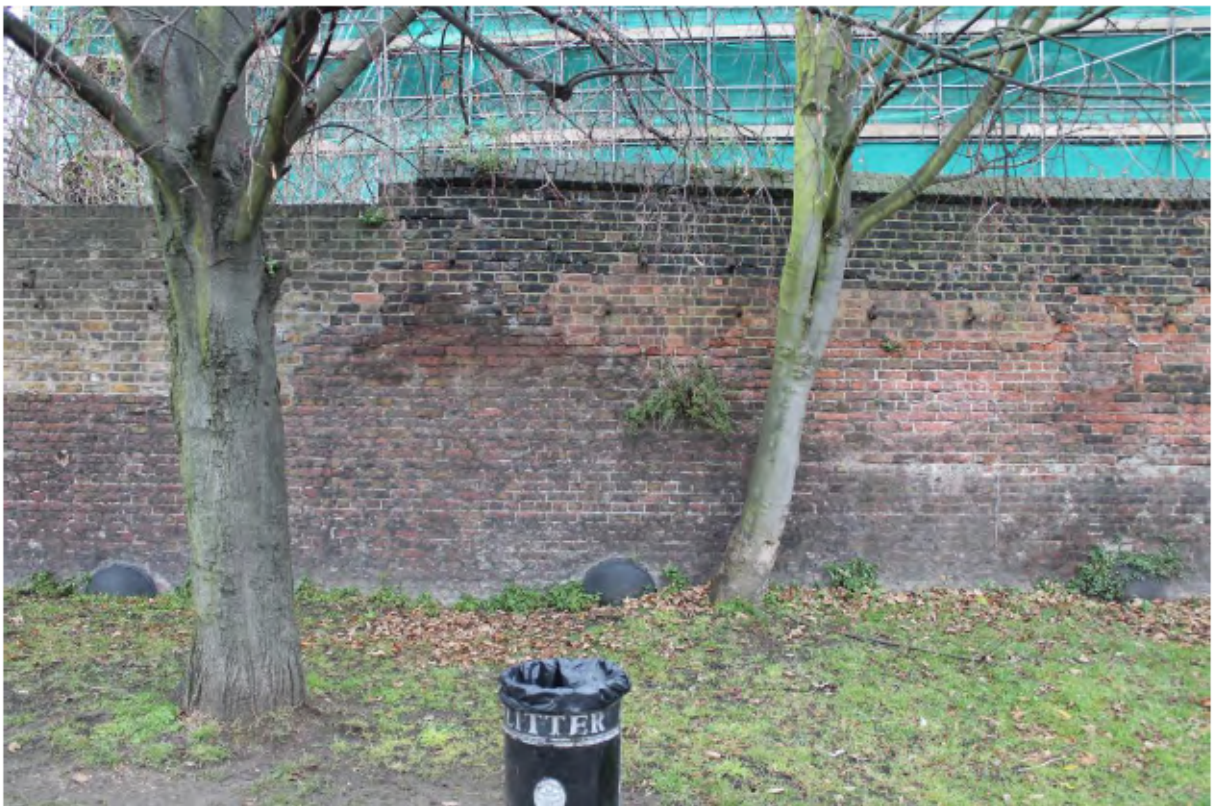
Plate 6: South-west (canal) side of the north canal wall with later rebuilding of the upper part of the wall (left), looking north-east at Point M

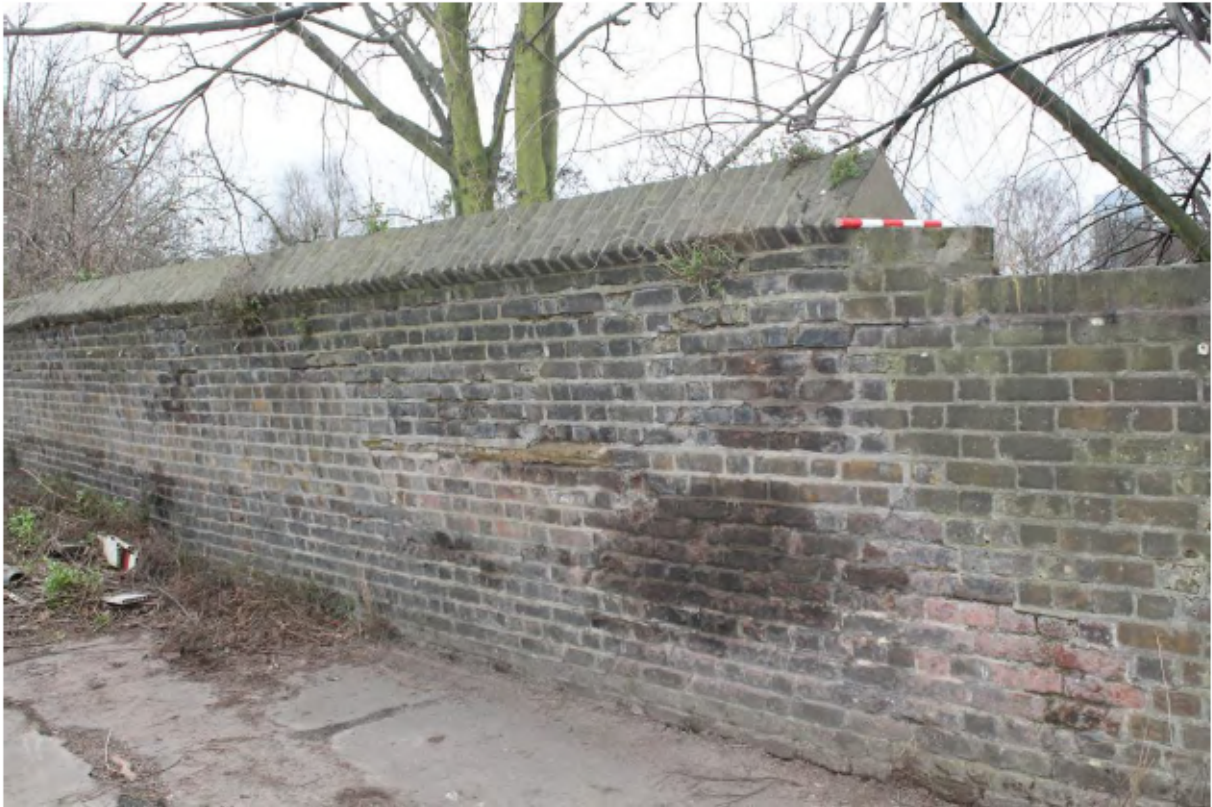
Plate 7: North-east (land) side of the north canal wall at Point M, looking south-east towards Pont L

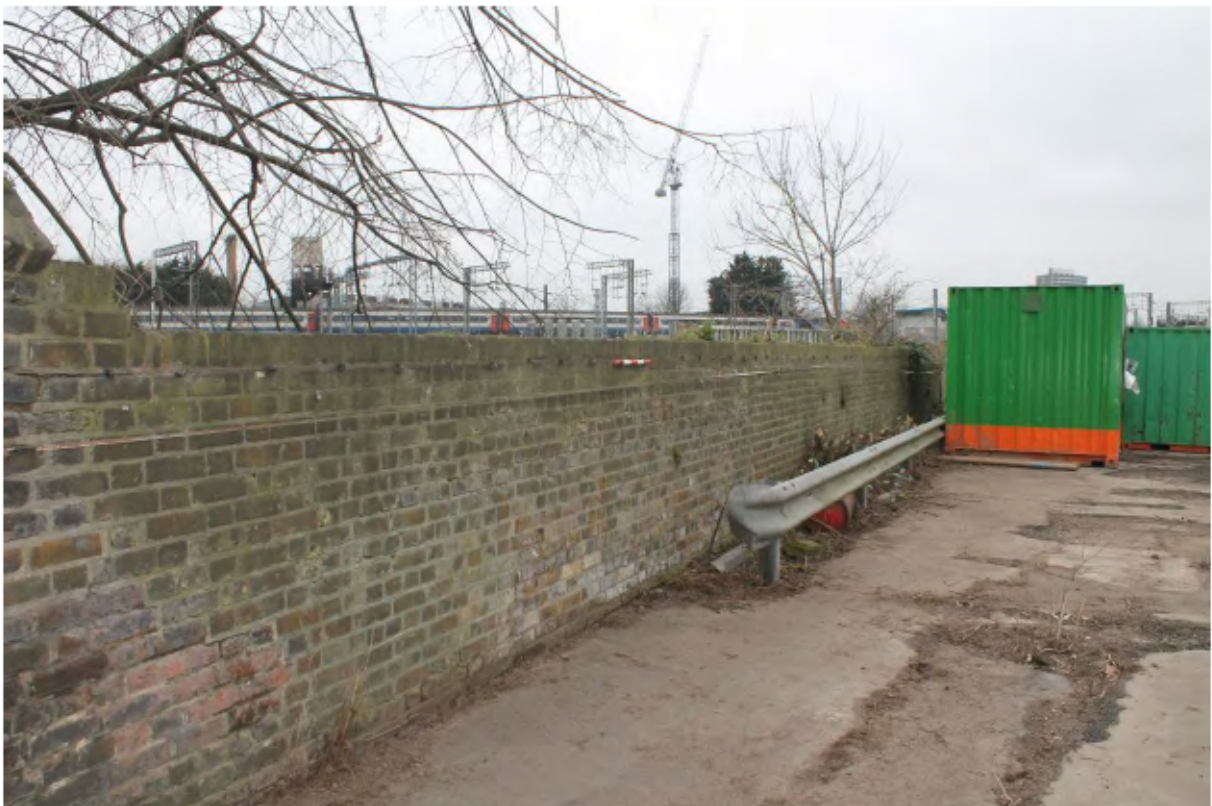
Plate 8: North-east (land) side of the north canal wall showing rebuilt yellow stock brick wall, looking north-west from Point M towards Point N

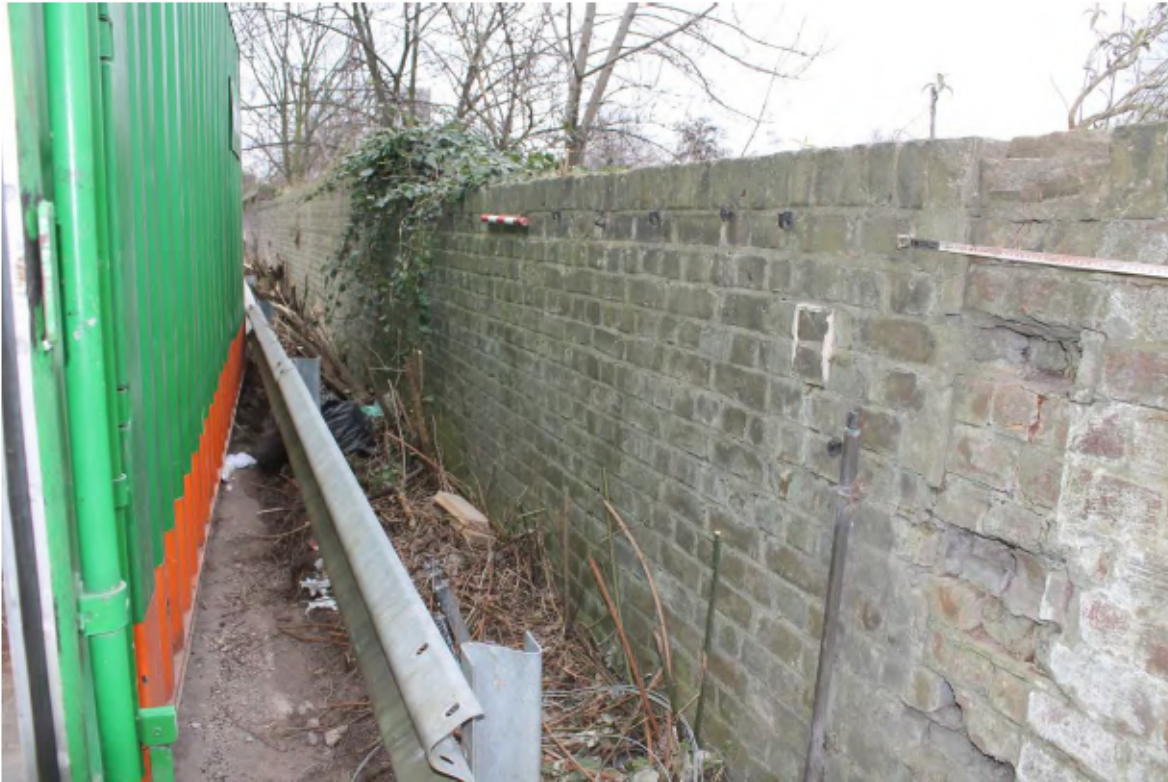
Plate 9: North-east (land) side of the north canal wall showing rebuilt yellow stock brick wall, looking south-east towards Point M

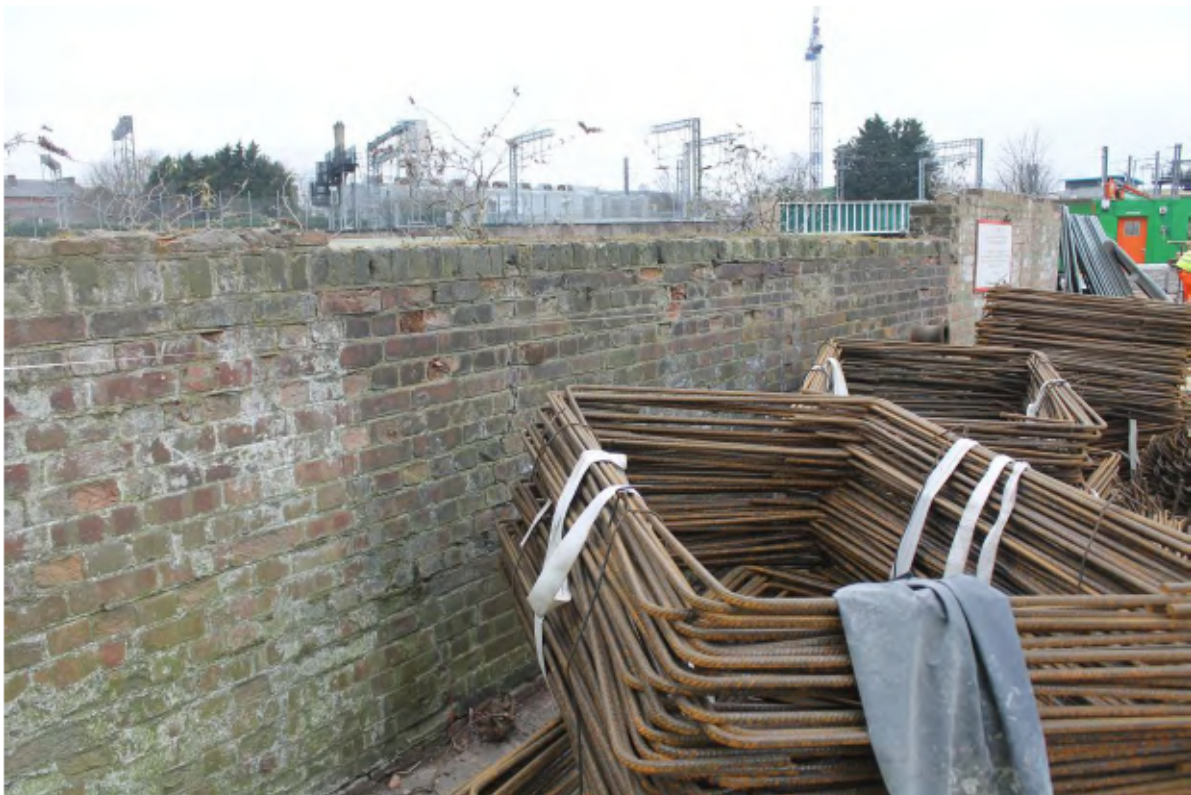
Plate 10: North-east (land) side of the north canal wall showing rebuilt Fletton brick wall, looking north-west towards Point N

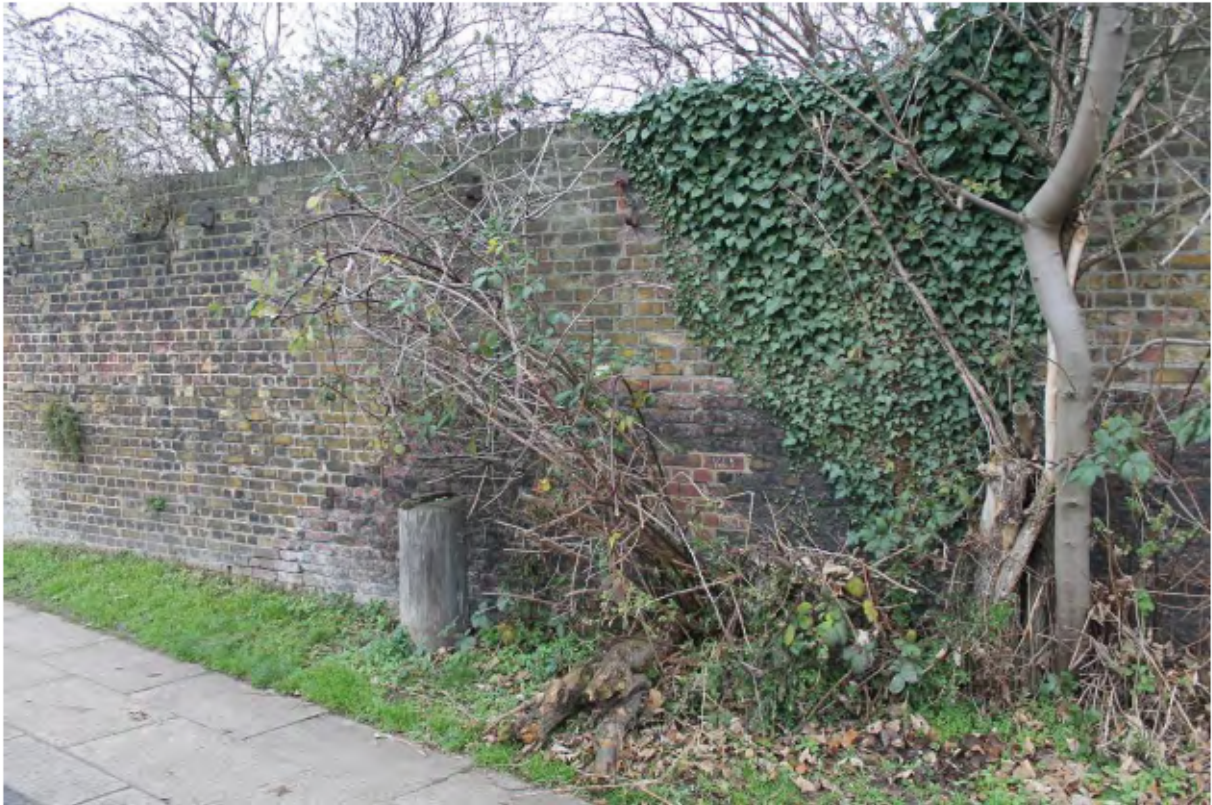
- 5.3.1 From Point M north-westwards towards Point N the upper section of the mid 19th century wall and coping had been replaced by a yellow brick wall of eighteen courses in height (**Figure 17**). The yellow stock brick wall was built in-line and directly onto the remaining lower 20 courses of the mid-19th century brickwork (**Figure 17; Plates 6 and 11**). The upper part of the wall was built using mainly 20th century yellow stock bricks, but incorporated a smaller number of over-fired red and purple/pink coloured bricks and equates with a rebuilding of the wall level with the higher ground surface on the Goods Yard (north-eastern) side of the wall (**Plates 8 and 9**). Each brick is regular machine made and all of them are pocked with voids where impurities in the clay have burnt out. The bricks are laid in quarter-lap English Bond and have been repointed using a cement-based mortar. For the section between Points M and N the wall is topped with a brick-on-edge coping course. At Point M the yellow stock brick wall butts up, using a ragged joint, against the upper courses of the c.1850 brickwork (**Figure 17; Plates 6 to 8**). The canal wall continues north-westwards in this vein for another 20.2m, at which point the yellow stock brick wall on the canal (south-west) side becomes full height (35 courses). It continues as a full-height wall for a further 59m to Point O (**Figure 17; Plates 11 to 13**).

Plate 11: South-west (canal) side of the north canal wall with full height yellow stock brick wall (left), looking north-west towards Point N

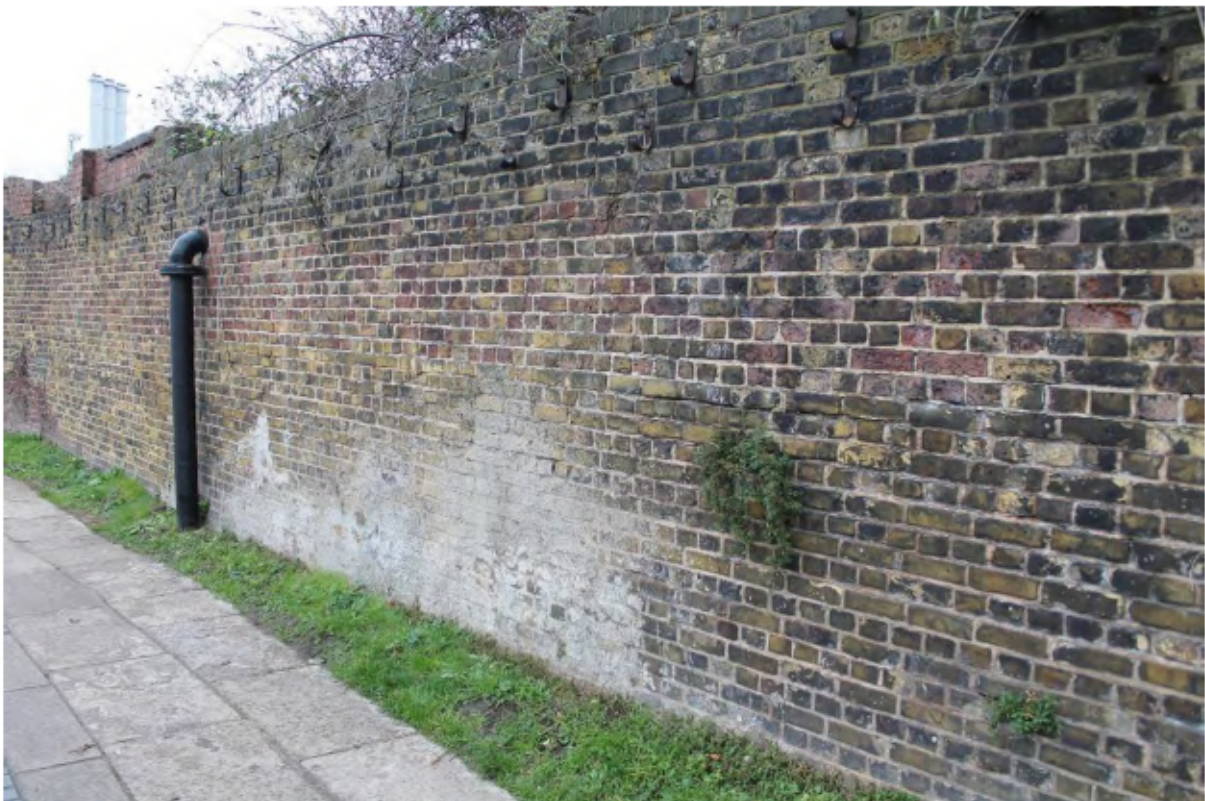
Plate 12: South-west (canal) side of the north canal wall showing 1951 water suction pipe looking north-west towards Point N (near the pipe) and beyond

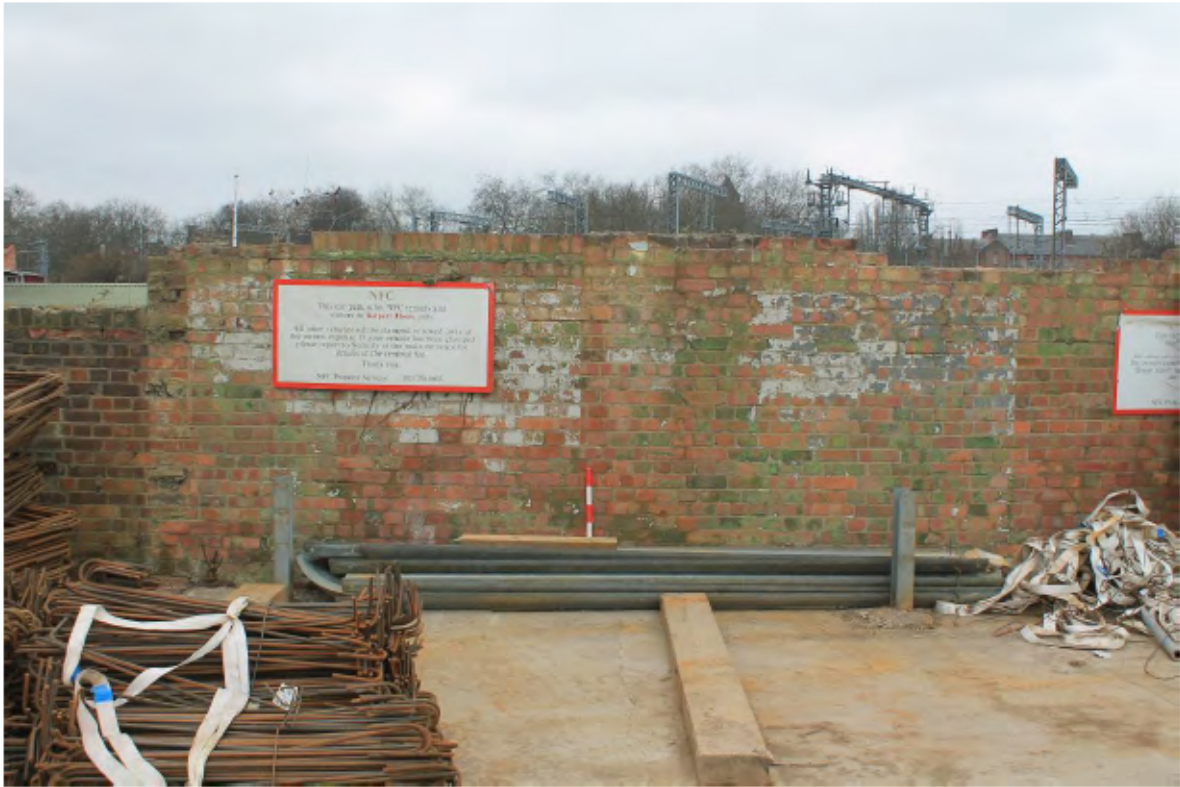
Plate 13: North-east (land) side of the north canal wall showing rebuilt Fletton brick wall, looking south-west with Point N to the left (south-east)

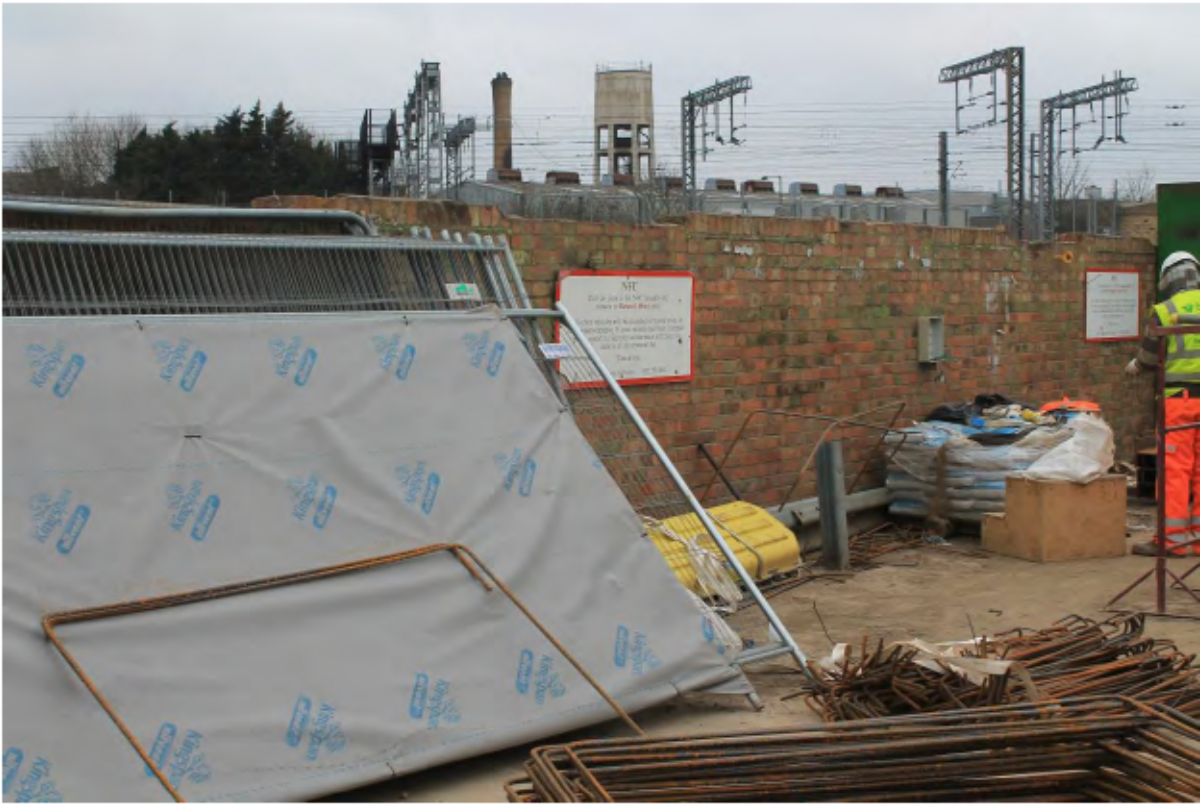
Plate 14: North-east (land) side of the north canal wall showing rebuilt Fletton brick wall, looking west with Point N to the left (south-east) and Point O to the right (north-west)

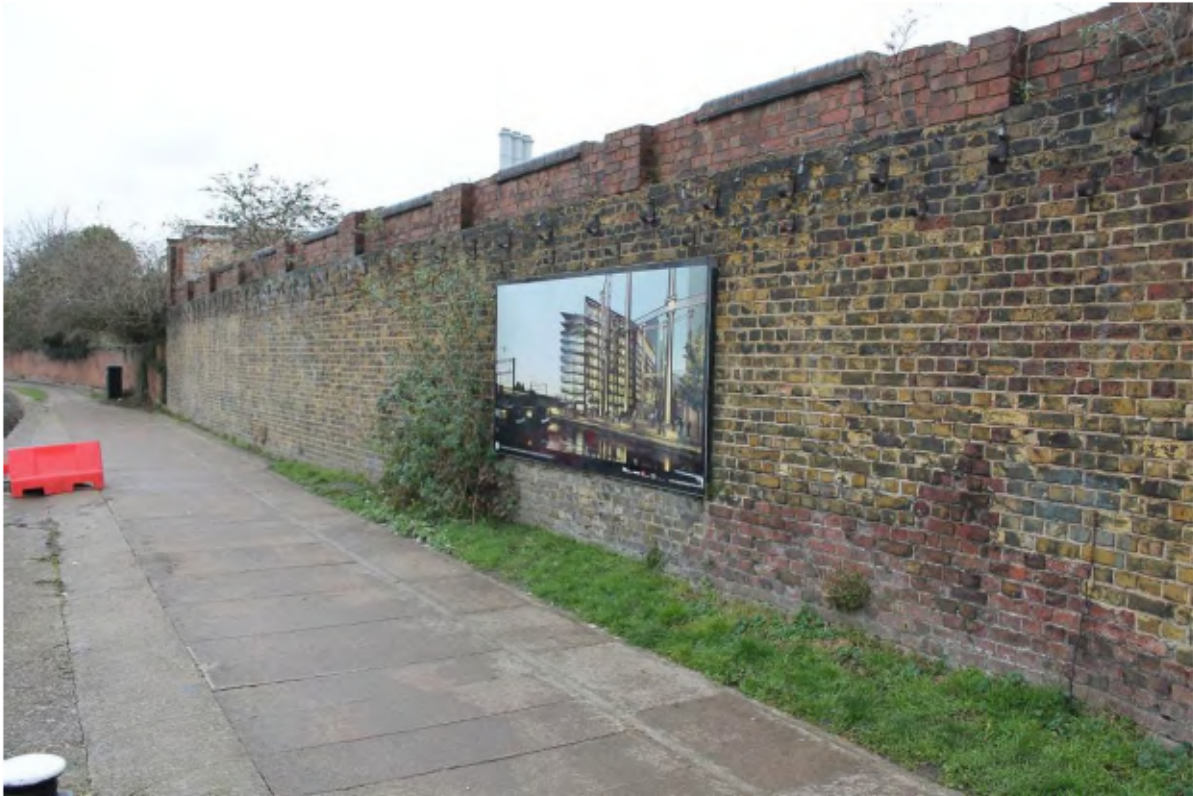
Plate 15: South-west (canal) side of the north canal wall showing overlying Fletton brick wall with integral pilasters and bases of openings looking north-west from Point N towards Point O and beyond

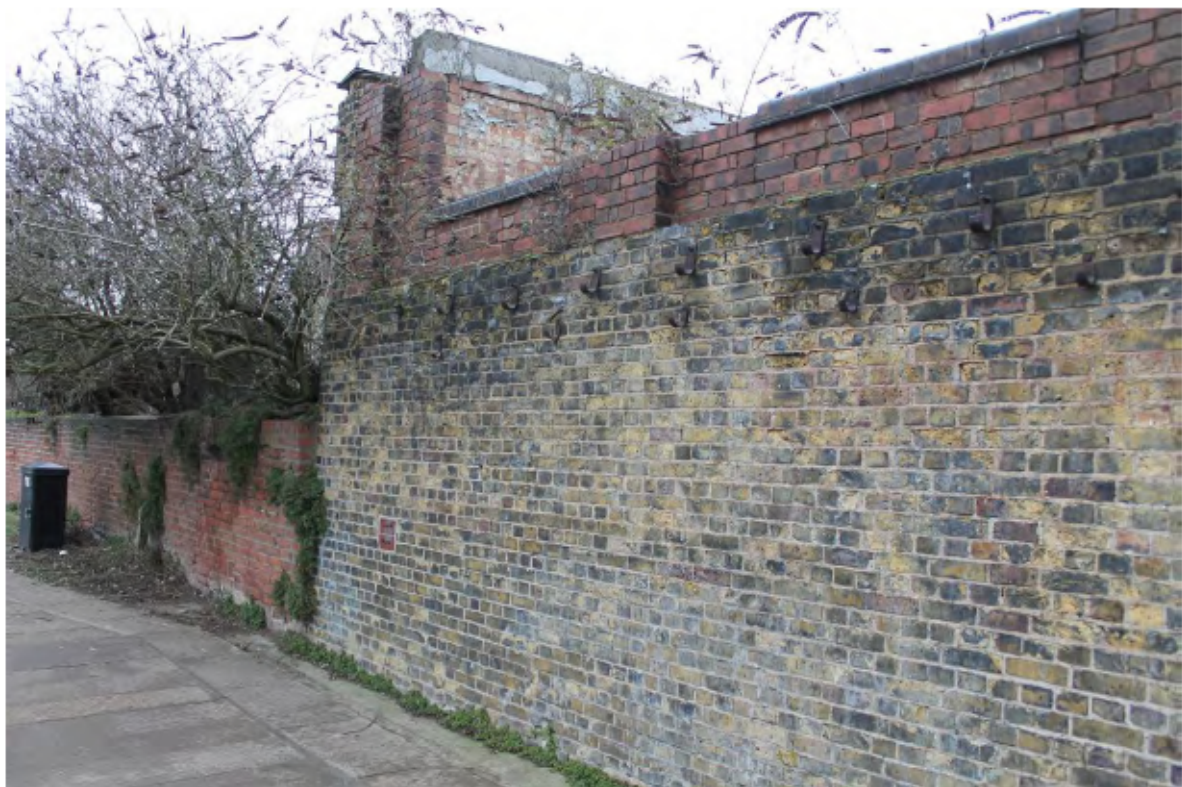
Plate 16: South-west (canal) side of the north canal wall showing overlying Fletton brick wall with integral pilasters and bases of openings looking north-west to Point O and beyond

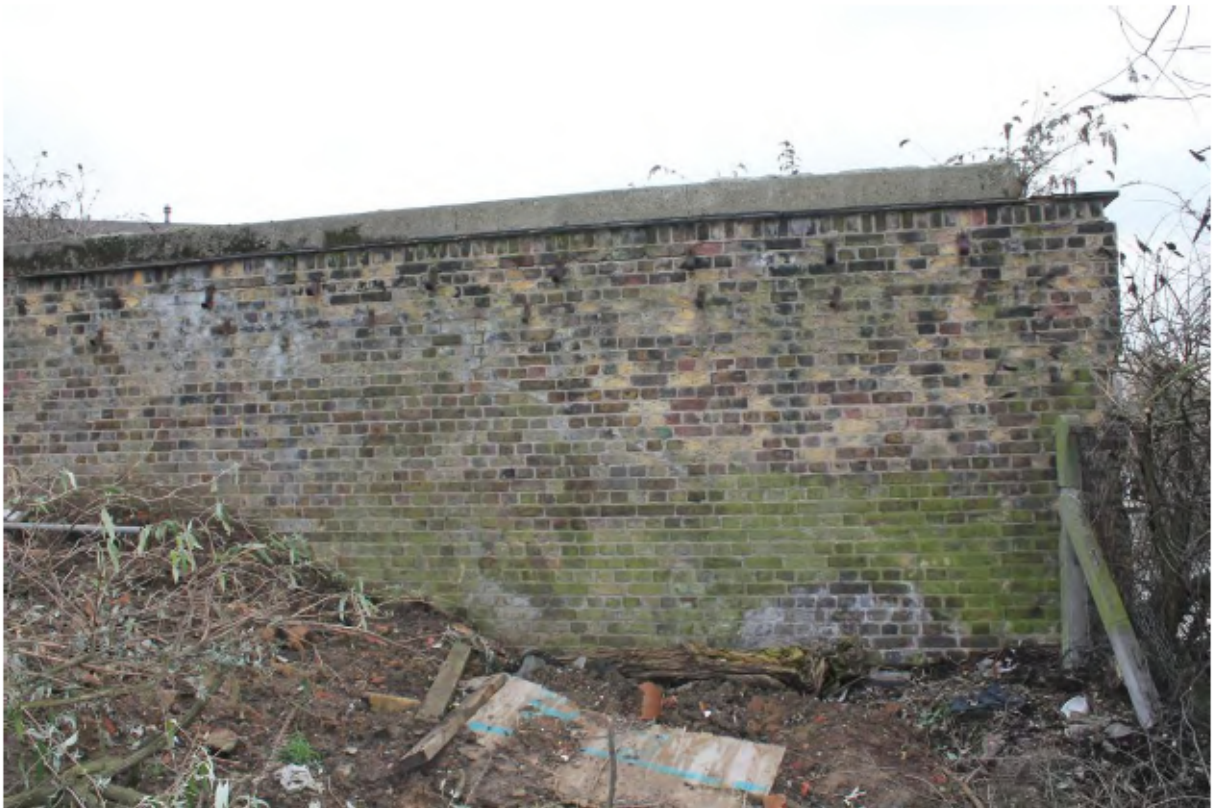
Plate 17: North-west side of return wall (Point O (right) to Point P (to the left), looking south-east

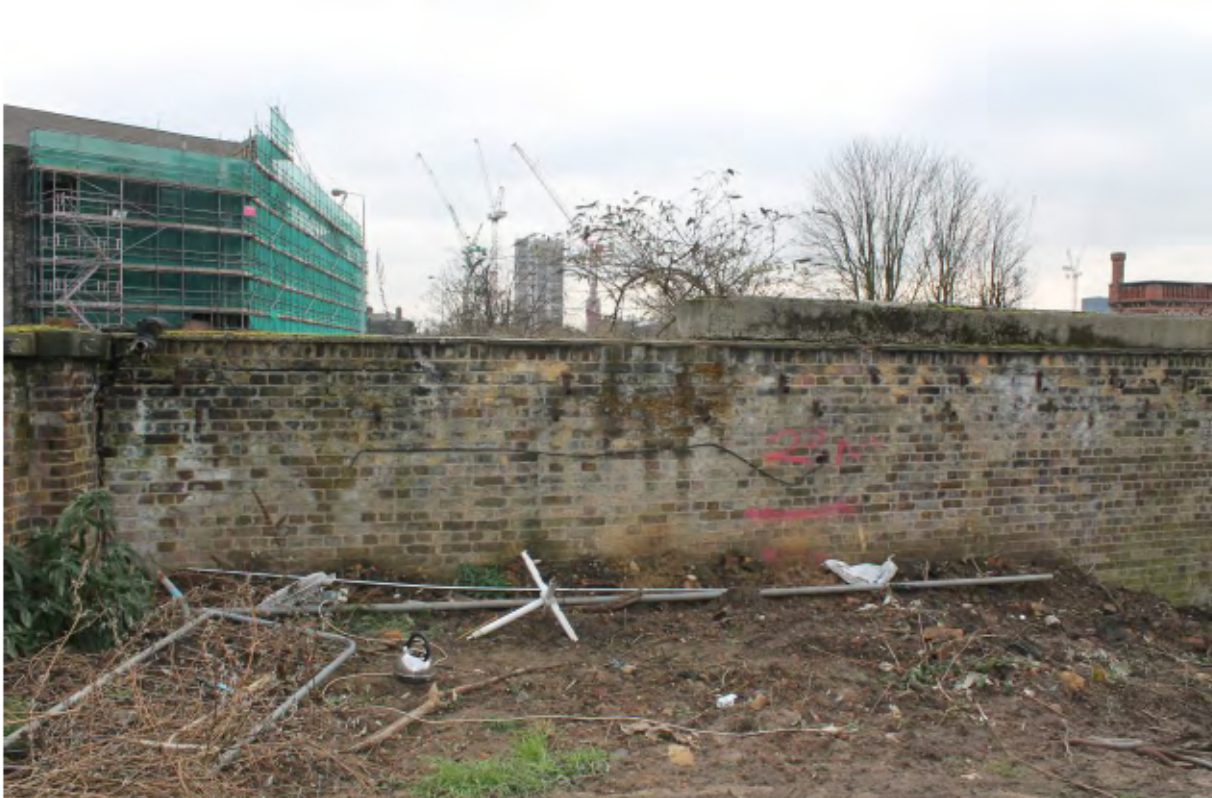
Plate 18: North-west side of return wall (Point O to the right) to Point P (left), looking south-east

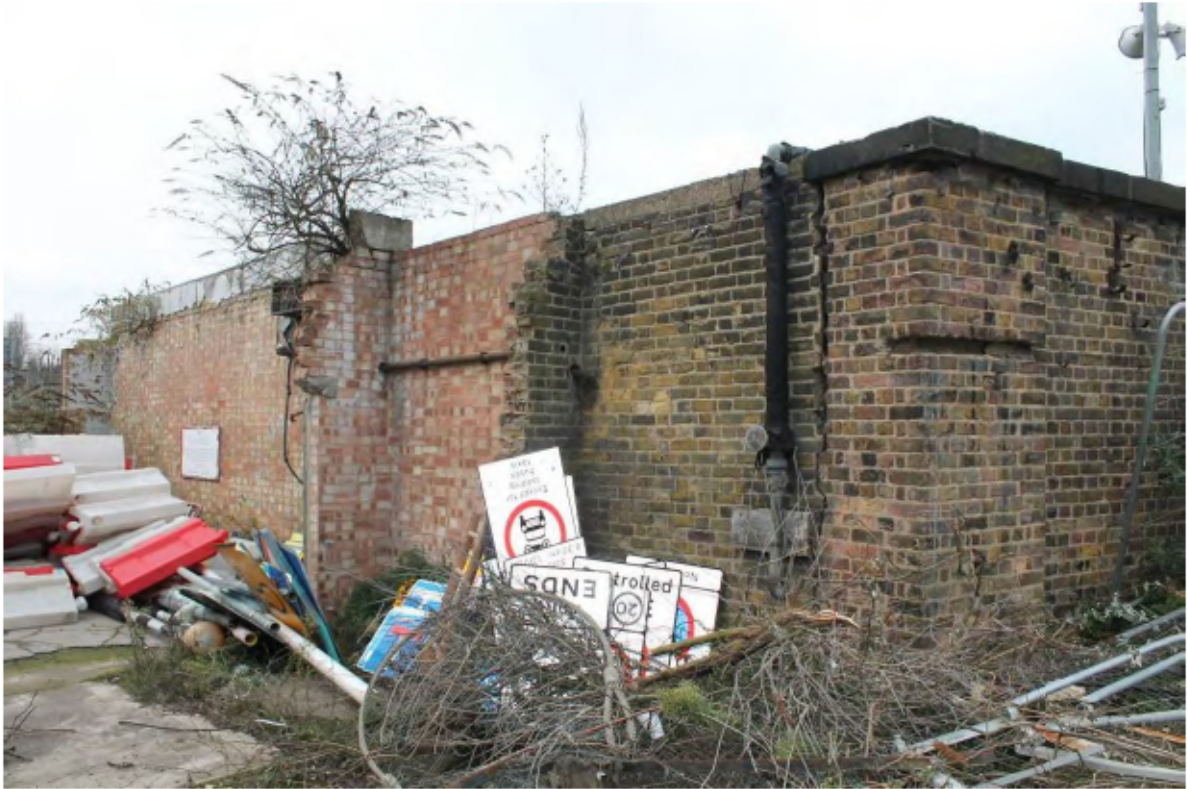
Plate 19: Pier (right) at Point P and remains of Fletton brick building, looking west towards Point O (left)

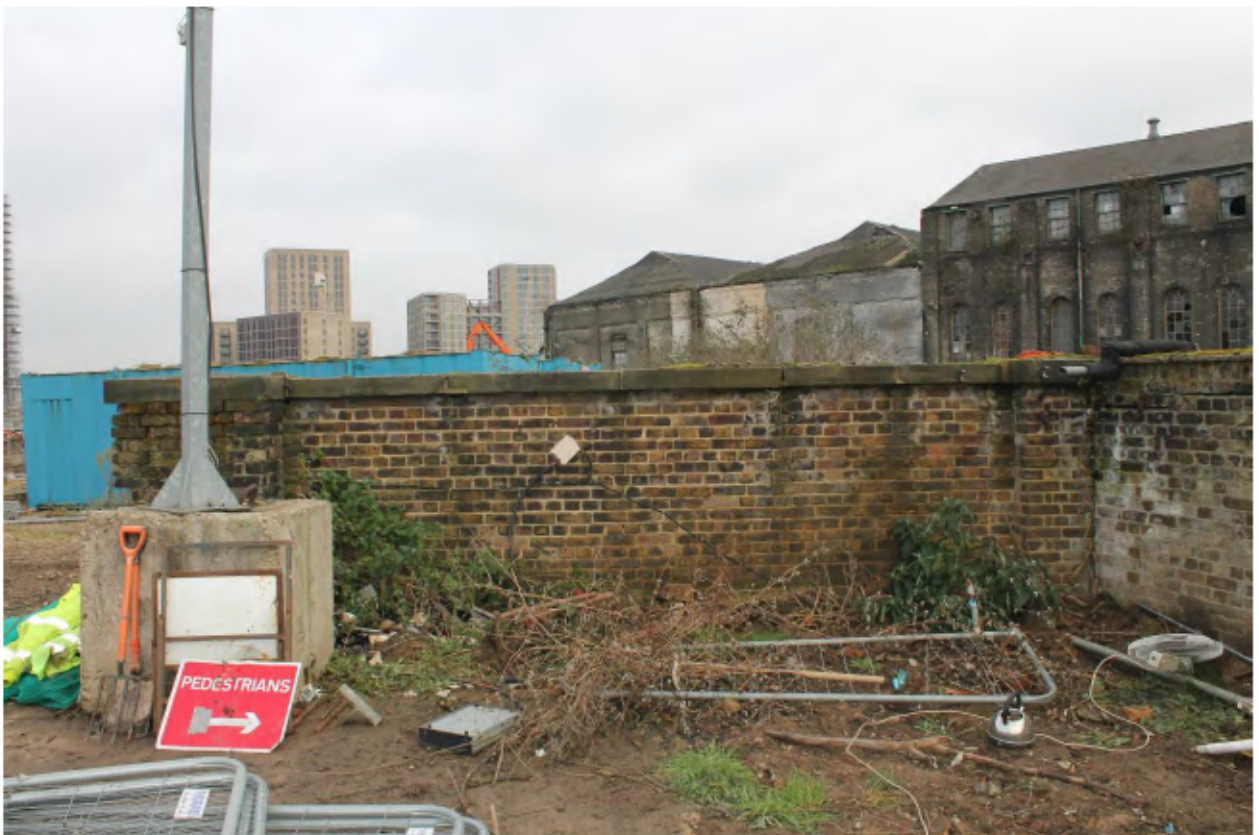
Plate 20: Pier (left) at Point Q and pier (right) at Point P, looking north-east
