**HISTORIC BUILDING
RECORDING OF THE NORTH
REGENT'S CANAL WALL
FROM ST PANCRAS LOCK
TO THE CTRL RAILWAY
BRIDGE, KING'S CROSS
CENTRAL, LONDON
BOROUGH OF CAMDEN**

PCA REPORT NO. R11577

NOVEMBER 2013

HISTORIC BUILDING RECORDING

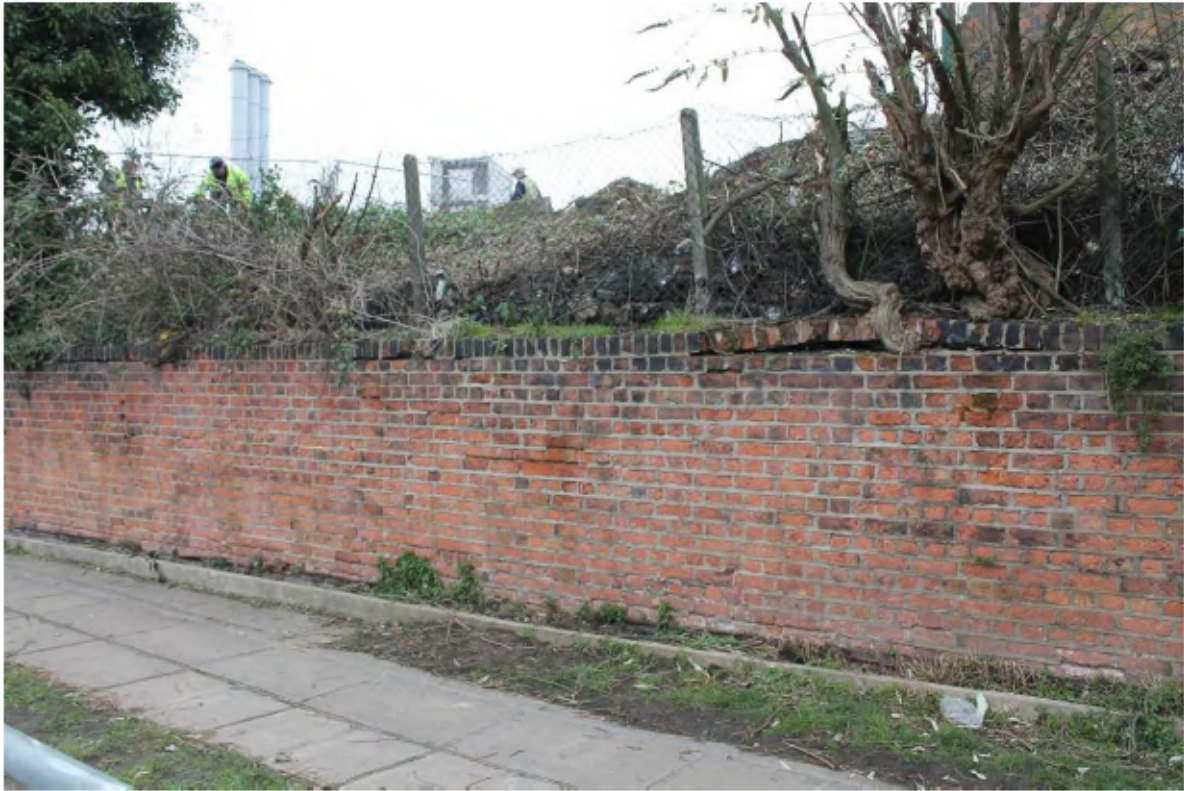
Plate 21: South-west (canal) side of the low red brick north canal wall with chain-link fence above, looking north between Point O and the CTRL Bridge

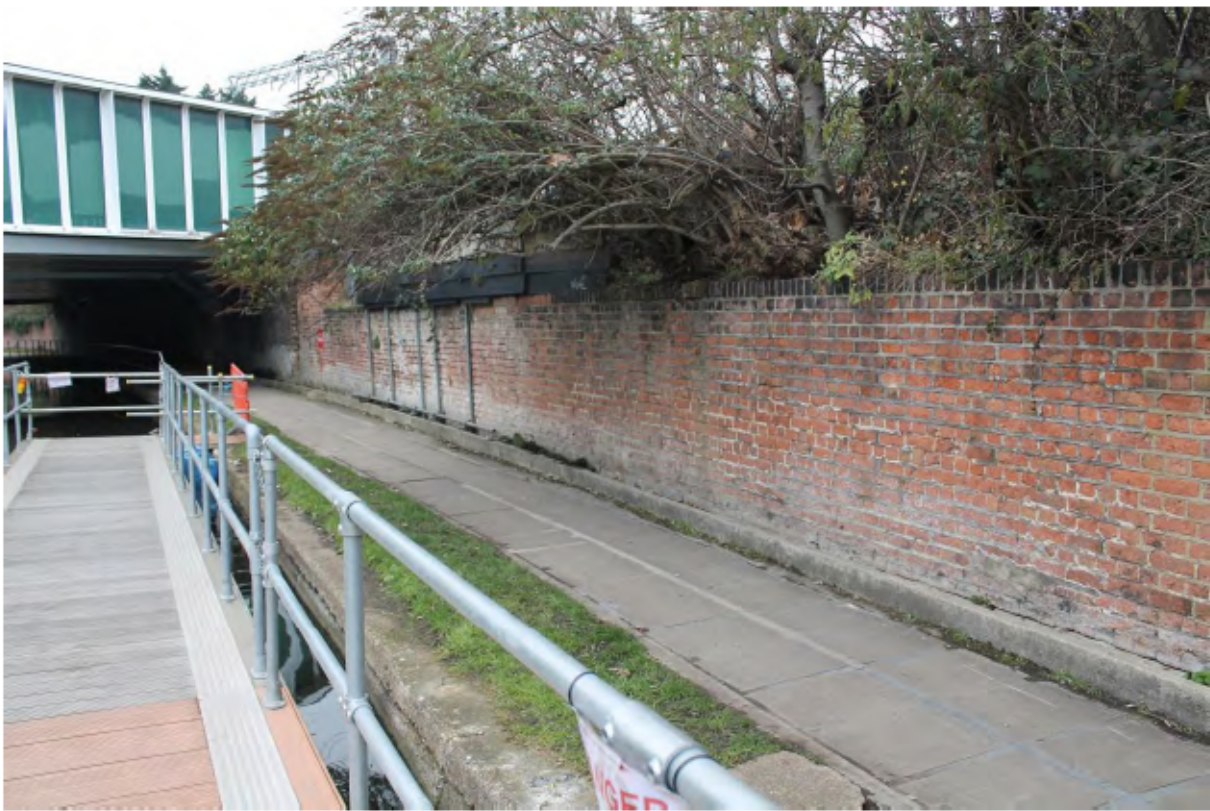
Plate 22: South-west (canal) side of the low brick north canal wall (centre and right) and CTRL Bridge (left) looking north towards Point R
