**55 SOUTHWARK STREET,  
SOUTHWARK,  
LONDON BOROUGH OF  
SOUTHWARK**

**ARCHAEOLOGICAL  
EVALUATION**

**REPORT: R11586**

# **An Archaeological Evaluation at 55 Southwark Street London SE1 1RU**

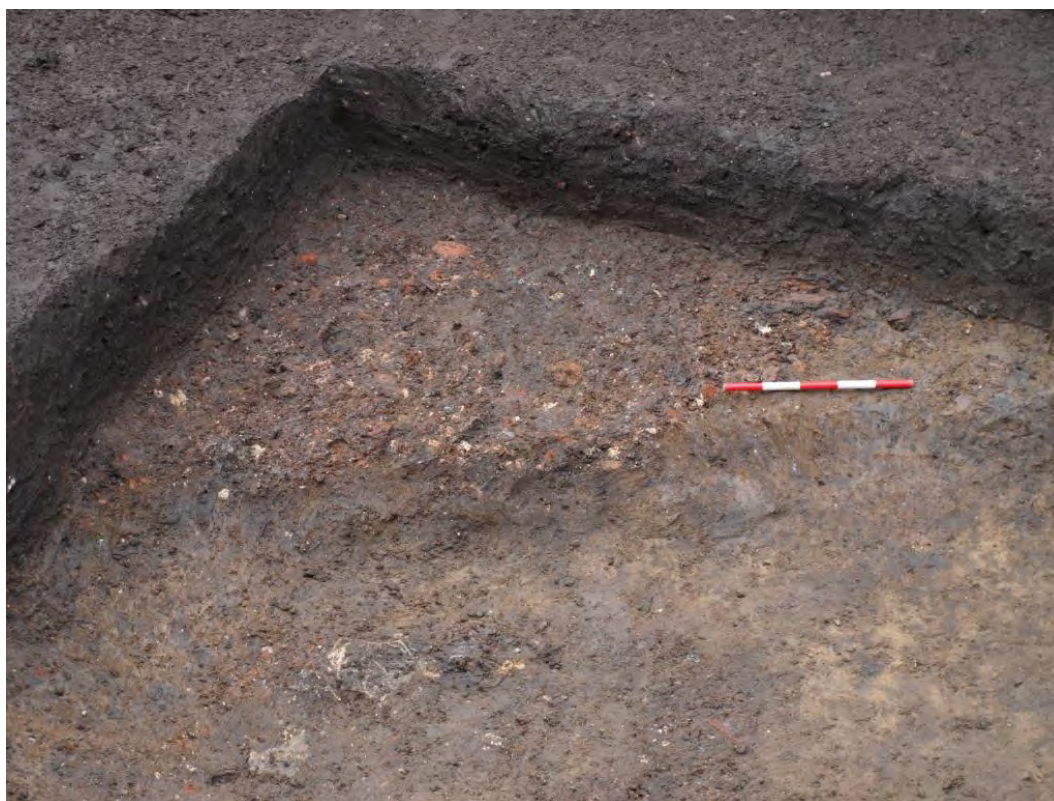
Plate 2: Roman demolition debris, layer [83]  
Scale 0.50m

- 7.2.4 Excavation in Trench 4 was also limited and only a small part of the Roman sequence was sampled. A large late Roman ditch [79], which is described below, ran through most of the base of the trench and this was only partially excavated in order to collect dating evidence. However, a small area of earlier stratigraphy was exposed and some of the layers and features partially excavated. A considerable quantity of building debris [83] was evident in the southwest corner of the trench (Plate 2, below). This layer contained large fragments of burnt daub, *opus signinum* (concrete) and ceramic building material. Unfortunately no pottery was recovered from this layer but the assemblage of building material, dated AD 55-80+, might be viewed as characteristic of a high status Roman building, probably dating to the 1st or 2nd centuries AD. It was unclear from the small truncated area of this deposit that lay within the trench whether the layer represented discarded building material or demolition debris from a building that had once stood on the site. This layer was recorded at a maximum of 1.01m OD.

- 7.2.5 A substantial sub-rectangular pit [82] had been truncated by the later ditch [79] and lay to the east of layer [83]. The original depth of this feature is unknown, as excavated it measured 1.65m north-south by 1.50m east-west and was 0.30m deep. This pit also contained a considerable quantity of building material, specifically ragstone rubble but also large fragments of *opus signinum* and tile. This material may have been discarded or the pit might be interpreted as a robber cut, which would imply the presence of a large masonry structure on the site. The pottery recovered from this feature has been provisionally dated AD 50-160. The truncated top of the pit was recorded at +0.84m OD.

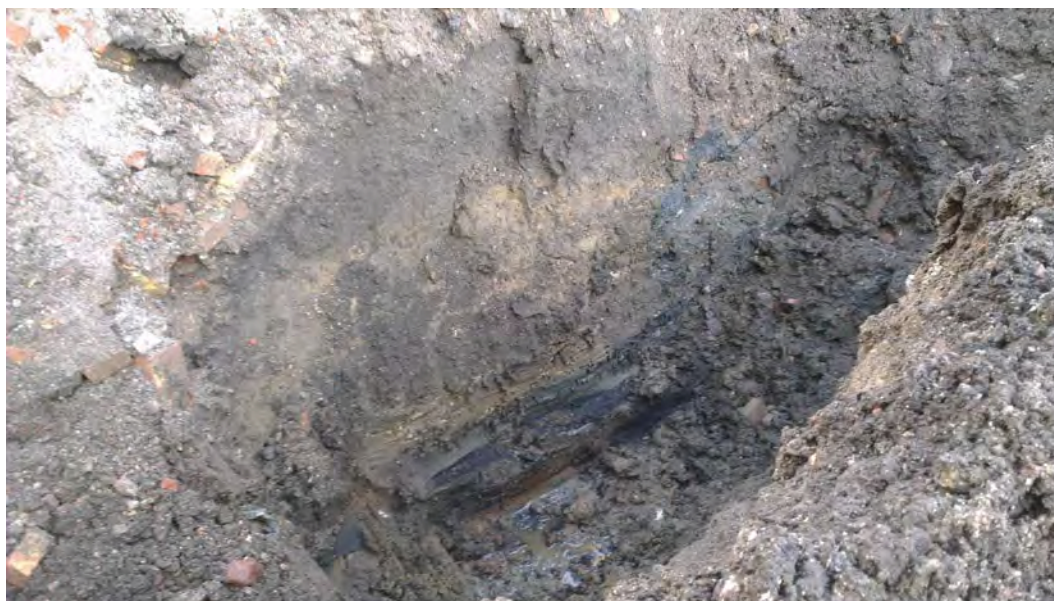
Plate 3: Part of timber structure [90]

- 7.2.7 The integrity of the archaeological resource located below the basement was amply demonstrated by a remarkable find was made whilst observing the removal of the concrete foundation which had supported the southern wall of the basement. The foundation in this area was much deeper than the basement itself and the other foundations found in this area. This provided a window into the earlier stratigraphy and by remarkable good fortune the line of the modern foundation coincided with a substantial timber structure [90] which was aligned roughly east-west (Figure 8 and Plate 3 above). The depth of the foundation trench prevented safe entry to the trench and at present the only record of its existence consists of digital photographs. However, observations made on site suggest that the structure was composed of a series of large squared timber baulks c 0.50m wide that were supported or held in place by upright posts.

- 7.2.8 The date of this timber structure is currently unknown as there was no opportunity to excavate the associated stratigraphy or even enter the trench to effect more detailed recording and recover dating material. However, the depth at which it was discovered, c. 5m below current ground level or c.-0.60m OD, demonstrated that this is almost certainly a Roman structure and one that is likely to date to the earlier part of the Roman period. The timberwork was traced over a distance of c. 5.80m east-west; the structure continued to the east beyond the limits of the foundation trench and passed beyond the northern limit of the trench to the west.

- 7.2.9 The alignment of structure [90] falls almost exactly along the predicted southern edge of the Southwark Street channel. It is therefore probable that this substantial timberwork represents an attempt to manage the embankment. If this interpretation is correct the nature of the material seen in the foundation trench in association with the timberwork is of some

- 9.1.2 The function of the timber structure seen in the base of the modern foundation trench is as yet unproven but the alignment of this feature suggests very strongly that it is a timber waterfront. Detailed recording could not be undertaken due to the depth of the machine excavated trench but it can be stated that the timbers exposed were of a size that is rarely seen in Roman Southwark and although they by no means resembled the massive baulks used in the quayside constructions found on the north bank they did suggest a very heavy duty structure.

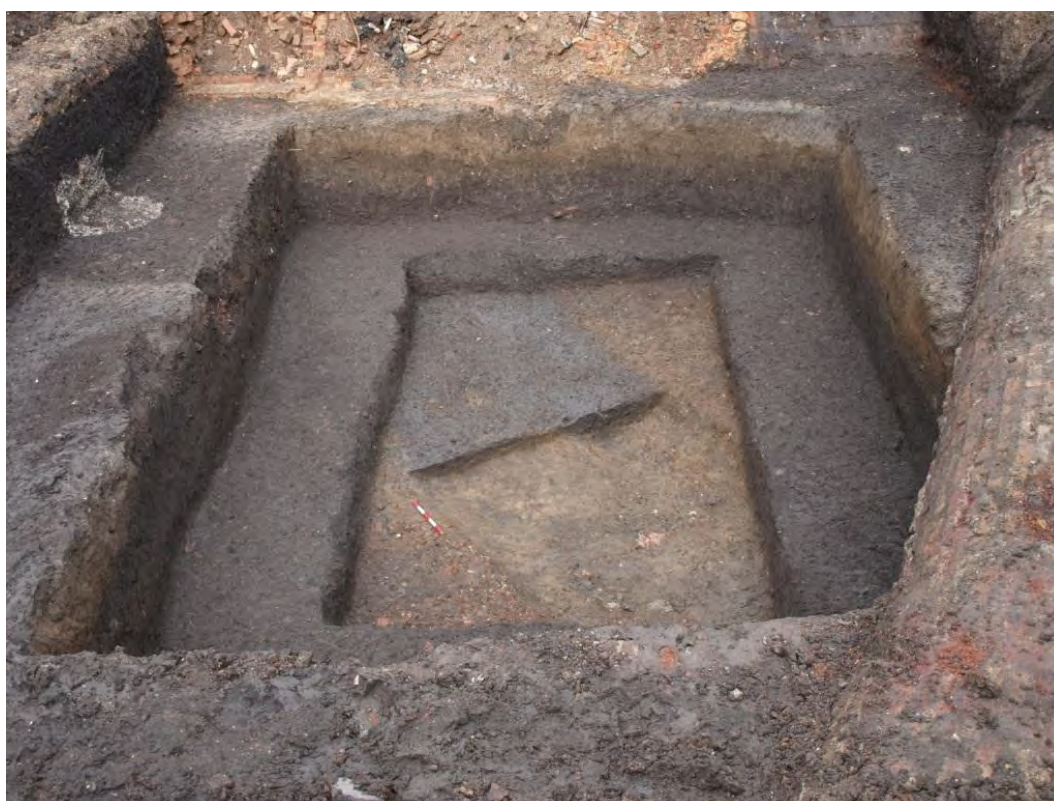
Plate 4: Fourth century Roman ditch [79]  
Scale 0.50m

- 7.3.5 Ditch [79] was only partially excavated; but might actually represent more than one feature. The base of the ditch was not flat at the point where excavation ceased and the profile of the base suggested that the feature excavated as a single ditch might represent two parallel ditches or more probably a shifting boundary that was redefined by the excavation of a new ditch. This possibility might be resolved by further excavation. As seen the ditch was very wide and flat-bottomed compared to its depth. It may originally have been considerably deeper but this might not be fully reflected by the excavation results as the top could have been truncated by later riverine erosion.

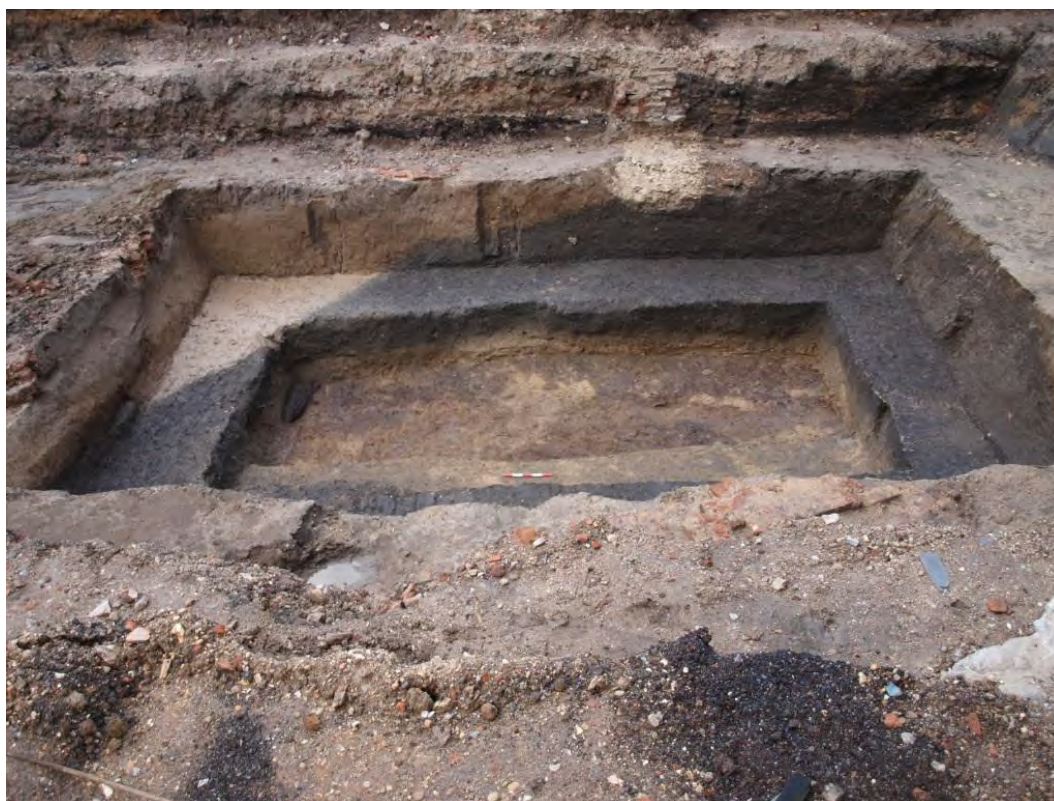
Plate 5: Trench 1 showing possible early medieval embankment  
Scale 0.50m

7.4.2 The development the site in the period following the decline of Roman rule and the re-establishment of urban life in Southwark would appear to be unremarkable if the results of Trench 4 were seen in isolation. However, Trench 1 presented a very different and intriguing picture. A dense mass of brown alluvium, layers [23] and [24], was evident in the southeastern corner of the trench but this did not appear simply as a capping above earlier horizontal deposits. The base of the alluvium shelved away sharply to the east and continued below the level of excavation, to the west the alluvium appeared to be contained by a mass of dark grey material which formed an embankment (Figure 9, Sections 1-4 and Plate 5, below). The latter was formed of two distinct units as recorded in Section 1. The base of the bank was recorded as layer [31]. This deposit was formed by a mixture of dumped material and alluvial deposition (see Appendix 3). It would appear that attempts were being made to contain tidal action in this area; clearly these were at best partially successful. A second layer [30] formed the top of the bank; this was composed almost exclusively of dumped material and clearly represented a renewed attempt to contain overbank flooding.

7.4.3 Both layers [30] and [31] contained Roman pottery assemblages which have been provisionally dated AD 50-160: layer [31] also contained ceramic building materials dated AD 55-160. These finds are clearly residual and are probably indicative of earlier Roman soils being extracted from the local area and used to form an embankment. The base of the bank

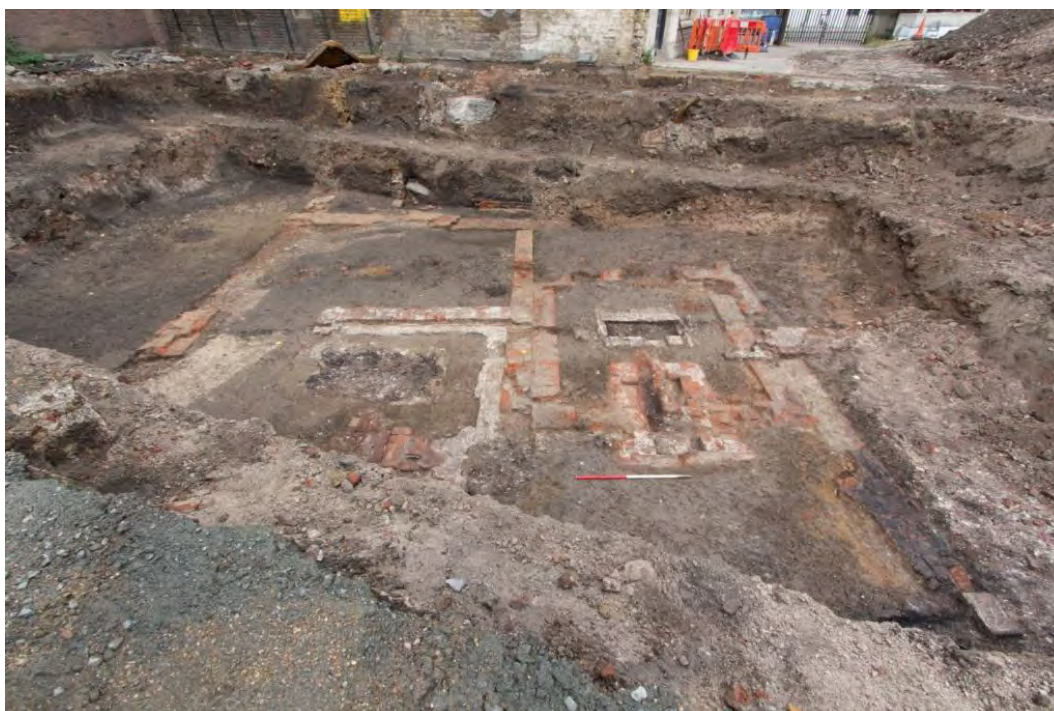
Plate 6: Trench 1 complex of post-medieval buildings  
Scale 1.00m

- 7.6.1 Extensive remains of buildings dating from the late 17th century onwards were uncovered in Trench 1 which measured c. 14m east-west by 8m north-south at the level where the buildings occurred (Figure 8 & Plate 6 below). A plethora of diverse elements of differing dates were recorded, all were found between 2.30m and 2.45m OD.

- 7.6.2 The earliest elements of the building complex consisted of three walls [3], [4] and [7] which had once formed parts of the same building and a brick-lined well [6] which lay to the north of them. The remains of the walls and the size of the one room which can be reconstructed suggested that a building of considerable size and some status had once been located in this

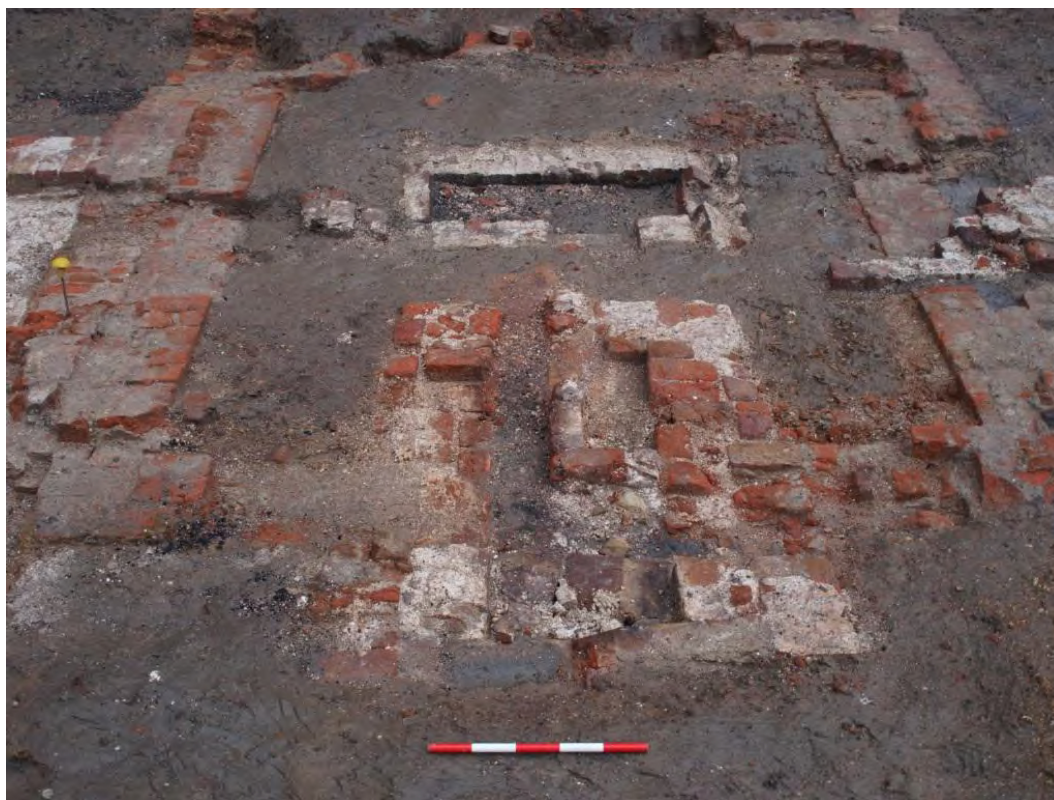
Plate 7: Industrial structures Trench 1  
Scale 0.50m

- 7.6.17 Wall [8] did not extend across the entire width of the earlier room, it measured 2.60m east-west by 0.32m north-south and effectively left a doorway or entrance 1.60m wide to its west which would have allowed access to the newly created room to the north. The latter would have measured 3.80m north-south by 4.32m east-west which roughly equates to 12' 6" by 14'.
