**AN ARCHAEOLOGICAL
WATCHING BRIEF AT
SUTTON HOUSE/BREAKER'S
YARD, 2 AND 4 HOMERTON
HIGH STREET, HACKNEY, E9
6JQ**

SITE CODE: SNH 13

REPORT NO: R11583

DECEMBER 2013

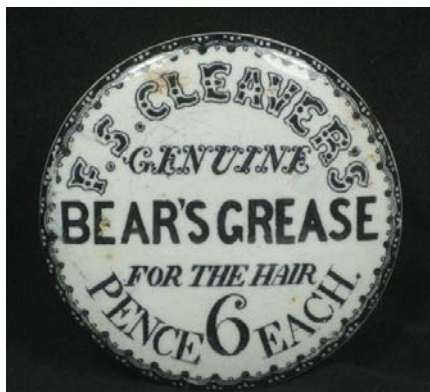
Bear's grease pot lid: complete profile with a black-transfer printed design on the top of the lid reading 'F. S. CLEA[VER'S]/GENU[INE]/BEAR'S [GREASE]/FOR T[HE HAIR/6]/PENC[E EACH]' (see Plate 1. for a complete example).

Plate 1. Black-transfer-printed whiteware, F. S. Cleaver's bear's grease lid.

The pottery recovered from context [6] is dated to the late 19th century by the latest form, the bear's grease pot lid.

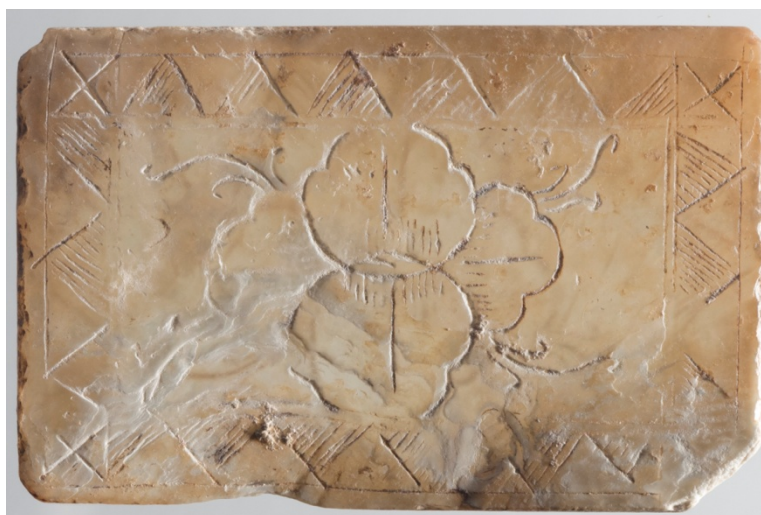
The Breaker's Yard example may not be standard mother-of-pearl (though it may have degraded) - it appears to be a variation called window-pane mother of pearl as it is almost translucent.

Plate 1: Gaming Counter Side A

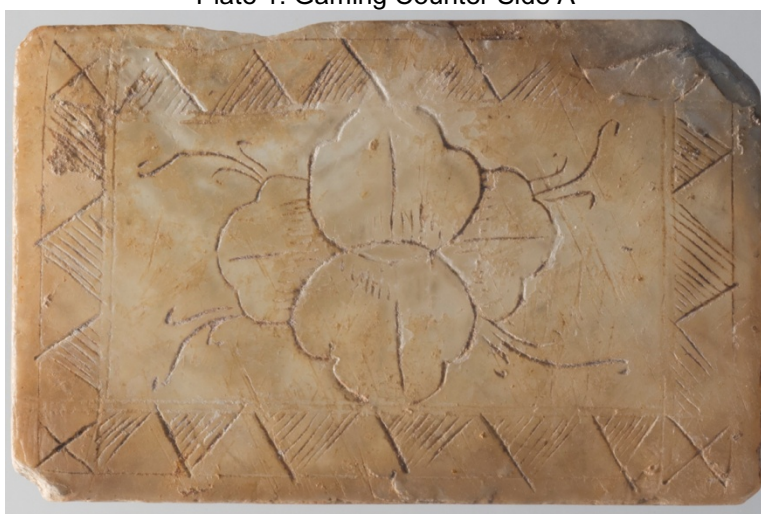
Plate 2: Gaming Counter Side B
