AN ARCHAEOLOGICAL EVALUATION AT
THE EXCHANGE BRIDGE CAR PARK,
GREENGATE/CHAPEL STREET, SALFORD,
GREATER MANCHESTER

EVALUATION REPORT

Pre-Construct Archaeology Limited Quality Control	
<i>Project Number</i>	K3372
<i>Site Code</i>	GSM 14
<i>Report Number</i>	RN11635

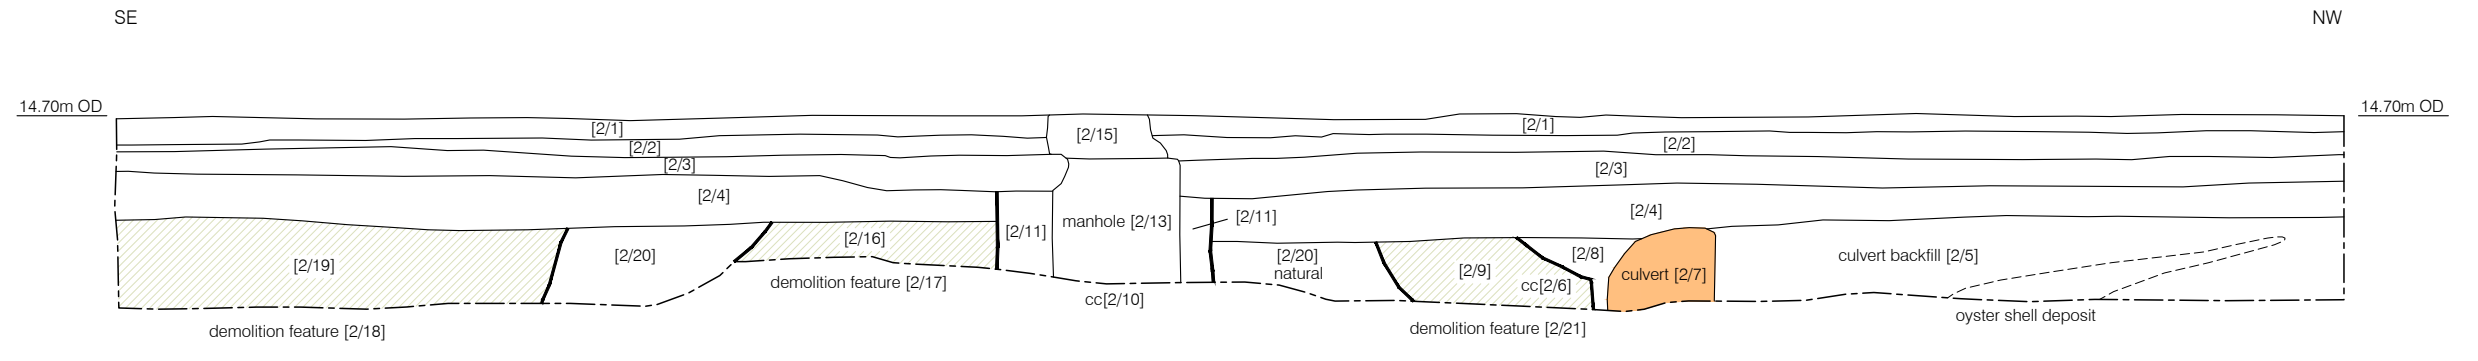
Figure 4
Trench 2 Plan & Section 1
1:50 at A3

Section 1
North East facing
Trench 2

- 5.4.7 Culvert [2/7] had been backfilled with brownish grey sandy clayey silt, [2/5], which was recorded for a distance of 4.20m, continuing to the north-west beyond the limit of the trench. A dump of oyster shell was observed within this backfill. If, as postulated, structure [1/26] in Trench 1 and structure [2/7] in Trench 2 do indeed represent the lowermost surviving parts of an arched brick culvert, then this was a substantial feature, c. 5.0m wide. A small assemblage of artefactual material recovered from the backfill of the culvert in Trench 2 included pottery and a 19th-century wine bottle; the pottery assemblage as a whole provides a date of 1830–1900 for the infilling of the culvert (see Appendices 3 and 4).

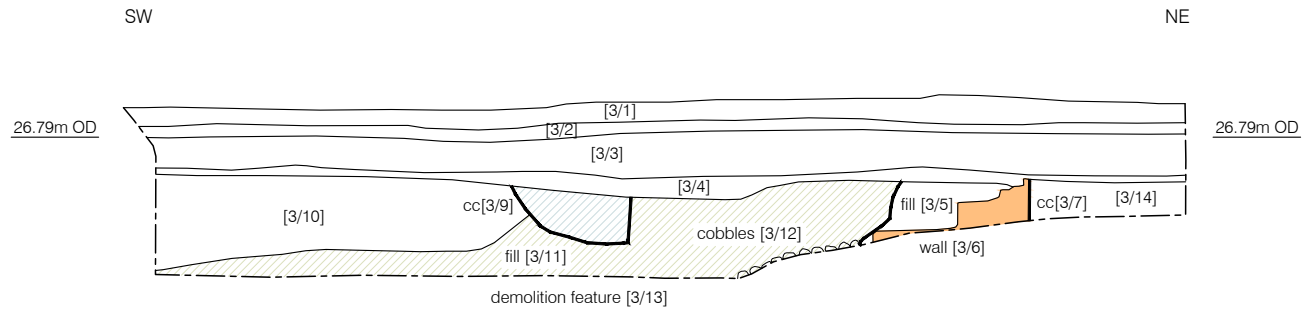
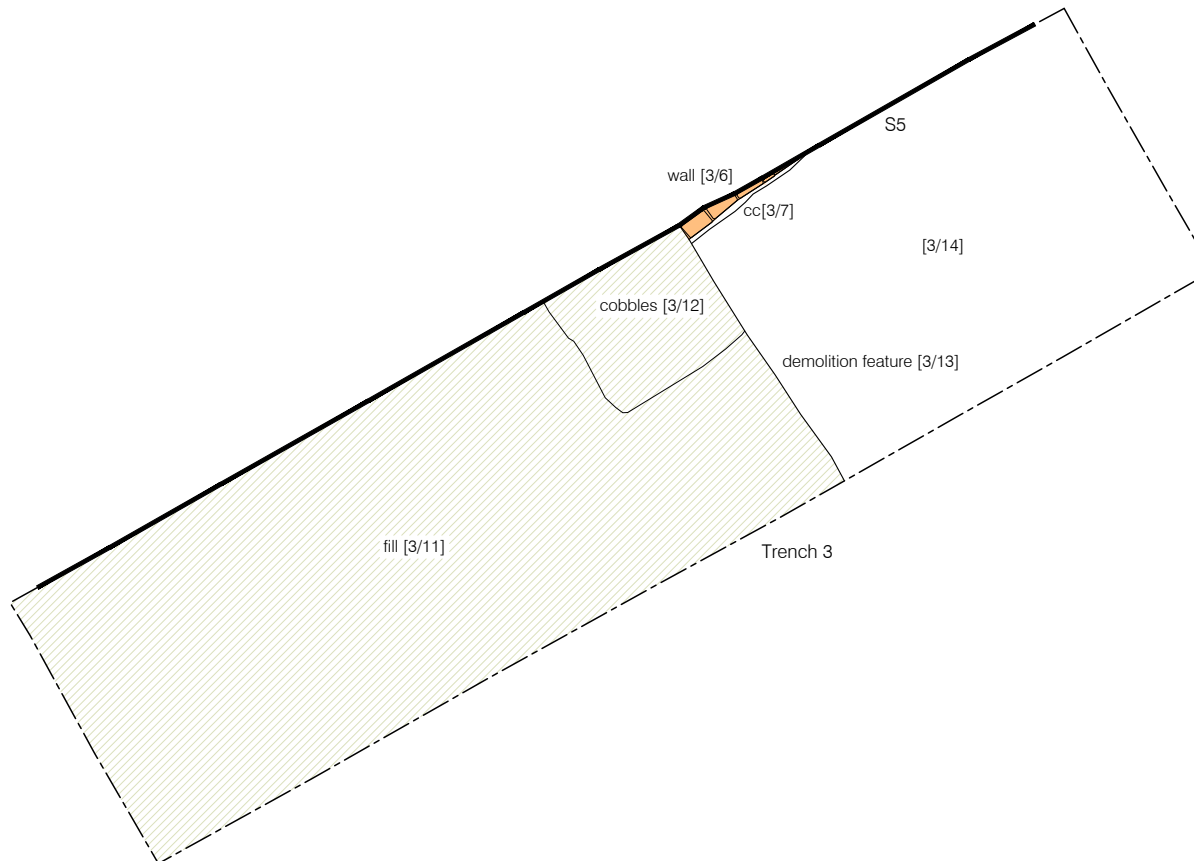
Figure 5
Trench 3 Plan & Section 5
1:50 at A4

Section 5
South East facing
Trench 3

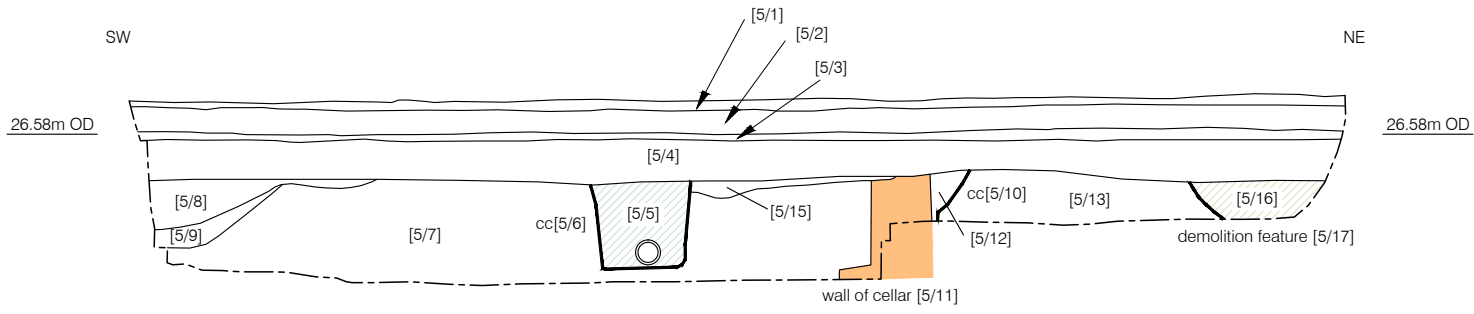
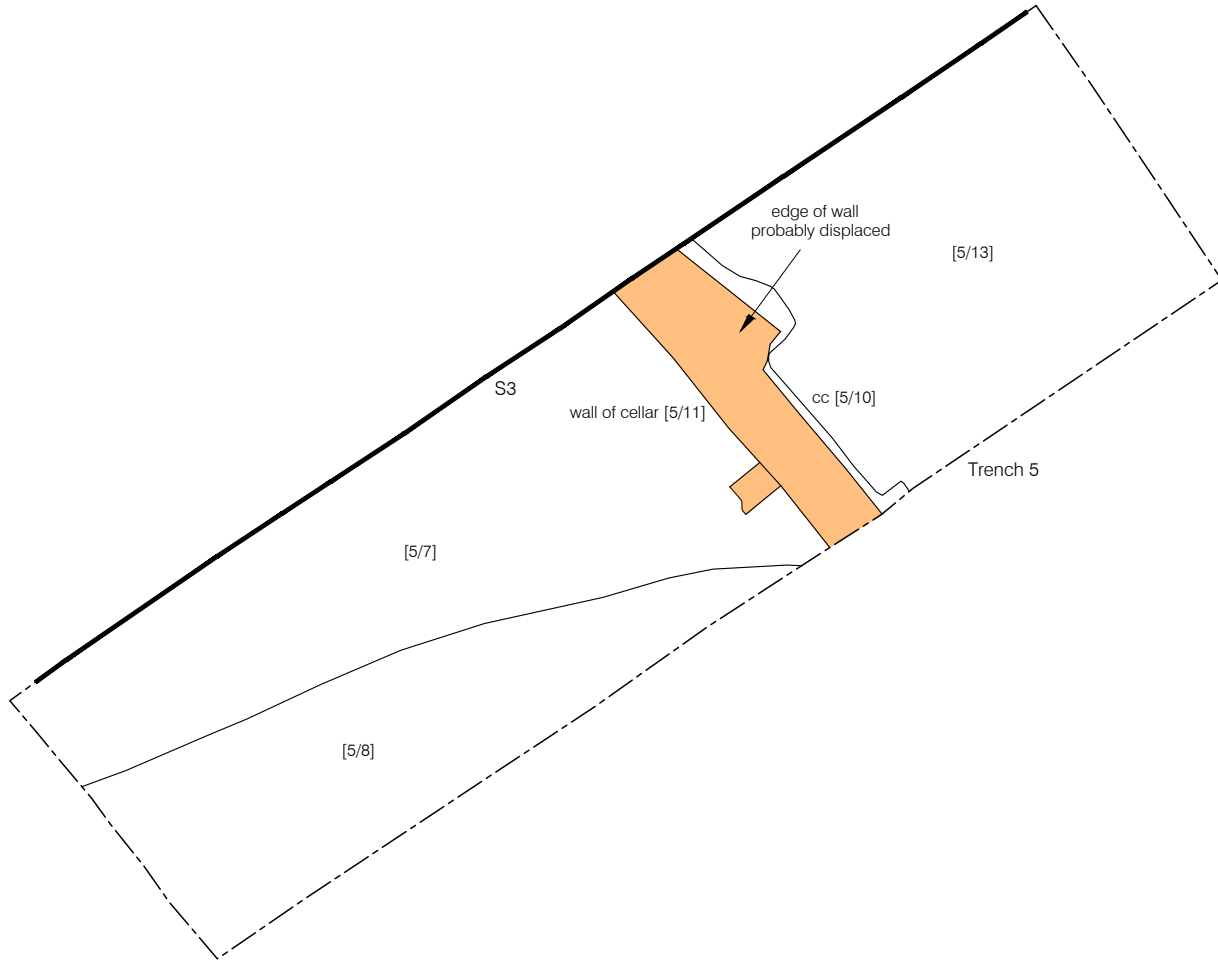
Figure 7
Trench 5 Plan & Section 3
1:50 at A4

Section 3
South East facing
Trench 5

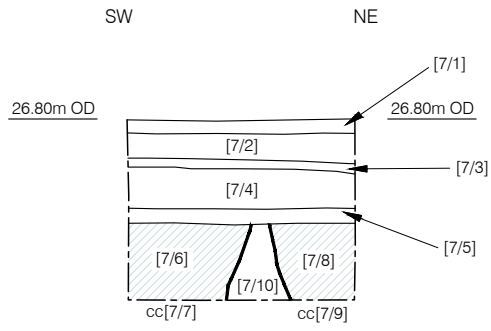
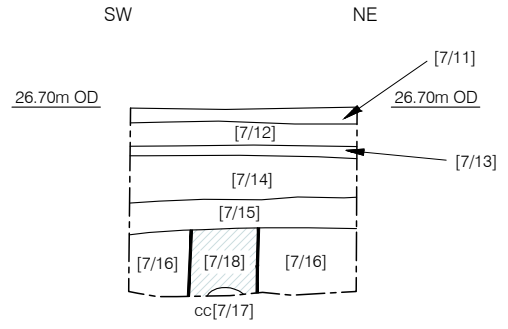
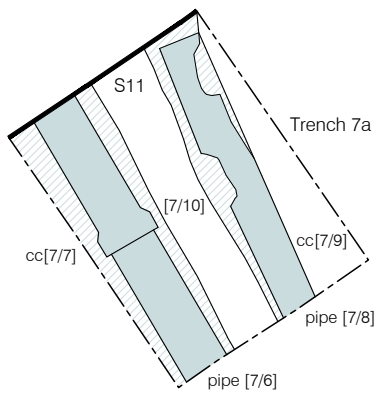
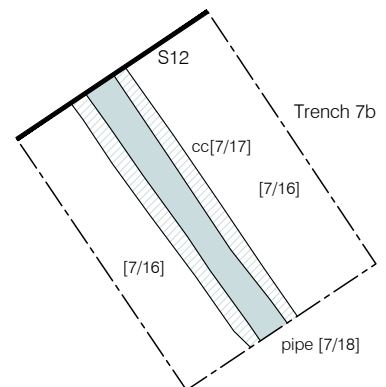
Figure 9
Trenches 7a & 7b Plans & Sections 11 & 12
1:50 at A4

Section 11
South East facing
Trench 7a

Section 12
South East facing
Trench 7b

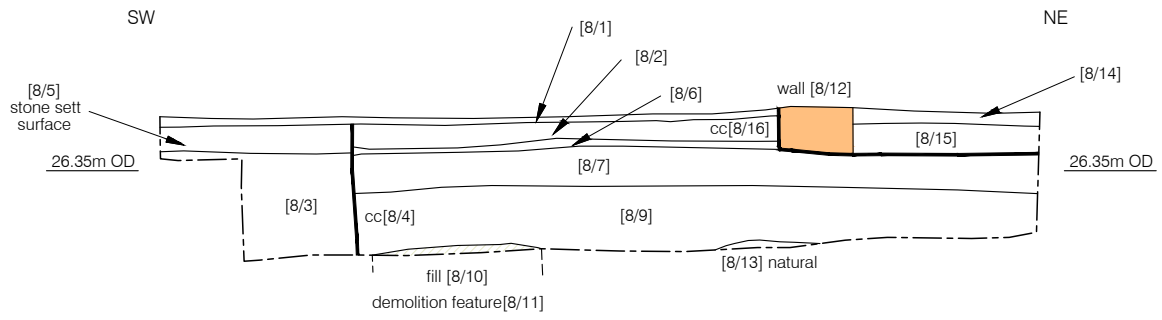
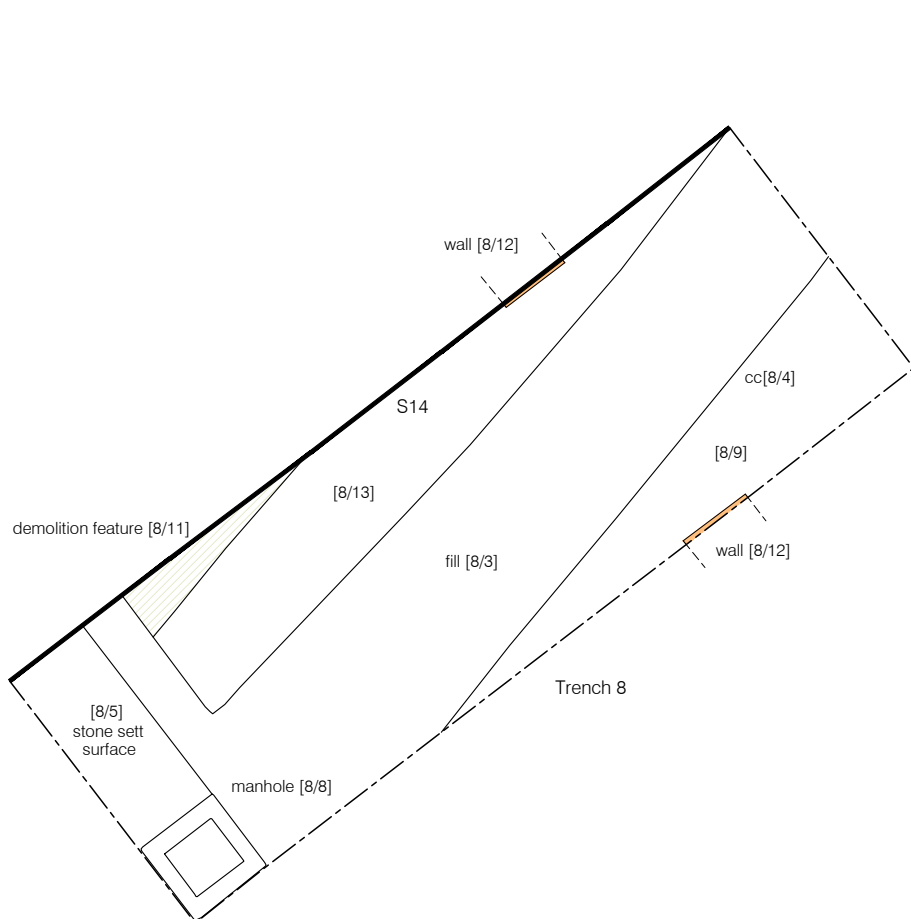
Figure 10
Trench 8 Plan & Section 14
1:50 at A4

Section 14
South East facing
Trench 8

- 5.6.4 Towards the north-eastern end of Trench 8 was a brick wall, [8/12], which extended across the trench and was uniformly 0.48m wide and 0.28m high. It was constructed with unfrogged red bricks (220mm x 100mm x 65mm), bonded by cementitious mortar. The wall was recorded within a broad construction cut, [8/16], also incorporating the concrete surface, [8/14] and a rubble bedding deposit, [8/15]. This wall was observed in the concrete surface extending from the corner of a brick pillar to the north-west, across Trench 8 to the corner of a brick pillar to the south-east and probably represents an early 20th-century partition wall, forming a separate bay.

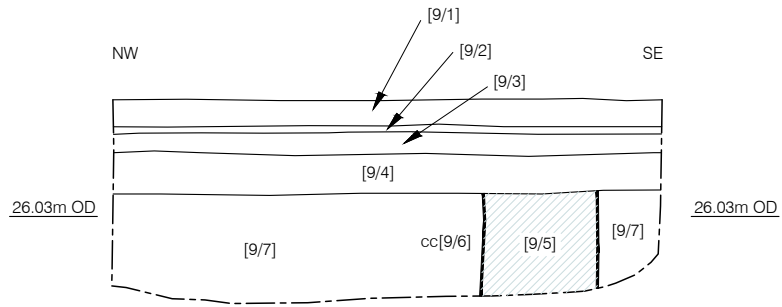
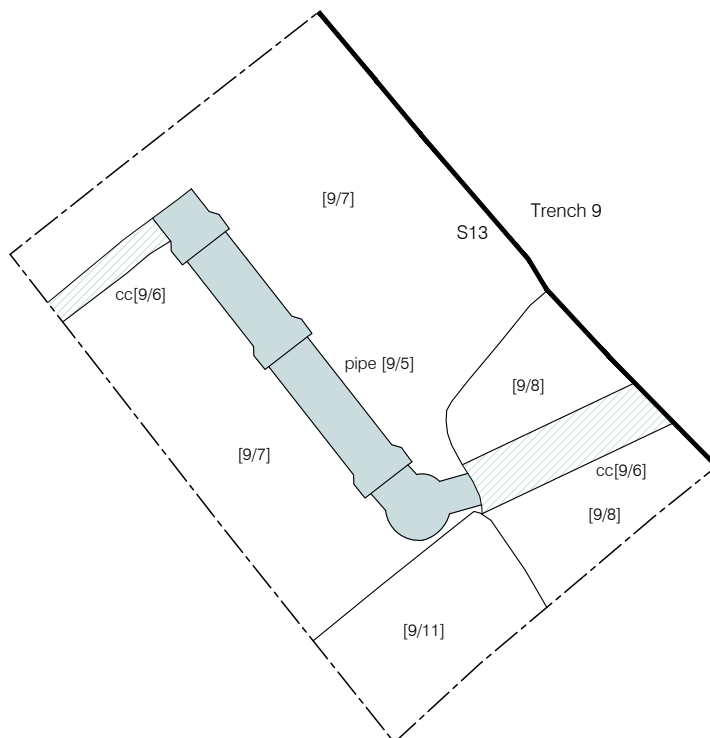
Section 13
South West facing
Trench 9

5.6.5 A substantial feature, [9/11], was recorded truncating the sett surface, [9/1], in Trench 9 and measured at least 1.80m NE-SW by 1.60m NW-SE and was at least 1.22m deep (Figure 11). Its backfill, [9/10], comprised sandy silt. This feature probably represents a recent geotechnical/engineering sample excavation to test the depth of the adjacent wall foundation. At the location of the test-pit the setts had been re-laid, [9/9].

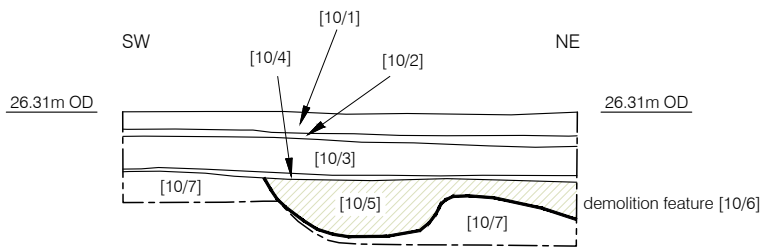
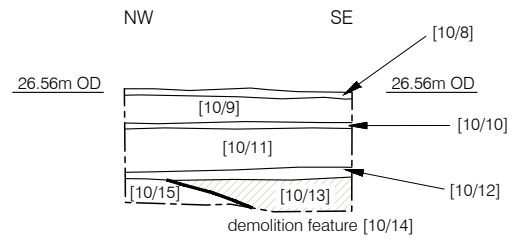
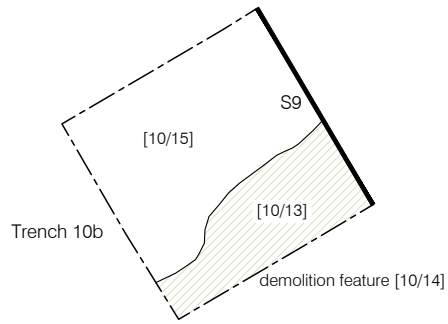
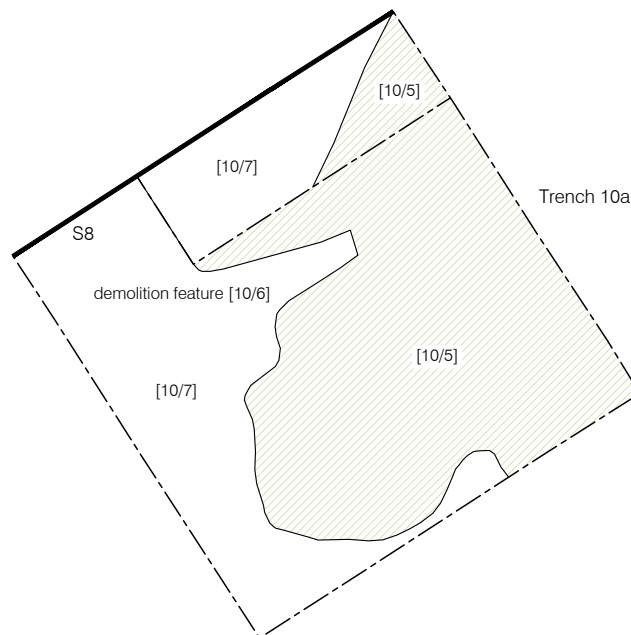
Figure 12
Trenches 10a & 10b Plans & Sections 8 & 9
1:50 at A4

Section 8
South East facing
Trench 10a

Section 9
South West facing
Trench 10b

- 5.5.18 Part of the south-western edge of an irregular-shaped substantial demolition feature, [10/6], was recorded in Trench 10a, cutting through fluvial deposit [10/7]. This was exposed for a maximum distance of 3.0m NW-SE by 2.50m NE-SW, continuing to the north-east and south-east, and it was up to 0.39m deep, encountered at a maximum height of 25.87m OD. Its single loose clayey silty sand fill, [10/5], contained frequent fragments of lime mortar and brick throughout.

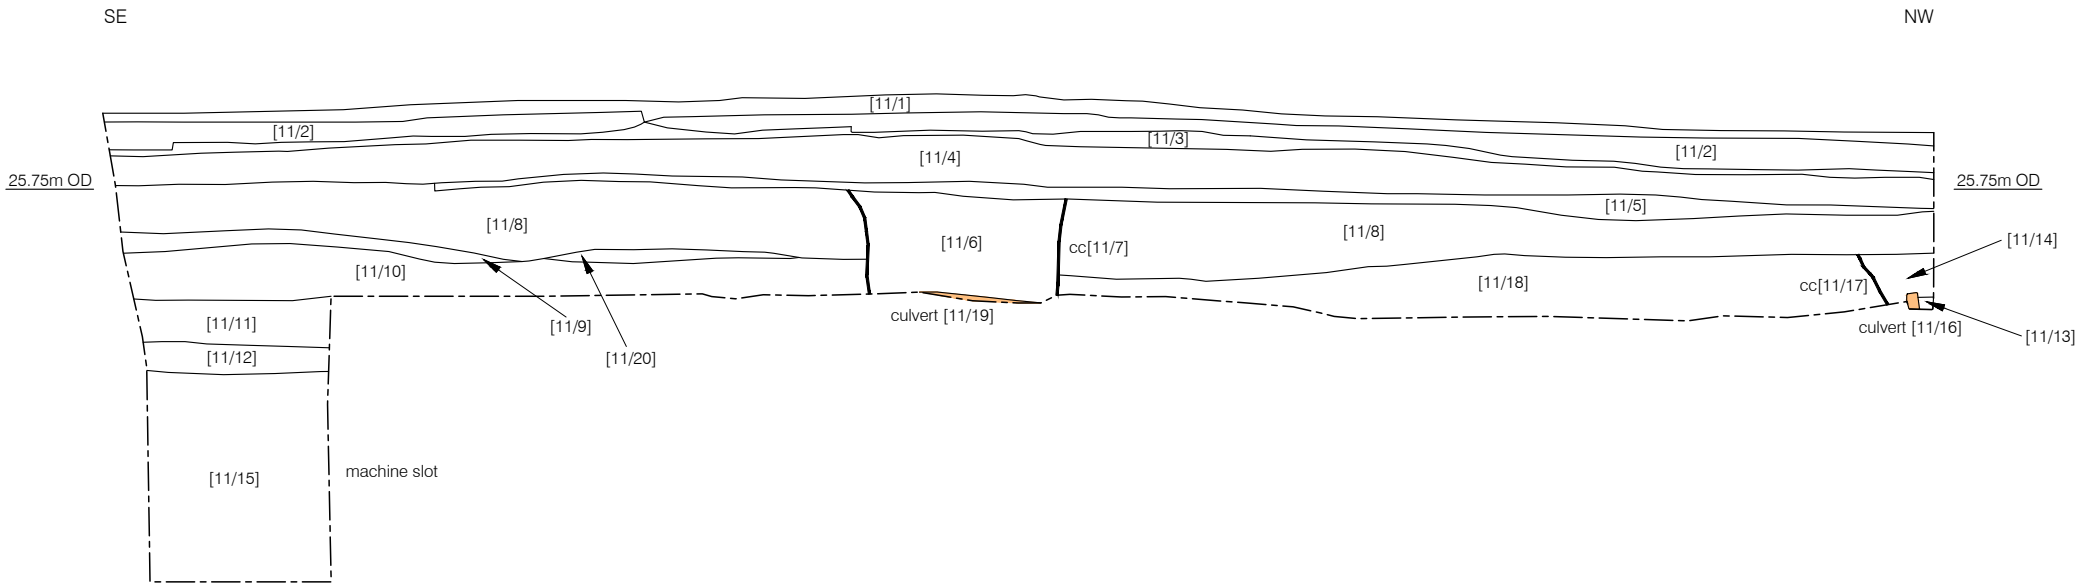
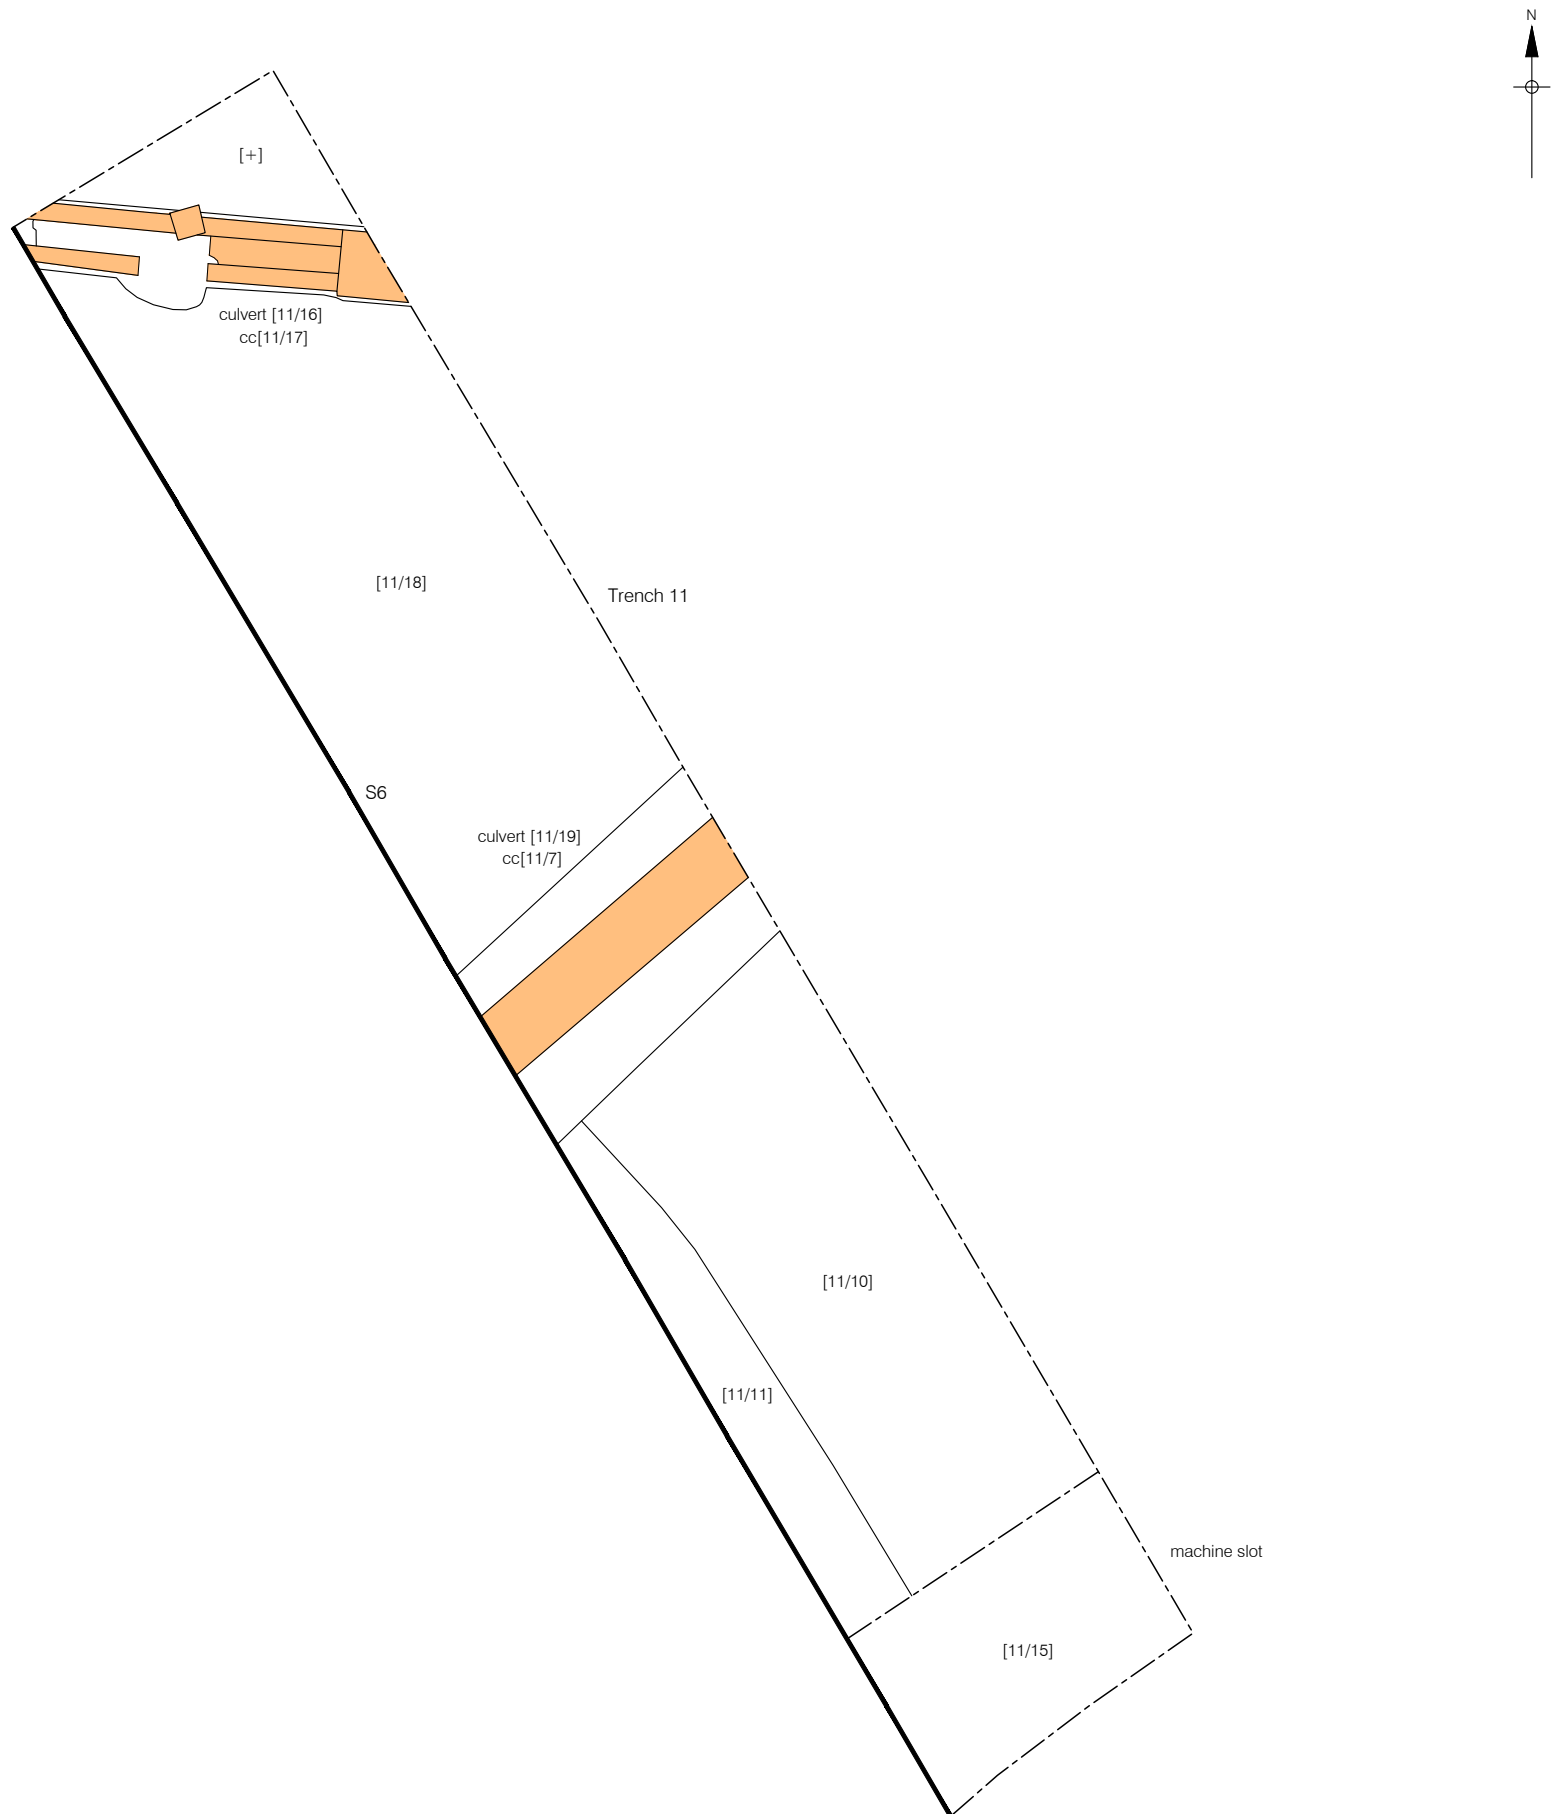
Section 6
North East facing
Trench 11

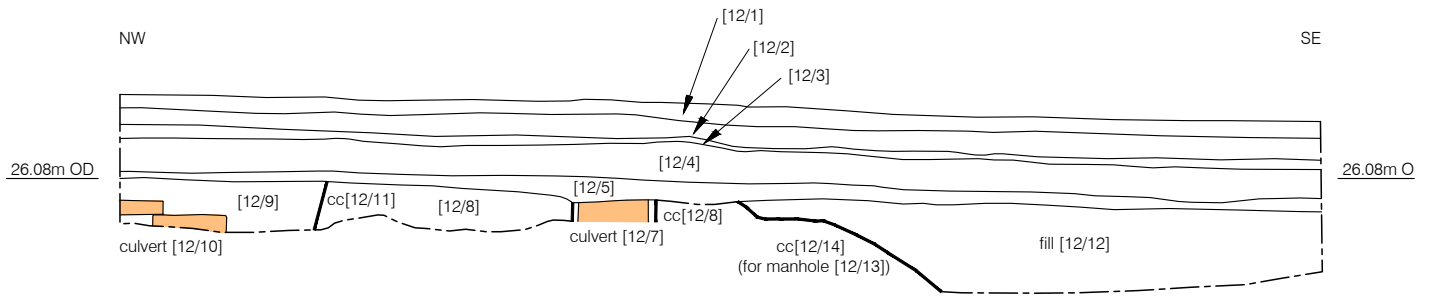
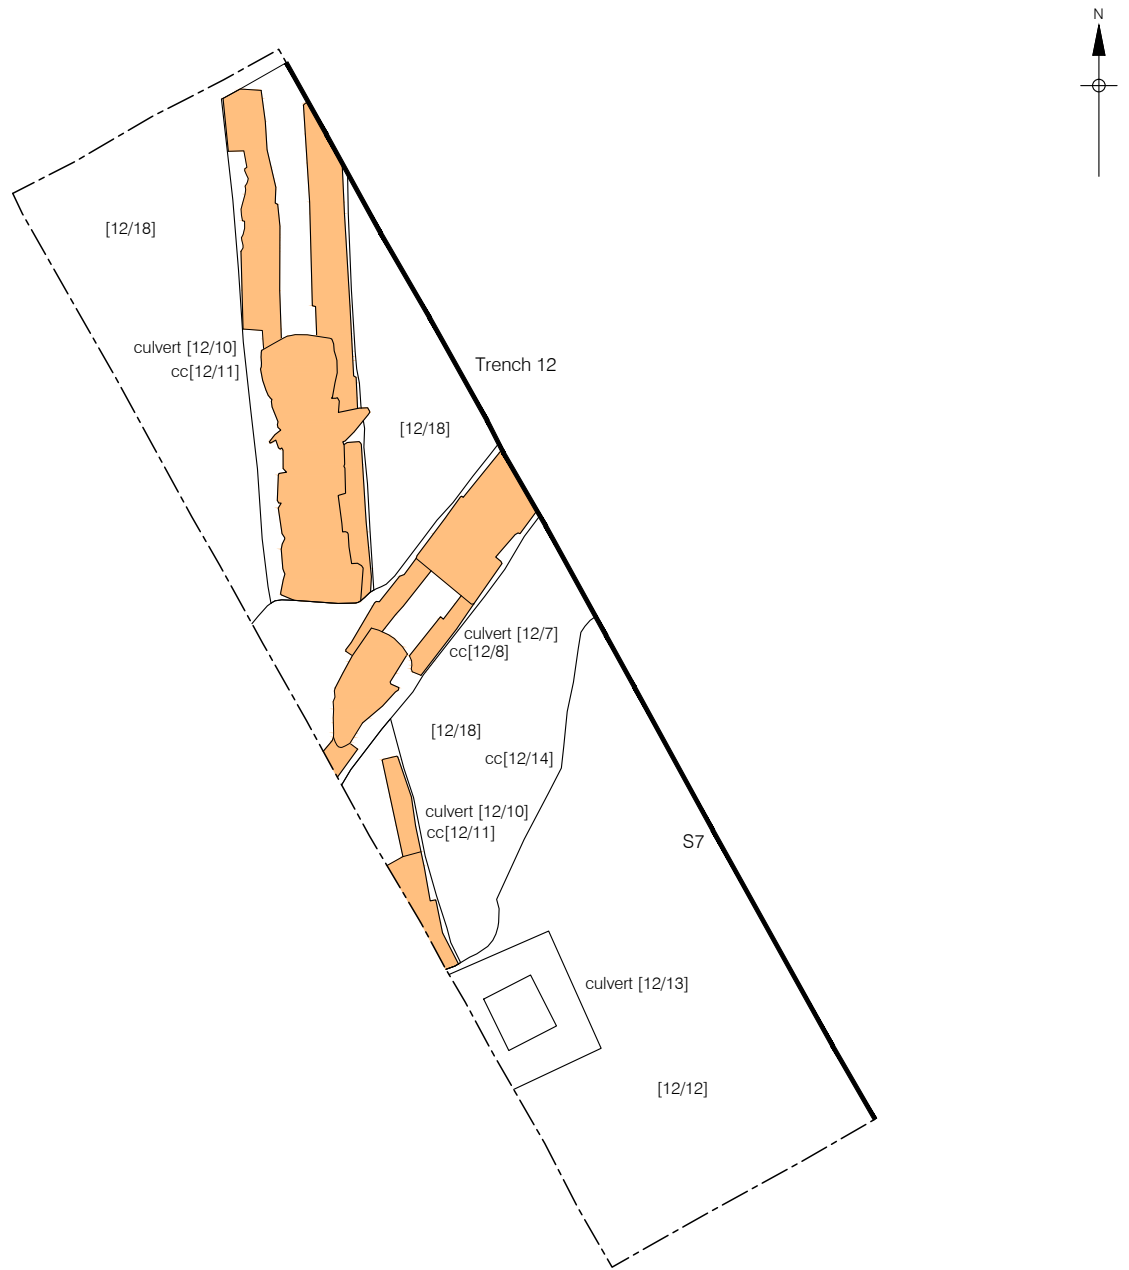
Figure 14
Trench 12 Plan & Section 7
1:50 at A4

Section 7
South West facing
Trench 12

- 5.4.28 Their stratigraphic relationship suggests that culverts [12/7] and [12/10] were not constructed contemporaneously. They may represent 18th- or early 19th-century drainage installed in association with the brewery depicted on Green's 1794 map, a manufactory which was replaced with the cotton mill depicted on the 1849 Ordnance Survey map (Figure 15).

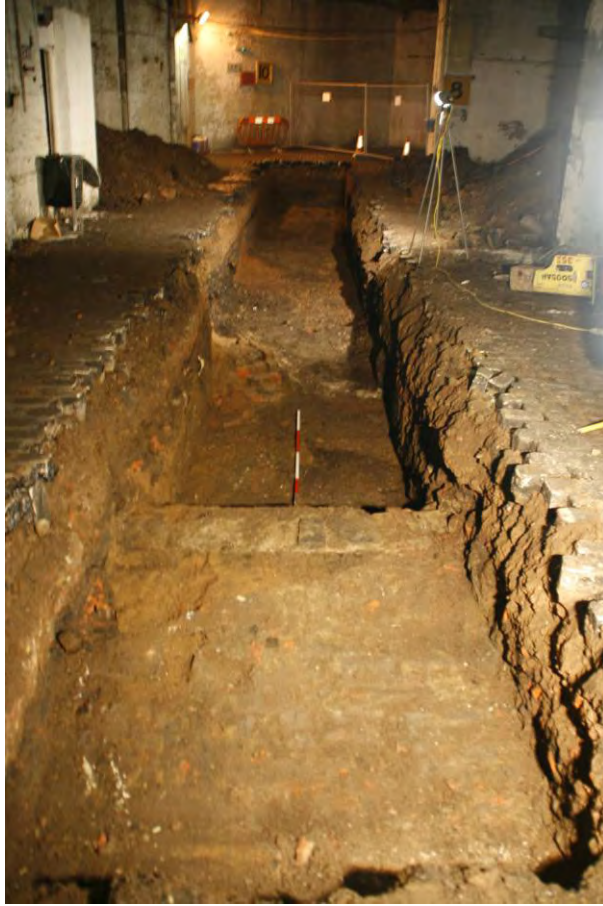
Plate 1. Trench 1, overview, wall [1/9] in foreground, looking north-east (scale 2m)

- 5.4.2 Cutting through demolition features [1/28] and [1/33] was a NW-SE aligned wall, [1/9], recorded within a narrow construction cut, [1/10], extending across the trench for a distance of c. 1.80m and continuing beyond the limits of excavation. The wall was 0.62m wide and was constructed with unfrosted handmade red bricks (average size 230mm x 110mm x 70mm) bonded with light grey lime mortar. Only one course of the wall survived, to a maximum height of 0.12m; this was in stretcher bond and was built on a c. 40mm thick bedding of lime mortar. The bricks used in the construction are not closely dateable and no other artefactual material was associated with the wall. Its NW-SE alignment is somewhat at odds with that of the brewery buildings depicted on later 18th-century mapping and those of the subsequent cotton mill; it more closely correlates with a regular arrangement of gardens plots (or possible structures) in the backlots, as illustrated on Cason and Berry's 1741 map.

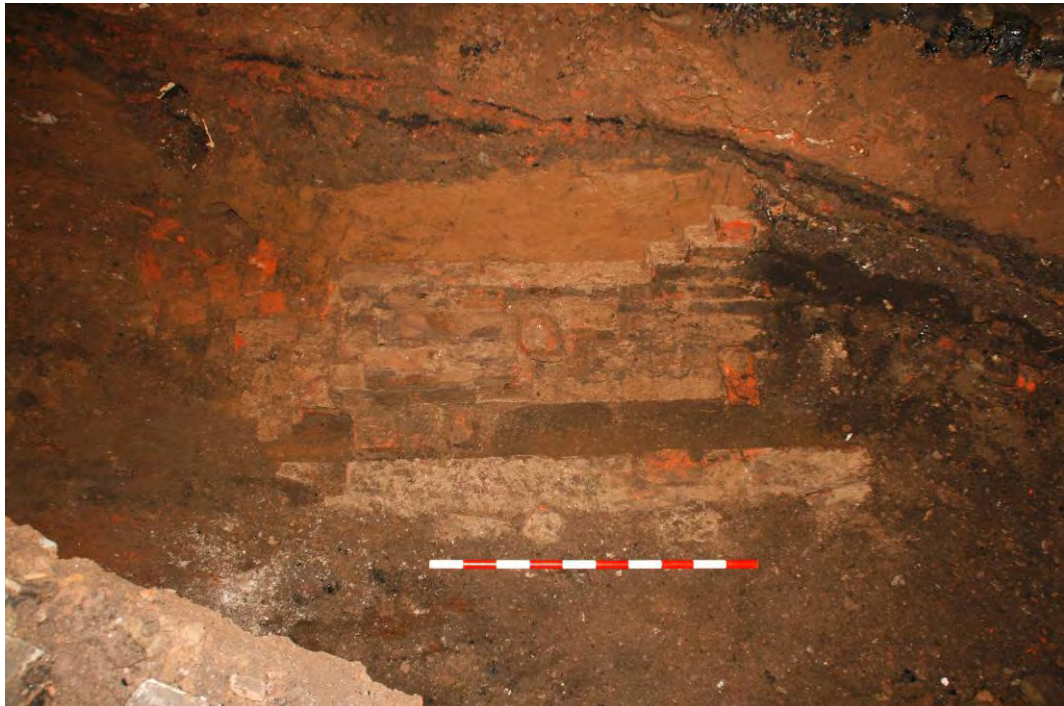
Plate 2. Trench 1, culvert [1/26], looking north-west (scale 1m)

- 5.5.5 Demolition feature [1/19], which truncated culvert [1/26] to the north-east, was recorded for a distance of c. 3.0m NW-SE by c. 3.0m NE-SW and was excavated to a maximum depth of 0.68m. No artefactual material was recovered from its single exposed fill, [1/18], which comprised loose ash and cinders.

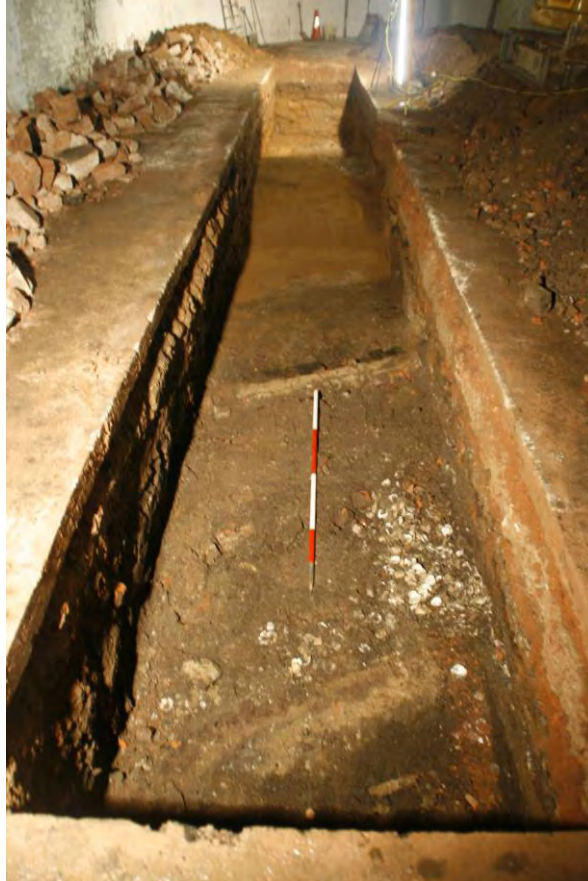
Plate 3. Trench 2, overview, culvert [2/7] in foreground, looking south-east (scale 2m)

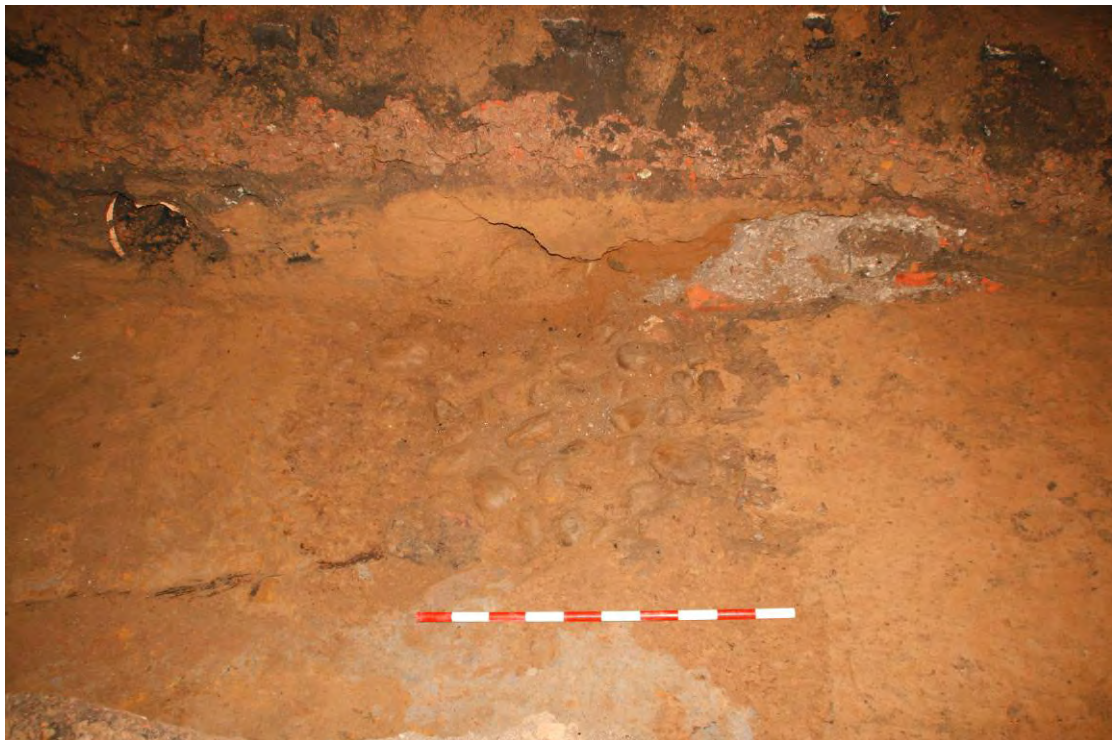
Plate 4. Trench 3, wall [3/6] and demolition feature [3/13], looking north-west (scale 1m)

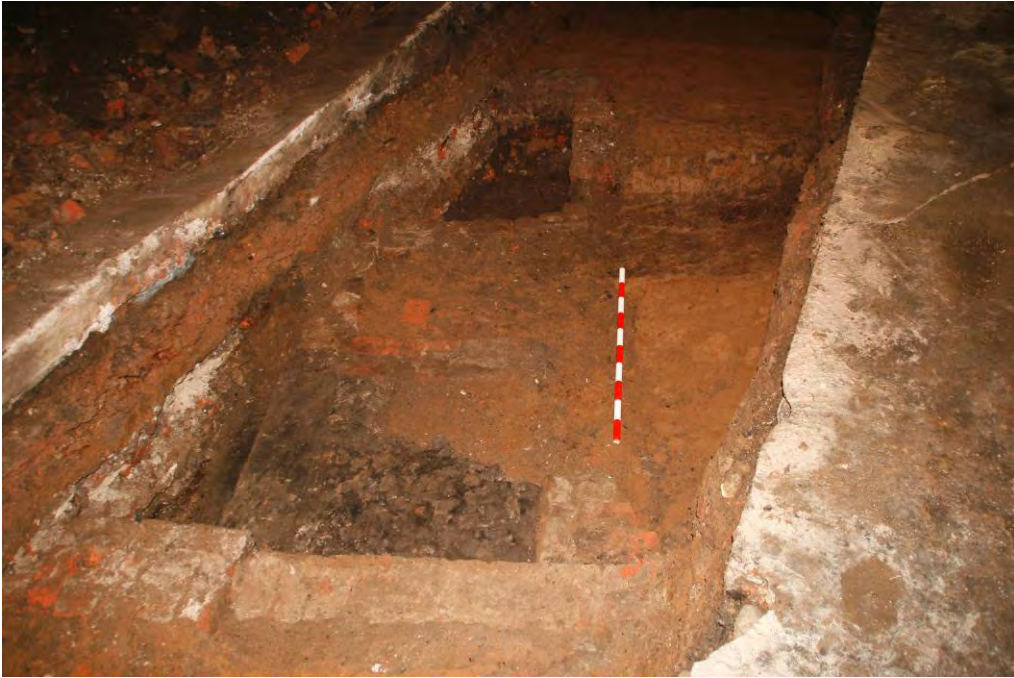
Plate 5. Trench 4, cellar [4/6], looking south-east (scale 1m)

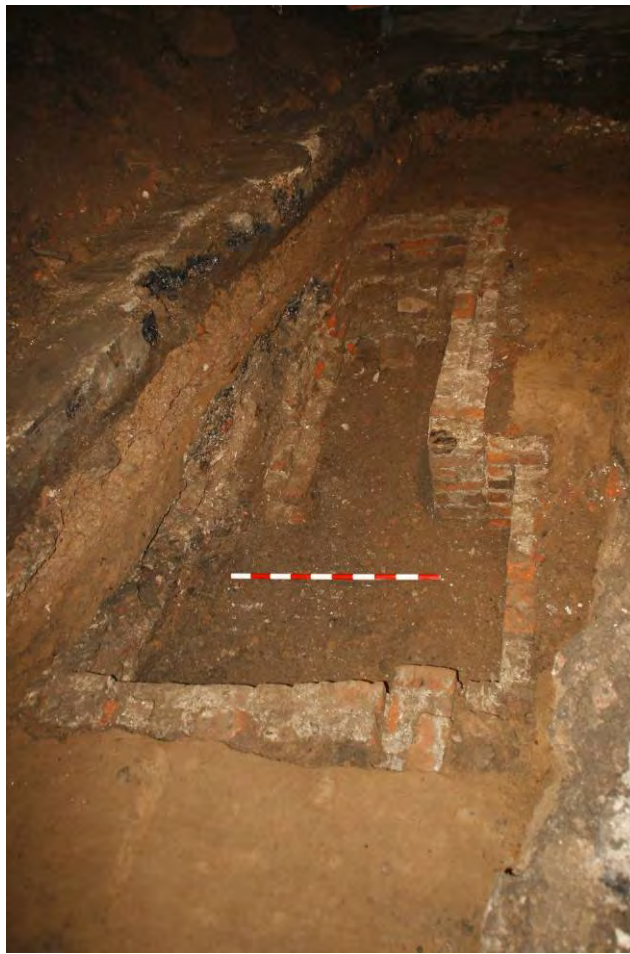
Plate 6. Trench 4, cellar [4/7], looking south-east (scale 1m)

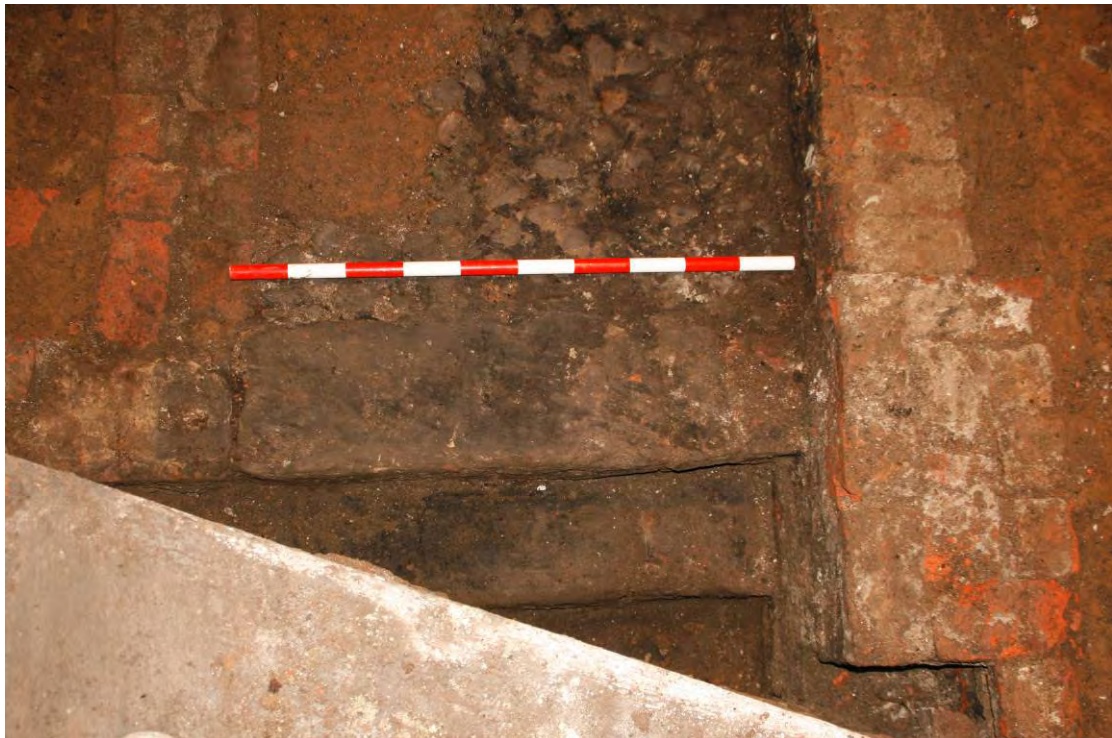
Plate 7. Trench 4, cellar [4/6] detail, steps [4/30], looking south-west (scale 1m)

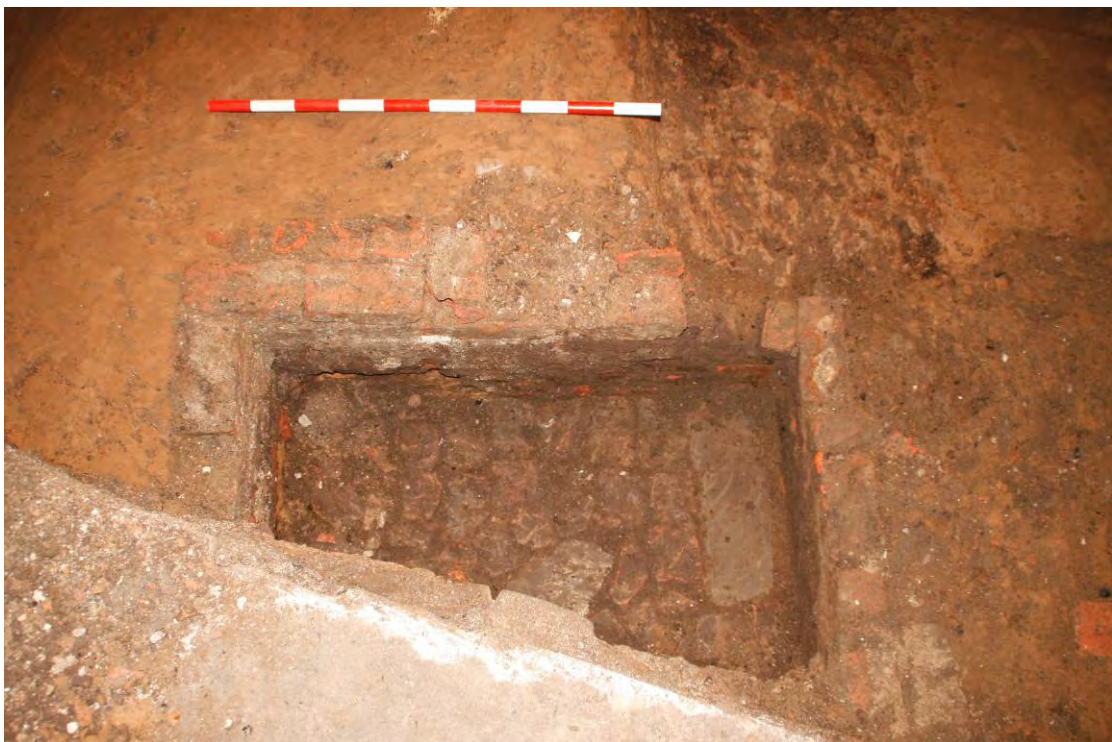
Plate 8. Trench 4, cellar [4/6] detail, surface [4/31], looking south-west (scale 1m)

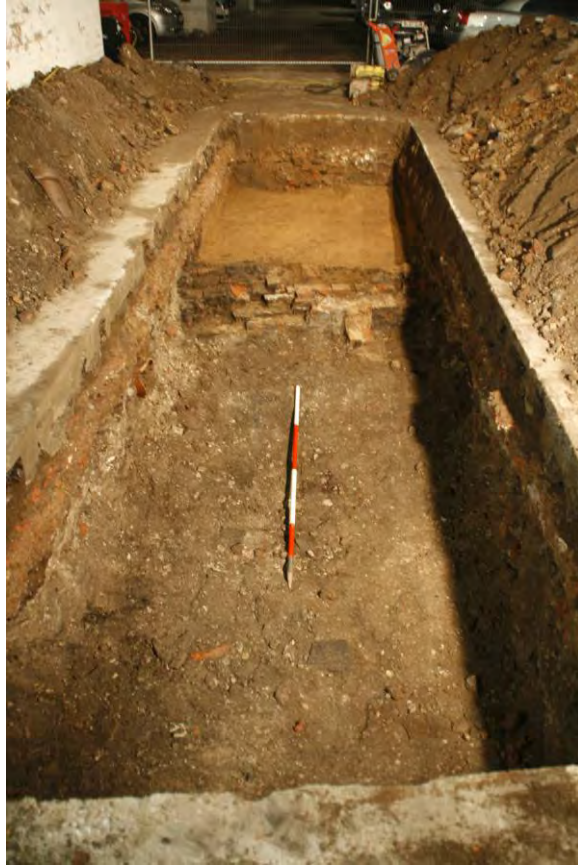
Plate 9. Trench 5, overview, cellar wall [5/11] in rearground, looking north-east (scale 2m)

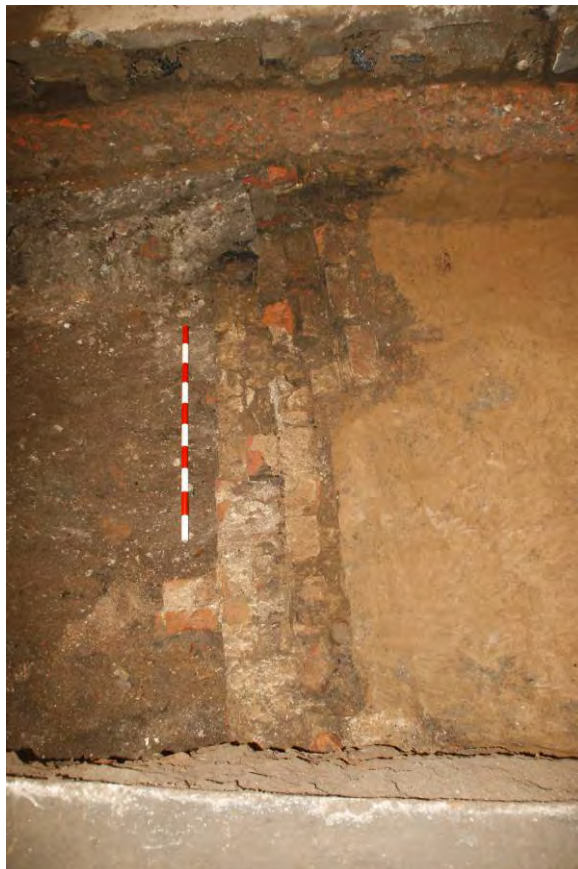
Plate 10. Trench 5, cellar wall [5/11] detail, looking north-west (scale 1m)

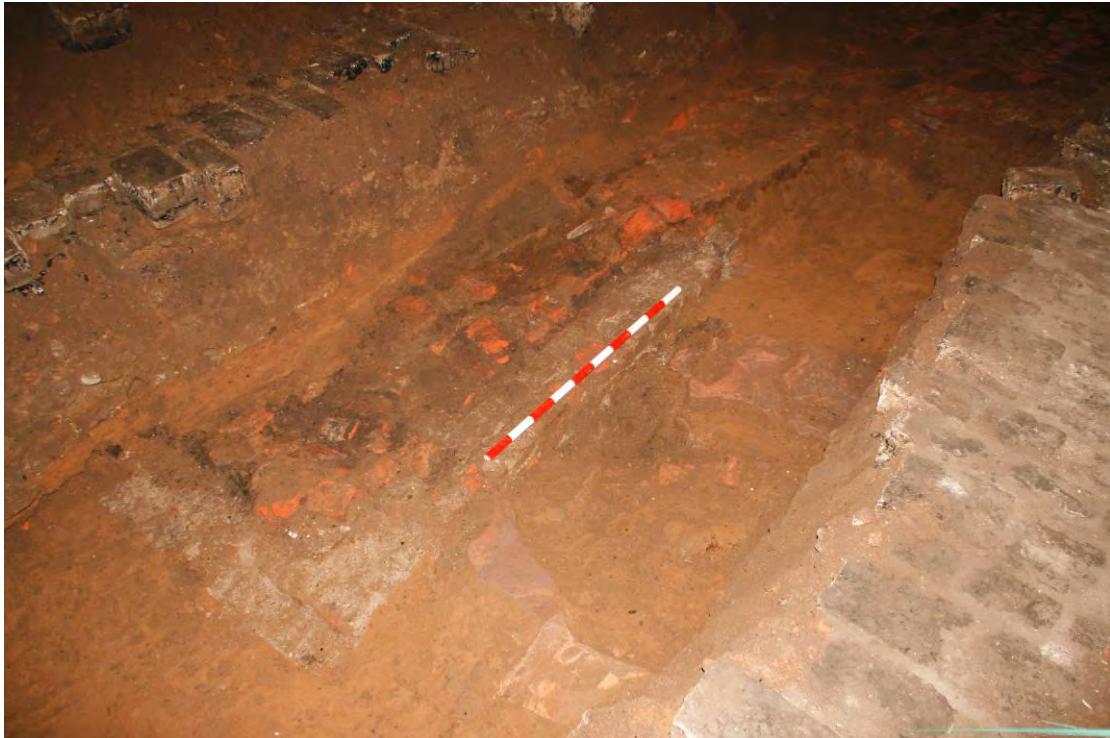
Plate 11. Trench 6, cellar [6/8], brick surface [6/7] and (pre-excavation) stone-lined well [6/13], looking west (scale 1m)

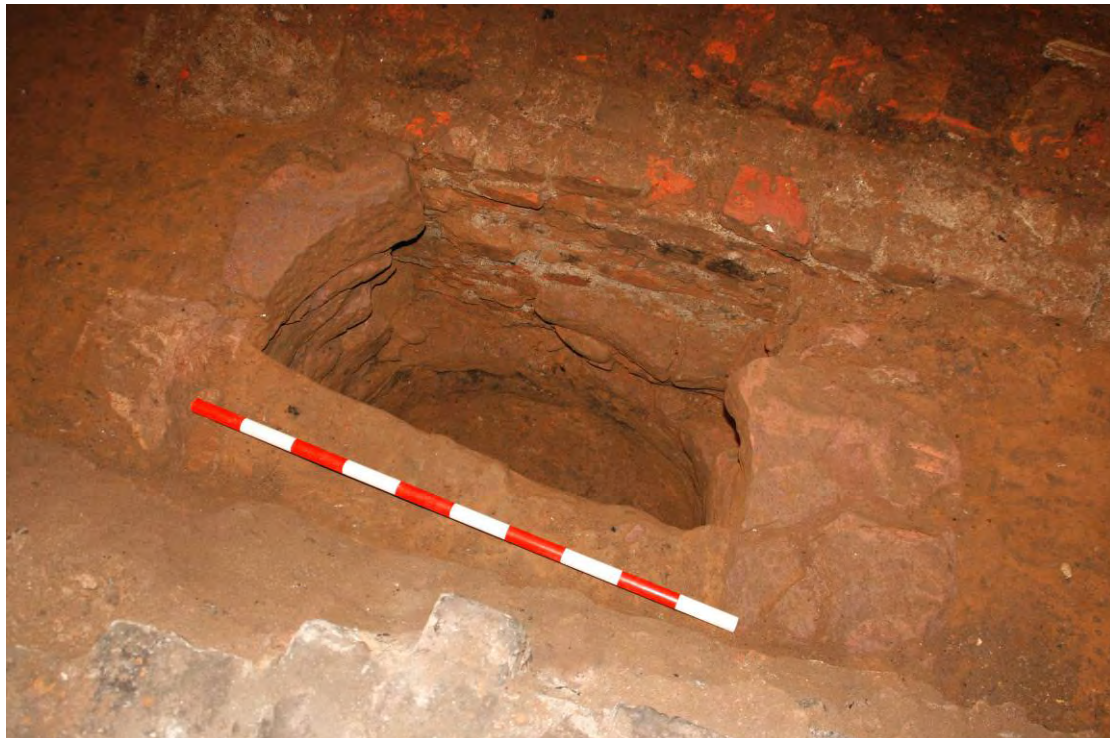
Plate 12. Trench 6, stone-lined well [6/13], looking north (scale 1m)
