AN ARCHAEOLOGICAL EVALUATION AT
THE EXCHANGE BRIDGE CAR PARK,
GREENGATE/CHAPEL STREET, SALFORD,
GREATER MANCHESTER

EVALUATION REPORT

Pre-Construct Archaeology Limited Quality Control	
<i>Project Number</i>	K3372
<i>Site Code</i>	GSM 14
<i>Report Number</i>	RN11635

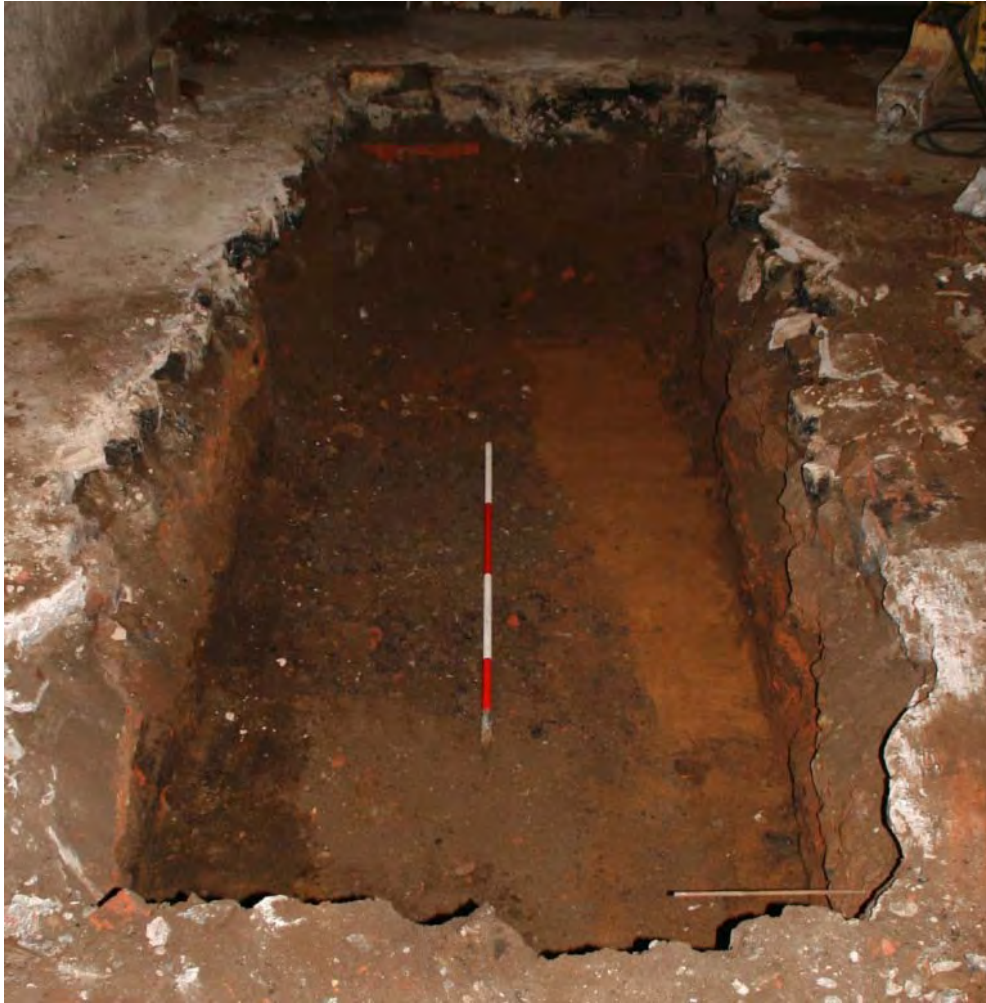
Plate 13. Trench 8, overview, drainage feature [8/4], looking south-west (scale 2m)

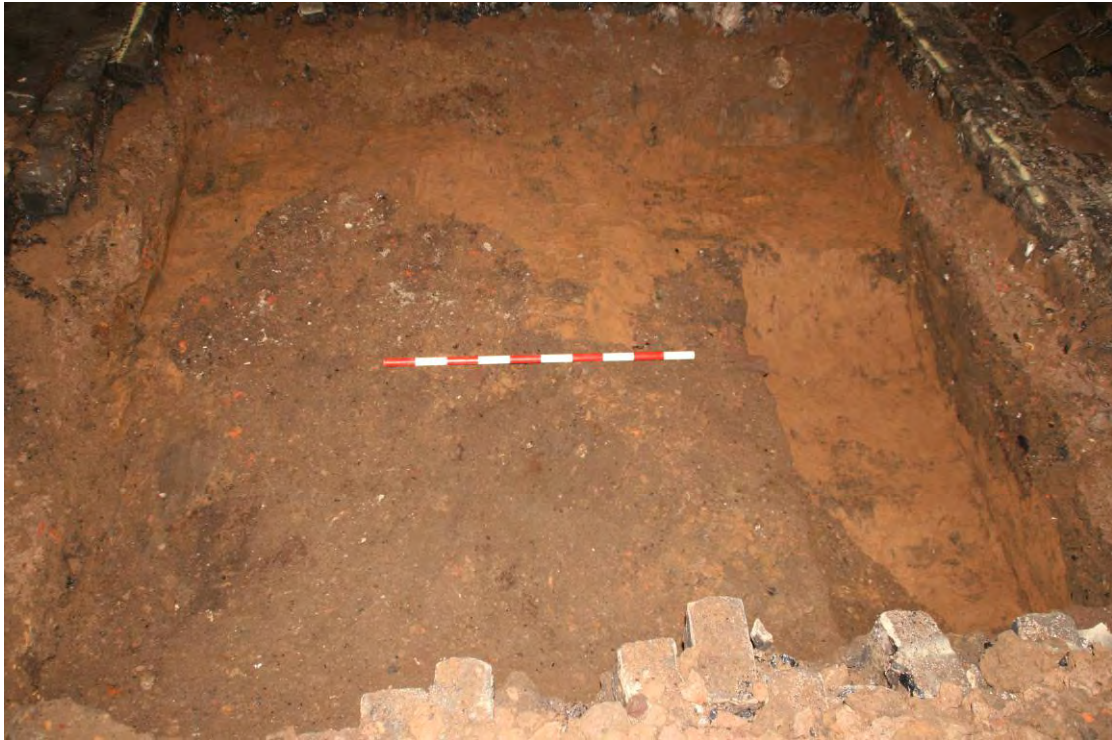
Plate 15. Trench 10a, demolition feature [10/6], looking south-west (scale 1m)

- 5.5.18 Part of the south-western edge of an irregular-shaped substantial demolition feature, [10/6], was recorded in Trench 10a, cutting through fluvial deposit [10/7]. This was exposed for a maximum distance of 3.0m NW-SE by 2.50m NE-SW, continuing to the north-east and south-east, and it was up to 0.39m deep, encountered at a maximum height of 25.87m OD. Its single loose clayey silty sand fill, [10/5], contained frequent fragments of lime mortar and brick throughout.

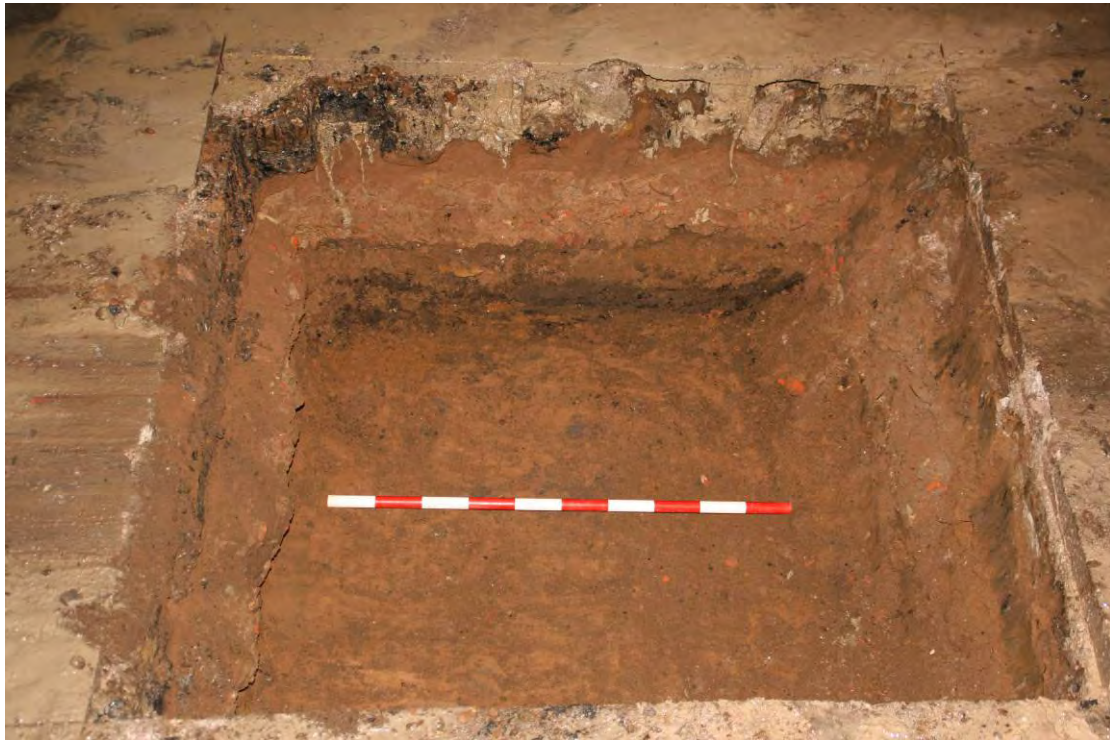
Plate 16. Trench 10b, demolition feature [10/14], looking north-east (scale 1m)

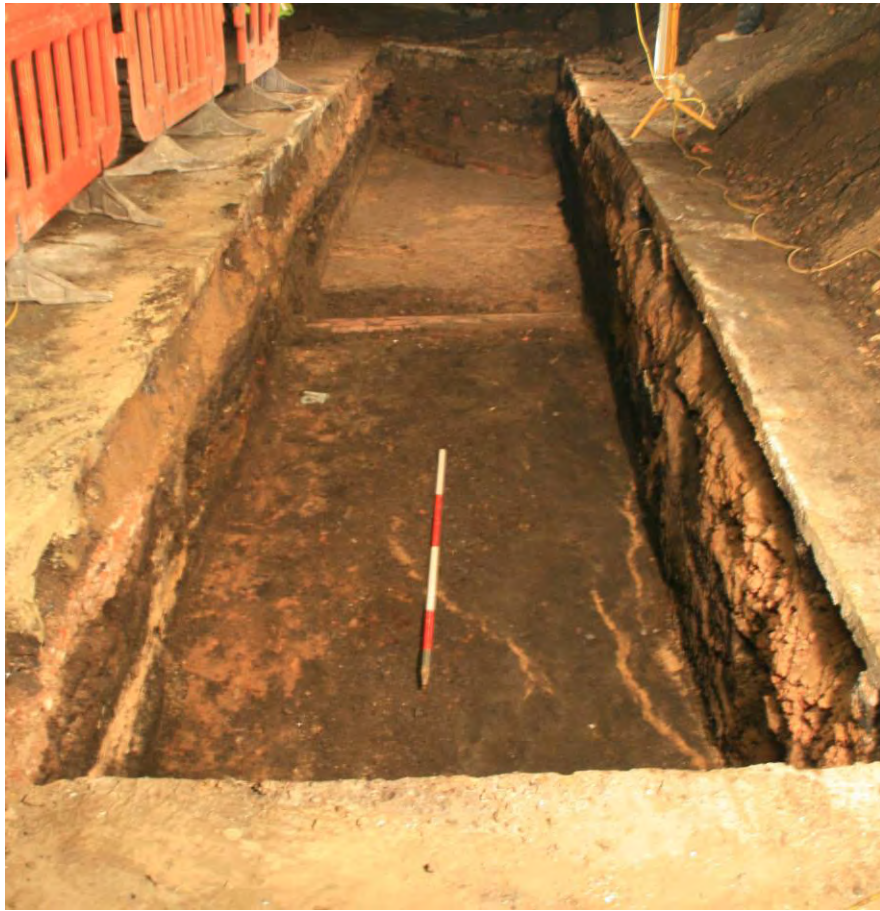
Plate 17. Trench 11, overview culvert [11/19] in foreground, looking north-west (scale 2m)

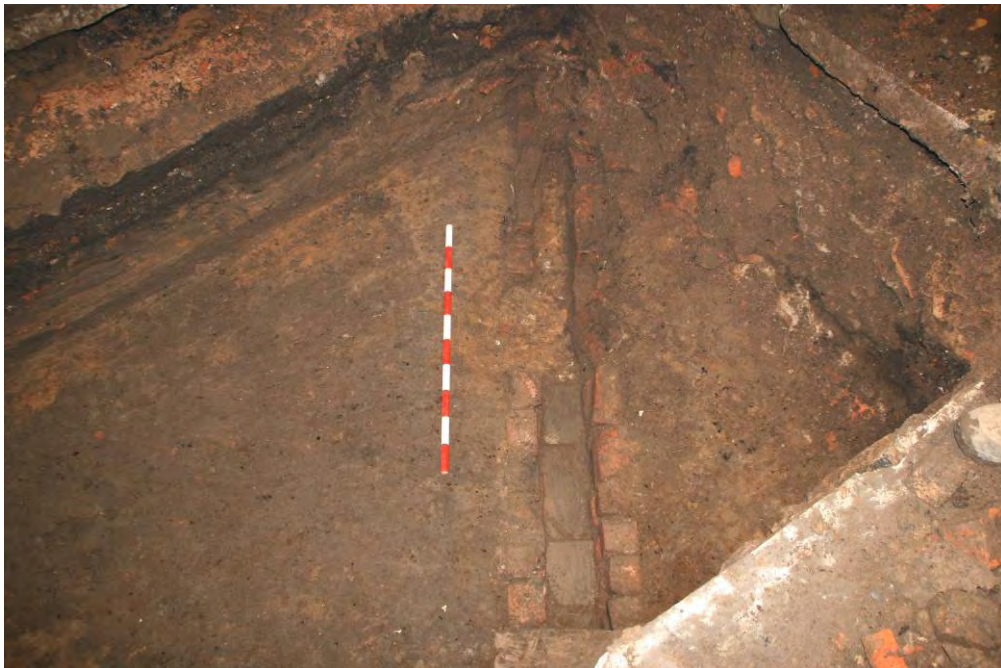
Plate 18. Trench 11, culvert [11/16], looking west (scale 1m)

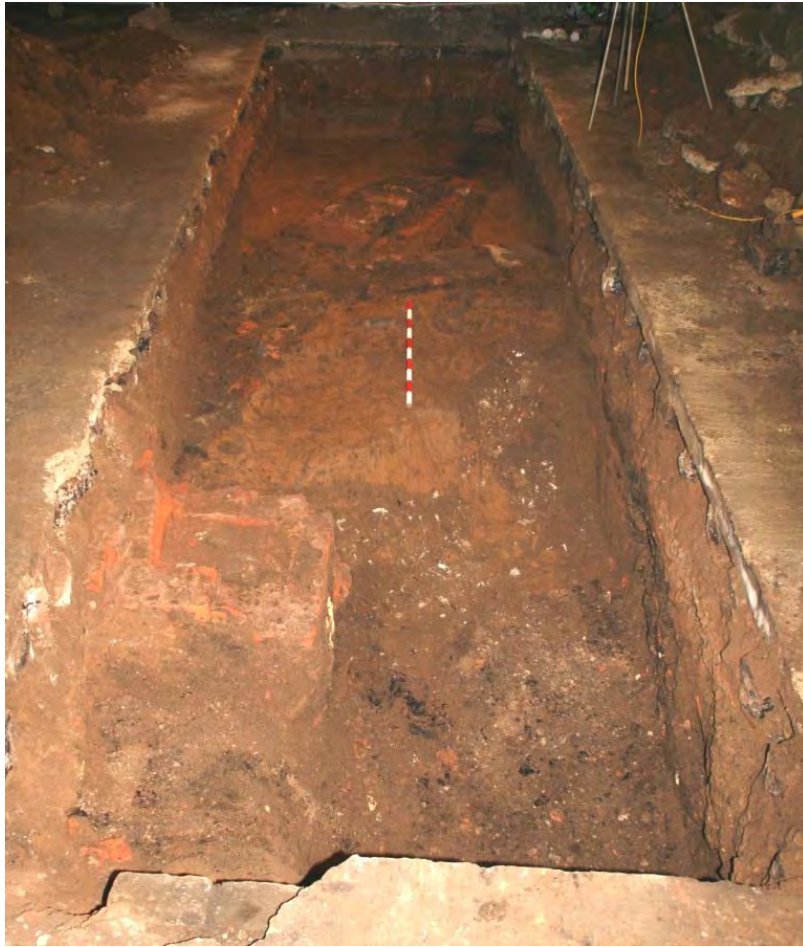
Plate 19. Trench 12, overview, culvert [12/13] in foreground, looking north-west (scale 1m)

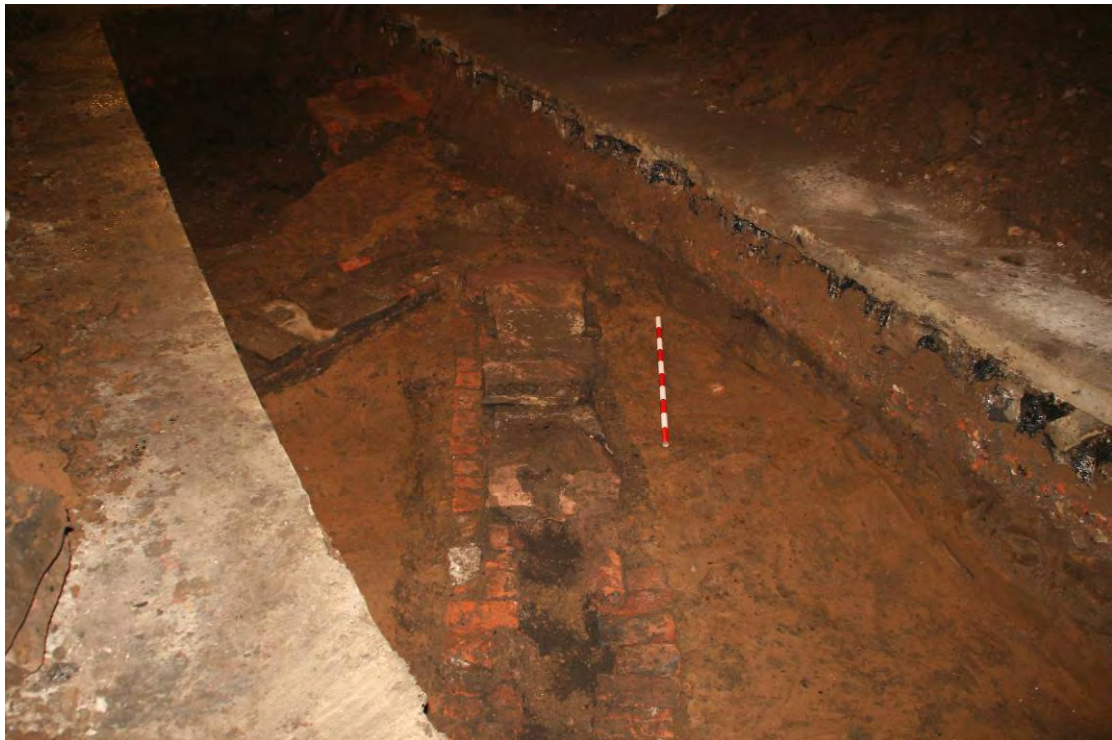
Plate 20. Trench 12, culverts [12/7] and [12/10], looking south (scale 1m)

- 5.4.28 Their stratigraphic relationship suggests that culverts [12/7] and [12/10] were not constructed contemporaneously. They may represent 18th- or early 19th-century drainage installed in association with the brewery depicted on Green's 1794 map, a manufactory which was replaced with the cotton mill depicted on the 1849 Ordnance Survey map (Figure 15).
