**STANDBY GENERATOR,
KENSINGTON PALACE,
KENSINGTON GARDENS, LONDON
W8 4PX**

**AN ARCHAEOLOGICAL WATCHING
BRIEF**

PCA REPORT NO: R11714

MAY 2014

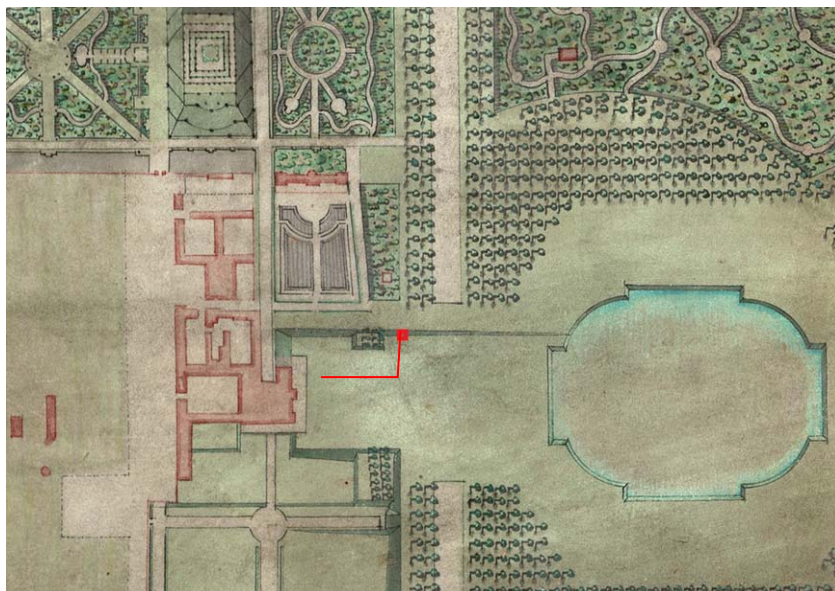
Plate 2: Bridgeman's Plan of c1733, showing approximate position of WB trenches

4.3.6 The garden arrangement at the Palace is best illustrated by Bridgeman's plan of c.1733 (Plate 3), onto which has been approximated the position of the watching brief trenches. It suggests that the trench is located upon the south-facing terrace which Bridgeman introduced to the East Front, the result of which are truncated islands of trees remnant from

the avenues of Wise's original scheme. Bridgeman realigned the central area of the East Front, squaring it with the palace, while elements of Wise's slightly oblique planting obviously remain and some may be preserved (if not terraced away) in the generator trench (pers comm. F. Keith-Lucas).

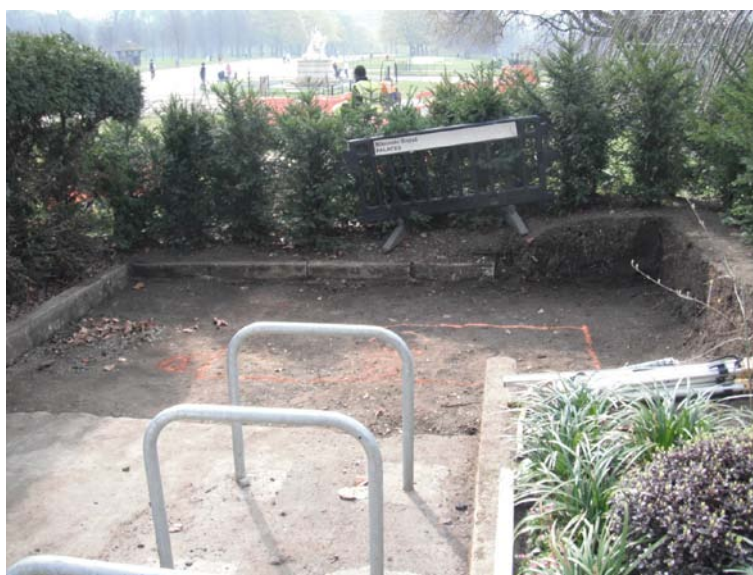
Plate 3: Generator Base Post Excavation-View: South

- 5.9 For the Generator Foundation Trench, an area at the southern end was reduced by 0.25m below the tarmac level on the eastern side and cut in to a raised planting bed on the western side removing the top approximately 0.75m of topsoil in order to create an even level to allow the construction of a concrete foundation.

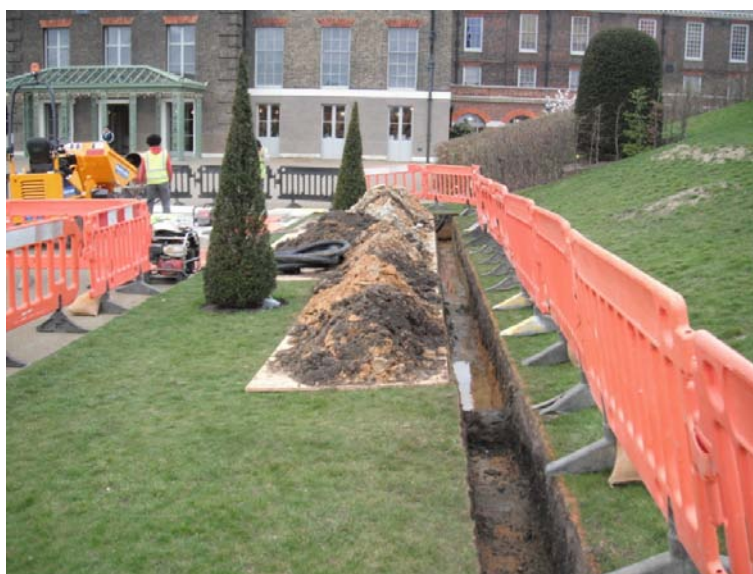
Plate 4: Cable Trench Excavation, western end –view west

- 5.10 A trench was then excavated in order to run a cable from the Standby Generator to connect with existing services. This Cable Trench ran from the south of the bicycle storage area running parallel with The Broadwalk across the grass for approximately 30m before following the curve of the grass towards the east. It then ran for approximately a further 65m in an east-west direction before turning 90° to the south and ran across the northern entrance road for approximately 9m where it connected up with an existing manhole. This portion running across the road followed the line of an existing cable trench and produced nothing other than modern backfill. The entire trench was 0.40m wide and was excavated to a depth of 0.60m.

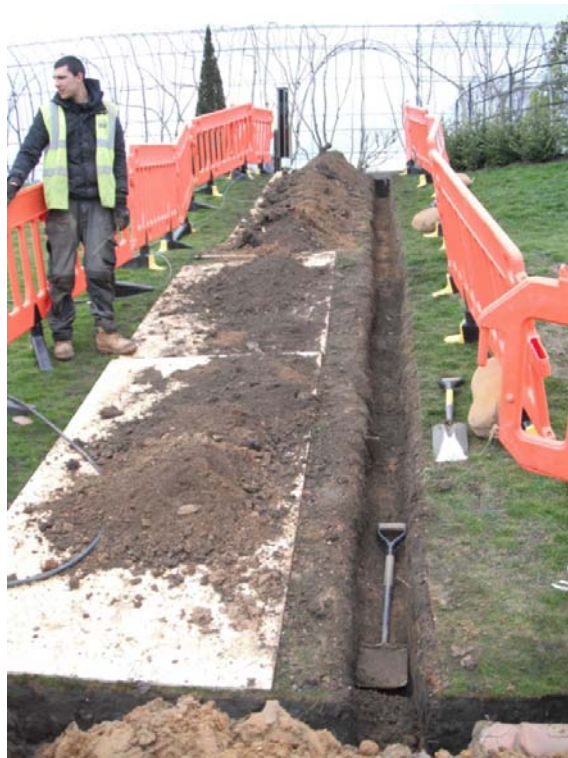
Plate 5: Cable Trench Extension northrn arm –view north

- 5.11 In addition to the scheduled works it was decided to excavate an extension to this trench approximately half way along the road up the bank towards the Sunken Garden in order to bury an existing cable that was currently lying above ground. This was excavated to a width of 0.30m wide and was 0.30m deep. While this was not part of the original schedule of works it has been included in this report.

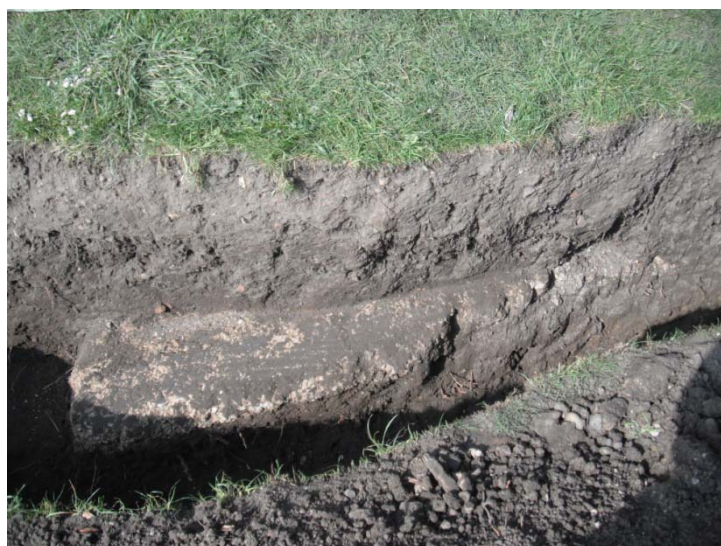
Plate 6: Garden Wall Foundation [4]-View: North West

- 6.2.1 Directly atop layer [5] was a lime cement mortar foundation [4] which was the foundation for a garden wall feature (Figure 3 and Plate 6). It had dimensions of at least 1.10m in an approximate north-south direction (running parallel to Broad Walk), was 0.15m wide and had a depth of 60mm. The feature continued northwards beyond the LOE of the trench, and its southern end had been previously truncated. The mortar was light yellow in colour with moderate inclusions of small rounded pebbles and moderate white flecks. Directly under [4] protruding from the section in layer [5] was seen a 19th century yellow stock brick fragment. Unfortunately it was not possible to derive an exact OD height for this feature as it lay part way up a bank, but its level has been calculated at approximately 24.90m OD, at a depth of 0.30m below ground level.

- 6.2.2 Immediately to the west of [4] was an in-fill deposit of crushed lime mortar [3] which is assumed to have been used as a bedding base for a plant bed. This had visible dimensions of 0.42m north-south, was 0.10m wide and a thickness of 60mm (Figure 3 and Plate 6).

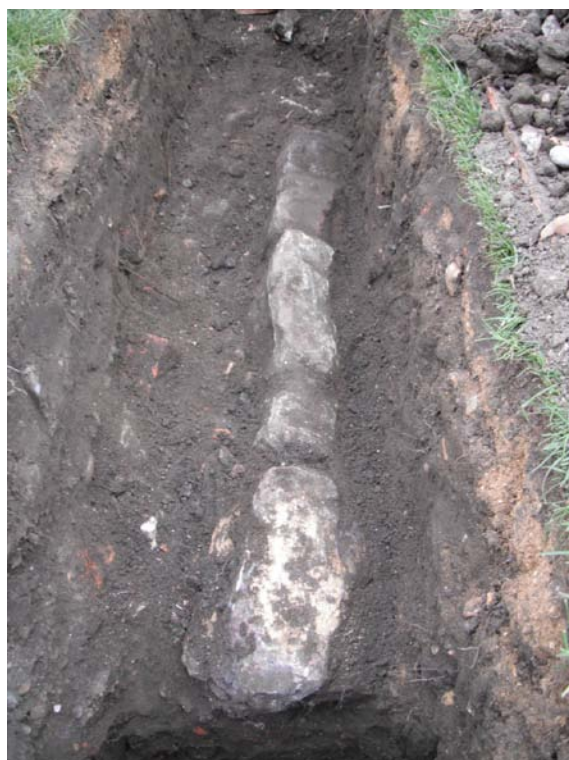
Plate 7: Path Edge [6]-View: North

- 6.2.3 At the most northern end of the trench, just before it joined with the Generator Foundation Trench, was seen an extremely crudely-built section of path edging [6] comprising a mixture of 19th century yellow and purple stock bricks, encased within mortar which implied their reuse from another location (Figure 3 and Plate 7). They were randomly laid on edge to form a linear boundary, aligned approximately north-south) with dimensions of at least 1.00m (the feature extended northwards beyond the LOE and was truncated to the south), was 0.15m wide and had a depth of 60mm. It was seen at a height of approximately 25.80m OD.

- 6.2.4 To the west of feature [6] was observed a crude metalised surface [7] comprising of very compact mid brown sandy silt in which were packed small and medium sized rounded and sub angular pebbles. It had dimensions of 1.00m (north-south) by between 0.20m and 0.38m, and was seen at a height of approximately 25.80m OD (Plate 7).
