**AN ARCHAEOLOGICAL EVALUATION AT
J.W. COATS & SONS, WARDLEY LANE,
WARDLEY, GATESHEAD,
TYNE AND WEAR**

Pre-Construct Archaeology Limited Quality Control	
<i>Project Number</i>	K3499
<i>Site Code</i>	WLG 14
<i>Report Number</i>	RN11041

Central National Grid Reference: NZ 3508 6194

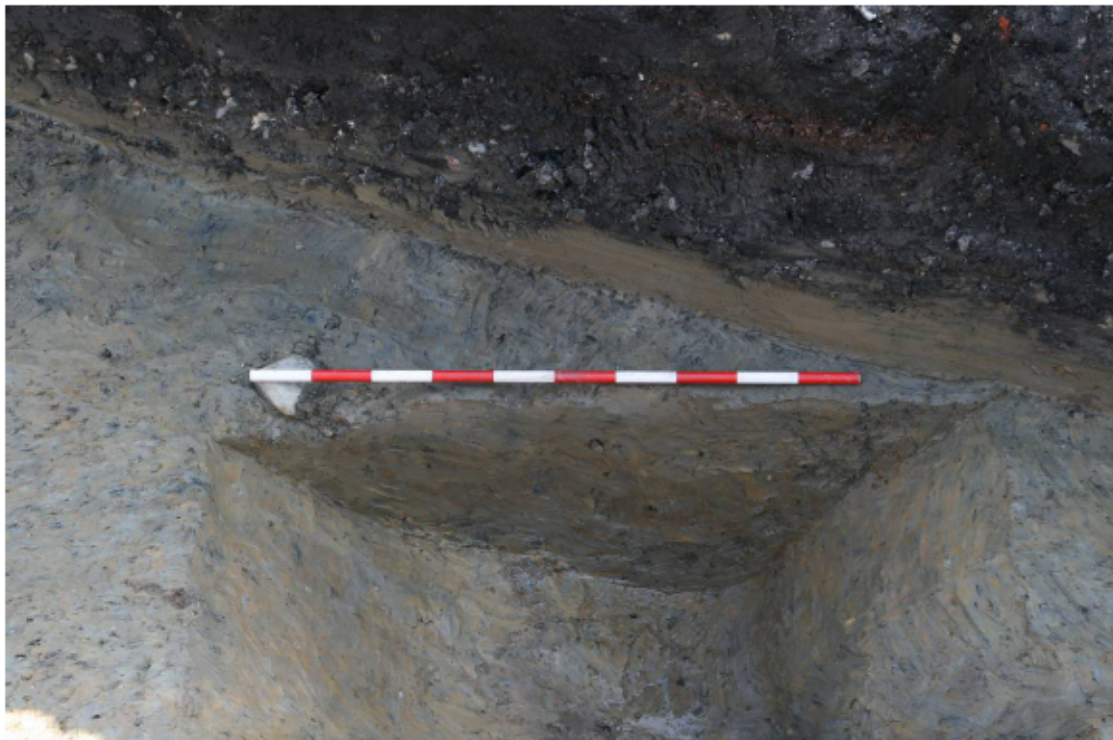
Plate 4: Trench 3, ditch [76], NW facing section (scale 1m)

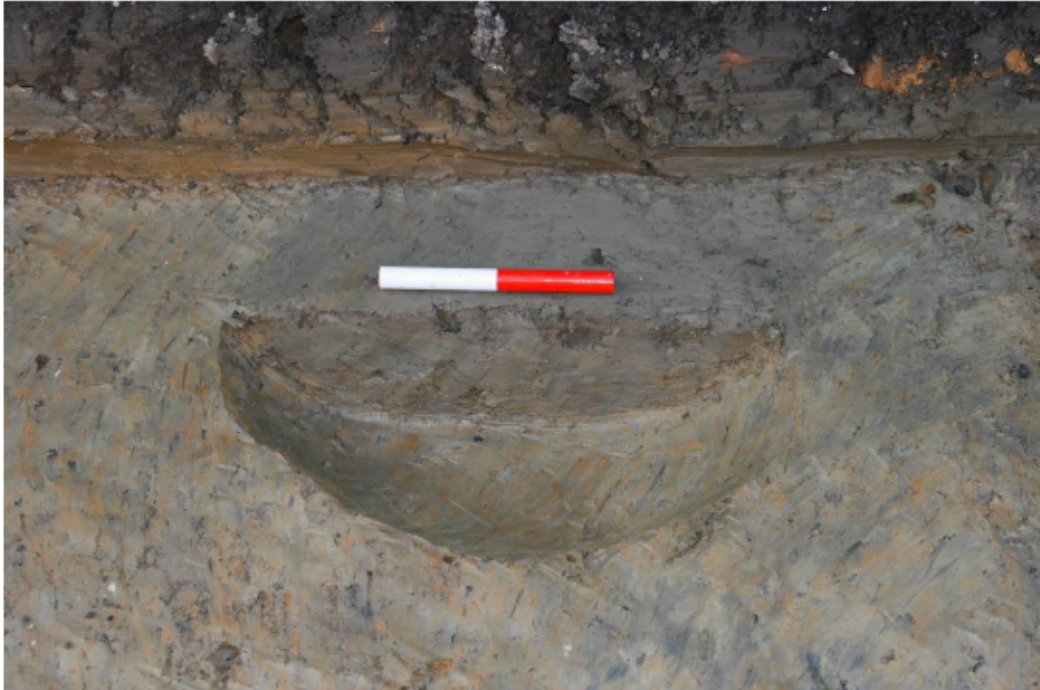
Plate 5: Trench 3, posthole [80], north facing section (scale 0.2m)

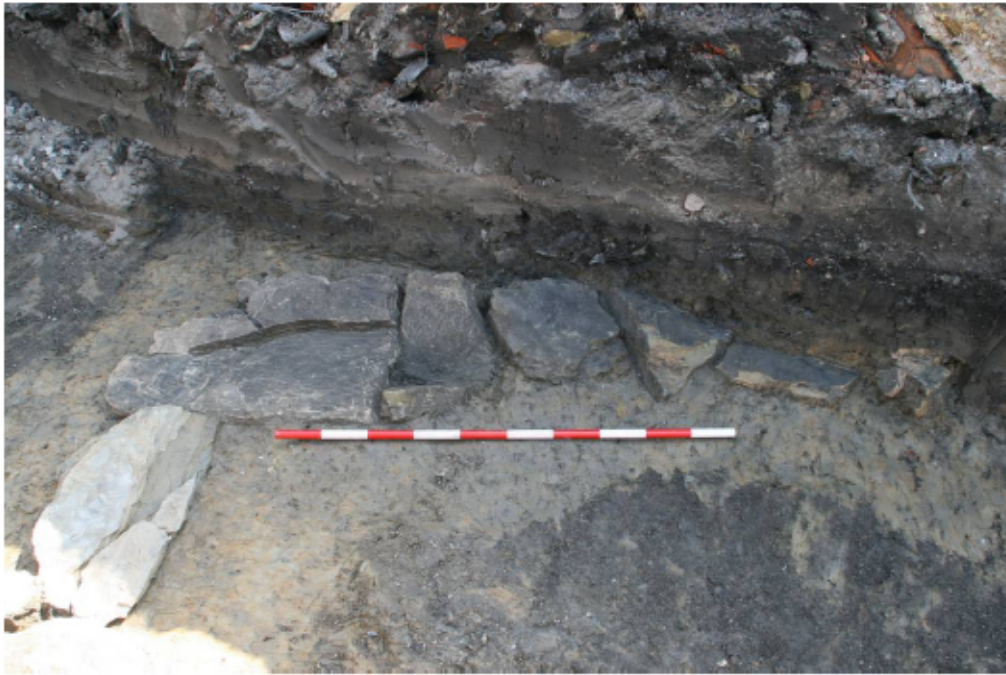
Plate 7: Trench 3, Wall [78] looking SE (scale 1m)

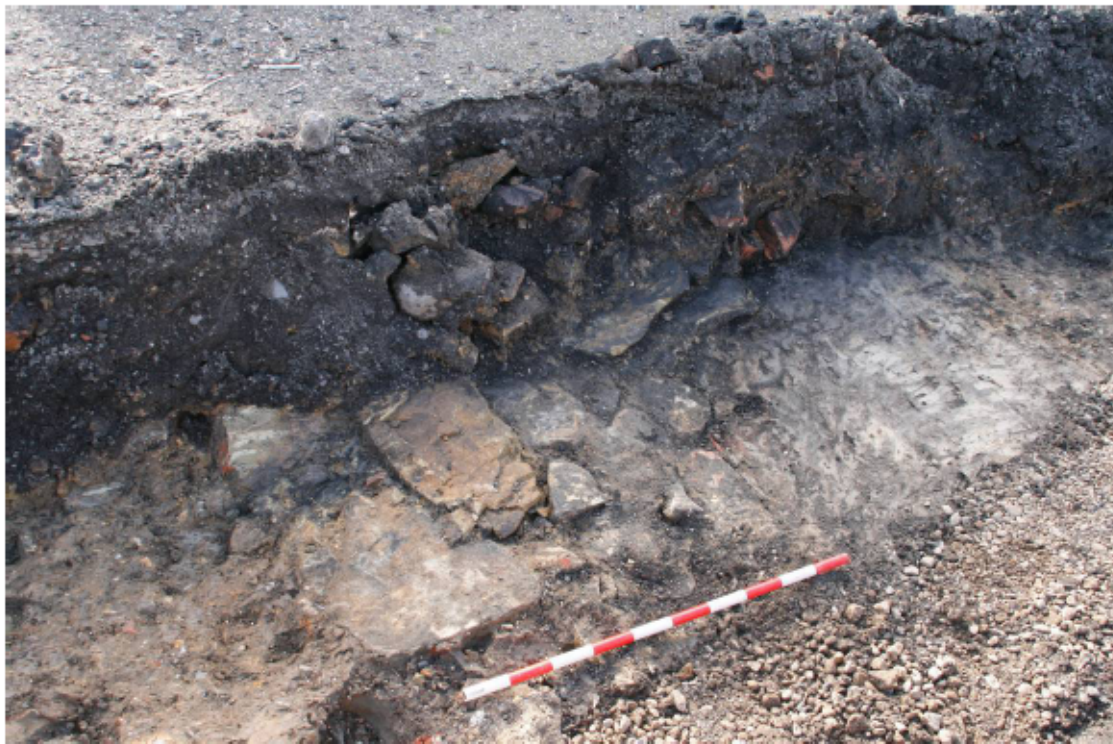
Plate 9: Trench 5, wall [39], looking west (scale 1m)

- 5.5.2 A substantial NE-SW aligned stone-built wall foundation, [39], was recorded within a broad construction cut, [36], measuring at least 2.40m wide. The wall foundation itself was exposed for a distance of 1.40m NE-SW, truncated to the north-east by a service trench, [46], and was c. 1.20m wide, surviving to a single course of large sandstone rubble (maximum 490mm x 440mm x 100mm) bonded with firm mid brown clay. It was encountered at a maximum height of 50.61m OD. The construction cut was backfilled with firm mid yellowish brown clay, [37], which yielded no artefactual material. This wall probably forms part of the buildings associated with Manor House Farm depicted on various 18th and 19th century maps. The map evidence indicates the arrangement of these buildings was substantially altered over this period of time and it is unclear if this wall represents part of the original 18th century or earlier build or the mid-19th century build.

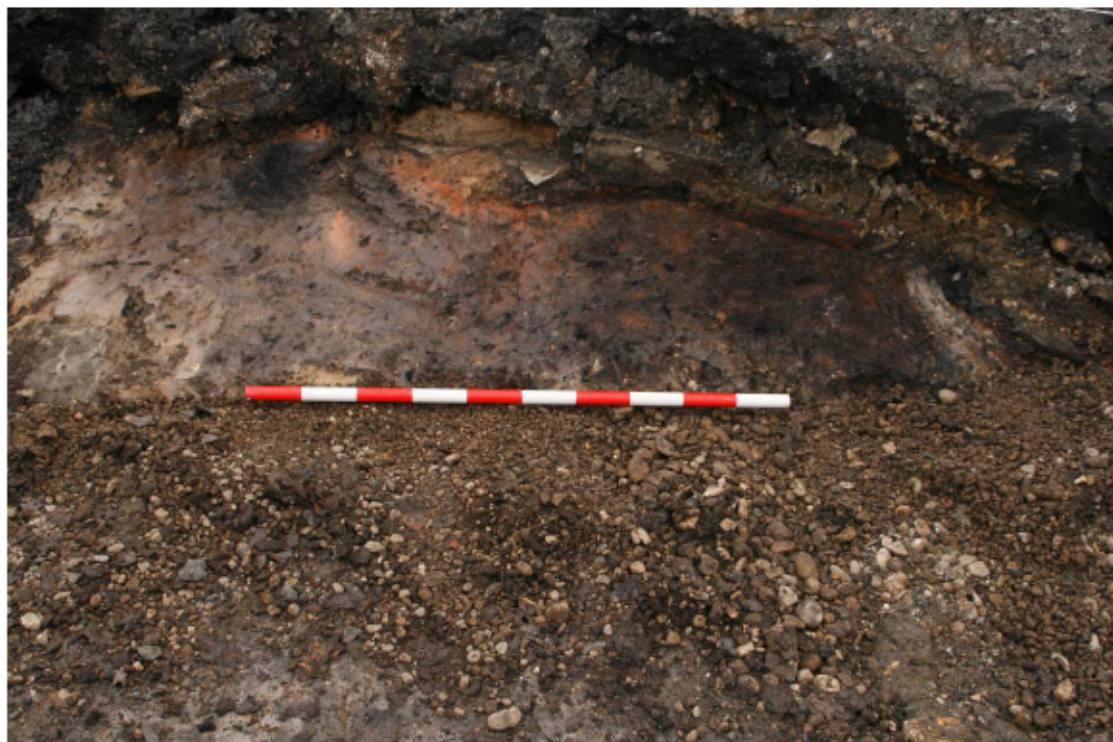
Plate 10: Trench 5, hearth [48], looking NE (scale 1m)

- 6.1.8 The stone-built wall foundation and basal portion of a possible hearth structure recorded in Trench 5 did not produce any artefactual material. However, this trench was sited within the vicinity of the north-eastern corner of the buildings of Manor House Farm. The earliest plan to show the farm dates from 1783 and the buildings were subsequently altered throughout the 19th century. With such a limited exposure, it is not possible to ascertain whether the structural elements recorded within Trench 5 were associated with the original farm, or subsequent 19th-century buildings. The structures recorded in Trench 5 were recorded at relatively shallow depth, c. 0.40m below the present ground level, at a maximum height of 50.66m OD.

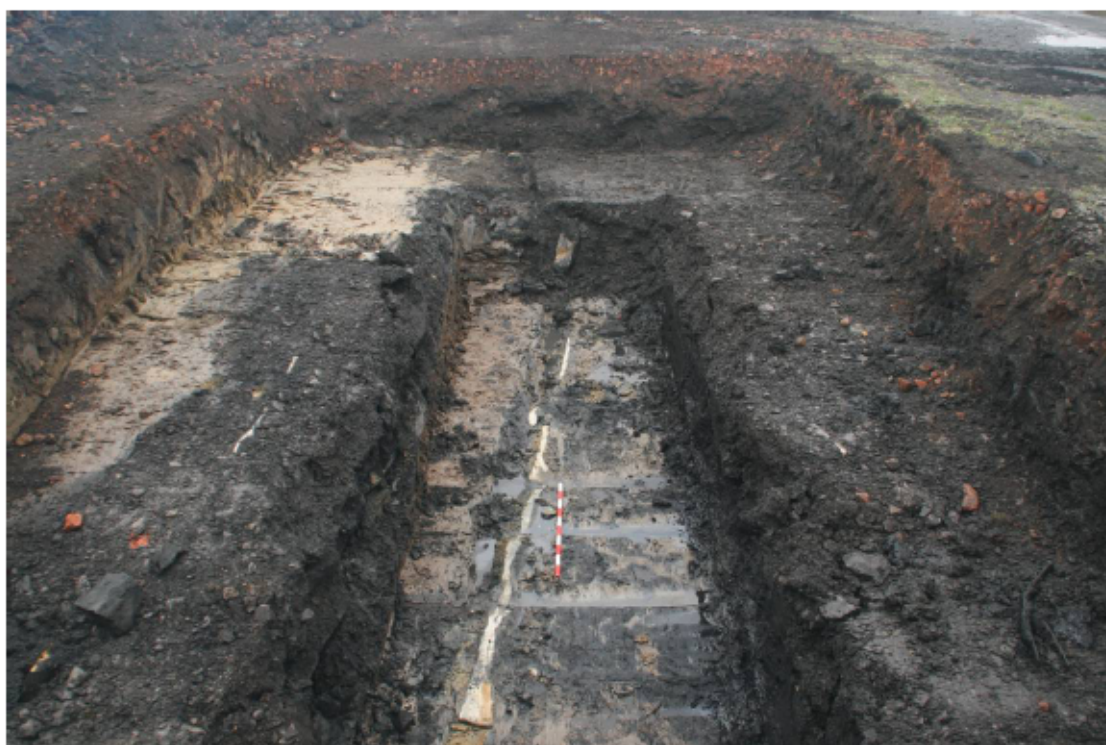
Plate 13: Trench 9, showing reservoir [3] stone-block retaining wall [9], looking SE (scale 1m)

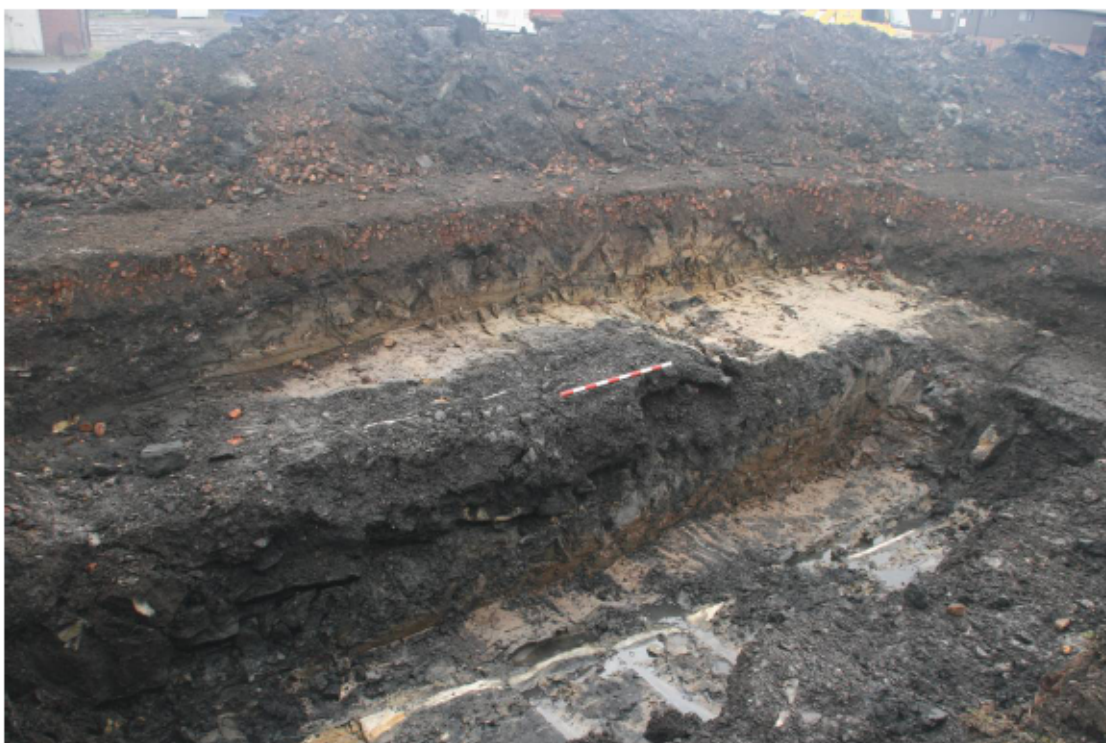
Plate 14: Trench 9, reservoir [3] stone-block retaining wall [9] in SW facing section (oblique) (scale 1m)

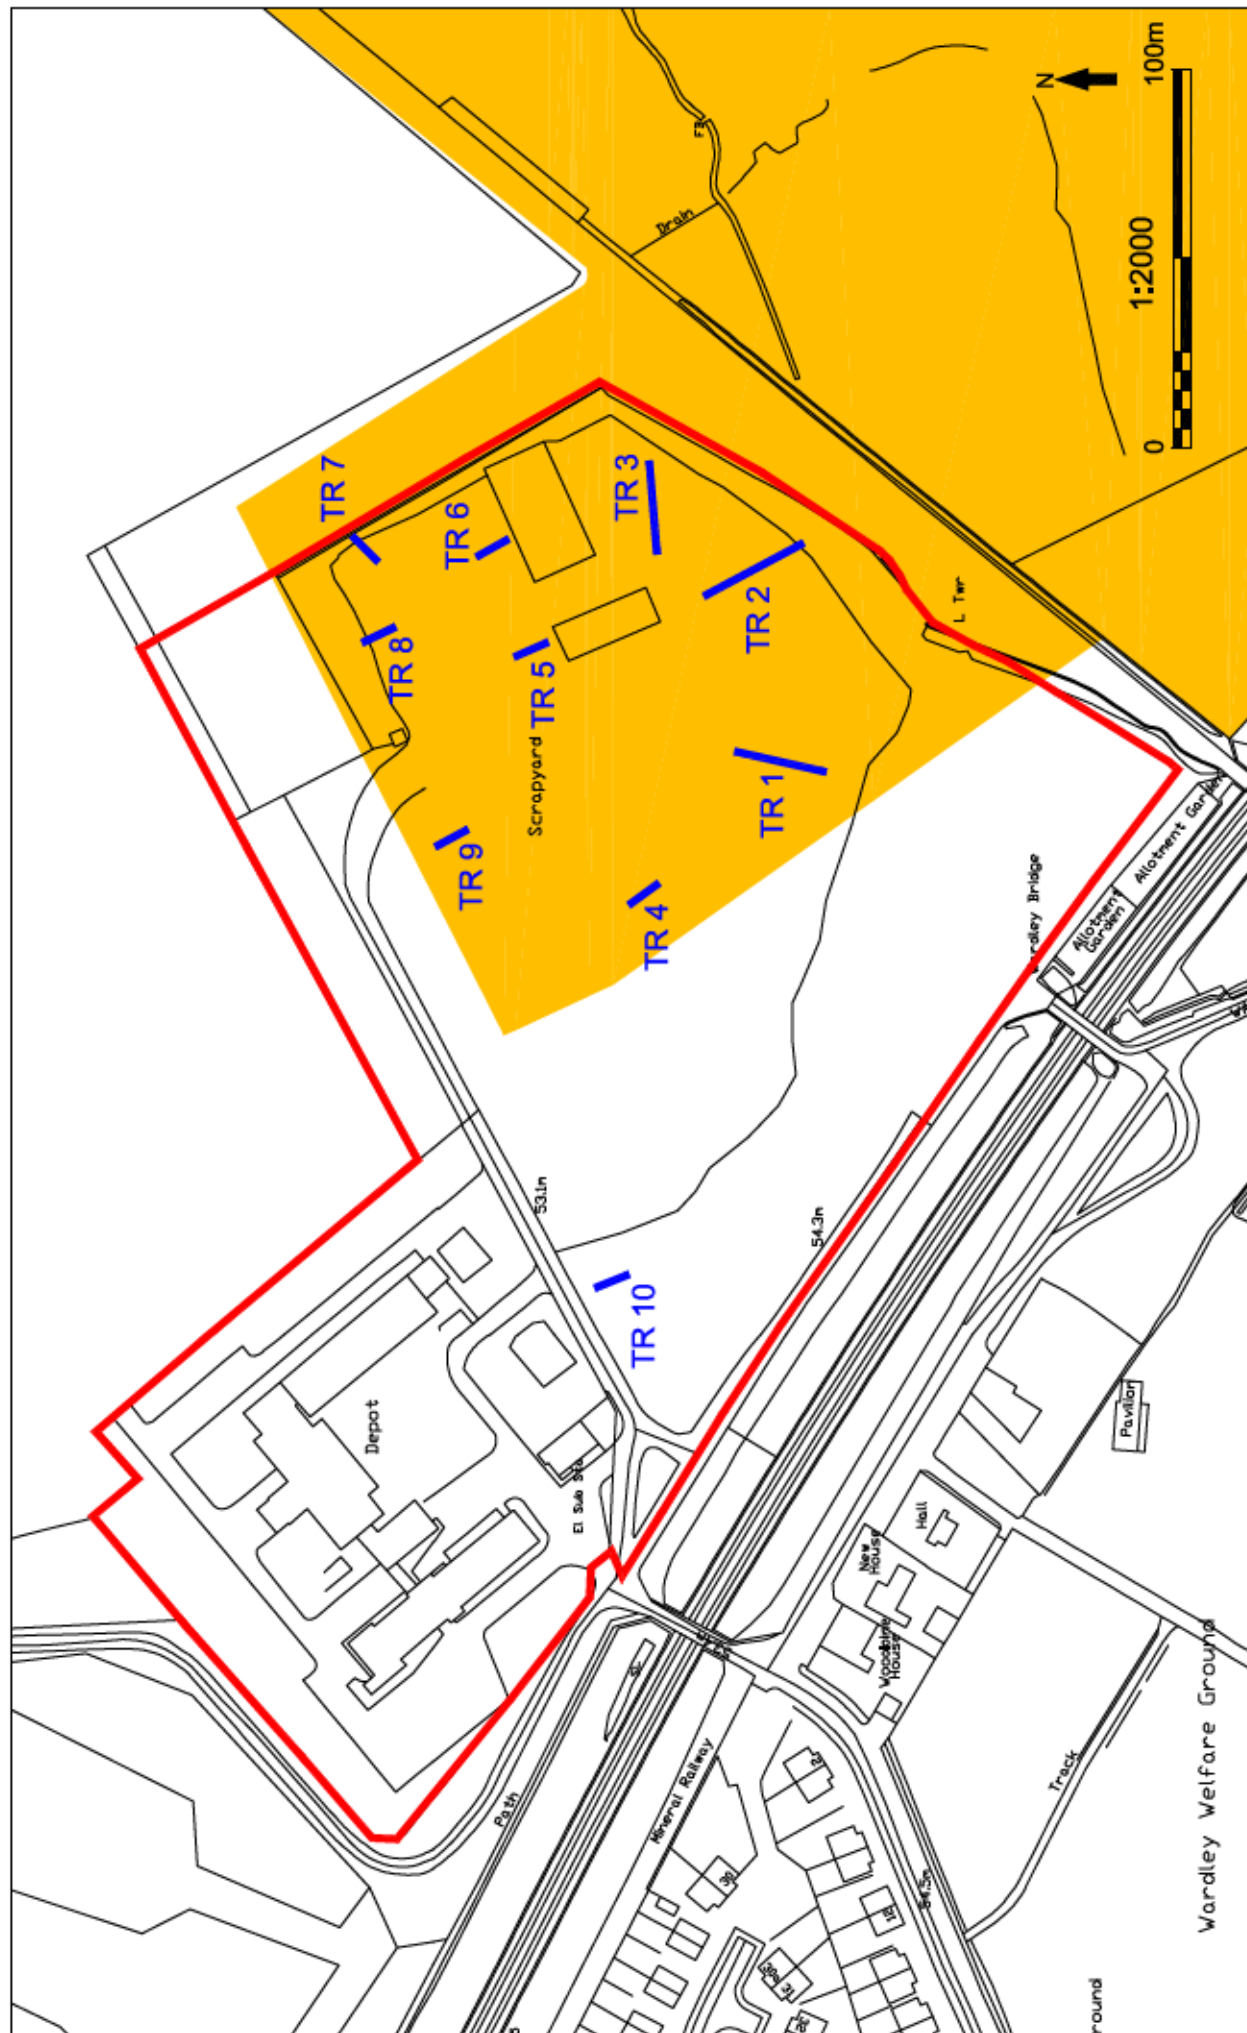
Figure 3: Proposed archaeological evaluation trench layout
(two 25m x 2m, one 30m x 2m & seven 10m x 2m)

1.7 An initial evaluation strategy comprising ten trenches (two trenches measuring 25m by 2m; one 30m by 2m and seven 10m by 2m) has been agreed to establish if the site or parts of the site have been truncated / disturbed and the degree of survival of any archaeological significant remains (see Figure 3). If the initial evaluation shows the survival of archaeological significant remains or deposits further archaeological works may be required which will have to be agreed in consultation with the Tyne and Wear Conservation Team and English Heritage prior to the development of the site.
