**ASSESSMENT REPORT  
ON ARCHAEOLOGICAL  
INVESTIGATIONS AT  
MALTBY ACADEMY,  
MALTBY, ROTHERHAM,  
SOUTH YORKSHIRE**

**PCA REPORT NO. R11776**

**JUNE 2014**

ASSESSMENT REPORT ON ARCHAEOLOGICAL  
INVESTIGATIONS

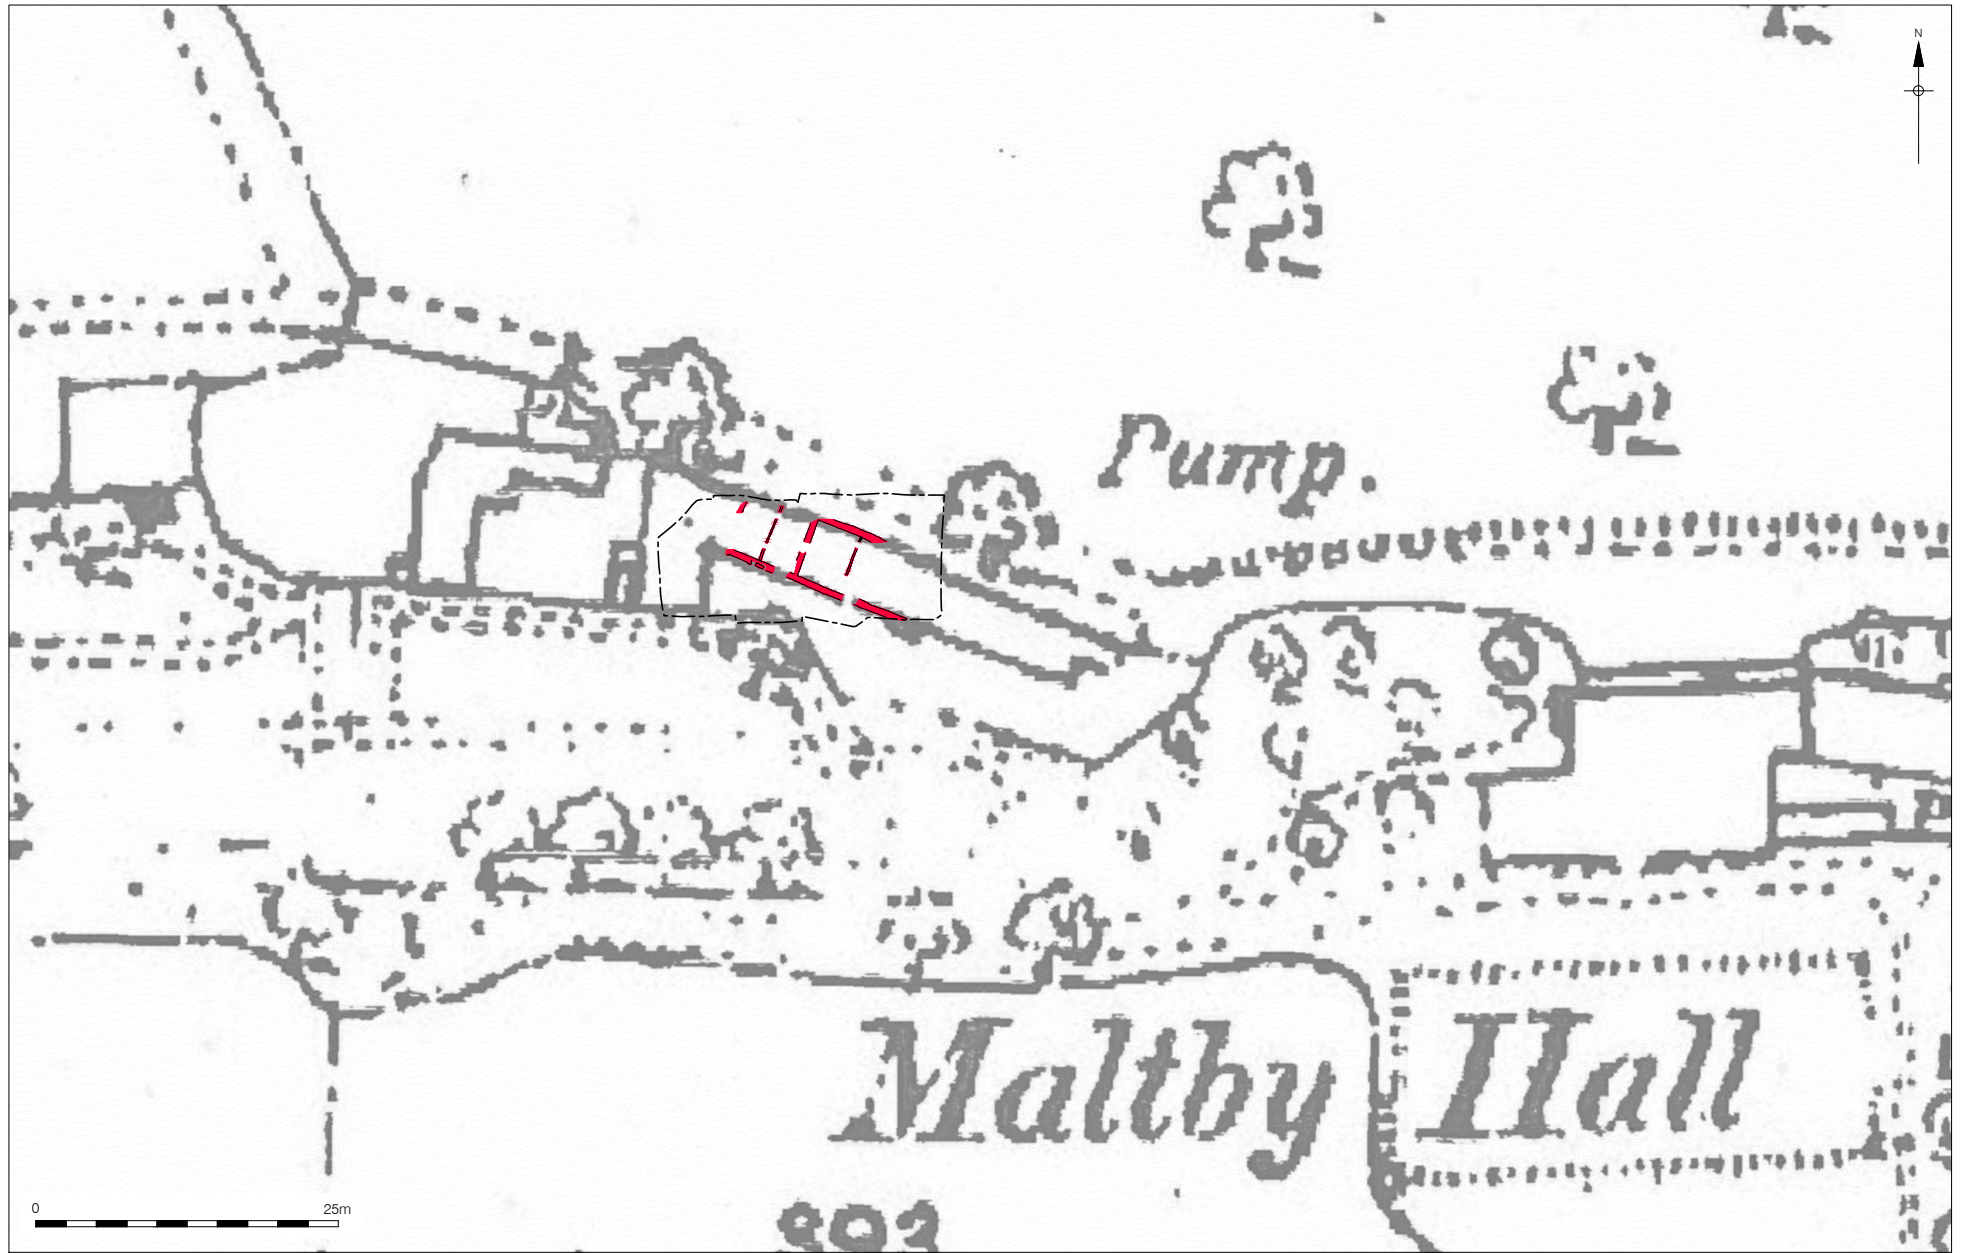
- 5.2.4 A 15m length of the north-west to south-east aligned south wall of the building [18] was exposed within Area 1, continuing beyond the south-eastern limit of excavation and truncated at the north-western end (Figure 3, Plates 2 and 5). Overlay of the outline of the excavated structural features

onto the 1888 and 1916 maps indicates that this represents the western part of the Maltby Hall outbuilding (Figures 4 and 5). The wall survived to a height of 0.5m, it had been reduced to a level just above the height of later internal floor surfaces, and was 0.5m wide. It was constructed with roughly squared limestone blocks (measuring up to a maximum of 0.4m x 0.3m x 0.1m) faced on both internal and external elevations and bonded with a whitish lime mortar. The south-east end of the wall was recorded at a height of 110.72m OD and the north-west end at 111.27m OD; this reflected the natural rise in ground level and not a higher surviving section of wall.

- 2.1.4 Historic maps have indicated that both areas have particular potential for post-medieval archaeology in the form of structural remains of Maltby Hall, which is of 19th century, possibly earlier, date. The Hall appears to have replaced an earlier 'Maltby Old Hall', which is thought to have been located further to the east, beyond Braithwell Road. In Area 1, where a new build is proposed, a range of buildings is depicted to the west of Maltby Hall on an Ordnance Survey map dated 1888 (Figure 4).

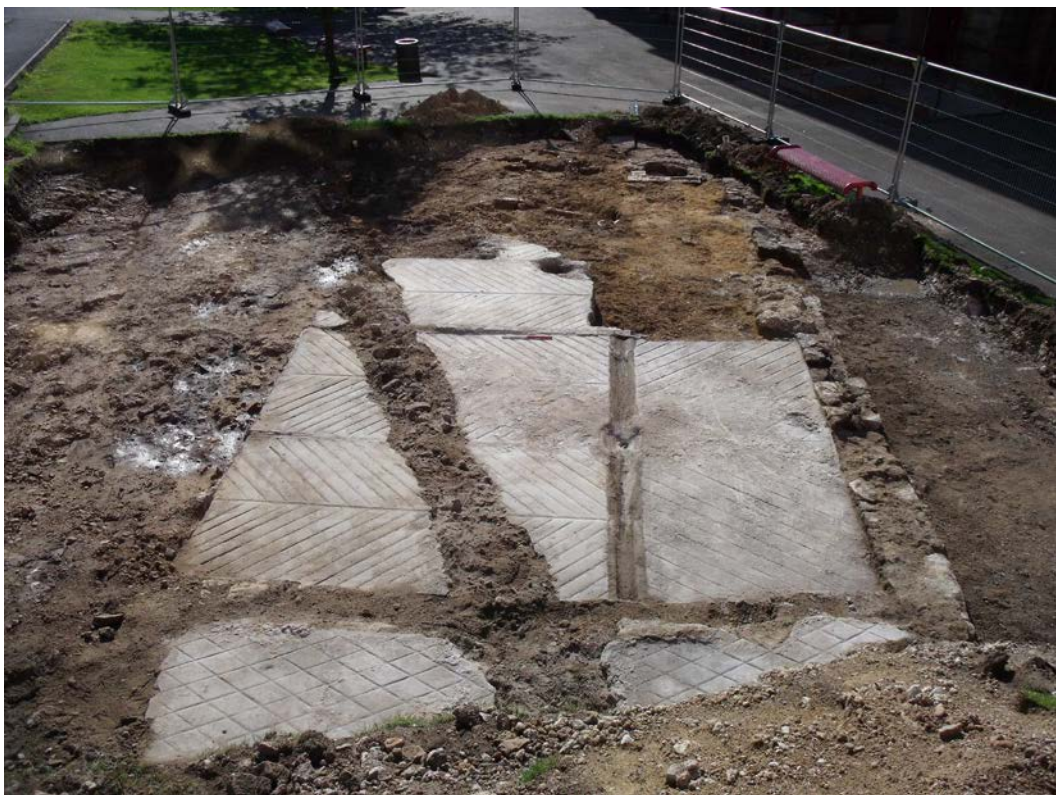
Plate 2: Eastern half of Area 1, post-excavation, looking east-south-east (scale 0.5m)

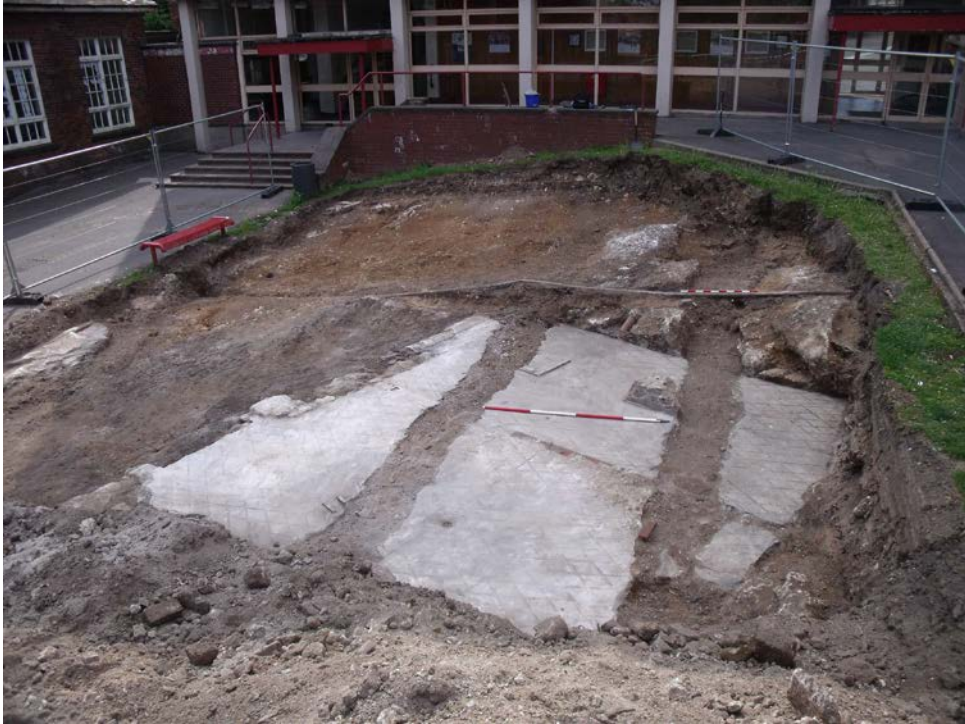
Plate 3: Western half of Area 1 post-excitation, looking west (scales 2m and 1m)

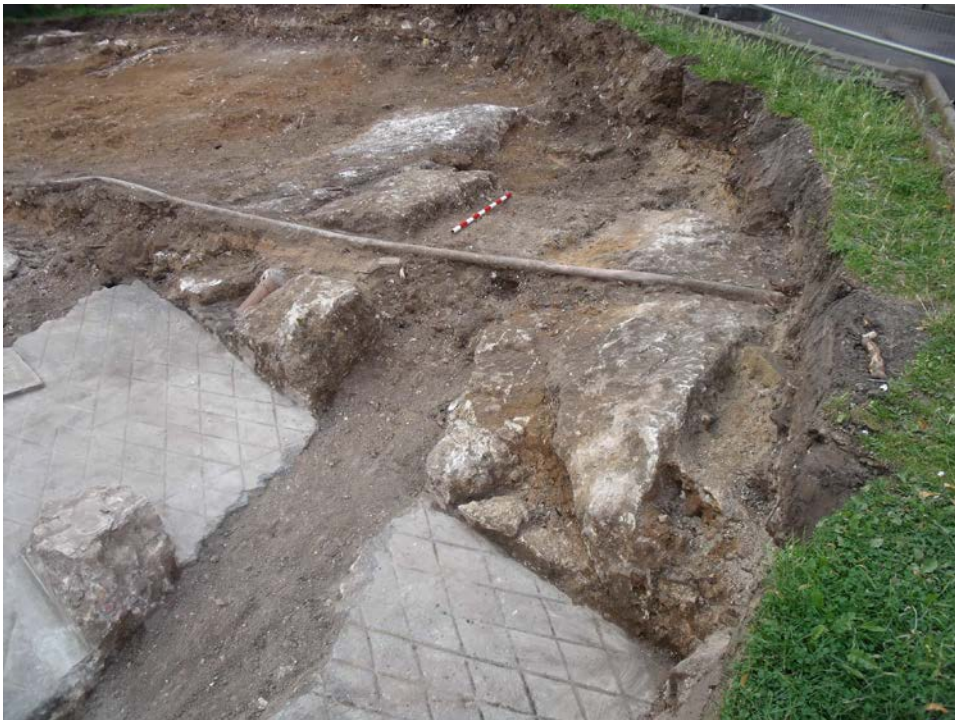
Plate 4: North-west corner of Area 1 showing bedrock and floor [45], looking north-west (scale 1m)

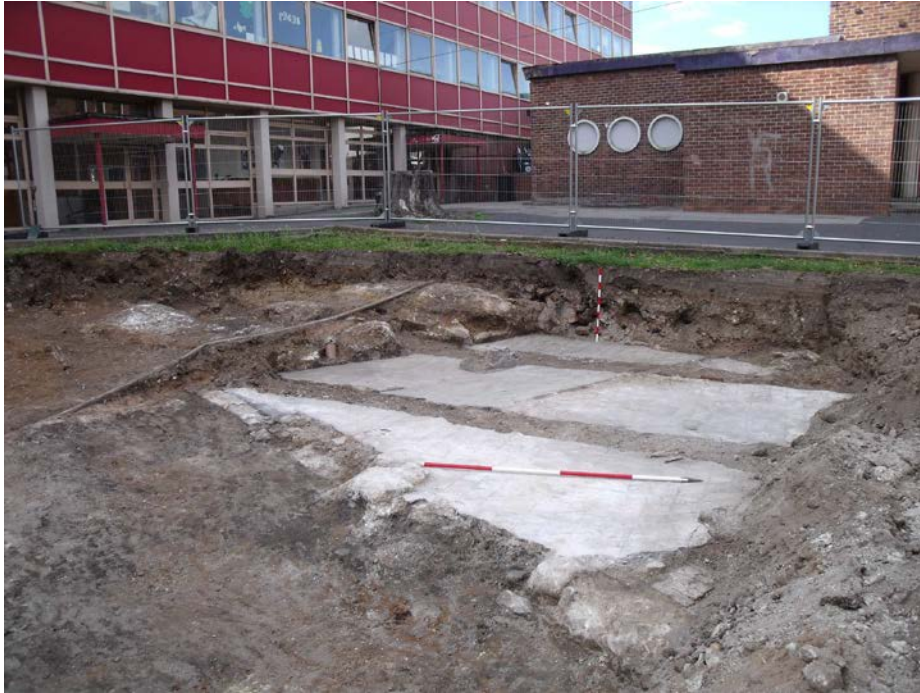
Plate 5: Western half of Area 1: entrance through wall [18] with floor surfaces [13] and [45], looking north (scales 2m and 1m)

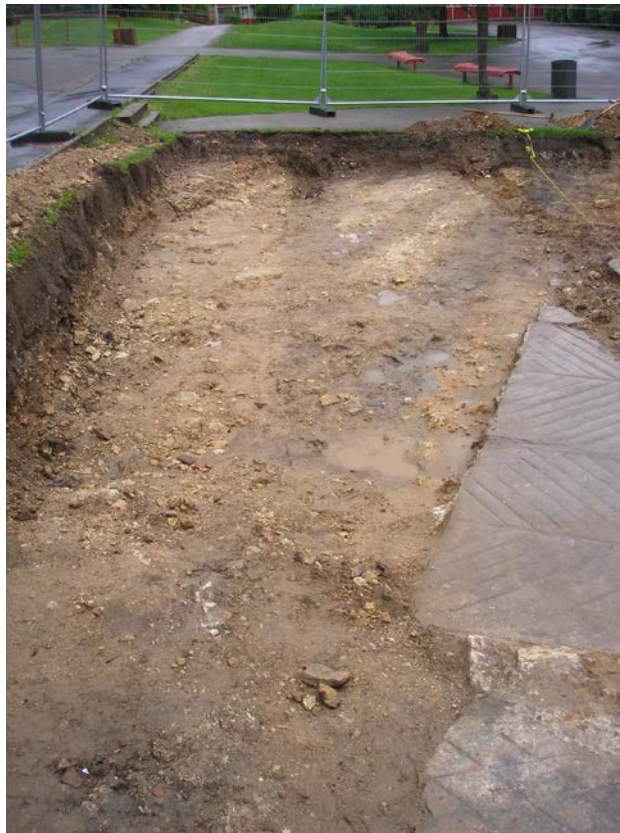
Plate 6: North-east corner of Area 1, exterior linear features and floor surfaces [14] and [15], looking east

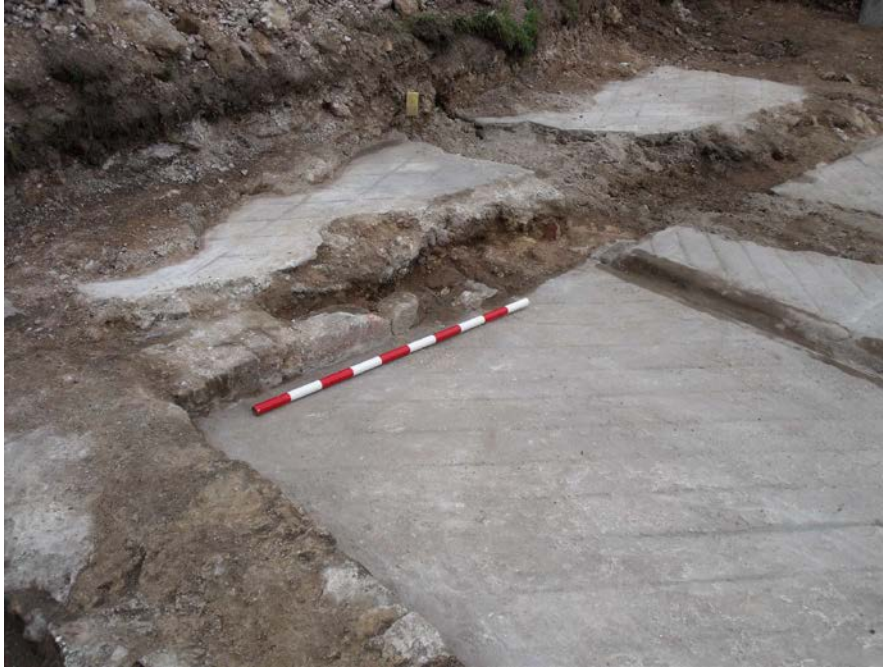
Plate 7: Eastern half of Area 1: external and internal elements of wall [18] with floor surfaces [13] and [14], looking north-west (scale 1m)

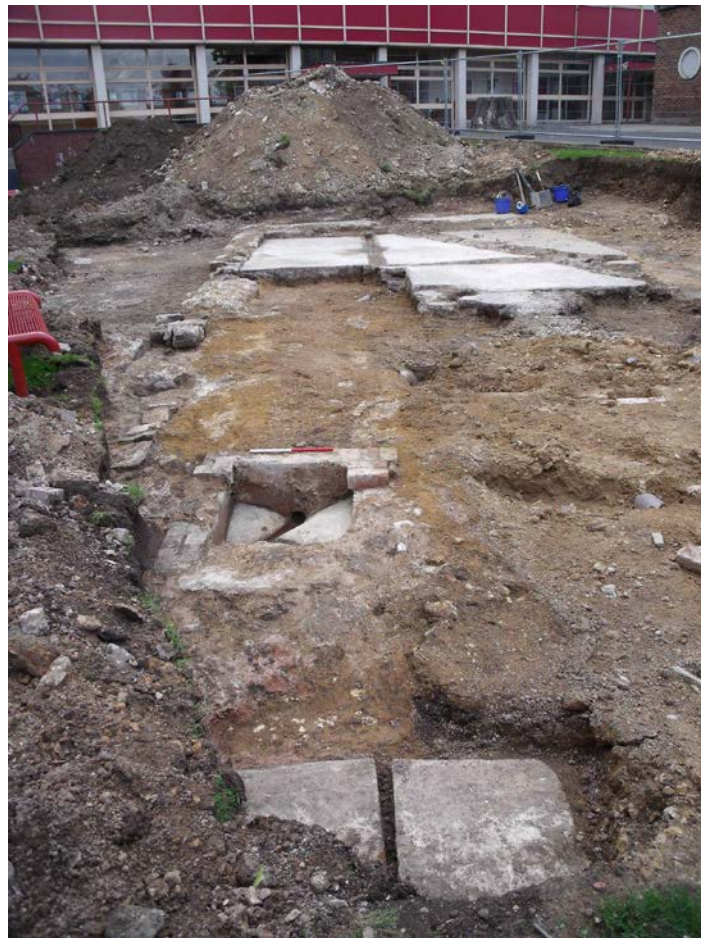
Plate 8: Eastern half of Area 1: south-east corner of Area 1, modern drain [25], looking north-west (scale 0.50m)

- 5.3.5 In the south-east corner of Area 1 was a brick and concrete drain junction [25], which redirected the flow from two drain pipes from the north-west and north-east, into a single pipe heading south (Plate 8). A large frogged brick stamped 'DMC Ld' had been used in the construction of this drain. This was manufactured at Darfield Main Colliery, a pit at Darfield village near Barnsley, probably in the 20th century (see Section 8). The drain was capped by a thin cement mortar layer [26], which contained two reused flagstones. This feature was probably inserted into a pre-existing drainage system as it was contained within the linear cut [30] that extended beneath concrete floors [14] and [15] of the building. It would appear that when the school buildings directly to the north of Area 1 were built in the mid-20th century, a new drain was added.
