**Welch's, Granta Terrace,
Stapleford, Cambridgeshire:
An Archaeological Evaluation**

Pre-Construct Archaeology Ltd	
Project Number	K3339
Report Number	R11659

An Archaeological Trial Trench Evaluation

Site Code: CWTS14

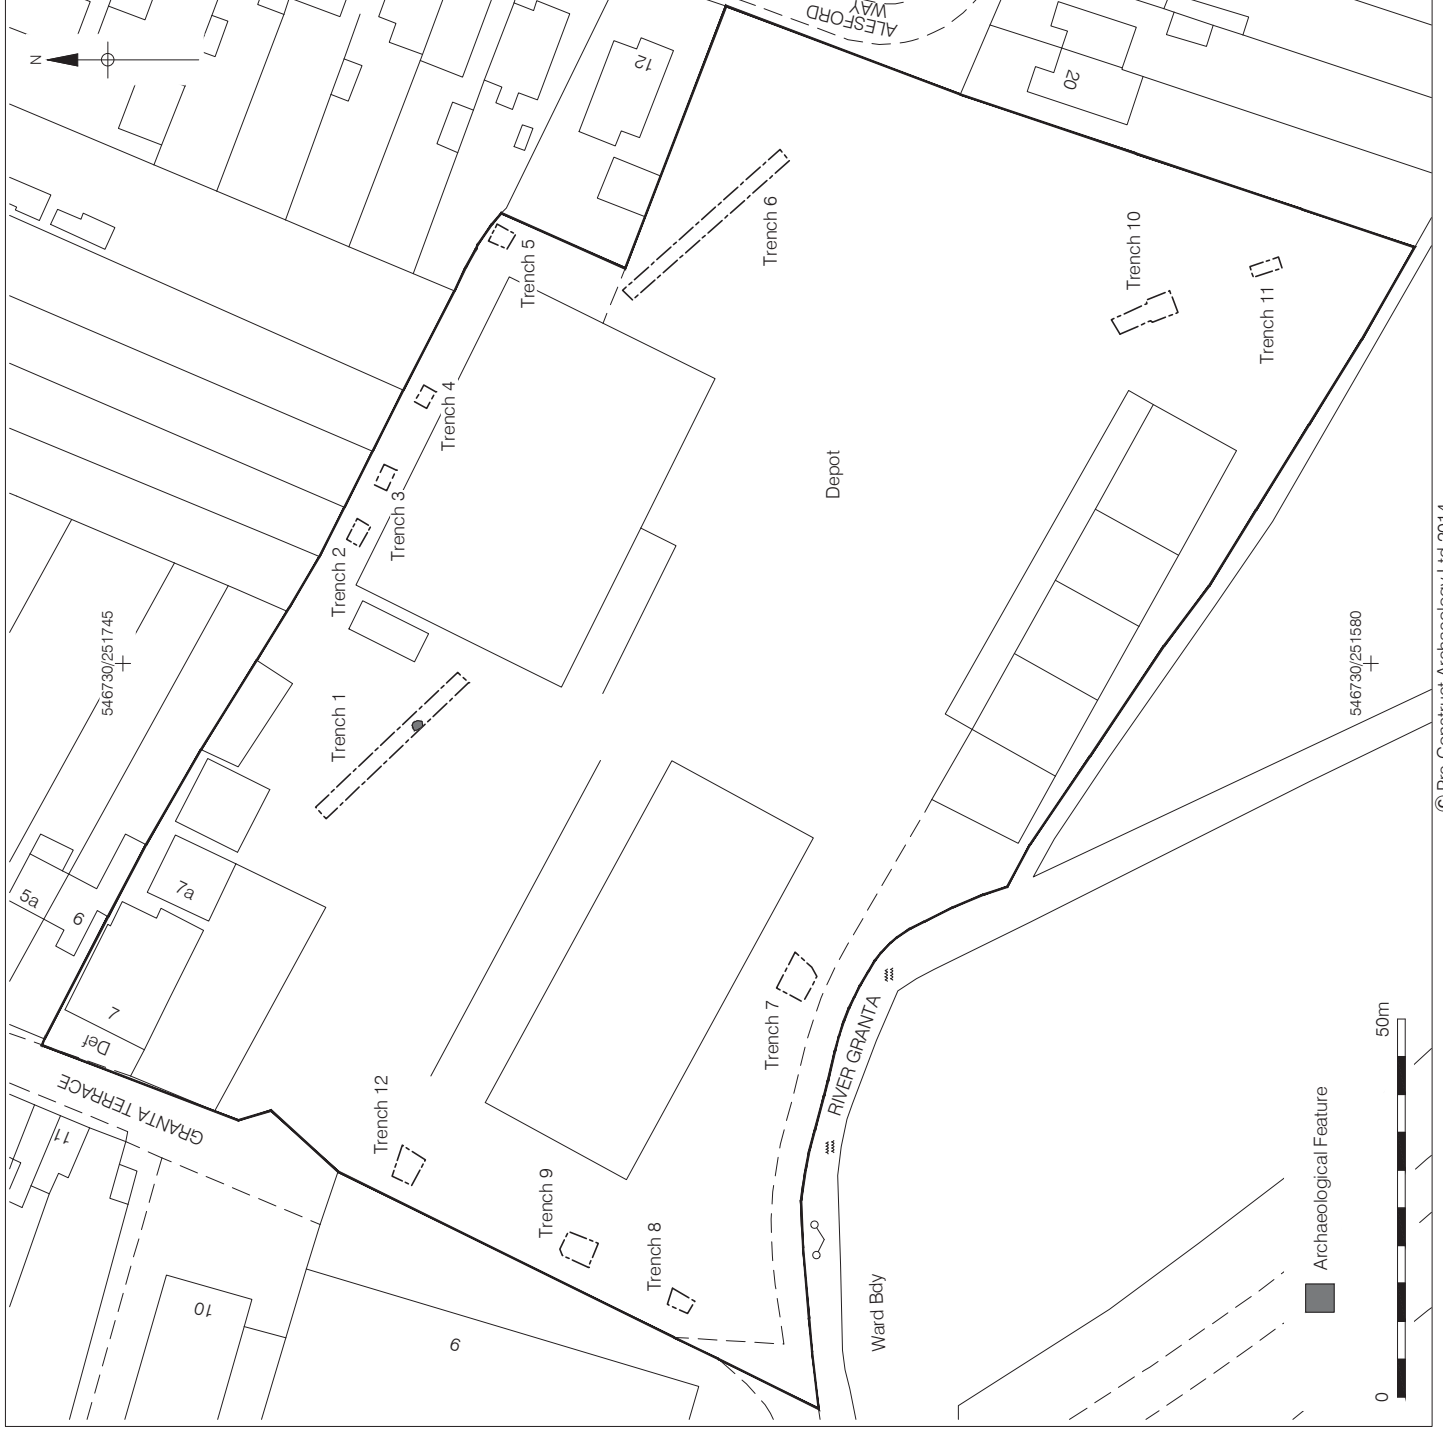
Figure 2
Trench Location
1:1,000 at A4

- 1.5 Two linear trenches measuring a total of 47m and a further 10 test pits measuring between 2m and 4m (totalling 207m²) were excavated and recorded between 1st and 7th May 2014 (Figure 2). The trenches and test pits demonstrated that the site had already seen significant ground disturbance and that the natural geological substrate was in most places buried below a considerable deposit of made ground or truncated by modern disturbance. A single modern pit was exposed in Trench 1 (Figure 3).

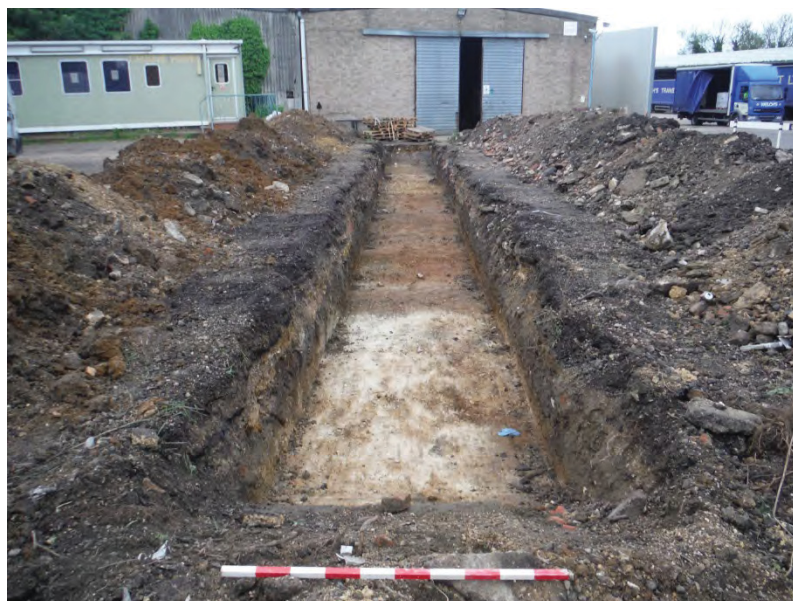
5.2.1 Trench 1 was aligned northwest to southeast and was 27m long. The stratigraphic sequence comprised an average of 0.48m of made ground (100), which overlay the former topsoil (0.24m) and subsoil (0.22m) deposits. The natural superficial geology was exposed at a depth of approximately 1m (Plate 1). The remains of a single pit [103] measuring 1.3m x 0.18m deep was recorded toward the centre of the trench. It contained no finds. A modern refuse pit was apparent within the upper topsoil and subsoil immediately above this undated pit and it is possible that the pit represents the disturbed base of this modern feature.

Plate 1: Trench 1 looking southeast

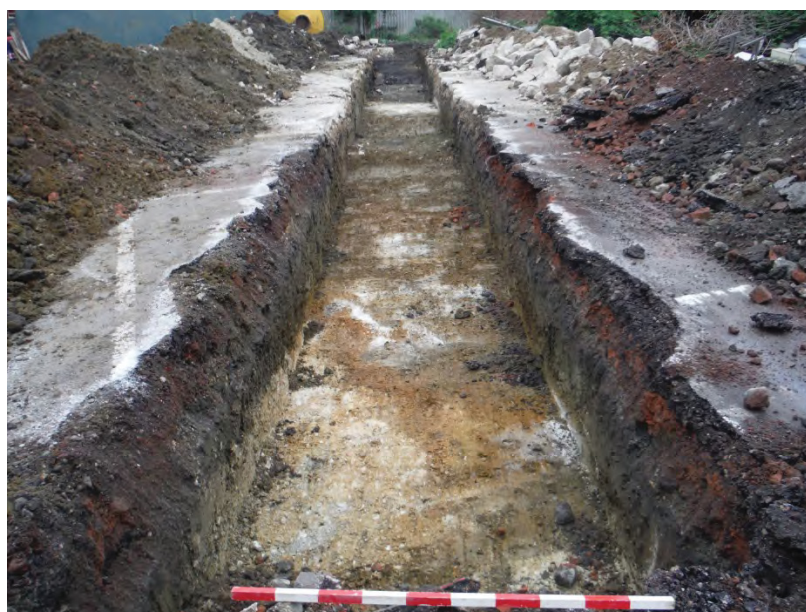
5.4.1 Aligned northwest-southeast Trench 6 measured 20m long and was located at the northeast corner of the development area (Plate 2). On average the made ground (100) measured 0.29m thick but was distinctly thicker at the eastern end of the trench. The topsoil and subsoil deposits measured an average of 0.28m and 0.22m respectively. At the western end of the trench, a large modern pit was exposed and filled with building debris, domestic and industrial waste. The natural substrate, exposed across the remainder of the trench, had clearly been impacted upon by modern disturbance. There were no archaeological features within this trench.

Plate 2: Trench 6 looking northwest with modern disturbance in the distance

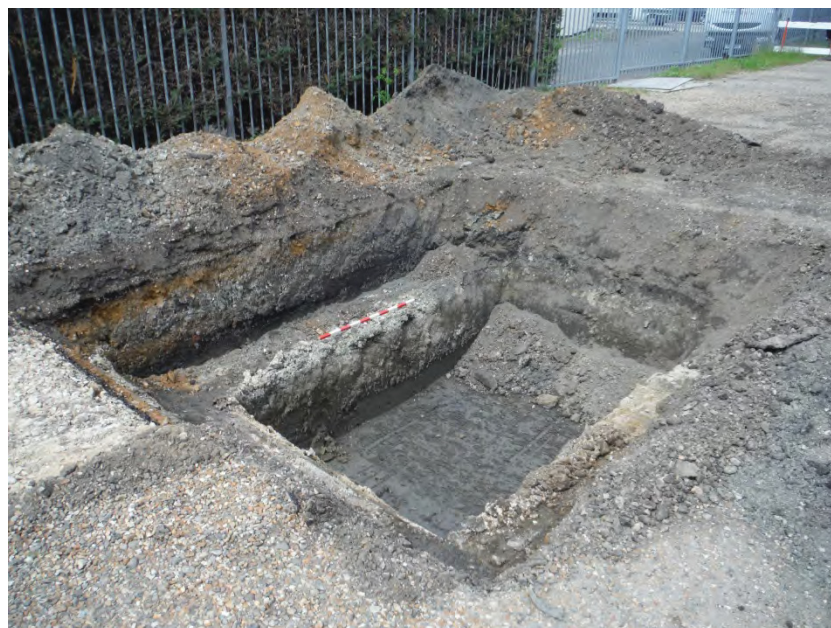
5.6.3 Trench 9 was also extremely deep, with thick made ground deposits (0.72m) overlying a distinct clay and rubble mixed deposit (0.62m thick). Sealed beneath these layers was an homogenous silt clay interpreted as the floodplain alluvium (Plate 3). This alluvial deposit measured more than 0.7m thick.

Plate 3: Trench 9 showing alluvium beneath thick made ground and levelling deposits

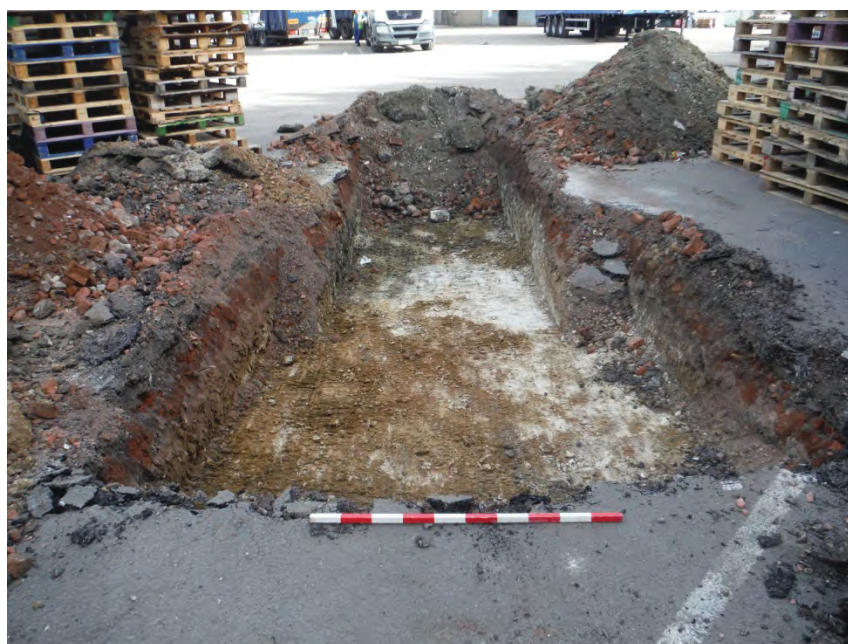
5.7.1 These last two trenches were located at the southeast corner of the site and aligned northwest-southeast. At the northern end of Trench 10 the sequence of deposits was similar to those trenches in the north of the site, and comprised 0.39m of made ground (100), overlying the topsoil (0.25m) and subsoil (0.19m) deposits. The natural gravel substrate was exposed here and subsequently the trench was boxed at its southern end (Plate 4). Here the ground had seen significant truncation and the upper made ground (100) measuring 0.46m, was seen to overlie an earlier made ground or levelling deposit (0.58m thick). The natural gravel was exposed throughout Trench 10 but no archaeological features were present.

Plate 4: Trench 10 looking northwest, showing surviving natural geology

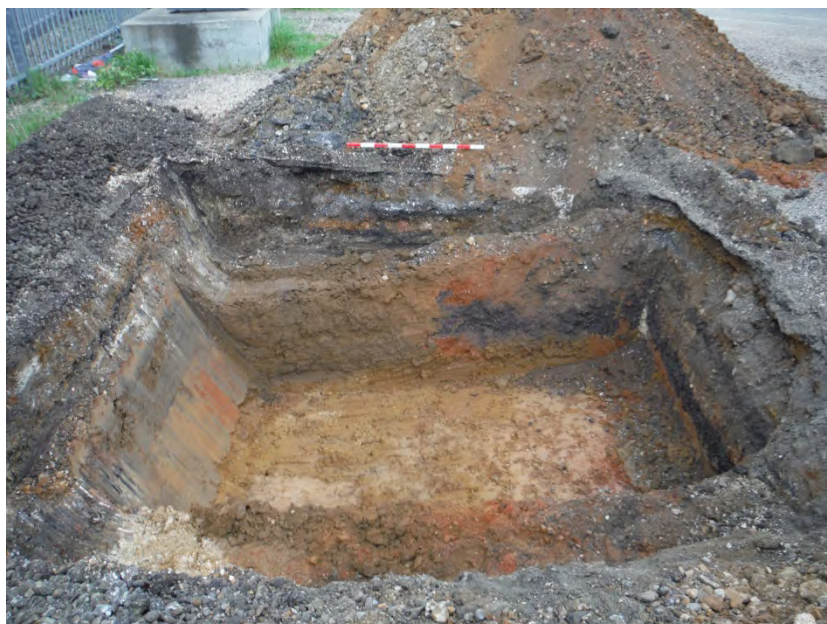
5.6.4 Trench 12 was located to the north of Trenches 8 and 9 and displayed a sequence of 0.63m of made ground (100) overlying a thick, sandy silt material measuring more than 0.9m thick. This material had seemingly been disturbed and is not thought to represent an undisturbed natural geology, but more likely re-deposited material (Plate 5).

Plate 5: Trench 12 looking north
