**Phase 3, Land at White Lodge
Farm, Higham Road, Burton
Latimer, Northamptonshire:**

**An Archaeological Trial Trench
Evaluation**

Pre-Construct Archaeology Ltd	
Project Number	K3257
Report Number	R11722

Central National Grid Reference: SP 90630 74225

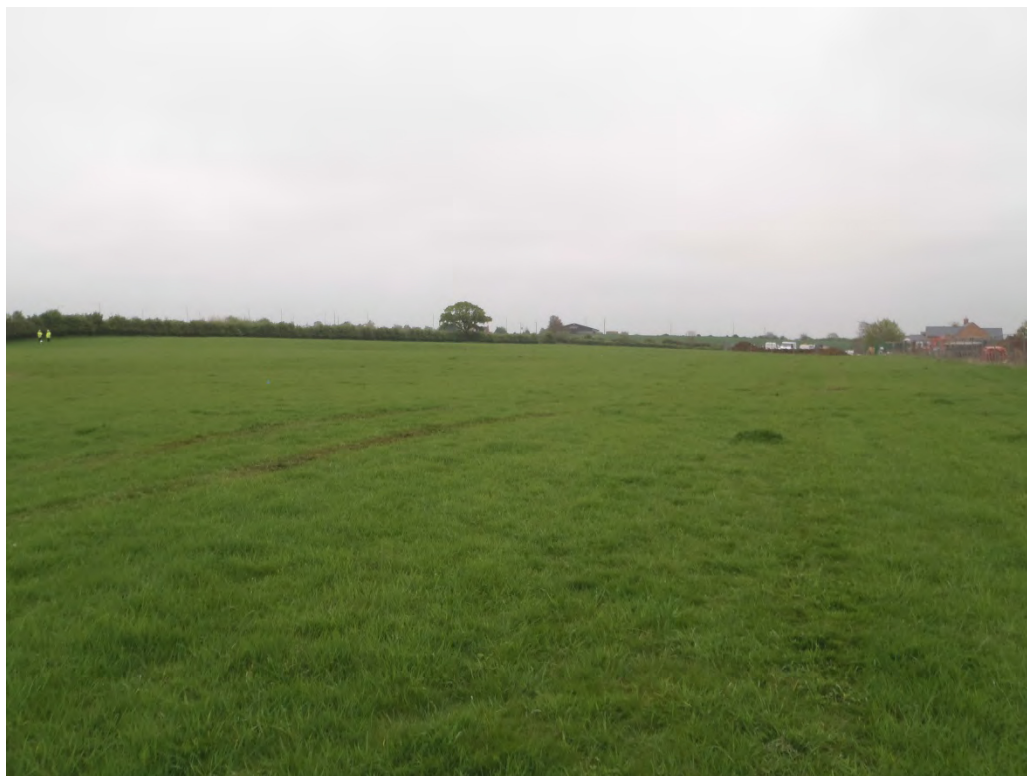
2.5 The proposed development lies within an open field (Figure 2, Plate 1) centred on NGR SP 90630 74225. The north and east boundaries of the site are flanked by open cropped fields. To the west is the ongoing Grace Homes construction site and to the south is Higham Road.

2.7 The high point of the site was around Trench 7 (Figure 2) at which point the ground sloped both southwards towards Higham Road (Plate 1) as well as sloping down slightly northwards.

Plate 1: The site, view south towards Higham Road

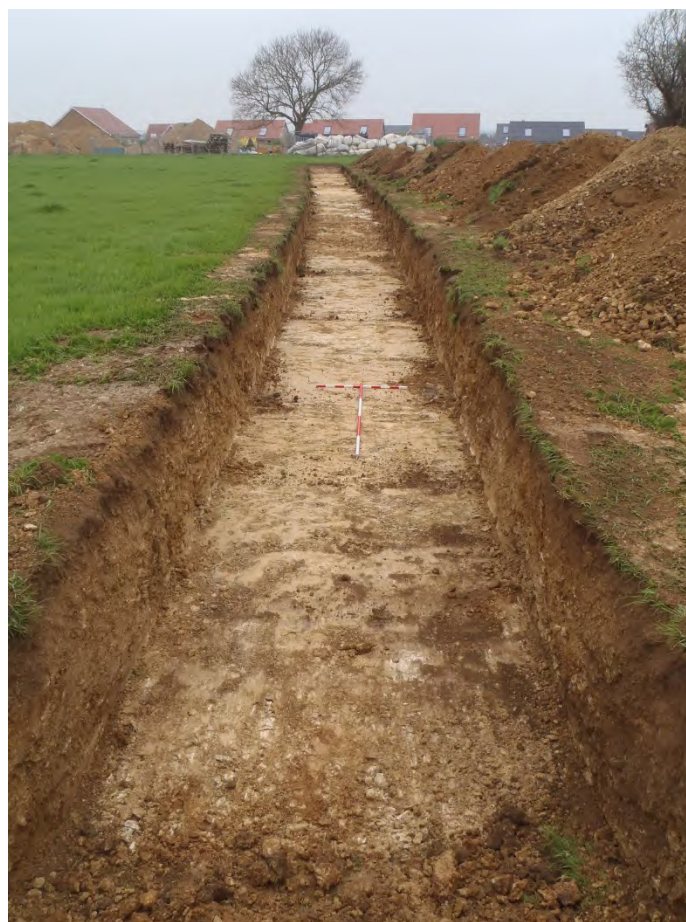
5.2.3 Trench 1 was aligned east to west, was 2.1m wide and 49.7m long (Figure 2 & Plate 4). The trench was machined to the natural geological horizon (102) of chalk and limestone to a depth of 0.48m below ground level at its western end and 1.02m below ground level at its eastern end. Trench 1 was machined through the quarrying backfill deposit (101) which measured 0.17m thick at the western end and 0.78m thick at the eastern end of the trench. Deposit (101) was overlain by topsoil (100) measuring between 0.24m and 0.3m deep.

Plate 4: West facing view of Trench 1

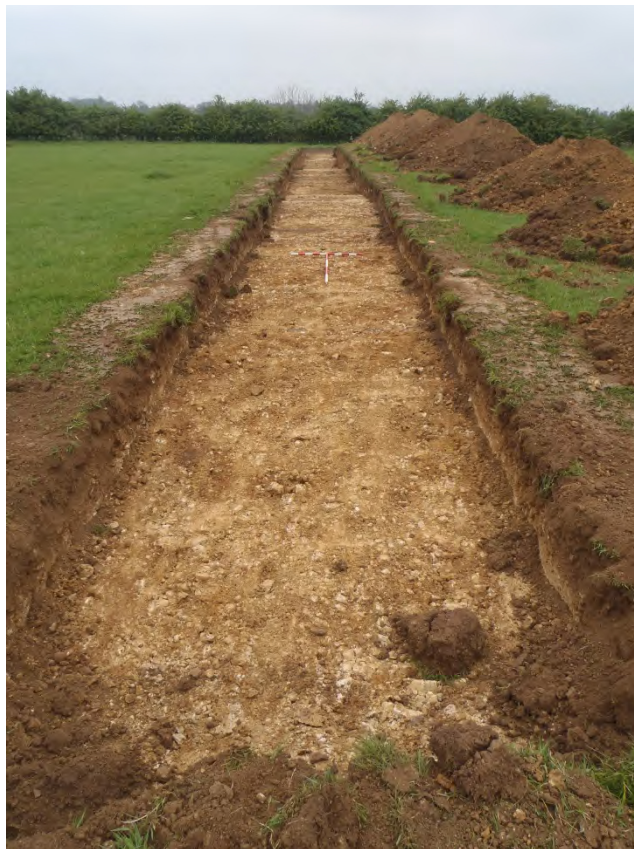
5.2.4 Trench 2 was aligned north-north-east to south-south-west, was 2.1m wide and 50.25m long (Figure 2 & Plate 5). The trench was machined to the natural geological horizon (102) of chalk and limestone to a depth of 0.68m below ground level at its northern end and 0.44m below ground level at its southern end. Trench 2 was machined through the quarrying backfill deposit

(101) which measured 0.4m thick at the northern end and 0.44m thick at the southern end of the trench. Deposit (101) was overlain by topsoil (100) measuring between 0.26m and 0.28m deep.

Plate 5: North facing view of Trench 2

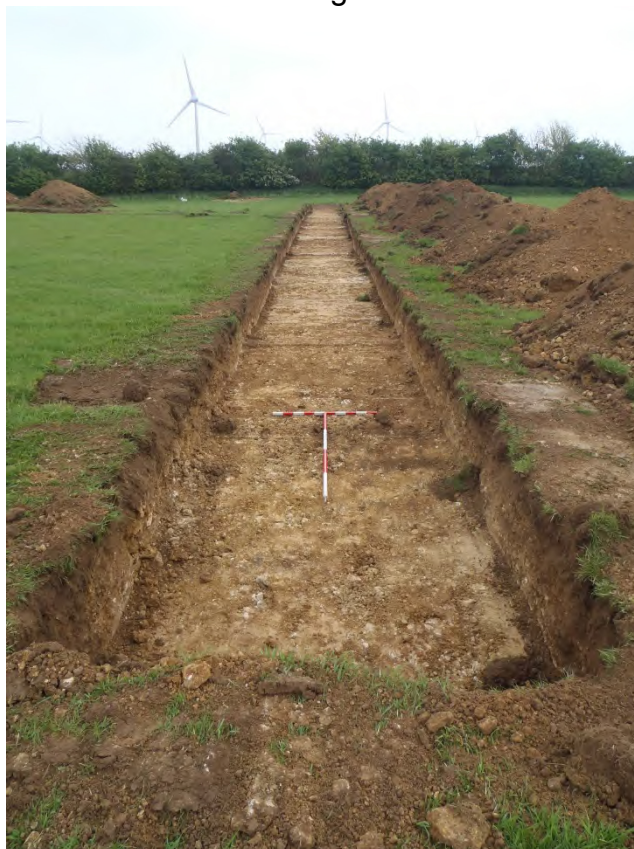
5.2.5 Trench 3 was aligned east to west, was 2.1m wide and 48.9m long (Figure 2 & Plate 6). The trench was machined to the natural geological horizon (102) of chalk and limestone to a depth of 0.68m below ground level at its western end and 0.46m below ground level at its eastern end. Trench 3 was machined through the quarrying backfill deposit (101) which measured 0.38m thick at the western end and 0.46m thick at the eastern end of the trench. Deposit (101) was overlain by topsoil (100) measuring between 0.2m and 0.3m deep.

Plate 6: East facing view of Trench 3

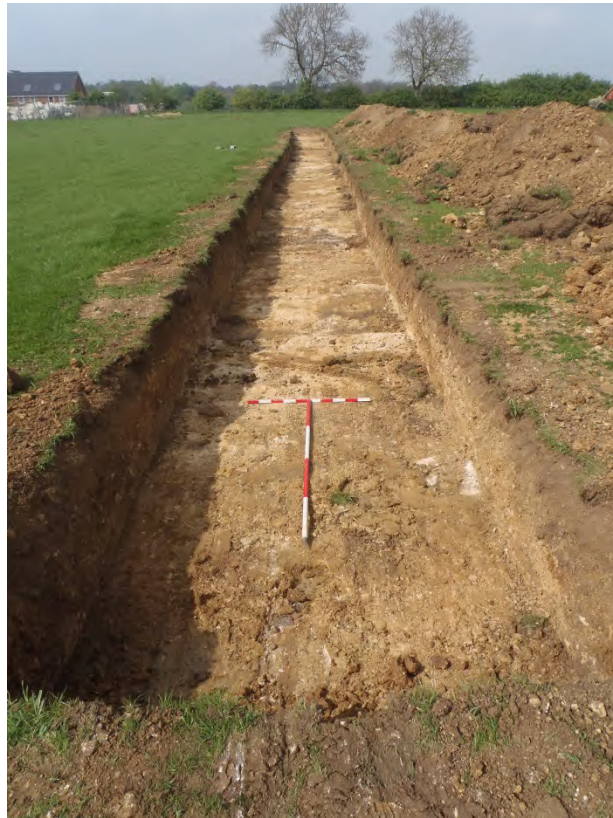
5.2.6 Trench 4 was aligned north to south, was 2.1m wide and 49.1m long (Figure 2 & Plate 7). The trench was machined to the natural geological horizon (102) of chalk and limestone to a depth of 0.77m below ground level at its northern end and 0.8m below ground level at its southern end. Trench 4 was machined through the quarrying backfill deposit (101) which measured 0.47m thick at the northern end and 0.57m thick at the southern end of the trench. Deposit (101) was overlain by topsoil (100) measuring between 0.23m and 0.3m deep.

Plate 7: North facing view of Trench 4

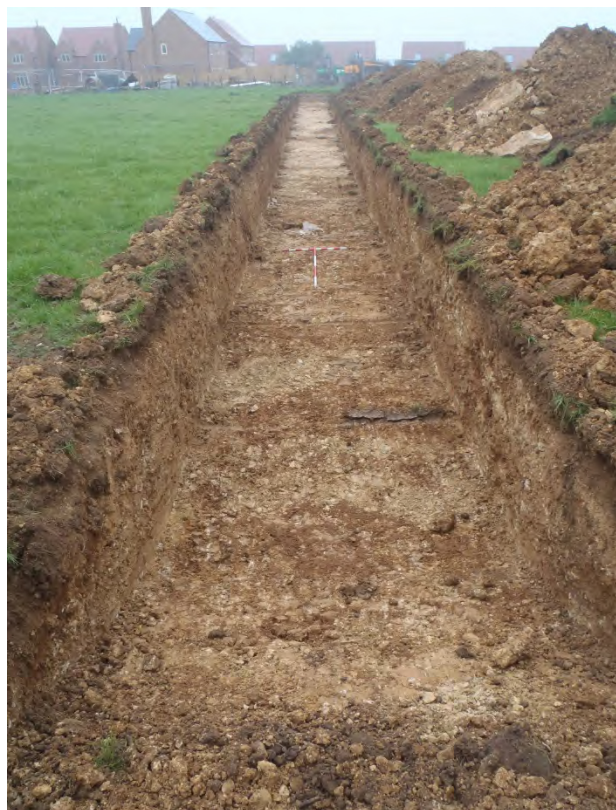
5.2.7 Trench 5 was aligned east to west, was 2.1m wide and 49.2m long (Figure 2 & Plates 8 & 9). The trench was machined to the natural geological horizon (102) of chalk and limestone to a depth of 0.79m below ground level at its western end while at the eastern end the trench was machined to an arbitrary depth of 1.3m. Machining stopped with (102) not reached due to instability of the limits of excavation (Plate 9). Trench 3 was machined through the quarrying backfill deposit (101) which measured 0.44m thick at the western end and over 1.1m thick at the eastern end of the trench. Deposit (101) was overlain by topsoil (100) measuring between 0.2m and 0.25m deep.

Plate 8: West facing view of Trench 5

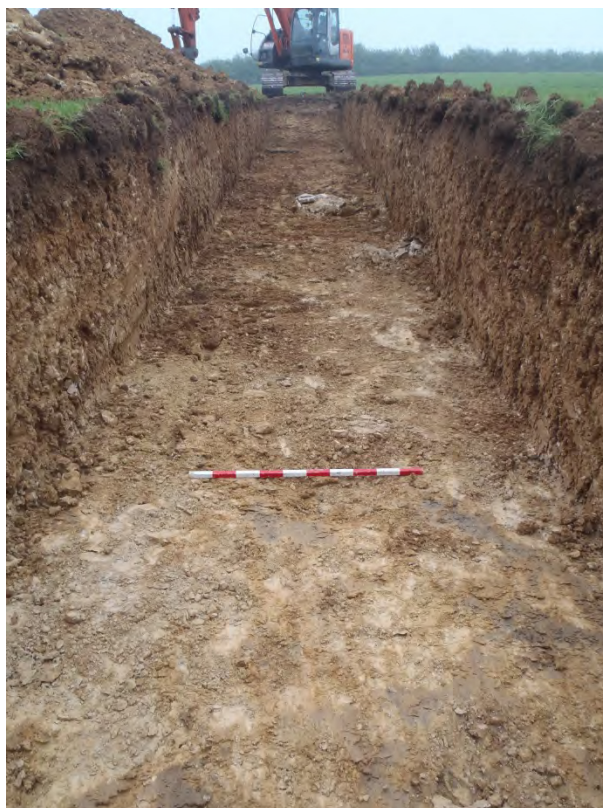
Plate 9: East facing view of Interface between (102) and (101) in Trench 5

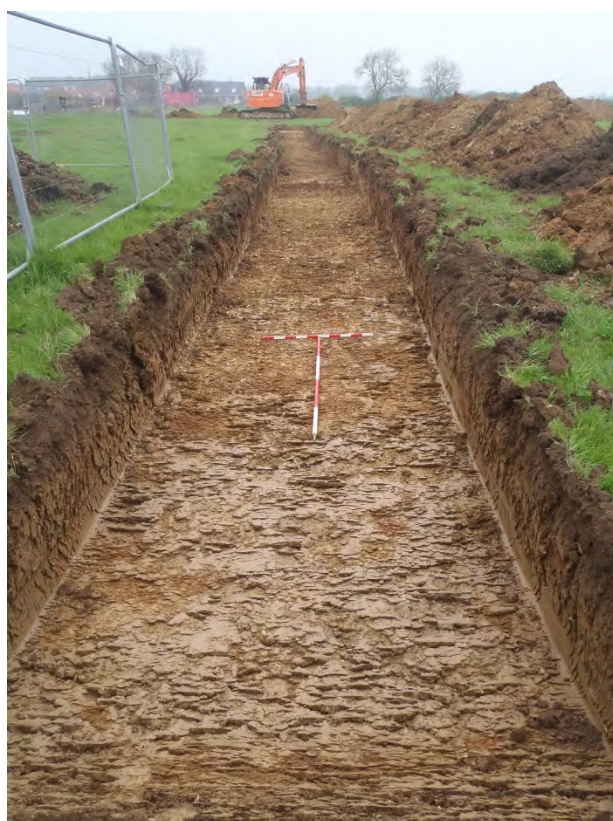
5.3.2 Trench 6 was aligned north-northwest to south-southeast, was 2.1m wide and 49.7m long (Figure 2 & Plate 10). The trench was machined to the natural geological horizon (102) of chalk and limestone to a depth of 0.7m below ground level at its northern end. The southern end of the trench was machined to the natural geological horizon (104) of clay measuring 0.74m below ground level (Plate 10). Trench 6 was machined through the subsoil deposit (103) which measured 0.4m thick at the northern end and 0.48m thick at the southern end of the trench. Deposit (103) was overlain by topsoil (100) measuring between 0.26m and 0.3m deep.

Plate 10: North facing view of Trench 6 with (104) in foreground

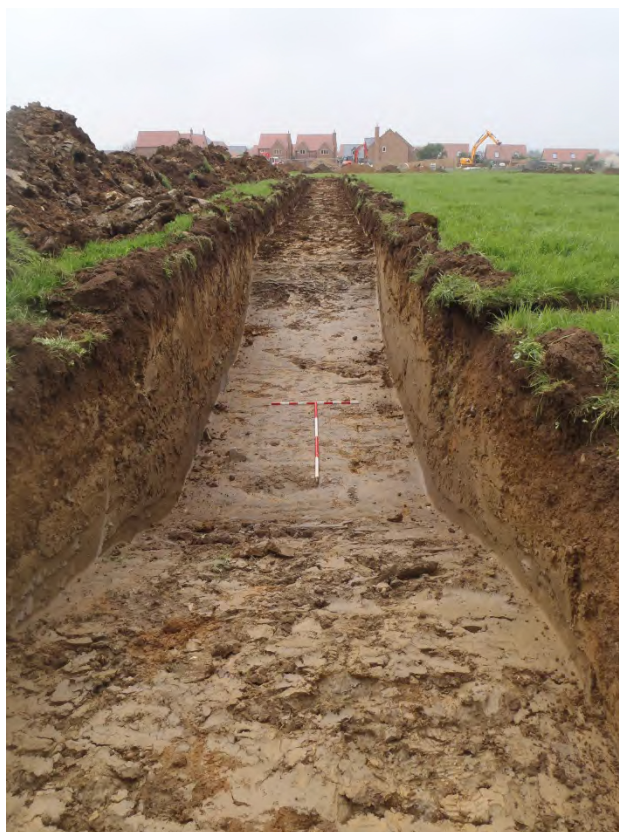
5.4.4 Trench 7 was aligned east to west, was 2.1m wide and 49.6m long (Figure 2 & Plate 11). The trench was machined to the natural geological horizon (104) of clay to a depth of 0.77m below ground level at its western end and 0.75m below ground level at its eastern end. Trench 7 was machined through the subsoil deposit (103) which measured 0.4m thick at the western end and 0.39m thick at the eastern end of the trench. Deposit (103) was overlain by topsoil (100) measuring between 0.36m and 0.38m deep. Towards the eastern end of Trench 7 was a 1.8m deep (below ground level) depression

(Plate 11) filled with subsoil (103) that appeared to be a geological hollow of no archaeological significance.

Plate 11: West facing view of Trench 7 with geological depression in foreground

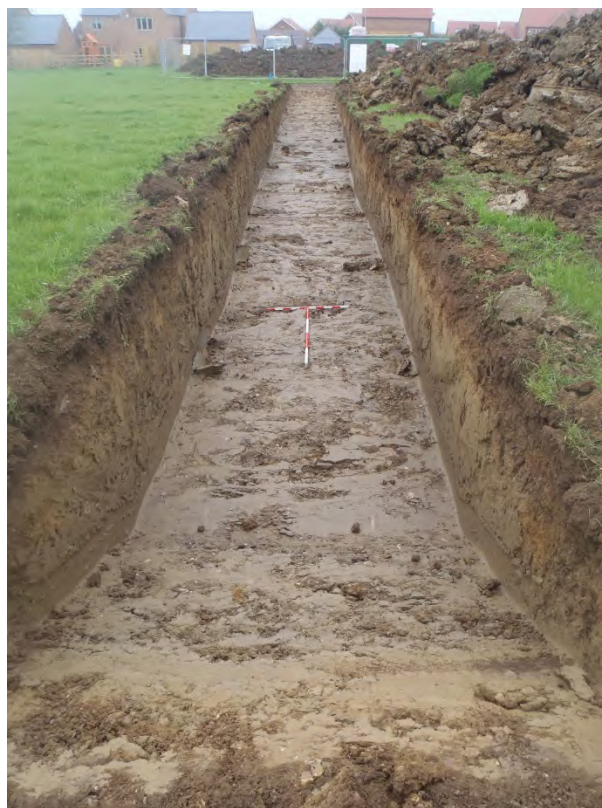
- 5.4.5 Trench 8 was aligned east to west, was 2.1m wide and 35m long (Figure 2 & Plate 12). The trench was machined to the natural geological horizon (104) of clay to a depth of 0.68m below ground level at its western end and 1.29m below ground level at its eastern end. Trench 8 was machined through the subsoil deposit (103) which measured 0.6m thick at the western end and 1.02m thick at the eastern end of the trench. Deposit (103) was overlain by topsoil (100) measuring between 0.23m and 0.27m deep.

Plate 12: West facing view of Trench 8

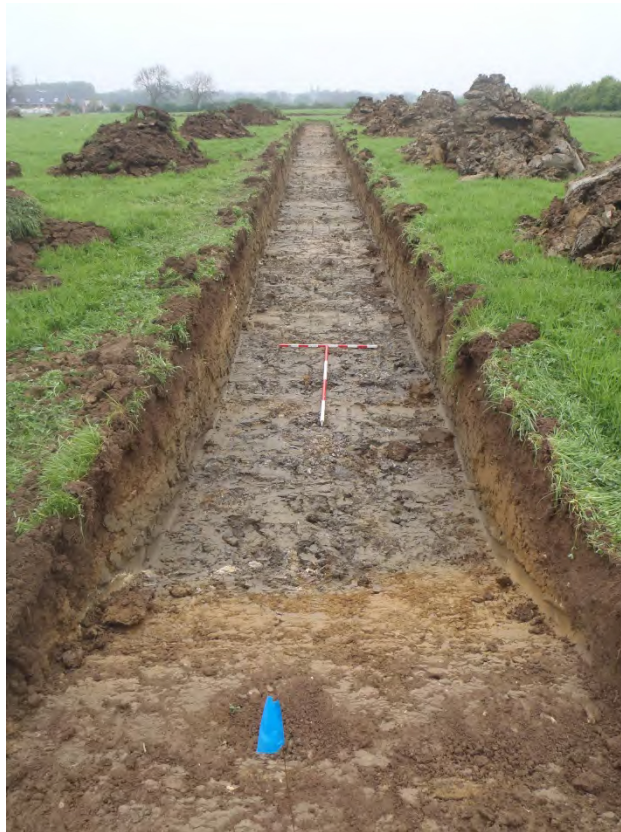
- 5.4.6 Trench 9 was aligned north-north-west to south-south-east, was 1.8m wide and 49.8m long (Figure 2 & Plate 13). The trench was machined to the natural geological horizon (104) of clay to a depth of 0.87m below ground level at its northern end and 0.82m below ground level at its southern end. Trench 9 was machined through the subsoil deposit (103) which measured 0.47m thick at the northern end and 0.45m thick at the southern end of the trench. Deposit (103) was overlain by topsoil (100) measuring between 0.3m and 0.37m deep.

Plate 13: North facing view of Trench 9

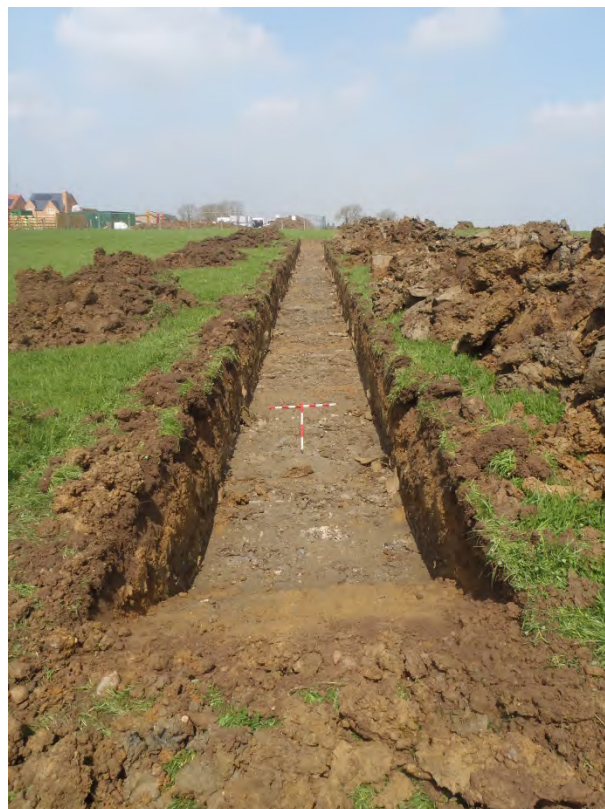
- 5.4.7 Trench 10 was aligned north-north-west to south-south-east, was 1.8m wide and 49.8m long (Figure 2 & Plate 14). The trench was machined to the natural geological horizon (104) of clay to a depth of 1.2m below ground level at its northern end and 1.12m below ground level at its southern end. Trench 10 was machined through the subsoil deposit (103) which measured 0.92m thick at the northern end and 0.82m thick at the southern end of the trench. Deposit (103) was overlain by topsoil (100) measuring between 0.24m and 0.3m deep.

Plate 14: North facing view of trench 10

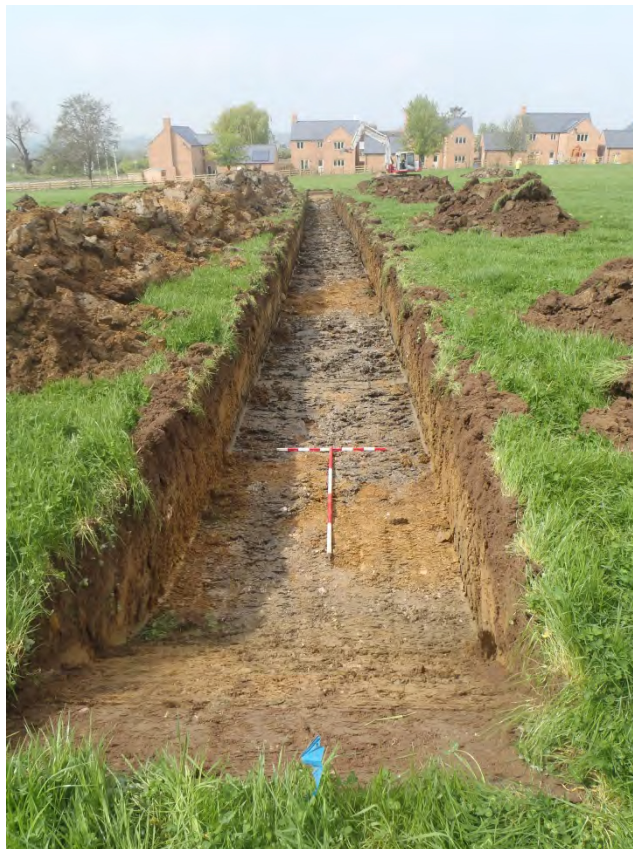
- 5.4.8 Trench 11 was aligned east to west, was 1.8m wide and 50.2m long (Figure 2 & Plate 15). The trench was machined to the natural geological horizon (104) of clay to a depth of 1.06m below ground level at its western end and 0.9m below ground level at its eastern end. Trench 11 was machined through the subsoil deposit (103) which measured 0.72m thick at the western end and 0.64m thick at the eastern end of the trench. Deposit (103)

was overlain by topsoil (100) measuring between 0.26m and 0.34m deep.

Plate 15: West facing view of Trench 11

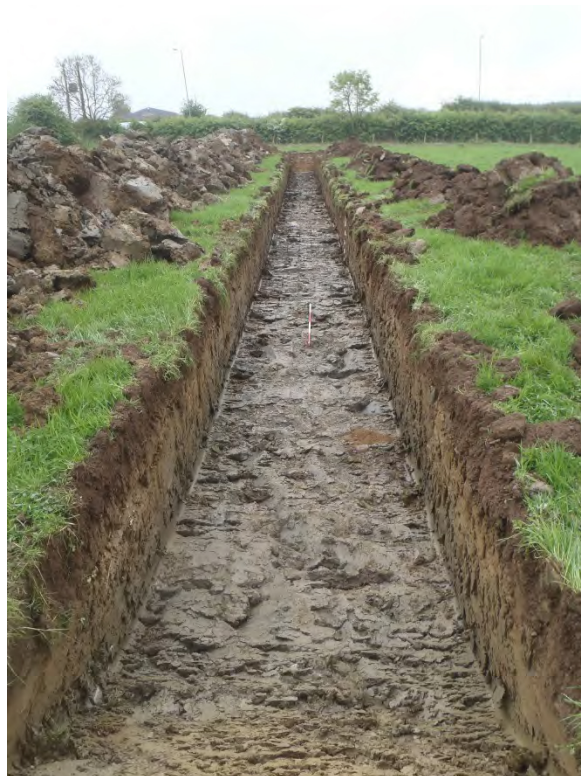
5.4.9 Trench 12 was aligned north to south, was 1.8m wide and 51m long (Figure 2 & Plate 16). The trench was machined to the natural geological horizon (104) of clay to a depth of 0.8m below ground level at its western end and 0.9m below ground level at its eastern end. Trench 12 was machined through the subsoil deposit (103) which measured 0.5m thick at the northern end and 0.7m thick at the southern end of the trench. Deposit (103) was overlain by topsoil (100) measuring between 0.2m and 0.4m deep.

Plate 16: South facing view of Trench 12

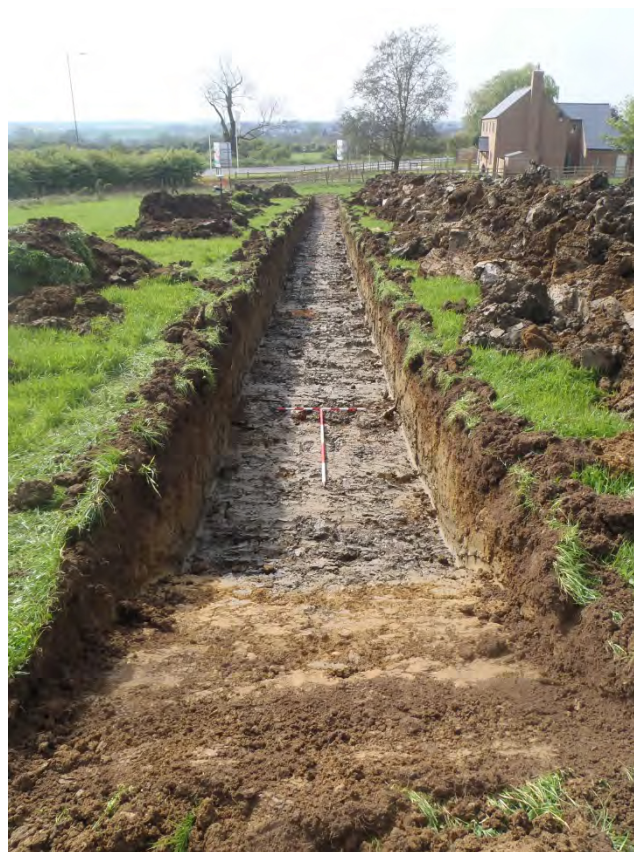
5.4.10 Trench 13 was aligned east to west, was 1.8m wide and 49m long (Figure 2 & Plate 17). The trench was machined to the natural geological horizon (104) of clay to a depth of 1.4m below ground level at its western end and 1m below ground level at its eastern end. Trench 13 was machined through the subsoil deposit (103) which measured 1.12m thick at the western end and 0.7m thick at the eastern end of the trench. Deposit (103) was overlain by topsoil (100) measuring between 0.28m and 0.3m deep.

Plate 17: West facing view of Trench 13
