**WALLAND FARM, BUCK'S  
CROSS, BIDEFORD, DEVON  
EX39 5DP**

**ARCHAEOLOGICAL  
EVALUATION REPORT**

**REPORT NO: R11735**

**JUNE 2014**

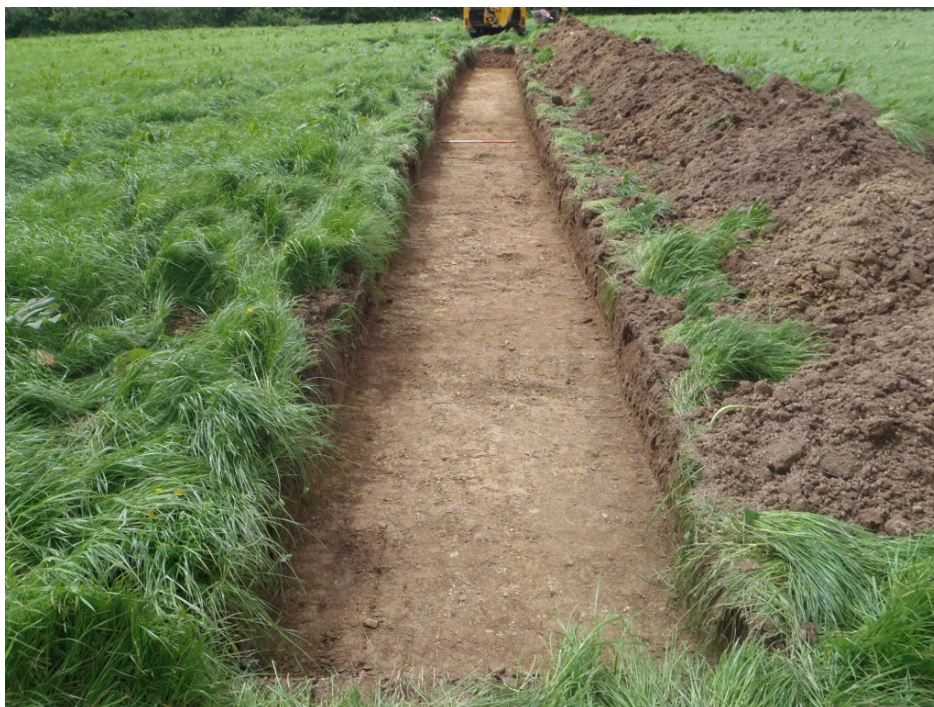
5.2.1 The earliest deposit encountered [3] comprised of a friable, mottled mid yellow red silty clay with lighter greyish yellow patches of sandy silty-clay, with occasional manganese flecking and occasional small to mediums sized sub-angular to angular stones. The top of the layer was recorded at a height of 0.43m BGL (194.77m aOD) and has been interpreted as natural subsoil (Figure 3; Plate 1).

Plate 1: Trench 1 showing natural subsoil layer [3], view to west (Shot ID: DWFB14 D1 (4))

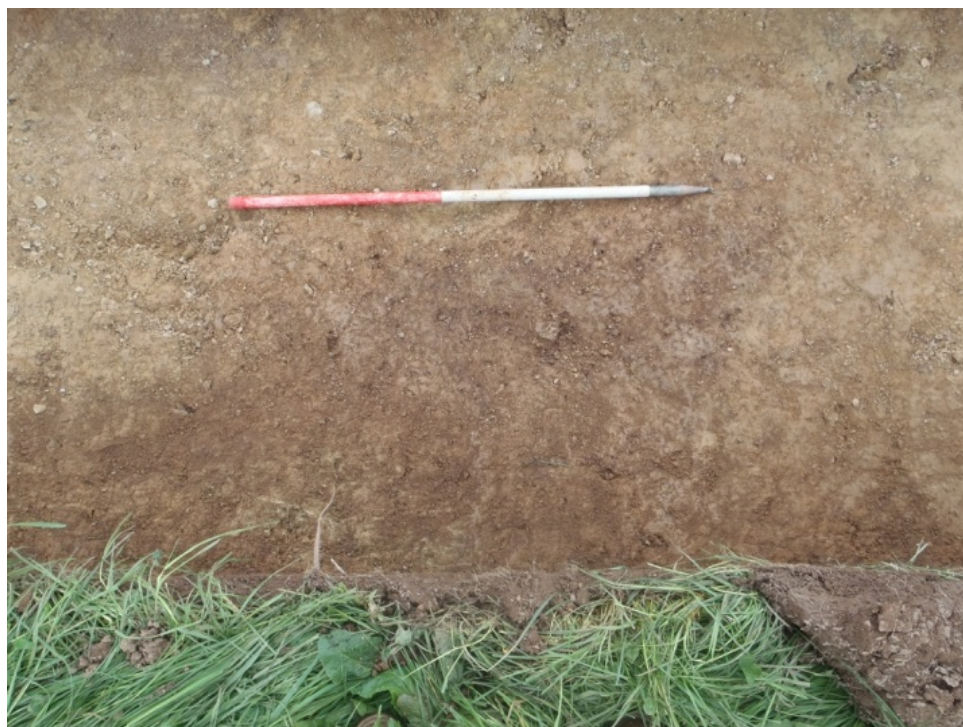
5.2.2 One possible feature was noted at the western end of the trench. Upon investigation this was found to be a natural tree throw, which was recorded at 0.58m BGL (194.68m aOD) and was 0.10m in depth (Figure 3; Plates 2 and 3).

Plate 2: Tree throw [4] prior to excavation, view to north (Shot ID: DWFB14 D1 (7))

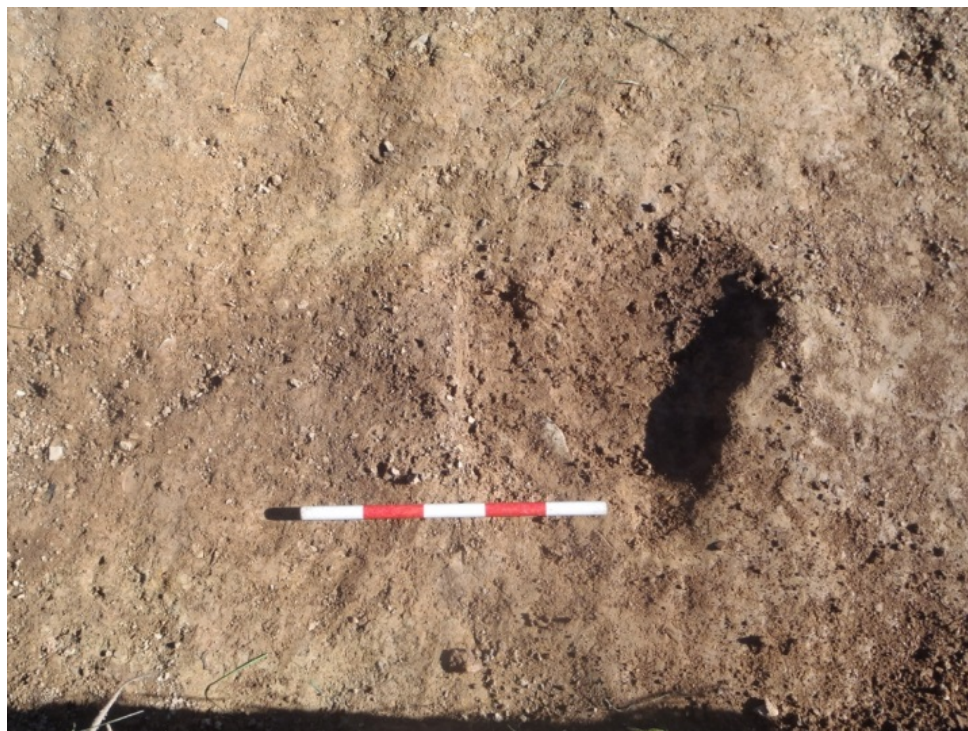
Plate 3: Overview of tree throw [4] post excavation, view to north (Shot ID: DWFB14 D1 (8))

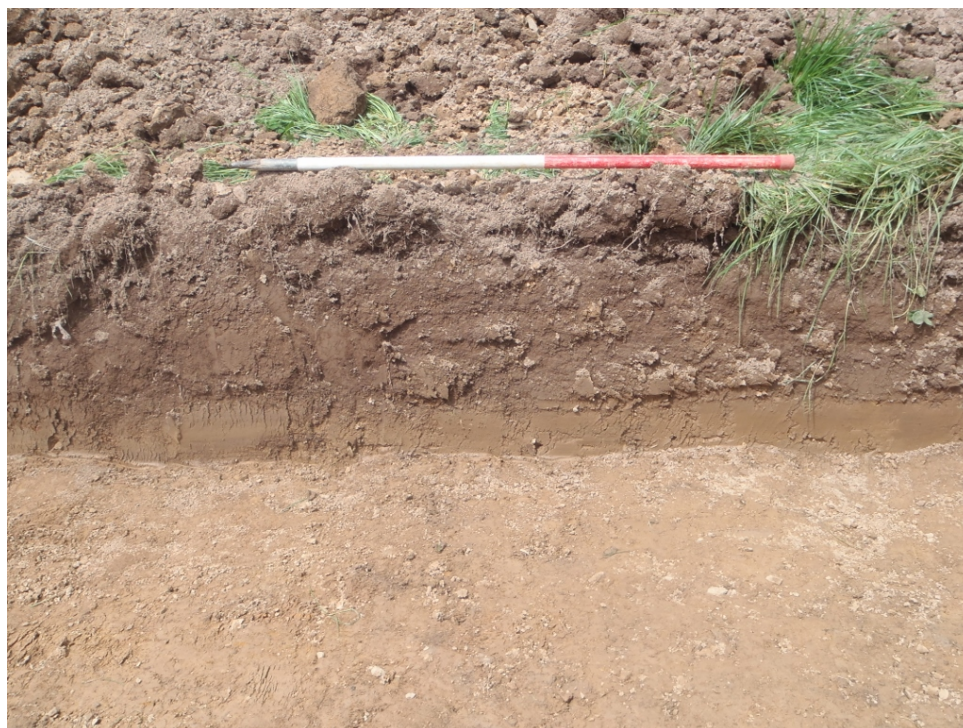
5.2.3 Overlying the natural in the remainder of the trench was a subsoil [2] comprised of a friable mid reddish brown silty clay, with frequent small to medium sized sub-angular to angular atones and occasional manganese flecking. The top of the layer was recorded at a height of 0.34m BGL (194.87m aOD) (Plate 4).

5.2.4 The subsoil lay beneath topsoil [1], which contained frequent rooting, rare amounts of manganese flecking, very rare amounts of CBM flecking and very rare amounts small angular to sub-angular stones. This was recorded at 195.21m (aOD) and was up to 0.33m in depth. This layer is associated with the site's use as agricultural farmland (Plate 4).

Plate 4: View of south facing section 1, view to north (Shot ID: DWFB14 D1 (6))

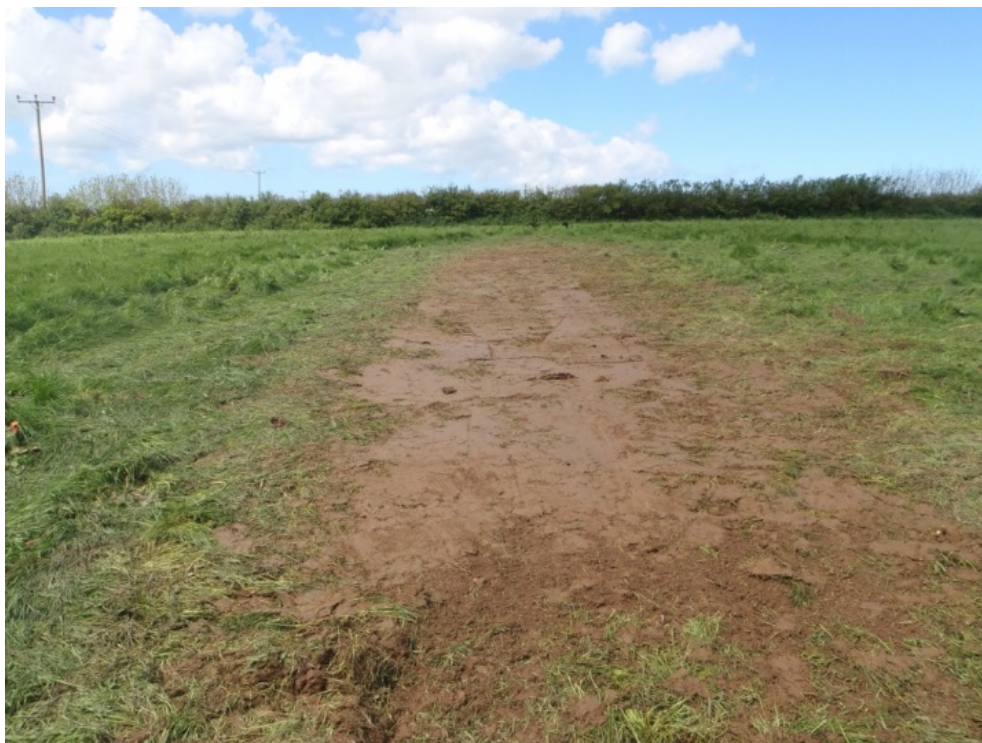
- 4.1.5 On completion the trench was backfilled using excavated spoil (**Plate 5**).

Plate 5: View to west showing backfilled trench (Shot ID: DWFB14 D1 (11))
