**HISTORIC BUILDING SURVEY OF  
NO. 99 BARTON ROAD (FORMERLY  
THE FOX AND HOUNDS)  
CONGERSTONE, LEICESTERSHIRE,  
CV13 6PE**

**JUNE 2014  
REPORT NO. 11734**

**Historic Building Survey of No. 99 Barton Road (formerly the Fox and Hounds Inn),  
Congerstone, Leicestershire, CV13 6PE**

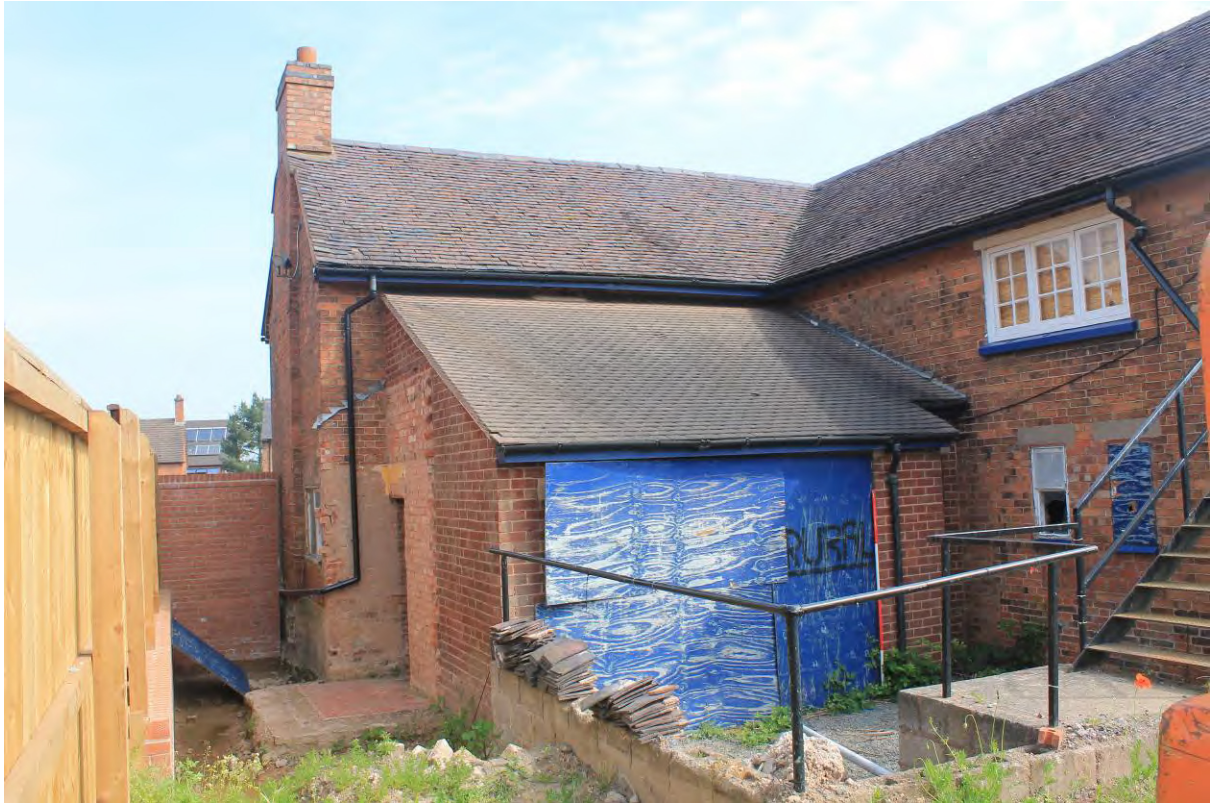
Plate 5 Western elevations and modern lean-to extension

- 6.13 To the south of the western gable wall was the western wall of the modern lean-to extension and the scar and foundations of small demolished accretion. The latter also had a lean-to roof (sloping down to the west) and the remains of its quarry tile floor were present adjacent to a narrow door opening at the junction of the two builds.

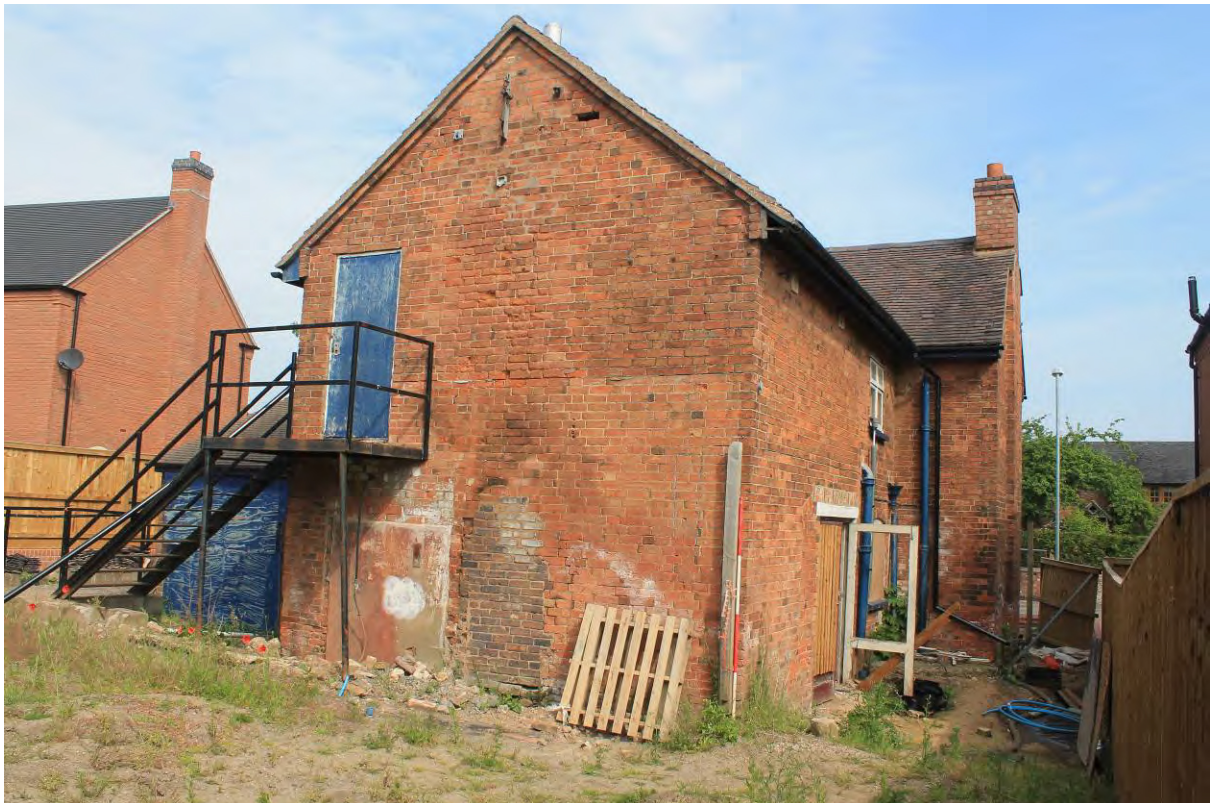
Plate 8 Eastern elevation and southern gable elevation

6.18 The south elevation comprised the southern gable wall to the rear projection and the southern facing elevation of the rear lean-to extension. The former was built blind on both levels, the present door at first floor a later insertion, possibly due to fire-regulations, to provide access to the adjacent metal framed fire escape. The chimney, which remains intact internally, has been removed above the level of the roof line. The brickwork in the area of the stack was noticeably degraded and patched, using blue brickwork toward the base.

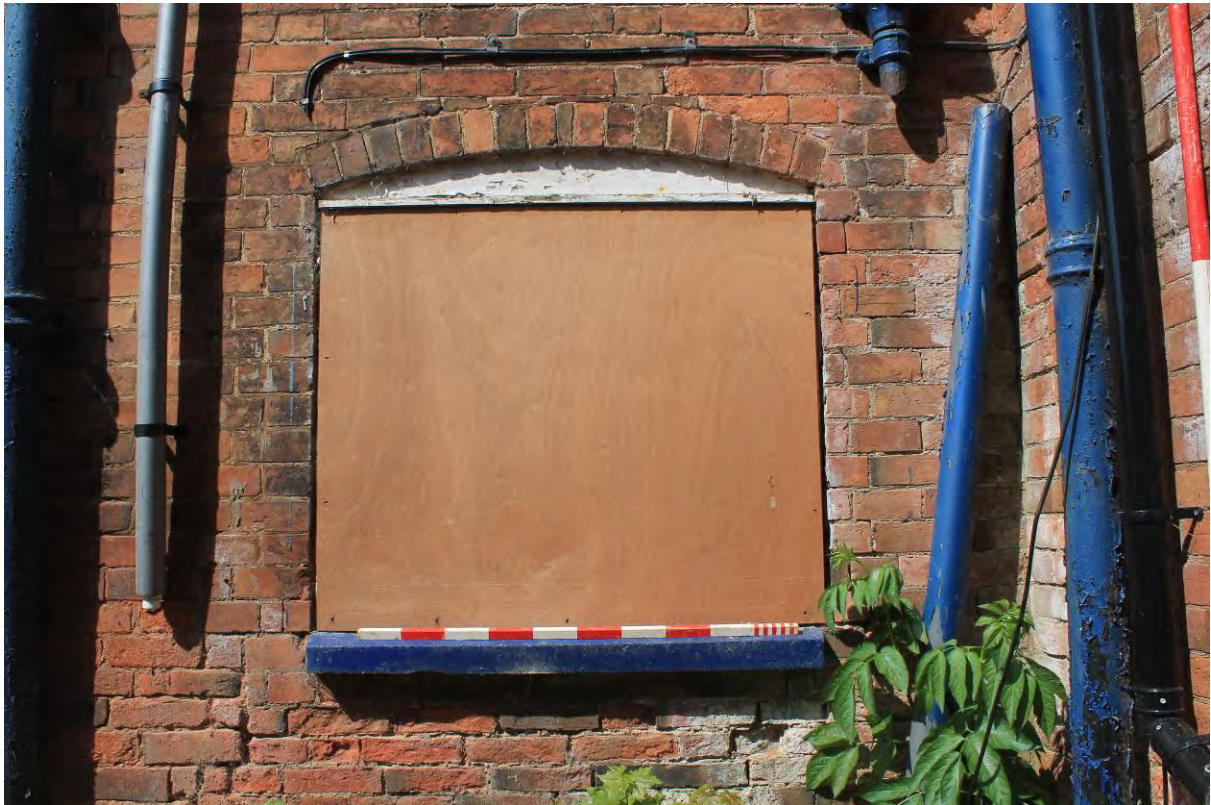
Plate 9 Eastern elevation ground floor window (original opening)

elsewhere and below on ground floor. Whilst the opening was original the sill was concrete and the window fenestration a modern casement divided two thirds by one third. As the casement had a flat head, the area below the arch had been blocked in using a timber panel. Of the two original window openings at ground floor the northern opening remained extant, retaining its brick voussoir and frame of the original single mullion window. The sill to the window was a replacement fake stone sill with a drip gully. The southern opening, built to the same arch headed style, had however been blocked when the present fully glazed French doors were latterly inserted. This also entailed the insertion of a concrete lintel to create the larger opening.

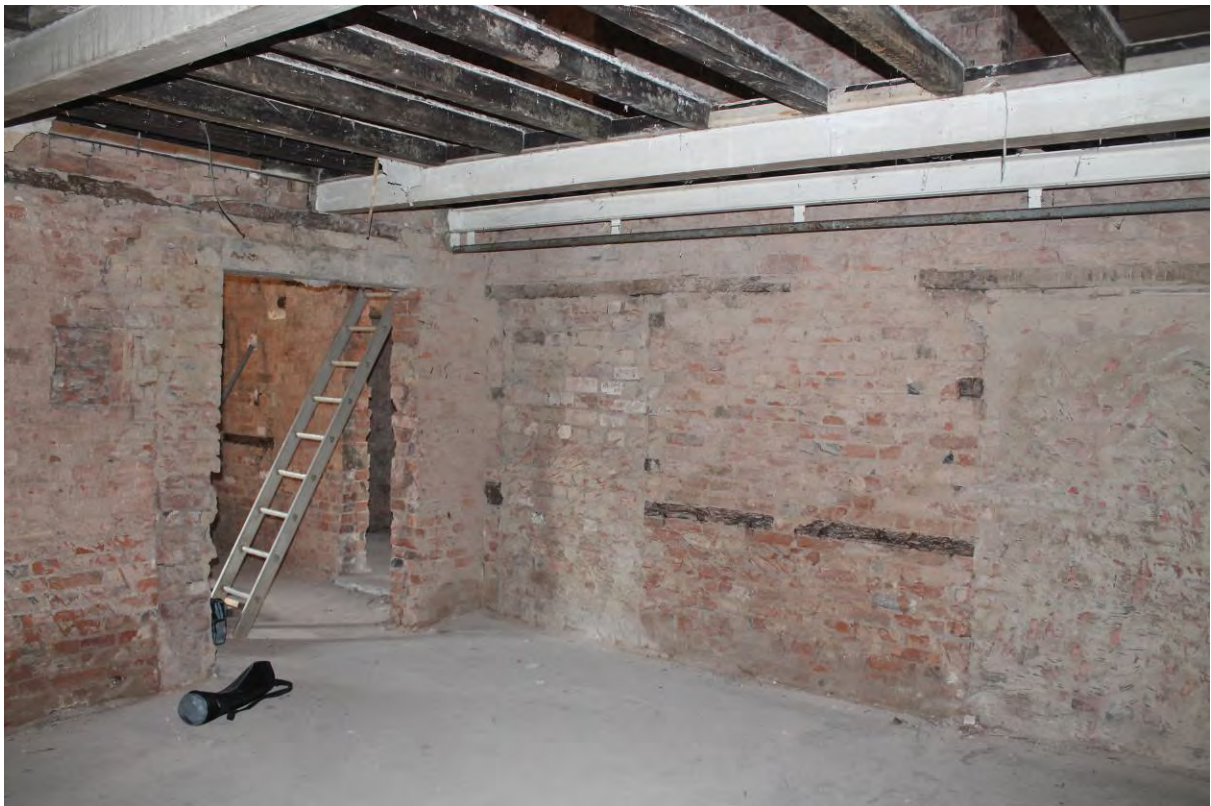
Plate 12 Room G1 looking south-west and showing blocked door openings

- 6.26 The door opening in the south wall of (G1) appears to have been a later insertion, broken through the internal wall when the two openings in the west wall were blocked.

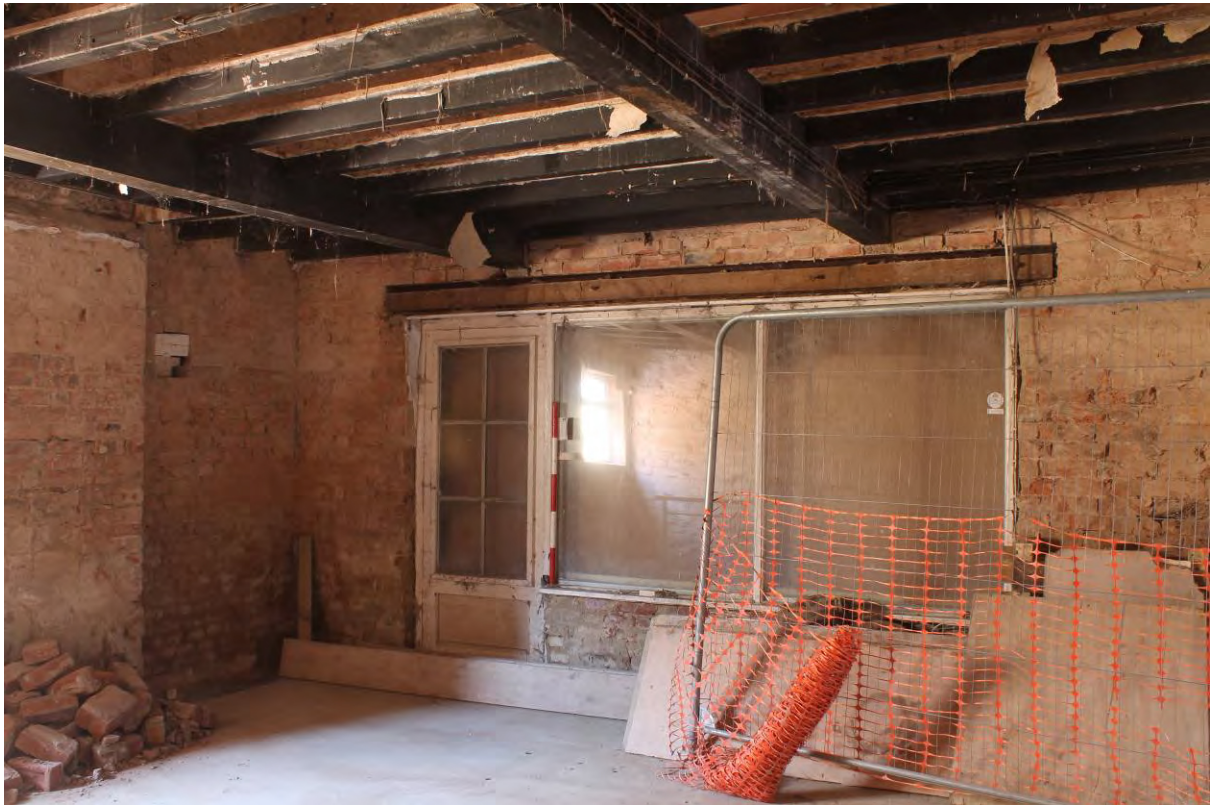
Plate 15 Room G6 looking north-west and showing inserted window

- 6.30 **Room (G6) (Plate 15)** corresponded in size, layout and later use with room (G1) to the east. It had been similarly altered by the insertion of a large modern glazed window opening to the front and removal of internal decoration. The door opening from (G3) was original using a typical timber lintel, although the opening from the rear extension (G5) had been broken through the rear, former exterior, wall. The fireplace (unlike G1) survived at this level and showed evidence of a brick arch or voussoir to the opening. This had latterly been blocked using on-edge, half brick thick, brickwork and a flue inserted. A small 'off the peg' casement window had been inserted to the south of the fireplace.
