**FORMER MIDDLESEX HOSPITAL  
ANNEX, CLEVELAND STREET,  
LONDON W1T 4JU**

**ARCHAEOLOGICAL WATCHING BRIEF**

**PCA REPORT NO: R11748**

**JUNE 2014**

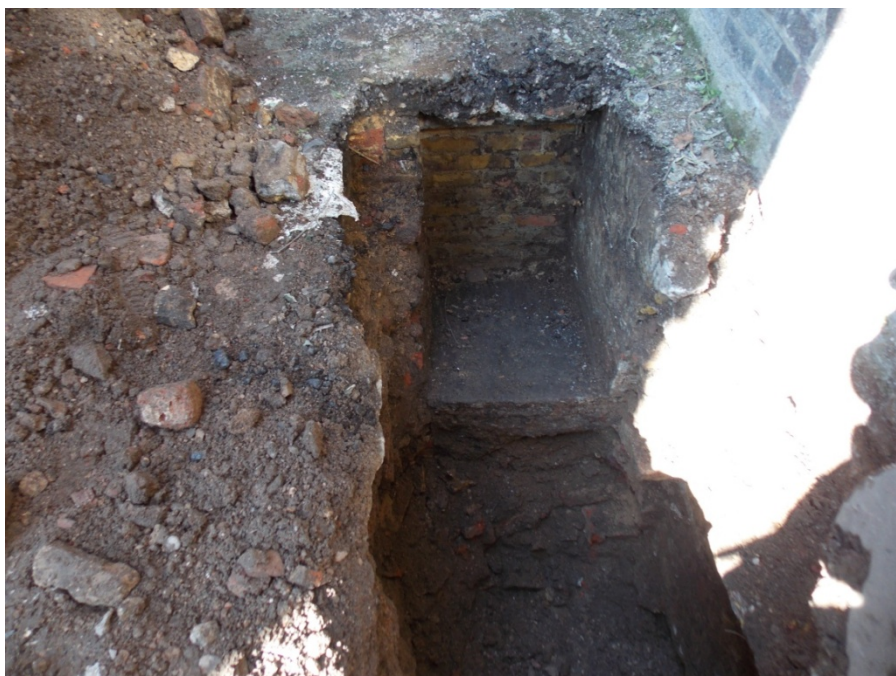
- 7.1.3 The construction layer, [1], was cut by the construction cut, [2], for a brick light well, [3], which had been built against the southeast wall of the southeast wing of the hospital annexe. Only the northeast side of the cut was seen during the excavation of the test pit. The excavated side was almost vertical with a sharp break of slope at the top; the base was not reached. Three sides of the light well survived to a maximum height of approximately 26.70m OD. It had been constructed using yellow stock bricks set in a hard mid-grey cement mortar. The concrete base of the light well sloped from 26.20m OD in the northeast to 25.90m OD in the southwest. When the use of the light well was discontinued it was backfilled with a deposit of light- to mid-grey silty sand with frequent brick and concrete fragments before it was sealed under the current tarmac surface.

*Brick light well, TP1*

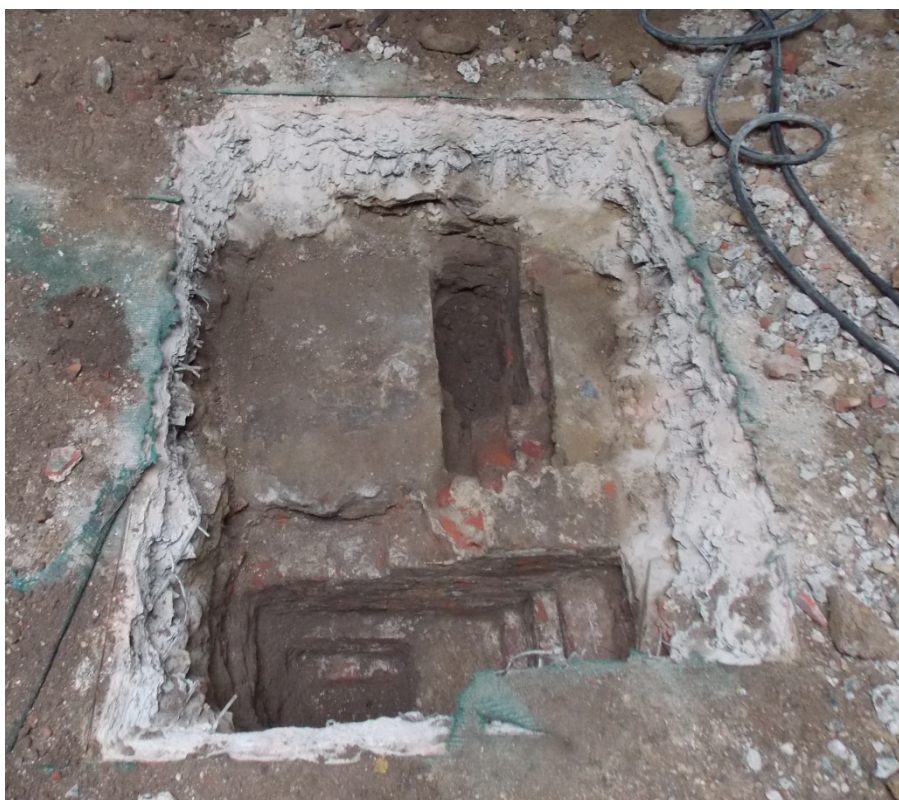
- 7.2.2 The structural remains uncovered in Test Pit 2 consisted of the southeast corner of a brick building, [4]. It rested on a concrete footing and had been constructed using yellow stock bricks set in hard mid-grey cement mortar. To the southeast what seemed like a yellow brick buttress, [5], had been built against the southeast side of the building. Like the building itself the buttress had been constructed on a concrete footing.

*NW Shot of TP2*

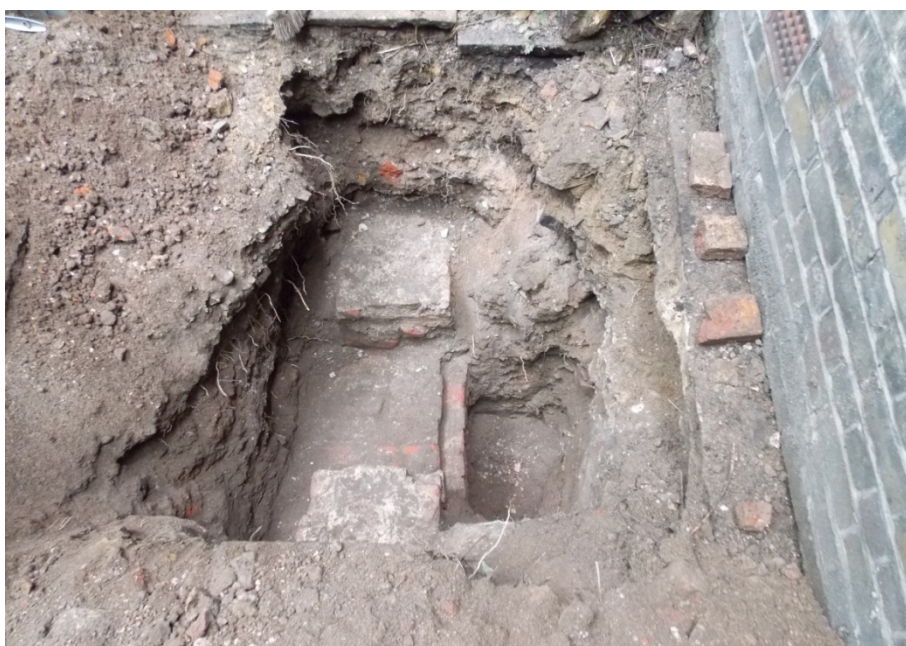
- 7.3.4 The top of deposit [11] had been cut by the construction cut, [10], for brick floor [8] and walls [6] and [7]. Only the lower 0.12m of the cut survived; the upper part was likely destroyed during the demolition of walls [6] and [7]. The construction cut was aligned roughly northwest-southeast and extended beyond the northwest and southeast limits of the test pit. Only one side of the cut was exposed and this was almost vertical with a sharp break of slope at both the top and base. Brick floor [8] had been laid within the cut and consisted of two courses of red bricks set in moderately hard light grey lime mortar. The top of the brick floor was at approximately 25.94m OD. Built directly on top of the brick floor were two red brick walls constructed using the same type of bricks and mortar as used for constructing the floor. The bricks of both wall [6] and wall [7] had been laid in English Bond with a wall thickness of 0.46m. It is likely that the two wall sections represent the continuation of the same wall and that the gap between them functioned as a doorway. This is suggested by the fact that the opposing sides of the wall sections were faced. At the highest point the walls survived to a height of 26.19m OD.

*NW Shot of TP3*

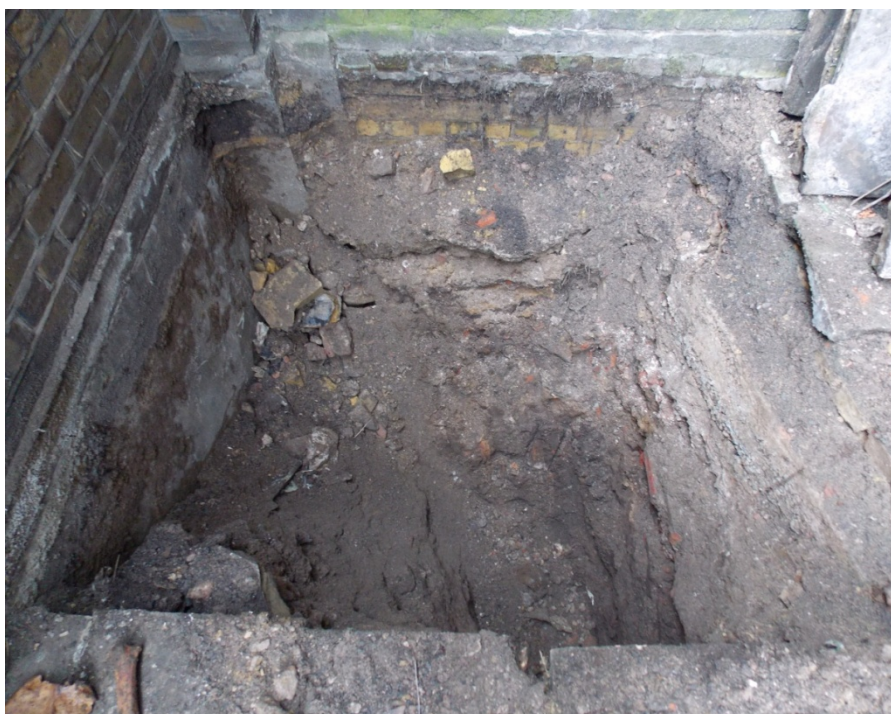
7.5.3 Sealing the silty clay deposit, [12], was a 0.70m thick layer of friable mid-brown sandy silt, [14], with frequent CBM flecks and occasional charcoal flecks. It was first encountered at 25.90m OD. A similar deposit, [11], was recorded in Test Pit 3.

*NE Facing Shot of TP5*

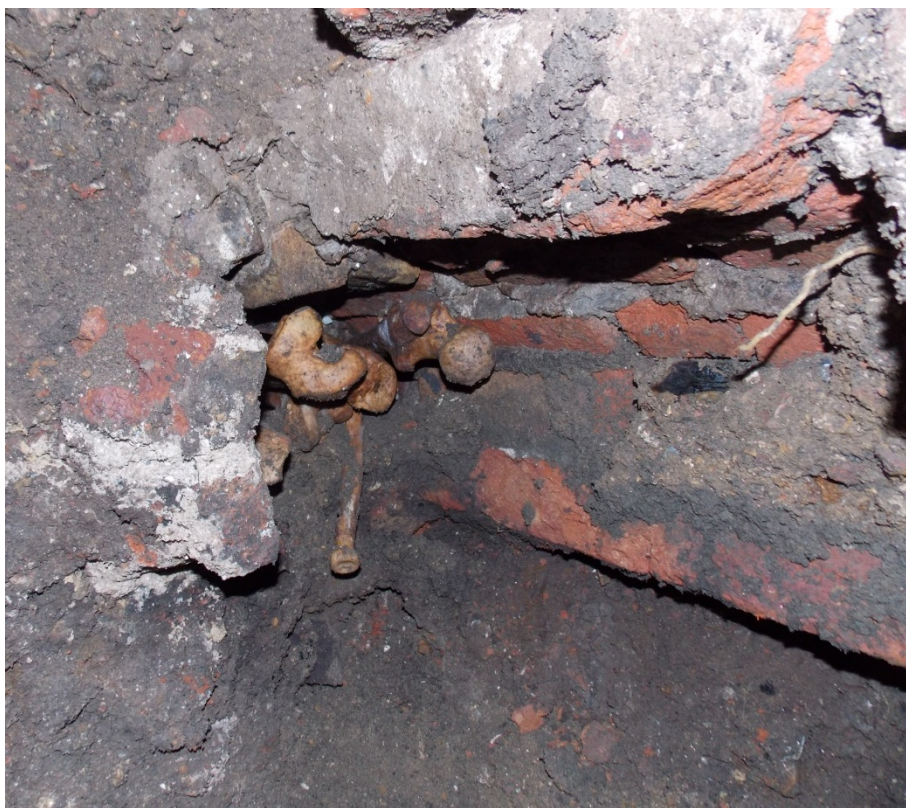
7.5.4 Following the excavation of Test Pit 5 part of the southwest section of the pit collapsed, revealing a 0.60m wide and 0.50m high roughly northwest-southeast aligned vaulted brick lined feature, [13], set back approximately 0.16m from the limits of the excavation. At the highest point of the vaulting the brick feature was recorded at 25.90m OD. The interior of the feature had been filled with disarticulated human bone. Sealing the brick feature was a layer of brick and mortar rubble, [+].

*SSW Facing Shot of TP5 Showing Disarticulated Human Remains Within Brick Culvert*

The fact that disarticulated human remains were observed in Test Pit 5 suggests that the cemetery was never entirely cleared after it fell out of use in the 1850s. When the wash house was constructed in the northeastern part of the site contemporary documents mention that hundreds of skeletons were removed although no indication is given to whether these were reburied on site or elsewhere. While both Test Pit 2 and 3 contained structural remains of the former workhouse buildings there is no guarantee that burials do not remain below these structures.

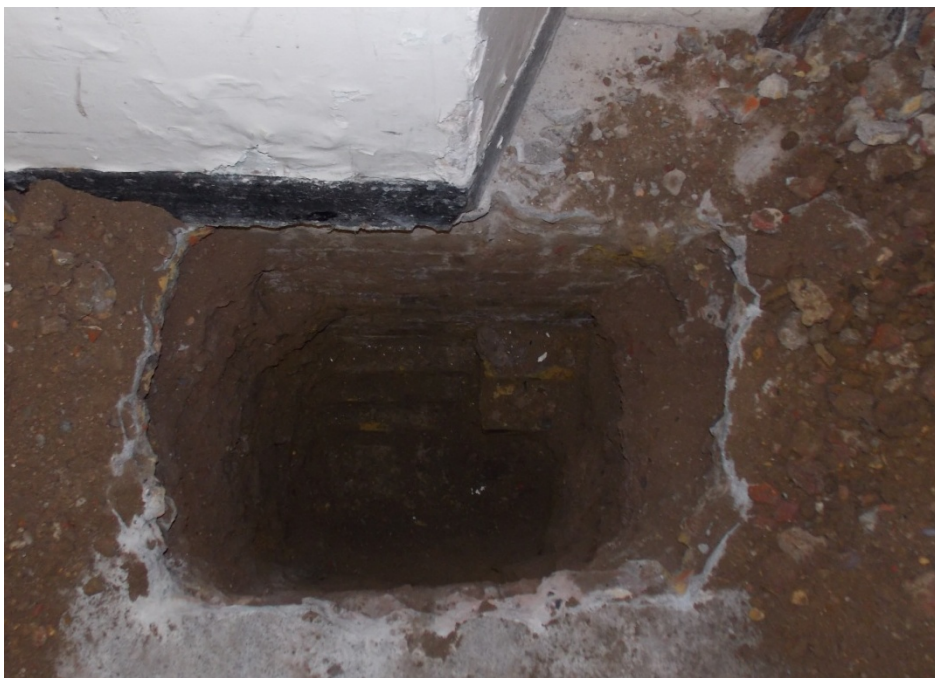
- 7.6.1 This test pit was located within the basement of the 18<sup>th</sup> century building at the southwestern end of the site. It was excavated between the northeast wall of the building and a modern service channel running parallel to it.
- 7.6.2 The test pit was excavated to a depth of 1.00m when a concrete slab was encountered. This was likely associated with the service channel immediately northwest of the test pit. No deposits of archaeological interest were exposed during the excavation of the test pit.

*SW Facing Shot of TP6*
