**99 BARTON ROAD,  
CONGERSTONE  
LEICESTERSHIRE**

**ARCHAEOLOGICAL  
EVALUATION**

**99 BARTON ROAD, CONGERSTONE LEICESTERSHIRE:  
EVALUATION REPORT**

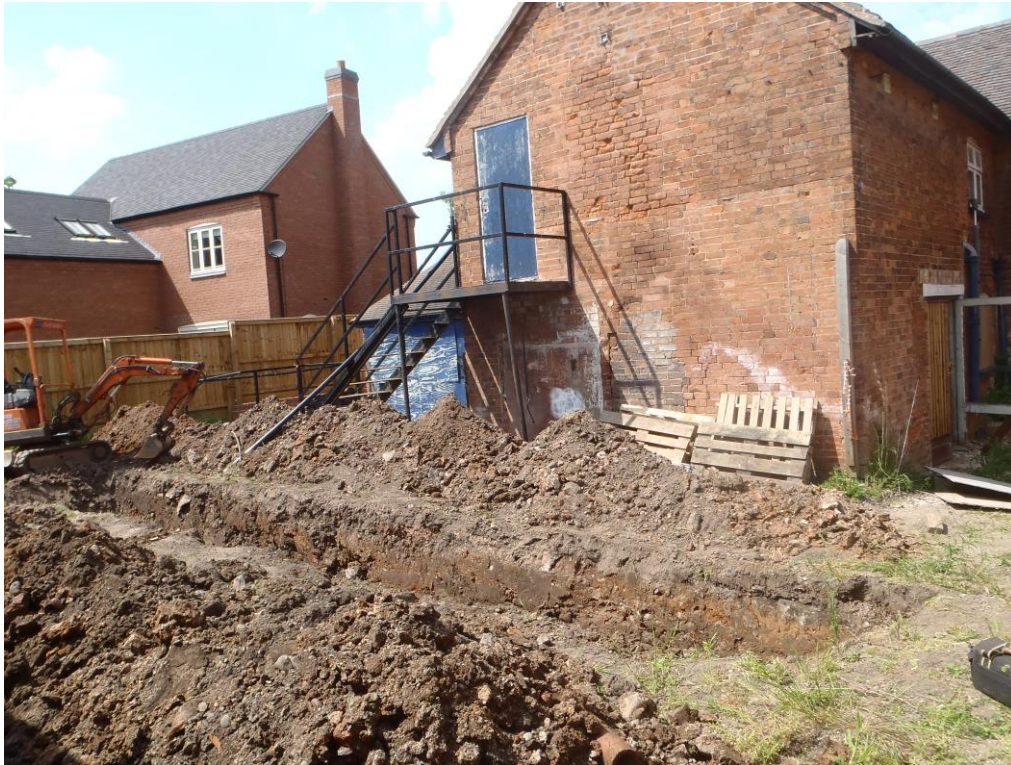
Plate 1: General View of Trench (looking North West)

5.2.1 Phase 2 represents the 18<sup>th</sup> century activity on the site. At the base of the trench, a compacted cobbled surface (103) was encountered. The surface comprised smooth water-worn stones c. 0.05 -0.12m in diameter, and in-filled with dark greyish silty clay with inclusions of fragmented brick (0.01-2mm in diameter). This cobbled surface overlay the natural (104) within the east portion of the trench. No datable material was retrieved from the cobbled surface apart from tiny chips of fragmented brick that was noted on the context sheet.
