**Land at Chelveston Airfield,
Bedfordshire, MK44 1AJ: An
Archaeological Evaluation**

AN ARCHAEOLOGICAL EVALUATION

Land at Chelveston Airfield, Bedfordshire, MK44 1AJ:

An Archaeological Trial Trench Evaluation

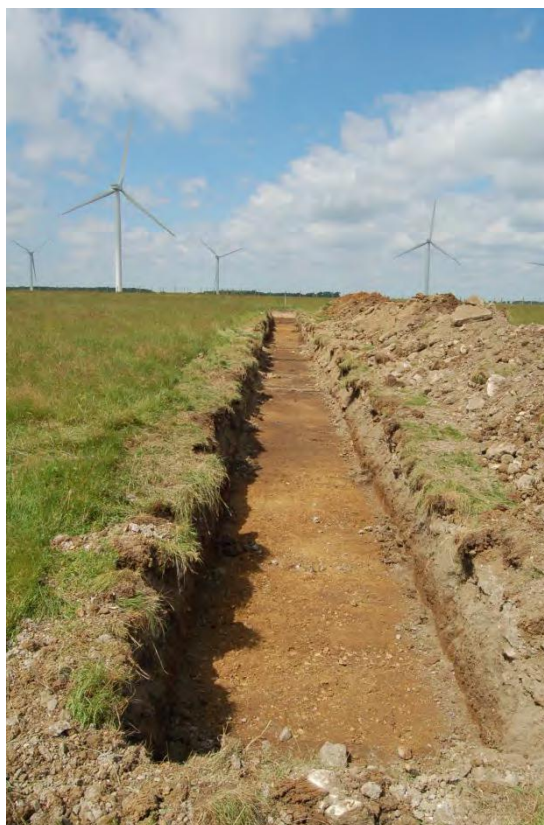
5.5.1 There was no evidence for archaeological activity in Trench 4, with only

modern features present. Trench 4 contained three modern pits and a northeast-southwest aligned pipe.

Plate 1: North facing view Trench 4 showing made ground (008)

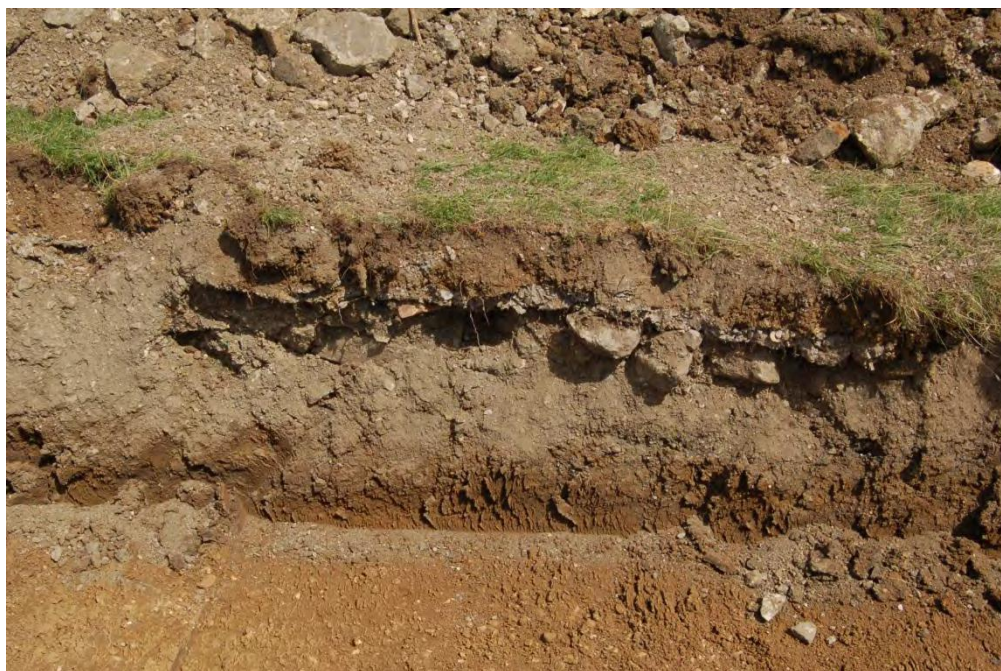
5.7.6 Trench 6 also contained a deposit of pale grey gravel and concrete mix (013). This was present towards the eastern end of the trench and measured 5.95m in length and 0.35m in depth. This deposit was undoubtedly associated with the use of the airfield and is probably related to deposit (012).

Plate 2: North facing view of Trench 6 showing (013) WWII hard standing

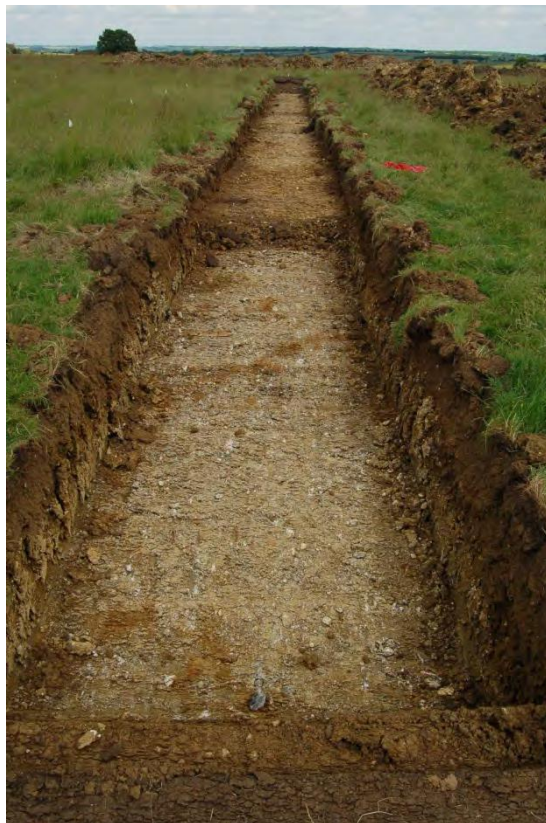
5.3.1 Trench 2 contained a single northwest-southeast aligned ditch [019] (0.5m long x 1.27m wide x 0.28m deep). The ditch was filled by (020); a pale grey-brown silty clay. The feature contained no dating evidence but is on a similar alignment to the modern services which suggests it may be fairly modern in date.

Plate 3: East facing view of Trench 2 showing ditch [019]
