**ARCHAEOLOGICAL INVESTIGATIONS AT HOUSESTEADS  
ROMAN FORT VISITOR FACILITY, BARDON MILL,  
NORTHUMBERLAND**

**JULY 2014**

**PRE-CONSTRUCT ARCHAEOLOGY**

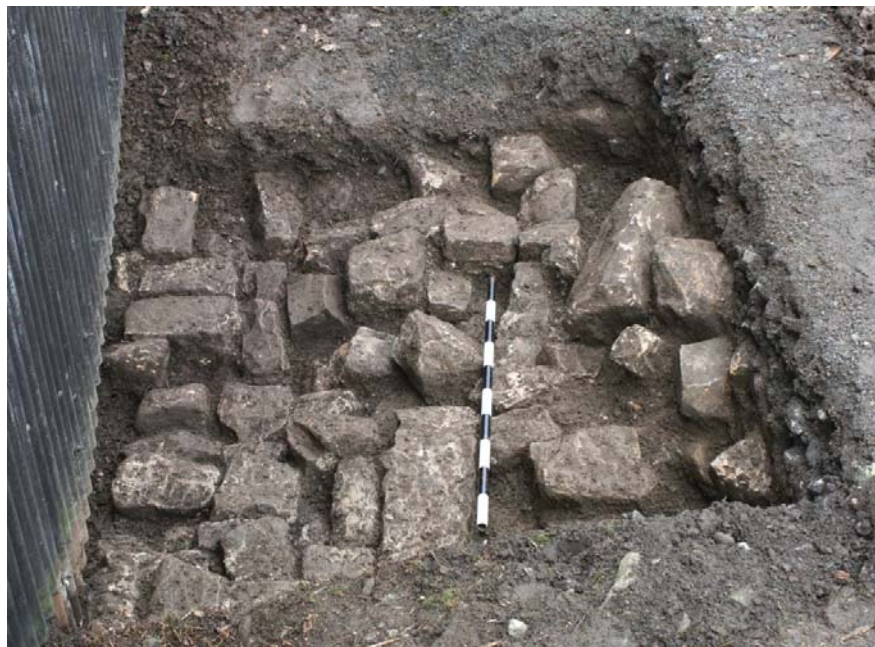
Plate 2. Evaluation trench with masonry and tumble as exposed, looking south (scale 1m)

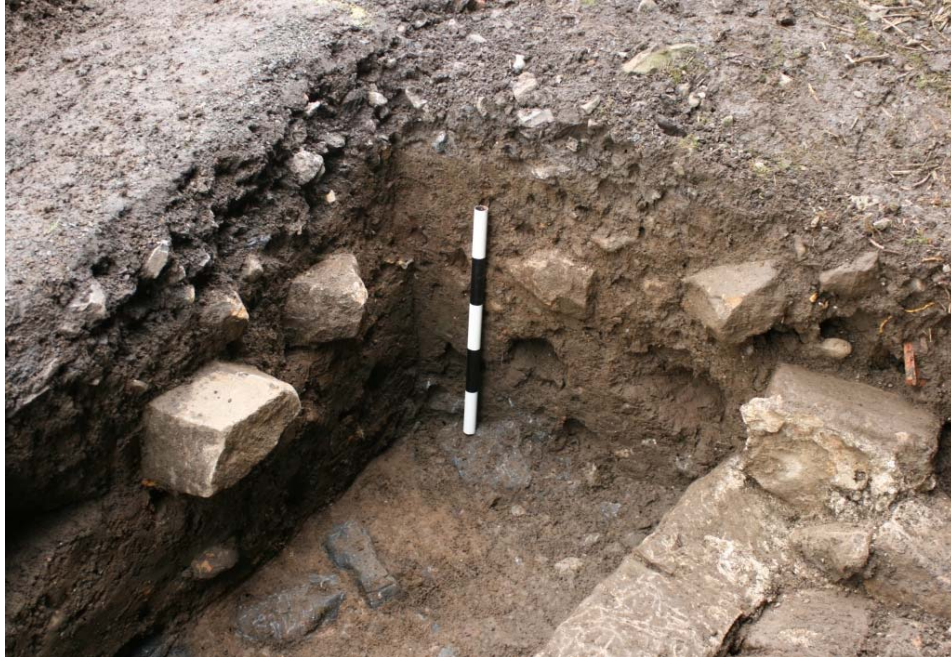
Plate 3. Evaluation trench fully excavated showing south-east facing section and wall [1], looking north (*scale 0.50m*)

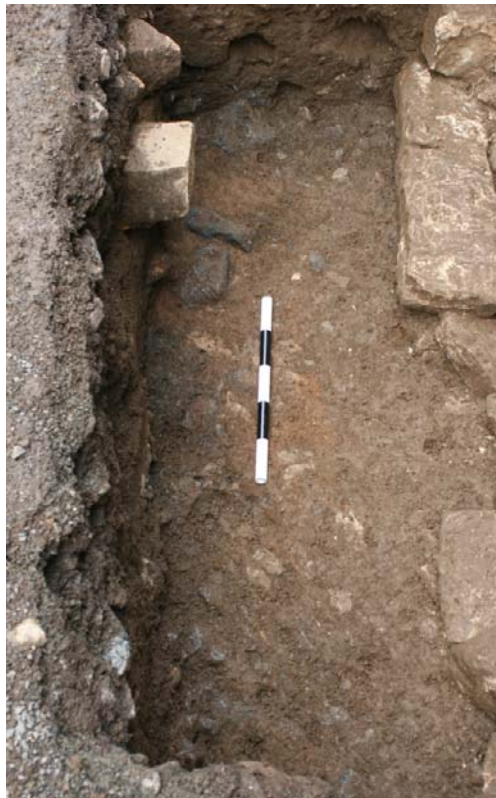
Plate 4. Evaluation trench fully excavated with wall [1] to east, looking north-west (*scale 0.50m*)
