**BEDFORD HOUSE, 215 BALHAM HIGH  
ROAD, LONDON BOROUGH OF  
WANDSWORTH**

**PHASE 1 & 2 GEOTECHNICAL  
WATCHING BRIEF REPORTS**

### **Watching Brief on Geotechnical pits**

### **Watching Brief on Geotechnical Pits-Phase 2**

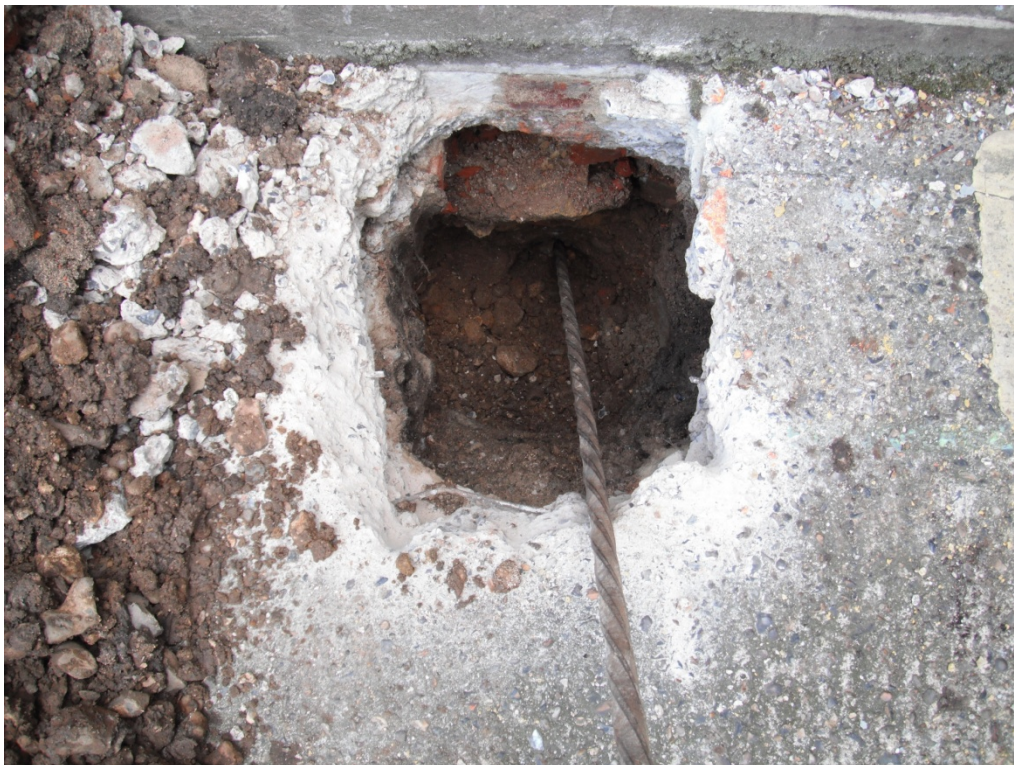
#### **TP1**

Two main fills were uncovered during the excavation of this test pit. The upper fill was context [1], a dark greyish brown sandy silt with frequent fragments of CBM. This layer was interpreted as post medieval made ground (which may also have contained a small quantity of asbestos). Below this was context [2]. This layer consisted of dark yellowish brown silty gravel, with no obvious inclusions. This deposit may have been re-deposited material within the construction cut for the wall to the north of the pit, or possibly represent the natural horizon. However, due to the relatively small size of the test pit, this could not be confirmed.

Test Pit 1 - Overview

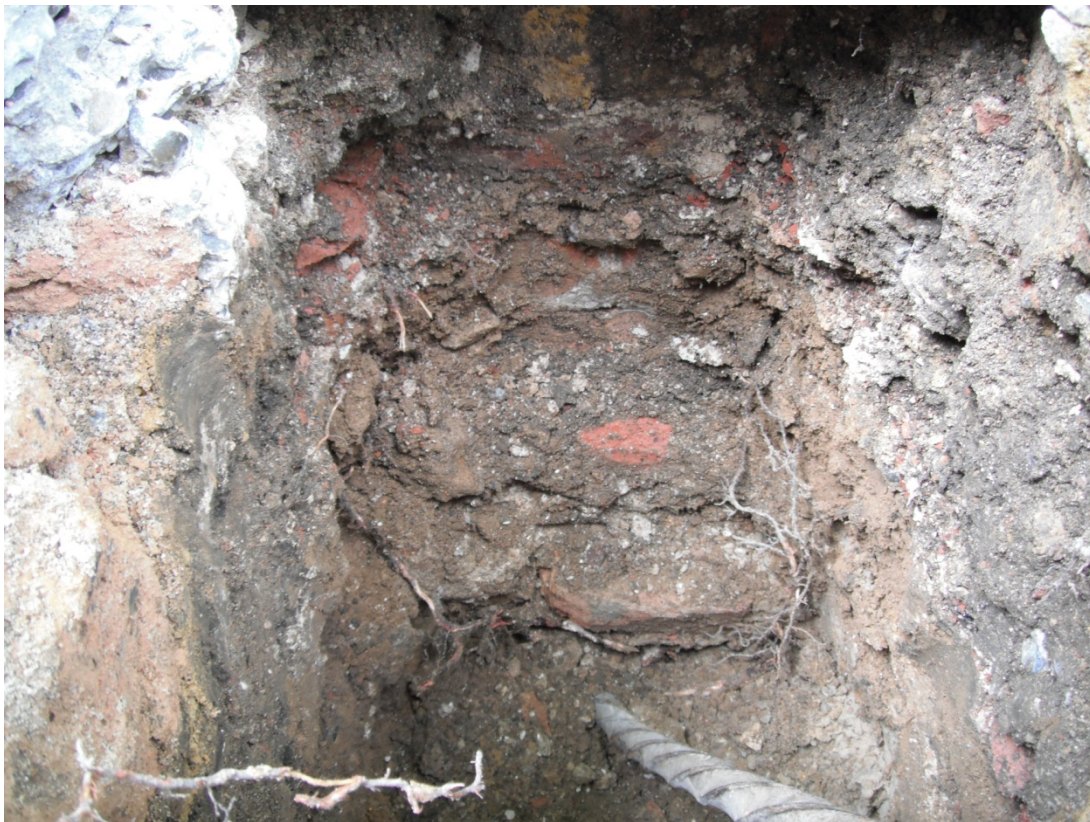
## TP2

Along the south side of TP2 the current existing modern wall was recorded sitting directly upon an earlier post-medieval structure. This earlier wall, context [3], extended from east to west and was constructed using an English bond. The materials used in its construction appeared to be type 3032 nr 3035 bricks and a light yellowy grey sandy mortar (late 18<sup>th</sup> – early 19<sup>th</sup> century). The brickwork stepped out twice, at 630mm below ground level (bgl) and 730mm bgl. It was not possible to observe the extent of construction cut [6] as it extended beyond the LOE. The latest deposit, context [4] was a post-medieval made ground and below that was a layer of re-deposited clay. Gravel deposits [7] were observed at 800mm bgl.

Test Pit 2 showing earlier stepped brick footing

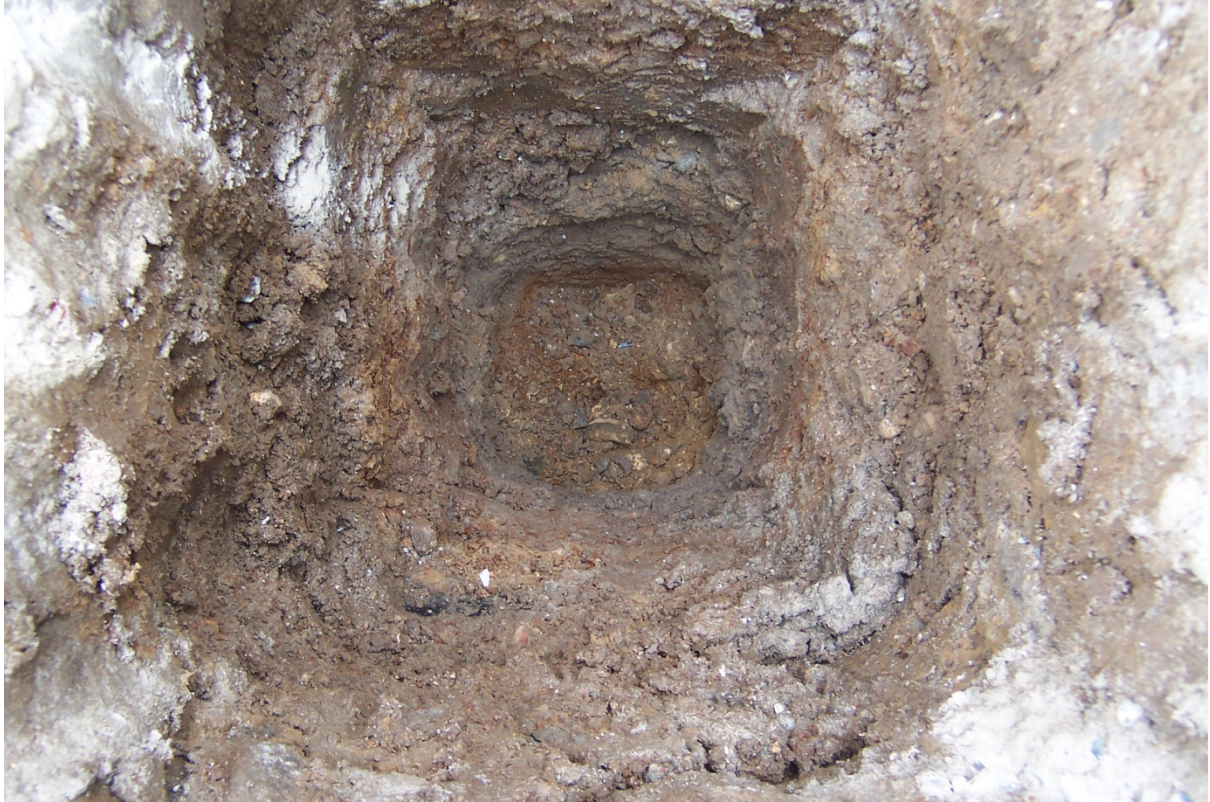
### Test Pit 3 (TP A)-Overview

Test Pit 3 was located towards the north of the study site on the eastern side of the car park and had dimensions of 0.50m (N-S) x 0.50m (E-W) and was excavated to a depth of approximately 1.22m below ground level (BGL hereafter).

The earliest deposit encountered in Test Pit 3 was natural sand and gravel [14] comprising of firm, mid yellow brown sands and gravels visible across the whole pit and seen at a depth of 1.10m BGL. It was seen to have a thickness in excess of 0.12m at the LOE.

Sealing the natural horizon [14] was a layer [13] comprising of a firm, mid-light grey, silty sand with very frequent small and medium round and sub angular pebbles. Seen at 0.90m BGL, it was visible across the entire test pit and had a thickness of approximately 0.20m.

Sealing layer [13] was a layer [12] of post-medieval/19<sup>th</sup> century made ground comprising of a mid brown sandy silt with inclusions of occasional fragments of cbm and small round and sub angular pebbles. Visible across the entire test pit, this deposit was seen at 0.15m BGL and had a thickness of 0.75m. The test pit was sealed at ground level by a concrete slab.

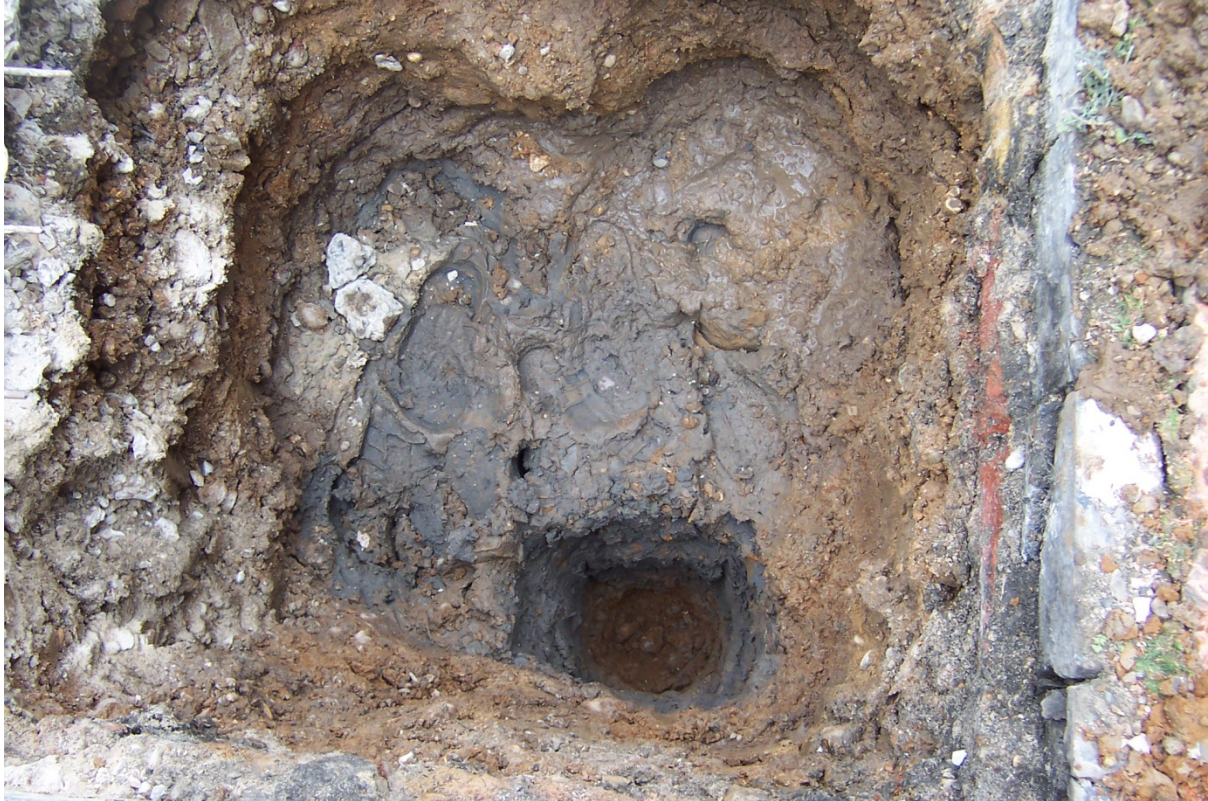
#### **Test Pit 4 (TP B)-Overview**

Test Pit 4 was situated towards the northern end of the study area on the western side of the car park. It had dimensions of 1.10m (N-S) x 1.10m (E-W) to a depth of approximately 0.80m BGL with a sondage being inserted in the north eastern corner down to a depth of 1.50m BGL.

The earliest deposit encountered in Test Pit 4 was natural sand and gravel [11] visible in a small (approx 0.30m x 0.30m) sondage in the north eastern corner of the test pit. It was seen at approximately 1.37m BGL with a thickness of 0.14m at the LOE. The natural sand and gravel [11] were sealed by a thin layer of naturally accumulated brickearth [10] comprising of soft, mid yellow-brown silty sandy clay with a thickness of 0.05m and seen at 1.34m BGL.

The brickearth [10] was sealed by a deposit [9] comprising of a soft, mid blue-grey silty sandy clay with inclusions of occasional flecks of cbm (or pot), occasional flecks of charcoal and occasional small round and sub angular pebbles. This deposit was visible across the entire test pit (1.10m x 1.10m), was seen at 0.80m BGL and had a thickness of 0.54m.

Sealing deposit [9] was a layer [8] of post-medieval/19<sup>th</sup> century made ground comprising of a moderately loose, mid yellow-brown, silty sand with moderate inclusions of cbm fragments and

small and large round and sub angular pebbles and occasional inclusions of slate fragments. This layer was visible across the entire test pit, was 0.55m thick and was seen at 0.24m BGL. The entire test pit was sealed by a concrete slab.

While it not possible to make definitive statements owing to the restricted size of the intervention, it cannot be discounted that deposit [9] within TP4 (B) was the fill of an unidentified feature. The nature of this deposit suggested natural silting over an extended period of time, and it is possible

that this feature is natural in origin. The fact that this deposit was some 0.54m in thickness would suggest a feature of, at least moderate, depth.

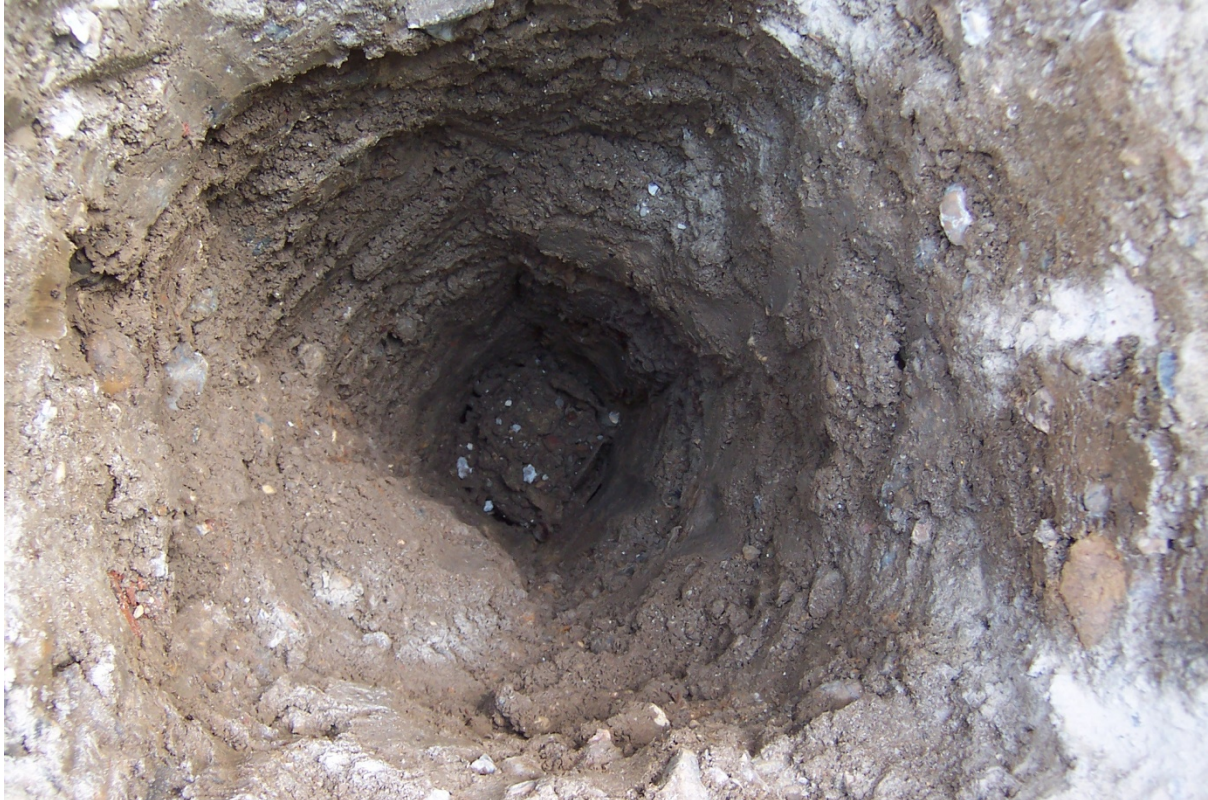
### Test Pit 5 (TP C)-Overview

Test Pit 5 was situated towards the southern end of the study site on the eastern side of the car park. It had dimensions of 0.50m (N-S) x 0.50m (E-W) and was excavated to a depth of approximately 1.22m BGL.

The earliest deposit encountered in this test pit was natural clay (?London Clay) [16] comprising of firm, mid yellow brown clay with no obvious inclusions. It was visible across the entire test pit and was seen at 1.10m BGL with a thickness of 0.20m to the LOE.

Layer [16] was sealed by a post-medieval/19<sup>th</sup> century layer [15] of made ground comprising of firm, mid brown sandy silt with frequent inclusions of small round and sub angular pebbles and moderate inclusions of cbm fragments. It was visible across the entire test pit and was seen at 0.30m BGL with a thickness of 0.80m. The entire test pit was sealed by a concrete slab.

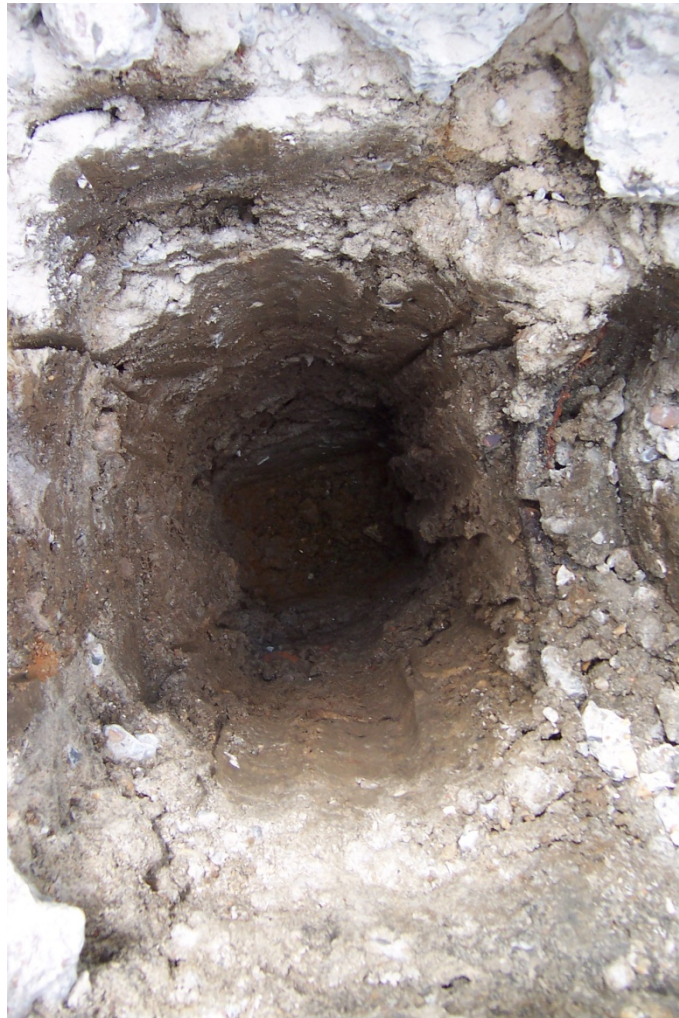
### **Test Pit 6 (TP D)-Overview**

Test Pit 6 was situated towards the southern end of the study area on the western side of the car park. It had dimensions of 0.50m (N-S) x 0.50m (E-W) and was excavated to a depth of 1.25m BGL.

The earliest deposits encountered in this test pit was natural sand and gravel [20] comprising of very compact, mid yellow brown sands and gravels. This deposit was visible across the entire test pit and was seen at 1.20m BGL and with a thickness of 0.05m at the LOE. Layer [20] was sealed by a thin layer of naturally accumulated brickearth [19] comprising of firm, mid yellow brown, sandy silty clay with no inclusions. It was visible across the entire test pit and was seen at 1.15m BGL with a thickness of 0.05m.

Brickearth layer [19] was sealed by a layer [18] of moderately compact made ground comprising of mid greyish brown sandy silt with very frequent inclusions of small round and sub angular pebbles. It was visible across the entire test pit and seen at 0.80m BGL and had a thickness of 0.35m. Layer [18] was sealed by layer [17] which is very similar in nature but with more inclusions and sand content. It comprised of a moderately compact mid grey brown sandy silt with moderate inclusions of cbm fragments and small round and sub angular pebbles. It was visible across the test pit and was seen at

0.20m BGL with a thickness of 0.60m. This layer is also likely to be post-medieval/19<sup>th</sup> century in date. The entire test pit was sealed by a concrete slab.
