**ASSESSMENT REPORT ON
THE BUILT HERITAGE
RECORDING OF A LENGTH
OF THE SOUTH MOAT
WALL, HM TOWER OF
LONDON, LONDON
BOROUGH OF TOWER
HAMLETS**

SITE CODE: TOL 139

PCA REPORT NO. R11796

JULY 2014

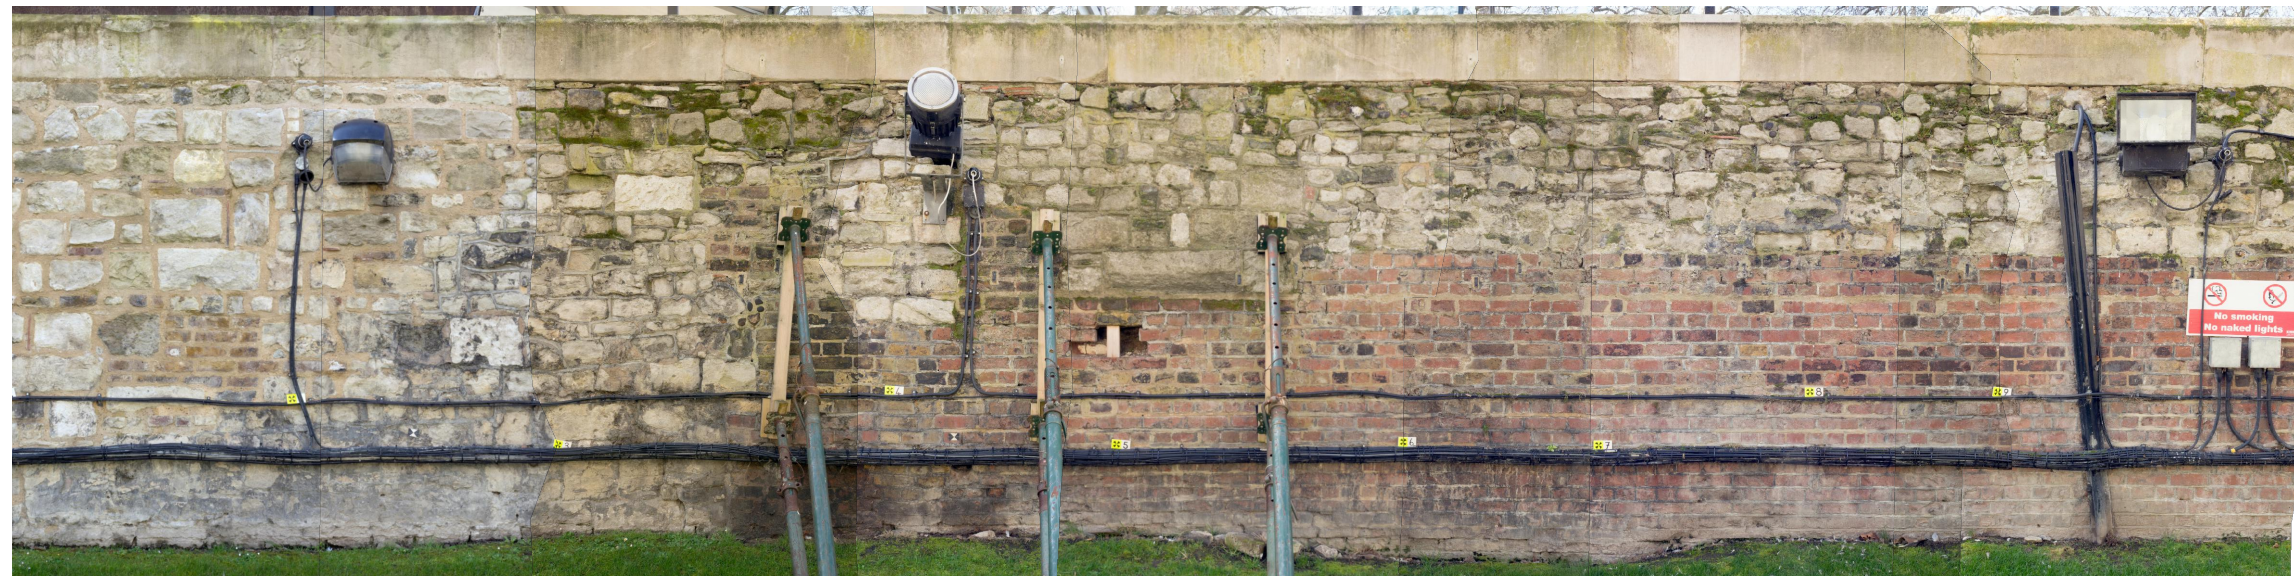
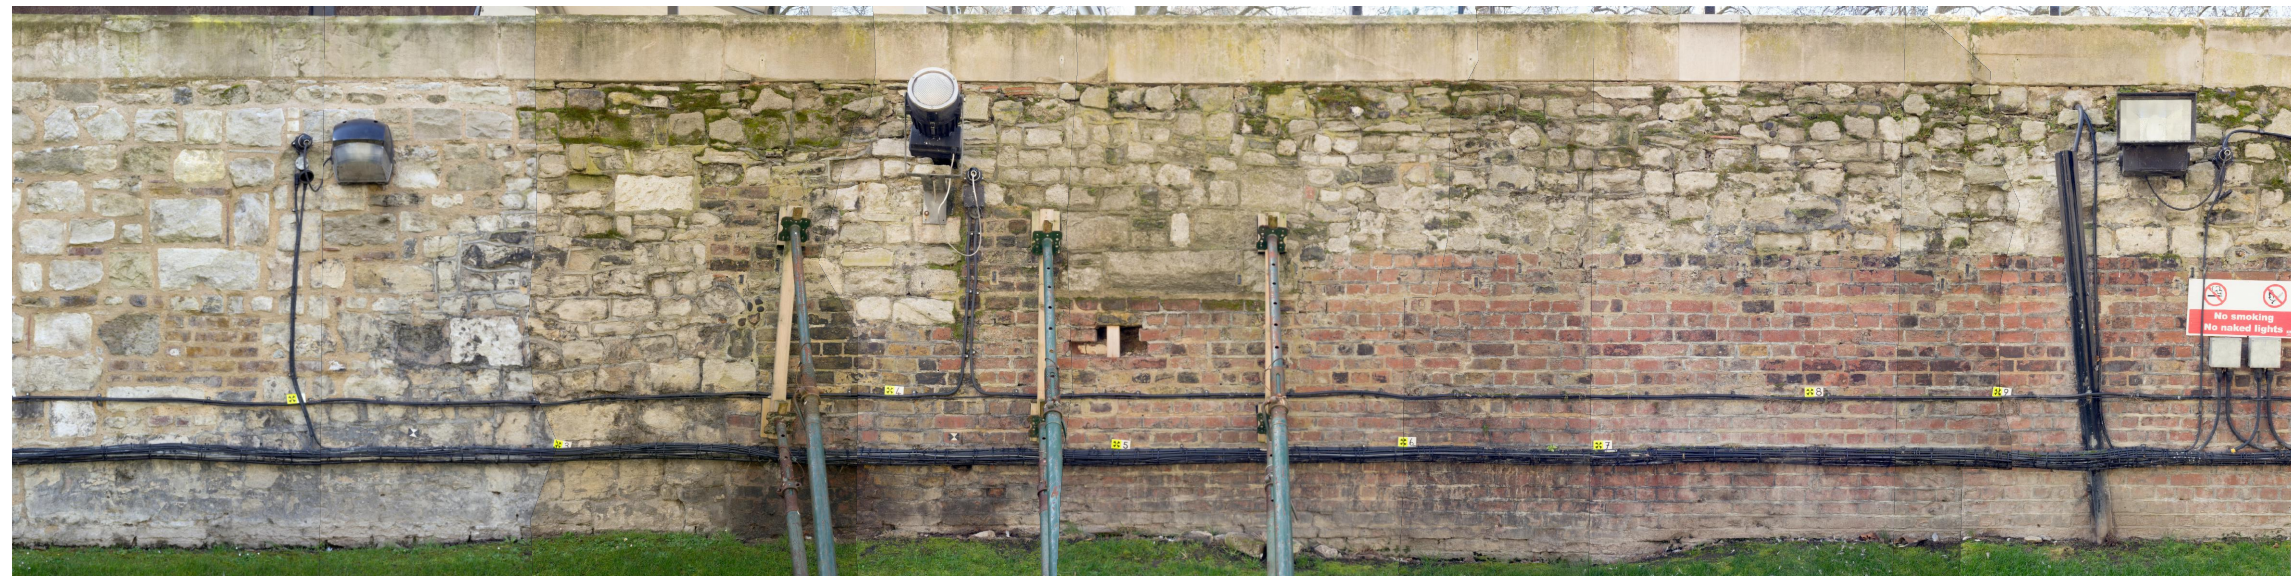
- 5.1.3 The brickwork was mainly bonded in 19th/20th century hard Portland cement (Type 2) (**Figure 4; Appendix 2**). A narrow horizontal line within the brickwork had been re-pointed in a late 19th/early 20th century hard brown Roman cement (Type 4). This may relate to previous opening up of the joint caused by hoop iron (which was found in this joint) or bowing of the wall (**Plates 4 and 5**). Dismantling showed that movement of the external face of the wall had caused a void to open up behind the brickwork. Tree roots, presumably from a former plane tree, were also observed clinging to the inner rubble core pushing the outer north face to the north (**Plate 6**).

5.1.9 A fine granite block and a coarser Aberdeen Granite lump in the wall were found within an area of wall that had been re-pointed in late 19th/20th century crumbly gravel mortar (Type 10; **Figure 4; Appendix 2**). These may have derived from granite setts from the adjacent Tower Walkway or from the 1886-1894 construction of Tower Bridge.

Type 1: Hard light grey-brown Portland type mortar
Date: C19th-20th

Type 3: Pale cream-dark grey clinker/charcoal rich mortar
Date: Late C18th - Mid/Late C19th

Type 4: Roman mortar. Very hard fine dark brown-grey concretionary mortar
Date: Late C19th - C20th

Type 10: Very loose grey mortar
Date: C18th - C19th

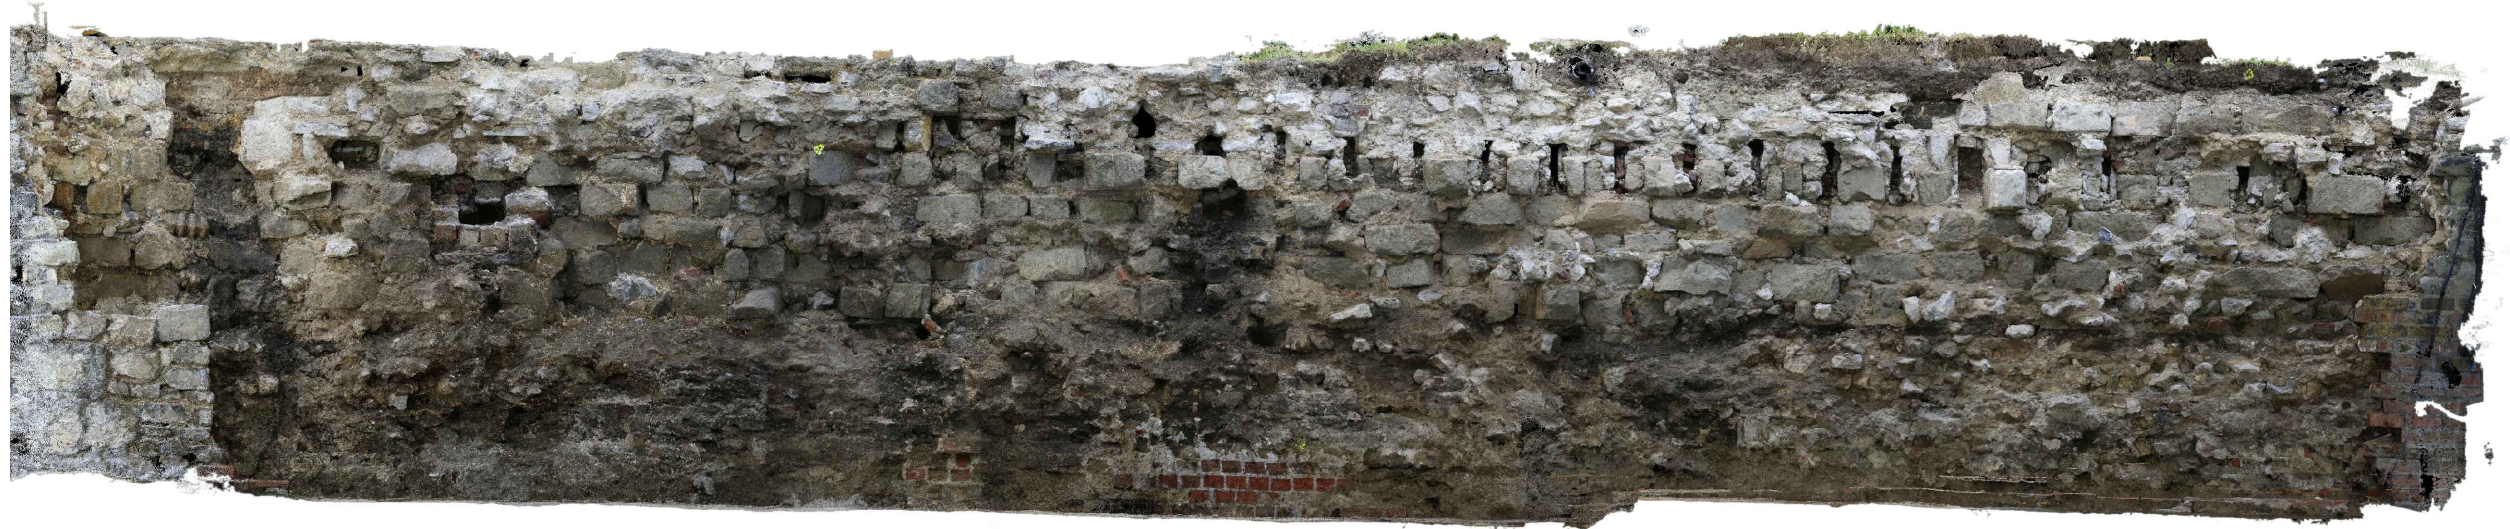
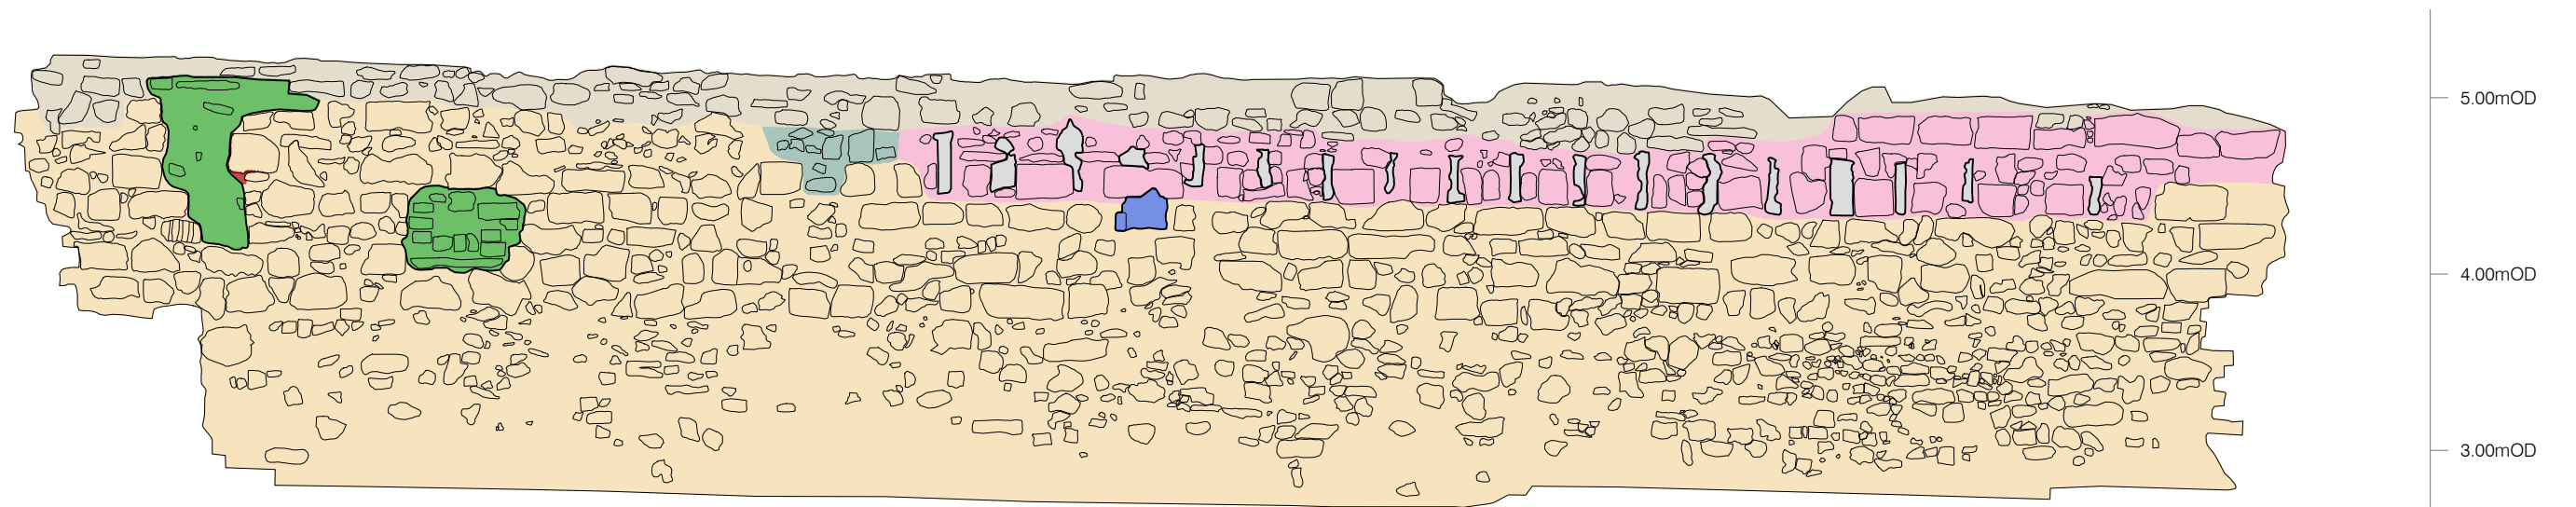
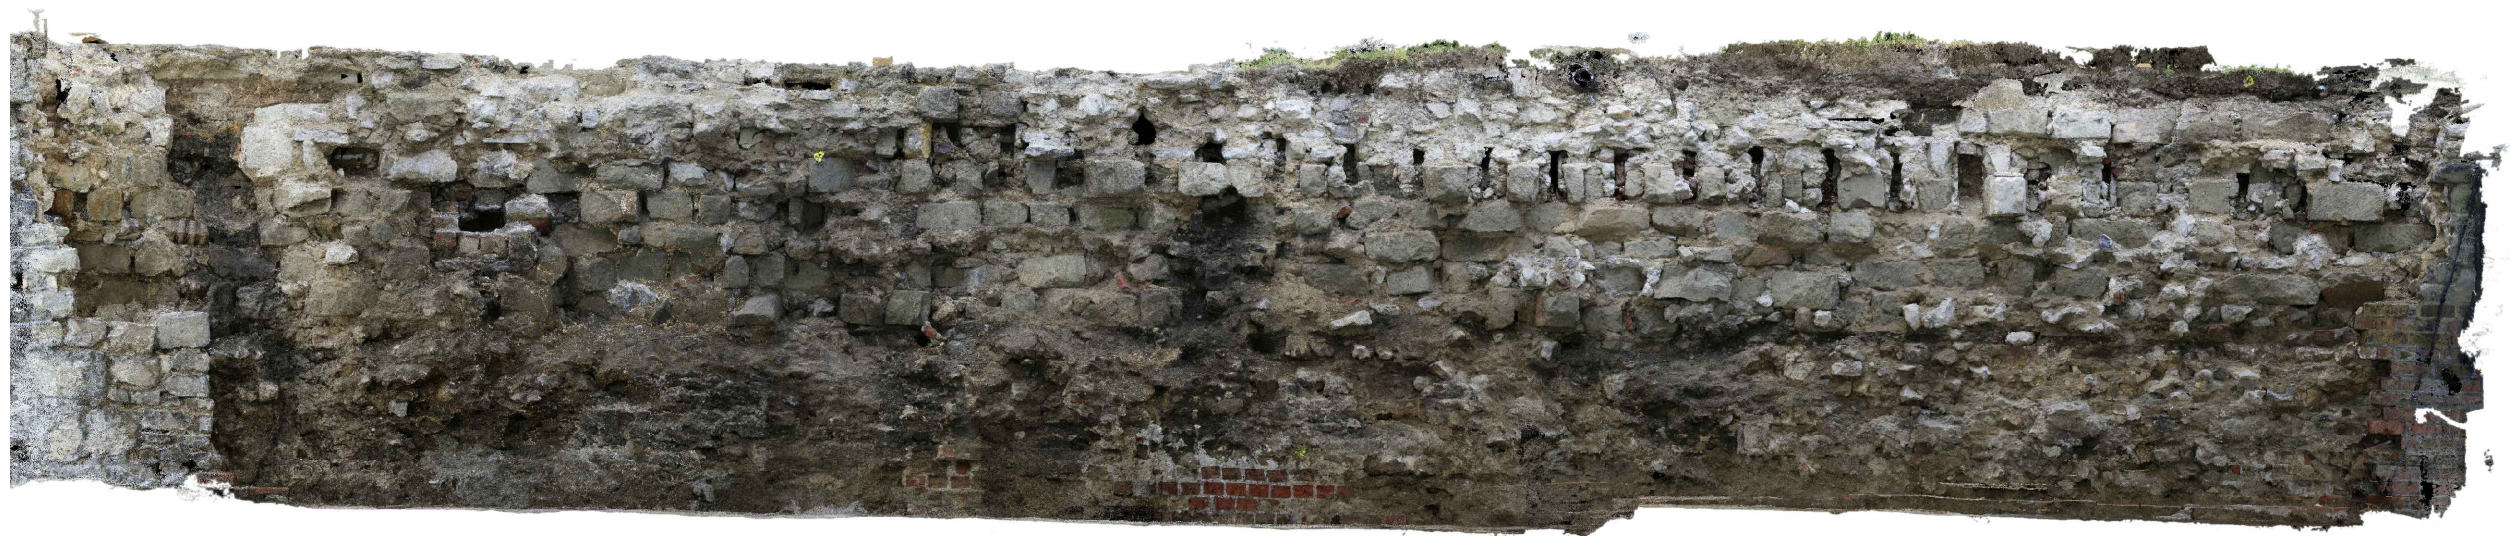
5.2.3 Most of the inner core of the wall was bonded in the same loose brown sandy mortar with clinker and calcareous inclusions (Type 7; **Figure 6; Appendix 2**). This loose sandy lime mortar has been found in 16th century and mainly 17th century buildings in London (Hayward pers. obs.). It was observed from the base of the wall up to a height of 1.6 to 2.2m. As well as Kentish Ragstone and Reigate stone, a number of fragments of red Tudor/Stuart bricks (fabric 3046) with a 1450 to 1666 date range, were also found in this

5.2.8 Three brick features were uncovered during the dismantling of the outer face of the wall (**Figure 5**). Flues 1 and 3 were situated towards the east end of the recorded length of wall while Flue 2 lay near the centre. They had been inserted in the inner core of the wall and were visible some 0.5 to 1m down from the top of the wall. Similar features have not previously been found in the two recorded lengths of South Moat Wall to the east (Mackinder 2012; Davies and Norton, 2004). They all had a dark-ashy backfill which suggests that they were flues.

- Type 2: Pale cream-dark grey clinker/charcoal rich mortar
Date: Late C18th - Mid/Late C19th
- Type 4: Roman mortar. Very hard fine dark brown-grey concretionary mortar
Date: Late C19th - C20th
- Type 5: Tufaceous mortar - white mortar with tufa like residue
Date: not known

- Type 6: Loose grey sandy lime mortar
Date: C18th - C19th
- Type 7: Loose brown sandy clinker mortar
Date: C17th - Early C18th
- Type 8: Hard very dark grey concrete type mortar with angular red brick inclusions
Date: Late C19th - C20th

- Type 11: Pale cream to dark grey mortar with charcoal/clinker inclusions
Date: Late C18th - Mid/Late C19th
- Beam slots

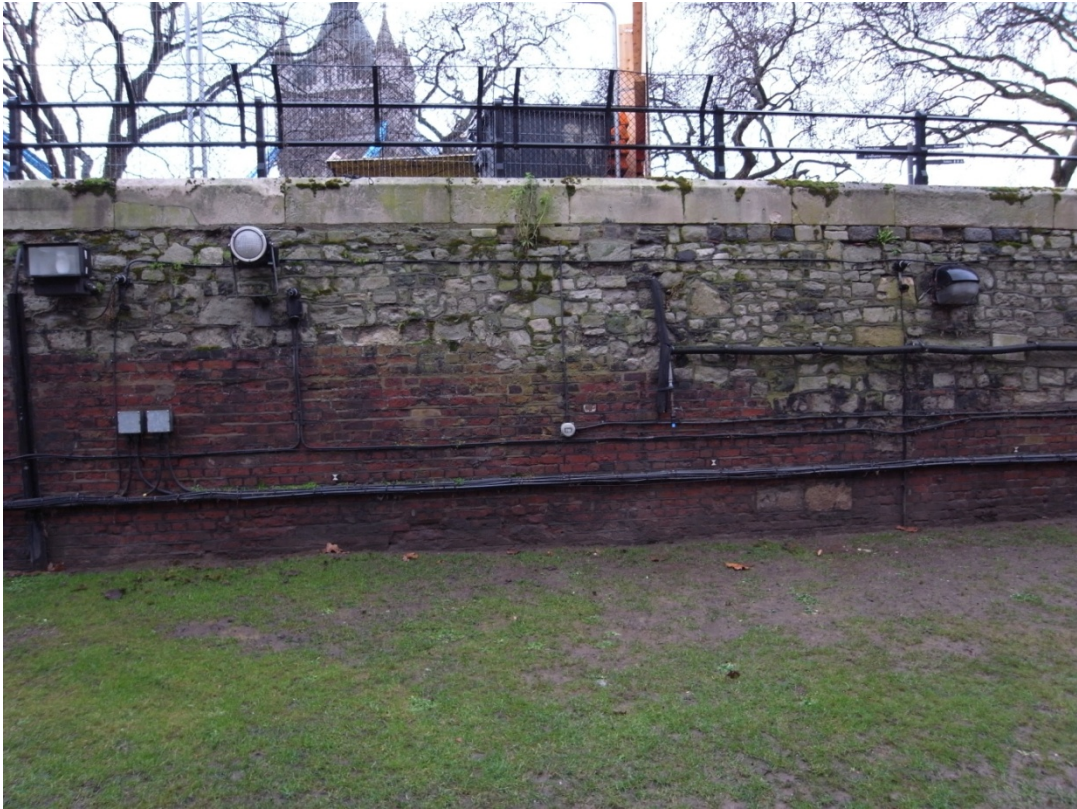
Plate 1: West end of the recorded length of the north elevation of the South Moat Wall (photograph provided by Alex Attelsey)

3.3.3 The rectified image was then digitised to produce an AutoCAD drawing with each stone in the wall individually drawn and the brickwork left as one context (**Figures 3 and 4**). Subsequently, when the face of the wall was being dismantled it was realised that a further 3.6m length of the wall to the west needed to be added to the original survey. This stretch of wall was hand drawn at a scale of 1:10 on site and added to the AutoCAD drawing (**Figures 3 and 4**). A photograph, prior to its dismantling and the erection of scaffolding, was supplied by Alex Attelsey, Conservation Building Surveyor, Tower of London, Historic Royal Palaces (**Plates 1 and 2**).

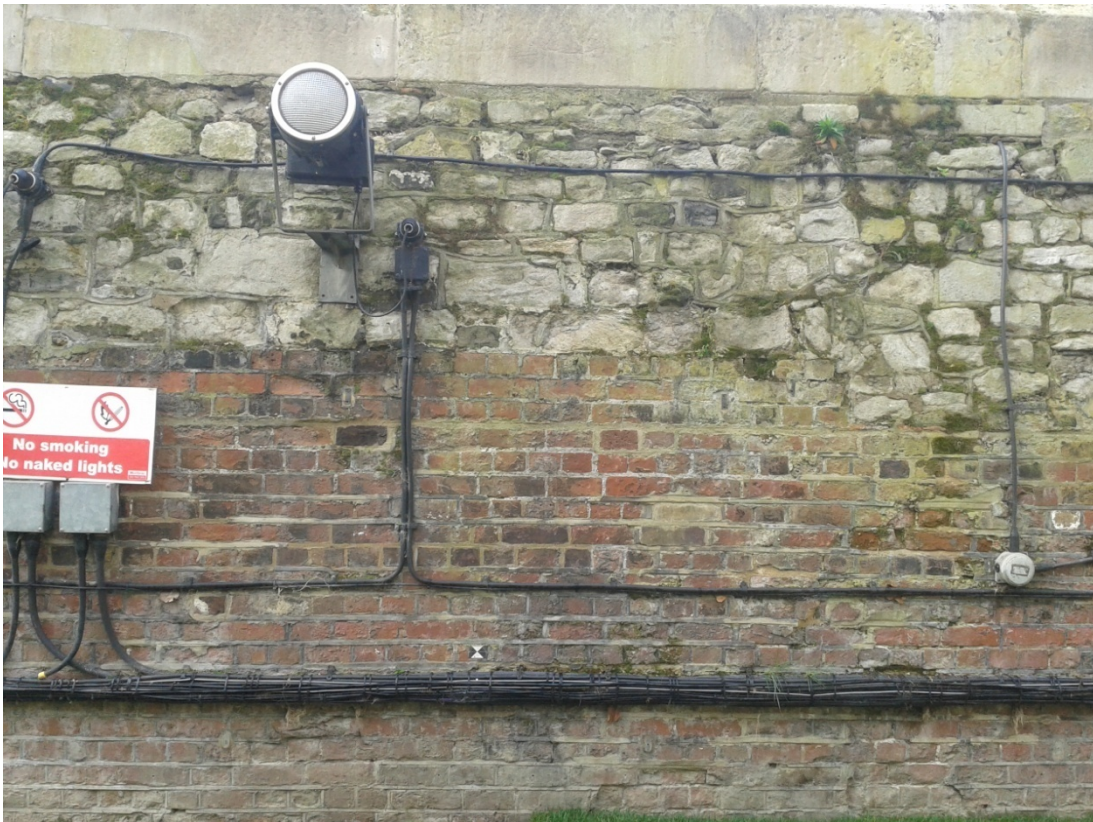
Plate 2: West end of the recorded length of the north elevation of the South Moat Wall (photograph provided by Alex Attelsey)

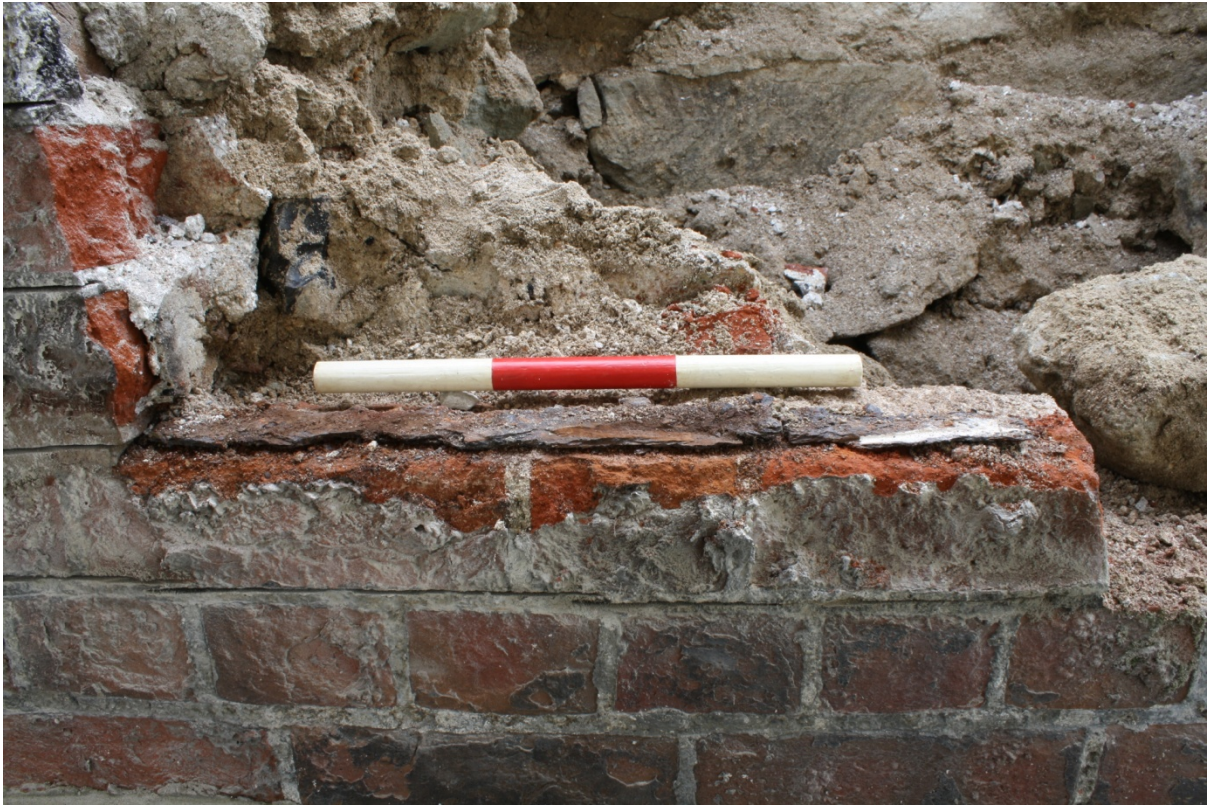
- 5.1.2 During the dismantling of this brickwork, hoop iron (a long band of wrought iron some 40mm wide by 1mm thick) had been laid horizontally in at least one of the mortar joints to reinforce the wall (**Plate 3**). Hoop iron was commonly used within brickwork in the late 19th/early 20th century. Over time the iron rusts causing the joint to expand and crack.

Plate 3: Hoop iron in a mortar joint within the brickwork of the outer north elevation found during dismantling, looking south

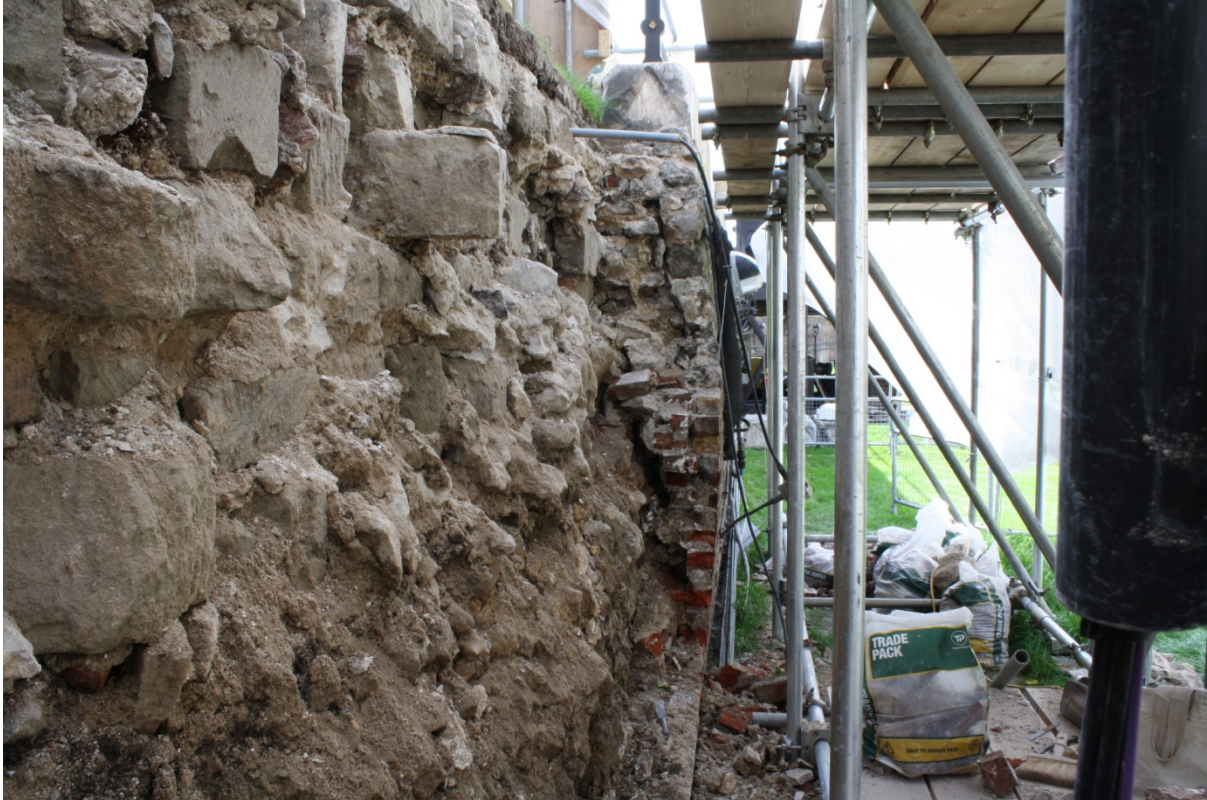
Plate 4: Bowing of the South Moat Wall at the west end of the recorded length, looking west

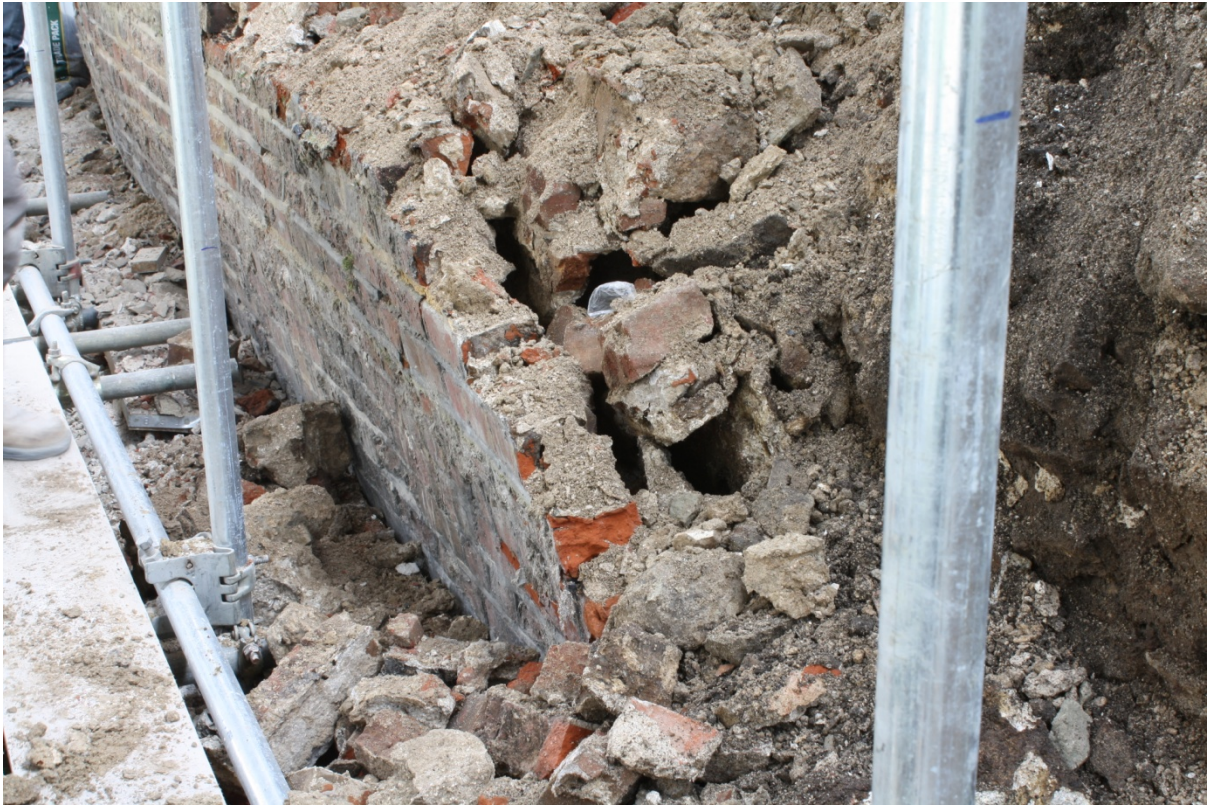
Plate 5: Lean of the brickwork in the recorded South Moat Wall, looking east

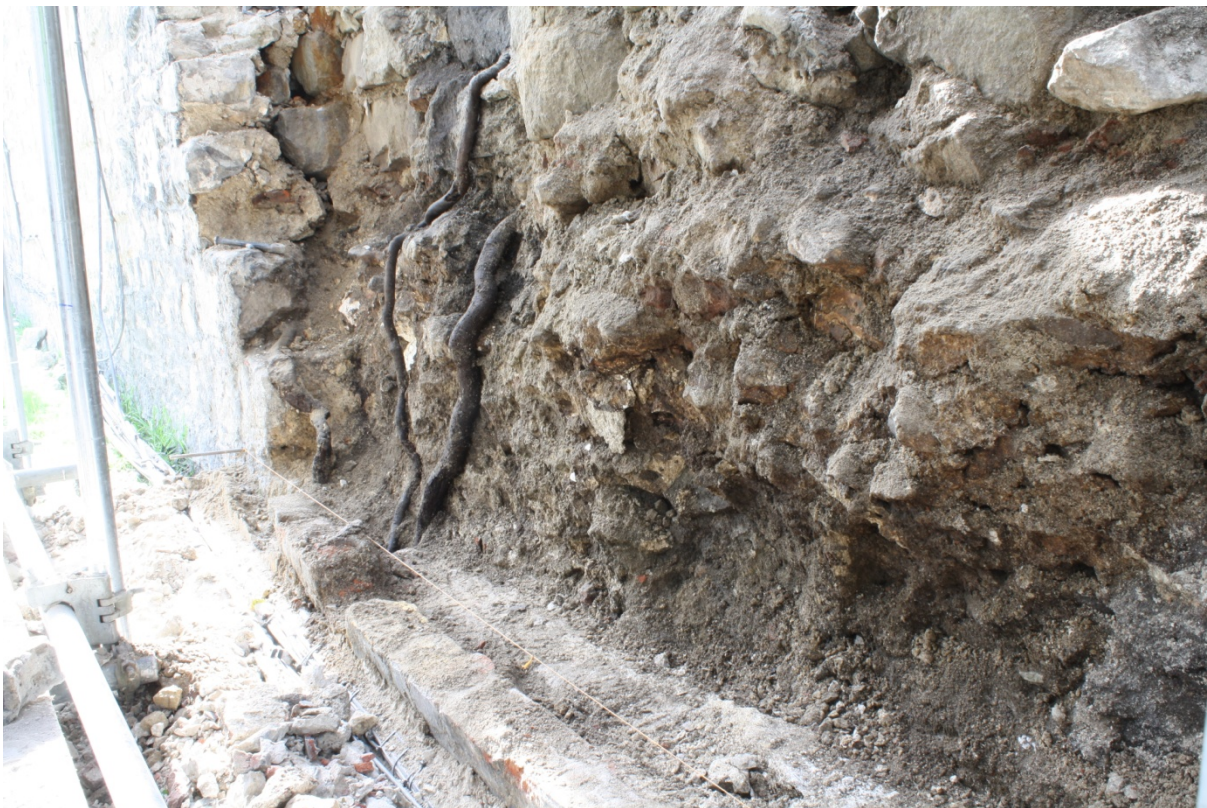
Plate 6: Tree roots observed once the outer face of the South Moat Wall had been dismantled, looking east

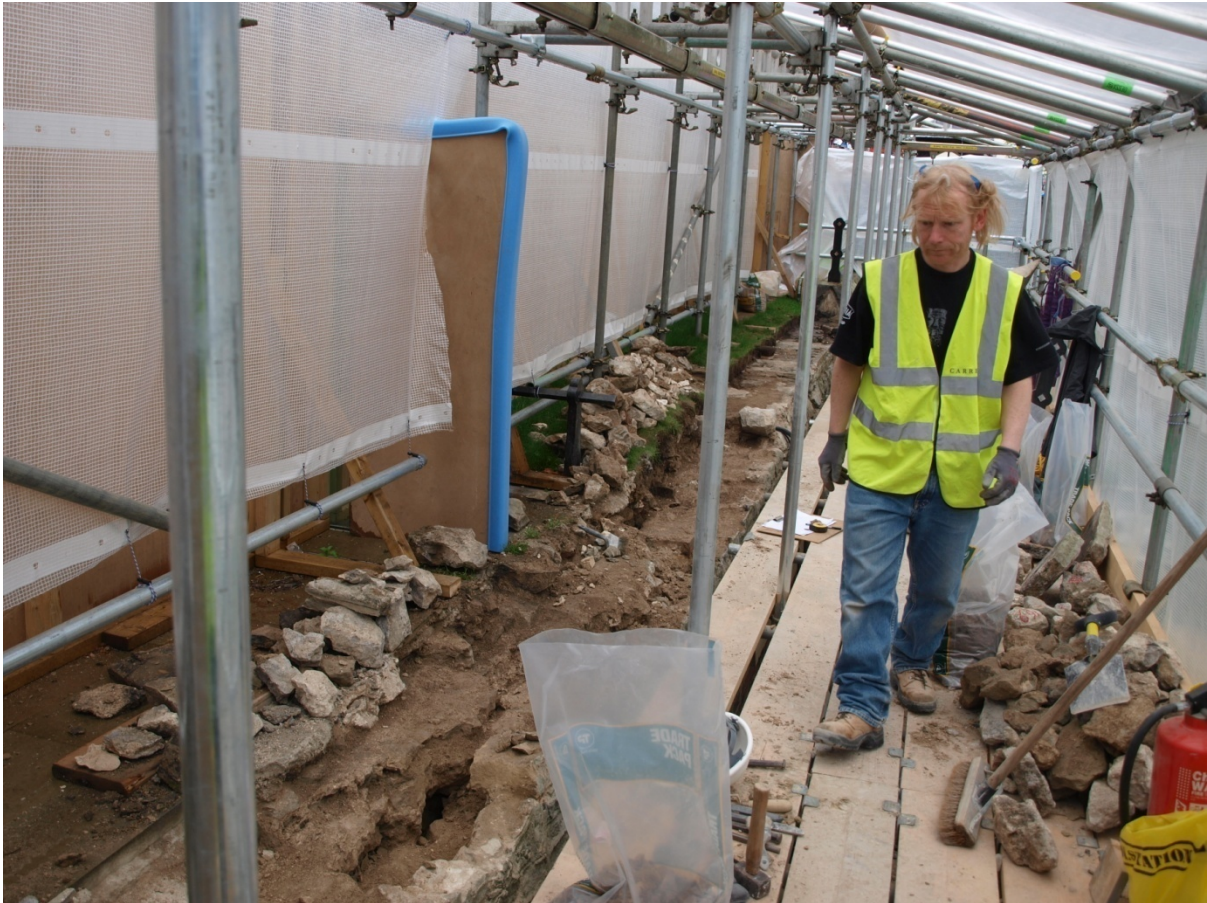
Plate 7: Dismantling of the outer face at the top of the South Moat Wall, looking east

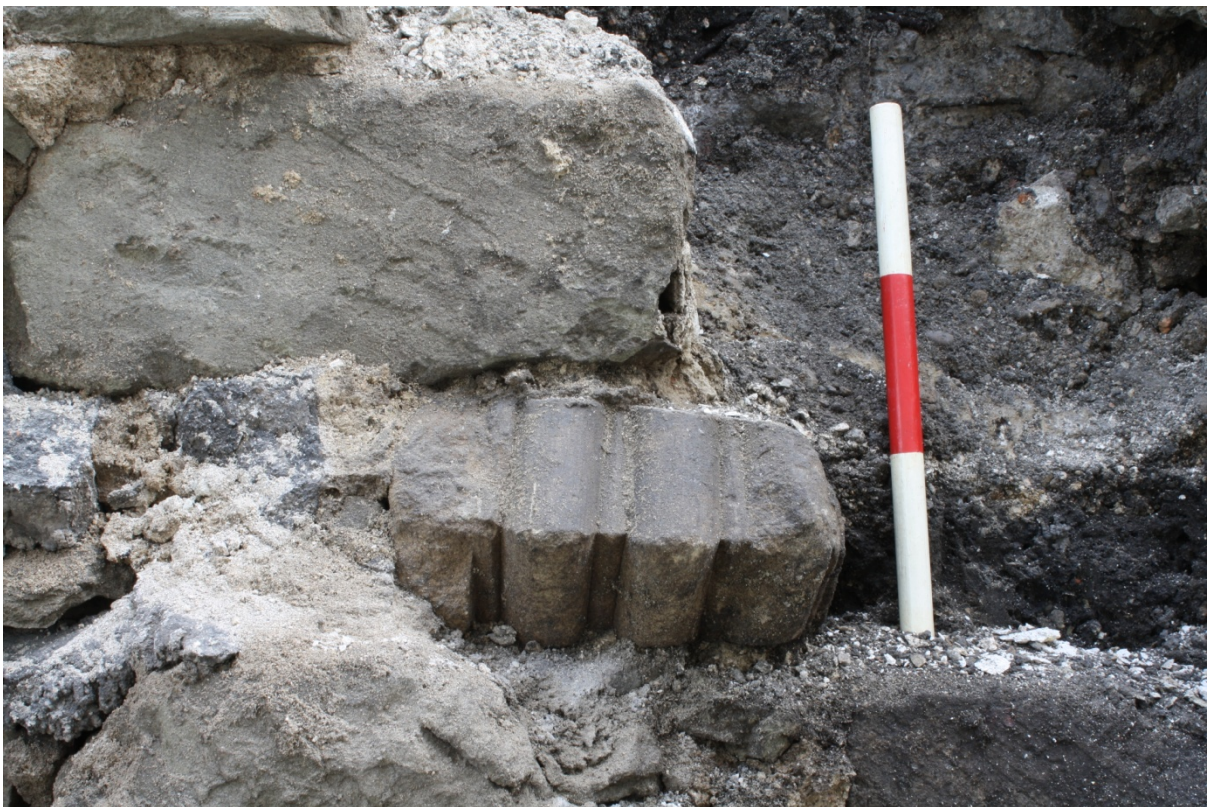
Plate 8: Moulded Caen stone within the inner rubble core to the east of Flue 1, looking south

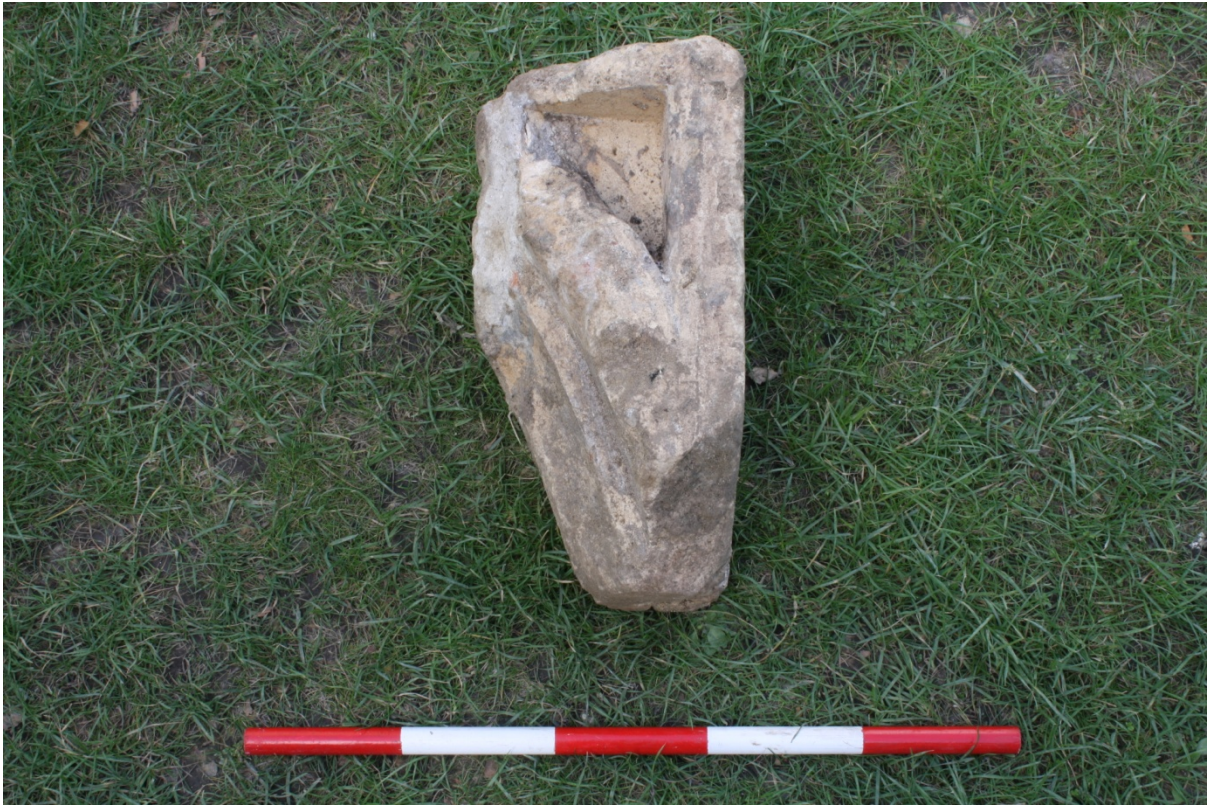
Plate 9: Window tracery in Caen stone found during the dismantling of the outer face of the South Moat Wall

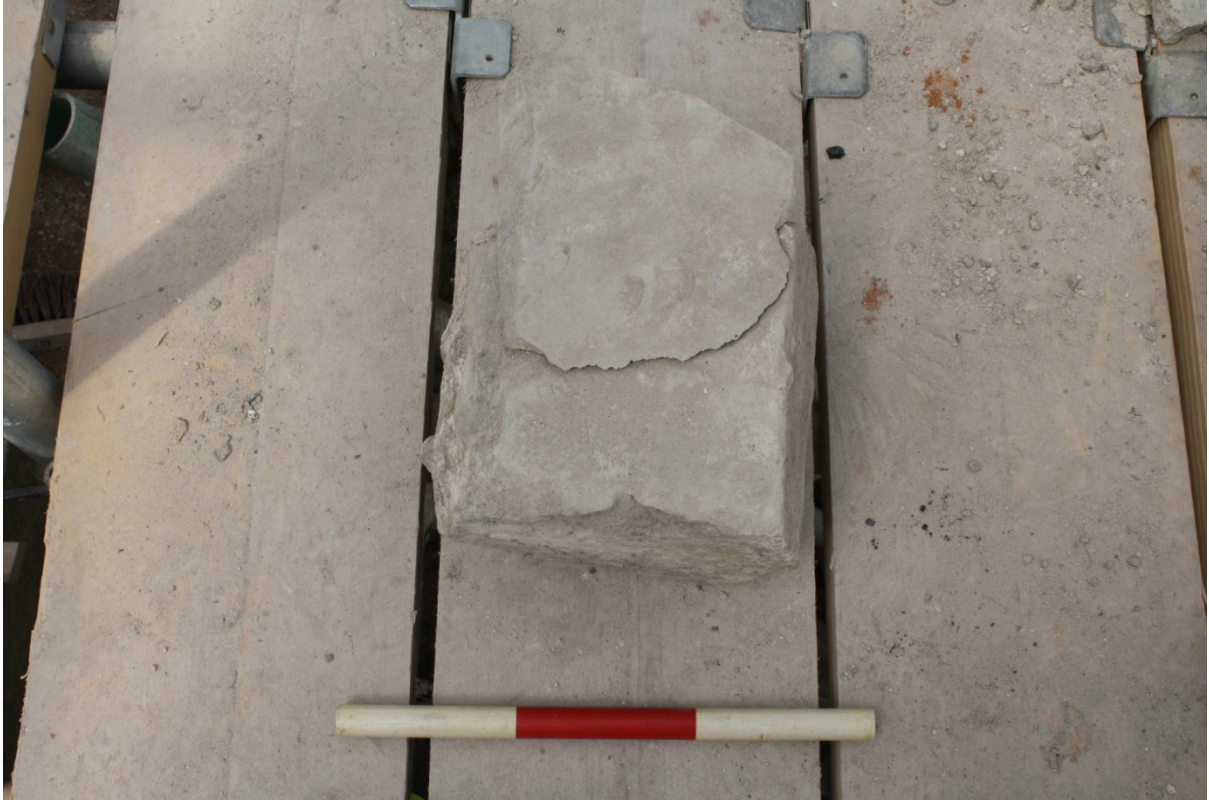
Plate 10: Caen stone chamfered on one side found during the dismantling of the outer face of the South Moat Wall

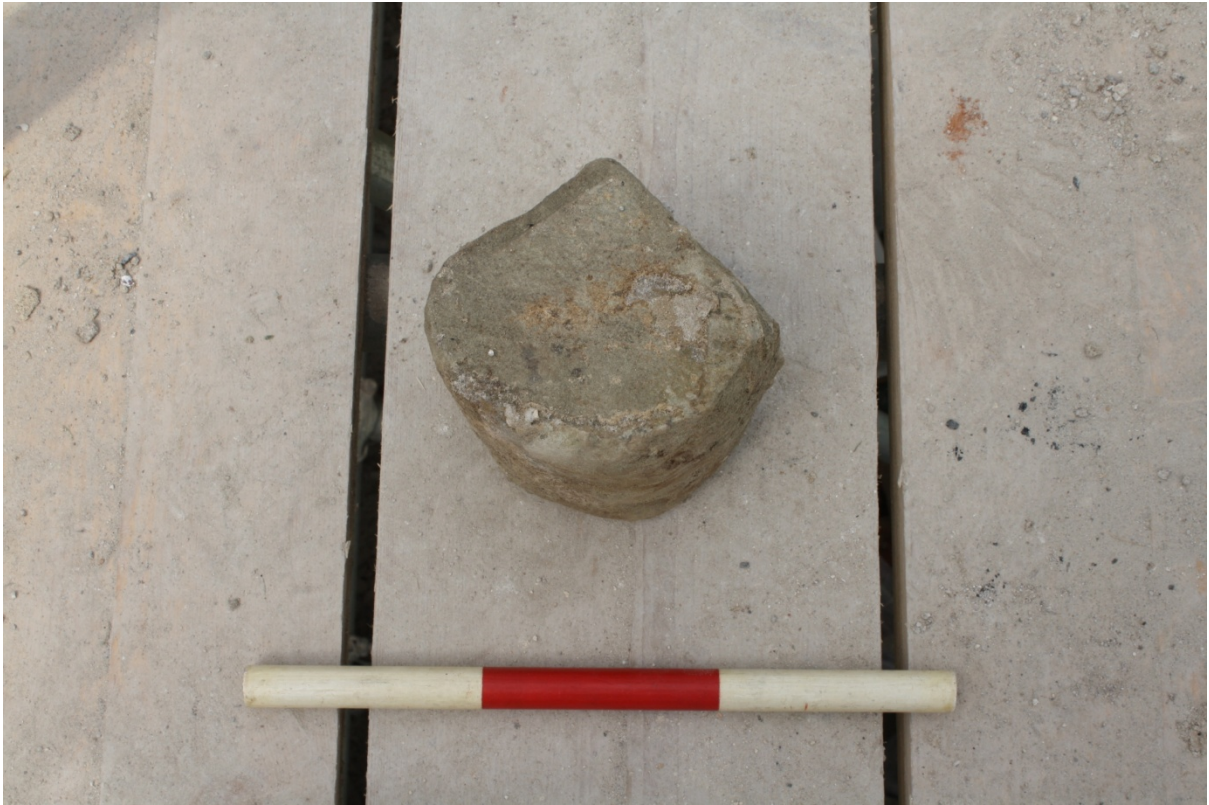
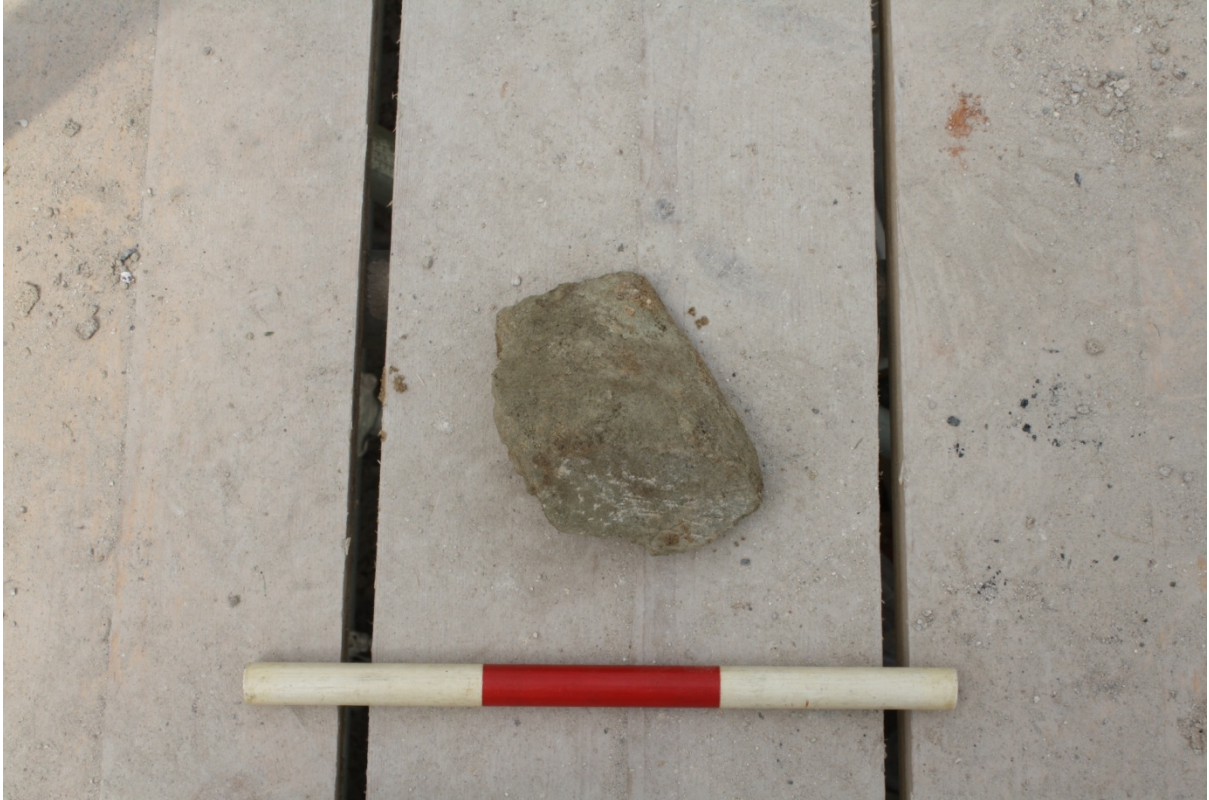
6.2.7 Moulded Reigate stone found in the wall included a piece with medieval roll-hill moulding adjacent to Flue 1 (**Plate 14**) and a number of shafts (**Plates 11 and 12**). These were also associated with the 17th/early 18th century brown mortar (Type 7).

Plate 11: Worked Reigate stone possibly from a shaft found during the dismantling of the outer face of the South Moat Wall

Plate 12: Worked Reigate stone possibly from a shaft found during the dismantling of the outer face of the South Moat Wall

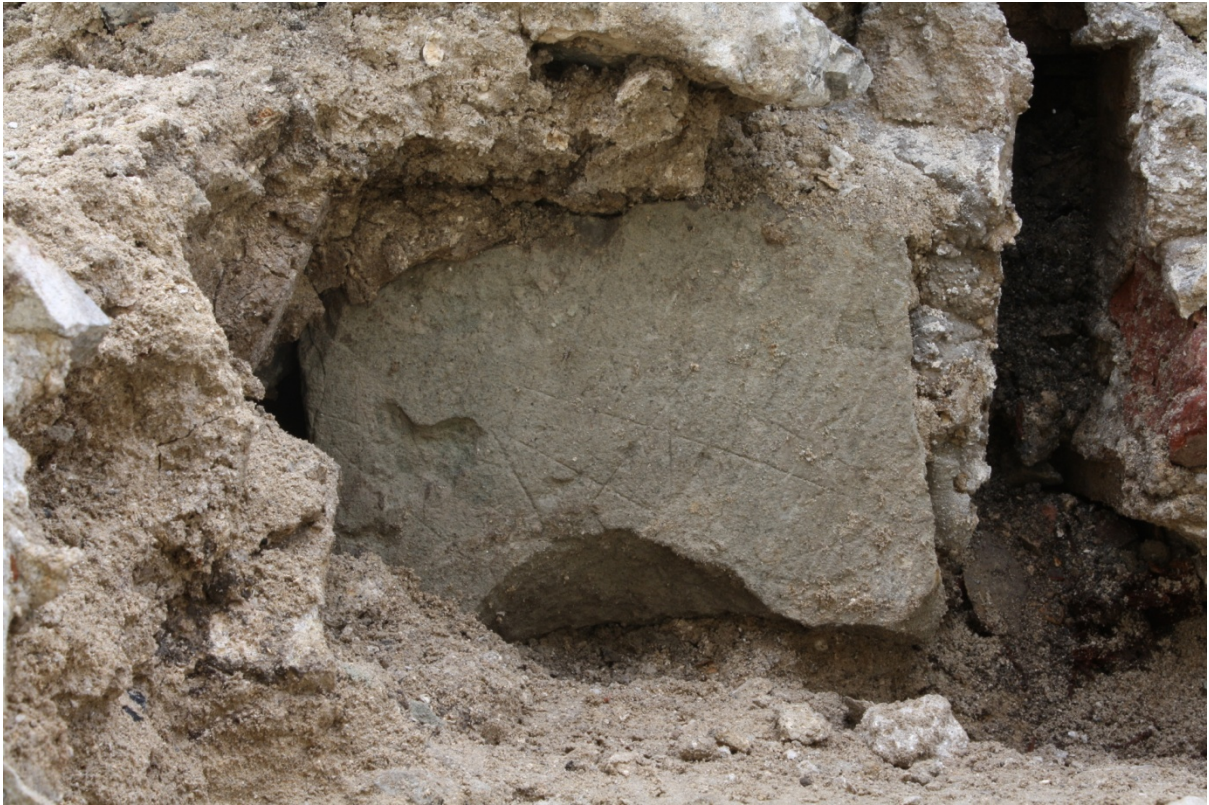
block of Reigate stone had been scored with lines (**Plate 13**). Another had a medieval roll-holl moulding (**Plate 14**), while another was L-shaped with a small recess (**Plate 15**). Part of a medieval Westminster plain glazed floor tile fabric (1225-1275) was also found in the wall.

6.2.6 Dismantling of the outer facing wall of the recorded length of the South Moat Wall uncovered a large number of low density Reigate stone ashlar, typically 240 x 180 x 120mm in size. Unlike the adjoining section of the wall, where the Reigate stone formed regular facing blocks (Mackinder 2012, 4), these had been disturbed and re-inserted at fairly regular intervals by the inserted 19th century timber floor. They were found some 0.8 to 2m from the top of the wall and were associated with 17th/early 18th century brown mortar (Type 7). One large lump of Reigate stone was scored with incised lines (**Plate 13**).

Plate 13: Reigate stone with incised lines within the inner rubble core to the east of a beam slot, looking south

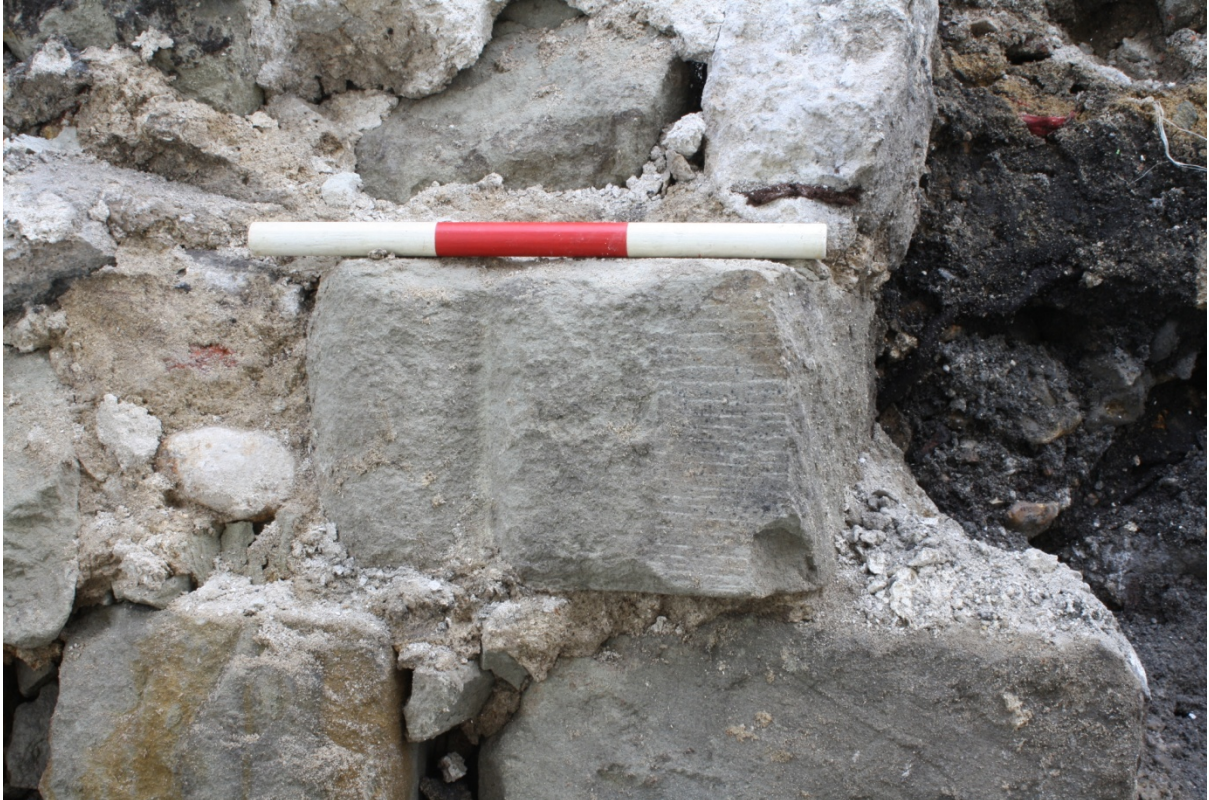
Plate 14: Reigate stone with medieval roll-holl moulding within the inner rubble core to the east of Flue 1, looking south

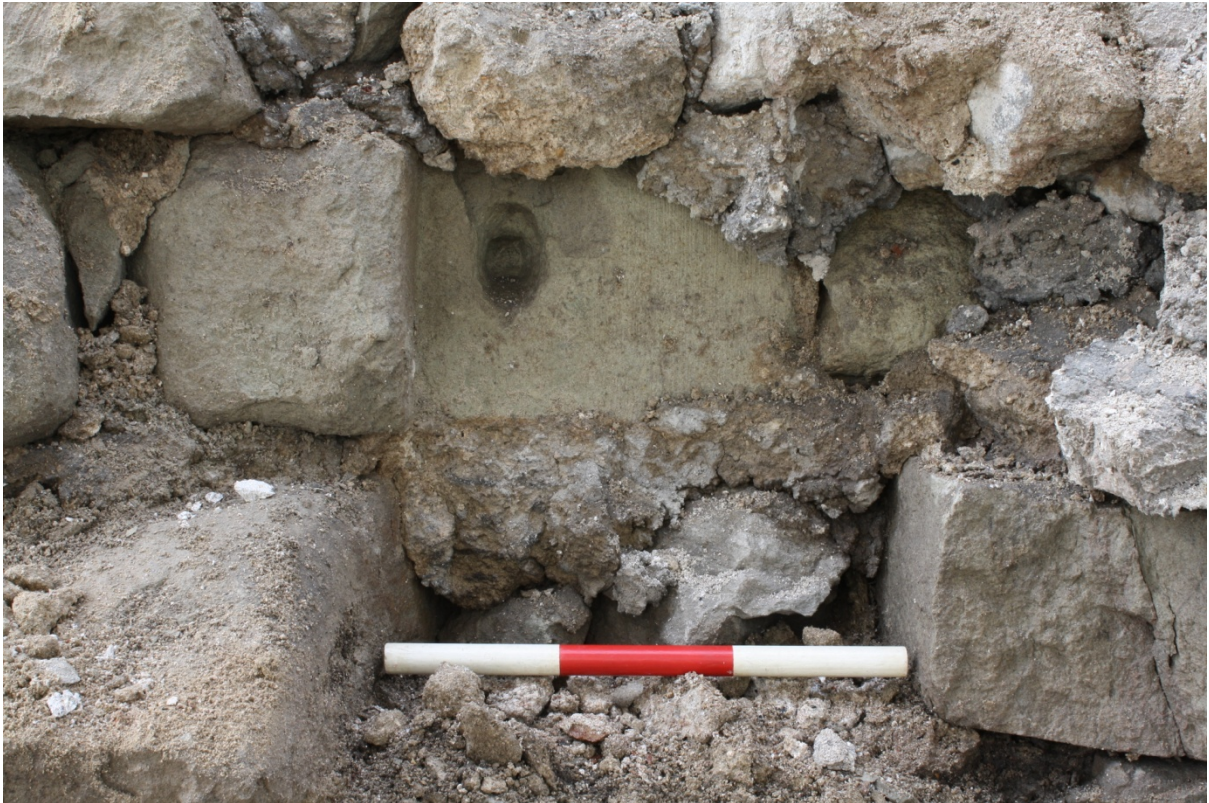
Plate 15: Worked Reigate stone within the inner rubble core, looking south
