**ASSESSMENT REPORT ON
THE BUILT HERITAGE
RECORDING OF A LENGTH
OF THE SOUTH MOAT
WALL, HM TOWER OF
LONDON, LONDON
BOROUGH OF TOWER
HAMLETS**

SITE CODE: TOL 139

PCA REPORT NO. R11796

JULY 2014

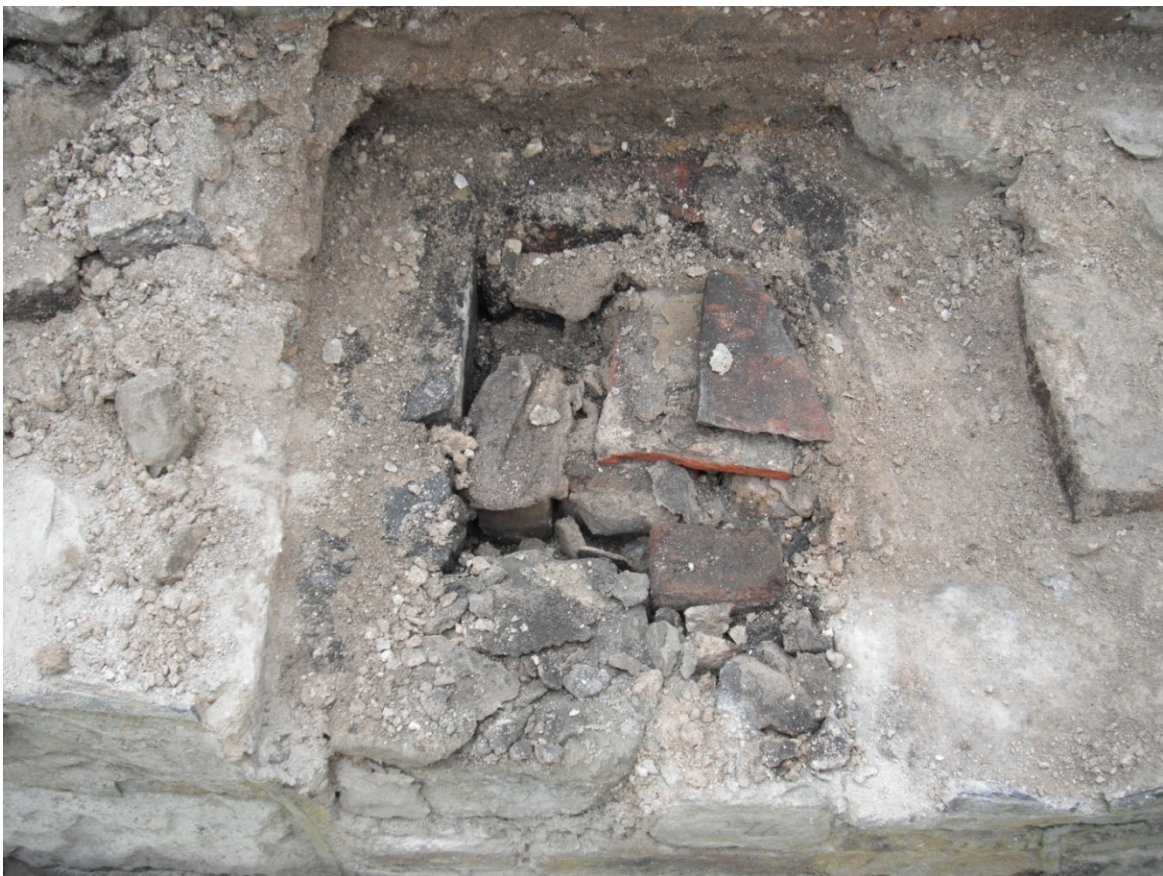
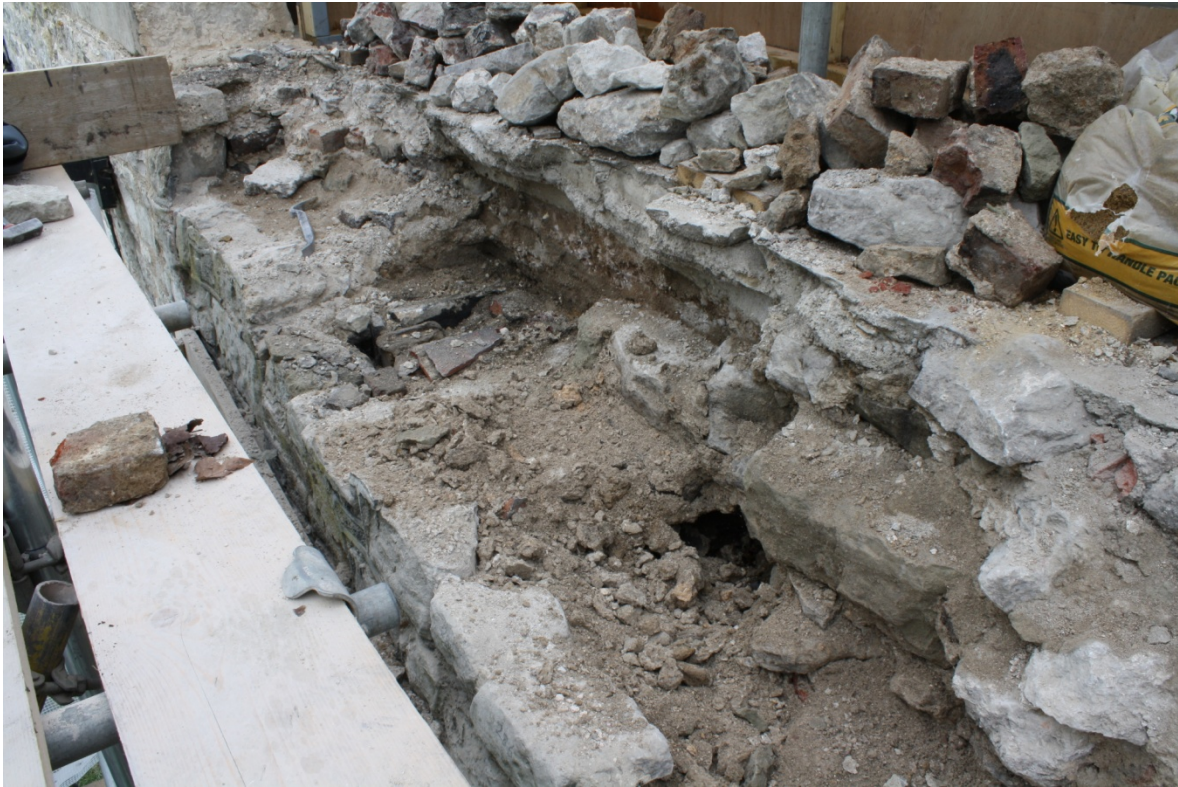
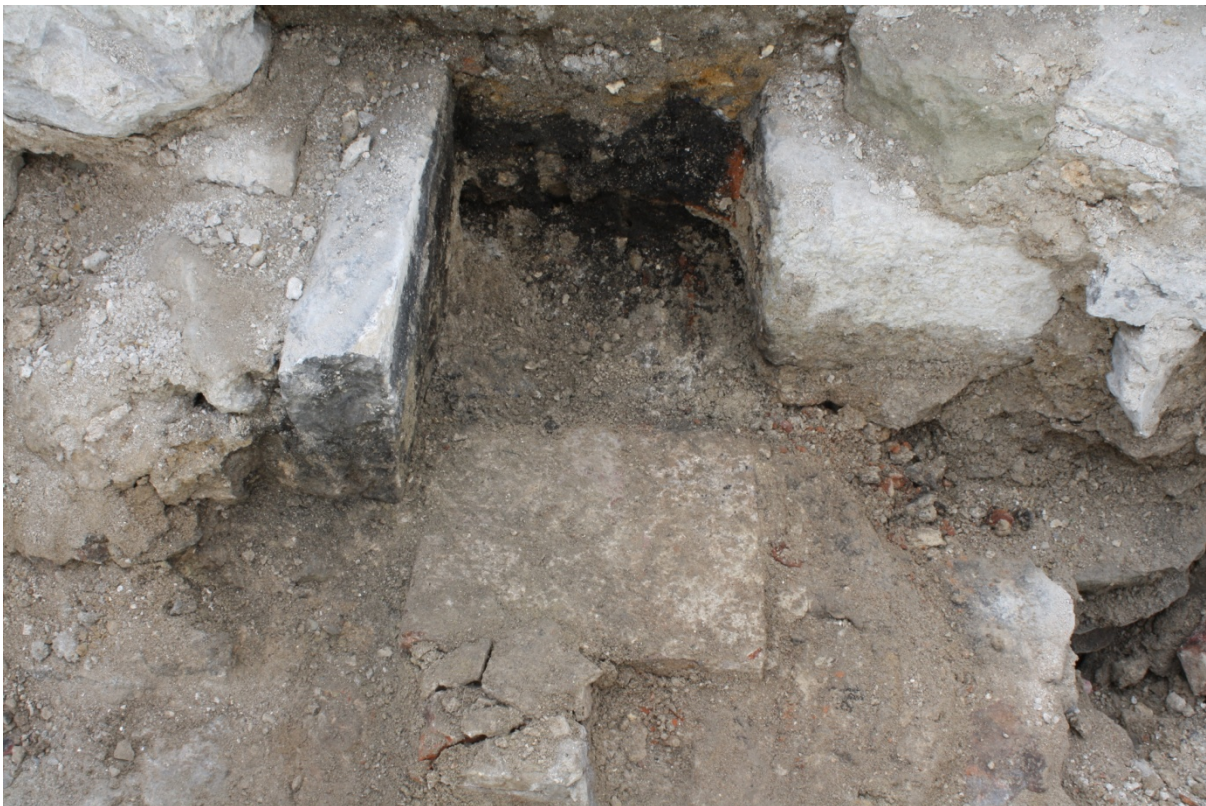
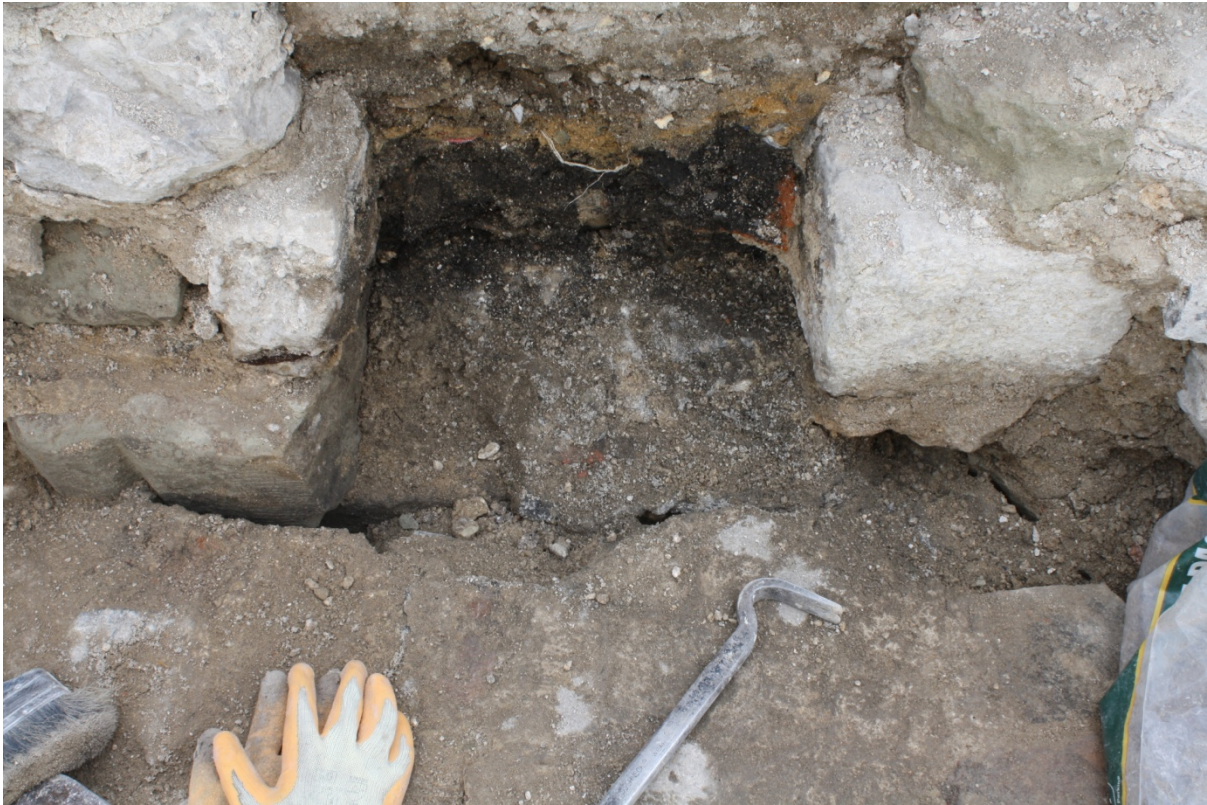
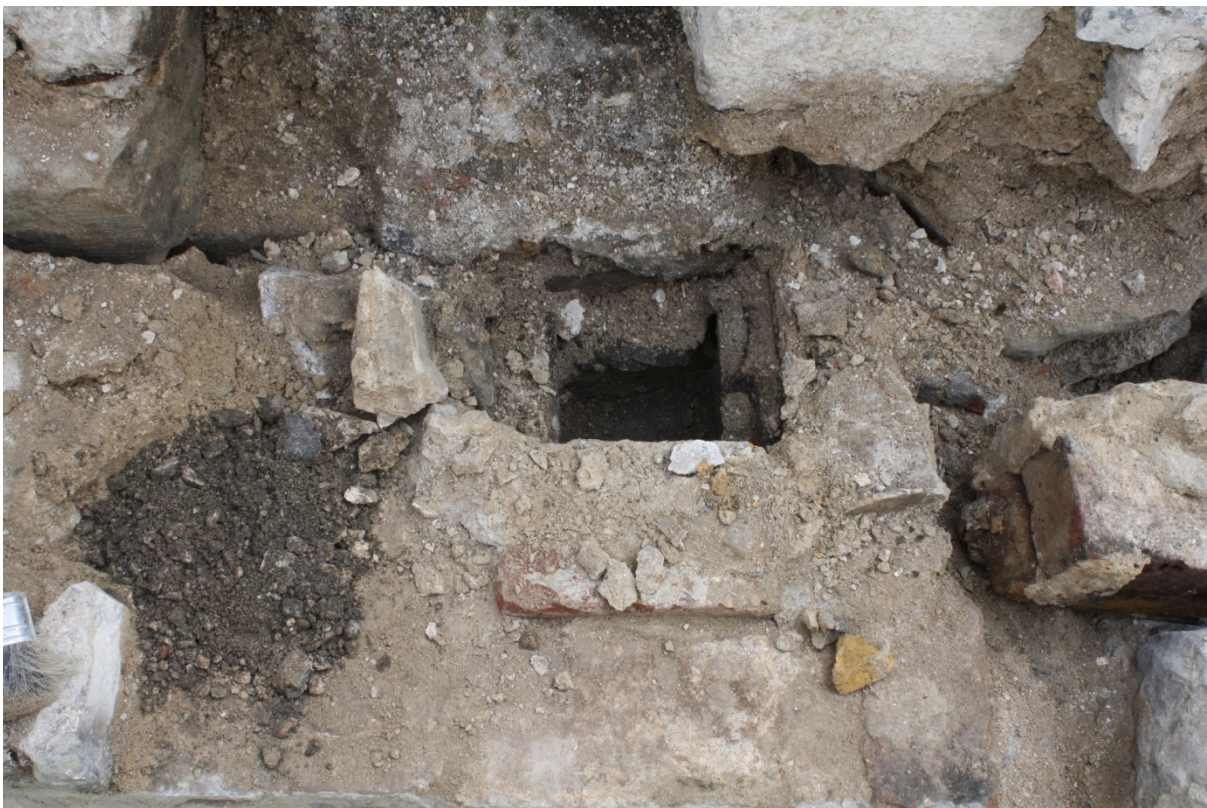
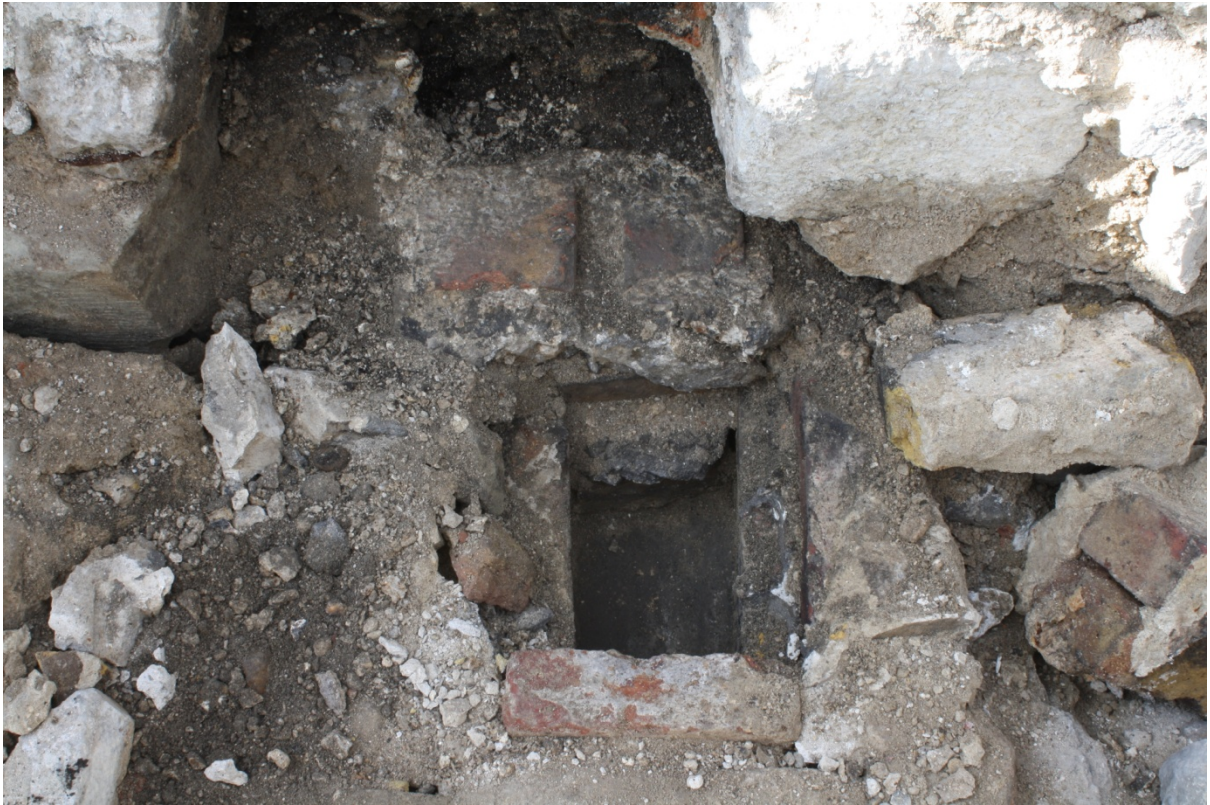
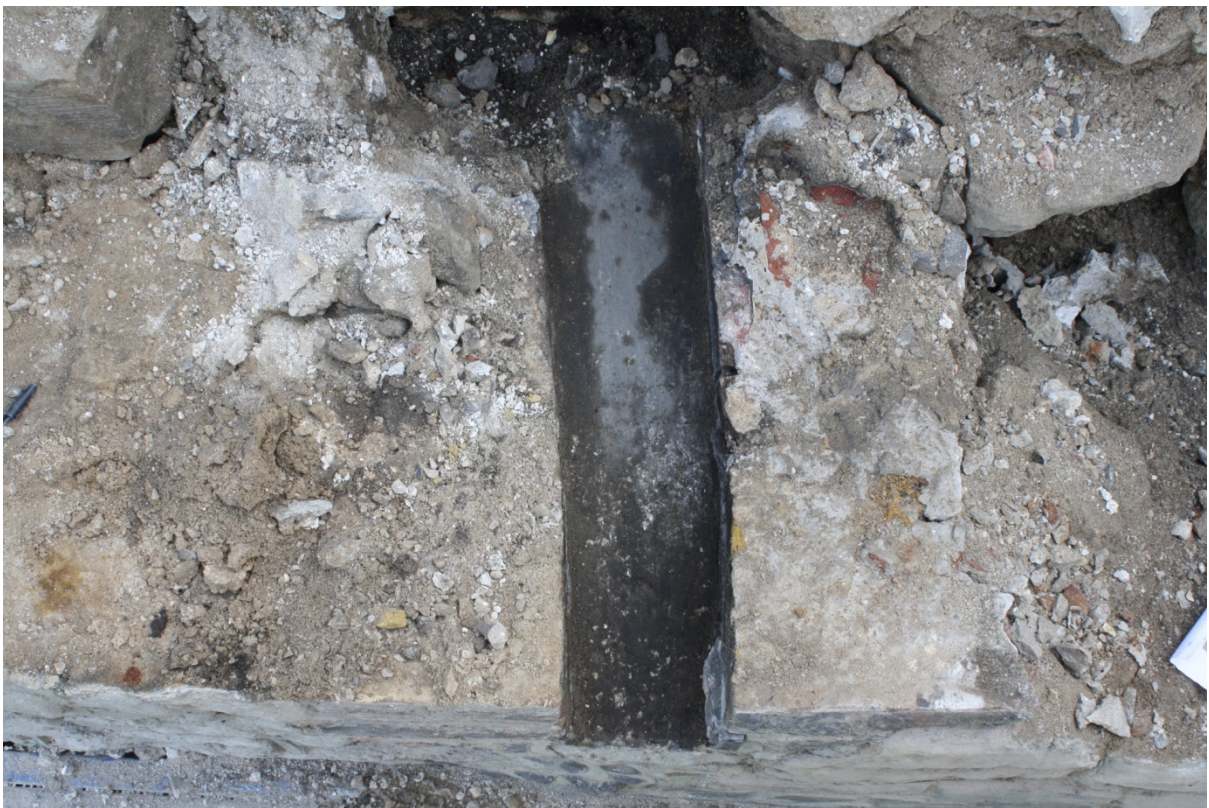
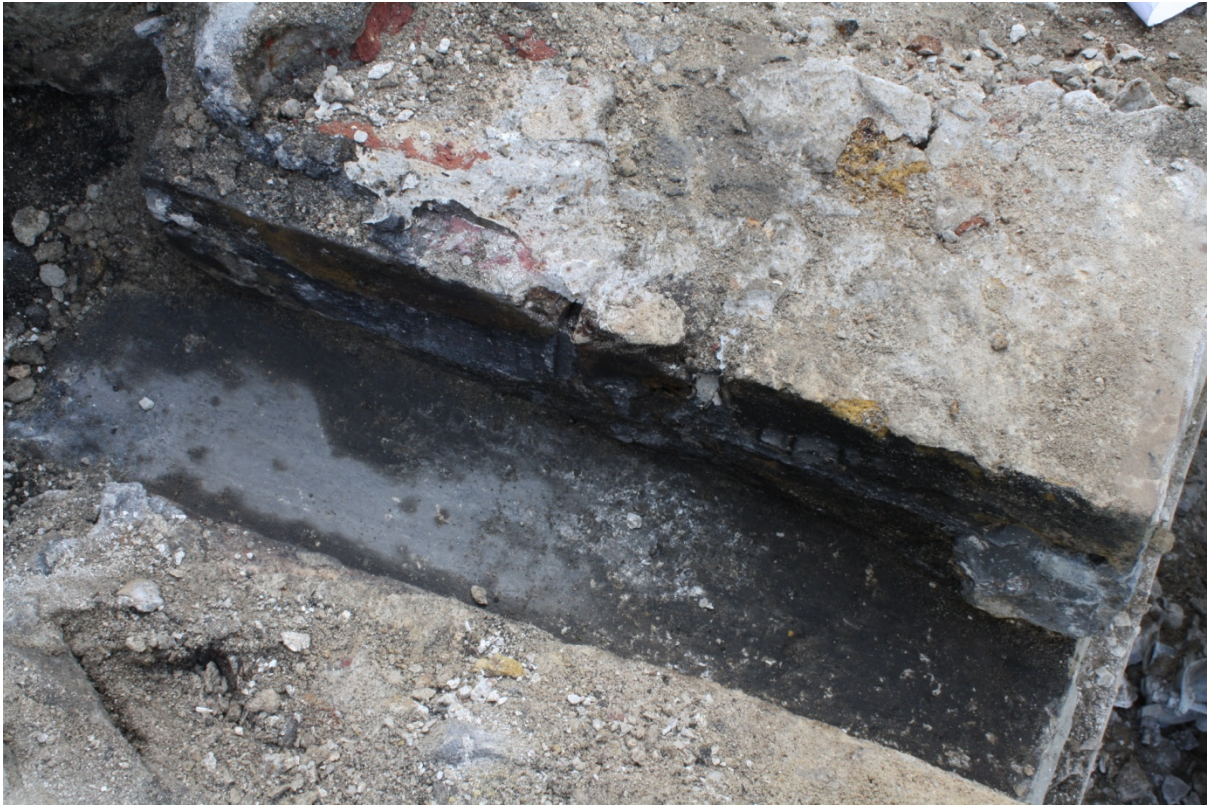
5.2.9 Flue 1 was visible as a patch of brickwork in the north (outer) elevation of the South Moat Wall before it was dismantled (**Figure 3**). The bricks had been re-pointed in a late 19th/20th century Roman cement. During the lowering of the outer face of the wall, the flue became visible in plan (**Plates 16 and 17**). It had been infilled with fragments of clay peg tile and brick. The square flue had been lined with bricks which had been burnt and blackened with soot (**Plates 18 to 21**). The flue was backfilled with a black ash. Towards the base of the flue it became apparent that two bricks in the north elevation of the outer wall had infilled an opening from the flue (**Plates 22 and 23**). A gully carved in a large slab of Purbeck limestone (stone 578; 15kg) appeared to have acted as a drain from the base of the flue to the north elevation of the wall (**Plates 23 to 26**). The narrow red bricks (230 x 95-100 x 63mm; fabric 3032R, 3034R) lining the flue are in keeping with the legislation on brick size from 1780 to 1850. Flue 1 was the only flue to include some yellow London stock bricks (fabric 3035), which date from 1780 to 1940. One of these yellow stock bricks was a large 'special' and formed the lintel of the flue opening in the north elevation of the South Moat Wall (**Plates 22 and 23**). The bricks in the flue lining were bonded in a late 18th/19th century pale cream with clinker mortar.

Plate 16: Plan view of Flue 1, looking down and south

Plate 17: Plan view along the top of the wall during dismantling showing rubble inner core and Flue 1, looking down and south-east

Plate 18: Plan view of Flue 1 during dismantling, looking down and south

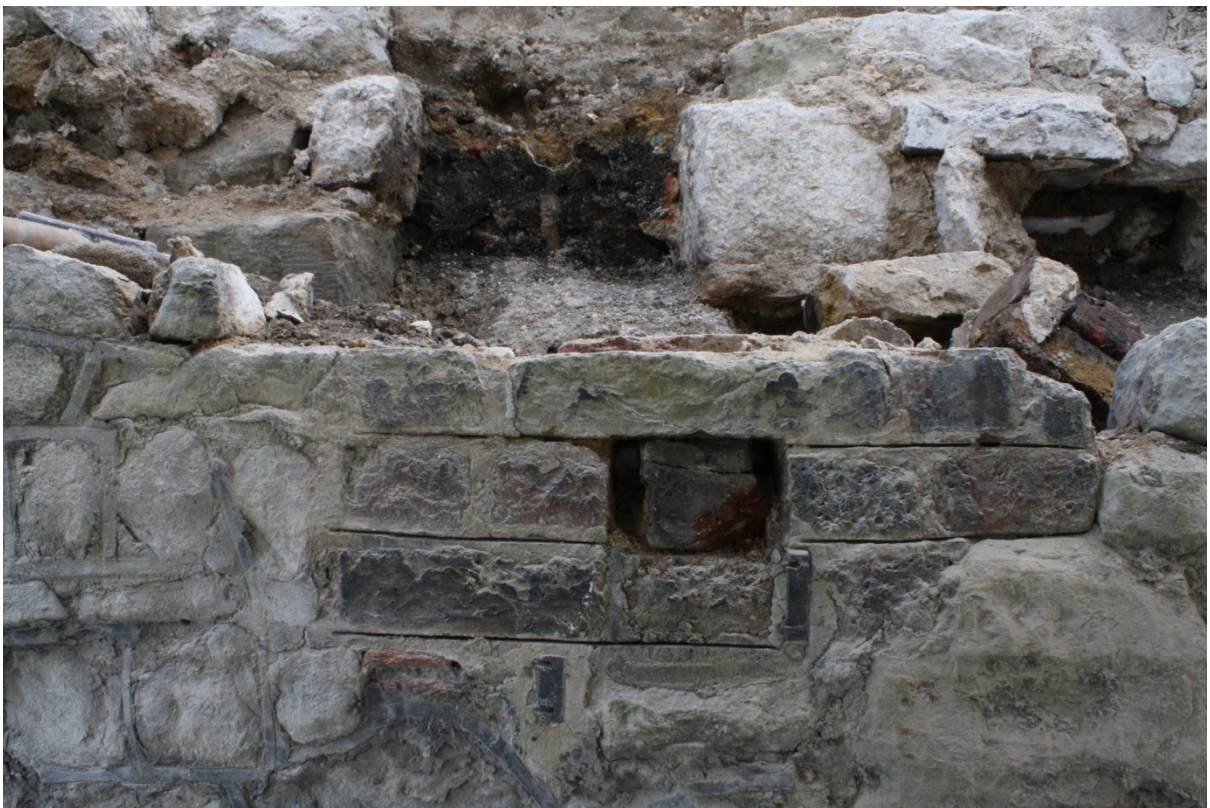
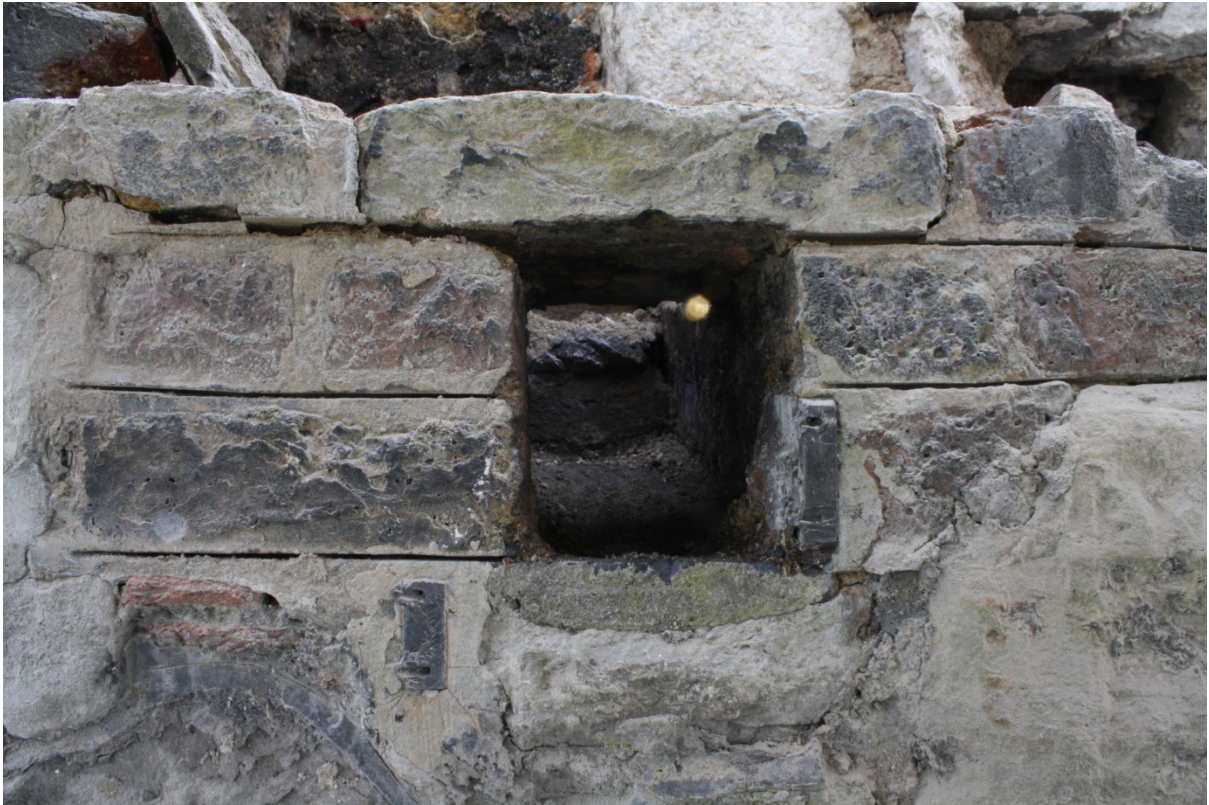
6.1.5 Yellow London stock bricks (fabric 3035 (1780-1940)) were produced from estuarine clays around the mouth of the Medway from the late 18th century onwards. This brick type was only found in the internal facing of Flue 1. One example was frogged. Another was a very large "special" brick used as a lintel for an opening for this flue (**Plates 22 and 23**).

Plate 22: North elevation of Flue 1 during dismantling, looking south

Plate 23: North elevation of Flue 1 during dismantling, looking south

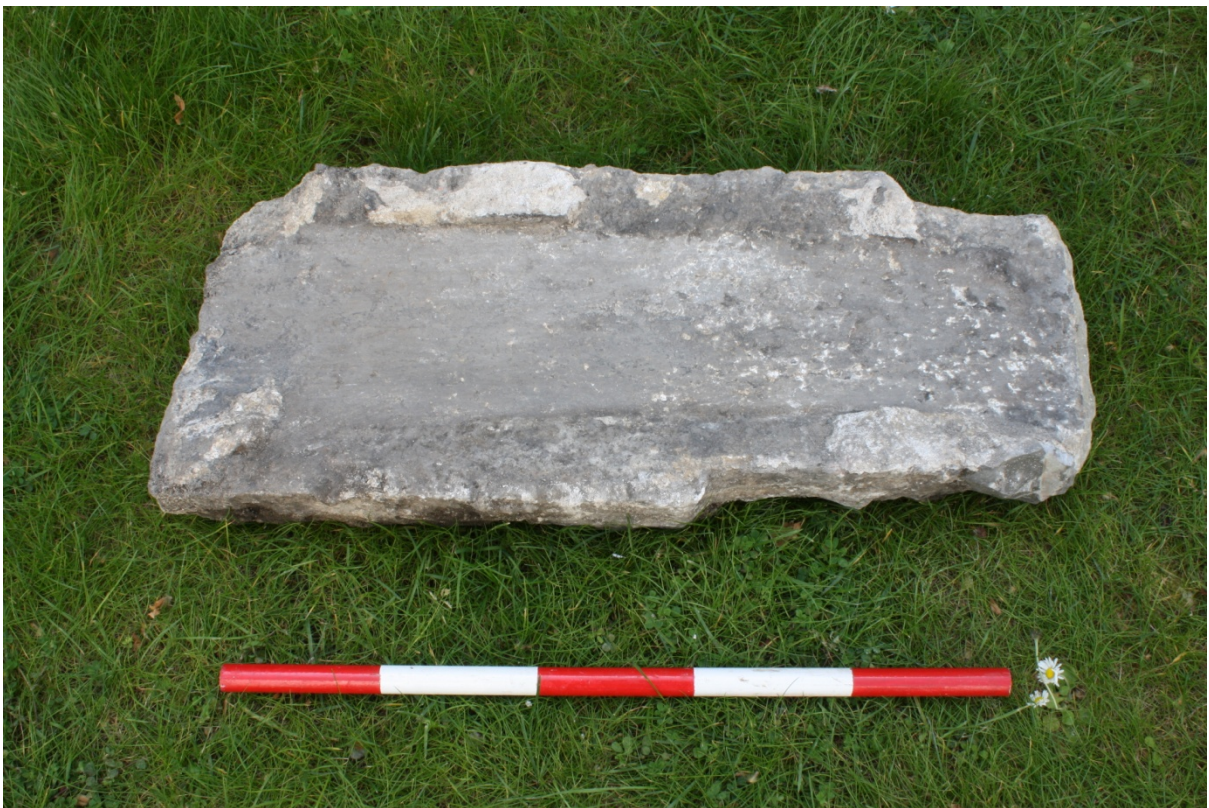
6.2.5 Flaggy slabs/blocks of this fossiliferous limestone were found in the upper 0.4m of the inner core of the recorded South Moat Wall. A large (15kg) flagstone (stone 578) had a carved gully (**Plate 26**). It was found at the base of 19th century Flue 1. Like Portland stone, Purbeck limestone only began to be used in London on a large scale from the late 17th century onwards. This stone type was not found in the lower 1.5m of the inner rubble core.

Plate 26: Plan view of *ex-situ* stone spout at the base of Flue 1 (0.5m scale)

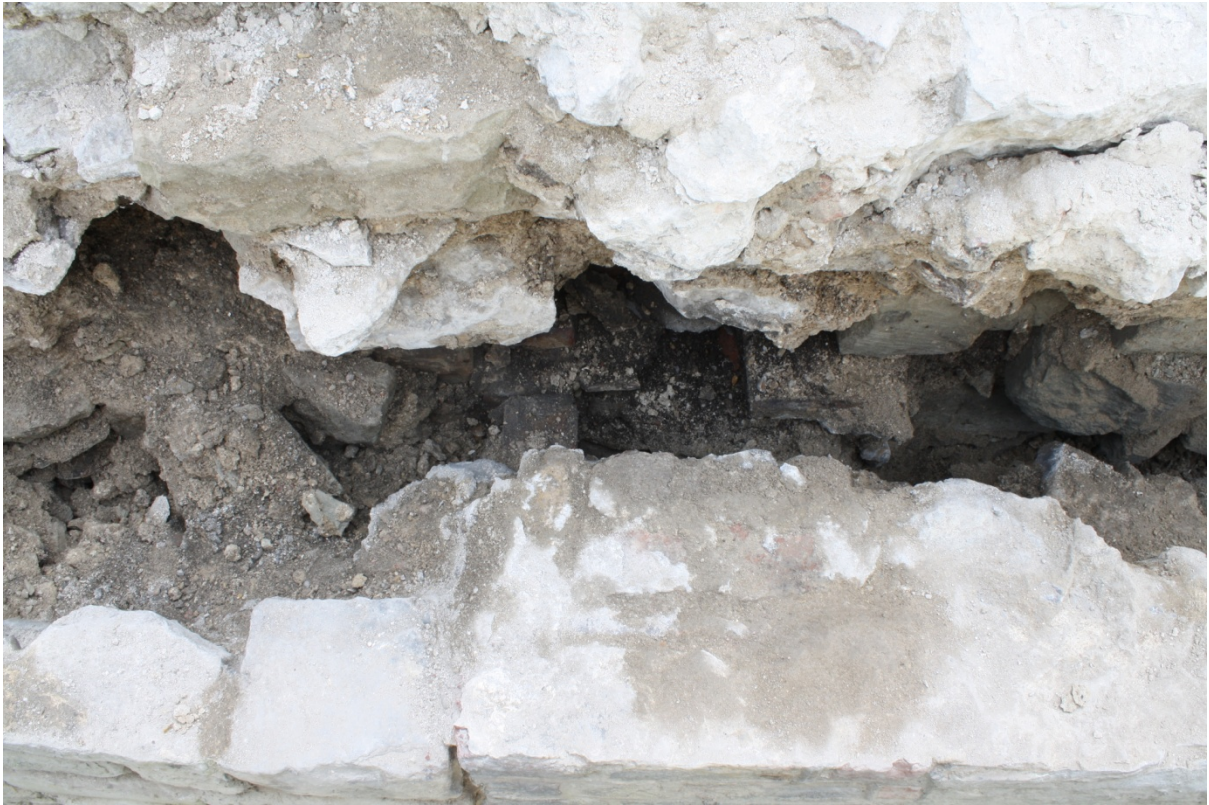
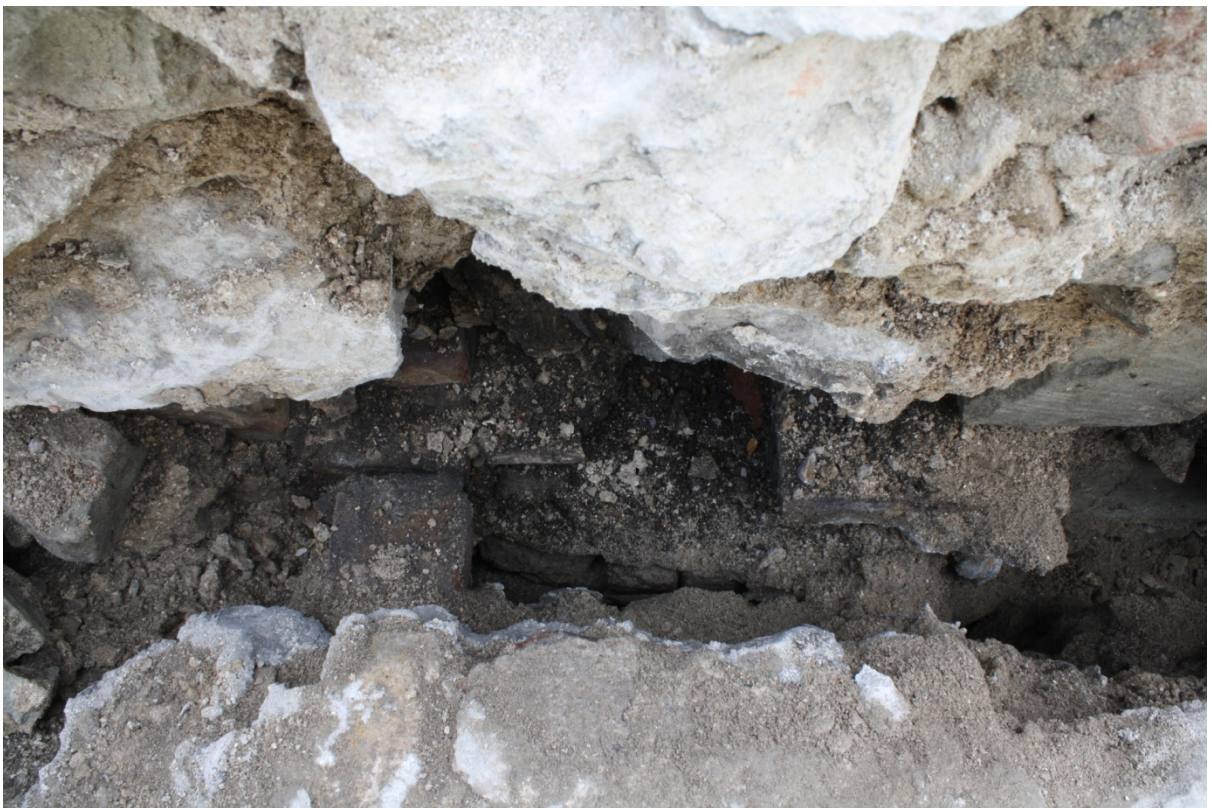
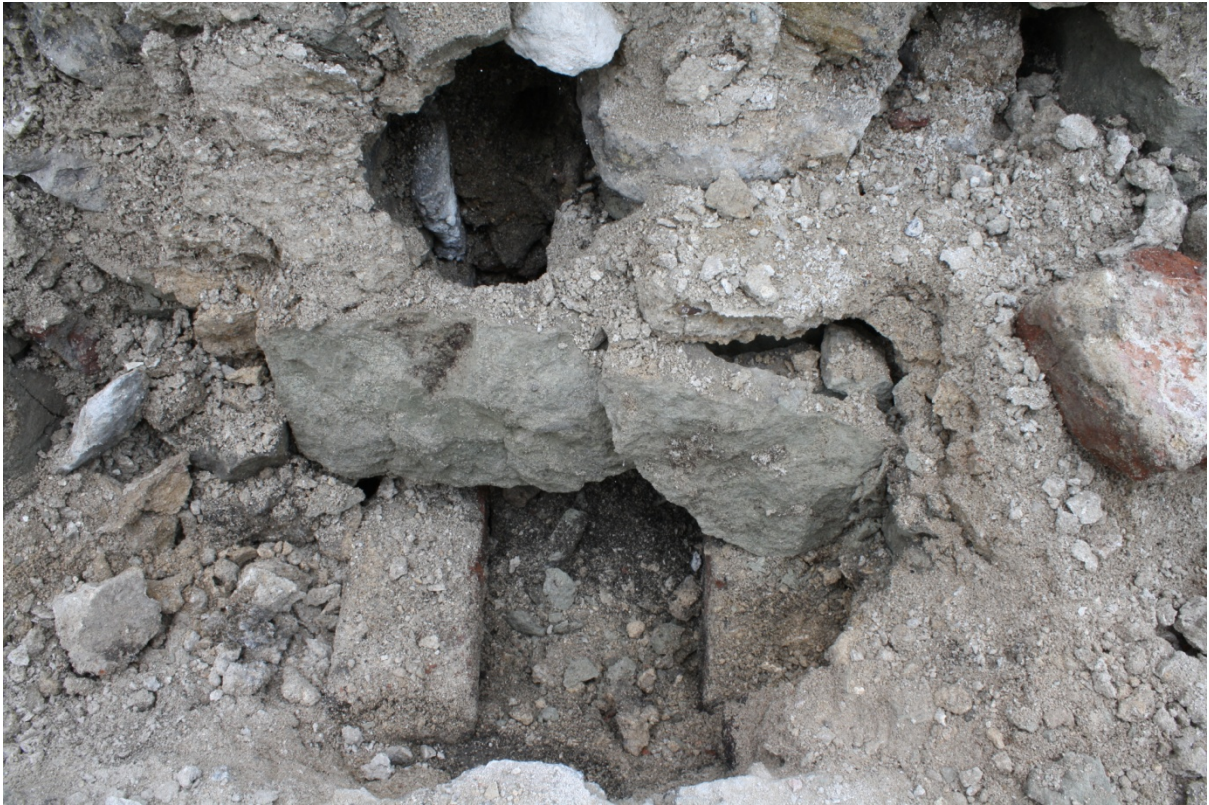
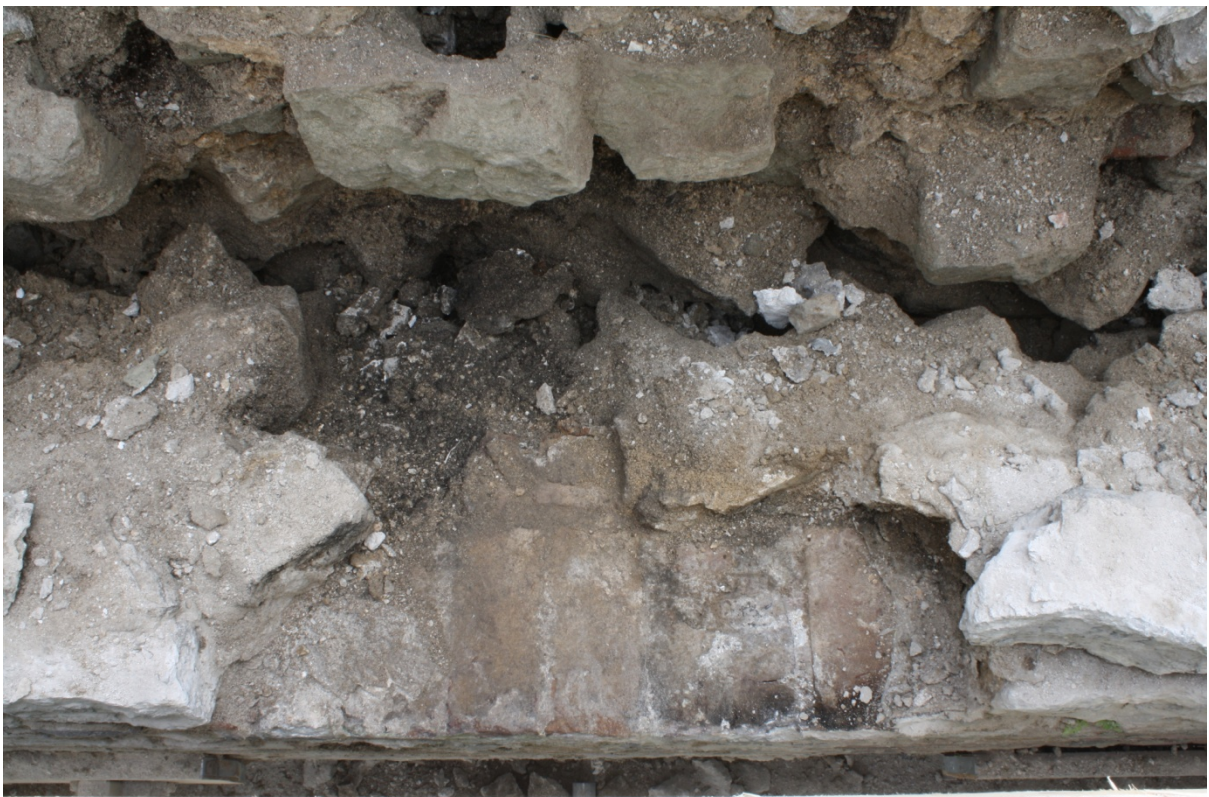
5.2.10 Flue 2 was uncovered towards the centre of the recorded section of the South Moat Wall. It was again first identified in plan within the inner core of the wall during the dismantling of the outer face of the wall (**Plates 27 and 28**). This flue was also lined with bricks and filled with black ash (**Plates 29 and 30**). The red bricks were in fabric 3032R and 3034R as in Flue 1 and some narrower bricks were also found above Flue 2. The flue had been constructed in the same late 18th/19th century mortar as Flue 1.

Plate 27: Plan view of Flue 2 during dismantling, looking down and south

Plate 28: Plan view of Flue 2 during dismantling, looking down and south

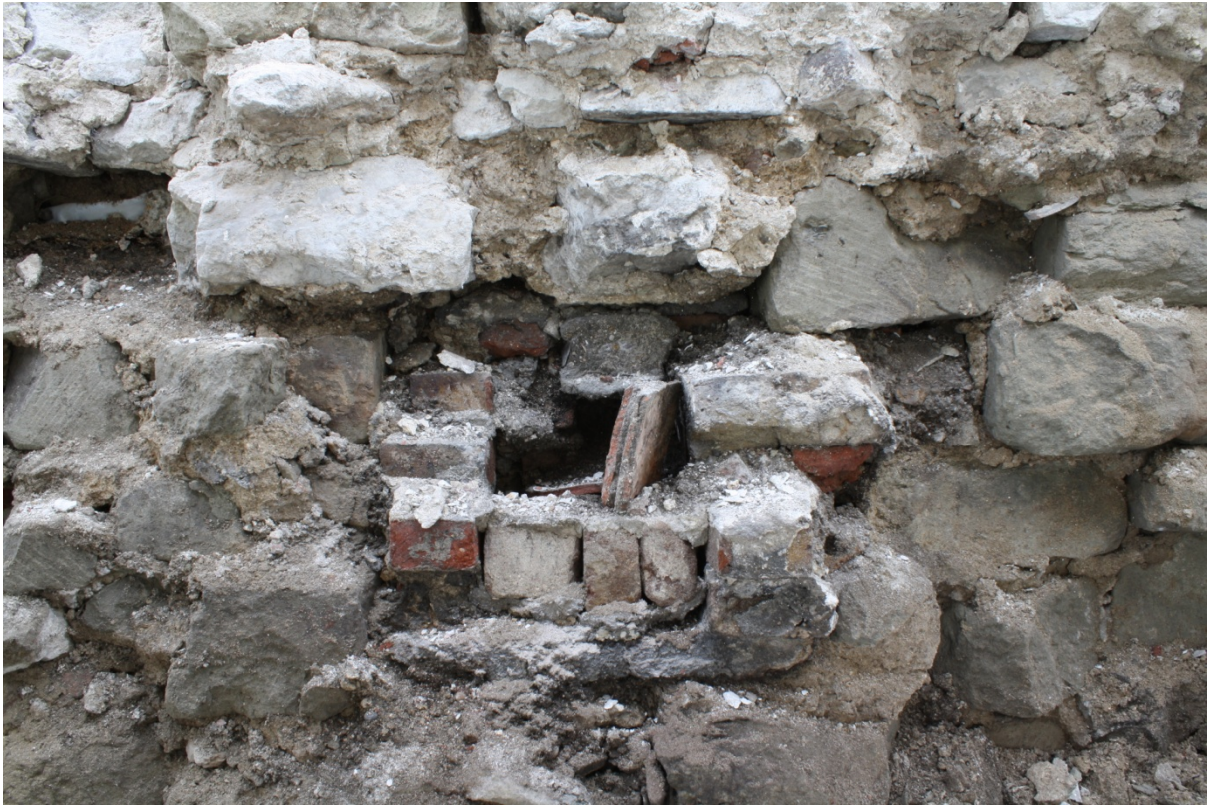
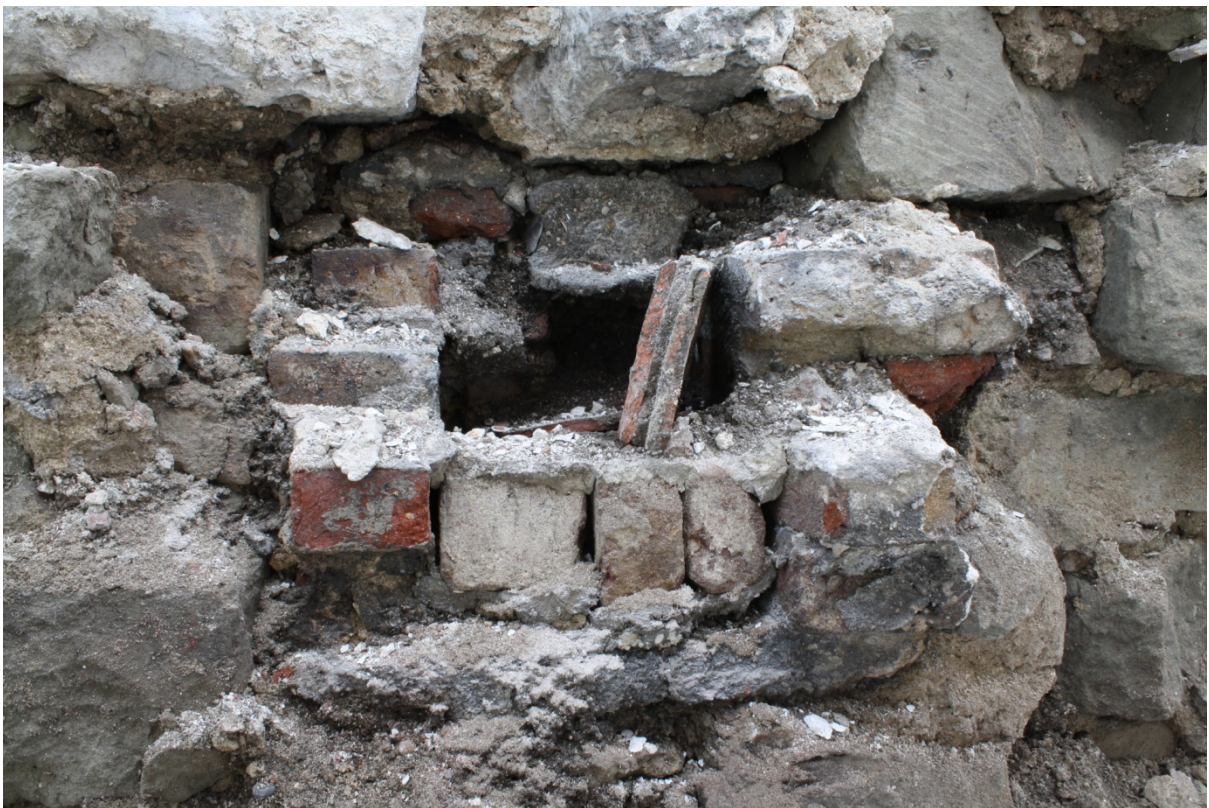
Plate 31: Flue 3 during dismantling, looking south

Plate 32: Flue 3 during dismantling, looking south
