**Flag Fen STW BAFF Plant
Scheme: An Archaeological
Watching Brief**

August 2014

Commissioning Client: Anglian Water

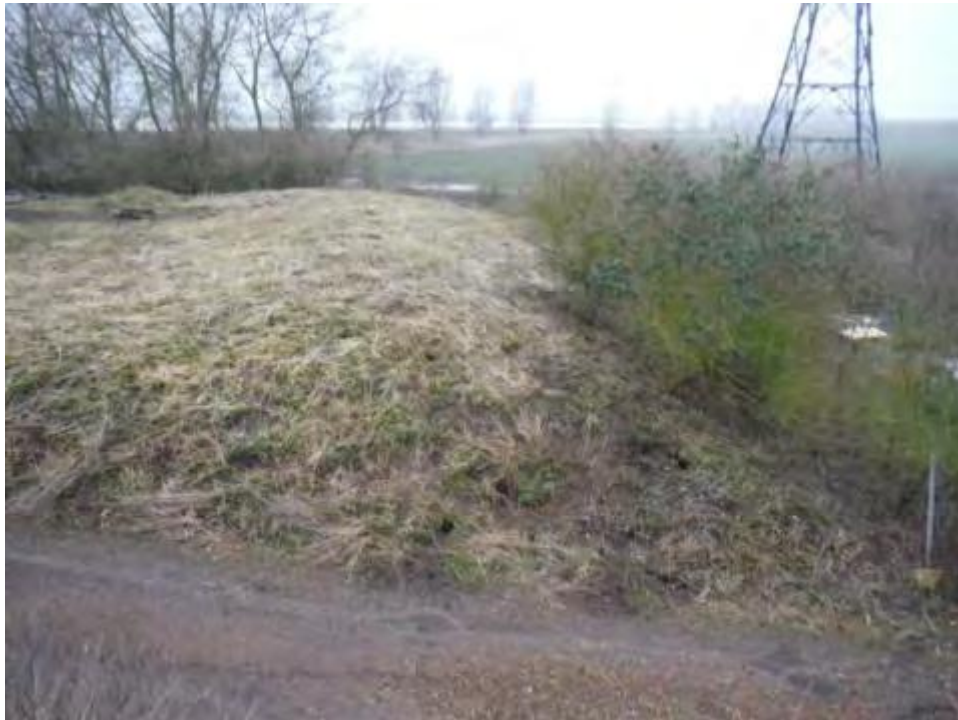
Plate 1: The location of the deep bed sand filter overlain by a modern soil bank.

- 7.2 The archaeological monitoring of the area for the new sand filtration bed showed that this area had previously been landscaped with the introduction of a considerable deposit of made ground to form an upstanding bank along the southern site boundary.

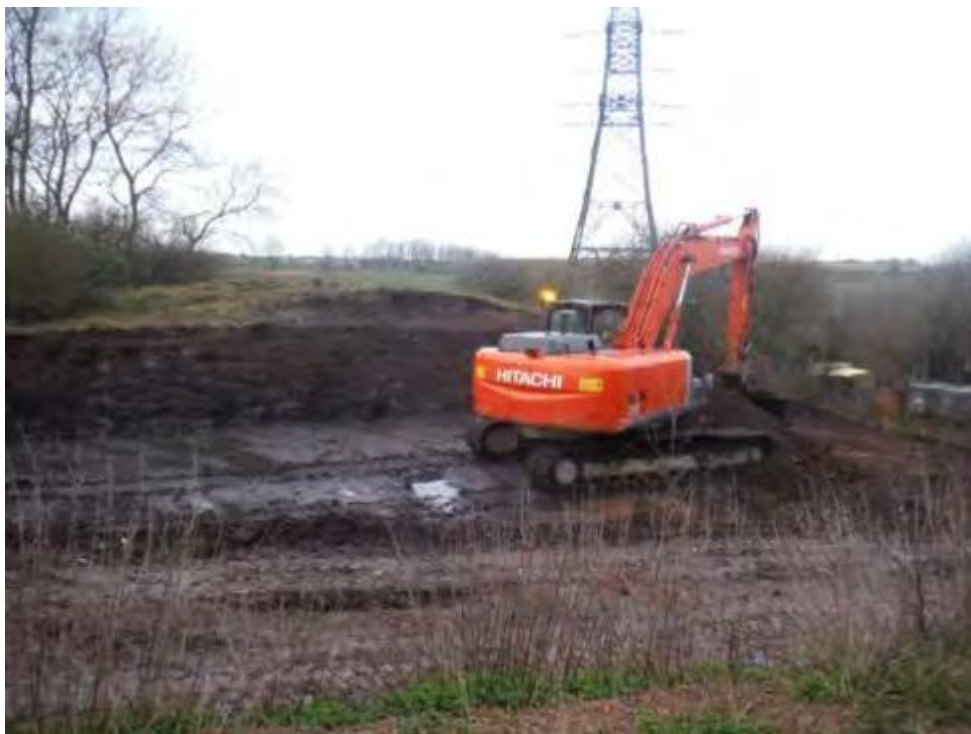
Plate 2: Initial removal of modern overburden looking NW.

- 7.3 The removal of this modern-deposited soil, which measured between 3.4m to 3.8m in depth, preceded the excavations for the foundations of the deep bed sand filter. These subsequent excavations uncovered undisturbed fen deposits of peat (6), at a depth of 1.76m AOD, which included organic material (wood and roots) and a partial red deer skeleton.

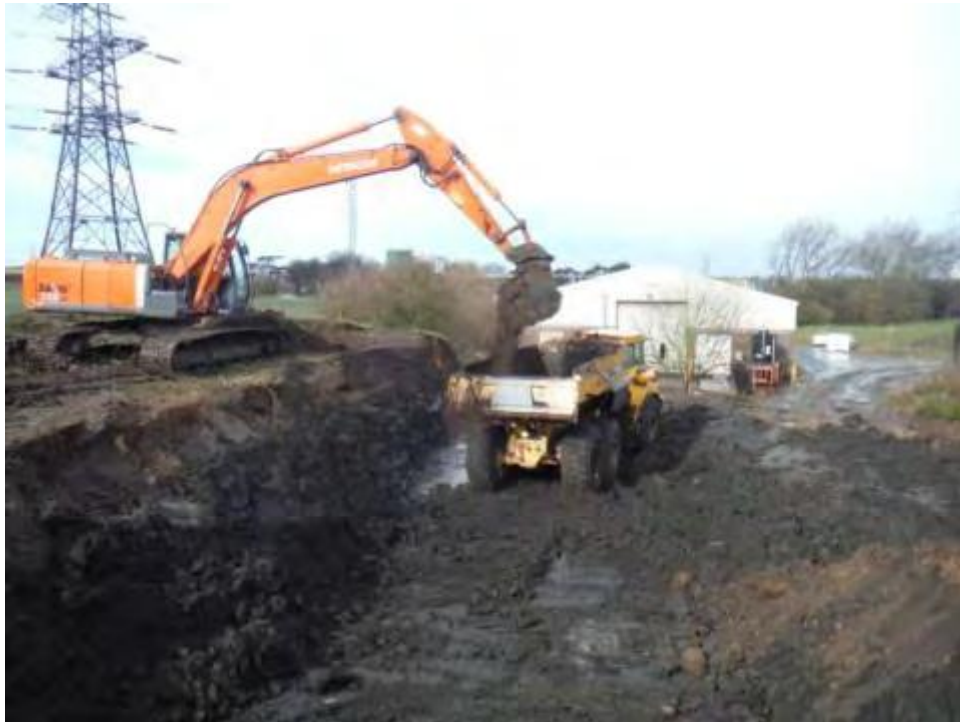
Plate 3: Ground reduction in area of deep sand bed, looking N

5.2.1 The foundation pit was excavated to the southwest of the existing plant, and measured approximately 41m by 29m. A low mound of modern made ground was located within the excavated area and subsequently removed during groundworks. The stratigraphic sequence subsequently comprised around 3.4m-3.8m of modern made ground overlying the fen deposits. No topsoil or subsoil were revealed during the strip; the made ground directly overlay peat (6), which survived to a maximum thickness of 1.2m and which in turn overlay fen clay (7). Below this, the natural geological horizon comprised a firm orange sandy gravel (9). The base of the sequence was situated at a height of -0.24m AOD.

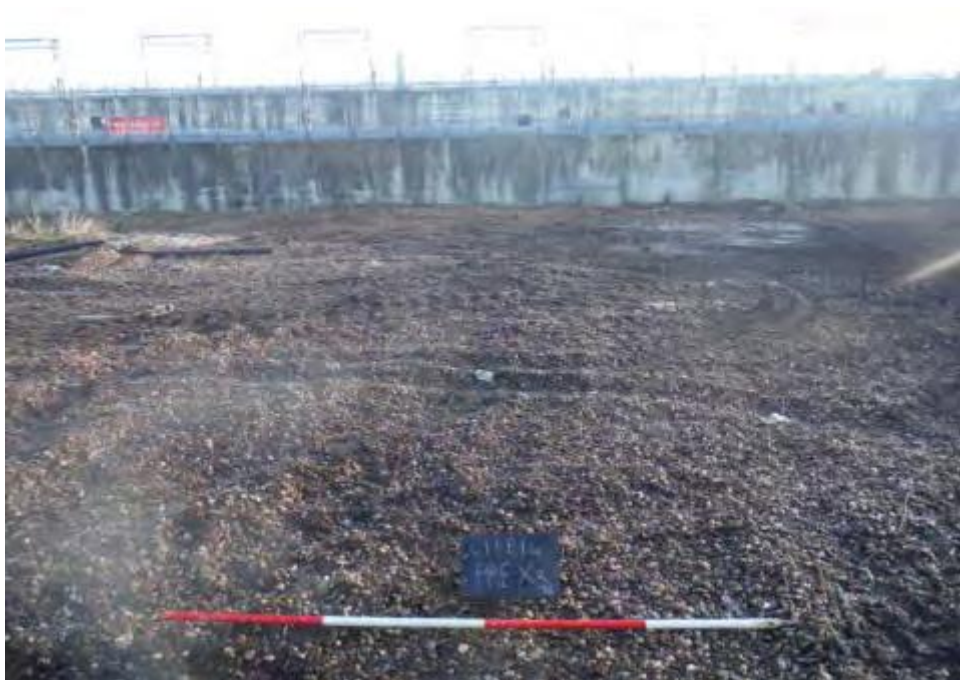
Plate 4 Pre-excavation looking north east toward water treatment tanks

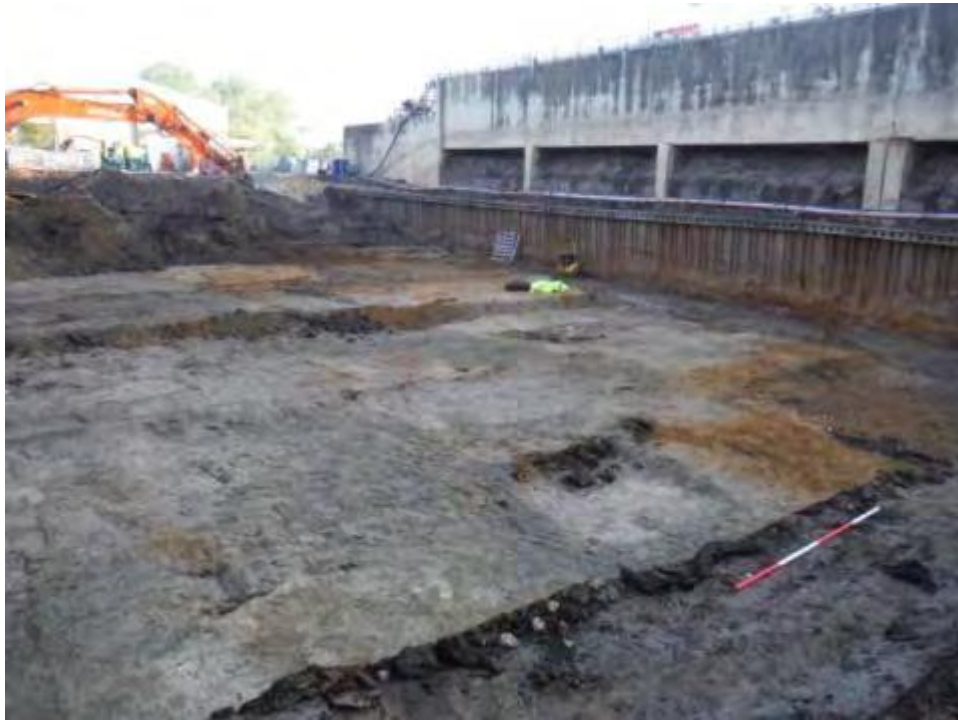
Plate 5 Showing grey clay marine deposit context 7

5.2.3 The fen clay (7) was seen to overly the gravel substrate across the whole excavated area. Two flint flakes were found within this deposit – a partial core fragment and a blade, likely of later Mesolithic/early Neolithic date (see Bishop, Section 6.1). This small assemblage highlights the potential for earlier prehistoric activity, however the flints were associated with marine-deposited clays and could have feasibly been transported from their original

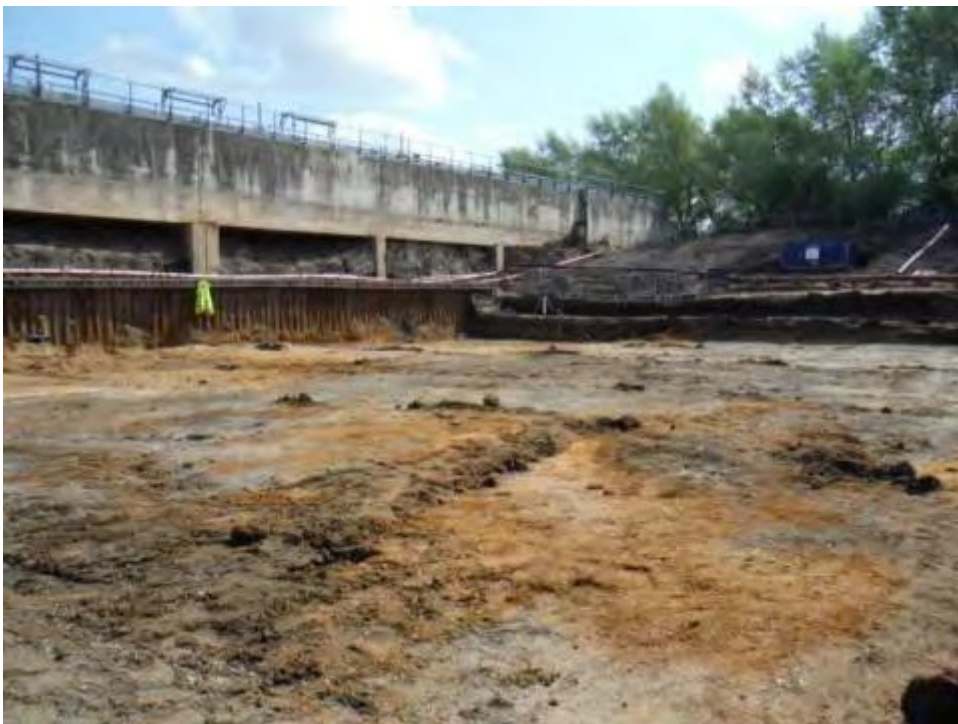
Plate 6 Final excavation level showing terrace gravels looking SE

- 7.5 A single posthole was likely to have been cut from higher in the stratigraphic sequence, although was only clearly visible cutting the lower terrace gravels, beneath the fen deposits. The lack of a surviving post suggests it may have been intentionally removed and the suspected relationship of the posthole to the fen deposits suggests it is also likely to be modern. The river terrace gravels were encountered at an elevation of -0.24m AOD.

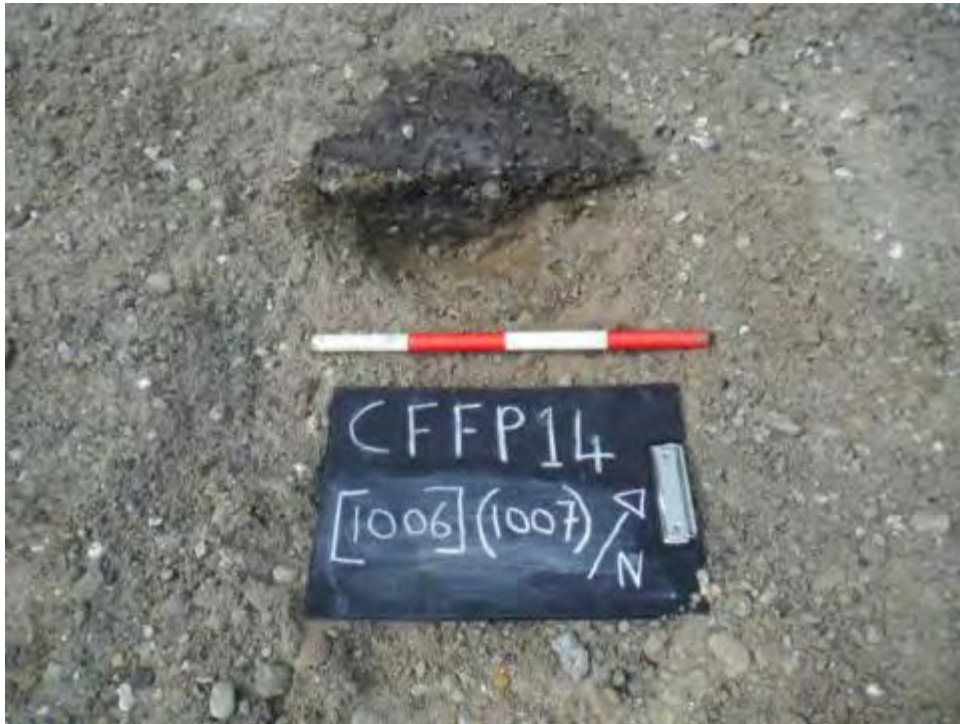
Plate 7 Post-hole 1006 looking NW

5.2.4 Upon removal of the clays, a small posthole [1006] was identified cutting the surface of the gravel. The presence of peat within the posthole fill (1007) indicates that the posthole was cut from higher within the stratigraphic sequence, although this cut was not clearly visible within the overlying clay and peat. The presence of the peat fill within this posthole suggests the feature post-dates the formation of the peat. Furthermore, the lack of survival of the post in such optimum preservation conditions suggests the post was deliberately removed.

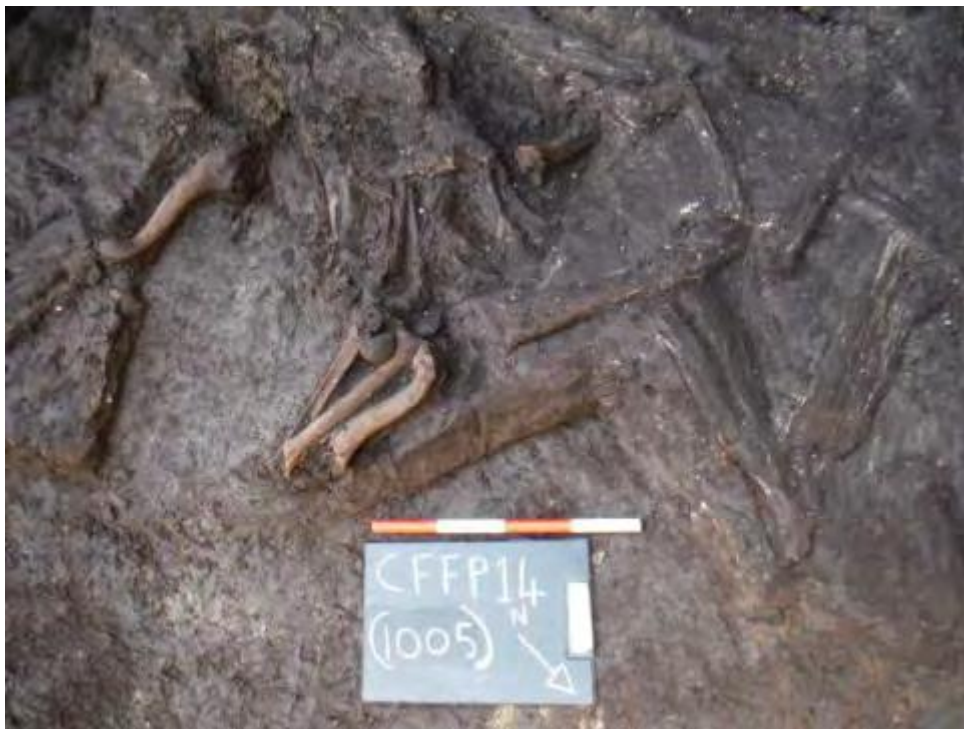
Plate 8 Animal Bone within fen peat (6) overlying the clays (7)

5.2.2 Within the fen peat, several pieces of unworked wood (partial branches and root fragments) were visible. None of these pieces displayed tool marks and the wood did not form a coherent structure of landscape feature. Within a small area to the northwest of the excavated pit, an assemblage (1005) of disarticulated red deer bones (seemingly from the same individual) and a probable curlew bone were found (see Rielly, Section 6.8), located within the peat deposit (6).

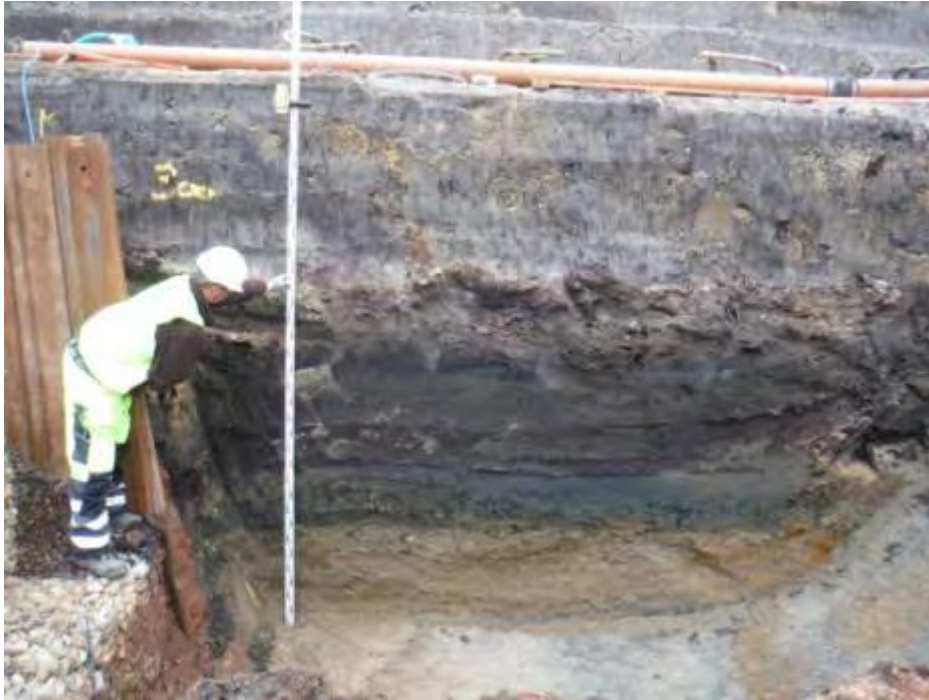
Plate 9 Showing stratigraphic sequence of modern soils, fen peat, fen clays and river terrace gravels.

- 8.1 The monitoring at the BAFF sewer works identified a typical stratigraphic sequence comprising modern soils, fen peat, fen clays which in turn overlay the terrace gravels. No remnant buried soils were identified during the groundworks. No worked wood fragments were found within the peats and the partial red deer skeleton did not display signs of butchery or human agency. The two flints recovered from the fen peat/clay interface were of comparable material, however the level of patination differed on each piece suggesting they have been found in a residual context.
- 8.2 No evidence for archaeological activity was identified during the monitoring at the BAFF plant.

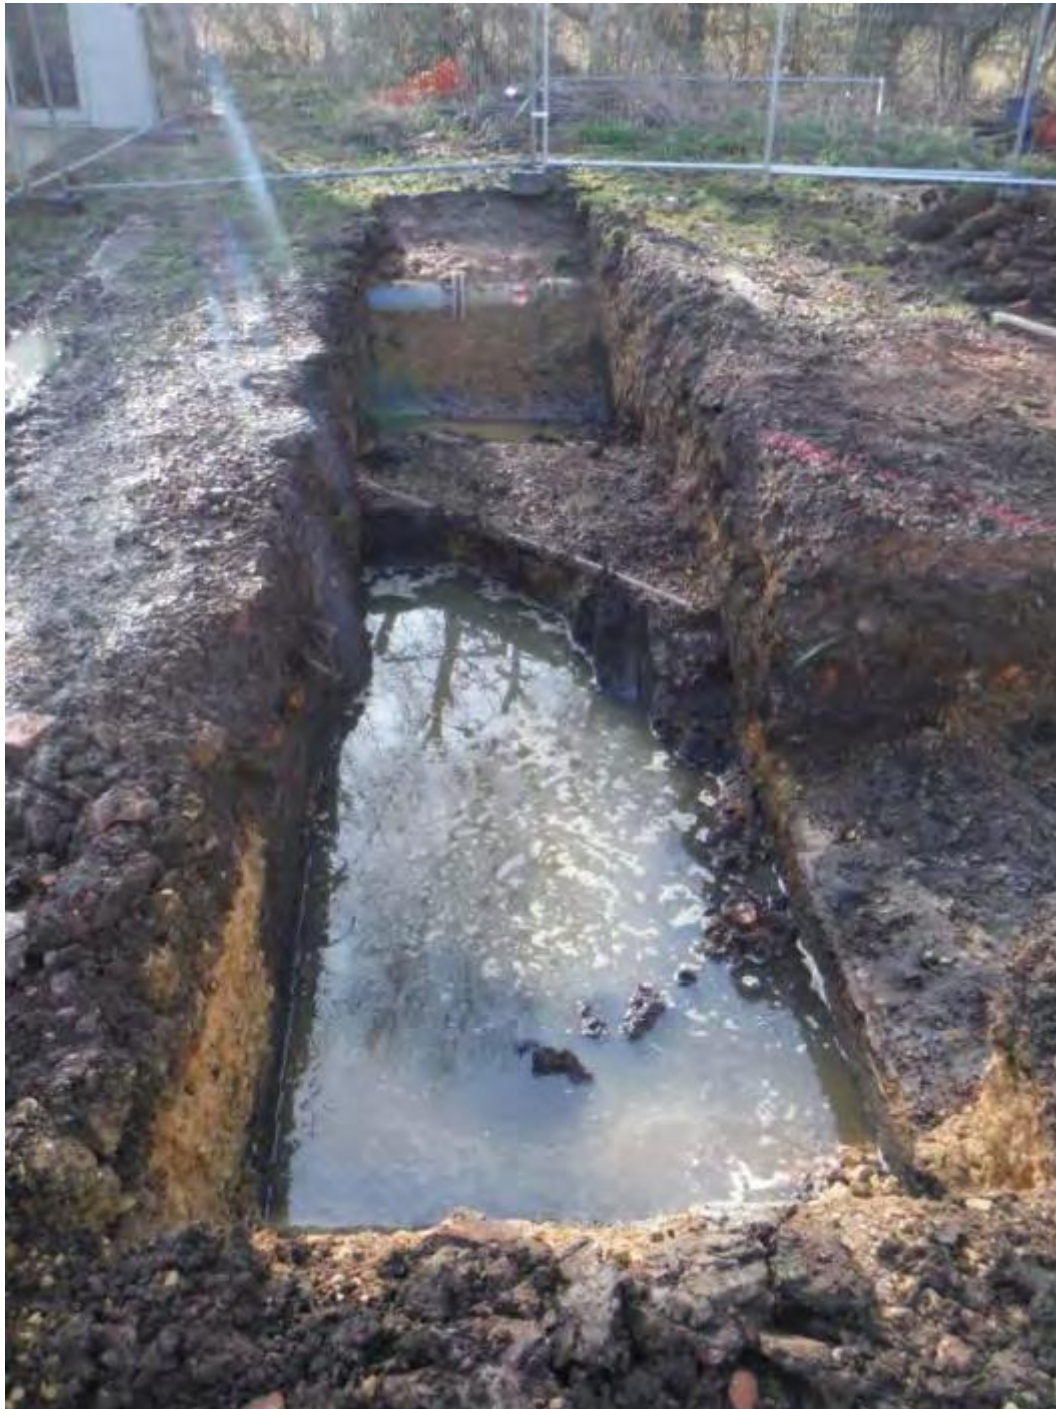
Plate 10 Looking south along initial trench (Trench 1). Modern disturbance and pipes visible in the background.

5.3.2 The first section of trench (Trench 1) was aligned north-south orientation and measured 7.5m in length, 1.5m in width and was excavated to a depth of 1.5m below present ground level. Several modern pipes and pipe trenches were revealed. The ground had been significantly disturbed in this area and the fen deposits overlying the geological substrate were largely replaced by modern made ground, although the geological horizon had seemingly not been impacted upon.

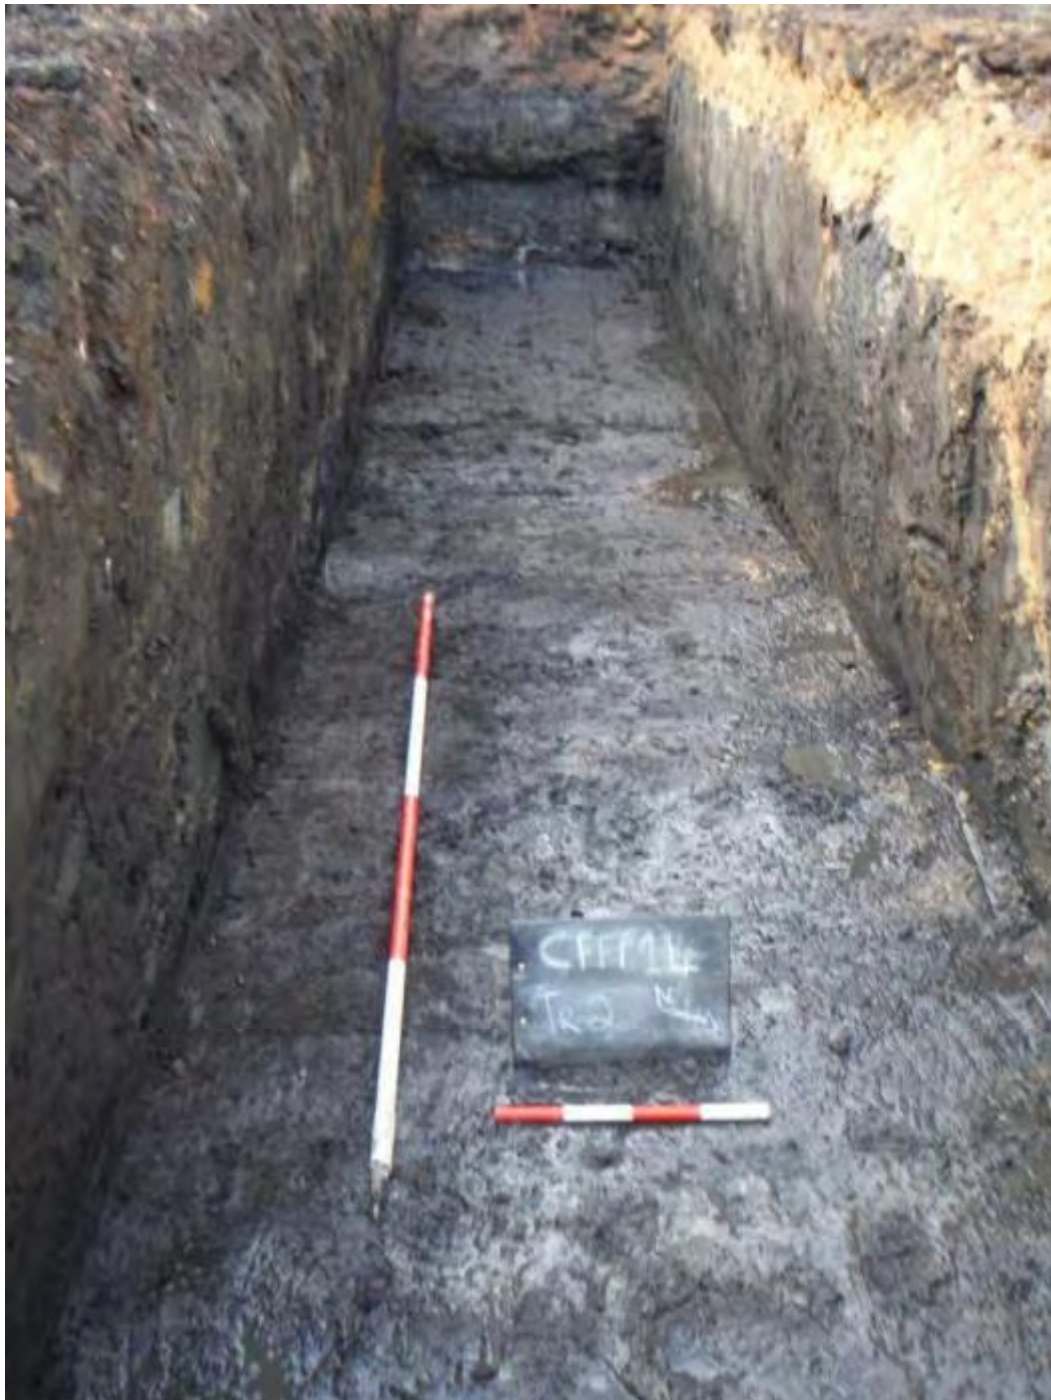
Plate 11 Second trench (Trench 2) looking SW

5.3.3 The second section of trench (Trench 2) was excavated along the south of the existing BAFF structure. The trench measured 10.7m in length, 1.5m in width and was excavated to 1.5m below present ground level. No services were revealed within this portion of trench, and the fen deposits remained largely intact. The upper 0.4m comprised modern hardcore, which directly overlay the fen peat. The peat deposit was very thick in this area and extended to the depth of the excavated trench. recognised at the surface or during the excavation of these soils. No archaeological finds or deposits were found in either trench.
