BEAUREPAIRE HOUSE,
BRAMLEY, HAMPSHIRE

ARCHAEOLOGICAL
EVALUATION REPORT

REPORT NO: R11804

AUGUST 2014

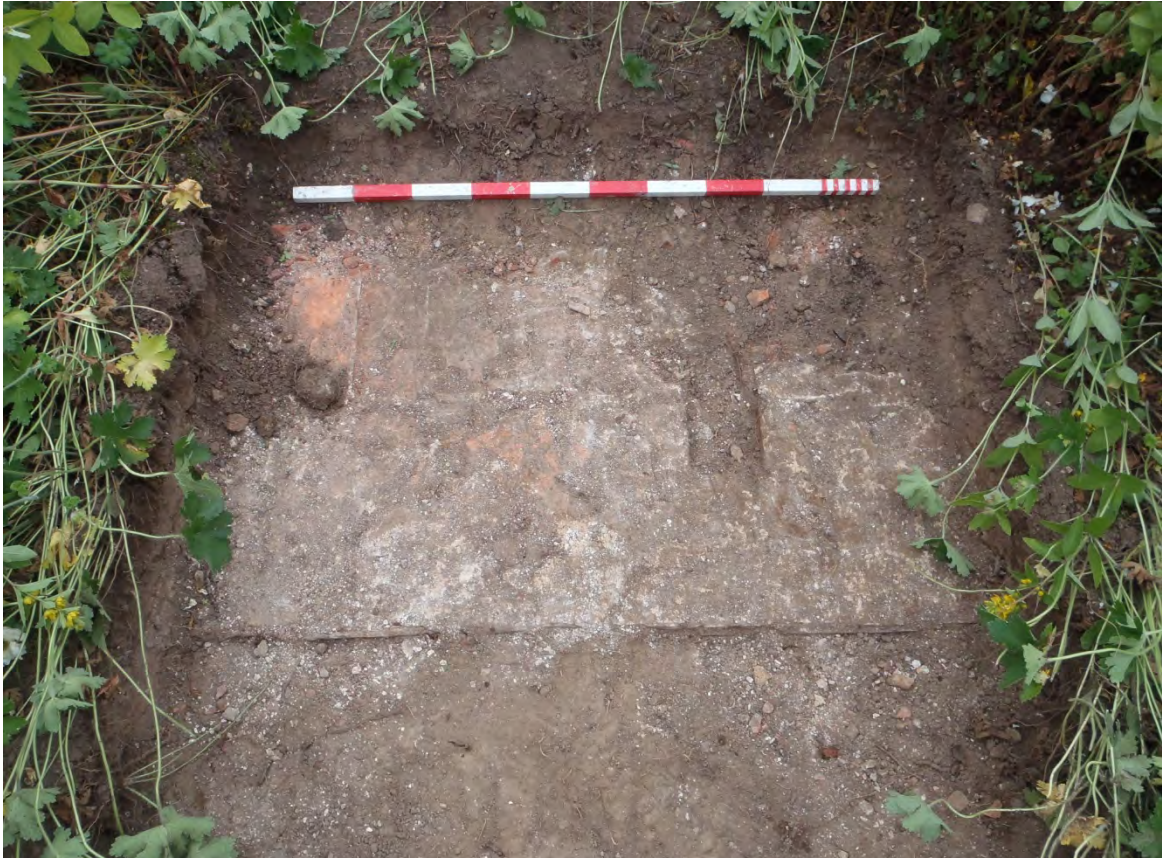
Plate 1 East facing plan shot of wall [1]

5.4.2 Elements of the eastern, western and southern exterior walls ([1], [4]/[27] and [12]) were identified. Wall [1] (**Plate 1**), was found towards the eastern end of trench 1 and was approximately 0.62m wide. Wall [12] (**Plate 7**), found in trench 2 running east-west, was approximately 0.71m wide. A small section of wall, on the southern face of wall [12] projected at a 45° angle into the eastern baulk of trench 2 and appears to be a remnant of the south-eastern tower of the 18th century villa. Wall [4]/[27] (**Plate 11**) found in trench 1 running north-south, had been heavily truncated, was comparatively less substantial than either wall [1] or [12].

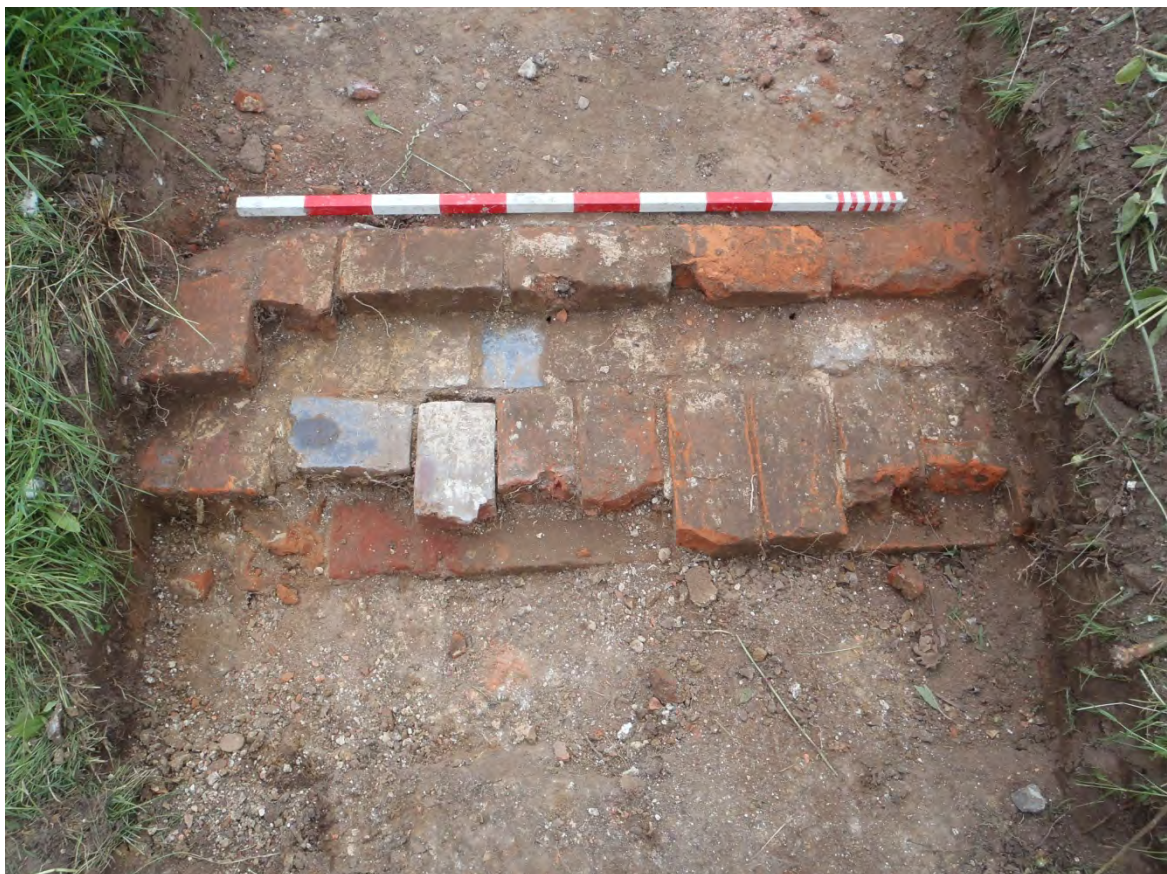
Plate 2 East facing plan shot of wall [2]

5.4.3 The internal faces of walls [1], [12] (**Plate 8**) and [2] (**Plates 2 & 3** - a wall identified in trench 1, running north-south, in between [1] and [4]), were all plastered and appeared to define a cellar underneath the 18th century villa. It had been backfilled with brick rubble [14].

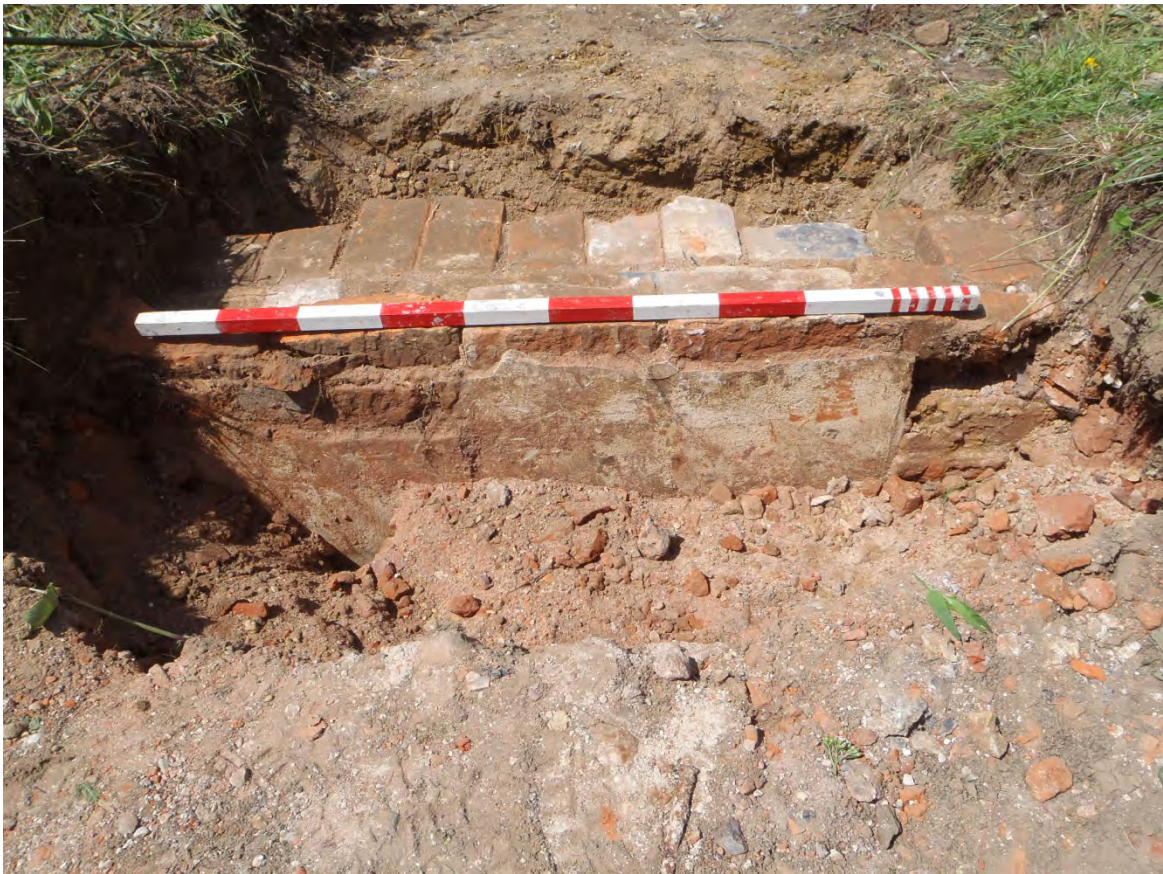
Plate 3 West facing oblique shot of wall [2]

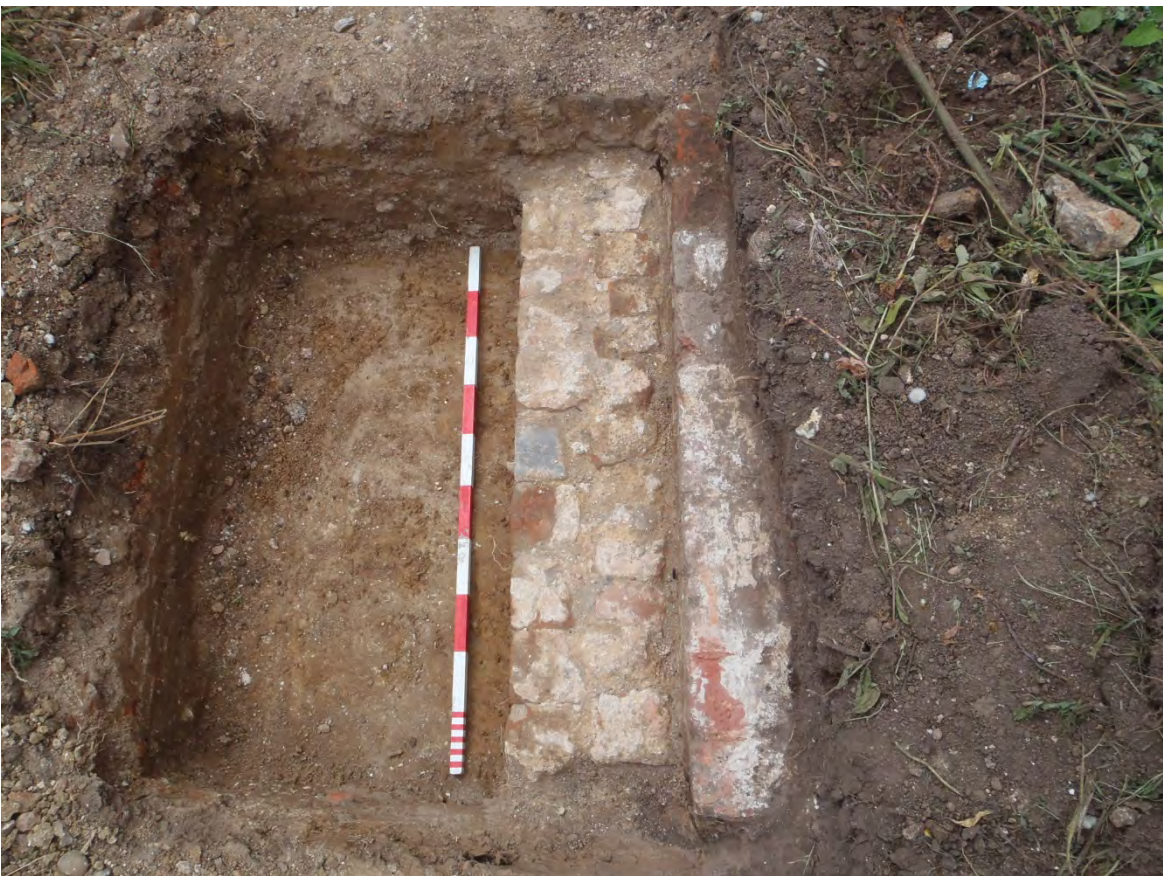
Plate 4 West facing plan shot of [3]/[16]

5.4.4 The brick built structural element [3]/[16] (**Plates 4 & 5**), identified in trench 1, appears to correspond with an internal entrance or doorway that is depicted on the plan of the 18th century villa (**Figure 3 & 5**). It comprises of two, stepped, courses and appeared to represent a single step.

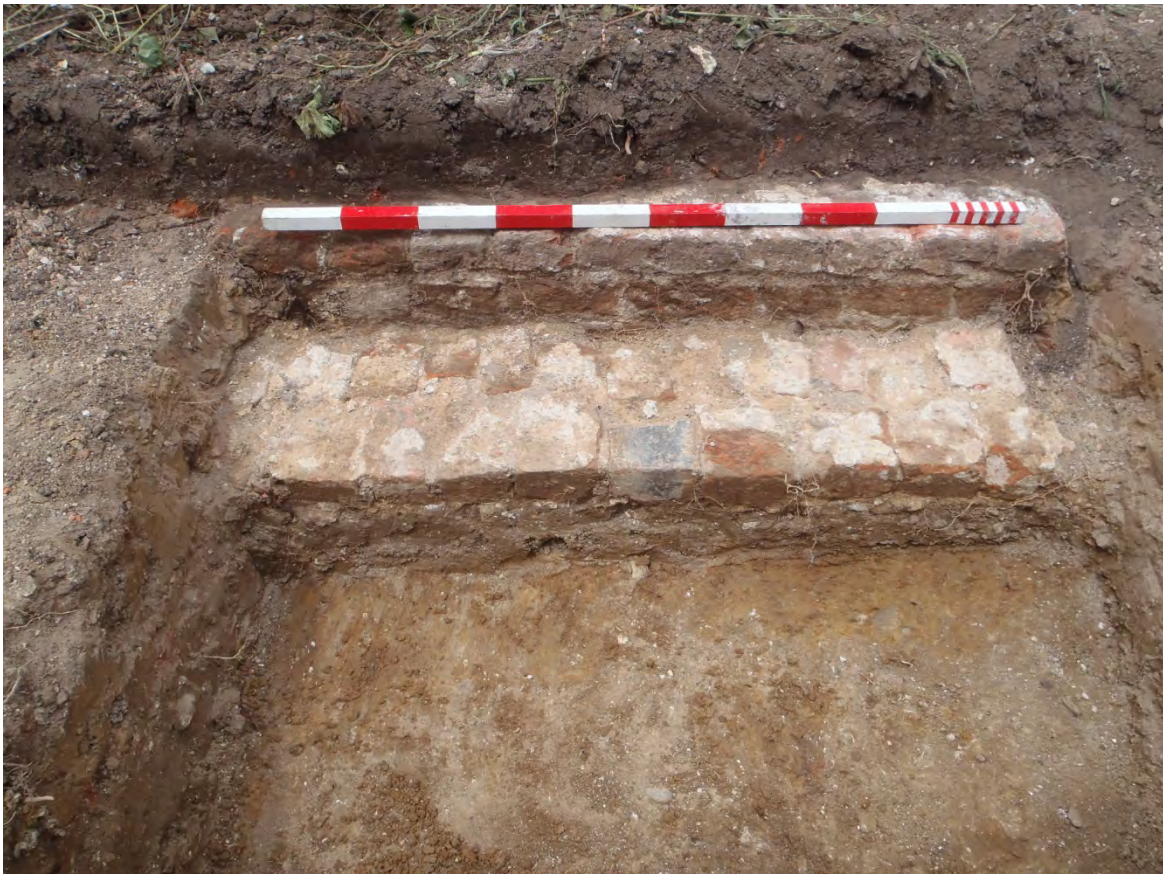
Plate 5 North facing oblique shot of [3]/[

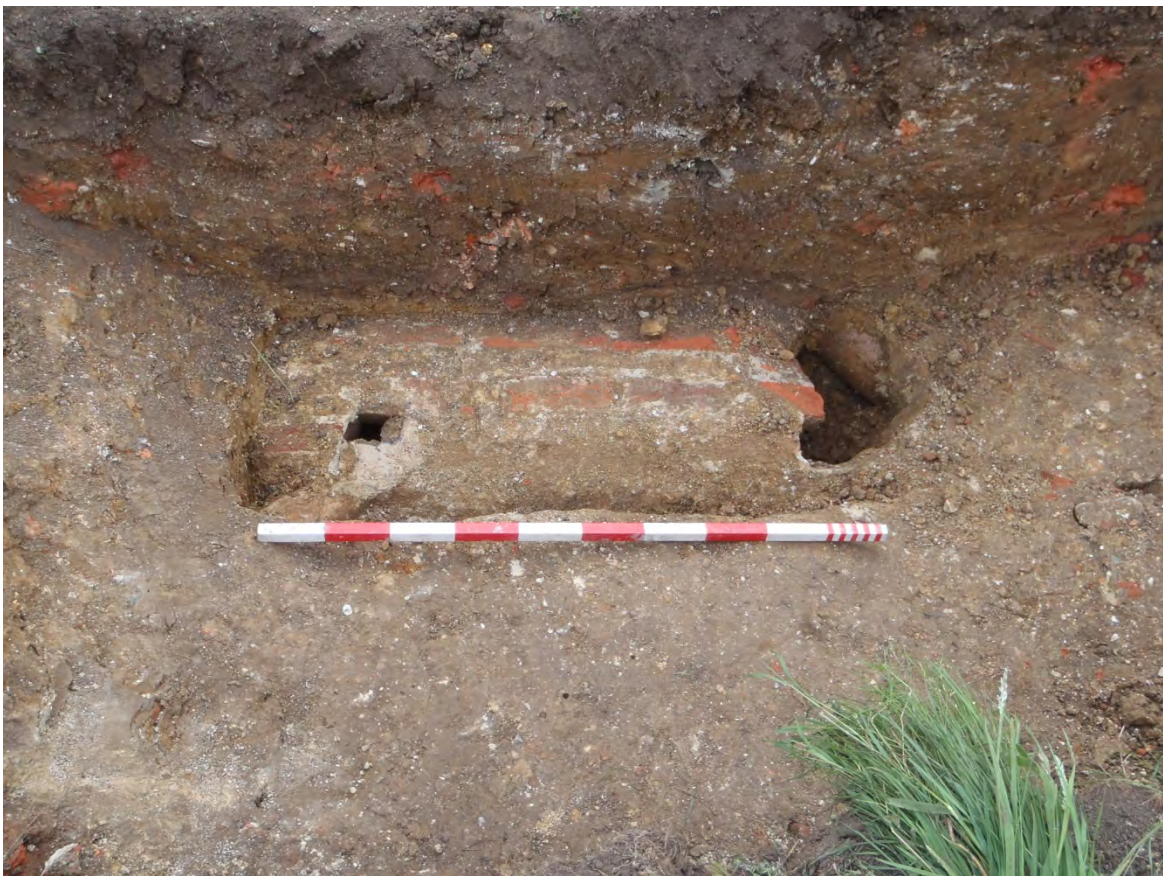
Plate 6 South facing plan shot of brick culvert [5]

5.4.5 The lowest deposits associated with the 18th century villa extension both represent forms of drainage. A brick culvert [5] (**Plate 6**) was identified in trench 1 running from the western wall of the 18th century villa towards the north-west. An 18th century drain, [15] (**Plates 9 & 10**), formed of sections of D- shaped ceramic pipe laid on top of tiles, runs from wall [12] to the south. The corresponding recess for a down pipe was visible in wall [12], however the drain was truncated immediately to the south of wall [12].

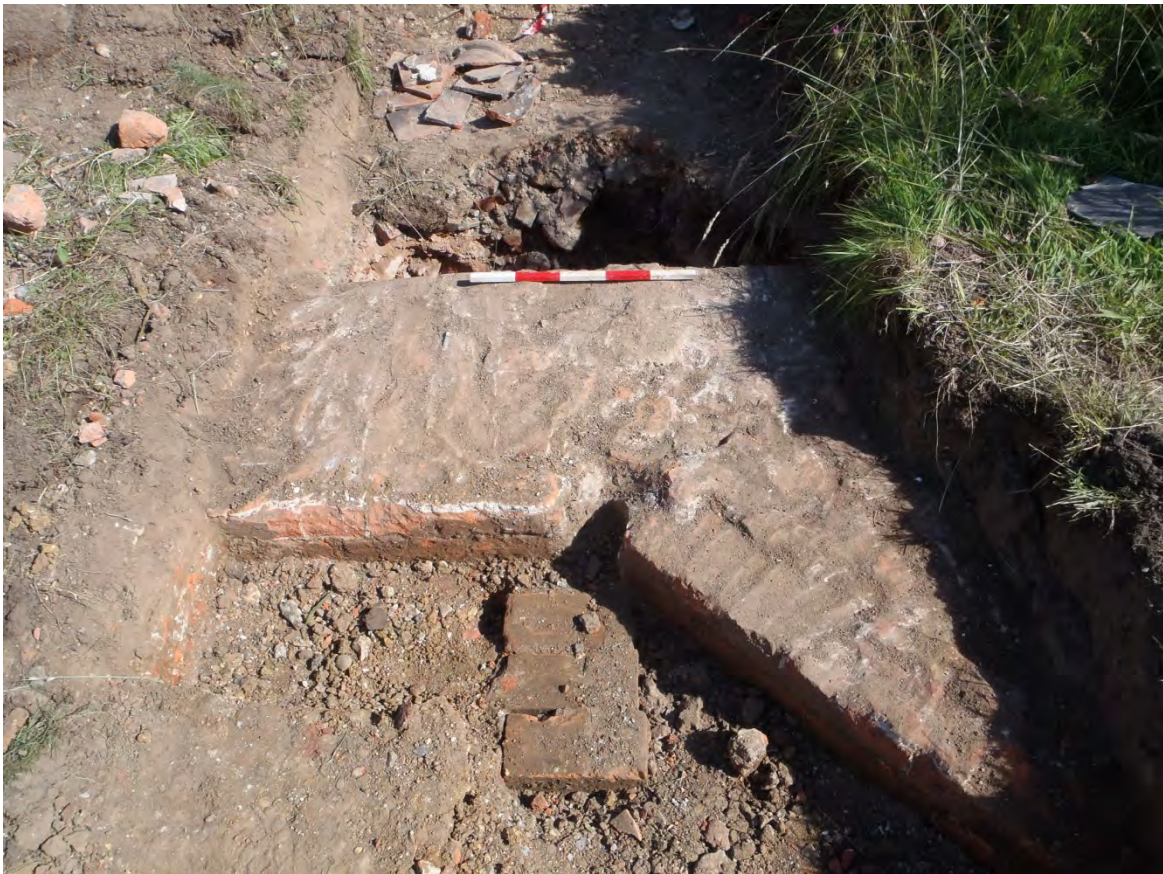
Plate 7 North facing plan shot of [12]

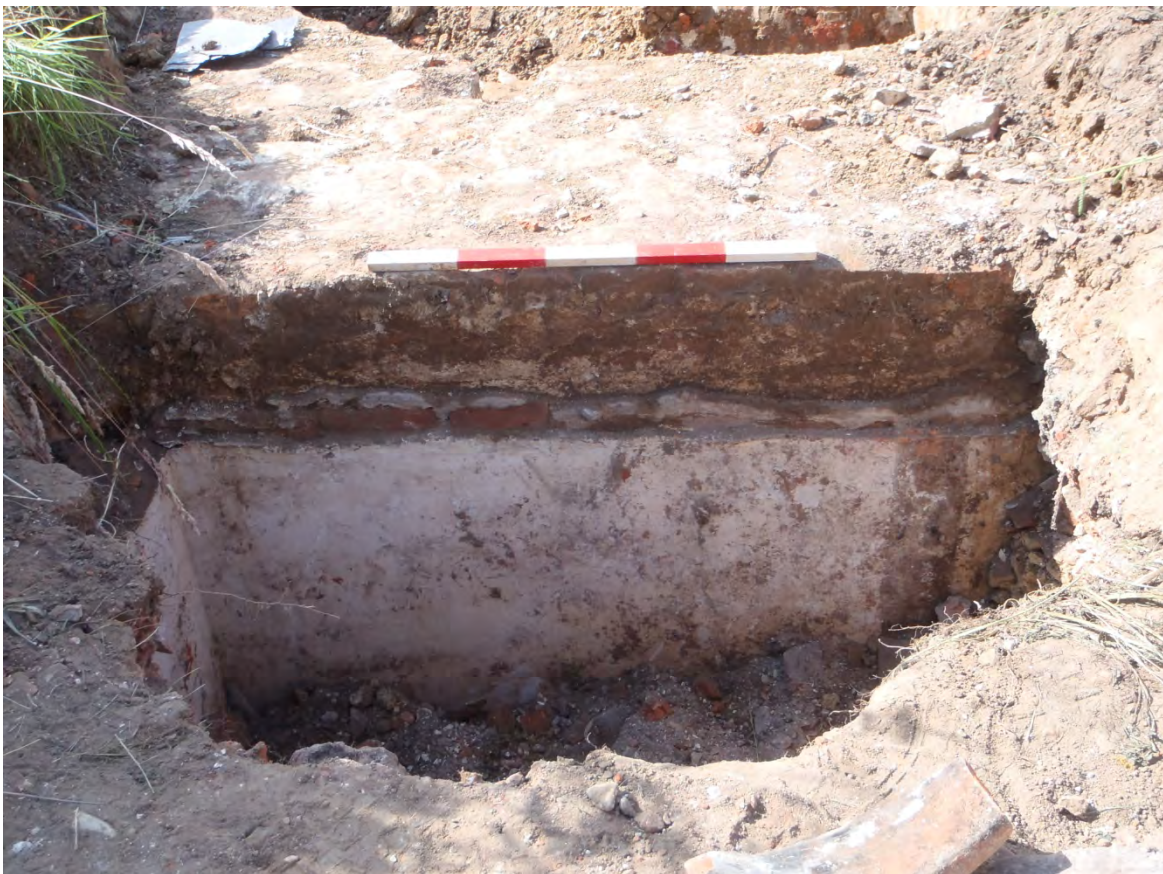
Plate 8 South facing elevation of internal face of [12] (showing plastering dropping down into cellar)

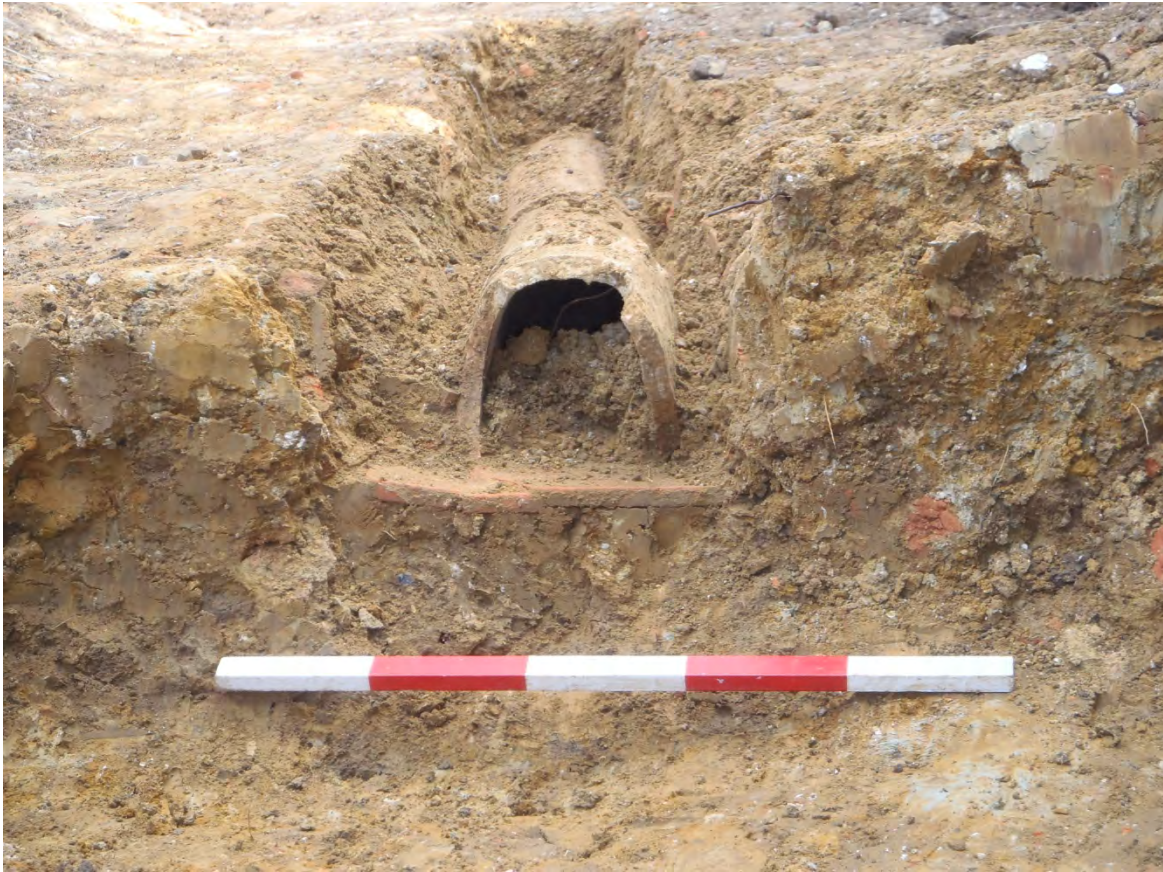
Plate 9 Section through D shaped land drain [15]

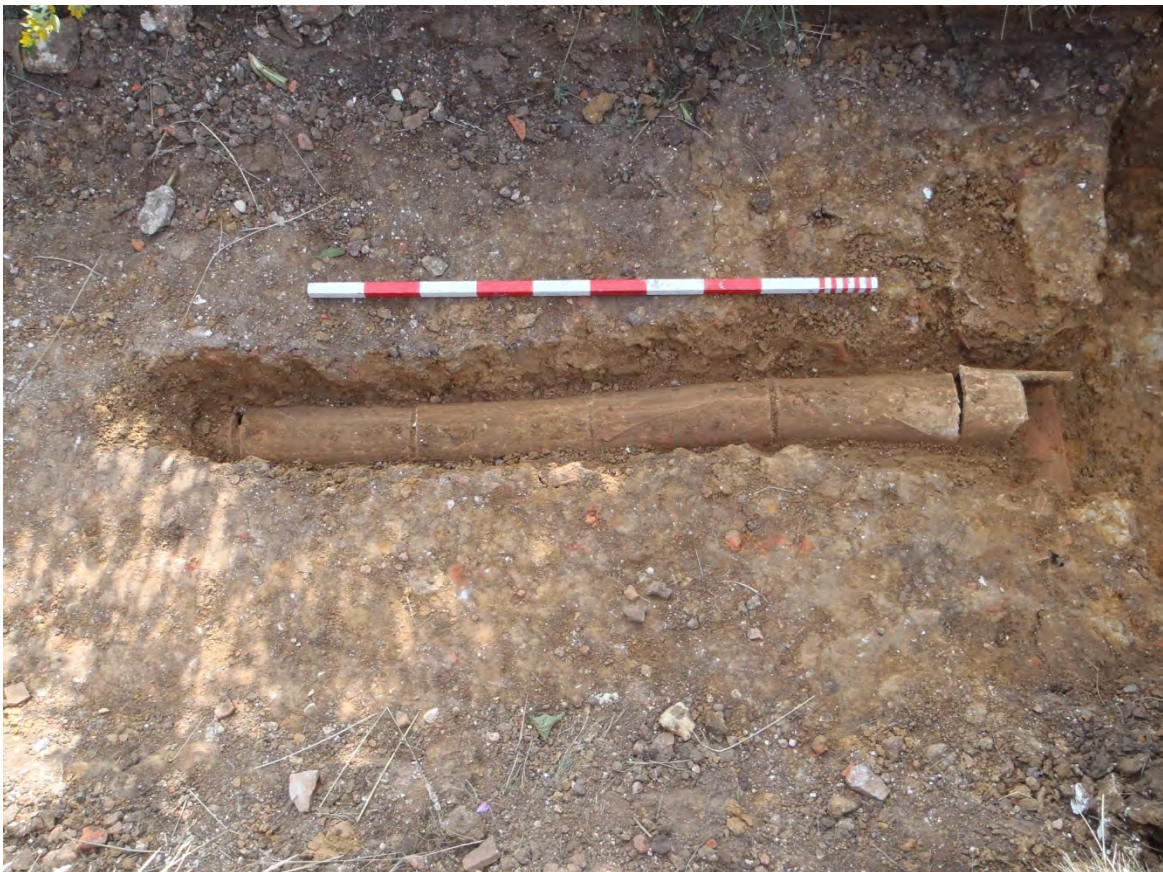
Plate 10 Plan shot of D shaped land drain [15]

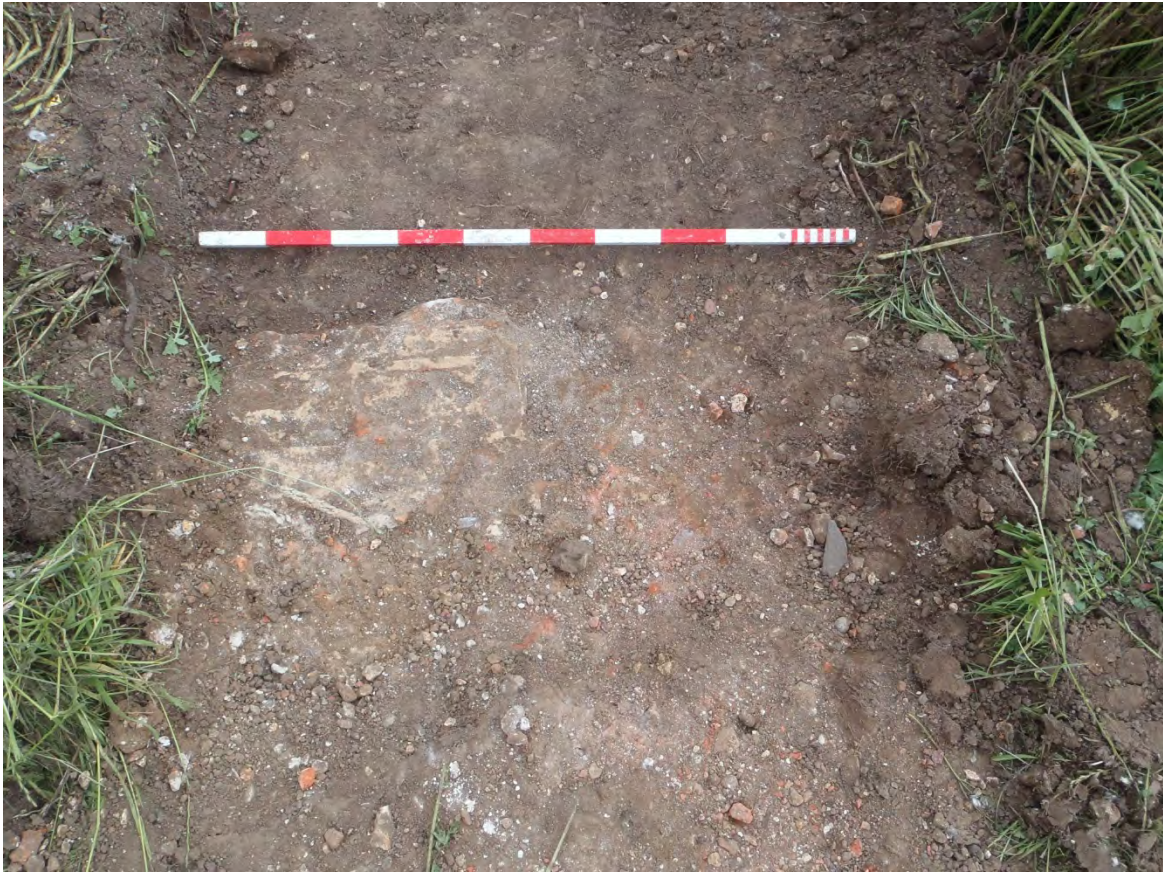
Plate 11 Plan shot of wall [4]

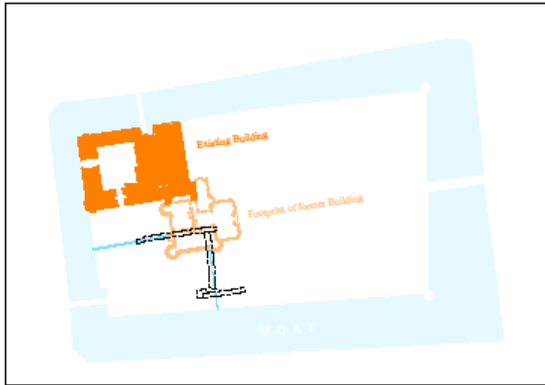
Figure 3
 Plan of Trenches 1-3
 1:125 at A3

5.4.1 Substantial evidence for the known 18th century villa extension was identified across trenches 1 and 2 (**Figure 3, 4 & Table 2**). It appears that the foundations for the villa were either cut into or built upon layers of the re-deposited natural.

- Existing Building
- Footprint of former Building
- Excavated masonry of former Building
- Excavated drainage system

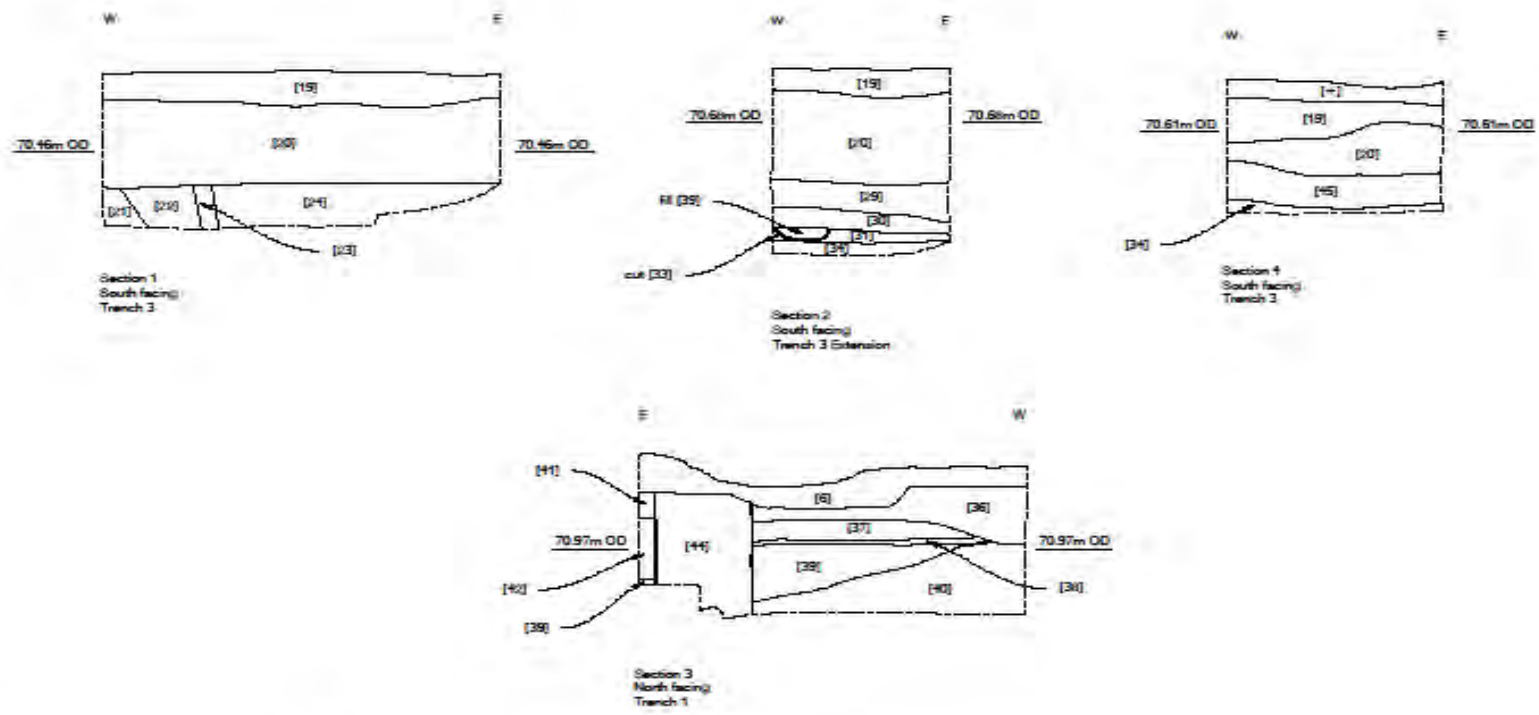
Figure 4
Sections 1-4
1:40 at A4

5.3.2 **Sections 1 & 2**, recorded in trench 3 (**Figure 4**), shows a sequence of layers of re-deposited clay. Layers [21], [22], [23] and [24] all appear to have been deposited at an angle. Flecks of CBM seen throughout all of these clay layers appear to be consistent, suggesting that the layers were deposited concurrently.

5.3.3 A small pit, [33] was identified in trench 3, cut into re-deposited clay layer [31] (**Figure 4, section 1**). No dating evidence or any other artefacts were recovered from the pit.

- 5.5.3 **Section 3 (Figure 4)** in Trench 1 showed a modern cut for a utilities pipe ([43]). This truncated all other contexts present beneath the topsoil layer [6]. The pipe appears likely to have served the 1980's extension to Beaurepaire House.

- 5.5.4 Above the 20th century deposits were layers of topsoil and garden soil. These are detailed in Table 4. The layer of [+], approximately 0.30m deep, as shown in **section 4 (Figure 4)**, relates to a build up of garden soil towards the eastern extent of the site.

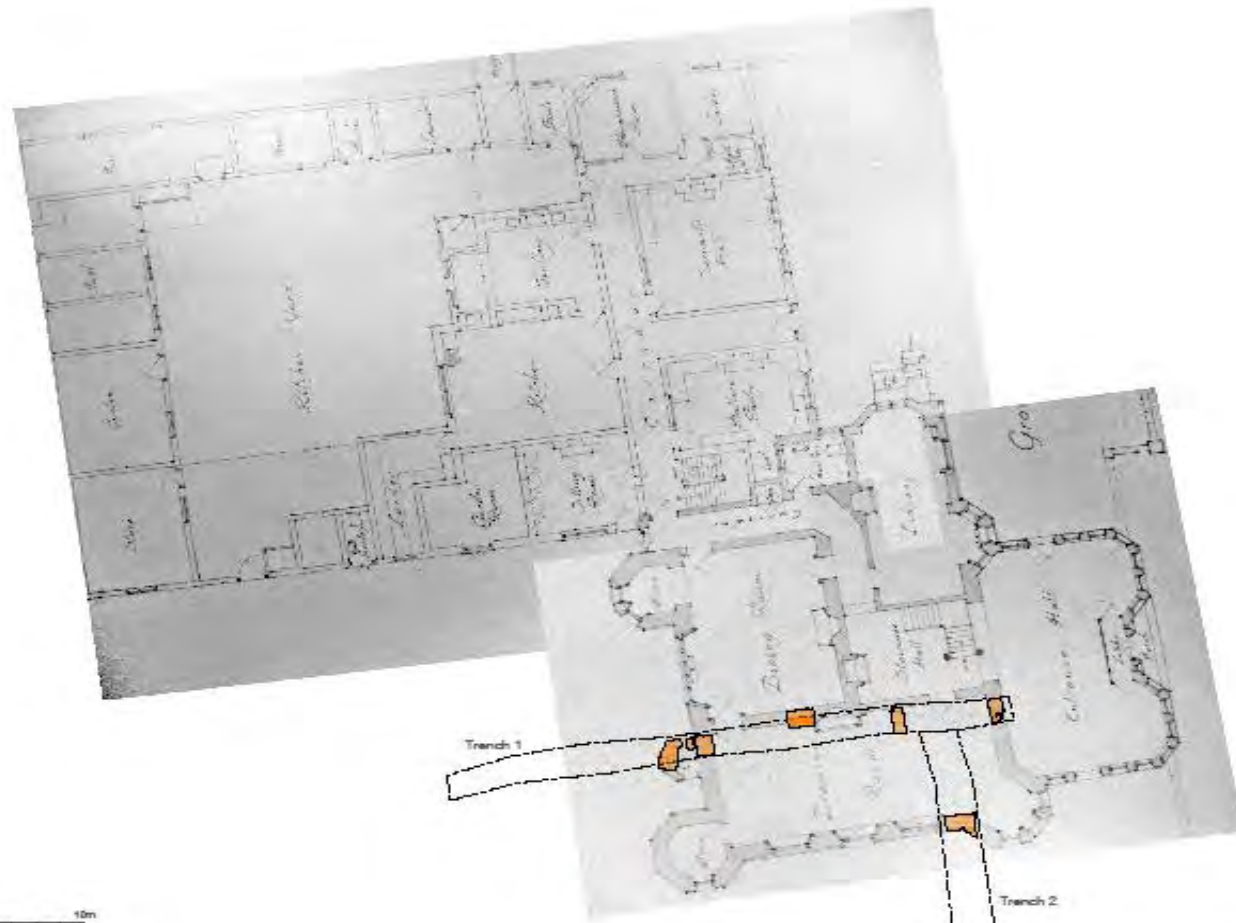
Figure 5
 Excavated Features overlain onto Ground floor plan of Beaupaire, 1941
 1:125 at A3

6.3.1 The evaluation revealed substantial evidence for the 18th century villa that burnt down in the in 1942. The walls revealed in trench 1 and 2 support the layout for the building depicted in the plan of Beaurepaire House shown on **Figure 5**. They also confirm and explain the geophysical anomalies that were found by the geophysical survey of the site.
