**Archaeological Monitoring at
Canonry House, Ely,
Cambridgeshire**

ARCHAEOLOGICAL MONITORING

Pre-Construct Archaeology Ltd	
Project Number	K 3693
Report Number	R 11836

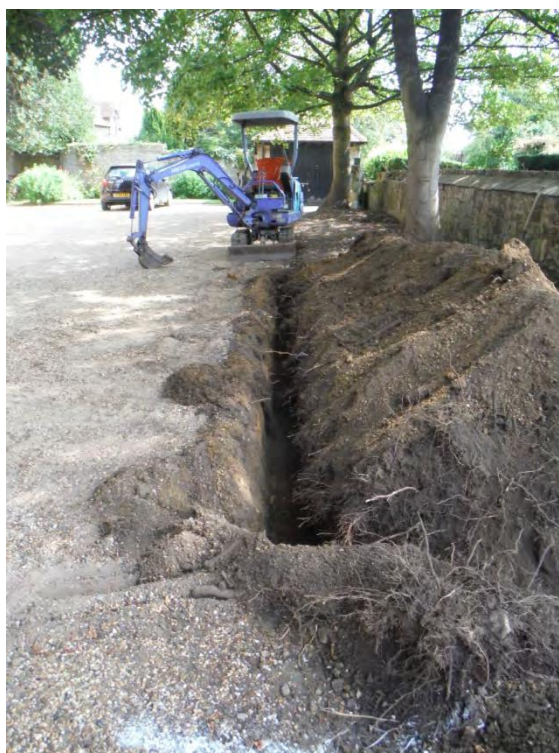
Plate 2: The cable trench, view east

- 4.1 The archaeological monitoring observed the excavation of a shallow trench 37m long, 0.4 to 0.5m wide and 0.45 to 0.65m deep (Figure 2; Plates 2,5). Four small spurs perpendicular to the main trench, 0.4 to 0.6m long, 0.4m wide and 0.4m deep, were monitored.
