ST JOHN THE
EVANGELIST'S
CHURCHYARD,
HOLLOWAY ROAD,
LONDON BOROUGH OF
ISLINGTON:
AN ARCHAEOLOGICAL
WATCHING BRIEF

SITE CODE: UHB13

PCA REPORT NO. R11854

SEPTEMBER 2014

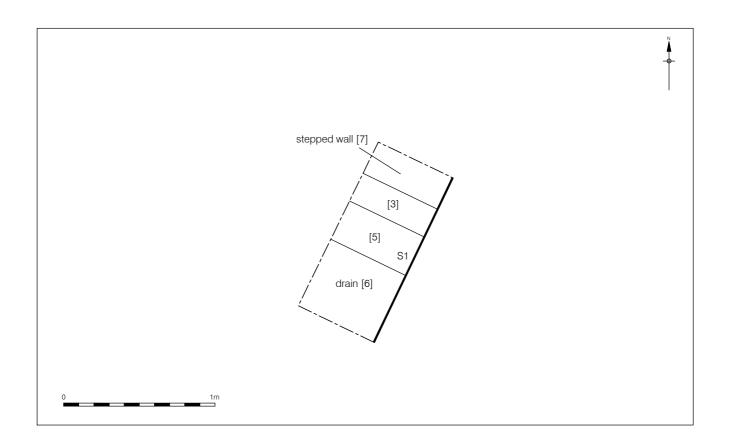
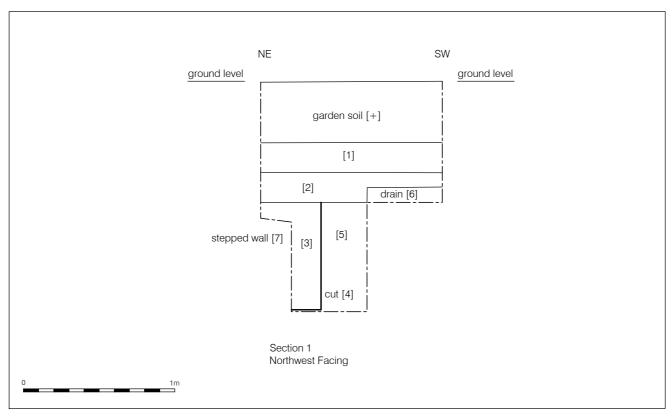
- 6.1 The earliest deposit encountered within the test pit was [5] natural yellowish brown, sandy silty clay at 0.8m below ground level (BGL) (**Figure 3**).

- A construction trench [4] for the boundary wall, running east-west with a vertical edge, was discovered at a depth of 0.8m BGL and cut the natural clay layer [5] to a depth of 1.5m BGL.

- 6.3 The 19th-century boundary wall [7] was erected in this construction cut with frogged reddish brown bricks in Flemish bond and hard, yellowish grey mortar. The wall, which was topped with limestone capping slabs, continued vertically to a depth of 0.9m BGL where the brick wall foundation stepped out to a width of 0.2m. This footing then continued down to the bottom of the wall at a depth of 1.5m BGL. The wall was approximately 3m in total height from the base of the footing to the top of the limestone capping stones.

- 6.4 The construction cut was backfilled with [3] light brown, sandy silt containing very frequent small fragments of limestone. This deposit was observed at 0.8m BGL and continued down to a depth of 1.5m BGL.

- 6.5 In the southern part of the test pit a low and narrow 19th-century drain [6] (**Plate 2**) was built on top of the natural clay. It was constructed with brownish red frogged bricks and bonded with hard sandy, yellowish grey mortar. The bricks were capped by limestone slabs measuring 0.36m long by 0.21m wide by 0.04m thick. The top of the limestone slabs were found at 0.7m BGL.

- 5.3 The test pit was located on site by Pre-Construct Archaeology Limited using sketch plans and hand measurements to local landmarks. A plan and section were drawn at a scale of 1:20 (Figure 3).

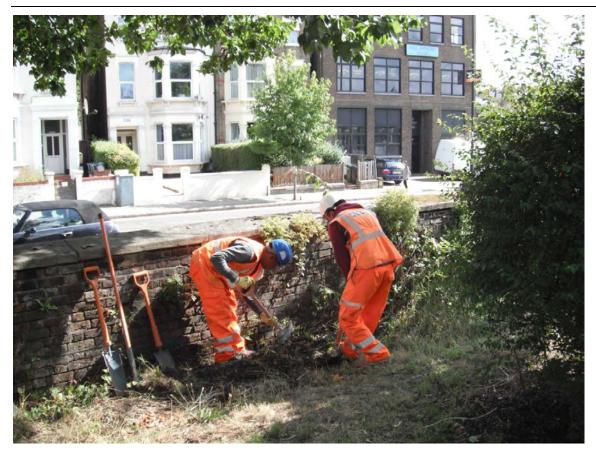
Plate 1 – Excavation of the test pit, looking east

- 5.1 The test pit was located against the south side of the north boundary wall around St John the Evangelist's Churchyard (**Figure 2**). The rectangular test pit measured 0.55m east—west by 1.2m north-south and was 1.5m deep. It was excavated by the groundwork contractors using hand tools (**Plate 1**). The test pit was excavated to investigate the depth of the boundary wall and its footings. The watching brief took place on 13th August 2014. The test pit was excavated until the base of the foundation of the wall was reached.

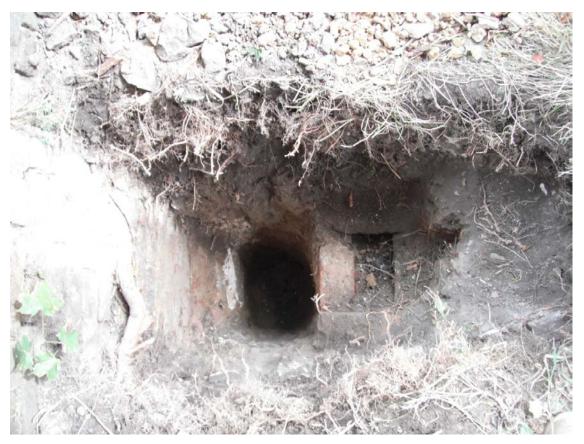
Plate 2 – Test pit with boundary wall to left (north) and drain to the right (south), looking east.
