**HISTORICAL BUILDING
RECORDING OF NOS 9 AND
10 TRINITY CHARE,
AN OUTBUILDING AND
A STONE WALL,
TRINITY HOUSE,
NEWCASTLE UPON TYNE,
TYNE AND WEAR**

PCA REPORT NO. R11870

SEPTEMBER 2014

Commissioning Client: North East Theatre Trust Limited

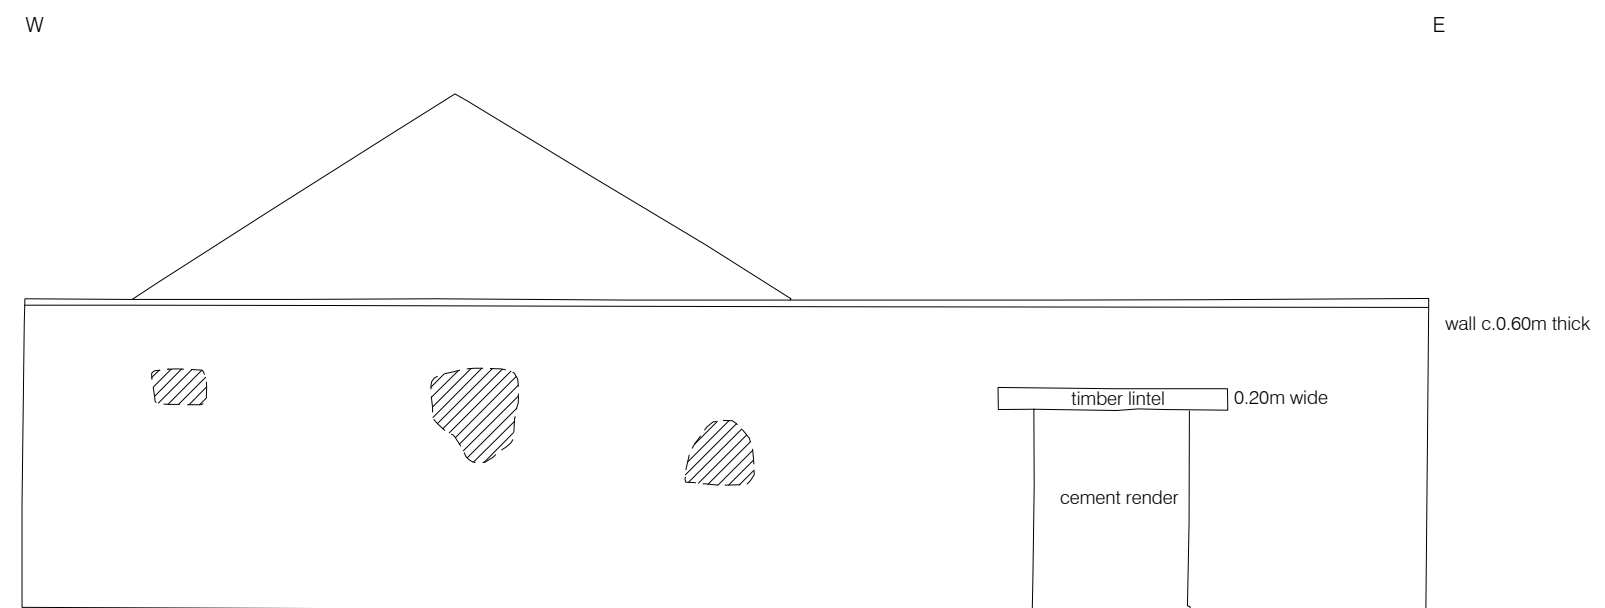
South elevation of stone wall

KEY
 brick infill (230 x 60mm)

North elevation of outbuilding and stone wall

- 6.2.1 The recorded wall is aligned east-west and abuts the south end of the west wall of the listed 1782 almshouses (Nos. 7 and 8 Broad Chare). It also formed the rear (south) wall of the listed outhouse (described below). Different sized sandstone blocks set in a random pattern were used in the wall's original construction, over time repairs in the form of brick in-fills and re-pointing has taken place (**Figure 9; Plates 3 to 7**).

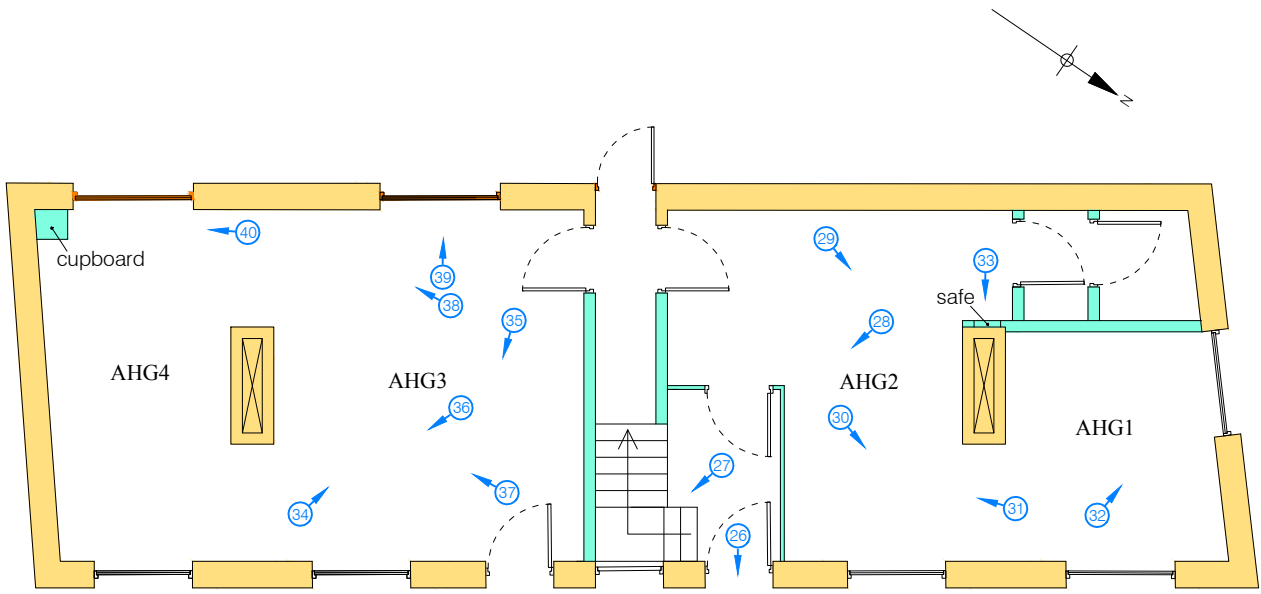
Figure 11
Ground floor and First Floor Plans of Alms Houses
1:100 at A4

Existing Ground Floor Plan - Alms Houses

Existing First Floor Plan - Alms Houses

- 6.4.6 The internal layout has been altered in the late 20th century, presumably in the 1970s as well as later. All that remains internally are the two chimney breasts (**Figure 11**). Although the east-west walls on each side of the staircase in the central bay are in the original location, the thinness of the walls suggests that they are later replacements.

- 6.4.7 A small hallway has been created by the addition of glass partition walls (**Figure 11; Plates 28 and 31**). The north doorway in the east elevation leads into this space (**Plate 26**). This was the original doorway into the north ground floor lodging. The original central doorway to the two first floor lodgings has been blocked low down by late 20th century stairs (**Plate 27**). The fireplace in the ground floor north lodging has been replaced in the late 20th century but the original chimney breast still exists (**Plates 29 and 30**). Corbels supporting a downstand between the chimney breast and the east wall are not thought to be original (**Plate 31**). The sash window with a low sill in the north wall is similar to those in the east wall (**Plates 30 and 32**). A safe has been placed in the west side of the chimney breast (**Plate 33**). The safe is late 19th/early 20th century in appearance and was presumably added after 1862 (**Figure 3**).

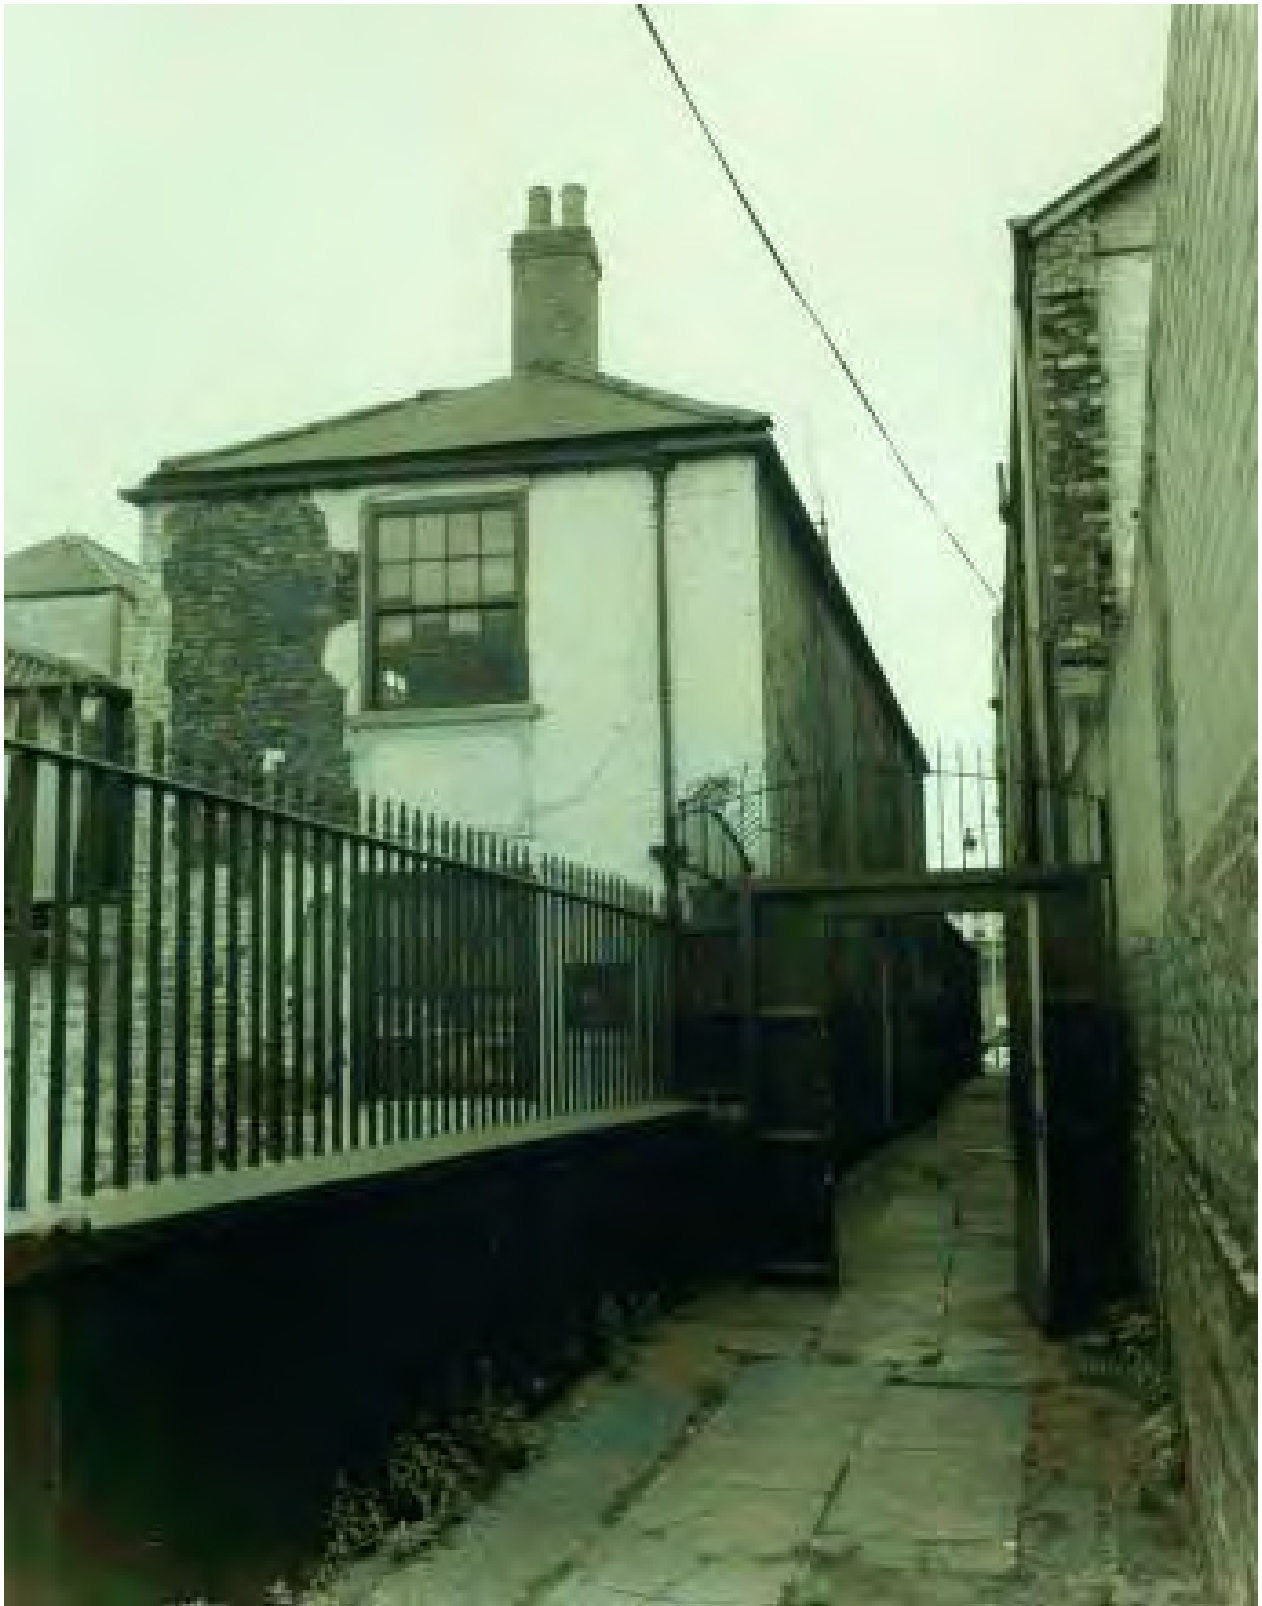
Plate 1a: Photograph taken in the 1970s showing the north elevation of Nos 9 and 10 Trinity Chare, looking south (© Tyne and Wear Archives).

1970s (**Plate 2**). This shows building contractors on site repairing the roof, windows have been removed and two skips are located in front of the building (**Plate 1a**). By this time much of the original interior detail had already been lost (Morrison, 2013, 2). Partition walls were added at this time in order to bring the building back into use as an office (*ibid.*).

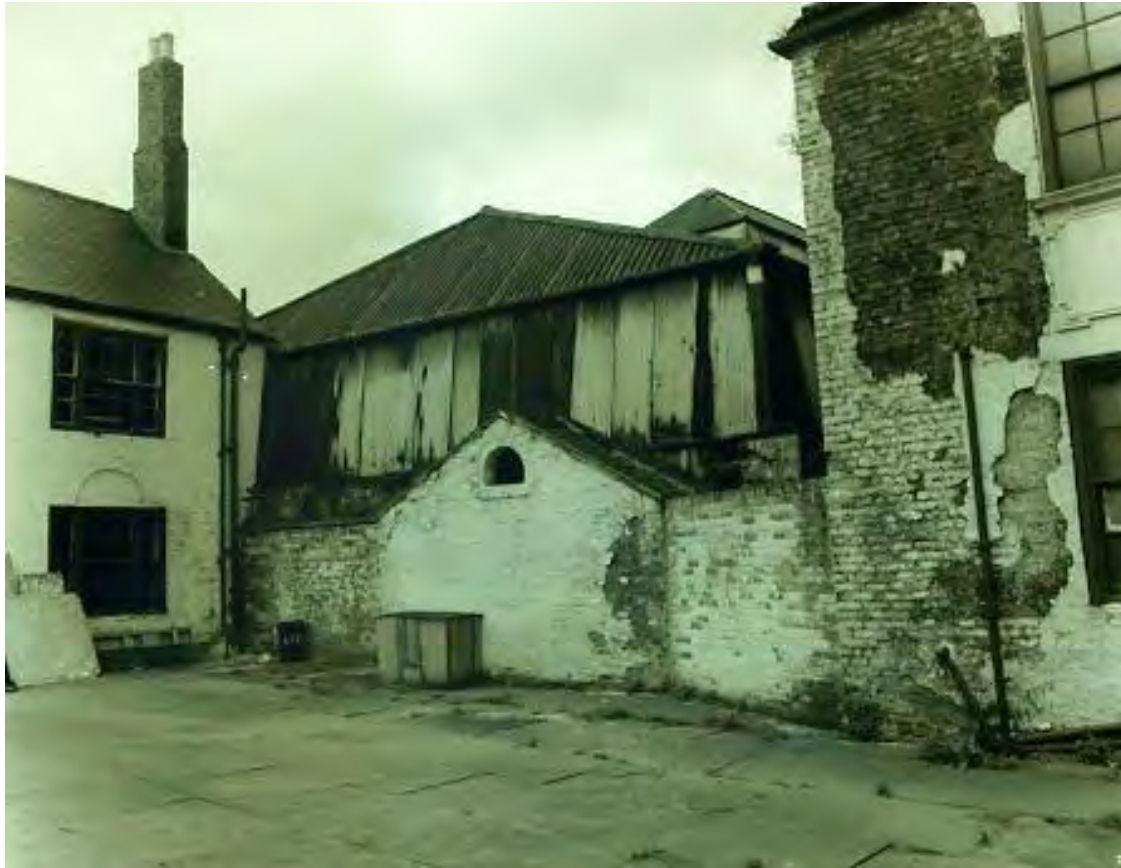
Plate 1b: Photograph of the outbuilding taken in the 1970s, looking south (© Tyne and Wear Archives).

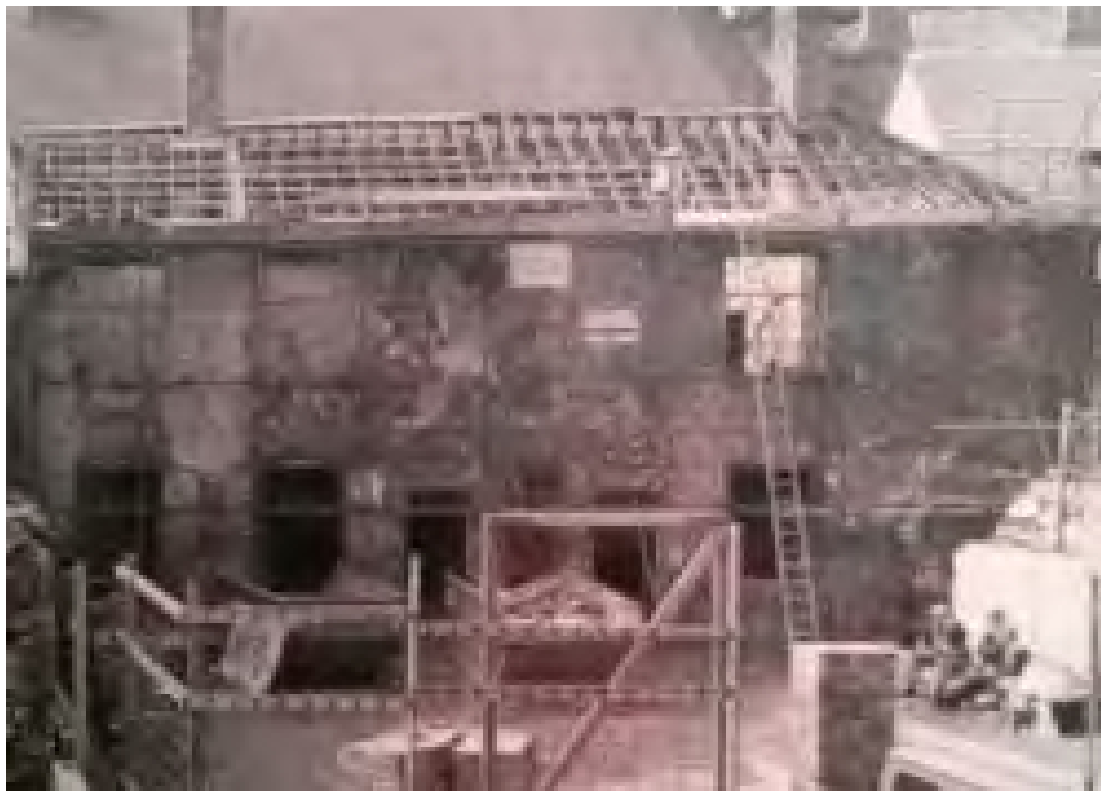
Plate 2: Photograph taken in the 1970s of Nos 9 and 10 Trinity Chare showing the front (east) elevation, looking west (from Dyer, 2014, 6)

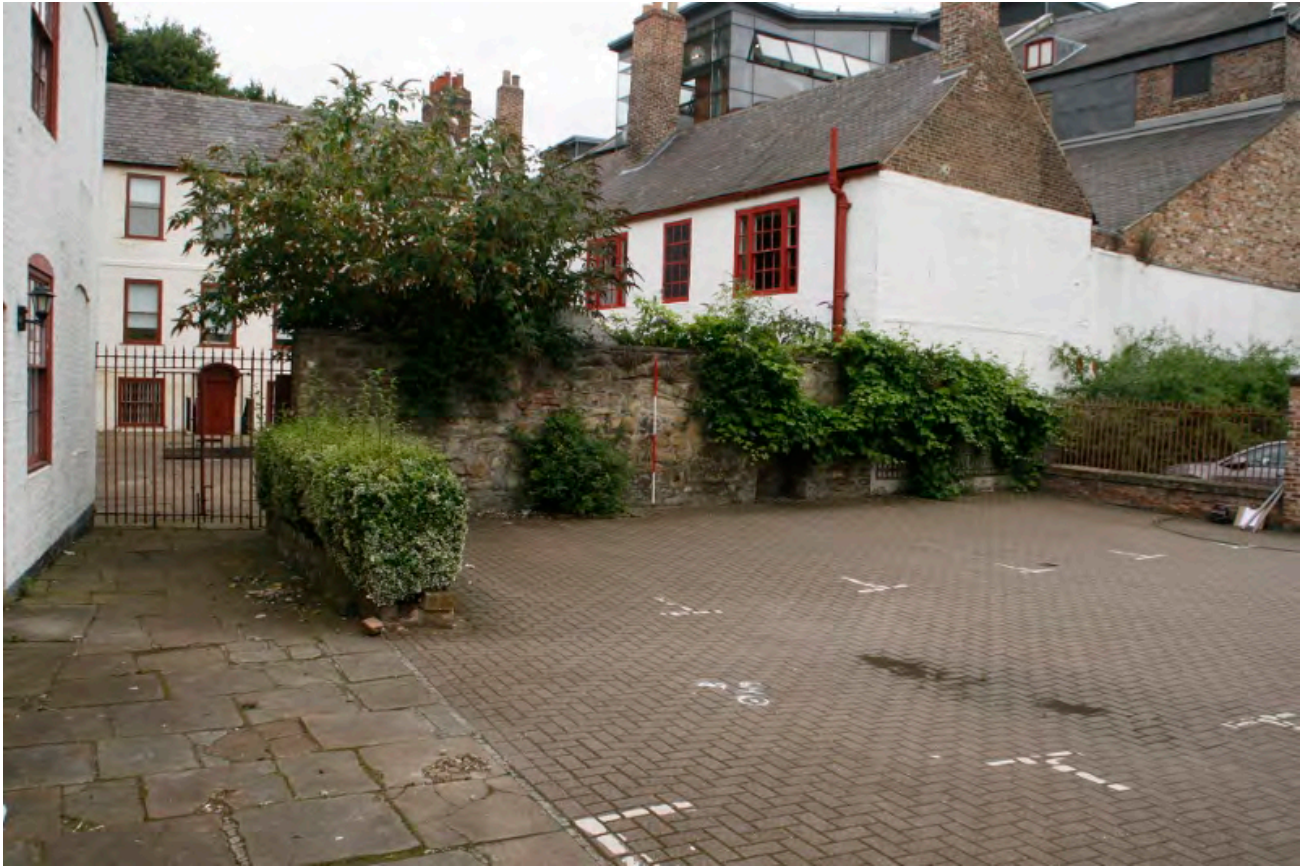
Plate 3: Sandstone wall, looking north (TRC14 BHD100 (01))

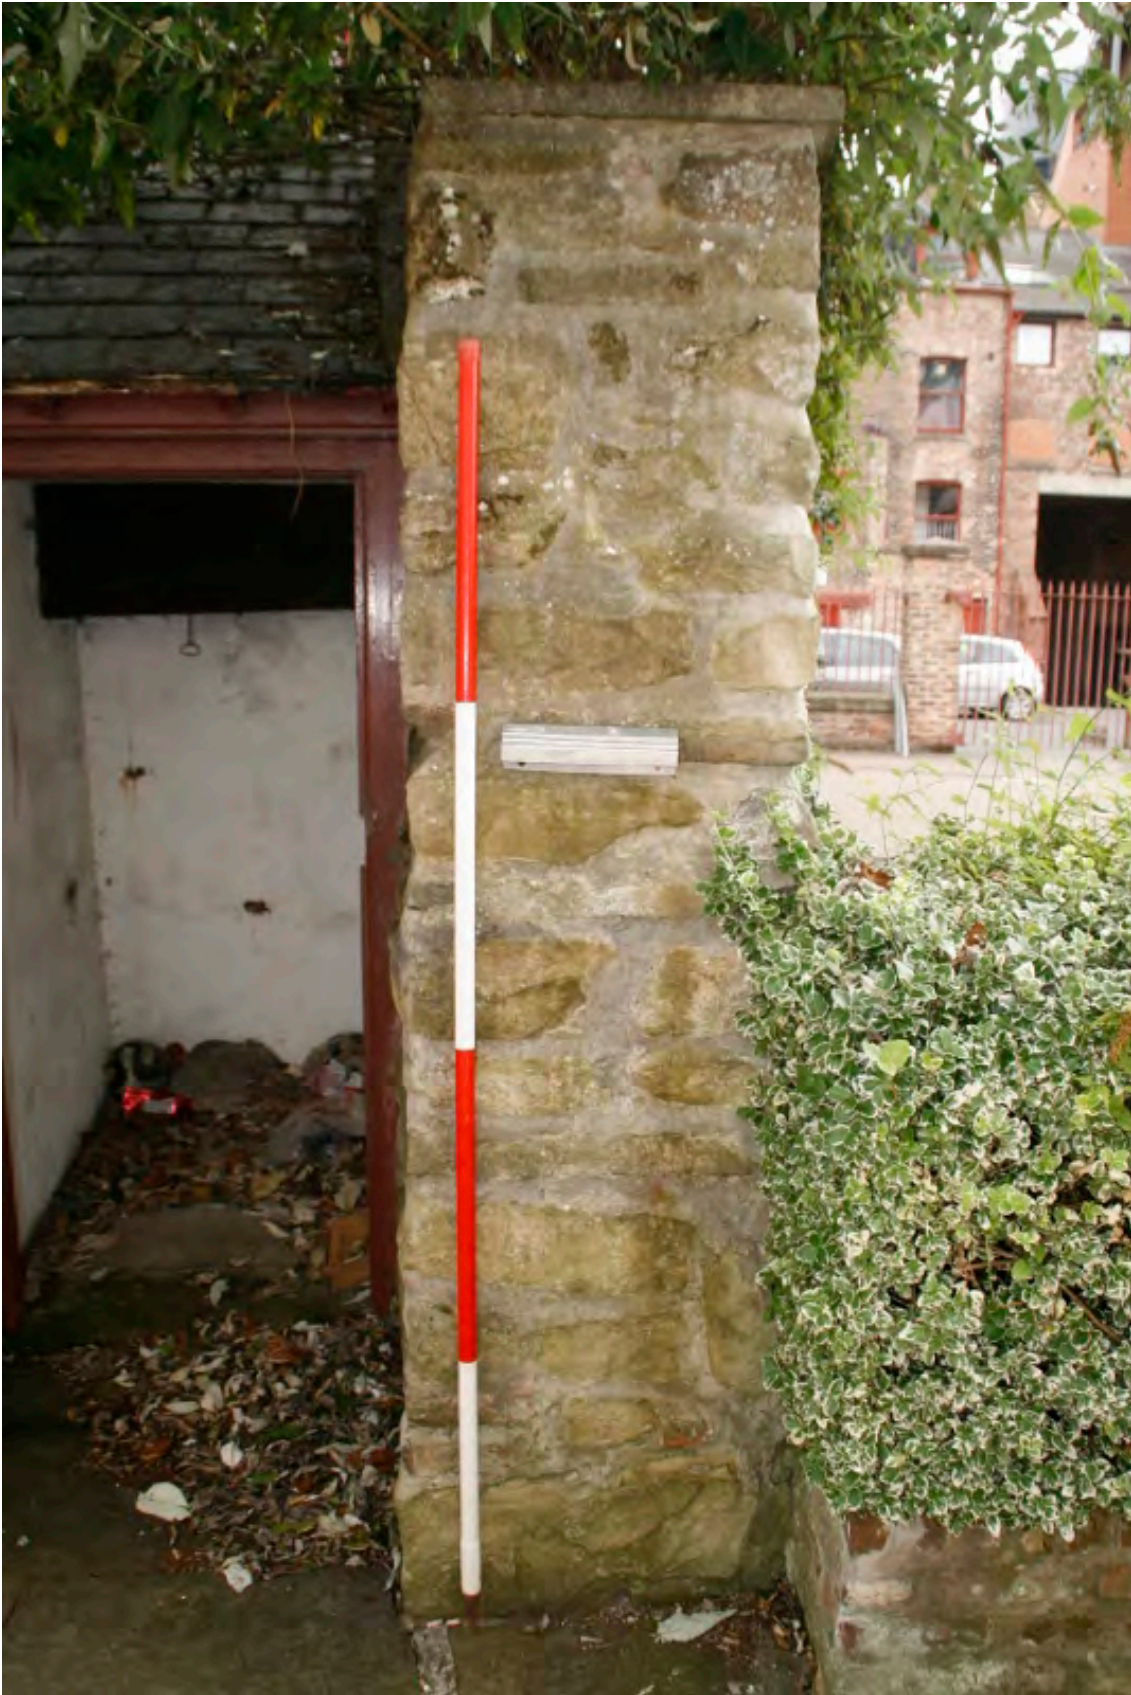
Plate 4: West end of the stone wall, looking east (TRC14 BHD100 (08))

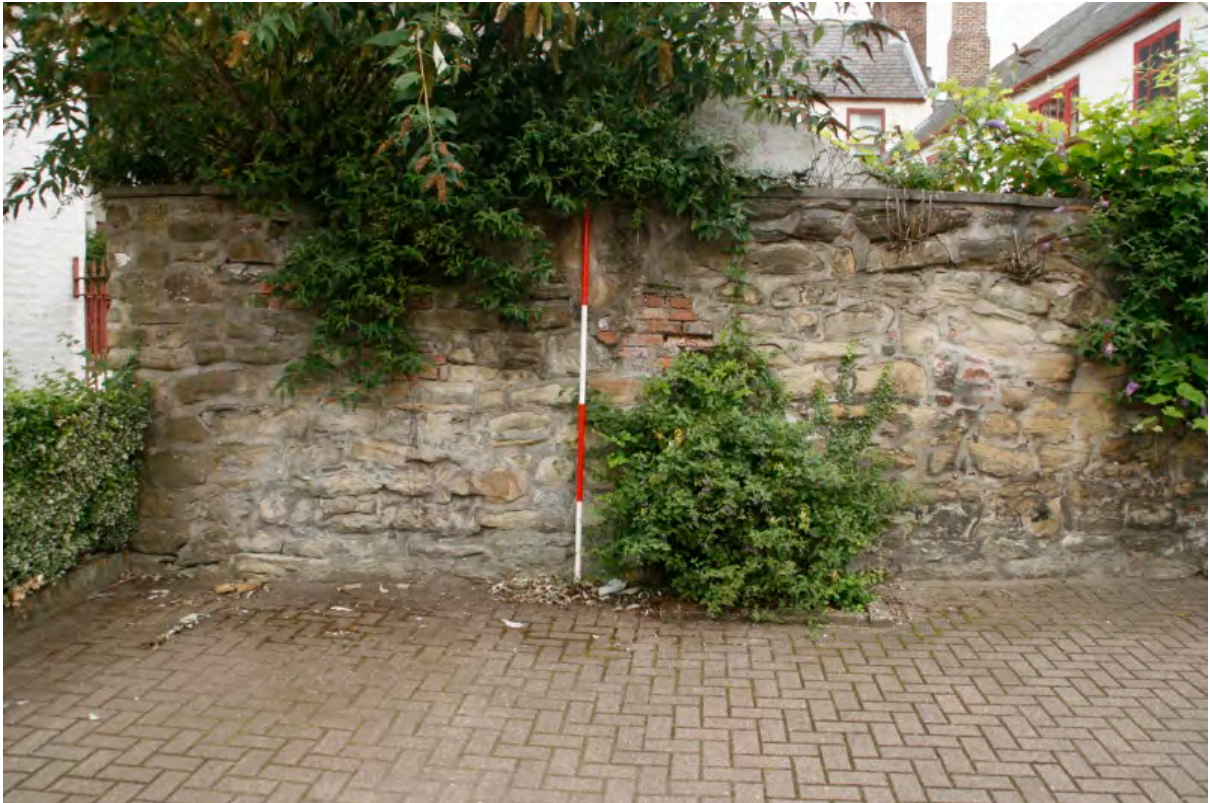
- 6.2.2 The brick in-fills are likely to be early repairs to the wall because they are in a soft lime based mortar compared to that of the later hard Portland based cement mix that was used to re-point the wall. Due to the incompatibility of the Portland based cement used to re-point the wall, the softer sandstone blocks had spalled and most of the earlier lime based mortar has crumbled away (**Plate 5**).

Plate 5: Red brick repair to stone wall, looking north (PCA Ref: TRC14 BHD100 (04))

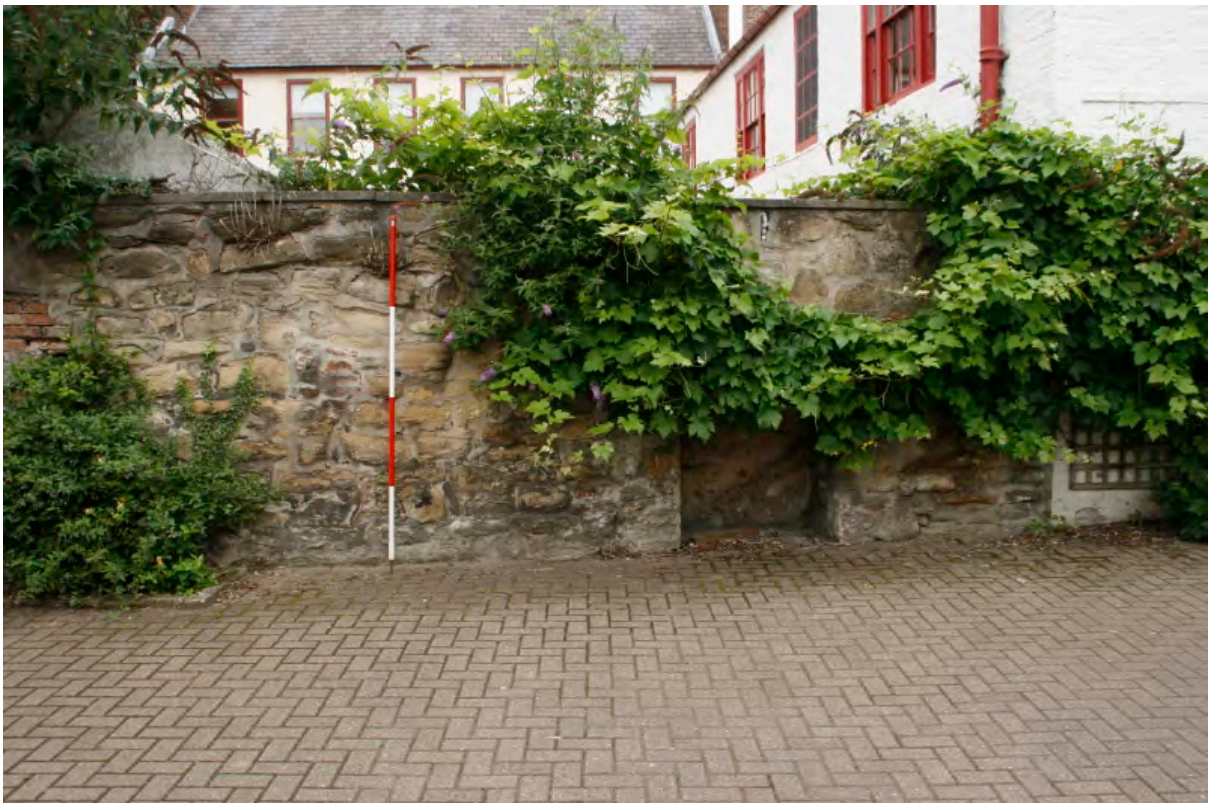
Plate 6: Blocked opening towards the west end of the stone wall, looking north (PCA Ref: TRC14 BHD100 (05))

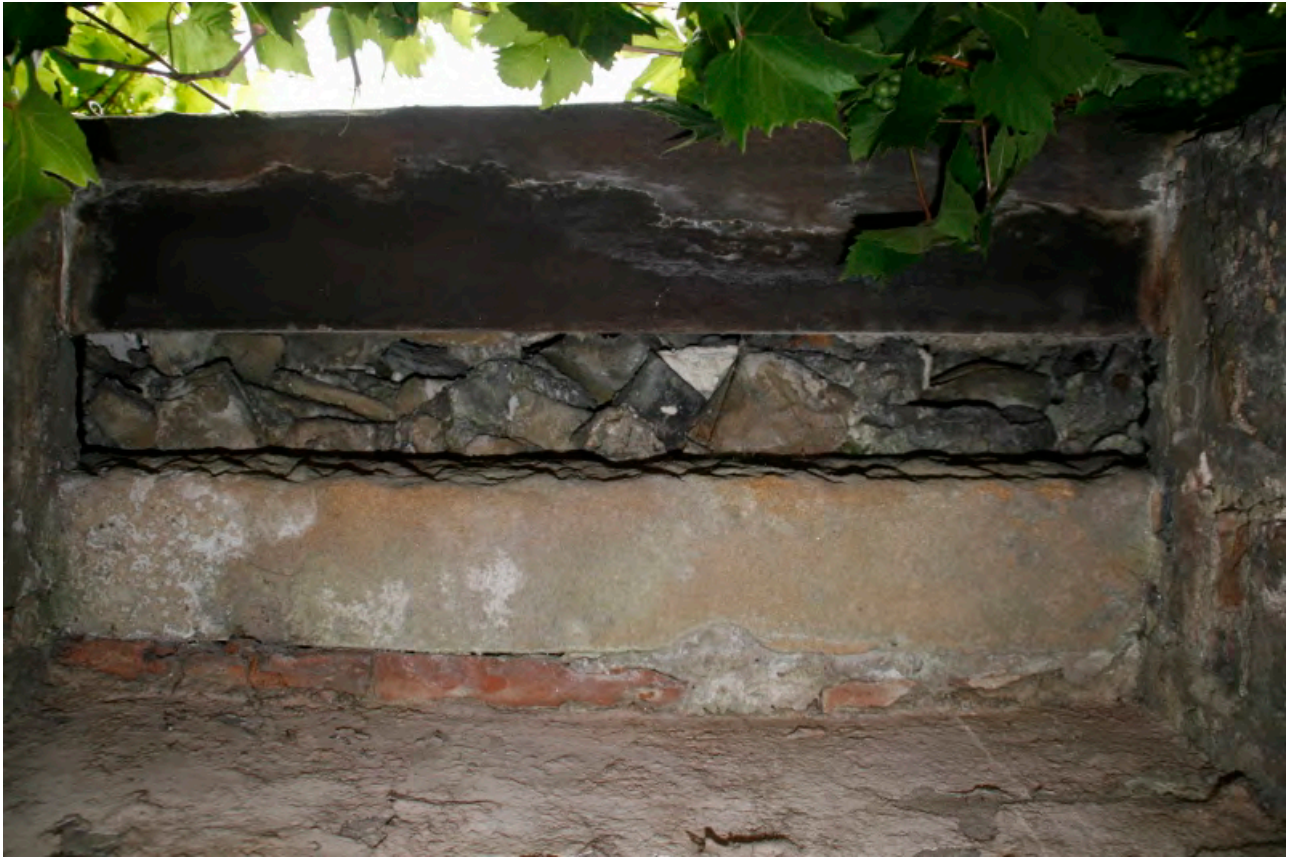
Plate 7: Interior view of blocked opening on the south side of the sandstone wall, looking up and north (PCA Ref: TRC14 BHD100 (07))

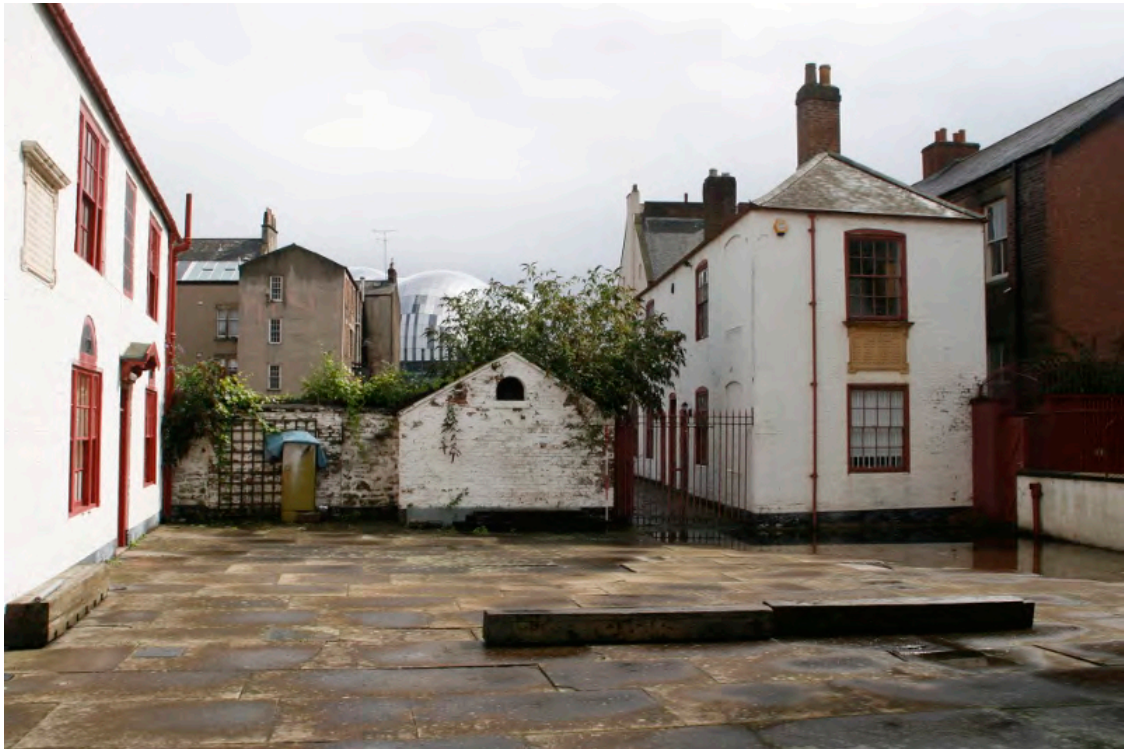
Plate 8: North elevations of the sandstone wall, outdoor toilet and almshouses, looking south (TRC14 BHD100 (76))

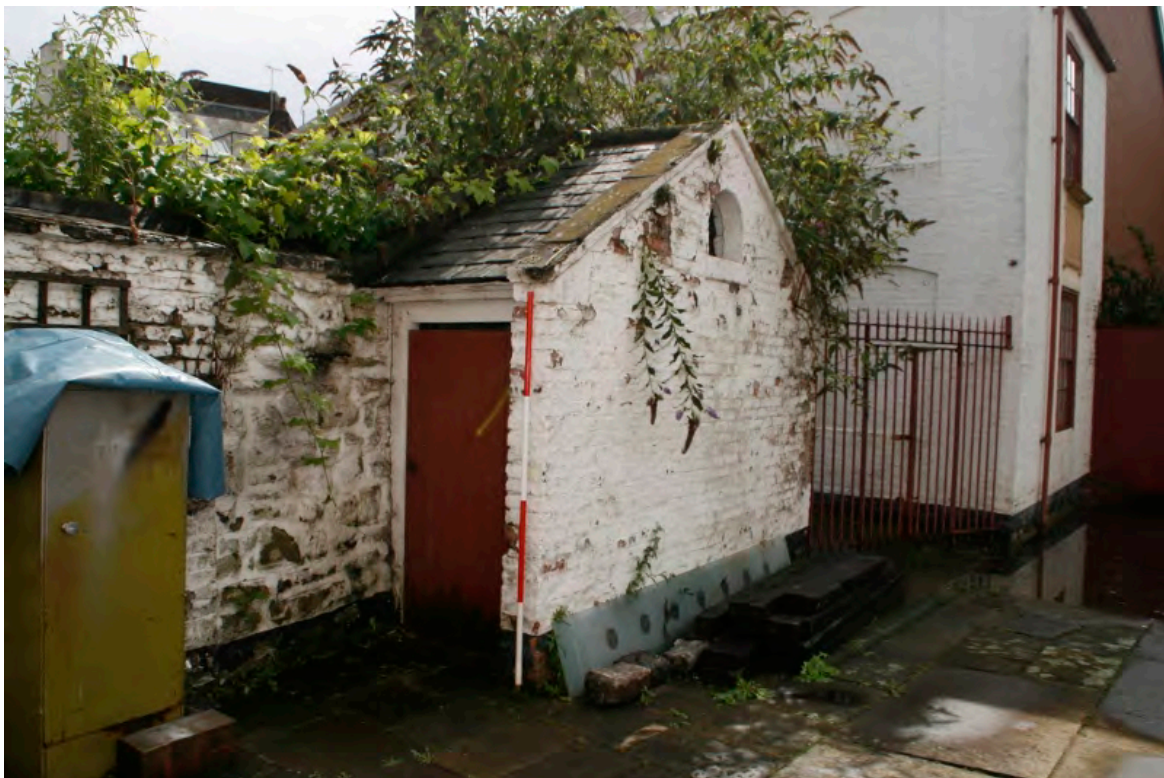
Plate 9: East and north elevations of the outdoor toilet, looking south-west (TRC14 BHD100 (81))

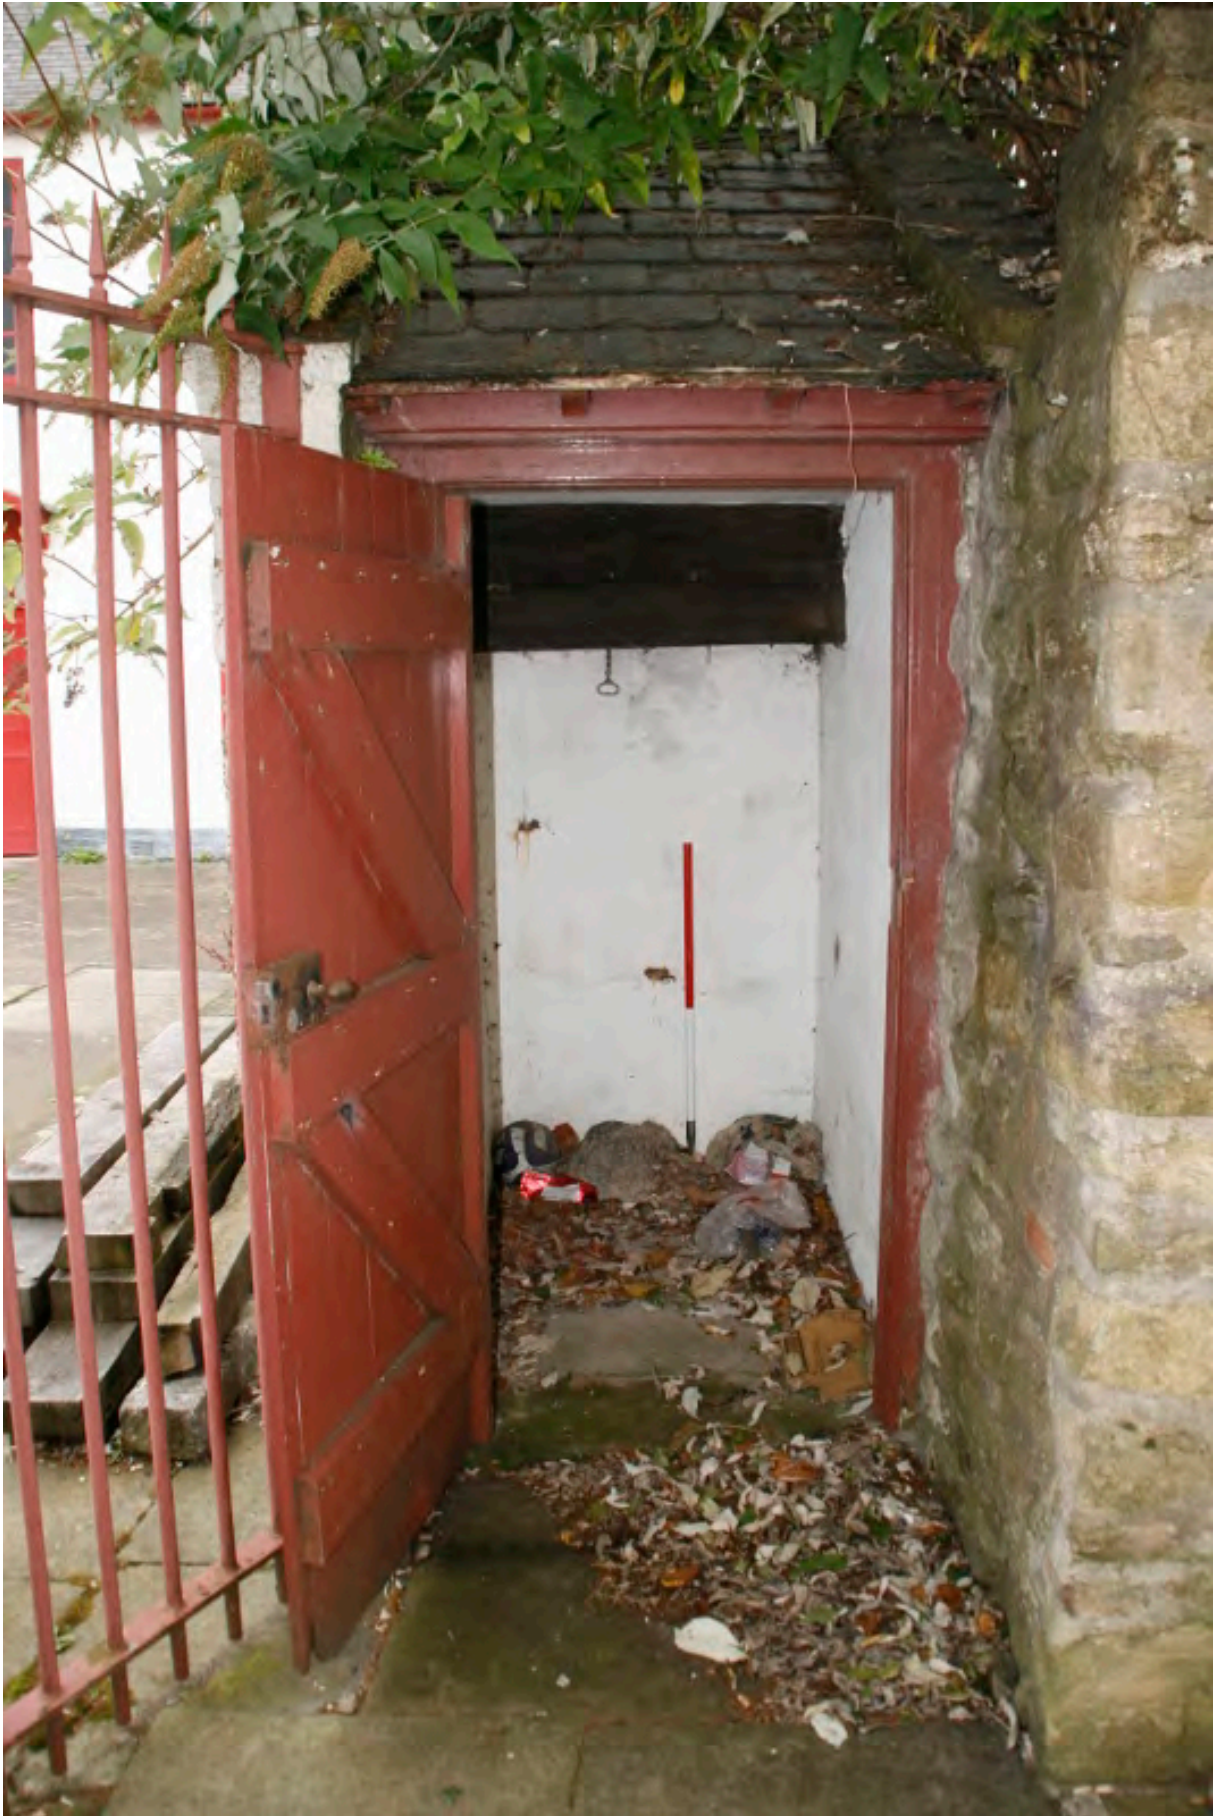
Plate 10: Interior of outside toilet at west end, looking east (PCA Ref: TRC14 BHD100 (09))

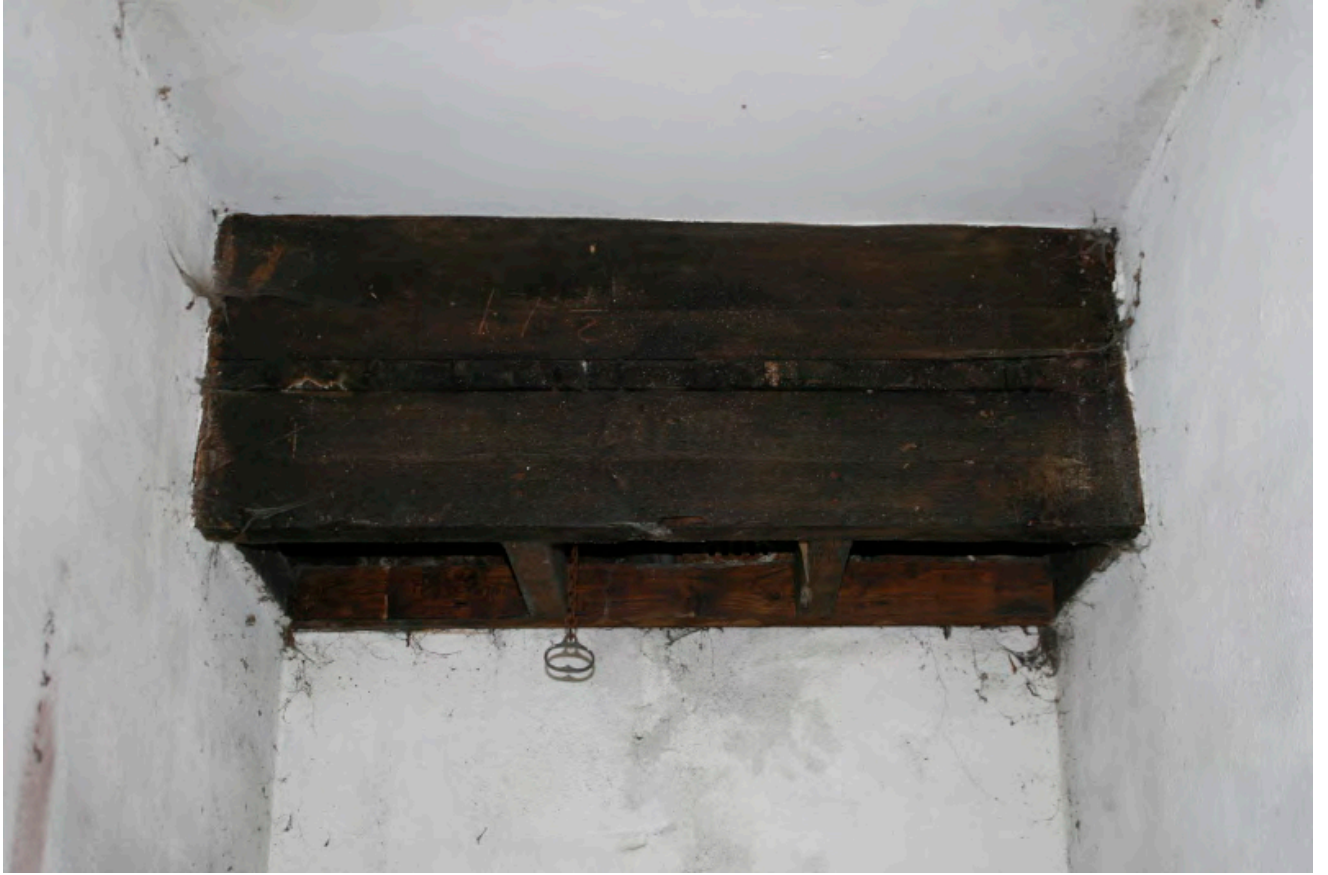
Plate 11: Wooden housing for toilet cistern (TRC14 BHD100 (11))

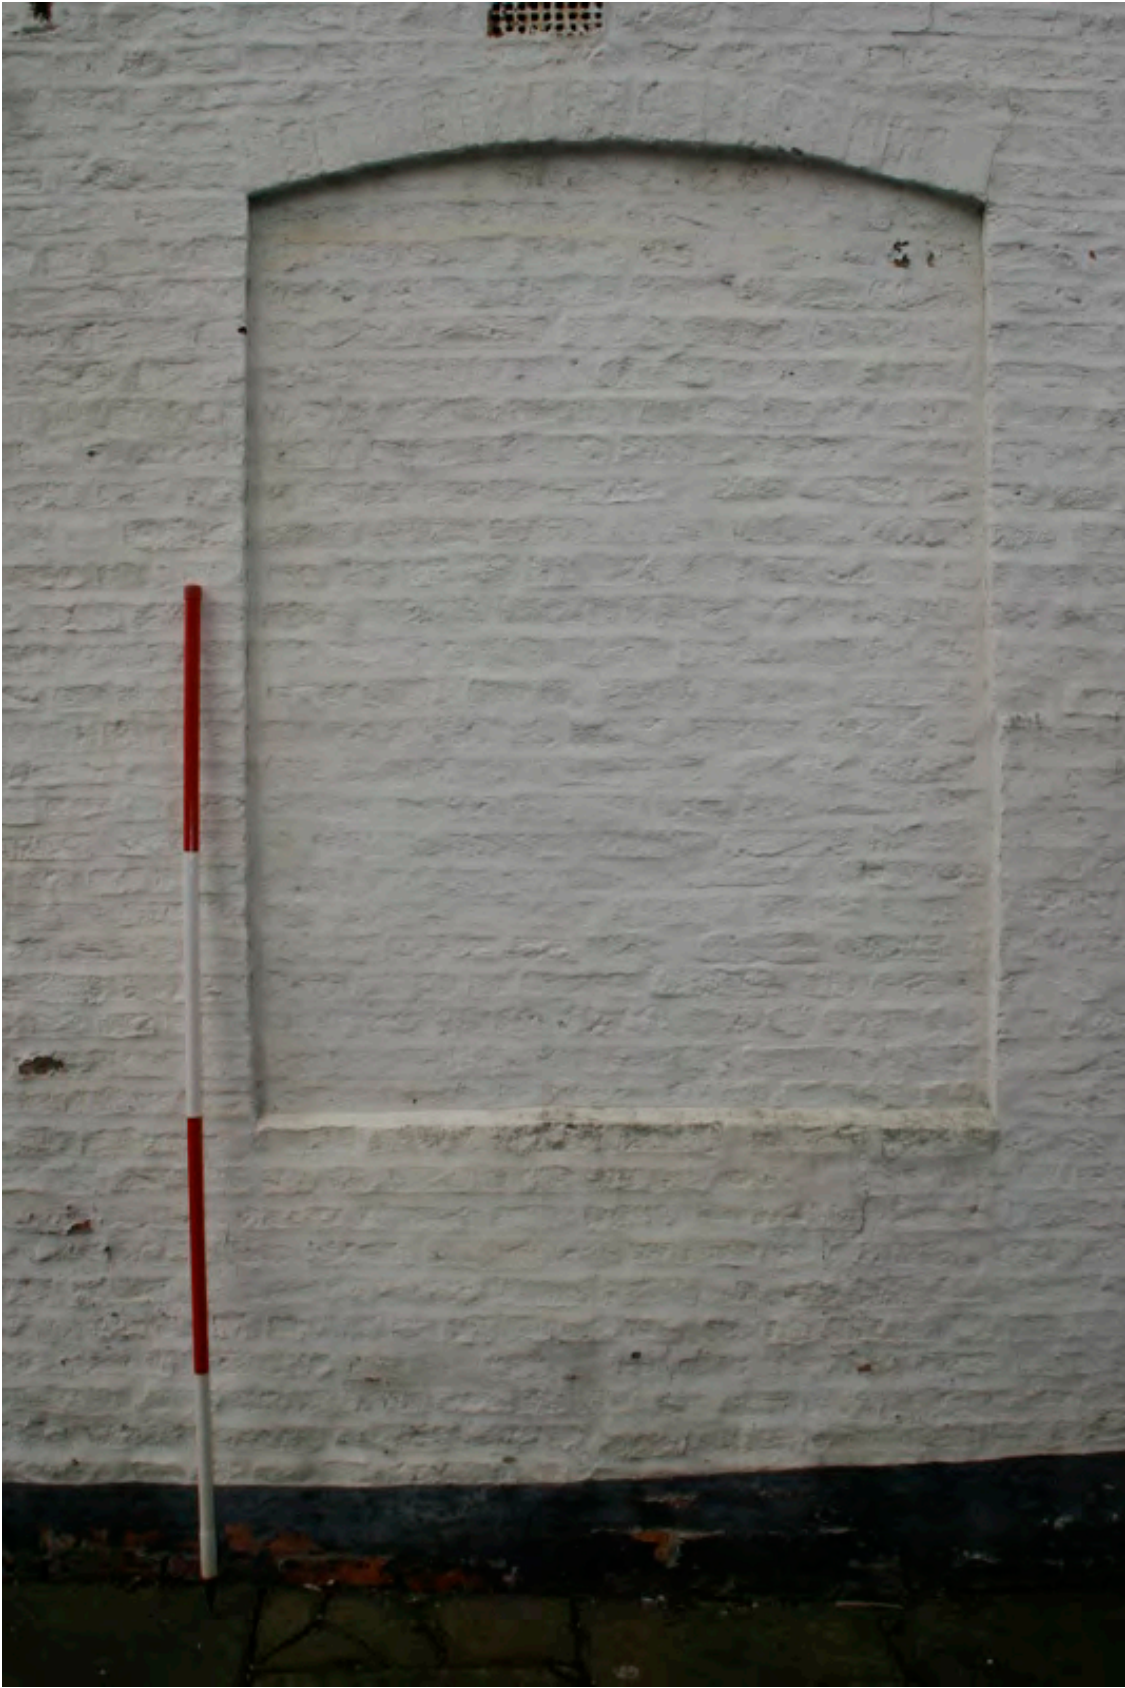
Plate 16: Blocked ground floor window at the north end of the front (east) elevation of the almshouses, looking west (TRC14 BHD100 (20))

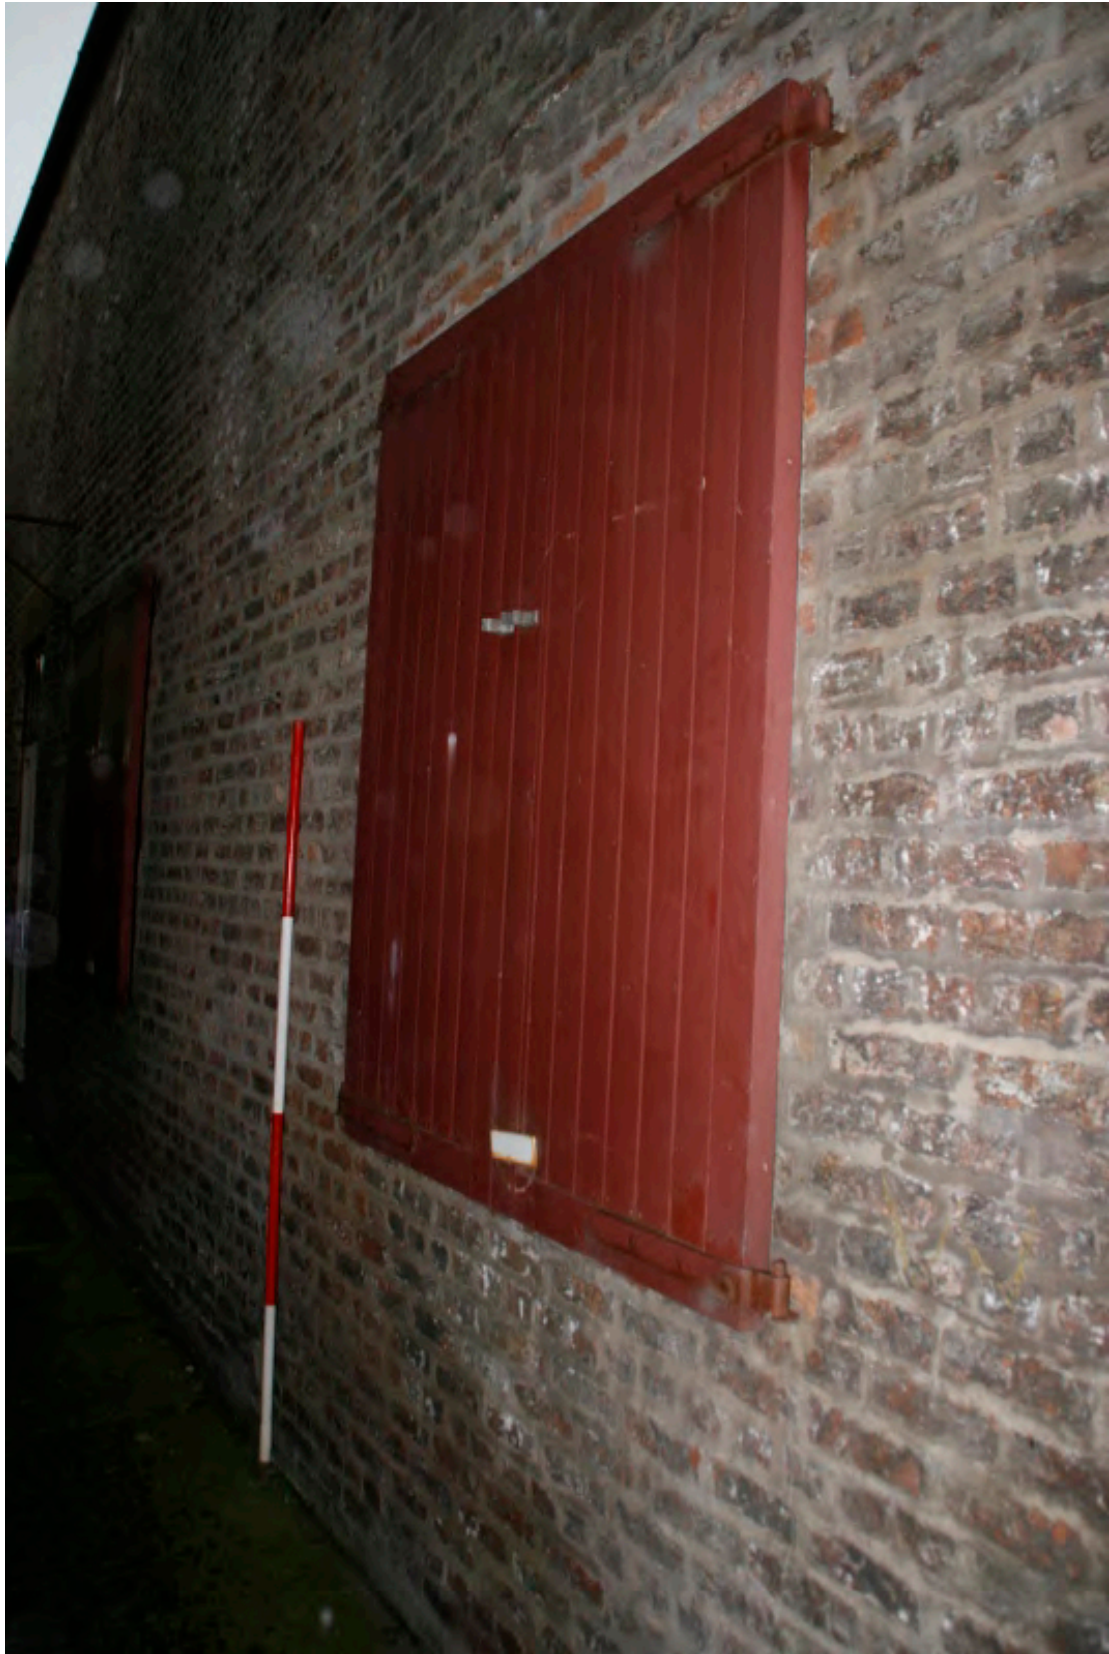
Plate 22: Inserted window with shutters at the south end of the rear (west) elevation of the almshouses, looking north (TRC14 BHD100 (66))
