**HISTORICAL BUILDING
RECORDING OF NOS 9 AND
10 TRINITY CHARE,
AN OUTBUILDING AND
A STONE WALL,
TRINITY HOUSE,
NEWCASTLE UPON TYNE,
TYNE AND WEAR**

PCA REPORT NO. R11870

SEPTEMBER 2014

Commissioning Client: North East Theatre Trust Limited

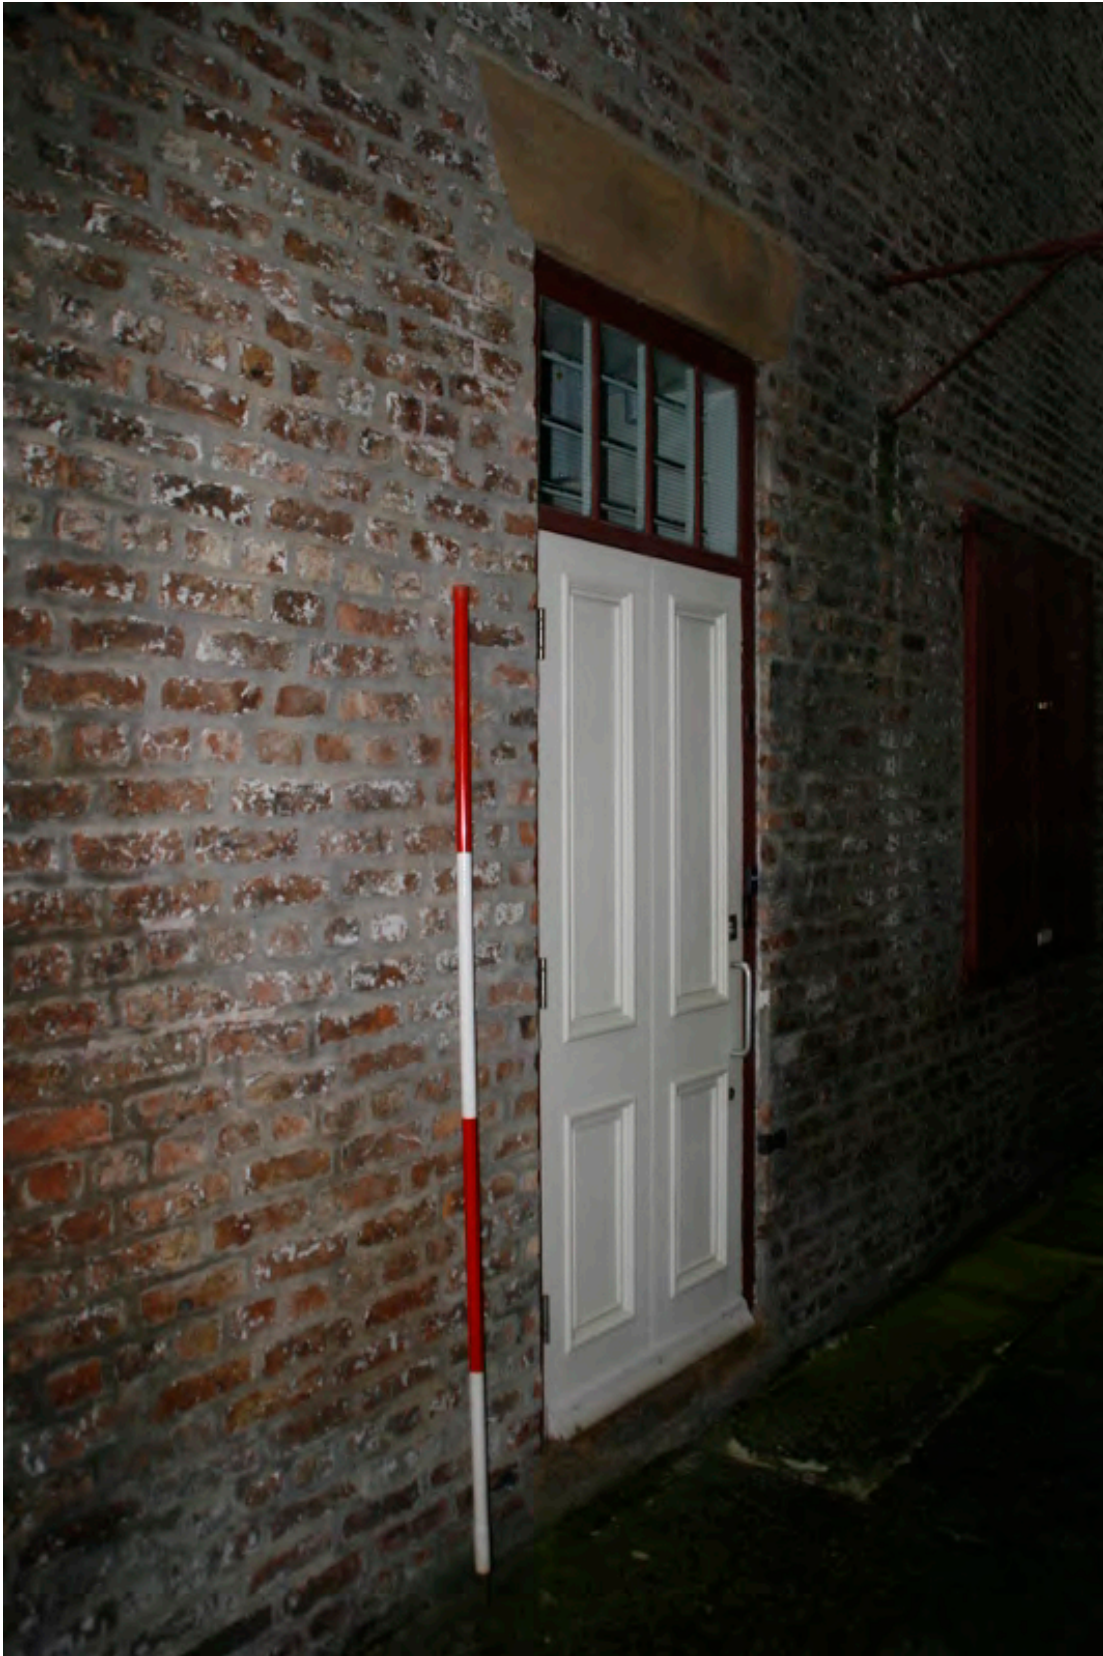
Plate 24: Inserted door with fanlight at the centre of the rear (west) elevation of the almshouses, looking south-east (TRC14 BHD100 (64))

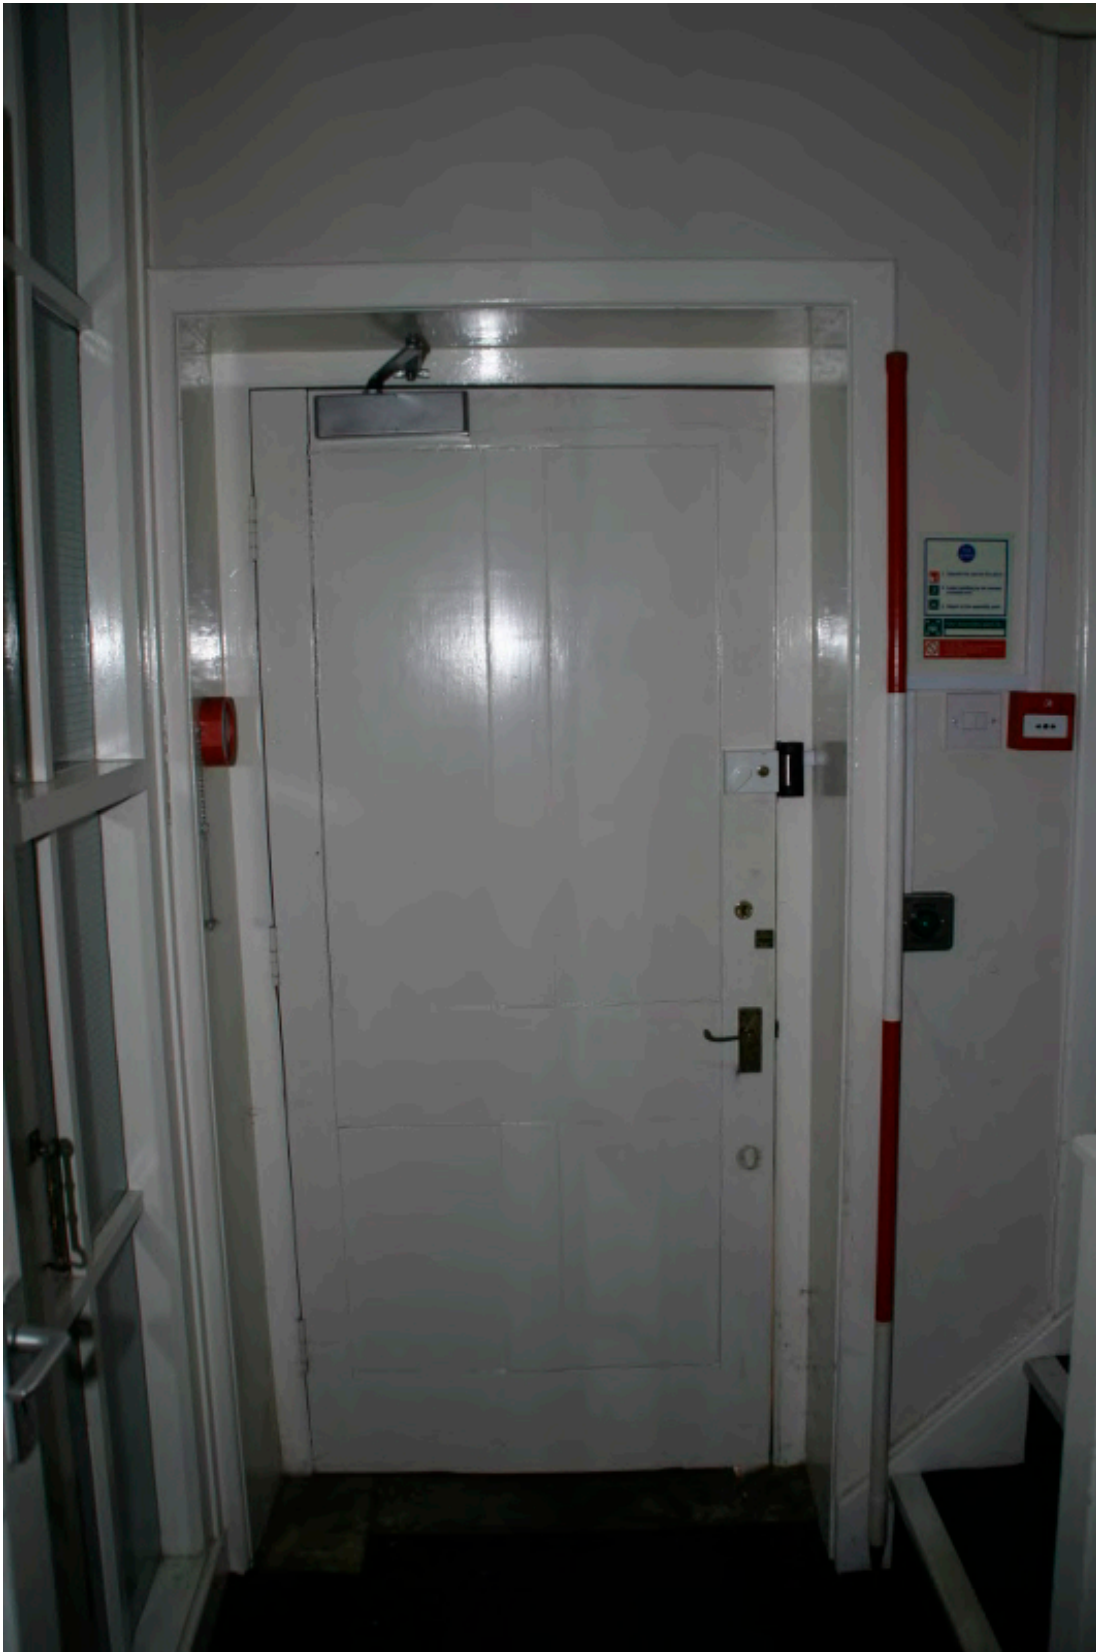
Plate 26: Door into almshouse, looking east (TRC14 BHD100 (48))

- 6.4.7 A small hallway has been created by the addition of glass partition walls (**Figure 11; Plates 28 and 31**). The north doorway in the east elevation leads into this space (**Plate 26**). This was the original doorway into the north ground floor lodging. The original central doorway to the two first floor lodgings has been blocked low down by late 20th century stairs (**Plate 27**). The fireplace in the ground floor north lodging has been replaced in the late 20th century but the original chimney breast still exists (**Plates 29 and 30**). Corbels supporting a downstand between the chimney breast and the east wall are not thought to be original (**Plate 31**). The sash window with a low sill in the north wall is similar to those in the east wall (**Plates 30 and 32**). A safe has been placed in the west side of the chimney breast (**Plate 33**). The safe is late 19th/early 20th century in appearance and was presumably added after 1862 (**Figure 3**).

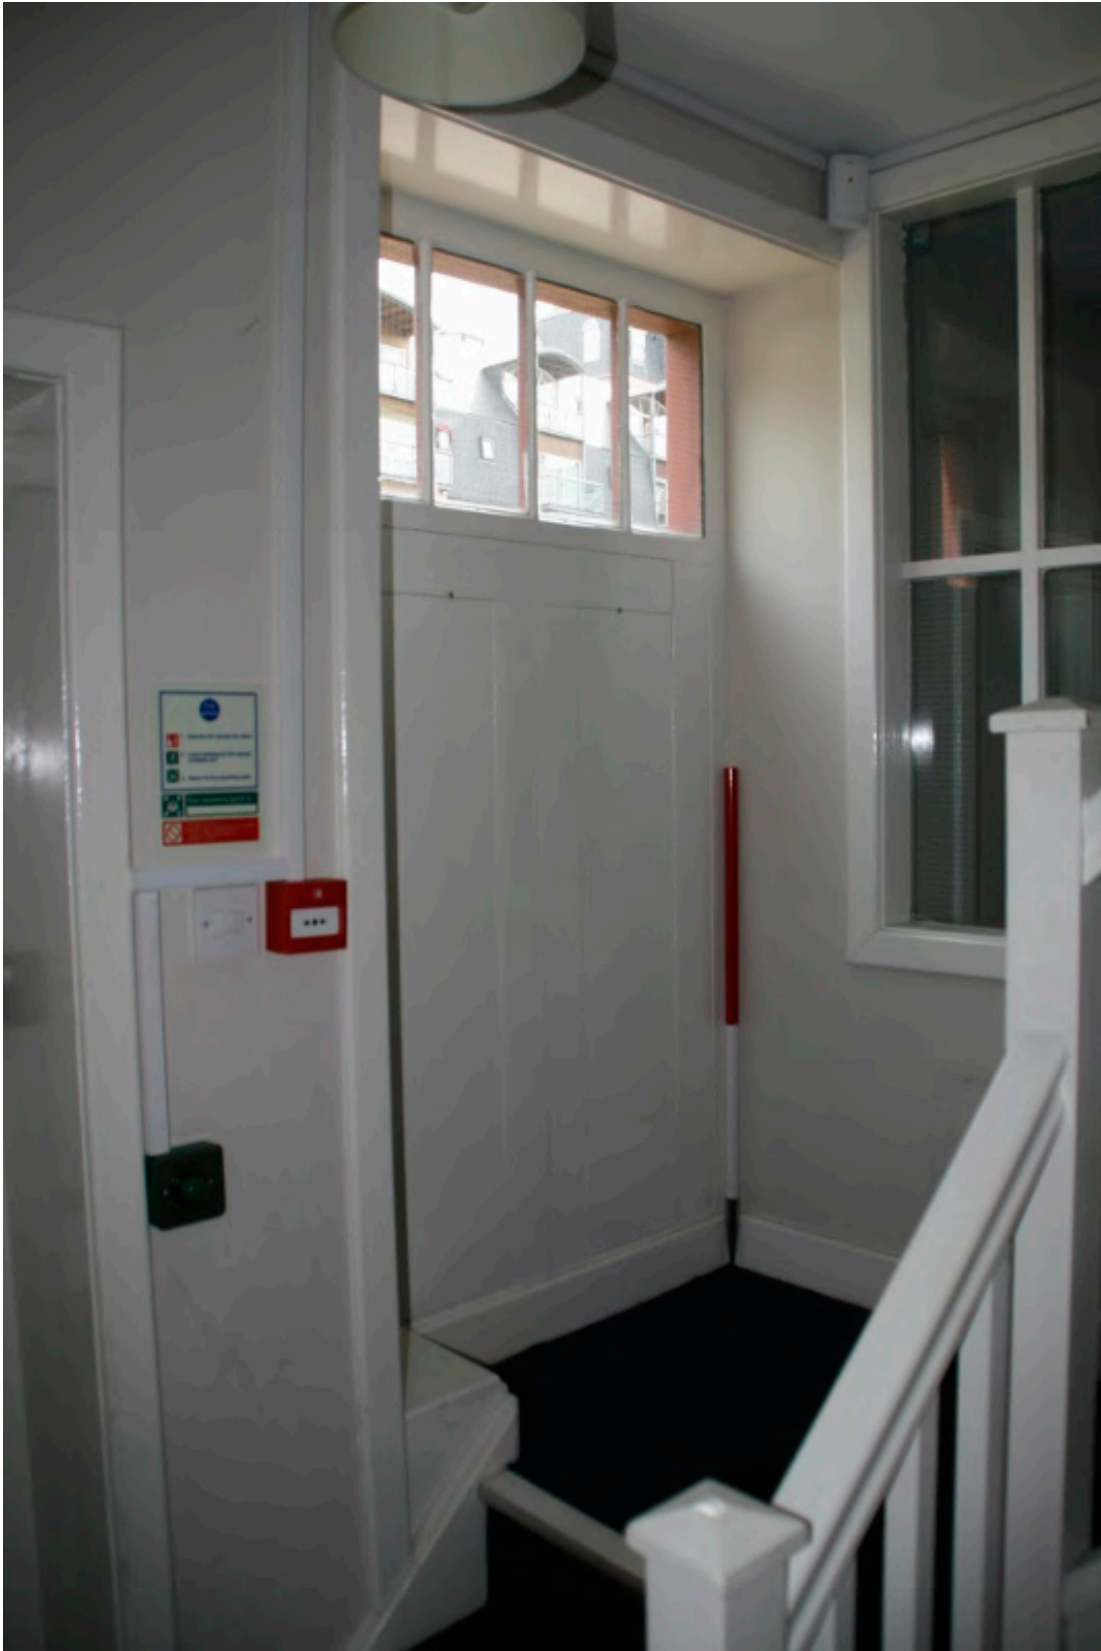
Plate 27: Altered central doorway into almshouses, looking south-east (TRC14 BHD100 (47))

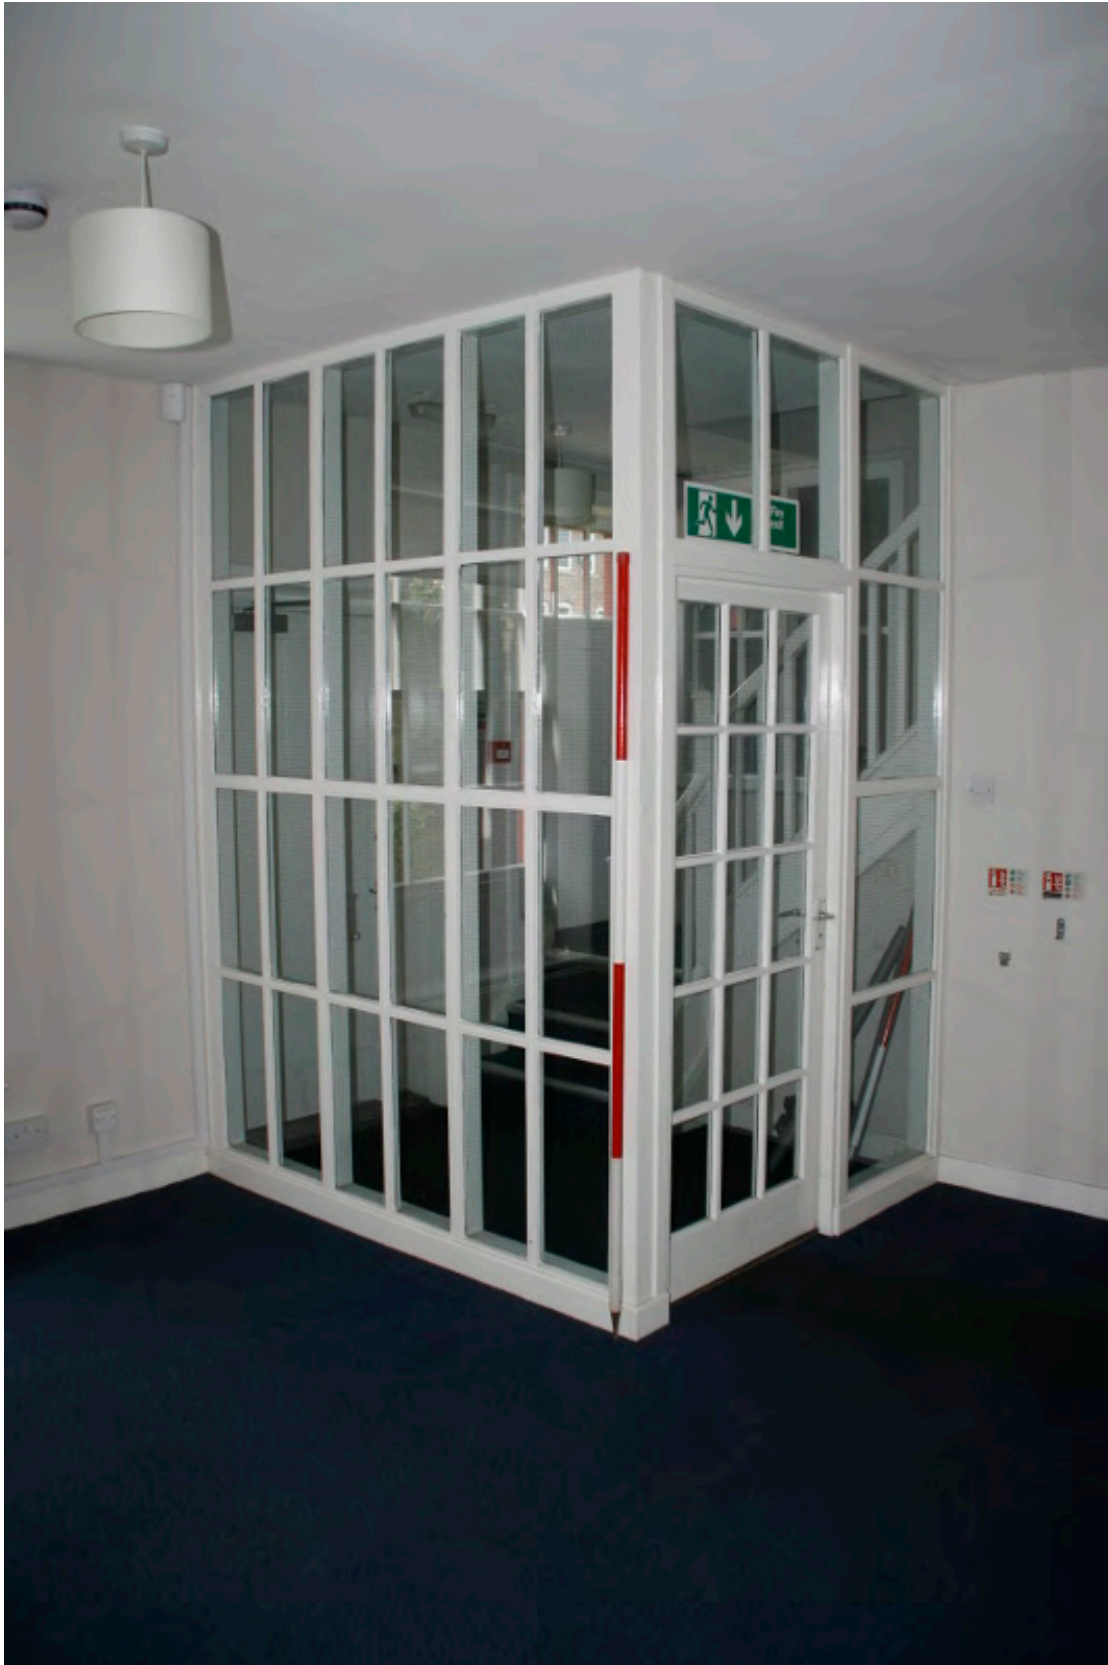
Plate 28: Modern ground floor entrance hall of almshouses and stairs leading to first floor, looking south-east (TRC14 BHD100 (40))

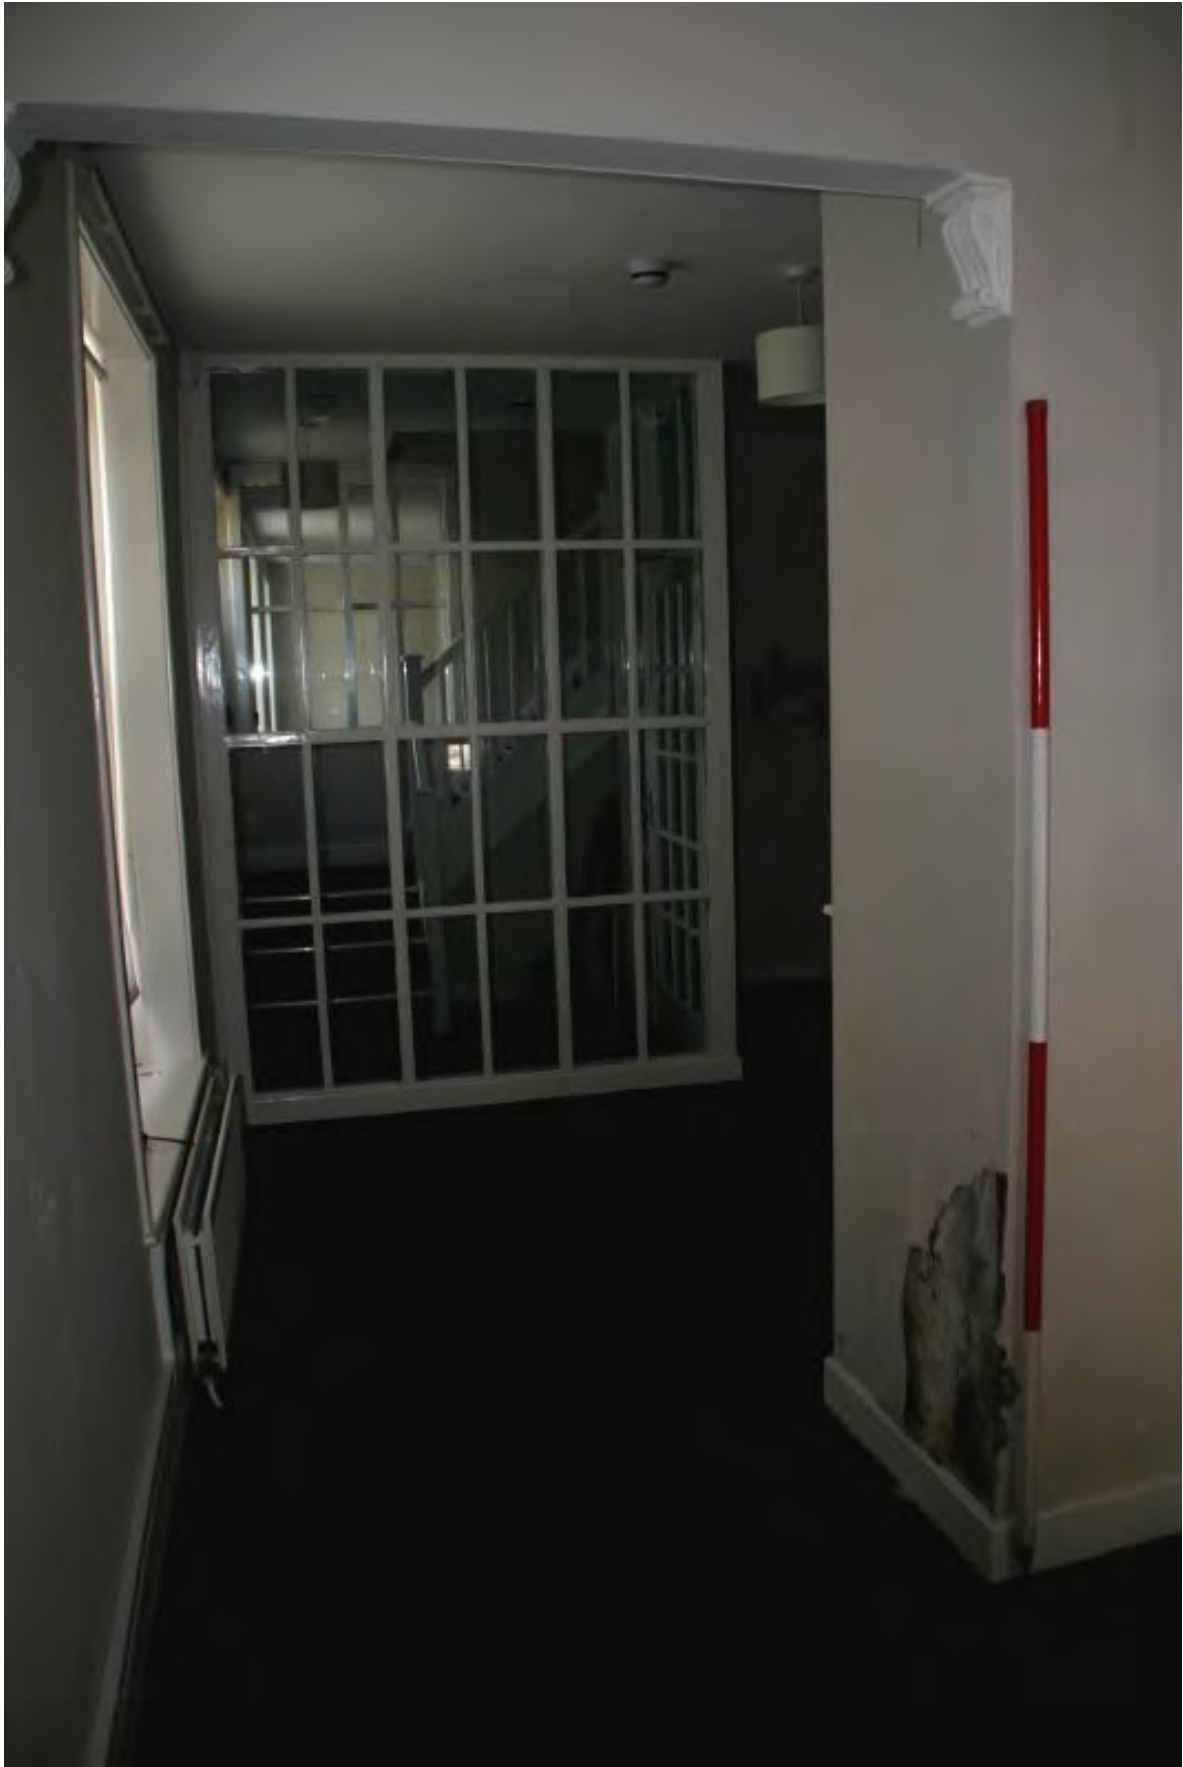
Plate 31: Room AHG2, looking south (TRC14 BHD100 (37))

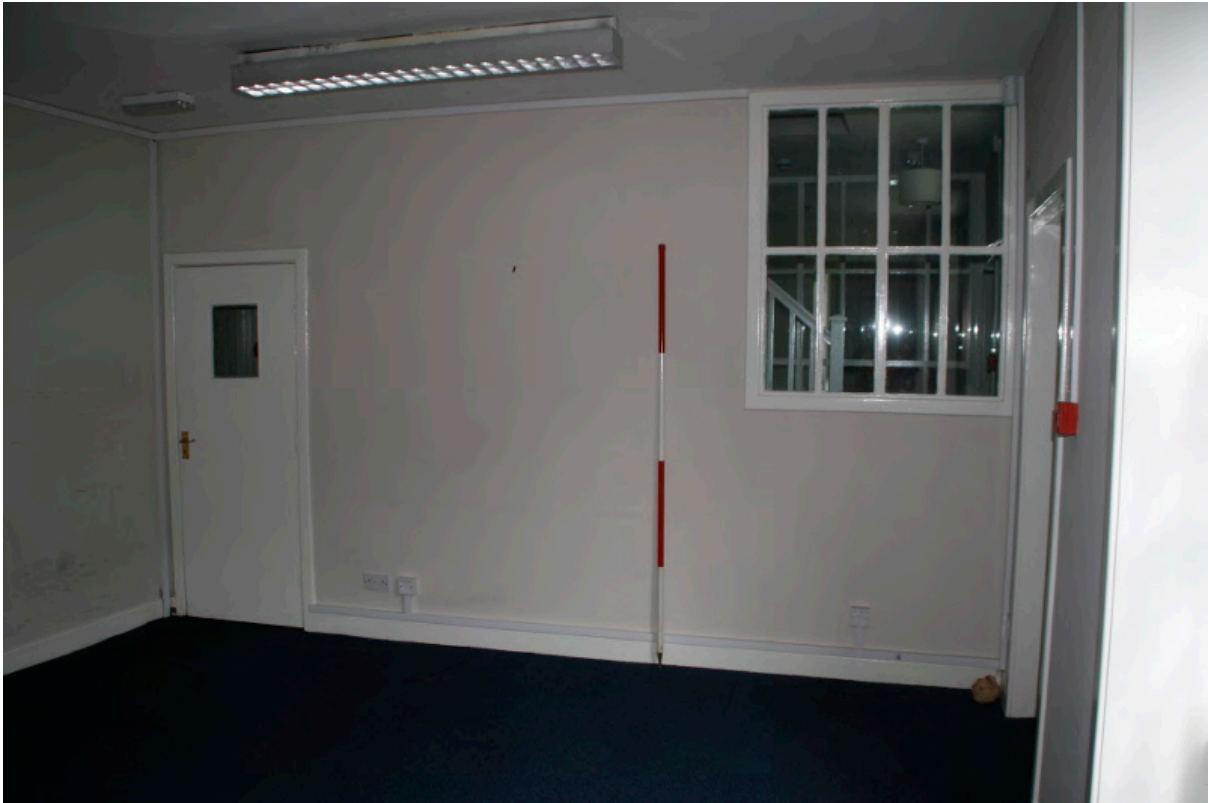
- 6.4.8 Although the north wall of the south ground floor lodging is in the correct location for an original wall, its thinness, its door and internal window suggests it is a late 20th century replacement (**Plate 34**). The original doorway and window openings in the east wall of the south ground floor lodging still survive (**Plates 35 and 36**). The original chimney breast also survives although the fireplace has been blocked (**Plate 37**). The inserted windows in the west wall are different from the windows in the east wall and have higher sills (**Plates 35, 36, 38 and 39**). The listing description suggest that they were added in the late 19th century. A cupboard has been fitted in the south-west corner of the south ground floor lodging (**Plate 40**). The cupboard is 20th century in appearance.

Plate 34: North wall of room AHG3, looking north (TRC14 BHD100 (34))

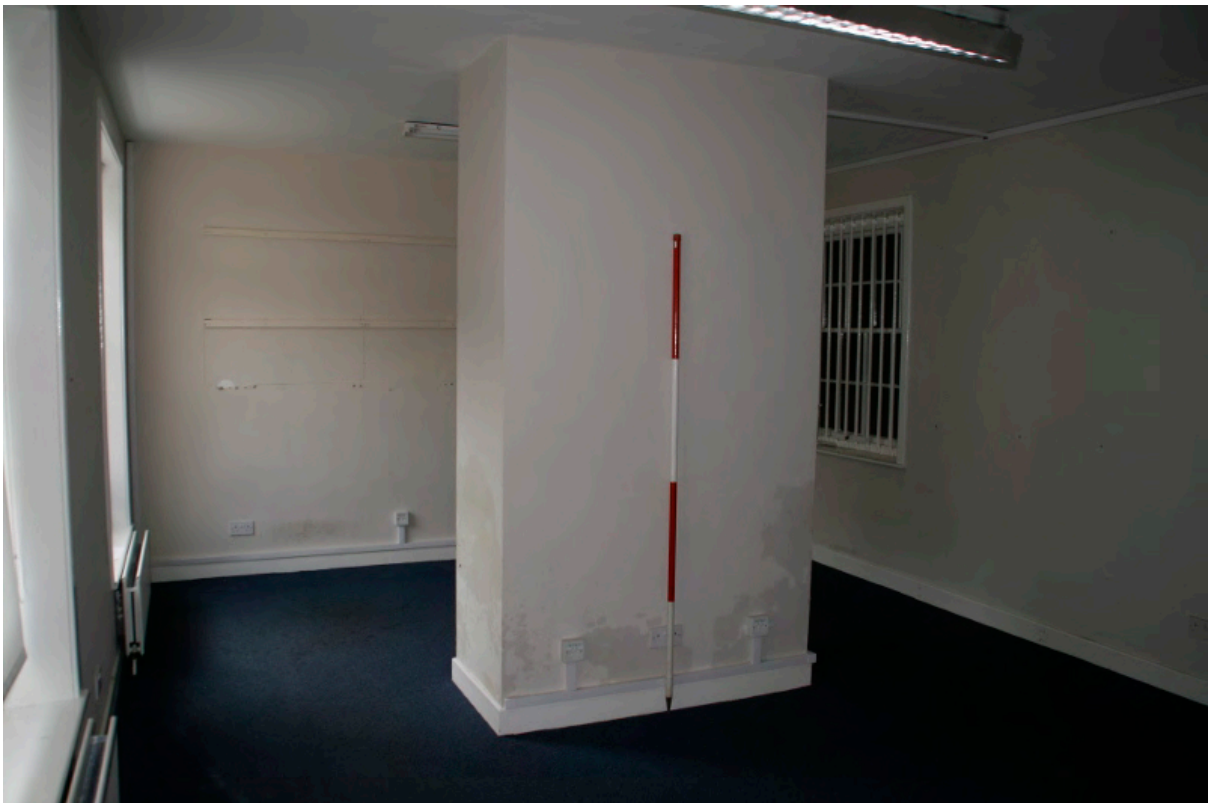
Plate 37: Original chimney breast/stack in room AHG3, looking south (TRC14 BHD100 (27))

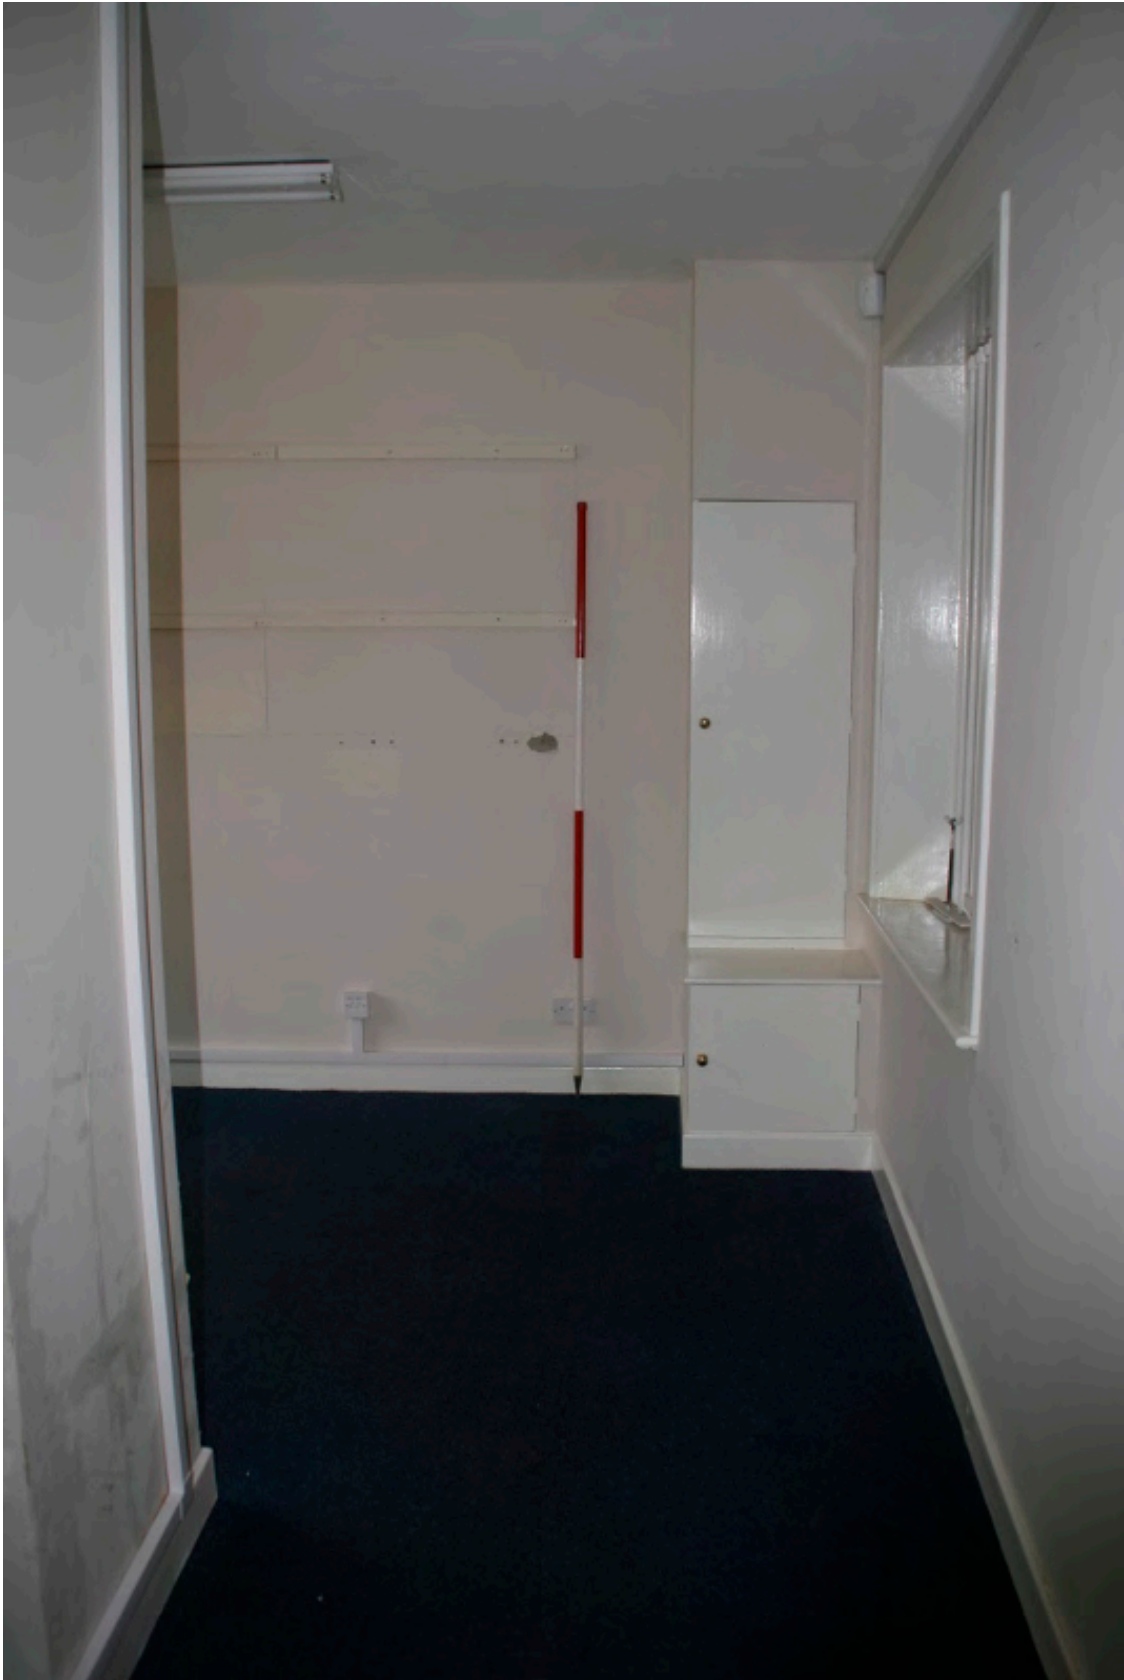
Plate 40: Cupboard in south-west corner of room AHG3, looking south (TRC14 BHD100 (28))
