**GRANBY GARDENS,
LUDGERSHALL,
WILTSHIRE, SP11 9SU**

**ARCHAEOLOGICAL
EVALUATION REPORT**

REPORT NO: R11896

OCTOBER 2014

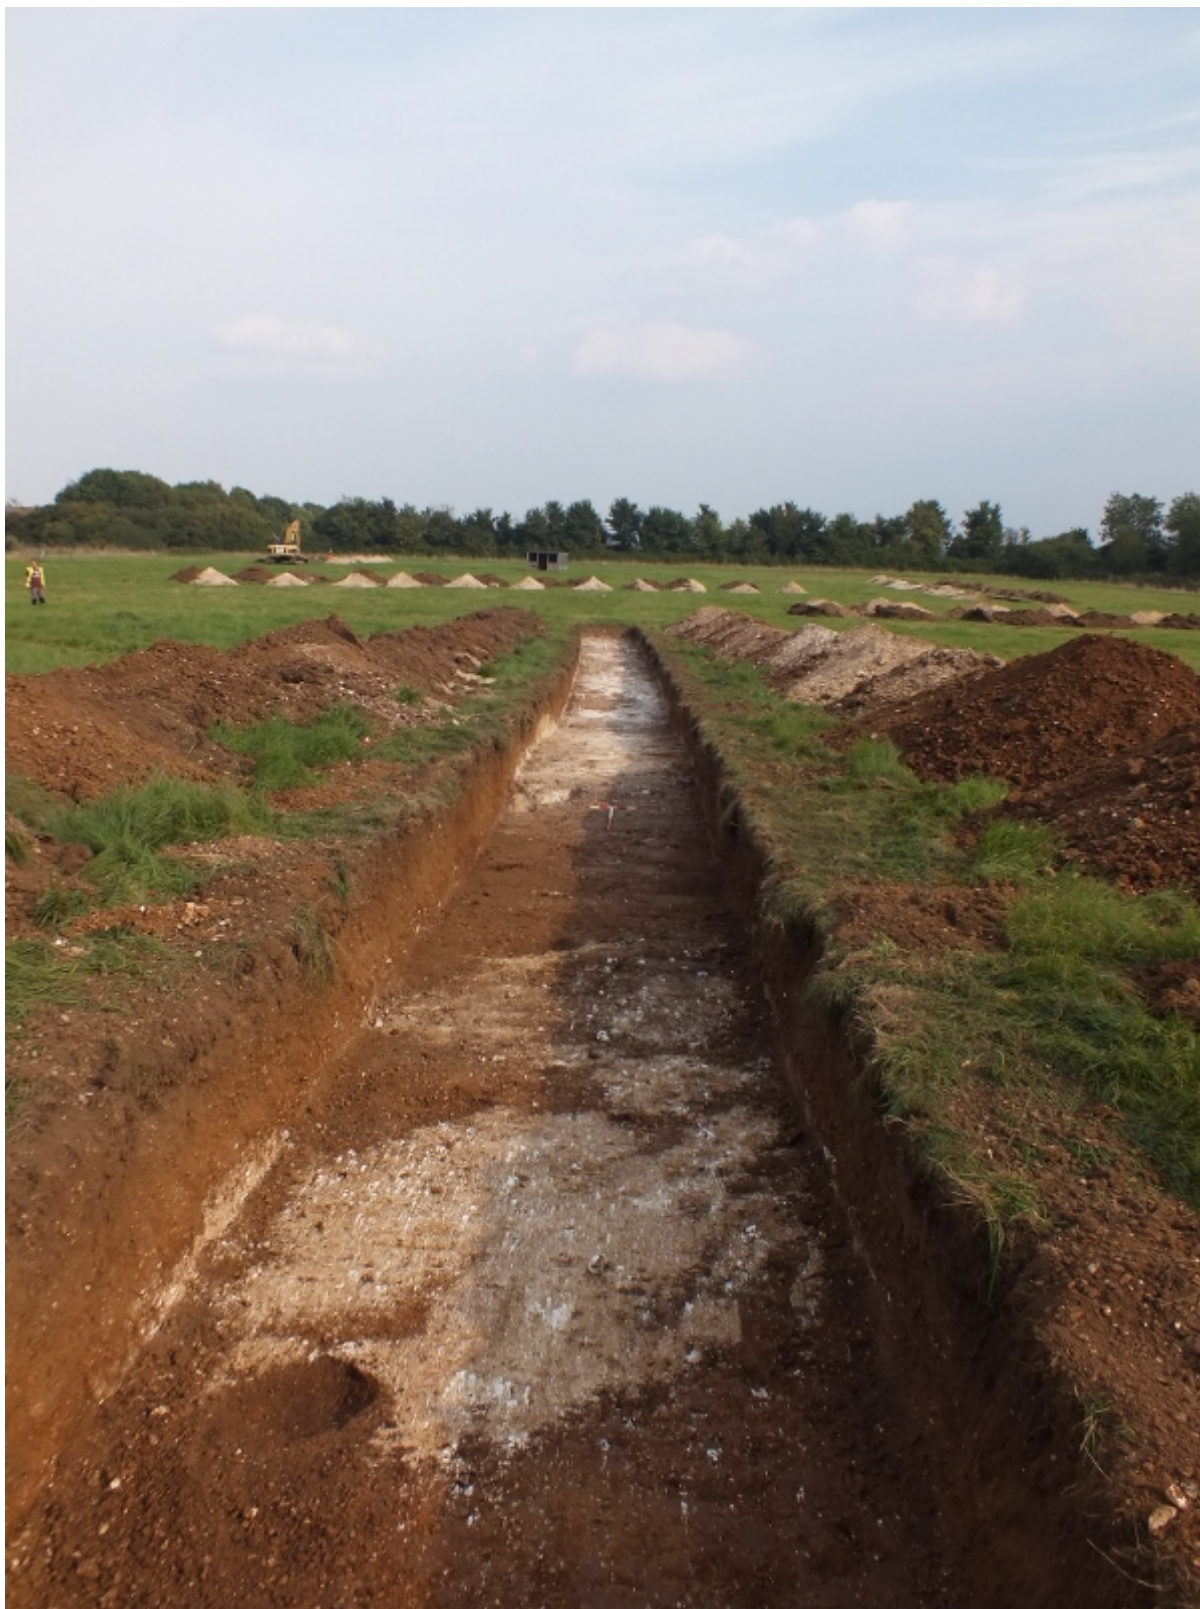
Plate 2: Natural glacial feature at west end of Trench 1, looking east (WGGL14 D1 (6))

- 5.2.1 All eight trenches (**Figure 2, Plates 1-8**) revealed a similar sequence of natural chalk sealed by a layer of subsoil beneath topsoil. The chalk was encountered at between 0.69m and 0.26m below ground level (BGL) and was typically mottled and scarred, containing patches of yellow-brown sandy clay, degraded chalk fragments and flint nodule fragments. The chalk was sealed by a layer of subsoil, typically brown loam with fragments of chalk and flint gravel and variously between 0.04 and 0.48m thick, in turn covered by topsoil up to 0.39m thick; representative sections were recorded in each trench and sections from Trenches 2, 6, 7 & 8 are shown on **Figure 4**. A single worked flint was recovered from the subsoil [11] in Trench 2 and the topsoil in all trenches contained fragments of ceramic building material and modern pottery (not retained).

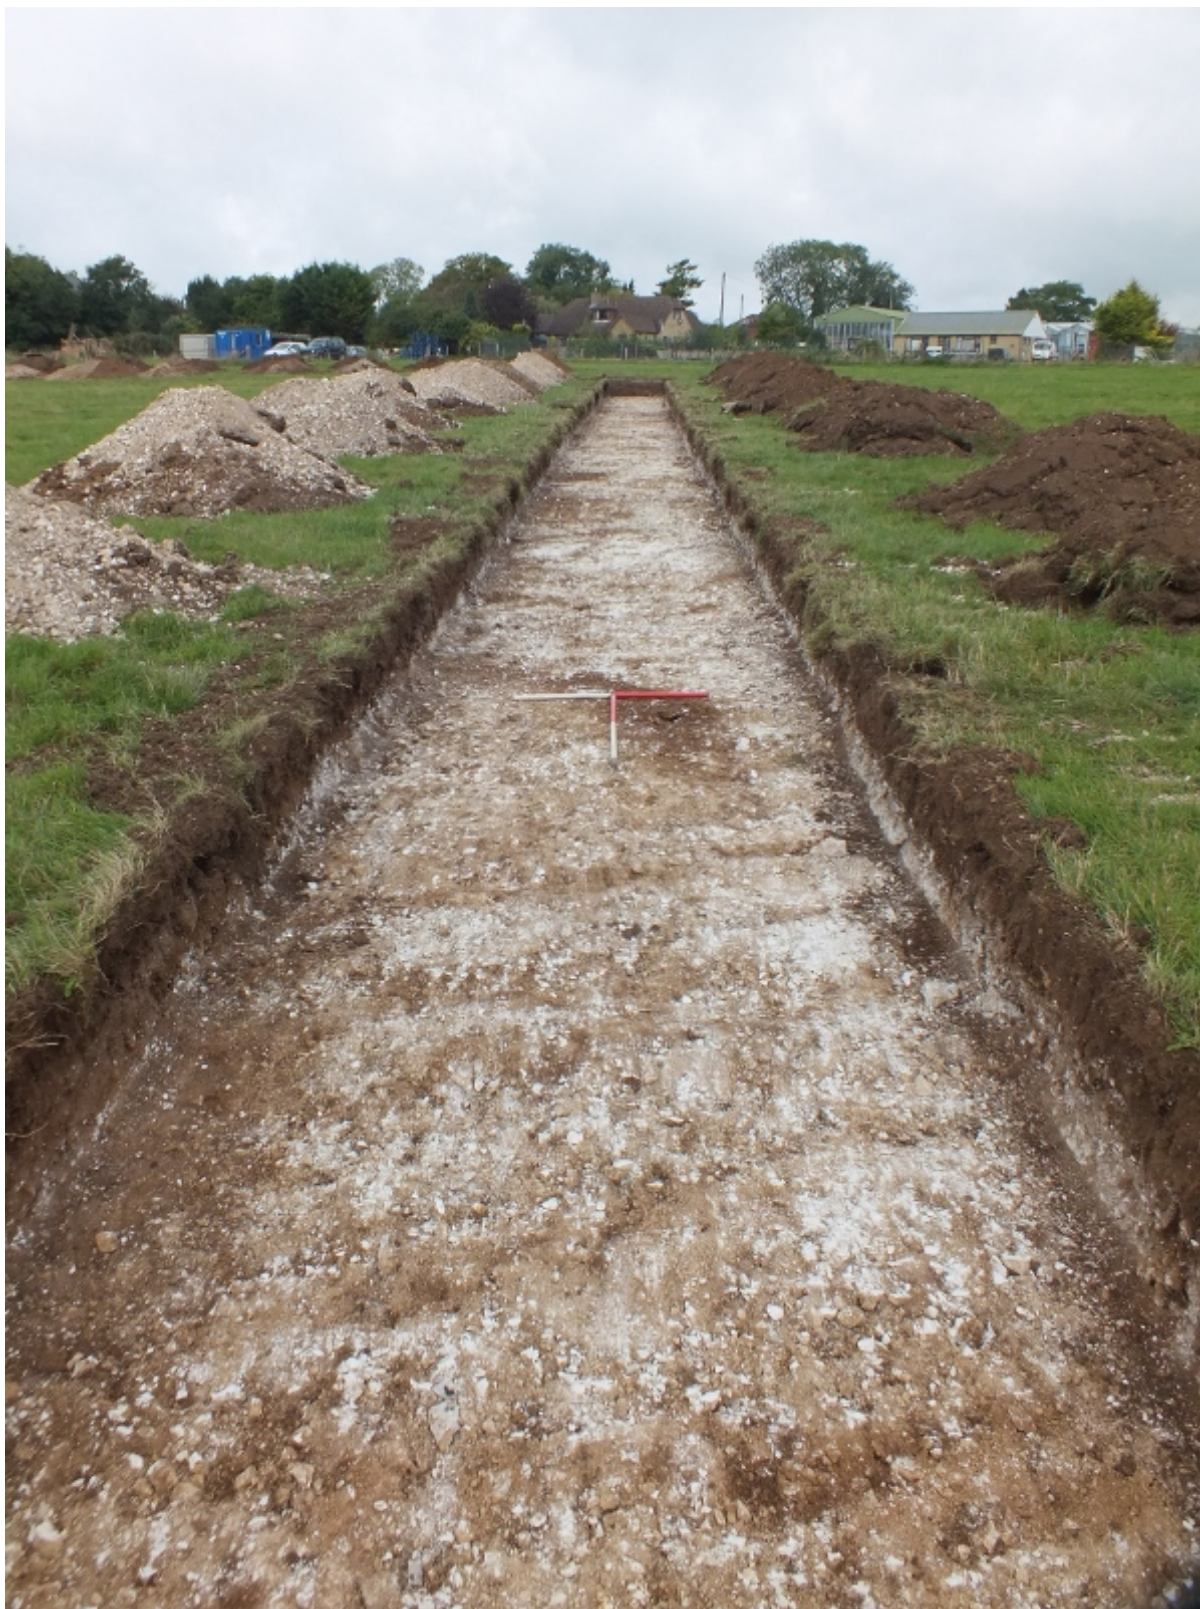
Plate 5: Natural glacial striations visible in Trench 4, looking north-west (WGGL14 D1 (13))

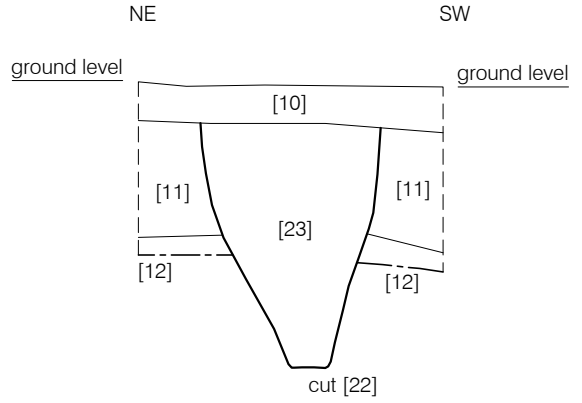
Figure 4
Sections
1:25 at A4

Section 2a
Trench 2
Northwest Facing

Section 2b
Trench 2
Northwest Facing

Section 6
Trench 6
North Facing

Section 7
Trench 7
West Facing

Section 8
Trench 8
South Facing

Trench	Context	Section	Type, Description and Date	Depth [max] BGL [m]
TR1	1	S1	Modern topsoil layer	0m – 0.39m
TR1	2	S1	Subsoil layer	0.39 – 0.69m
TR1	3	S1	Natural Chalk bedrock	0.69m - beyond LOE of trench base
TR2	10	S2a & S2b	Modern topsoil layer	0m – 0.24m
TR2	11	S2a & S2b	Subsoil layer	0.24m – 0.49m
TR2	12	S2a & S2b	Natural Chalk bedrock	0.49m - beyond LOE of trench base
TR2	22	S2a & S2b	E-W linear cut containing [23]	0.46m -
TR2	23	S2a & S2b	Fill of cut [22] containing	0.46m -
TR3	4	S3	Modern topsoil layer	0m – 0.31m
TR3	5	S3	Subsoil layer	0.31m – 0.48m
TR3	6	S3	Natural Chalk bedrock	0.48m - beyond LOE of trench base
TR4	7	S4	Modern topsoil layer	0m – 0.35m
TR4	8	S4	Subsoil layer	0.35m – 0.47m
TR4	9	S4	Natural Chalk bedrock	0.47m -
TR5	13	S5	Modern topsoil layer	0m – 0.09m
TR5	14	S5	Subsoil layer	0.09m – 0.35m
TR5	15	S5	Natural Chalk bedrock	0.35m - beyond LOE of trench base
TR6	24	S6	Modern topsoil layer	0m – 0.14

TR6	25	S6	Subsoil layer	0.14m – 0.40m
TR6	26	S6	Natural Chalk bedrock	0.40m - beyond LOE of trench base
TR7	16	S7	Modern topsoil layer	0m – 0.21m
TR7	17	S7	Subsoil layer	0.21m – 0.69m
TR7	18	S7	Natural Chalk bedrock	0.69m - beyond LOE of trench base
TR8	19	S8	Modern topsoil layer	0m – 0.22m
TR8	20	S8	Subsoil layer	0.22m -0.26m
TR8	21	S8	Natural Chalk bedrock	0.26m - beyond LOE of trench base
