STRAWBERRY HILL HOUSE, LONDON BOROUGH OF RICHMOND UPON THAMES

REVIEW OF PREVIOUS GROUNDWORK
AND ARCHAEOLOGICAL WATCHING
BRIEF ON CONSTRUCTION WORKS
ASSOCIATED WITH A NEW ANCILLARY
BUILDING

PCA REPORT NO:R11873 SEPTEMBER 2014

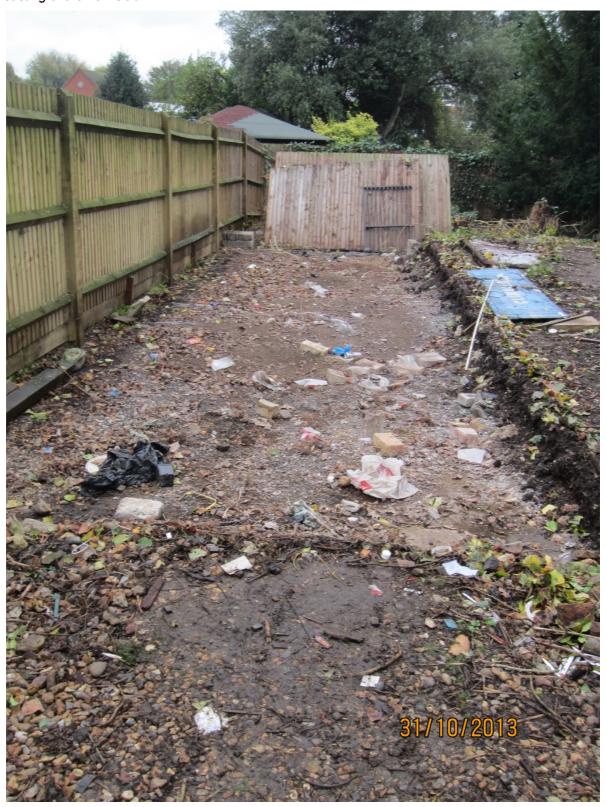
Plate 1: Pre-ex shot of proposed footprint of ancillary building following removal of temporary container. The levelling visible for the previous temporary container caused greater impact than the casting of the new slab.

8.1.1 Prior to the archaeological evaluation being undertaken, the slab for the new ancillary building had been cast – the construction work associated with this process was not archaeologically monitored. Due to the location of the building within the root protection zone of a native Black Poplar tree the slab was necessarily designed with no below ground disturbance other than the nine <200mm diameter screw piles. An initial site visit following the casting of the slab by PCA confirmed that, in accordance with the requirements of the approved Tree Preservation Plan and Method Statement, the impact to the area was restricted to the pile locations only.

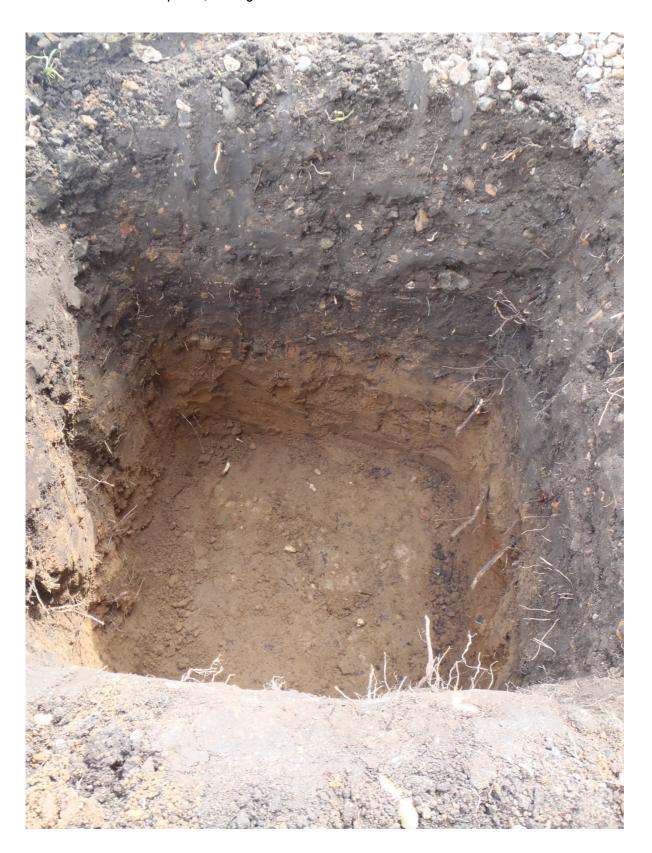
Plate 2: Gatepost 2, looking south

- 7.5.2 To the south of Gatepost 1, Gatepost 2 was 0.60m² in plan and extended to a depth of -0.75m BGL. Natural clay [7] was seen at a height of -0.45m BGL. No cut features were seen cut into the surface of this layer. It was directly overlain by modern topsoil. The sequence suggests modern landscaping has removed all overlying strata down to natural heights the area has been raised with modern topsoil deposits.

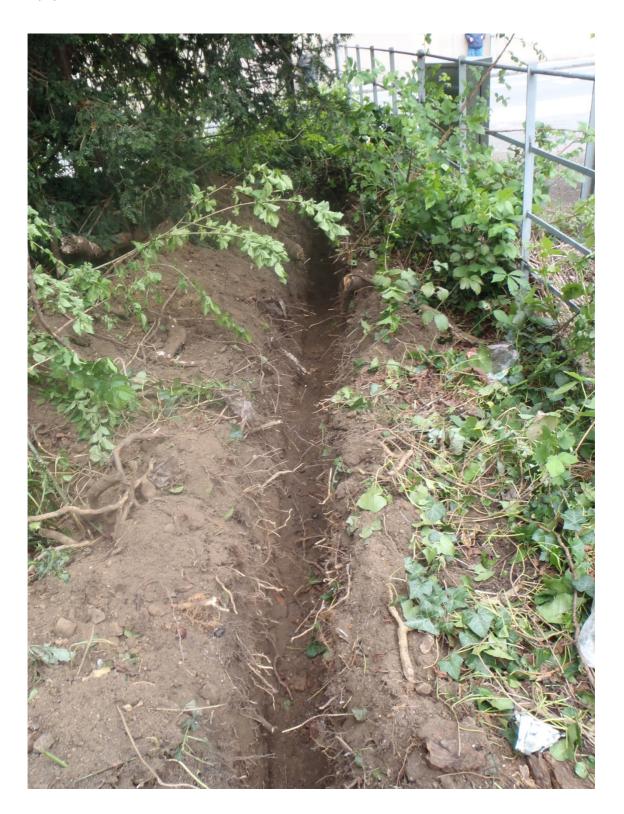
Plate 3: Telecommunications trench, looking northeast across area of former 18<sup>th</sup> century garden maze

- 7.4.1 A service trench for a telecommunications cable measuring approximately 0.50m wide that extended from the eastern side of the new ancillary building was excavated by mini-digger and by hand under archaeological supervision on 29th April 2014. The trench was roughly 44m long and extended over an area suggested by historical cartographic records to have once been very close to the location of an 19th century garden maze. Sections recorded along the length of the trench typically observed 0.12m of topsoil to overlie a mixed horizon of garden soil, reburied topsoil, redeposited natural clay and root disturbance ([6]). Towards the southern end of the trench at 0.55m BGL, natural clay layer [7] was directly overlain by modern topsoil/garden soil, suggestive of modern landscaping of the area.

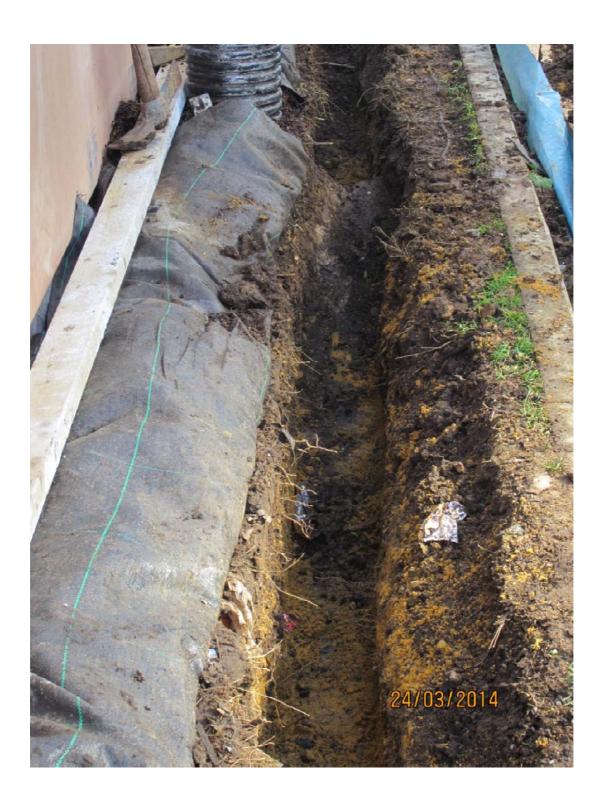
Plate 4: Electricity Service Trench, looking west

7.2.1 An electricity service trench was excavated on the 24th March 2014. The trench was positioned towards the northwest of the new ancillary building. It extended to a depth of -0.30m Below Ground Level (BGL) and revealed a stratigraphic sequence of 0.1m of modern sharp sand to be overlain by 0.20m of modern top soil.
