**AN ARCHAEOLOGICAL WATCHING BRIEF:
MARKET SQUARE, SOUTH SHIELDS,
TYNE AND WEAR**

WATCHING BRIEF REPORT

Pre-Construct Archaeology Limited Quality Control	
<i>Project Number</i>	K3684
<i>Site Code</i>	SSM14
<i>Report Number</i>	RN11047

National Grid Reference: NZ 436060 567100

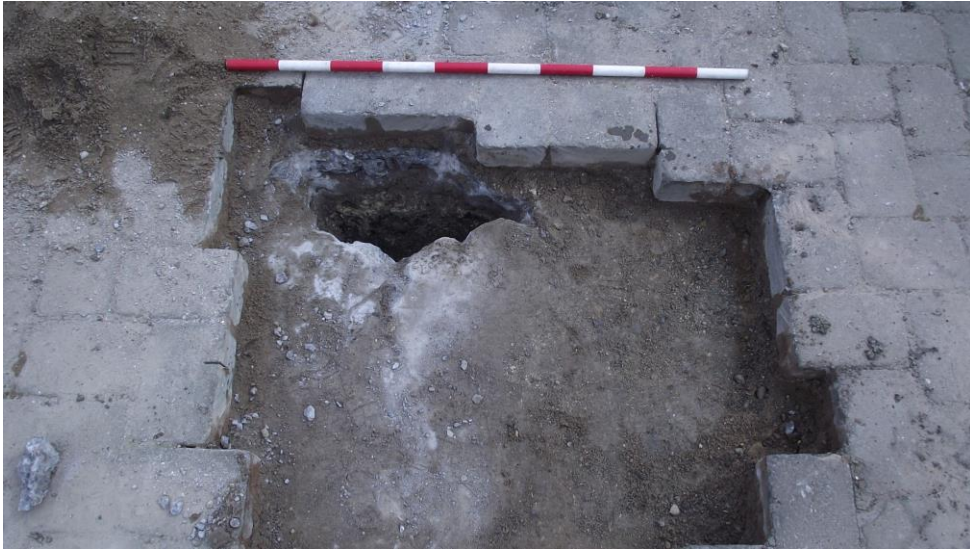
- 5.4.2 Levelling deposit [5] was overlain by a 70mm thick deposit of crushed dolomite, [11], which was the bedding layer for a very hard 0.14m thick concrete deposit, [10] (Plate 7). This was encountered at a height of 10.07m OD at a depth of 0.11m below the existing ground level.
- 5.4.3 As in all other test pits the uppermost deposits comprised the bedding deposit, [2], for the brick paving, [1], which in this area lay at 10.18m OD.

Plate 6: Test Pit 4 sondage cut through concrete surface [10], facing south (scale 1m)

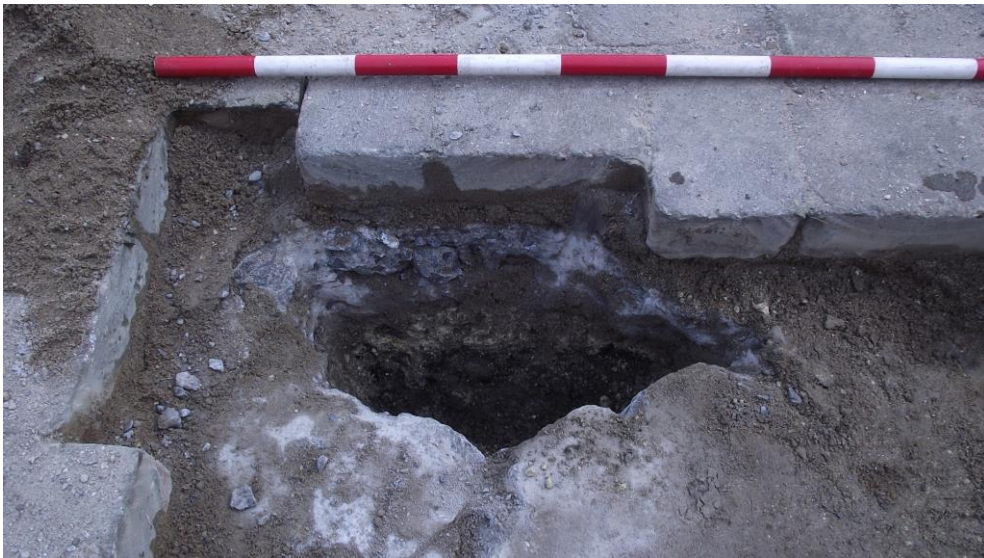
- 5.4.1 The lowermost exposed deposit within Test Pit [4] comprised levelling deposit [5]. This deposit was only exposed within a small area in the south-eastern corner of the test pit due to the presence of an indurated concrete surface which proved difficult to excavate (Plate 6). In this test pit, deposit [5] was exposed for a maximum thickness of 0.10m and encountered at height of 9.87m OD.

Plate 7: Test Pit 4 north facing section (scale 1m)
